In accordance with the Board's rules, the Air Line Pilots Association (ALPA) submits the attached comments concerning the accident involving Trans World Airlines Flight 800, which occurred on July 17, 1996, off Long Island, New York.

**SUBMISSION OF THE
AIR LINE PILOTS ASSOCIATION
TO THE
NATIONAL TRANSPORTATION SAFETY BOARD
REGARDING THE ACCIDENT INVOLVING
TRANS WORLD AIRLINES FLIGHT 800
OFF LONG ISLAND, NEW YORK
ON JULY 17, 1996**

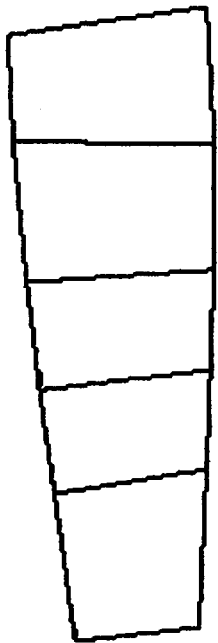
CWT Side View
(looking through tank from right to left)

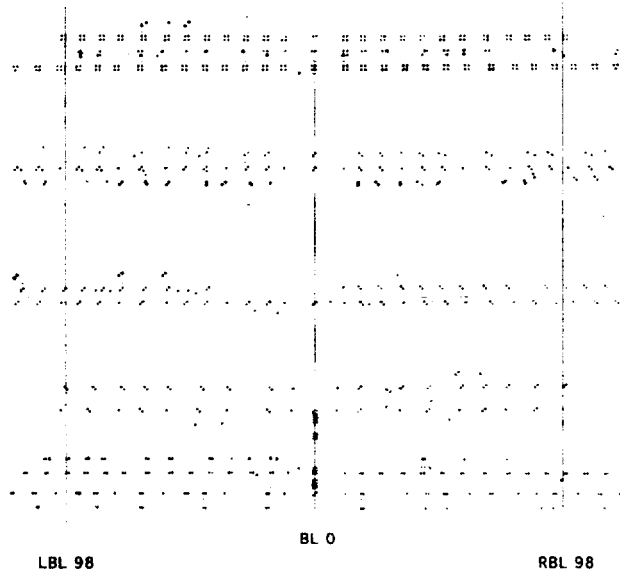
Figure 1

Shear Tie Failure Map

(looking down through tank from top to bottom)

1. Arrows indicate direction of shear tie movement relative to skin
2. Magenta color indicates direction derived from structure remaining on skin
3. Blue color indicates evidence derived from structure remaining on stiffener

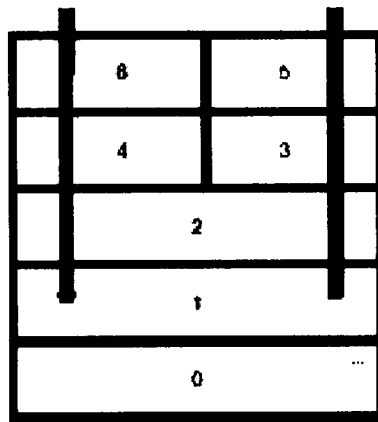
**Map of Tank Bay Designations
from Quarter Scale Test Report**

**(bay designations used in this document
are the same)**

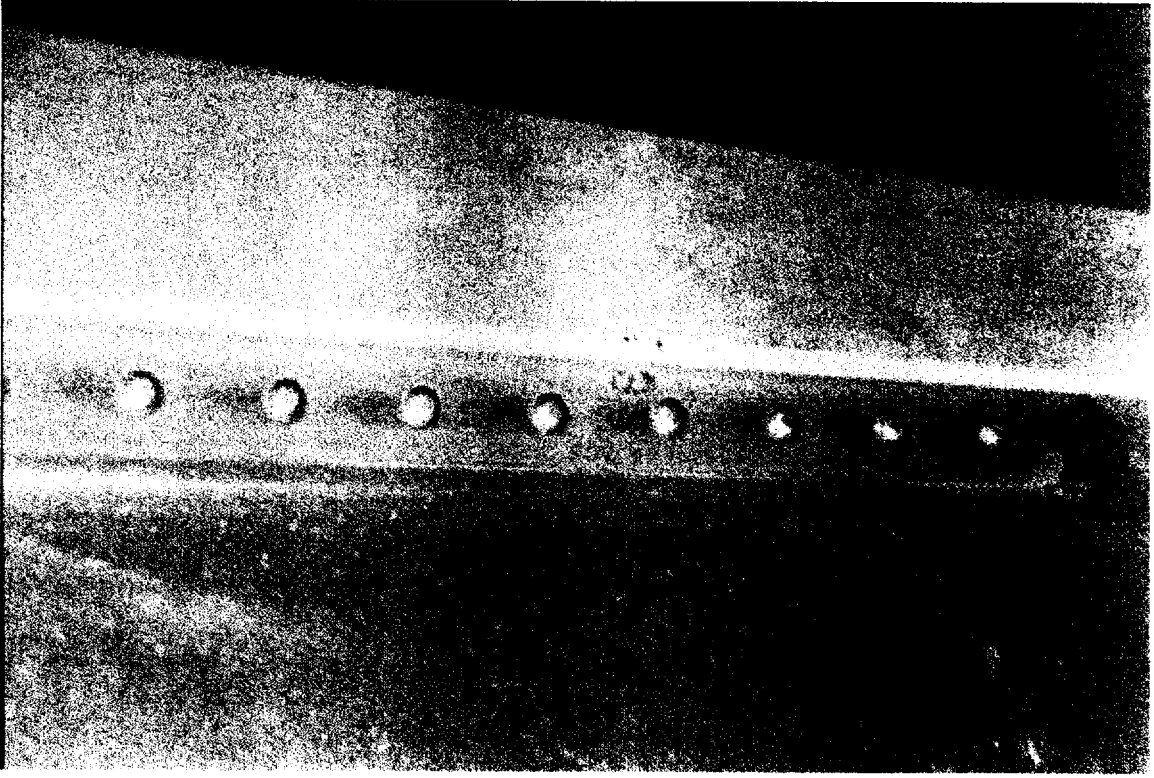
Figure 24

1. Remaining fastener heads exhibit soot accretions with flow generally upward
2. Empty holes do not exhibit soot accretion around fastener head shadow
3. Most empty holes do not exhibit any soot accretion
