Accident Investigation Party Submission
NTSB Accident File: CEN11FA599

Operator: Air Methods Corporation
(dba LifeNet in the Heartland)

Model: Eurocopter AS350 B2
Aircraft Number: N352LN

Date of Accident: August 26, 2011

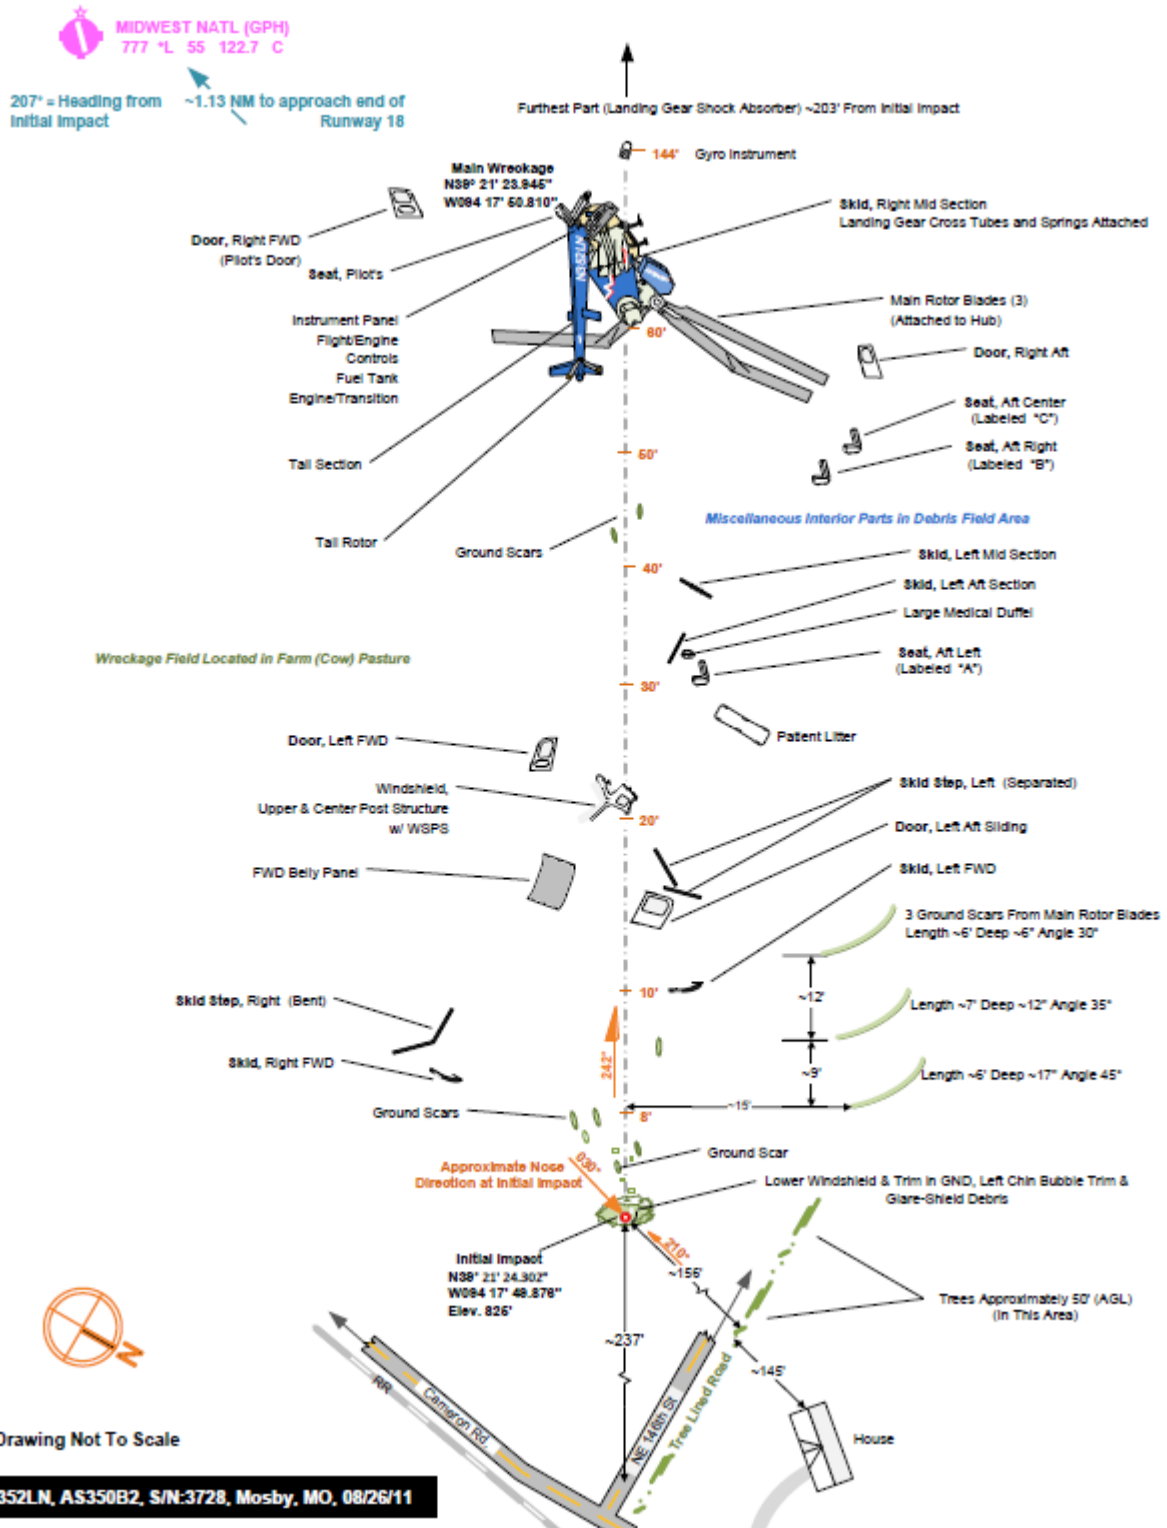
travel). An approximate 2 foot section of the lower right windscreen was found embedded 10 inches deep at the initial impact point at an 80° angle, which, again, corresponds to an approximate nose down aircraft attitude of 40°. The fuselage was broken open separating the patient litter and three rear seats from the aircraft. The pilot's 'Sicma' energy attenuating seat remained attached to the floor mounts and exhibited a near full attenuation and slight displacement to the left.

Three separate main rotor blade strike ground scars were found at the beginning of the wreckage path, to the right of center. The main rotor blades remained attached to the rotor head and mast. Due to the post impact vaulting of the wreckage along the energy path, one blade came to rest bent down and inward more than 90° in a flapping fashion at the root, and the other two blades were relatively straight. Similarly, the two tail rotor blades exhibited little impact damage and were relatively straight, although one blade was partially separated at the blade root.

The on-site examination of the engine revealed that the axial compressor blades exhibited blade rub opposite the direction of travel. Metal shavings were found in the engine bleed air valve. The Module 5 input pinion nut slippage mark was found intact and not misaligned, which was consistent with an engine rotating but not making power at impact.
