September 29, 2011

WRP10FA371 N509AM
Mr. Van McKenny
Investigator-in-Charge
National Transportation Safety Board
Gardena, CA 90248

PROPOSED FINDINGS OF FACT:

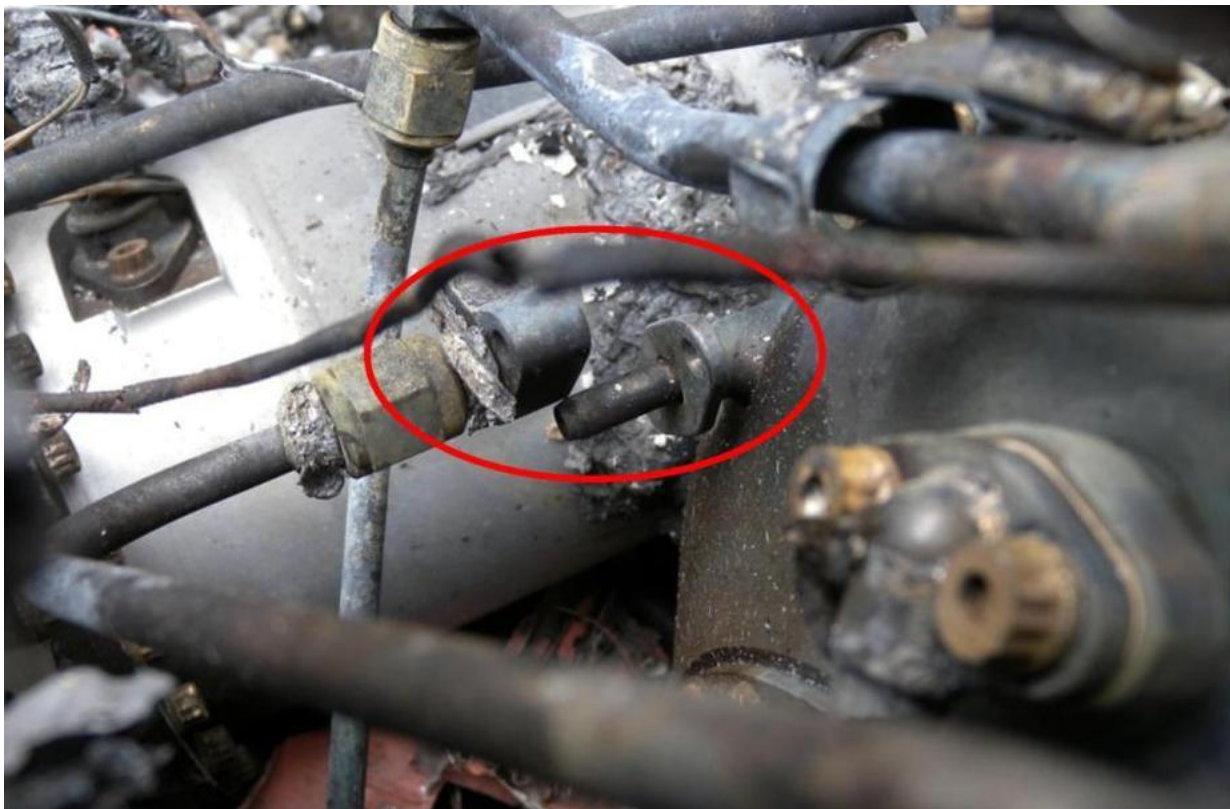
5. External examination of the engine at the accident site revealed that the fuel union had become detached from the flange on the compressor case. According to a Turbomeca representative, if this fuel line becomes disconnected, fuel starvation to the engine occurs. The fuel supply line remained attached to the union and the hydro-mechanical unit (HMU). The intermediate gasket was located in the fuselage debris, directly below the fuel union (See photo 1 Engine at Accident Site and illustration 1).

Photo 1 engine at accident site, fuel union had become detached from the flange on the compressor case

Specifically, the main fuel inlet jet union to the engine which HSN had removed during engine disassembly was not reinstalled utilizing the required hardware resulting in fuel starvation. This particular area of disassembly would not have been a routine inspection area for the Air Methods mechanics to inspect as part of the normal engine removal and reinstallation process. This engine was presented to Air Methods and signed off under an HSN FAA approved repair station as an "Airworthy" component or engine and it was not safe for flight.

- Require the use of torque striping on the bolts that attach the fuel union to the flange.
- Require all helicopter manufactures to provide a critical airspeed which would provide for maximum glide distance during an autorotation. The pilot had no reference airspeed for maximizing the distance travelled after experiencing the engine failure.

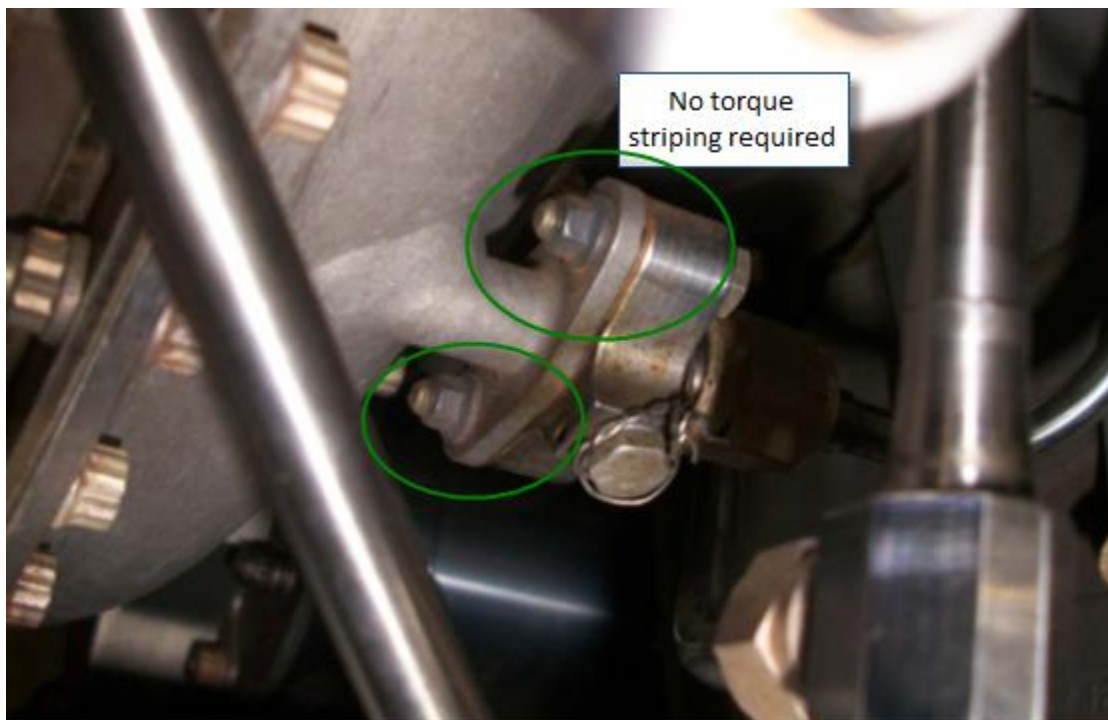
Photo # 2

11. If the hardware is reused and finger tight it would look very similar to the picture shown (see photo 2).
12. As discussed in Airworthiness Group Chairman’s Factual Report. “A used nut and bolt were similarly tightened, resulting in an exposed bolt shank length of about 13.5 millimeters. The threaded end of the used bolt was also observed to extend beyond the end of the nut by about half a thread. Comparative dimensions taken from an exemplar engine installation revealed that with the nuts and bolts installed and tightened to the specified torque on the union flange, approximately 1.5 threads were exposed beyond the nut, resulting in a bolt shank length of about 13 millimeters.” If the hardware is reused the visual difference between a properly torqued bolt and a hand tightened bolt is .5 millimeters shaft length and 1 thread (see photo 3).

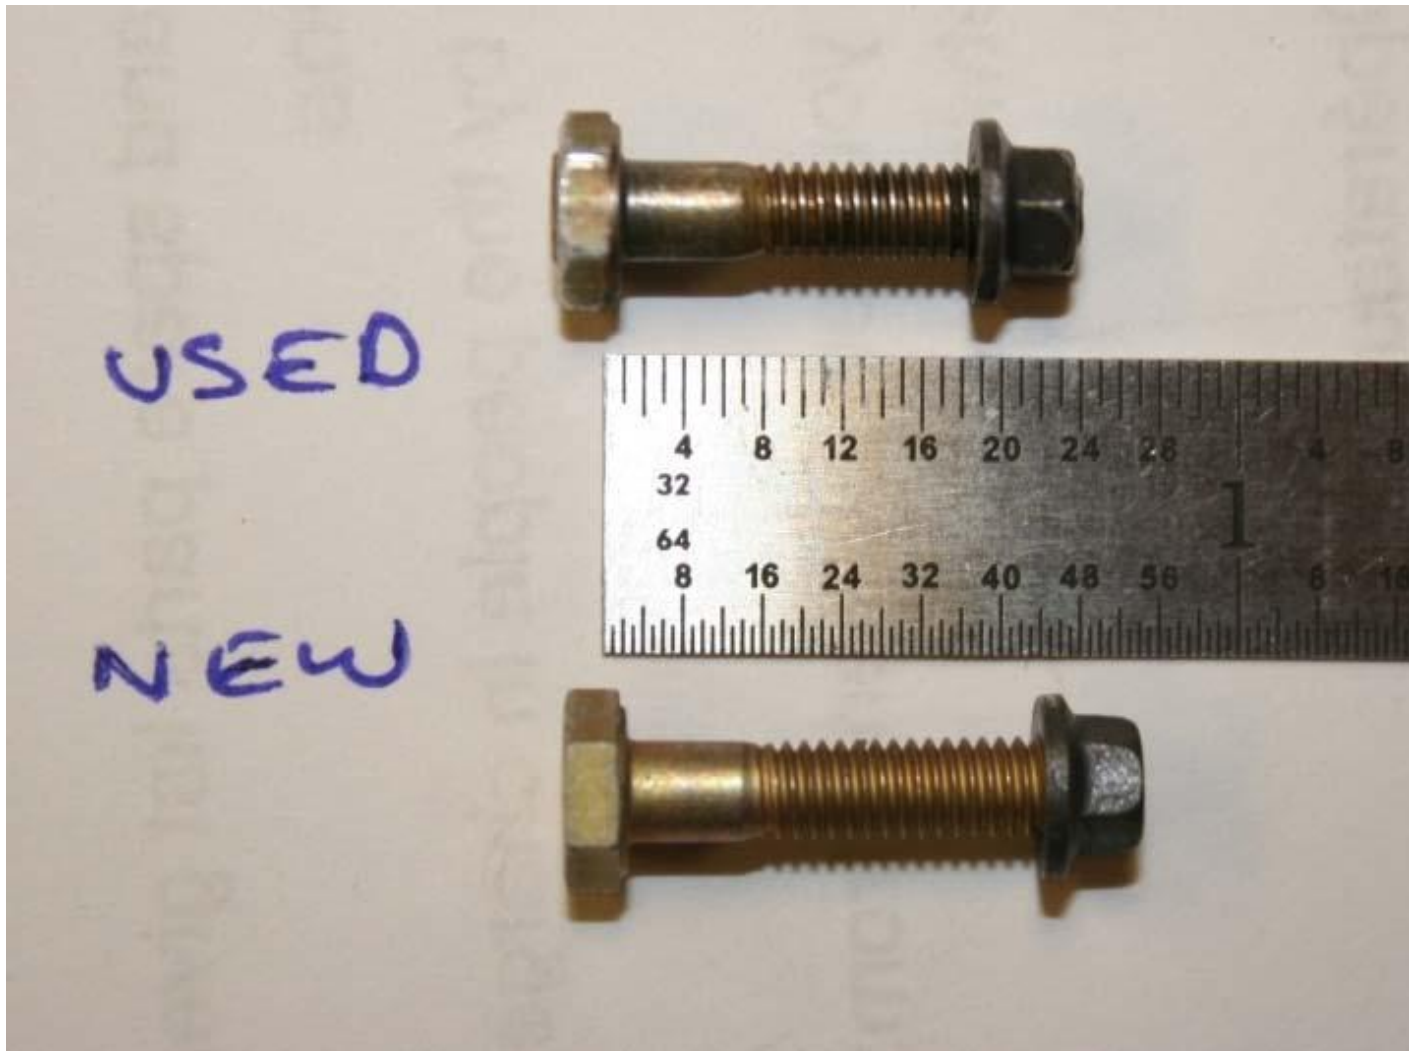
Photo 3 new and used union attachment nuts and bolts, with the nuts tightened by hand.

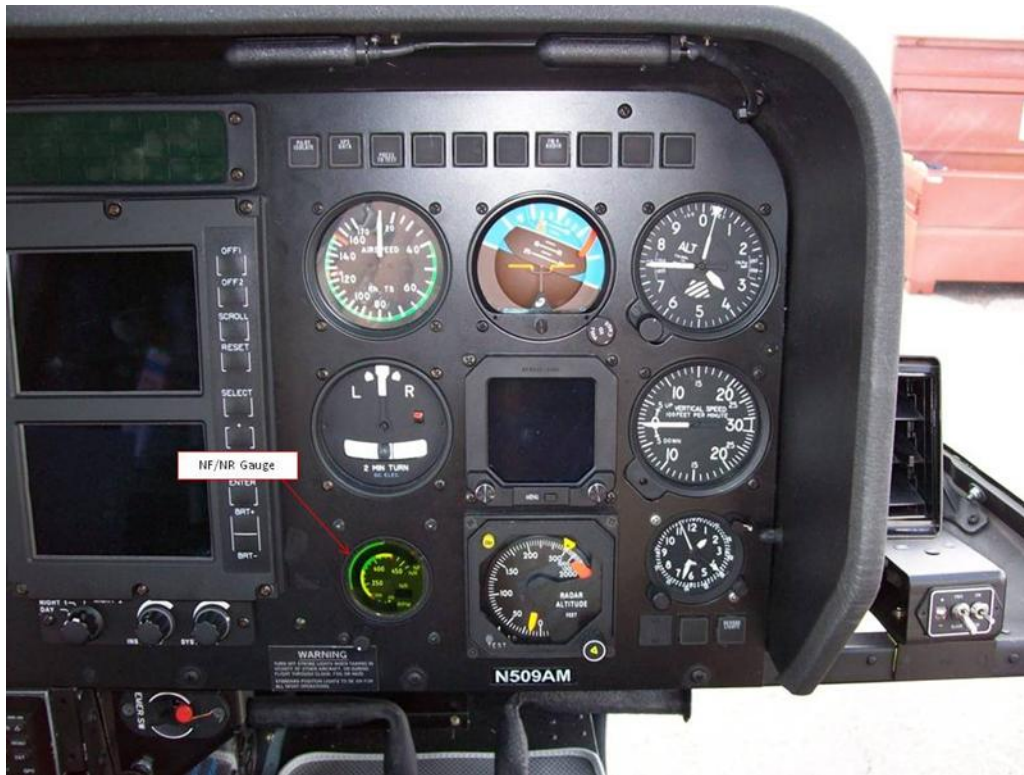
18. The rotor rpm gauge is a dual gauge representing engine free turbine speed (NF) and rotor rpm (NR) displayed using LED bars along the arc of the gauge. The gauge itself is approximately 2 inches in diameter and resides in the lower left portion of the pilot's instrument panel. (see photo 4).

Photo4 – N509AM NF/NR gauge indicated by red arrow.

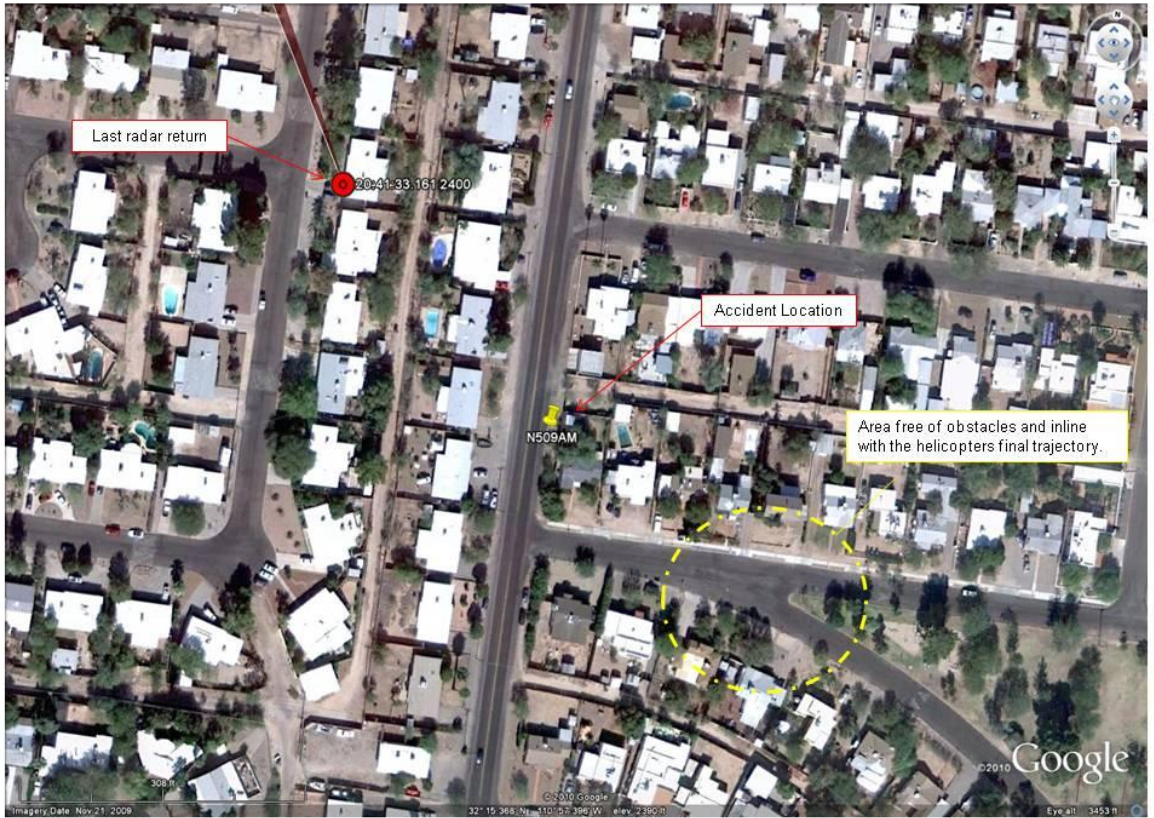
24. In the vicinity of the accident location, there was an open area that was free of obstacles. This open area was about 570 feet from the final radar return, and about 300 feet from the point of terrain impact, in line with the final flight path trajectory of the helicopter (see photo 5).

25. There were very few suitable landing sites other than the area depicted by the yellow circle in photo 5. The pilot was likely headed for the open area and encountered a set of wires that were perpendicular to his flight path and immediately west of the accident site (see photo 6). The pilot likely traded airspeed and used collective pitch to climb over and avoid the wires which resulted in low rotor RPM which could severely reduce controllability of the helicopter (see photo 7 likely flight path over wires, photo 8 eyewitness photo seconds before impact). This would have likely resulted in an uncontrollable helicopter and high rate of descent terminating in a hard landing (see photo 9, at accident site).

Photo 5 showing possible landing area free of obstacles

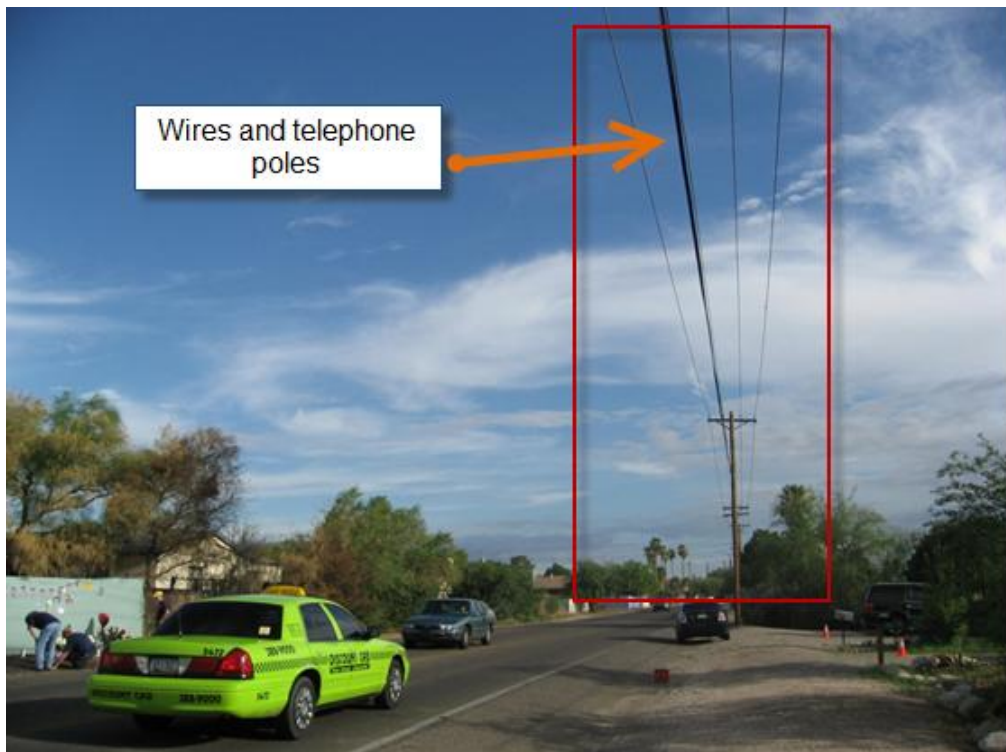
Photo 6 wires on west side of street

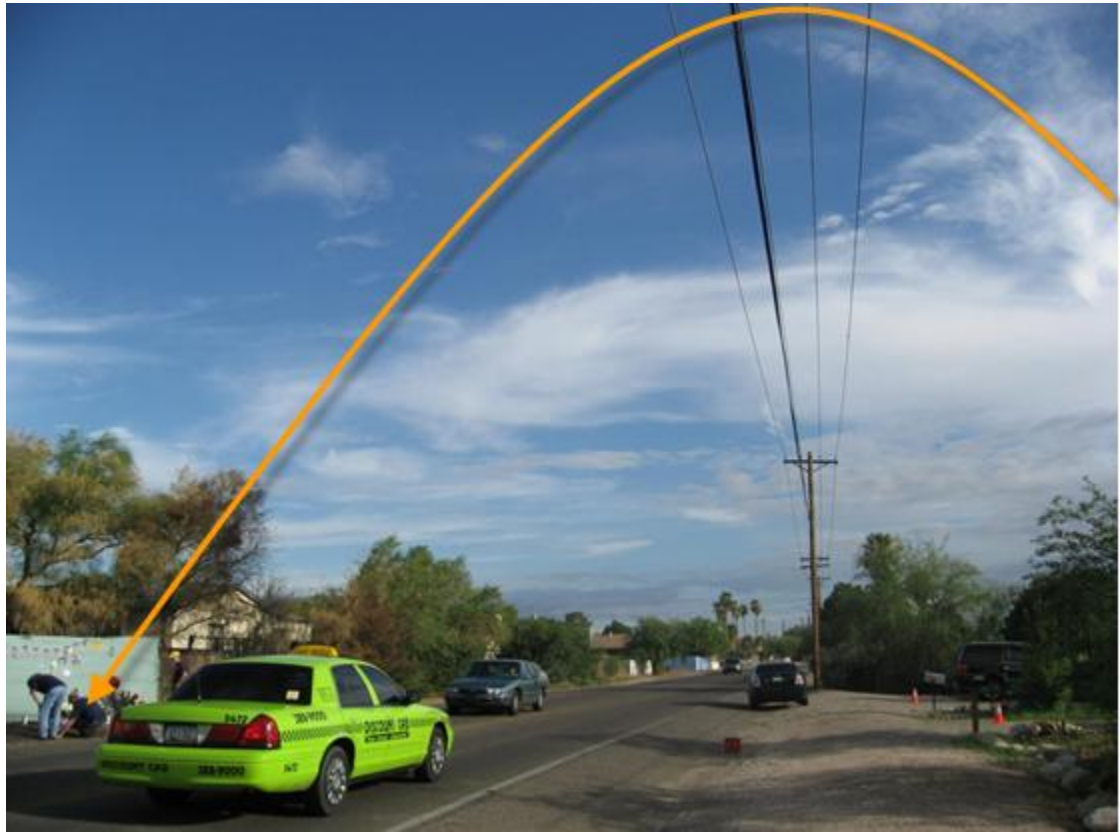
Photo 7 likely flight path to avoid wires

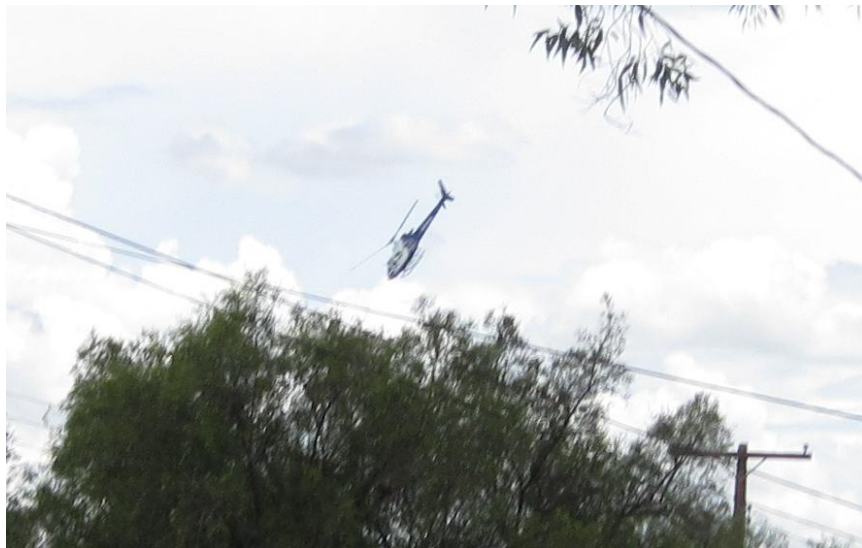
Photo 8 Eye Witness photo seconds before impact

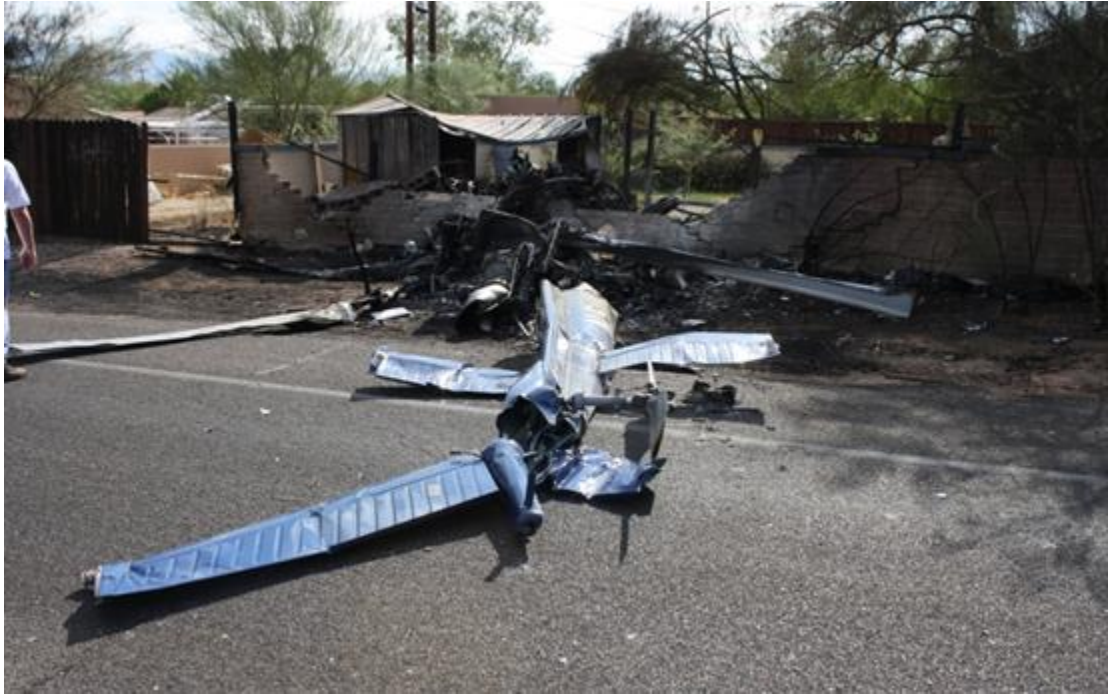
Photo 9 Aircraft at accident site
