**NATIONAL TRANSPORTATION SAFETY BOARD**

**AIR TRAFFIC CONTROL FACTUAL REPORT**

**CEN16MA036**

Location: Akron, Ohio  
Date/Time: Tuesday, November 10, 2015, 1452 eastern standard time (EST)  
Tuesday, November 10, 2015, 1952 coordinated universal time (UTC)  
Airplane: Execuflight flight 1526 (EFT1526), a British Aerospace HS 125-700A

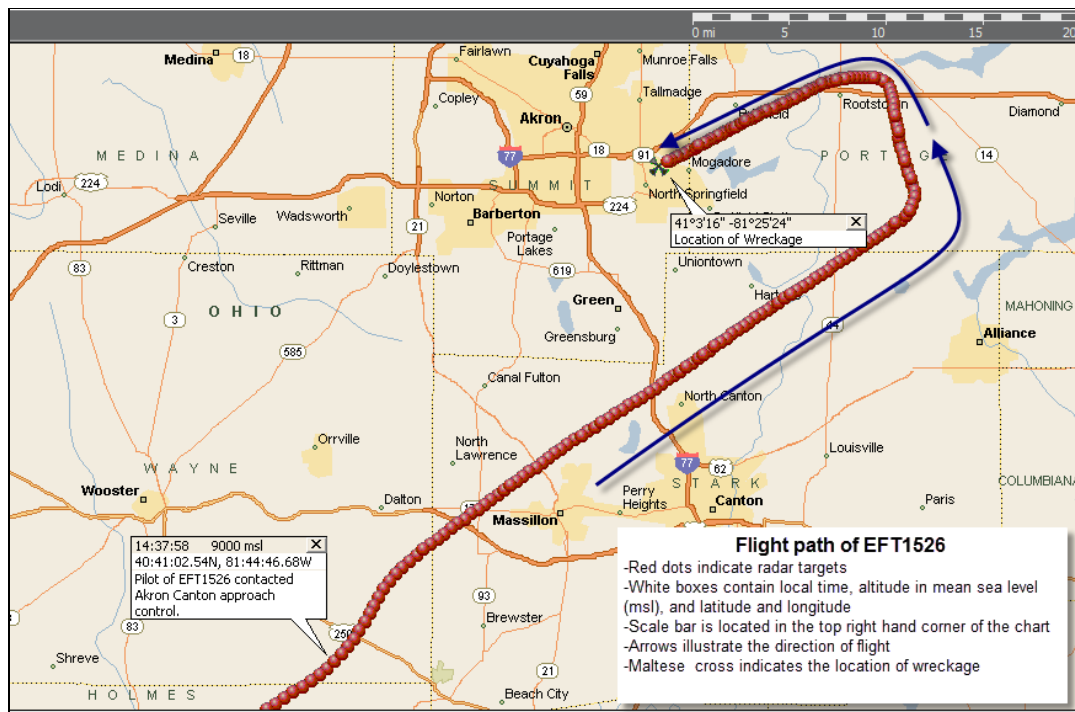
Figure 1. Radar graphic of EFT1526’s flight path after checking in with CAK approach.

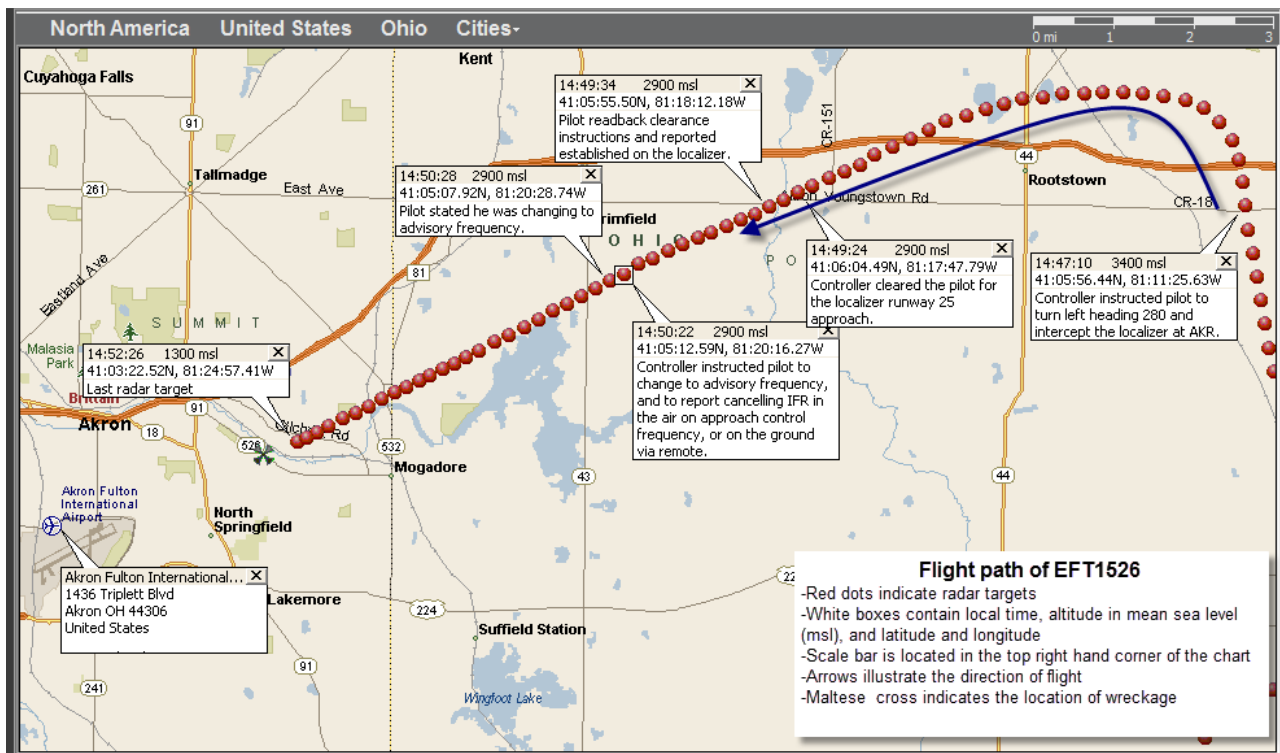
Figure 3. Radar graphic illustrates EFT1526’s flight path after turning to intercept the localizer.
