NATIONAL TRANSPORTATION SAFETY BOARD

Group Chairman's Factual Report

AIR TRAFFIC CONTROL

DCA14IA037

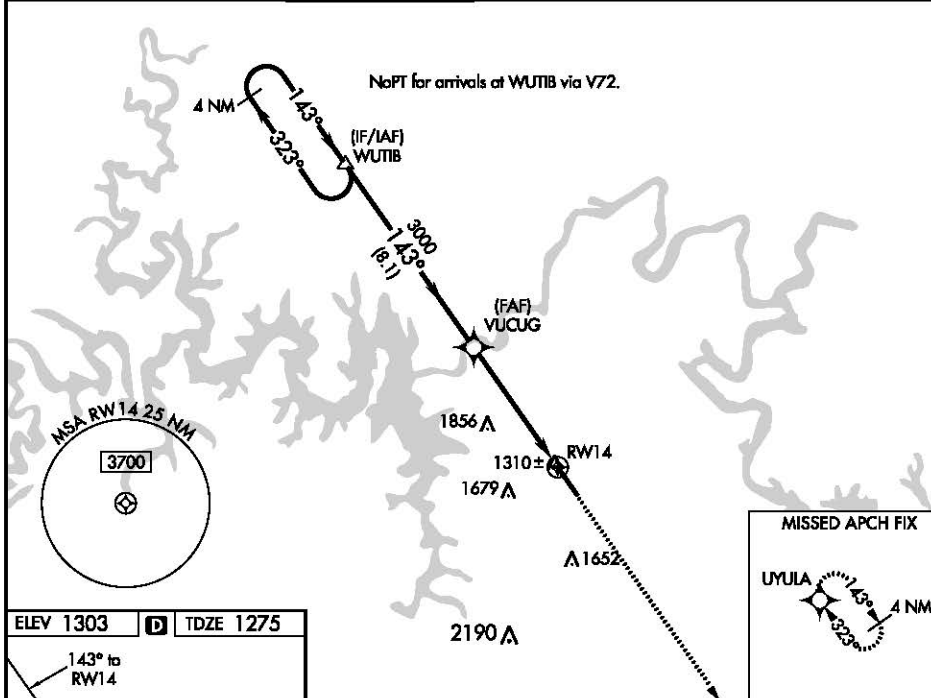
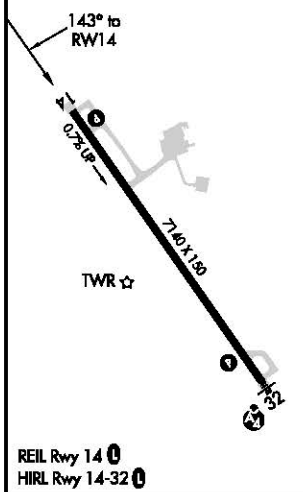
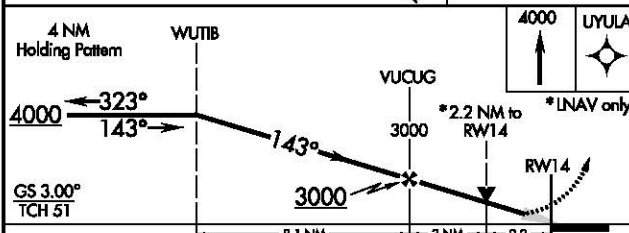
Figure 1 – RNAV (GPS) Runway 14 approach to BBG displaying the VUCUG final approach fix

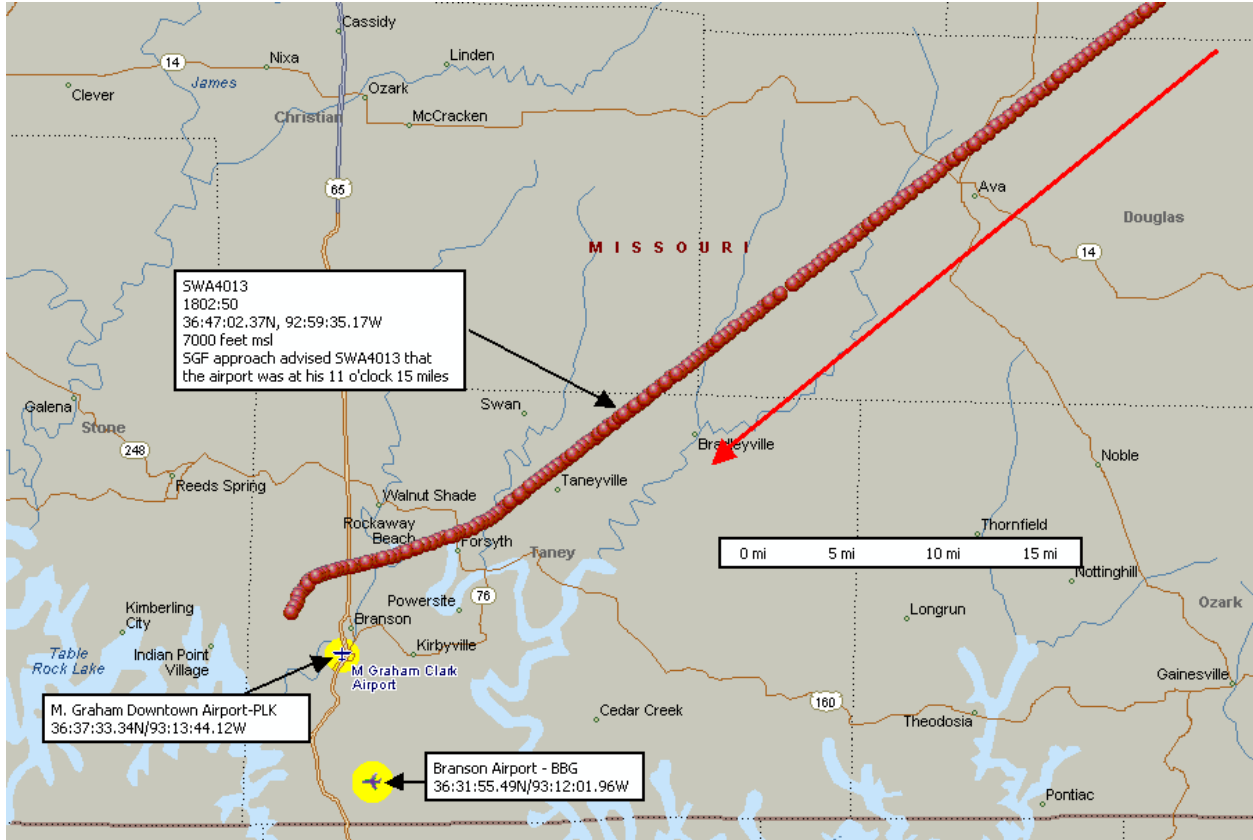
At 1800:10, the approach controller advised the BBG tower controller that SWA4013 was 20 miles northeast of BBG for the visual approach to runway 14. The BBG controller acknowledged the information. At 1802:50, the SGF approach controller advised the pilot of SWA4013 that the airport was at his 11 o'clock position and 15 miles. Radar data indicated that the airport at SWA4013's 11 o'clock at 15 miles was PLK, not the destination airport, BBG. BBG was approximately 20 miles from SWA4013. (see figure 2.)

Figure 2 – Radar flight track of SWA4013 incited by red dots. Direction of flight is indicated by a red arrow.

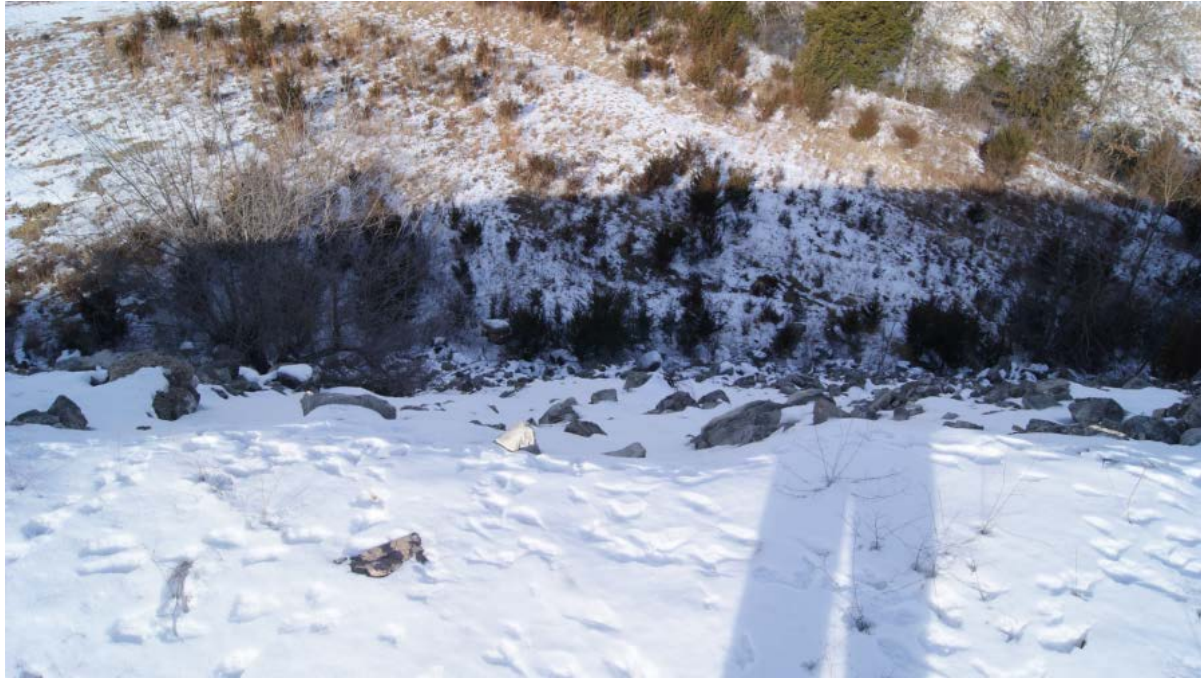
Figure 3 – The approach end of runway 12/departure end of runway 30 at PLK facing northwest.

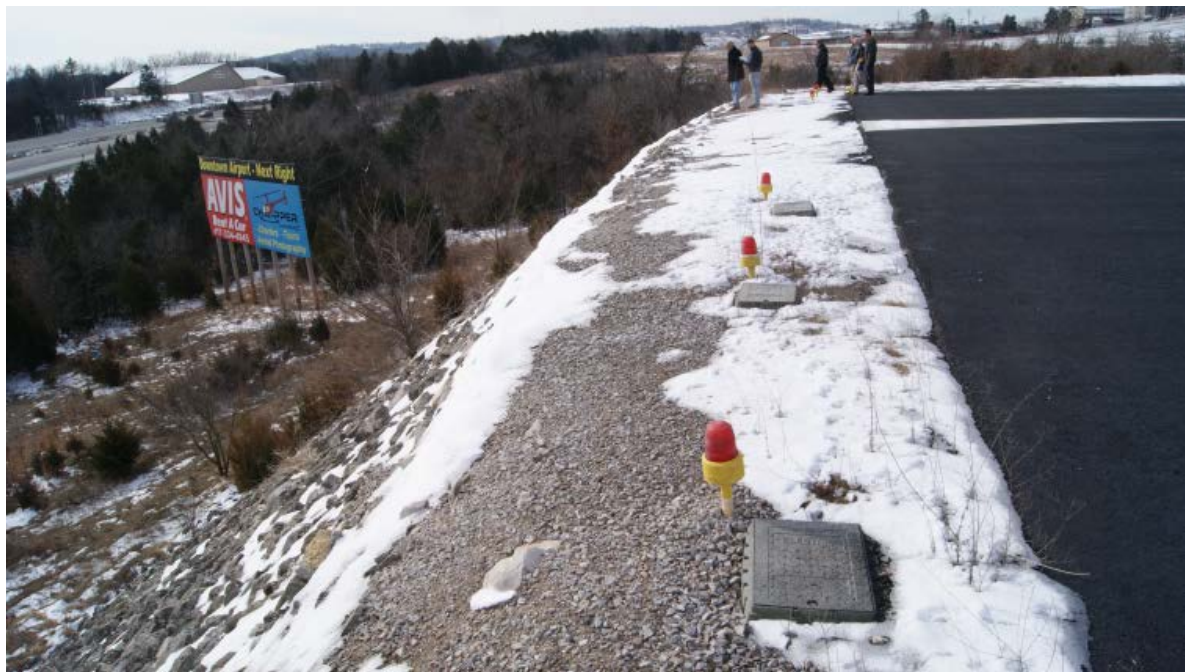
Figure 4 – The approach end of runway 30/departure end of runway 12 facing southwest

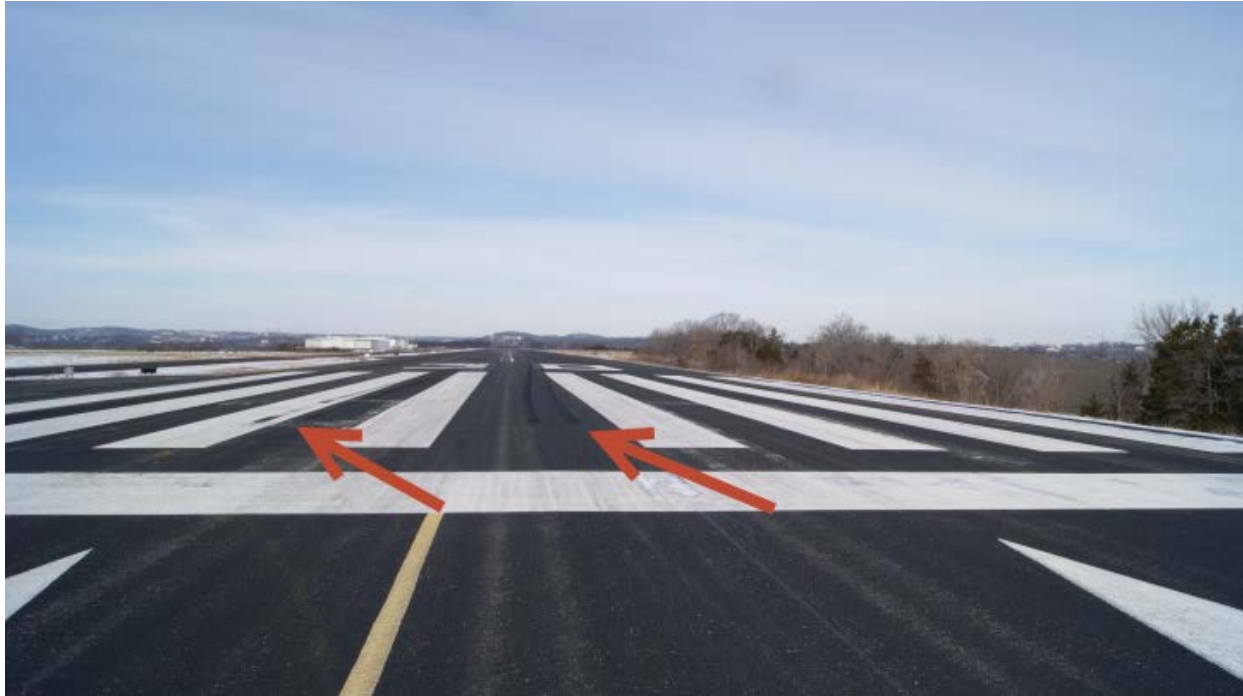
SWA4013's left main landing gear touched down 284 feet from the displaced threshold of the approach end of runway 12. The right main gear touched down 315 feet from the displaced threshold. Visible tire marks indicated that the aircraft came to a stop in the departure end of the runway 12/approach end of runway 30 RSA, 3109 feet from the displaced approach threshold of runway 12. (see figure 5)

Figure 5 – The departure end of runway 12/approach end of runway 30 at PLK. SWA4013 main mount tire tread marks are indicated by red arrows.

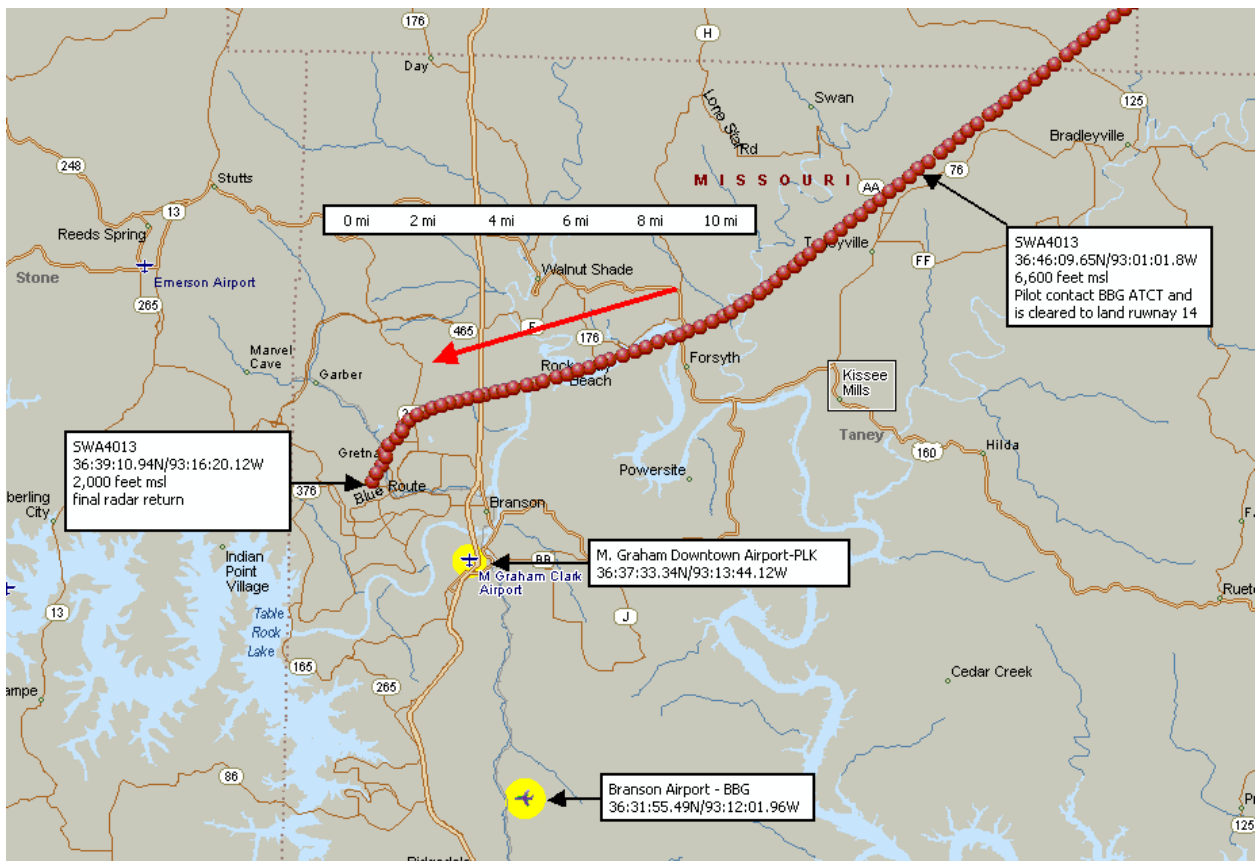
After checking in with the BBG ATCT at 1803:15, the tower controller cleared SWA4013 to land on runway 14 at BBG. The tower controller recalled observing SWA4013 maneuvering and assumed the aircraft was turning out to establish a straight in approach to runway 14. The controller did not observe the aircraft land at PLK. After SWA4013 advised BBG that they had landed at the wrong airport at 1809:45, the BBG controller confirmed that SWA4013 had landed and called SGF to ask if the approach controller had observed SWA4013 land at PLK. The approach controller advised that SWA4013 had dropped off radar near PLK. (see figure 6)

Figure 6 - Radar flight track of SWA4013. The radar flight track is indicated by red dots. The direction of flight is indicated by a red arrow.
