NATIONAL TRANSPORTATION SAFETY BOARD

Air Traffic Control Specialist Report

ANC15FA021

Aircraft: N9247C, a Cessna 180

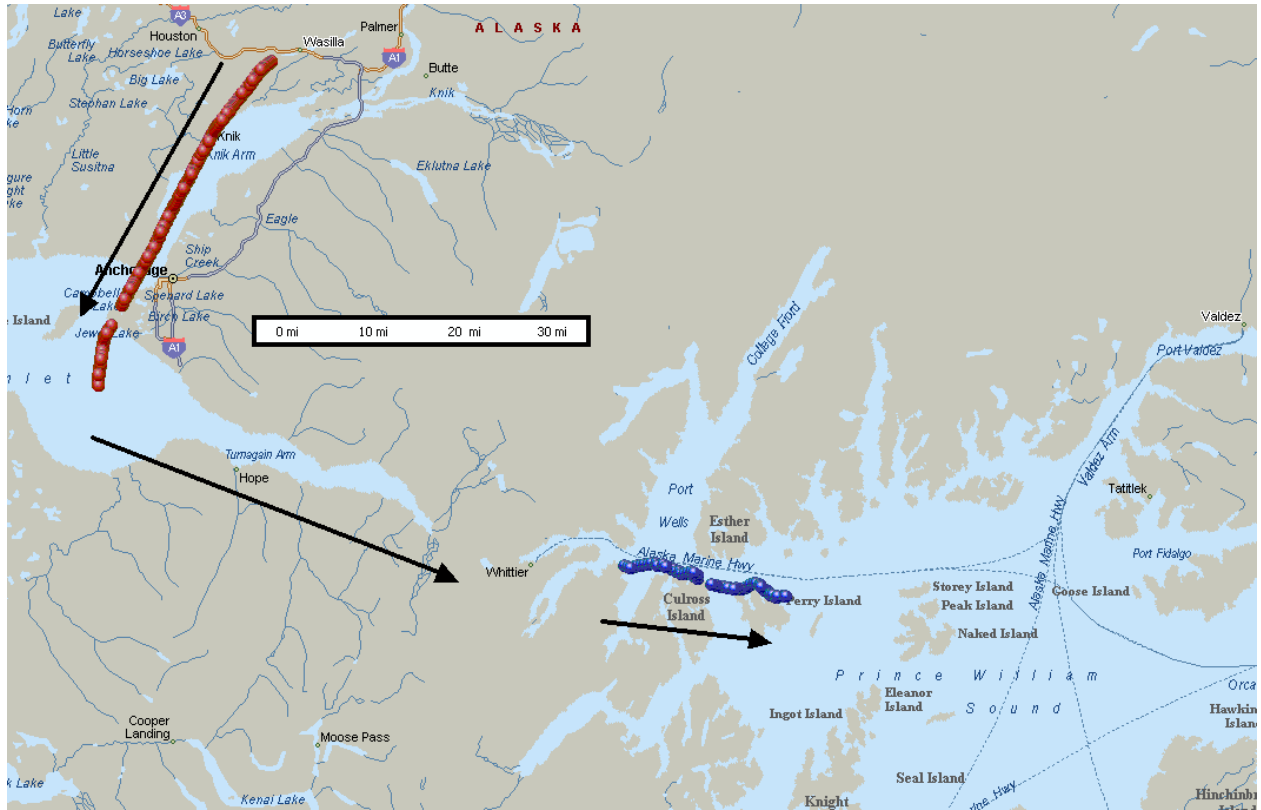
On April 14, 2015, about 1330 Alaska daylight time, a wheel-equipped Cessna 180 airplane, N9247C, is presumed to have sustained substantial damage during impact with ocean waters, about 18 miles east of Whittier, Alaska, following a reported loss of engine power. The airplane was being operated as an instrument flight rules (IFR) cross-country personal flight under the provisions of Title 14 Code of Federal Regulations (CFR) Part 91, when the accident occurred. The instrument rated private pilot, the sole occupant of the airplane, sustained fatal injuries. Instrument meteorological conditions (IMC) prevailed along the route of flight, and the airplane was operating on an IFR flight plan. The flight departed the Wasilla Airport (IYS), Wasilla, Alaska, about 1205, en route to the Valdez Pioneer Field Airport (VDZ), Valdez, Alaska. (See figure 1)

Figure 1 – Radar flight track of N9247C. Black arrows indicate direction of flight. Red dots indicate radar data from the ANC ASR and blue dots indicate radar data from the MDO SSR.

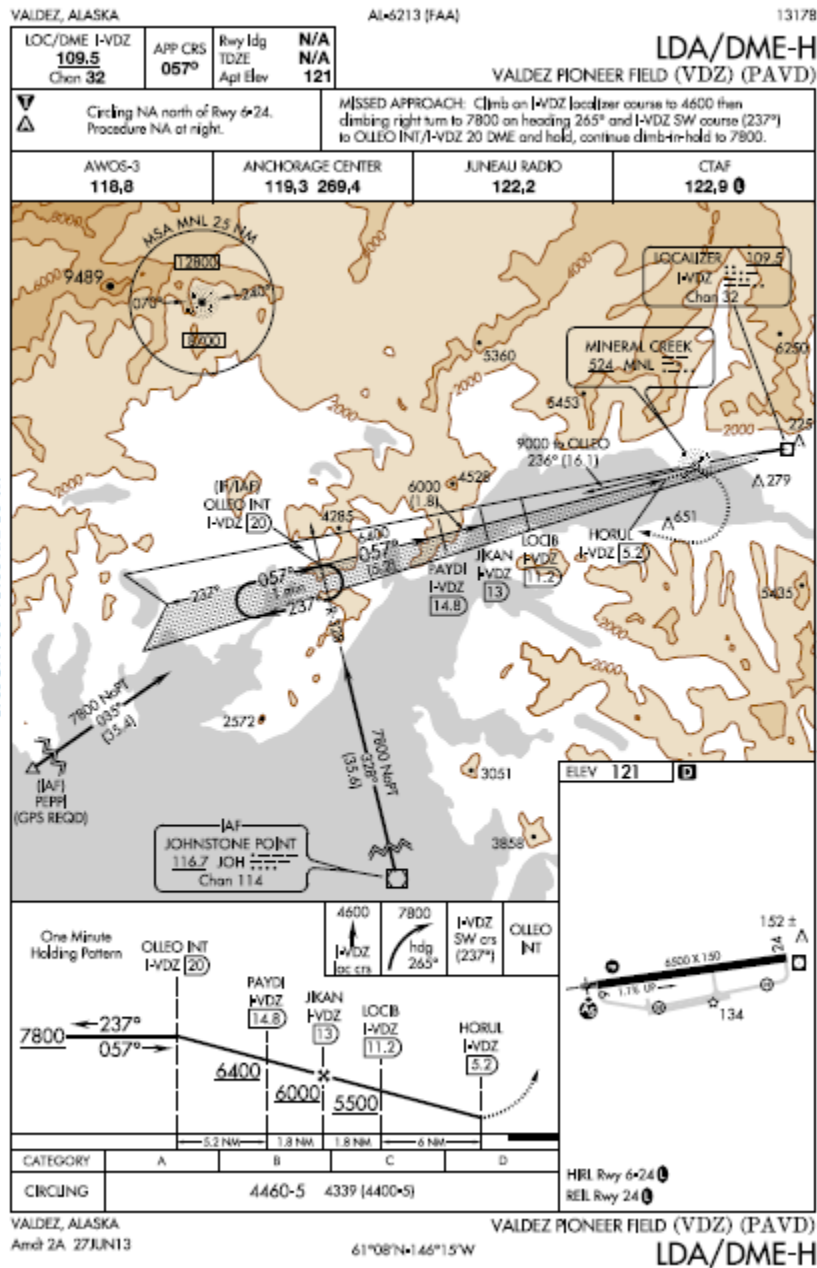
A post-accident review of archived Federal Aviation Administration (FAA) radar data and radio communication recordings revealed that, about 1315, the on-duty Anchorage Air Route Traffic Control Center (ZAN) radar controller cleared the airplane for the LDA/DME H instrument approach to the Valdez Airport. (See figure 2) At that time, the airplane was about 60 miles southwest of the Valdez Airport, at an altitude of about 10,000 feet above mean sea level (msl). Shortly after the pilot began a descent from 10,000 feet msl, he advised the ZAN controller of an engine problem. The pilot stated his intentions to descend below a cloud layer and land on a nearby island. Shortly after, radar contact with the airplane was lost. A radio communication for the accident airplane was relayed through another airplane in the area that he was at 5,500 feet msl and still in the clouds. No further radio transmissions were received from the pilot, and an emergency locator transmitter (ELT) signal was broadcasting shortly thereafter for approximately 20 seconds.

Figure 2 – VDZ LDA/DMA-H approach procedure

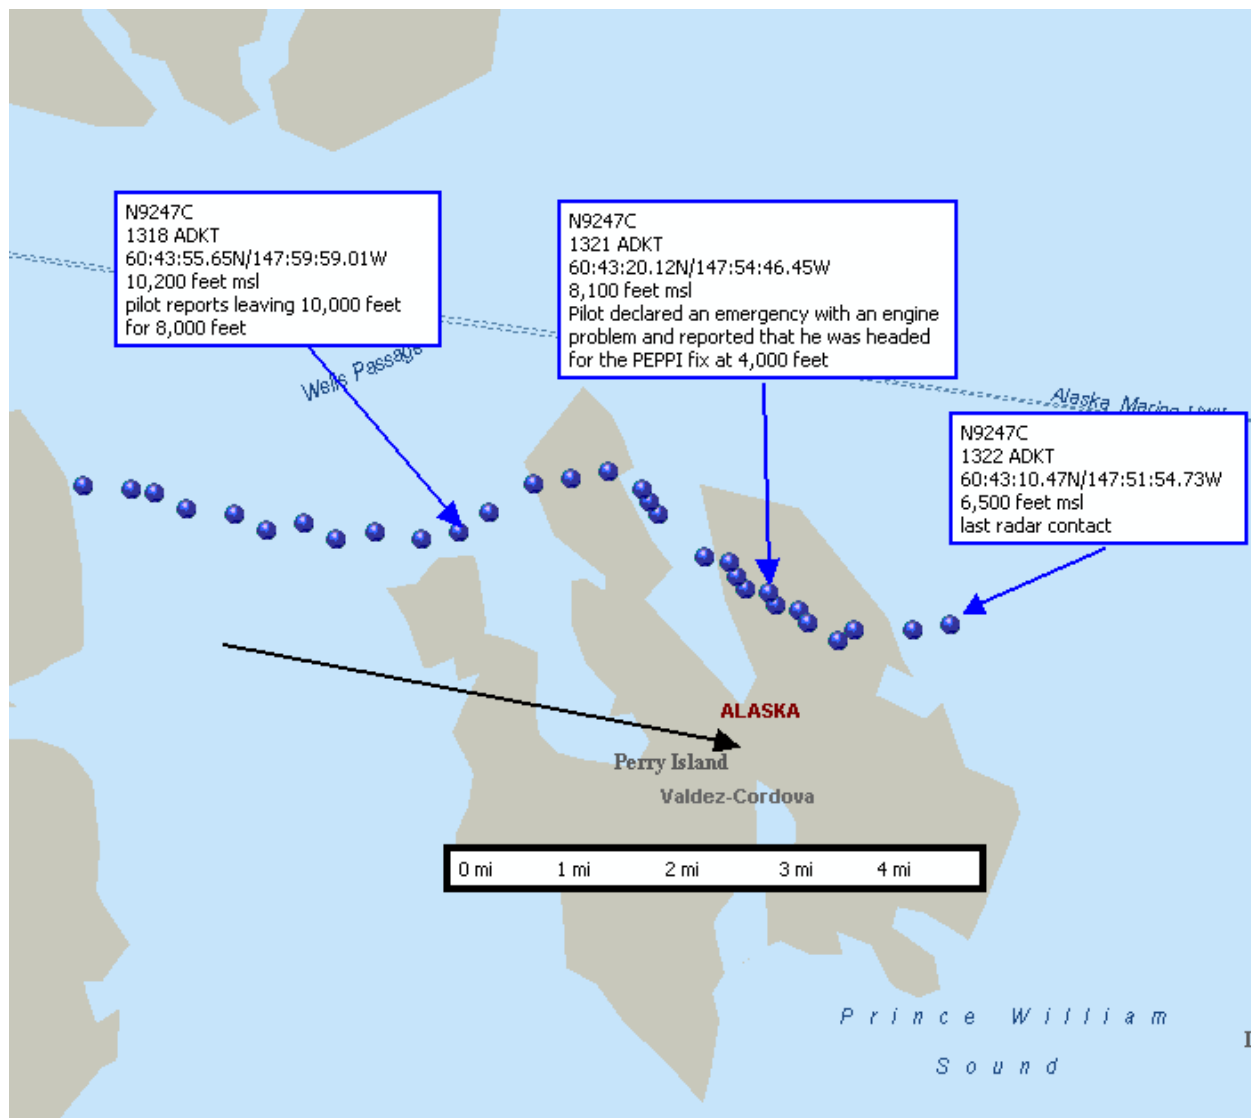
Figure 3 – Final radar track of N9247C. Radar returns are indicated by blue dots. Direction of flight indicated by black arrows.

At 1323, the controller advised the pilot that he was no longer in radar contact but that he was last observed northeast bound with the island behind him. The pilot acknowledged with “four seven charlie copy.” There were no further communications between N9247C and air traffic control (ATC).
