Factual Report – Attachment 2
Previous Safety Recommendations

DCA17IA148

Safety Recommendation

In reply refer to: A-11-12 through -15

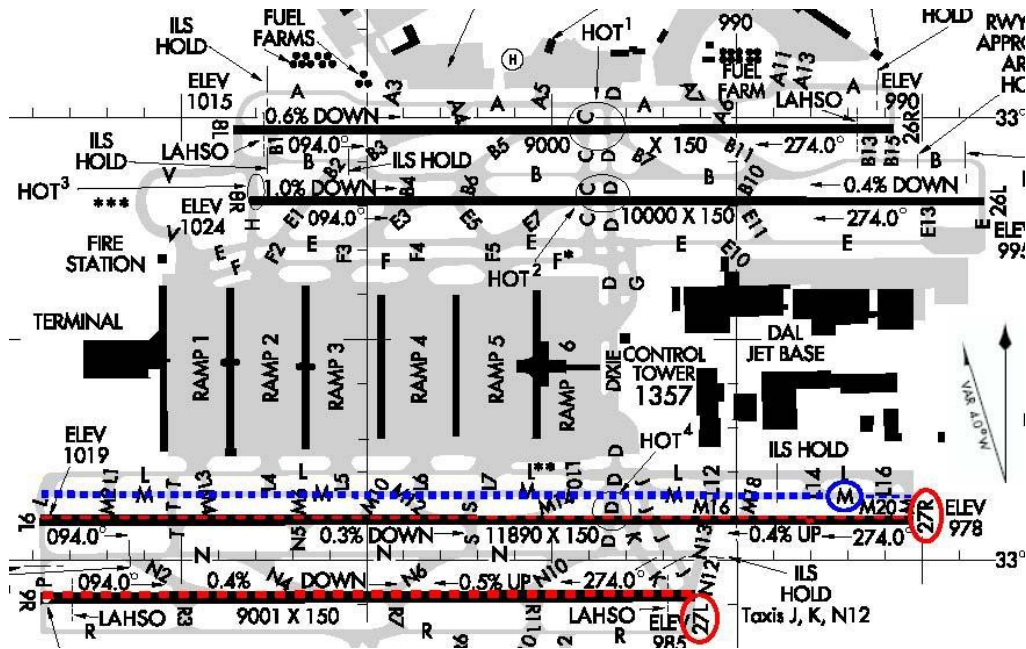
Figure. Diagram Showing ATL Runways 27L, 27R, Taxiway M

During the descent and approach, the flight crew was assigned a number of runway changes; the last of which occurred near the final approach fix for runway 27L. While the flight was on final approach, the crew was offered and accepted a clearance to sidestep to runway 27R³ for landing (see figure for a diagram of ATL runway configurations). Although the flight crew had previously conducted an approach briefing for runways 27L and 26R, they had not briefed the approach for runway 27R and were not aware that the approach light system and the instrument landing system (ILS) were not available to aid in identifying that runway.⁴

According to the captain, who was the flying pilot, he maneuvered for the sidestep from runway 27L to 27R and lined up on “the next brightest set of lights” he saw. He said that he saw “bright edge lights and centerline lights” and thought he had the runway in sight. The first officer was preoccupied during the final approach with attempting to tune and identify the ILS frequency for runway 27R. Just prior to the airplane touching down, the captain realized they were landing on a taxiway. The airplane landed on taxiway M, 200 feet north of, and parallel to, runway 27R. The local controller did not notice the crew’s error until after the airplane had landed. The taxiway was unoccupied, and the flight crew was able to stop the aircraft safely and taxi to the gate.
