## NATIONAL TRANSPORTATION SAFETY BOARD

### Group Chairman's Factual Report

# AIR TRAFFIC CONTROL

OPS15IA011AB

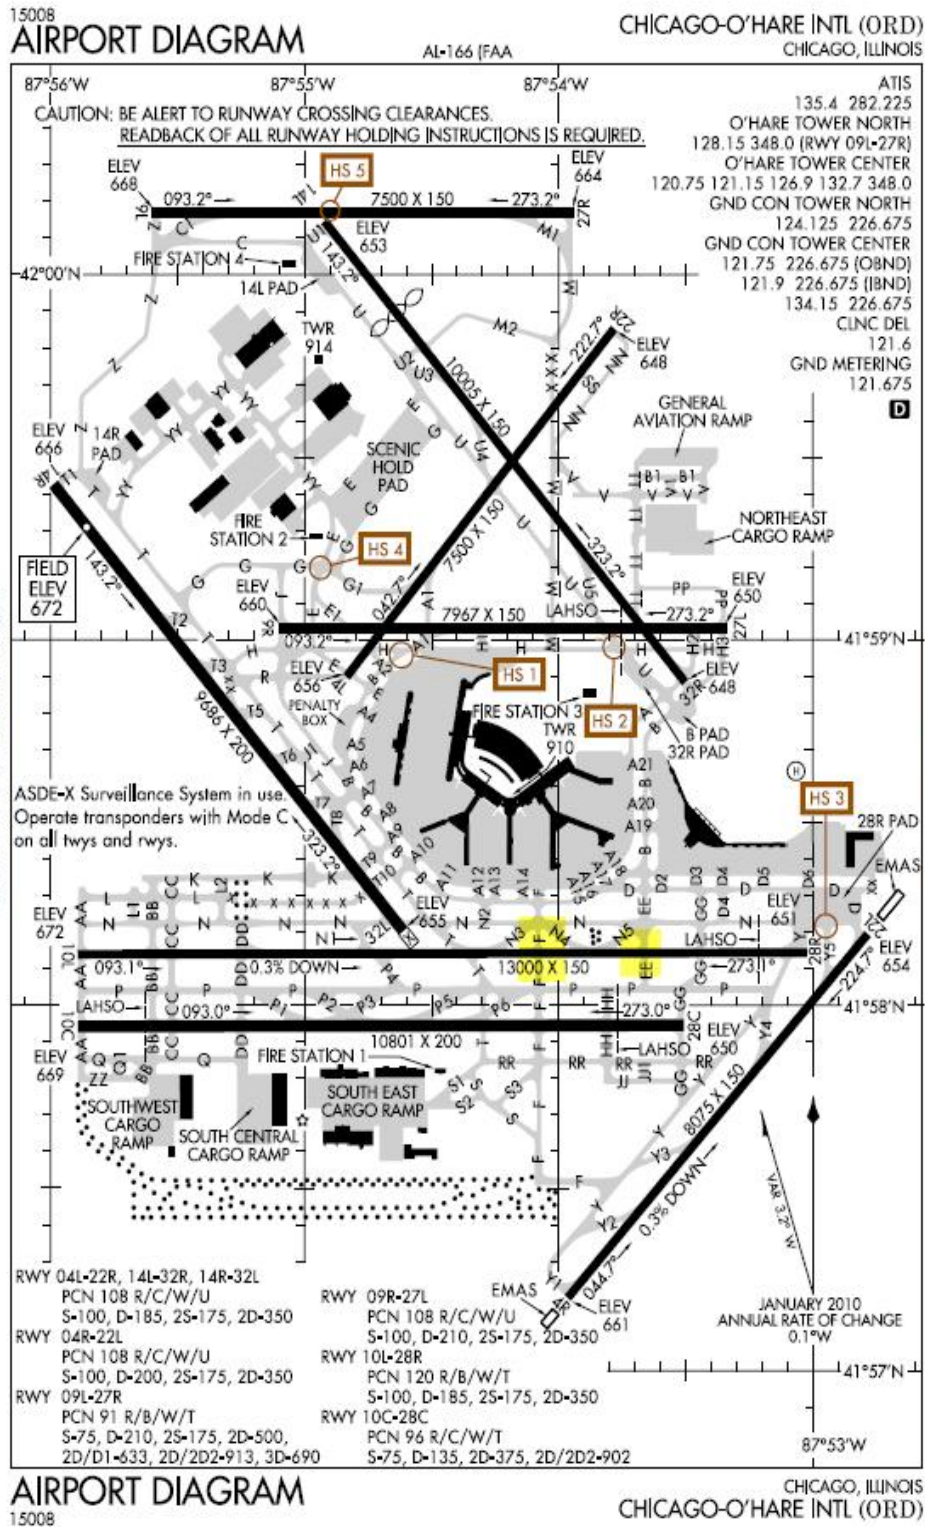
According to the ATM, ORD was on a west flow. Aircraft were landing on runway 28C and departing from runway 28R. Pending the results of investigations, the ATM closed taxiway F between taxiway P and N. The ATM directed face to face briefings of the event with all personnel. The quality control department met with management of both airlines involved to discuss the event and possible mitigation strategies.

Figure 1 – Chicago-O’Hare International Airport Diagram with taxiway F and taxiway GG at runway 28R highlighted in yellow

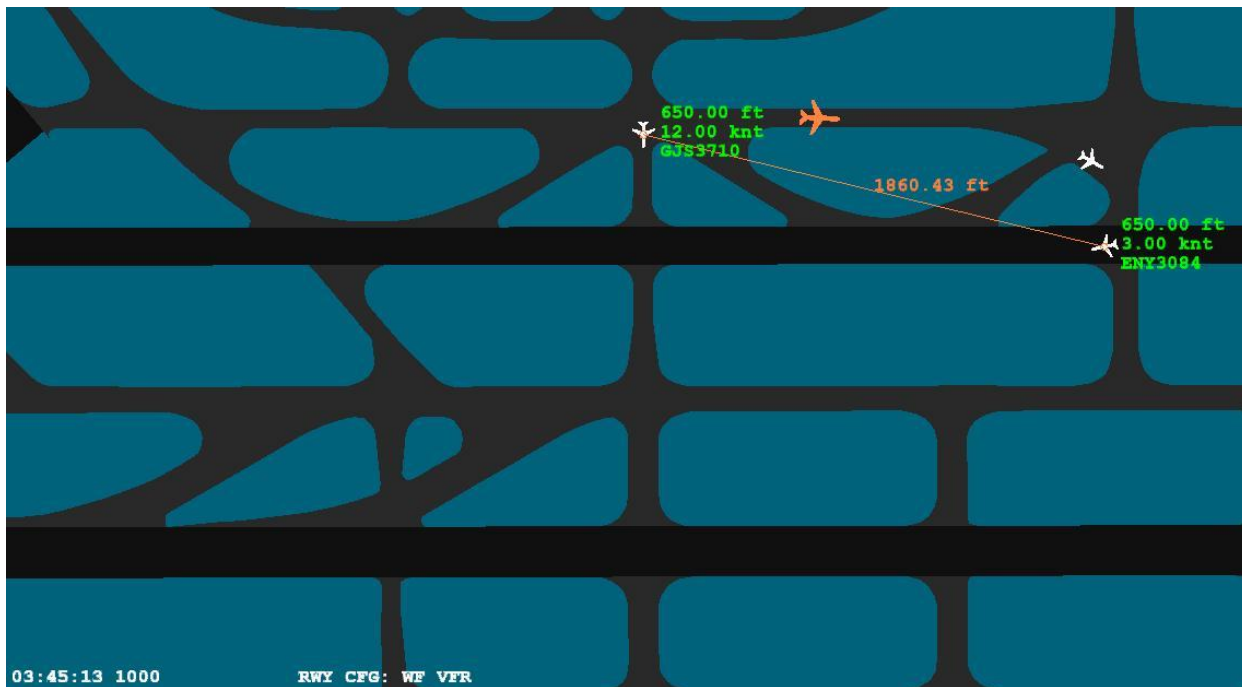
According to recorded ASDE-X data, ENY3084 began departure roll on Runway 28R at Taxiway EE at 2145:17. GJS3710 was about 265 feet north of the runway 28R edge line, taxiing south on Taxiway F at approximately 11 knots. (See figures 2 through 4.)

Figure 2 – ASDE-X presentation of ENY3084 and GJS3710 at 2145:13.

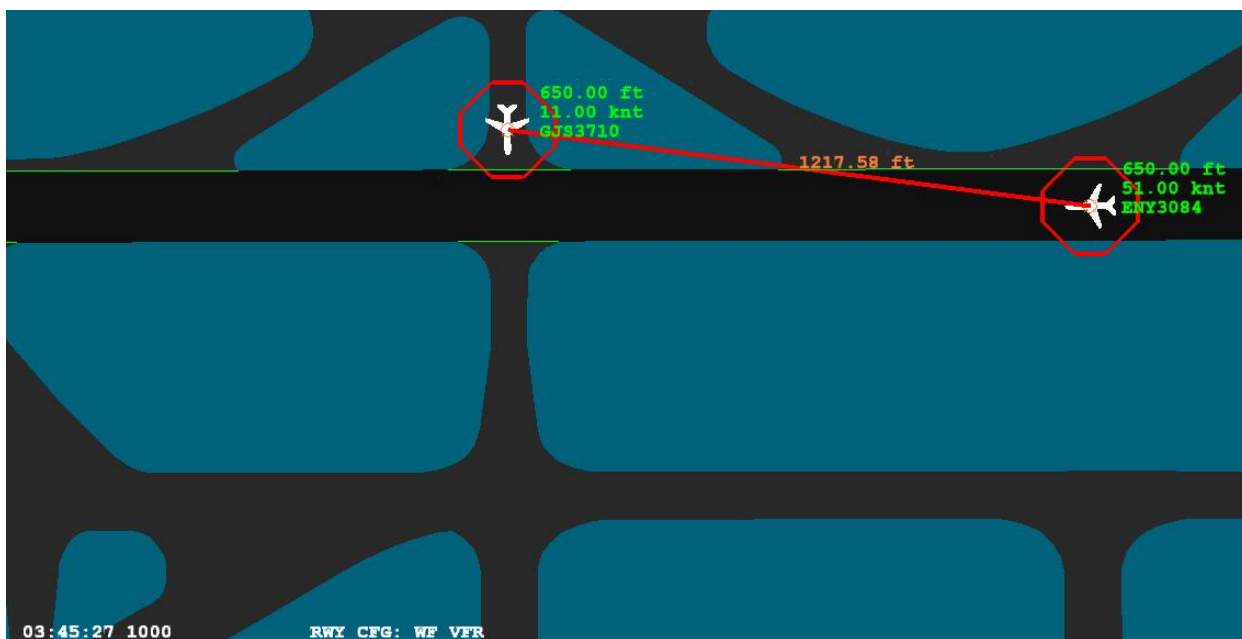
At 21:45:28, an ASDE-X alert was issued when ENY3084 met the velocity (47 knots) and acceleration (2.5 knots/sec) parameters that are required by the ASDE-X to be considered a departure. At this time, ENY3084 was traveling at approximately 56 knots and was approximately 1041 feet from the runway 28R/taxiway F intersection. GJS3710 was approximately 42 feet from crossing the runway 28R edge line and was traveling at approximately 11 knots.

Figure 3 – ASDE-X presentation of ENY3084 and GJS3710 at 2145:27

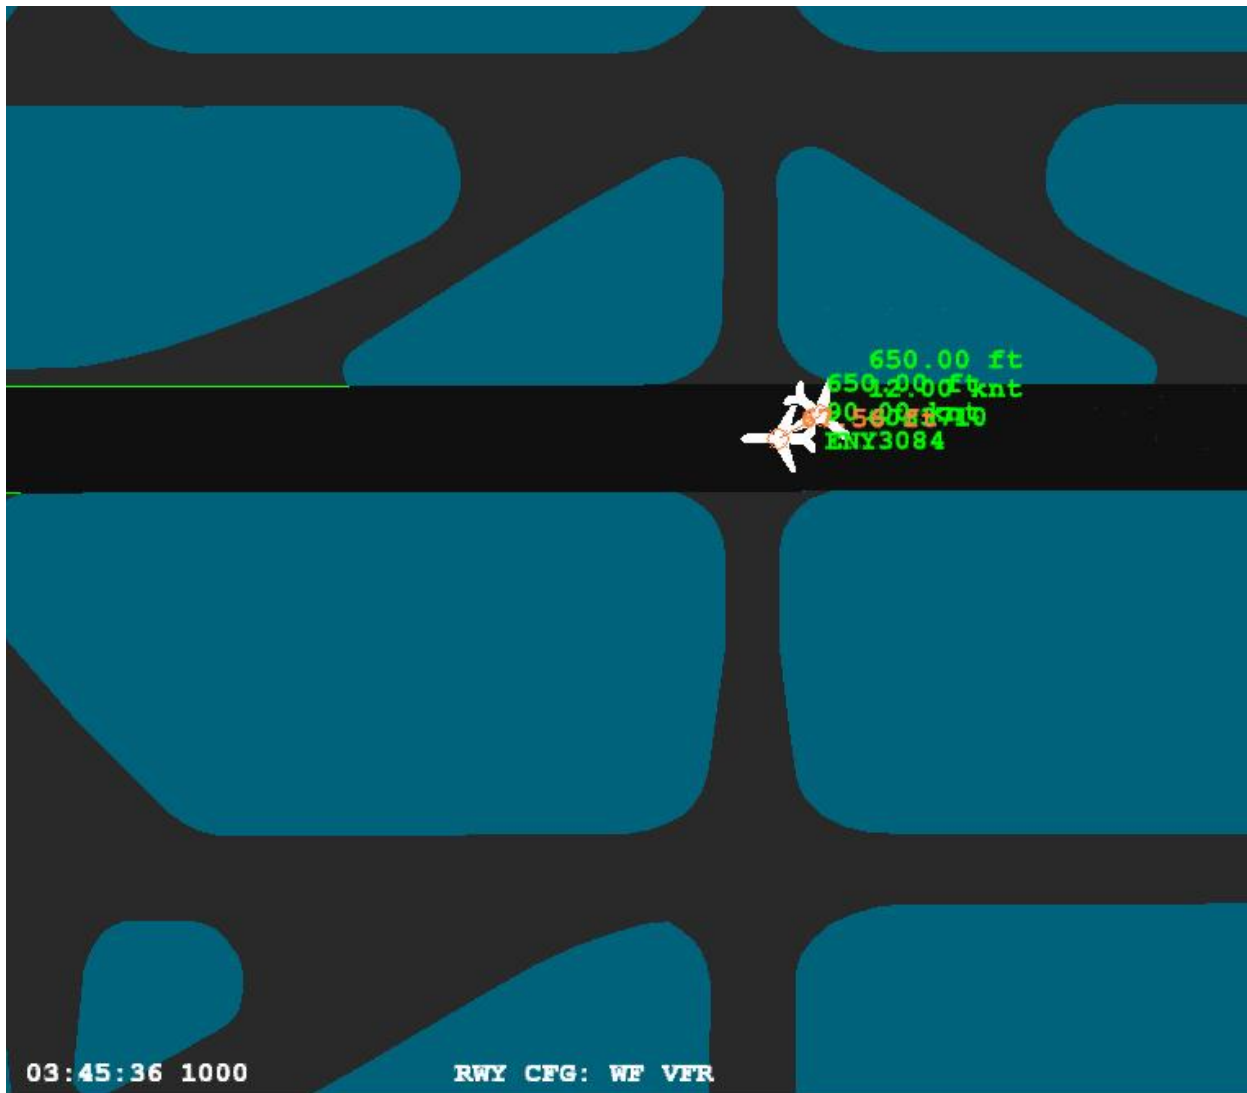
At 21:45:36, ENY3084 passed GJS3710 on runway 28R. The ASDE-X could not resolve the minimum separation distance. The positional accuracy of the ASDE-X is +/- 20 feet.

Figure 4 – ASDE-X presentation of ENY3084 and GJS3710 at 2145:36
