NATIONAL TRANSPORTATION SAFETY BOARD

Group Chairman's Factual Report

AIR TRAFFIC CONTROL

WPR15MA243AB

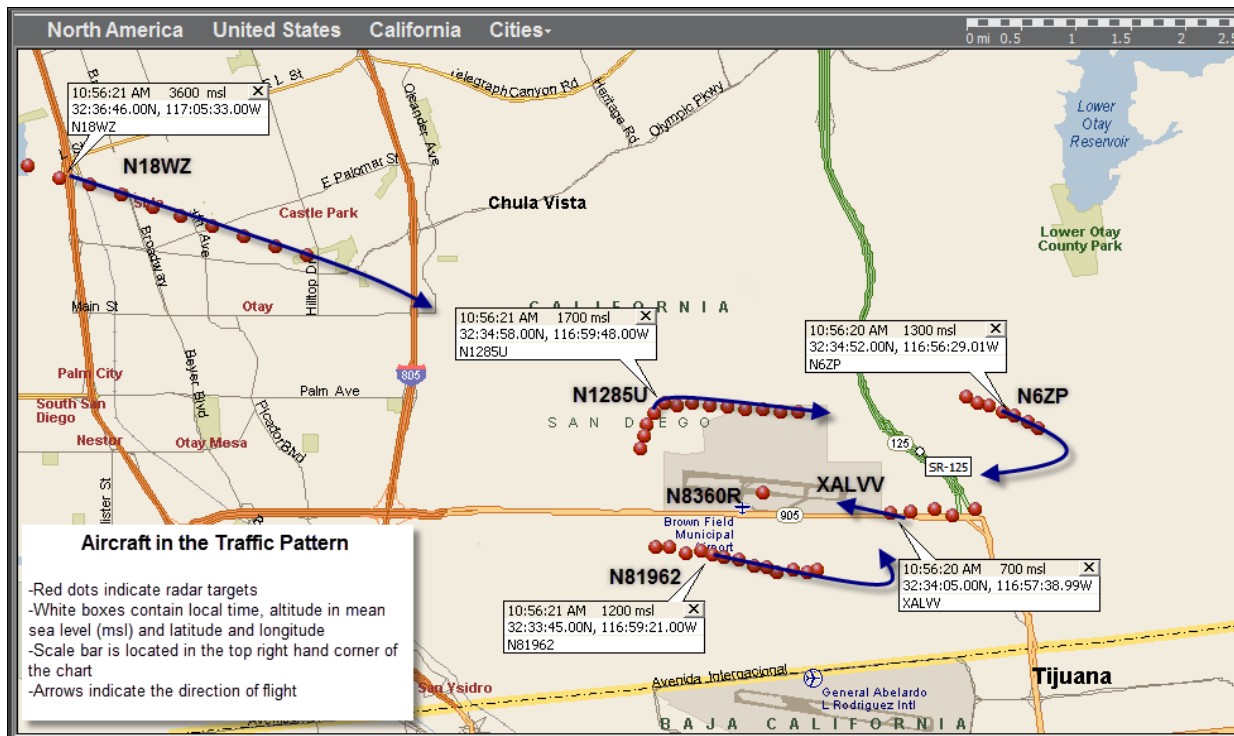
At 1056:31, the local controller advised the pilot of N1285U that on the next approach he could expect runway 26L. The pilot read back the instructions. Figure 1 is a radar graphic that illustrates the position of all aircraft that were in the SDM airspace at that time. N18WZ was eastbound at 3,600 feet inbound for landing runway 26R; N1285U was turning right downwind at 1700 feet for a touch and go runway 26L; N6ZP was on a right base at 1,300 feet for a touch and go runway 26R; XALVV was at 700 feet descending, on short final for landing runway 26R; N8360R was conducting a touch and go over runway 26L; and N81962 was on a left downwind at 1,700 feet descending for landing on runway 26L.

Figure 1. Radar graphic illustrates the number and positions of flights at 1056 PDT, three minutes before Eagle1 checked in with SDM ATCT.

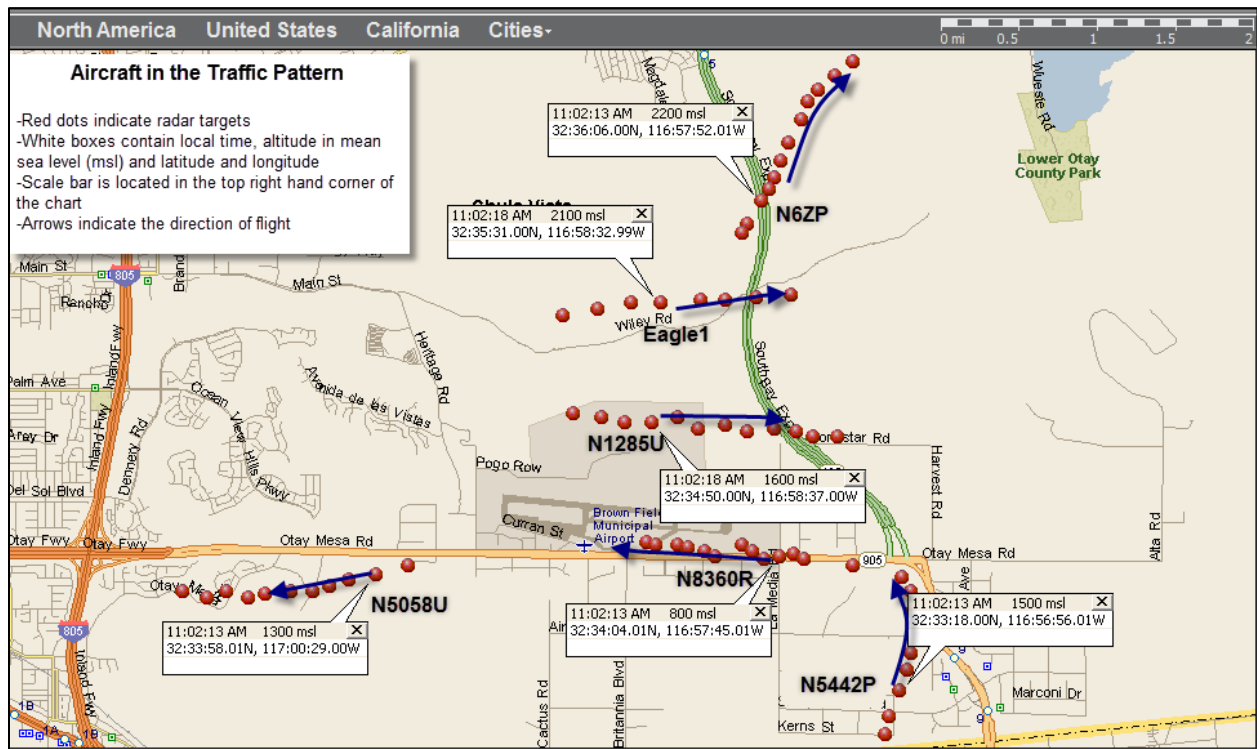
At 1102:14, the pilot of Eagle1 reported, "... right downwind abeam traffic to the left and right in sight." Figure 2 is a radar graphic that illustrates the position of all of the aircraft that were in the SDM airspace at that time. Radar data indicated there were three aircraft to the right and one airplane to the left of Eagle1. To the left of Eagle1 was N6ZP, departing the pattern northeast bound at 2,200 feet. To the right of Eagle1 was N1285U, eastbound on a downwind for runway 26R at 1,500 feet; N8360R westbound on a short final for runway 26L at 800 feet; and N5442P northbound on a right base for runway 26L at 1,500 feet.

Figure 2. Radar graphic depicting the location of aircraft in the SDM airspace when the pilot of Eagle1 reported traffic to the left and right in sight.

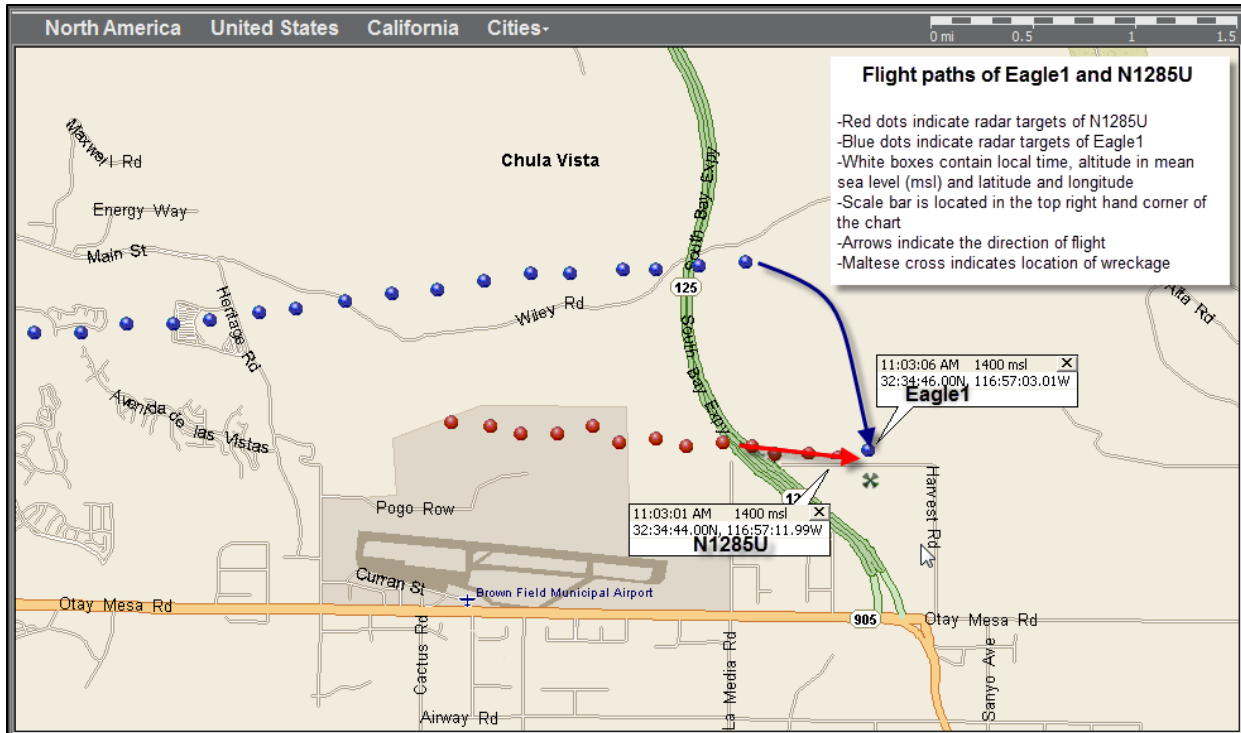
At 1103:08, the local controller asked the pilot of N1285U, "Are you still on downwind sir right downwind." The pilot did not respond. Figure 3 shows the flight track and the last radar targets immediately before the accident.

Figure 3. Radar graphic illustrating the flight paths immediately before the accident.
