## **NATIONAL TRANSPORTATION SAFETY BOARD**

### **Group Chairman's Factual Report**

#### **AIR TRAFFIC CONTROL**

**DCA16IA200**

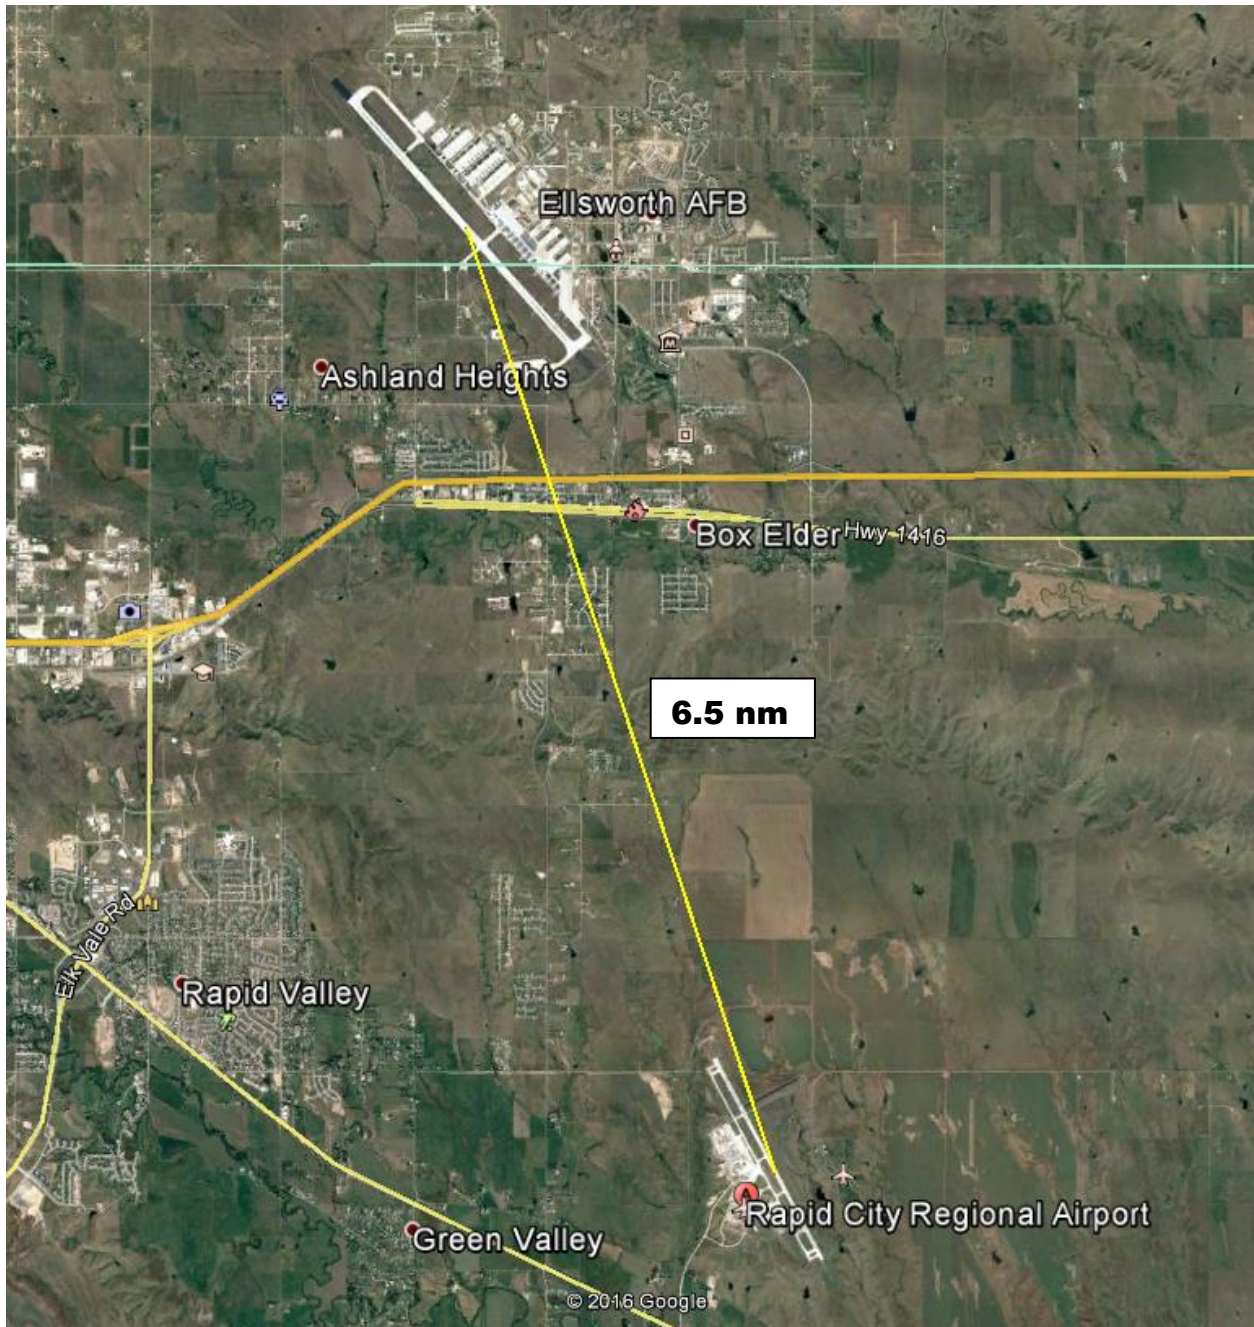
DAL2845 was an Airbus A320 operating as a scheduled Title 14 Code of Federal Regulations part 121 air carrier flight between Minneapolis and Rapid City, South Dakota (RAP). Weather conditions in the vicinity were reported as clear with 10 miles visibility. Calculated sunset at Rapid City was 2038 local time. RAP has two runways: 14/32 and 5/23. Runway 14/32 is used for air carrier operations, and is 8701 feet long by 150 feet wide. RCA has a single runway 13/31 that is 13497 feet long and 300 feet wide. The runways are located 6.5 nm apart. (Figure 1)

Figure 1 – Ellsworth AFB (RCA) and Rapid City Regional Airport (RAP), located 6.5 nautical miles apart.

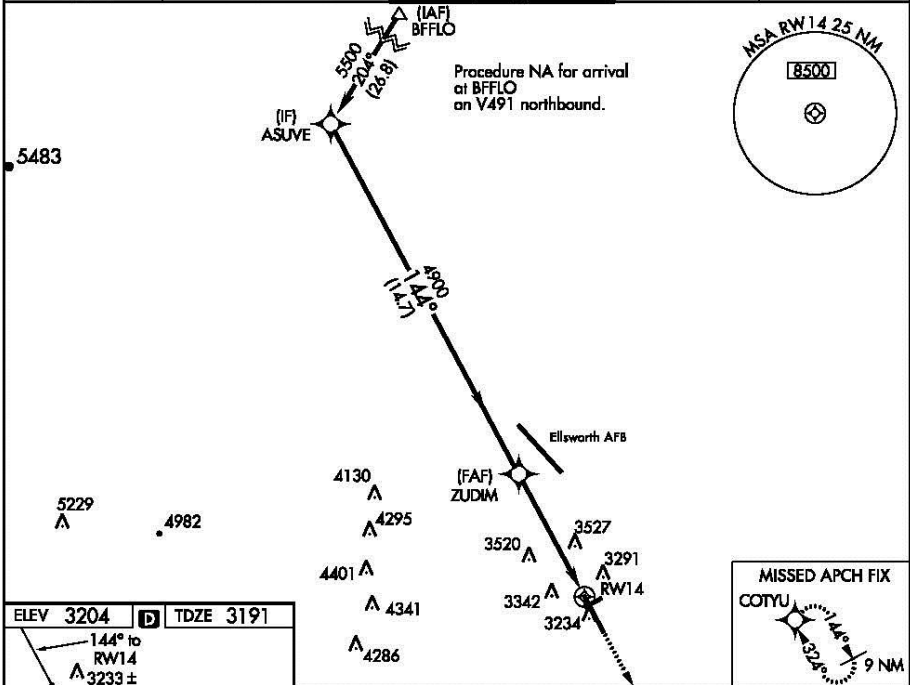
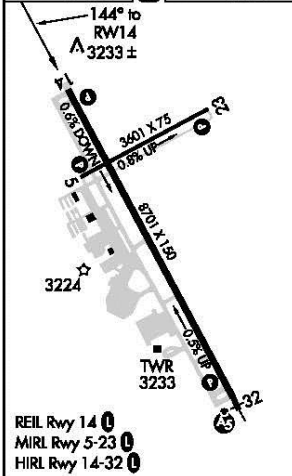
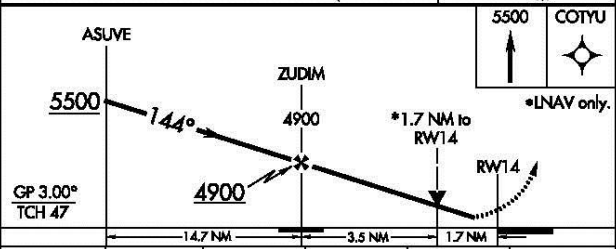
Because of the demonstrated possibility of mistaken identity, DATCF standard operating procedures in place before this incident required that pilots be advised of the proximity of RCA to RAP, as was done in this case. In addition, the location of RCA was added to Federal Aviation Administration approach charts for RAP to increase pilot awareness of the base and the possibility of confusion. Following this incident, DATCF management directed that their controllers, “...ensure that pilots arriving north of RCA on a Visual Approach to RAP report both airfields in sight, except for pilots that report that they are familiar with the local area.” In addition, RAP ATCT management directed their controllers to not issue landing clearances to aircraft inbound from the vicinity of RCA until the arriving aircraft passed the base.

Figure 2 – Example Federal Aviation Administration approach chart depicting Ellsworth AFB near the final approach course to runway 14 at RAP. DAL2845 was cleared for a visual approach.

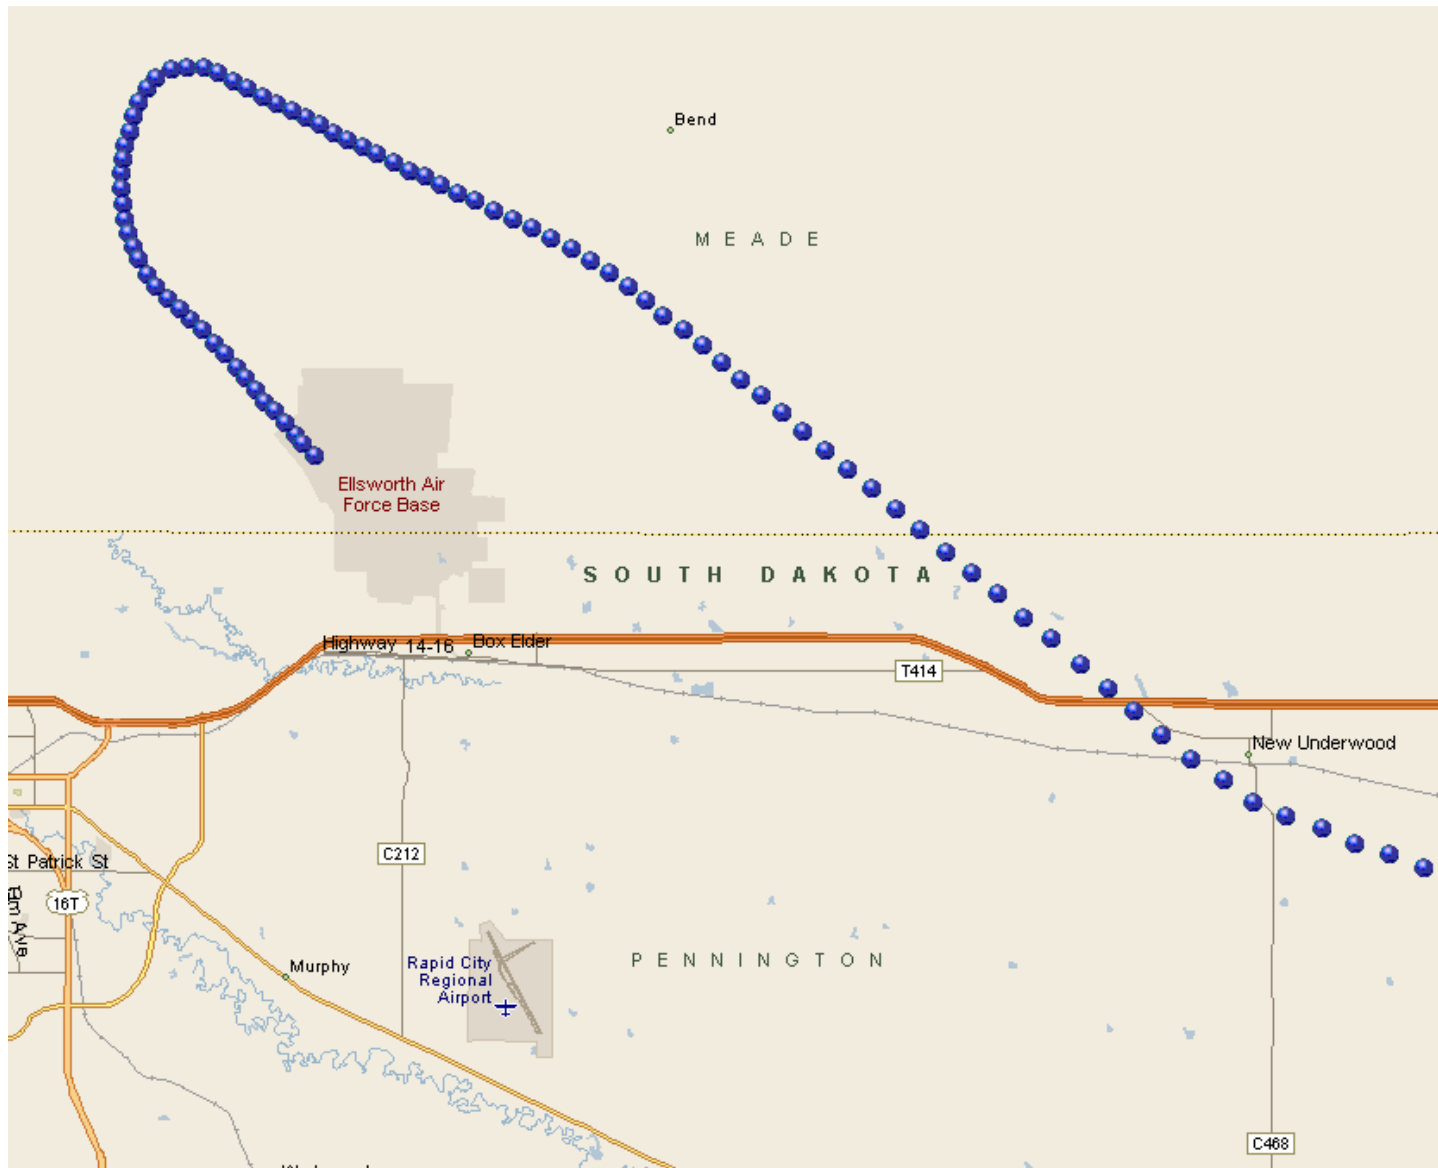
The EA controller provided radar vectors for the visual approach and advised the tower controller at RAP of the inbound flight. At 2036, the EA and RAP controllers engaged in a discussion about DAL2845 being unusually high and fast. At 2037, the EA controller tried to turn DAL2845 to heading 230, but the pilot responded, "Like to keep her a little high. You mind if we keep going out a little bit longer?" The controller instructed the pilot to continue present heading and advise when ready to proceed inbound. The extended downwind track took the aircraft northeast of RCA.

Figure 3 – DAL2845 track during vectors for the visual approach to RAP (located 6.45 nm SE of Ellsworth AFB).

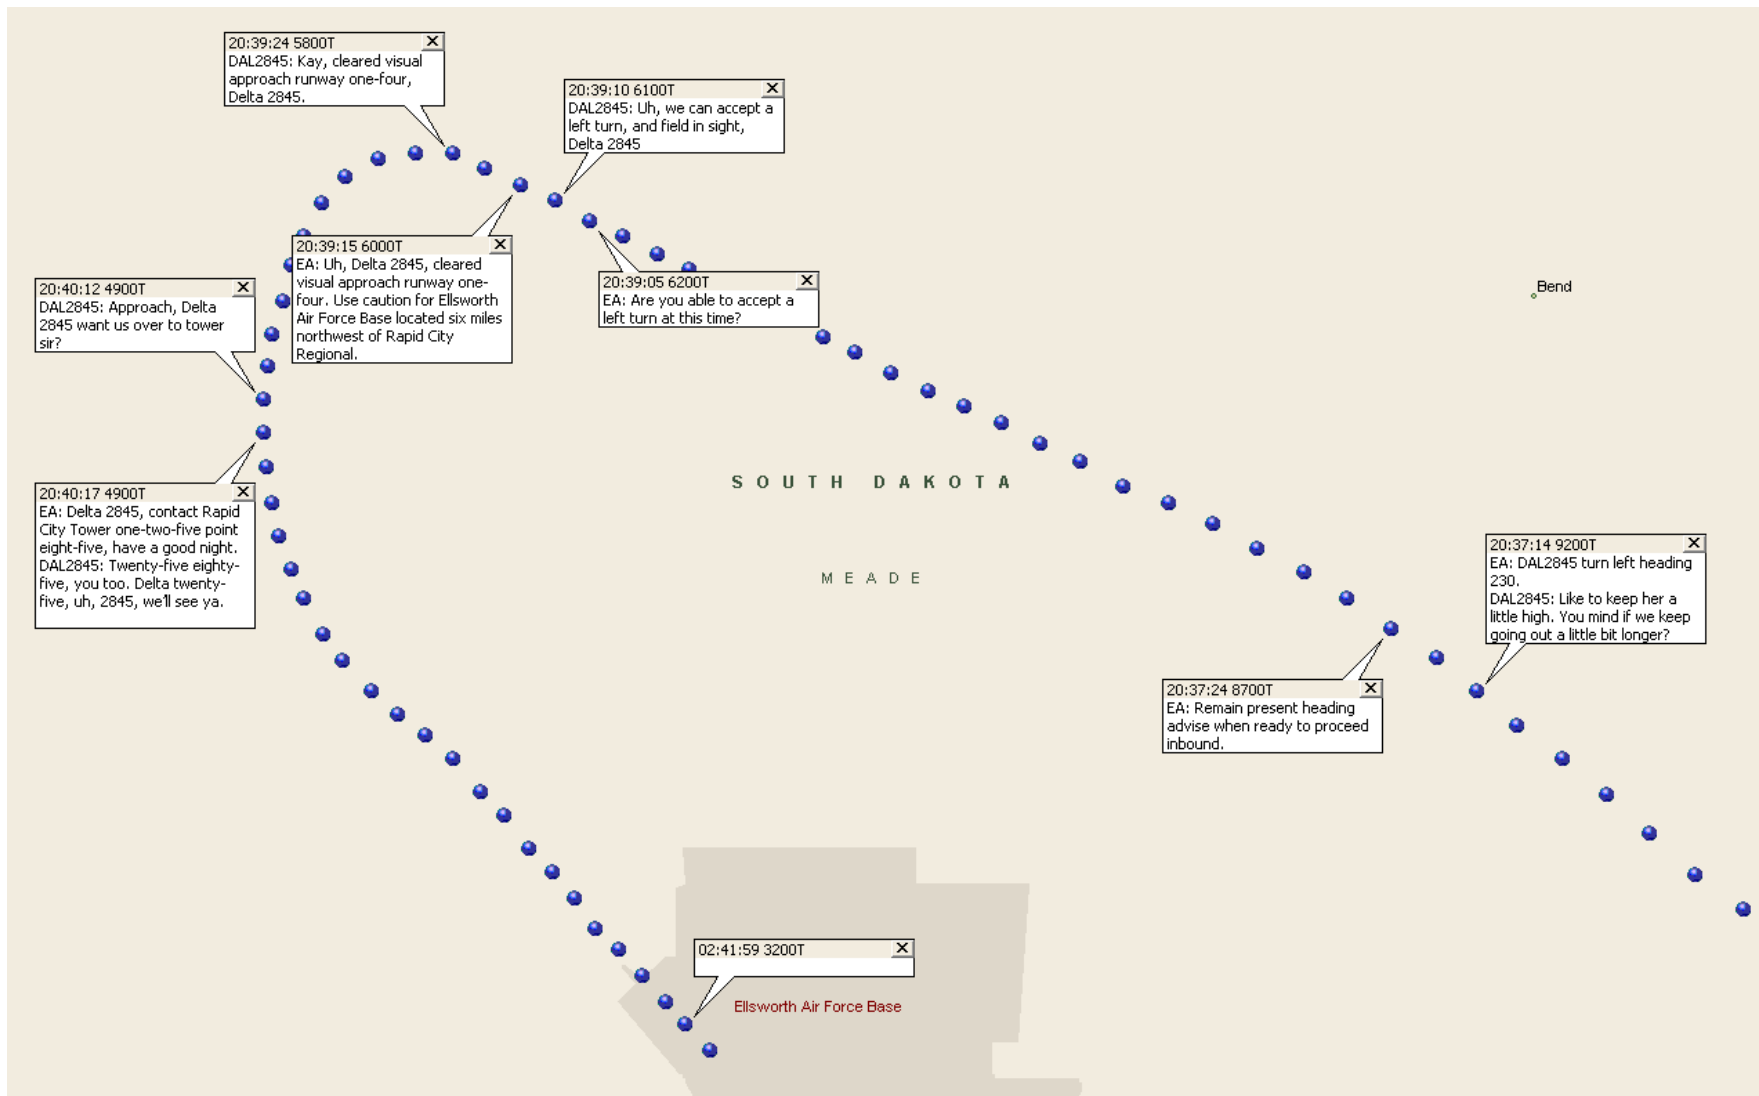
At 2040:10, the pilot transmitted, "Approach, Delta 2845 want us over to tower sir?" The EA controller instructed the pilot to contact RAP tower on 125.85, and the pilot acknowledged. At 2040:39, the pilot contacted RAP ATCT reporting inbound to runway 14, and the RAP controller cleared him to land on runway 14. At 2042:16, about 1 minute and 30 seconds after being cleared to land, the pilot reported that DAL2845 had landed at RCA.

minimum safe altitude alert. Review of DATCF radar data showed that as DAL2845 approached the RCA area, STARS applied MSAW rules for RCA arrivals instead of RAP arrivals. Consequently, no alert was generated in this incident. This behavior has been identified in other “wrong airport” landings. On May 4, 2015, the NTSB issued safety recommendation A-15-10 to the FAA (which also uses STARS), asking that FAA, “Modify the minimum safe altitude warning (MSAW) software to apply the MSAW parameters for the flight plan destination airport to touchdown, rather than automatically reassigning the flight to another airport based on an observed (and possibly incorrect) trajectory.”<sup>1</sup> The recommendation is currently classified “Open – Acceptable Alternate Response.” According to information provided by Department of Defense STARS operational support staff located at Patuxent River Naval Air Station (responsible for DATCF STARS), changing MSAW behavior will likely require Raytheon Corporation to modify the STARS baseline software.

Figure 4 – DAL2845 ground track with selected communications.
