NATIONAL TRANSPORTATION SAFETY BOARD

Group Chairman's Factual Report

AIR TRAFFIC CONTROL

CEN16FA211

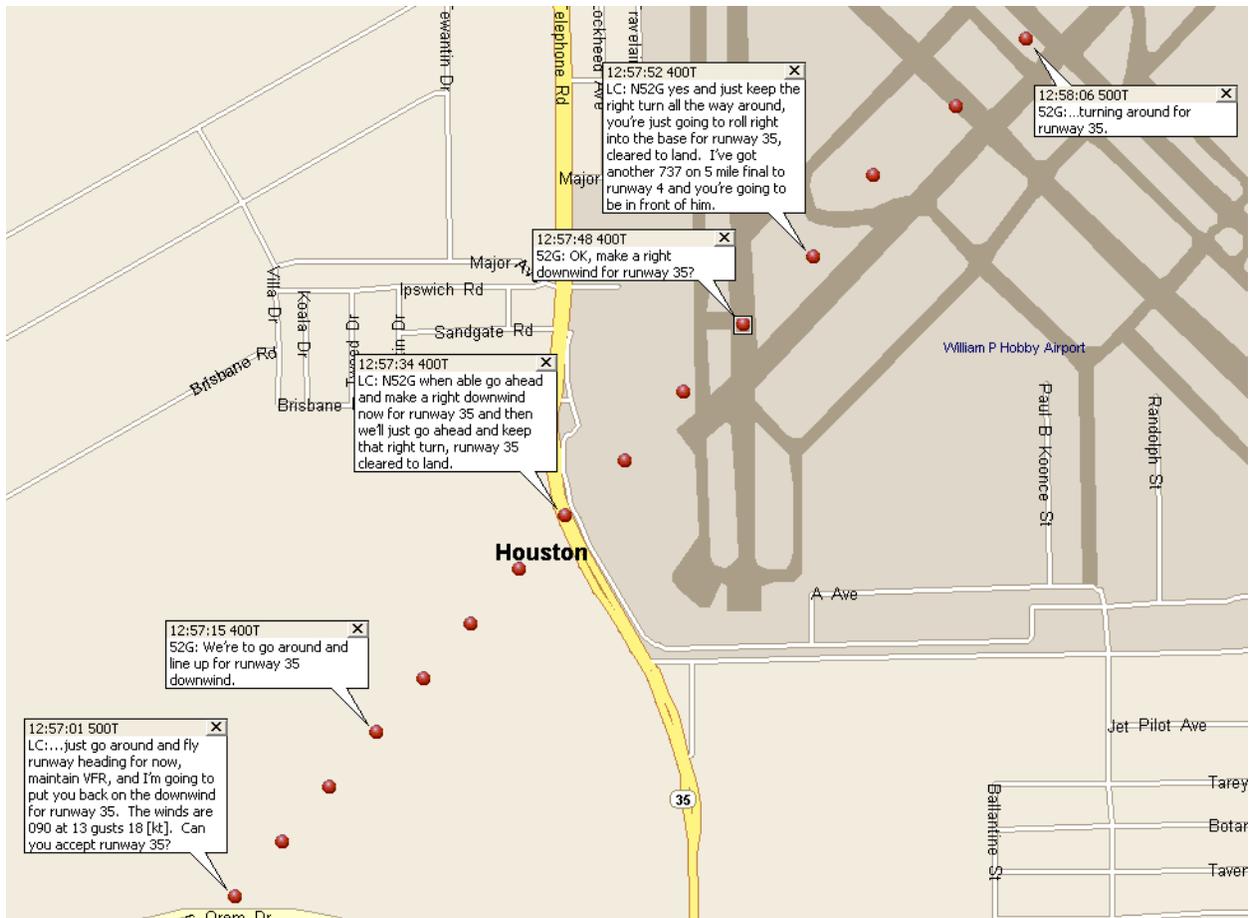
Figure 2 – Initial approach to runway 4 and ATC-directed go-around.

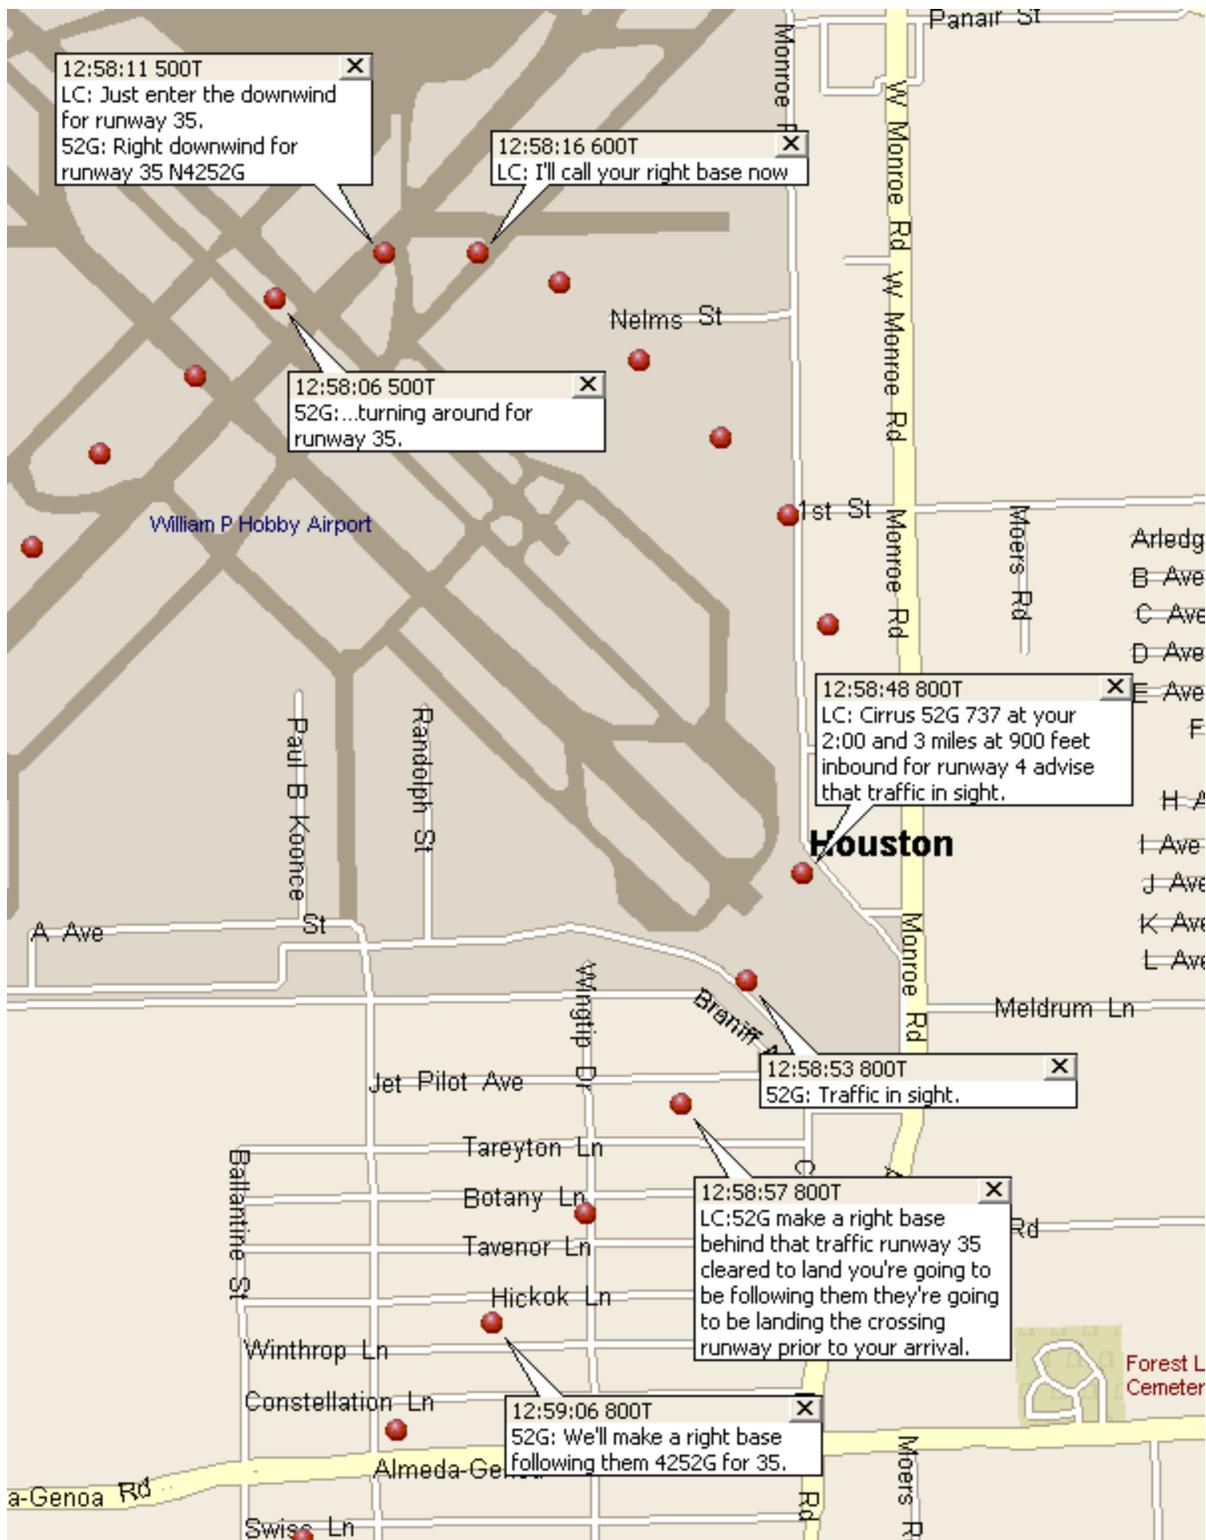
Figure 3 – Maneuvers following the initial go-around.

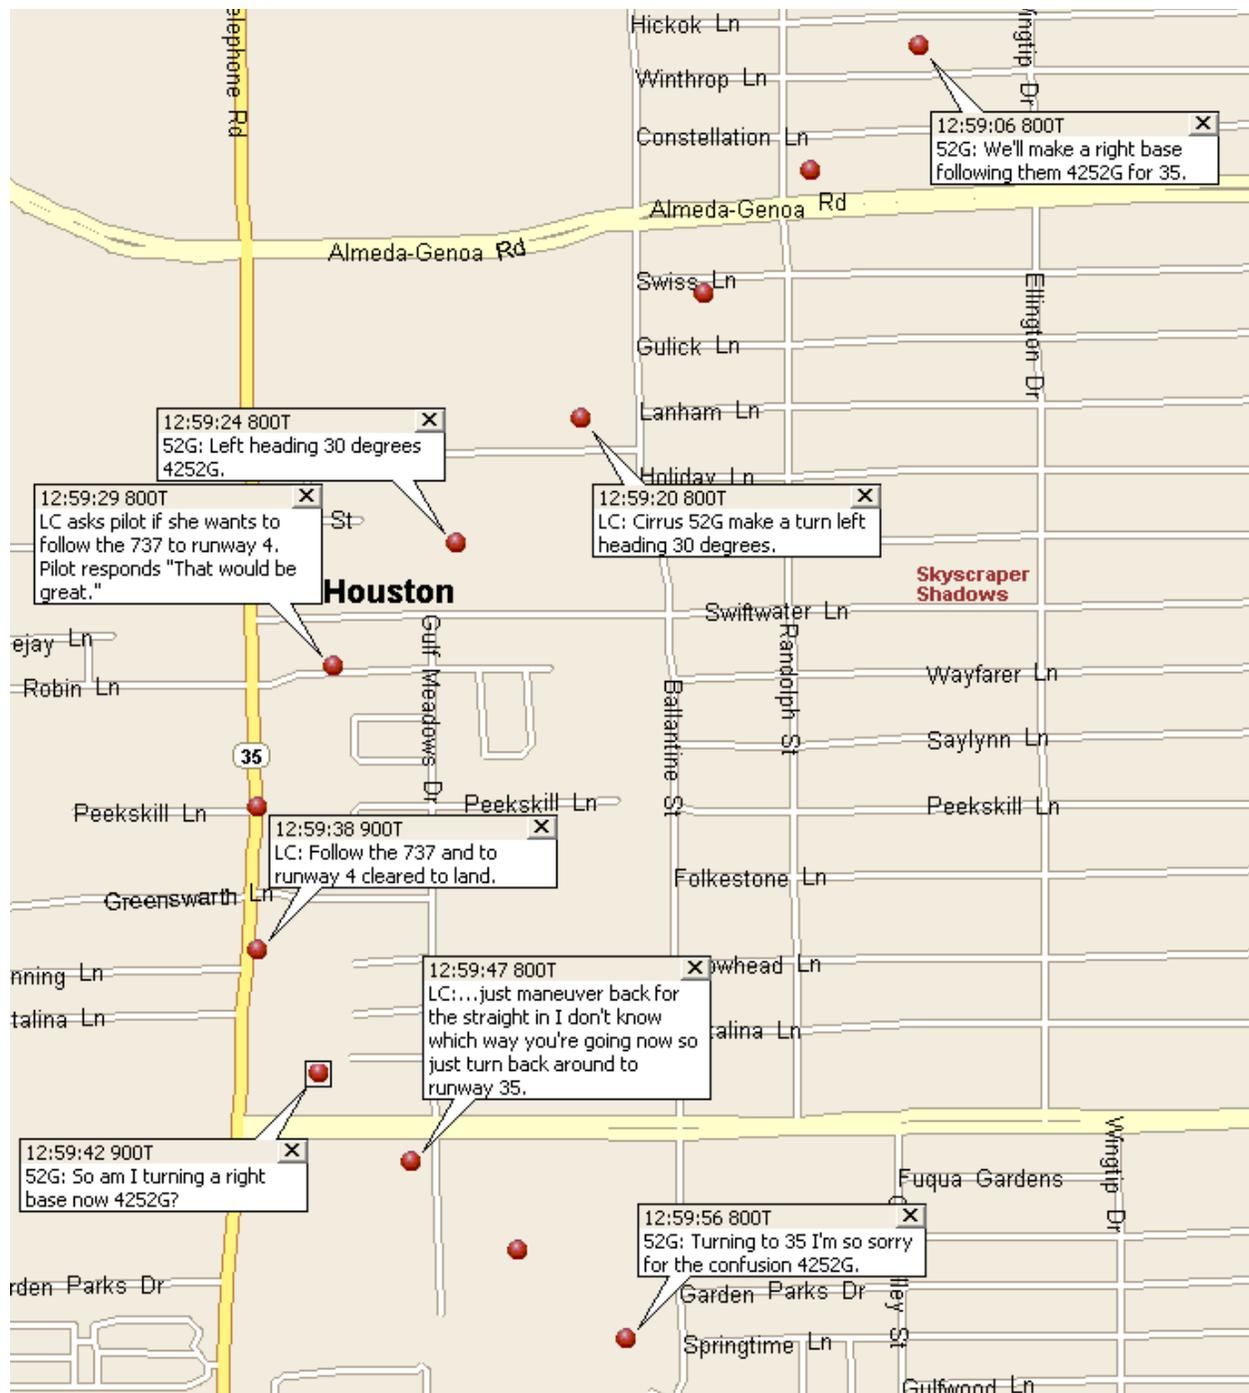
Figure 4 – Continued pattern maneuvers.

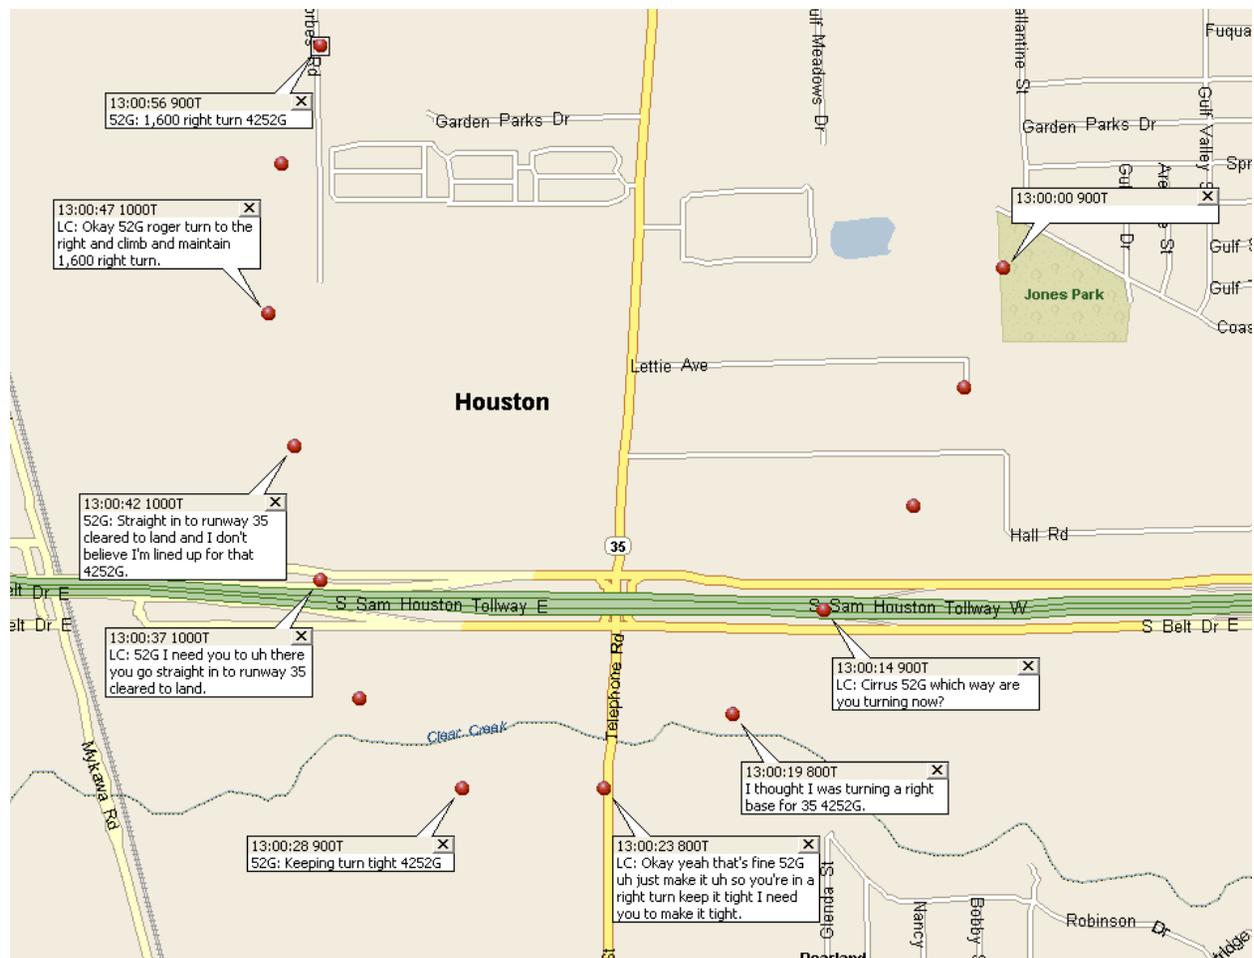
Figure 5 – Continued pattern maneuvers.

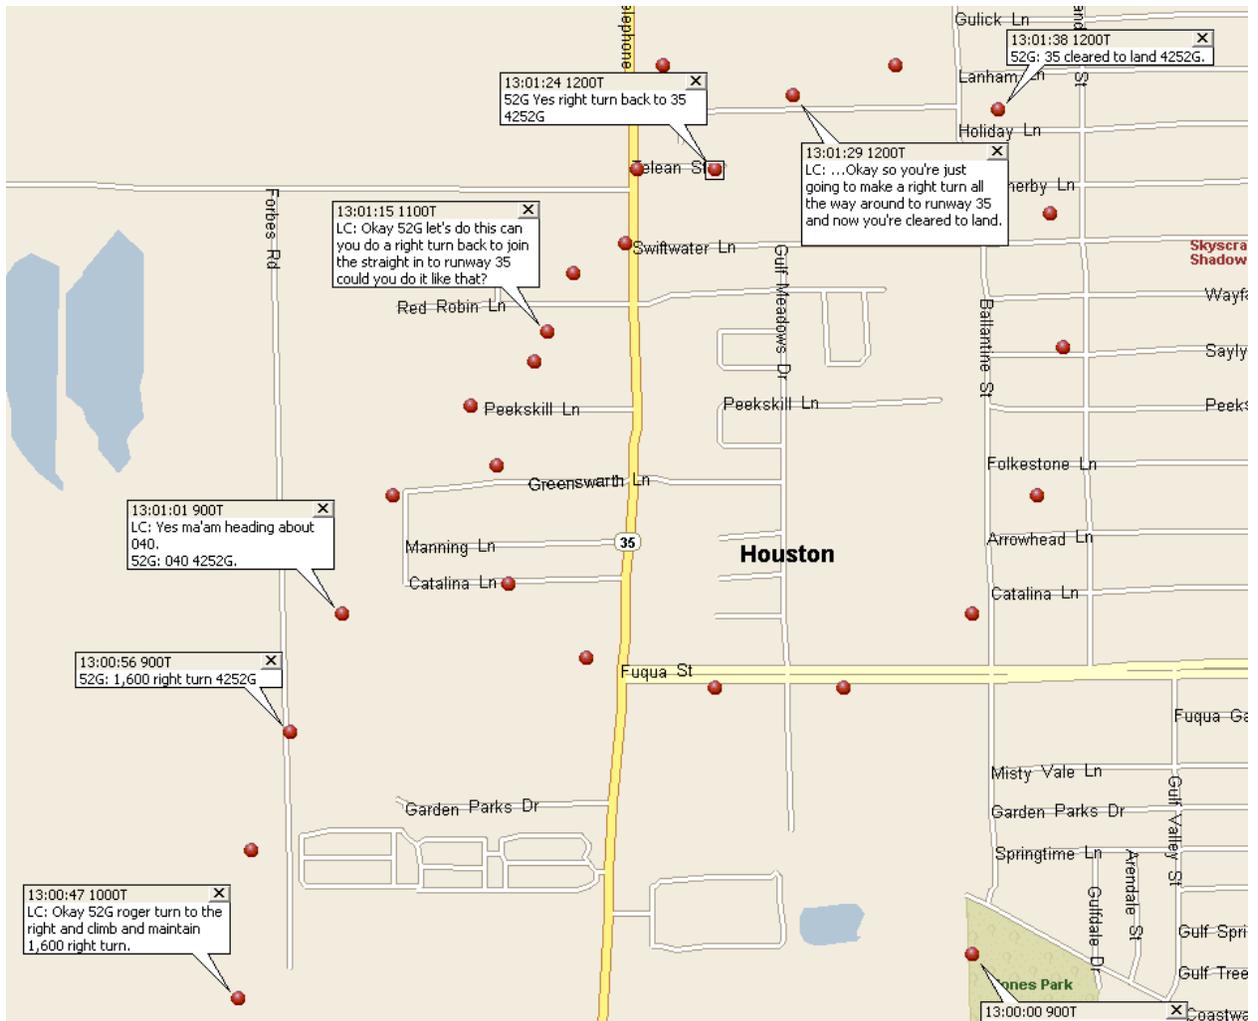
Figure 6 – Changing approach from runway 4 to runway 35.

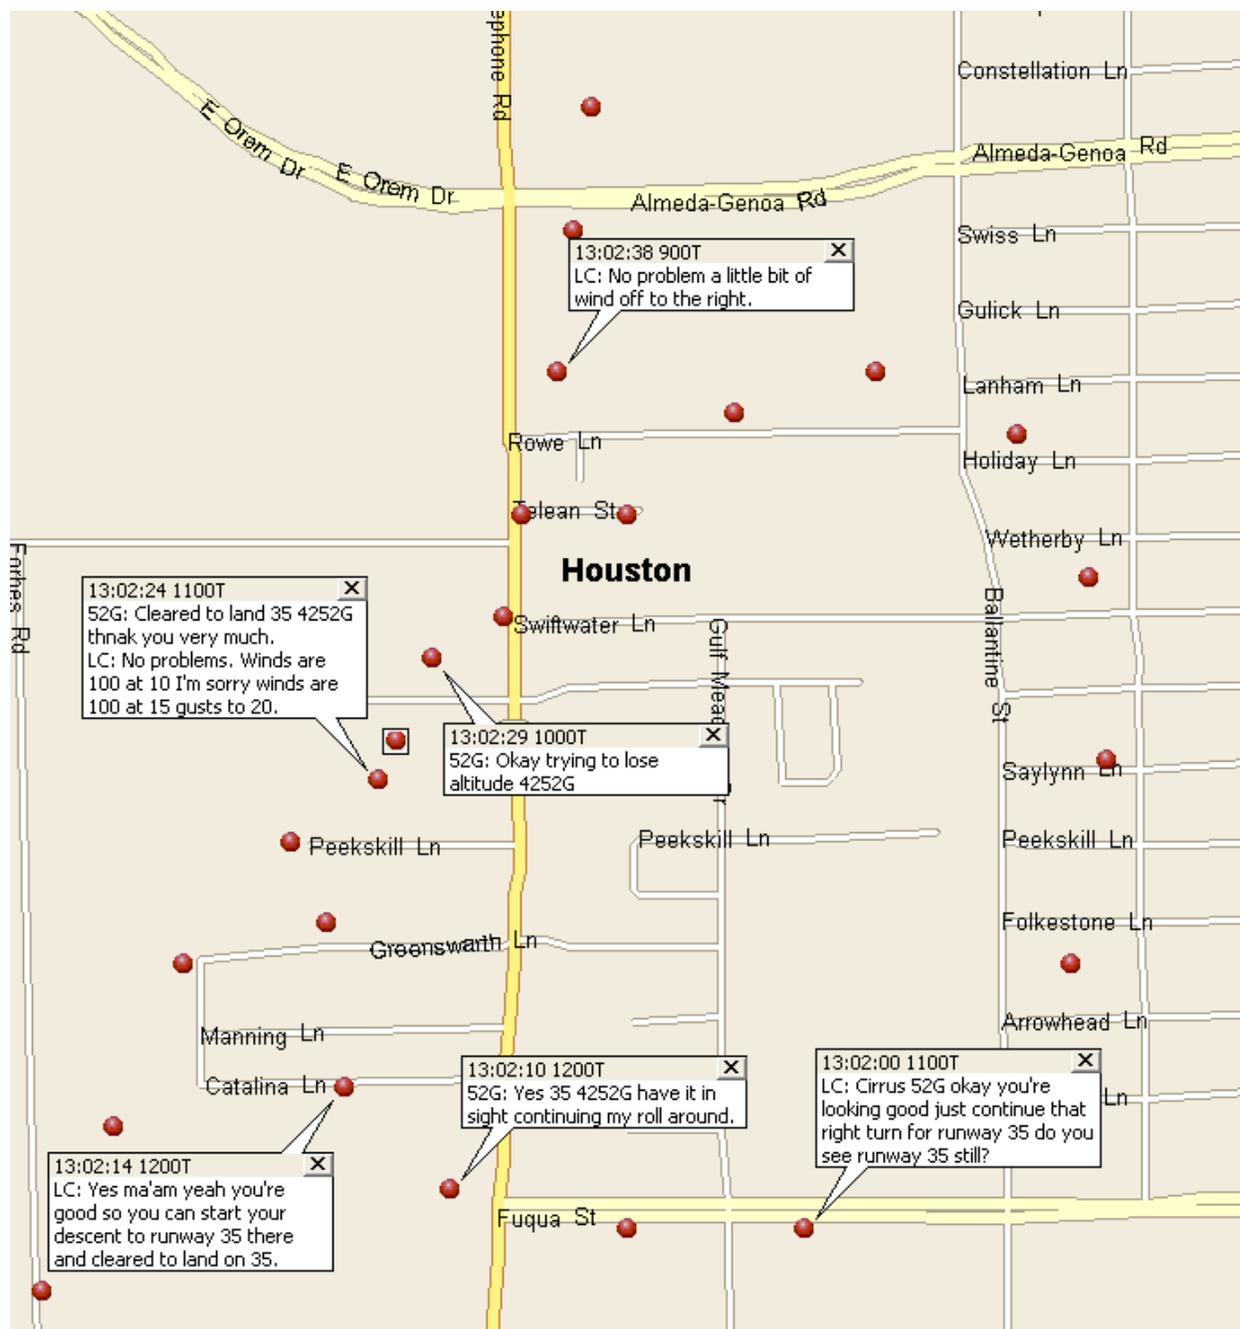
Figure 7 – Setting up for initial straight-in to runway 35.

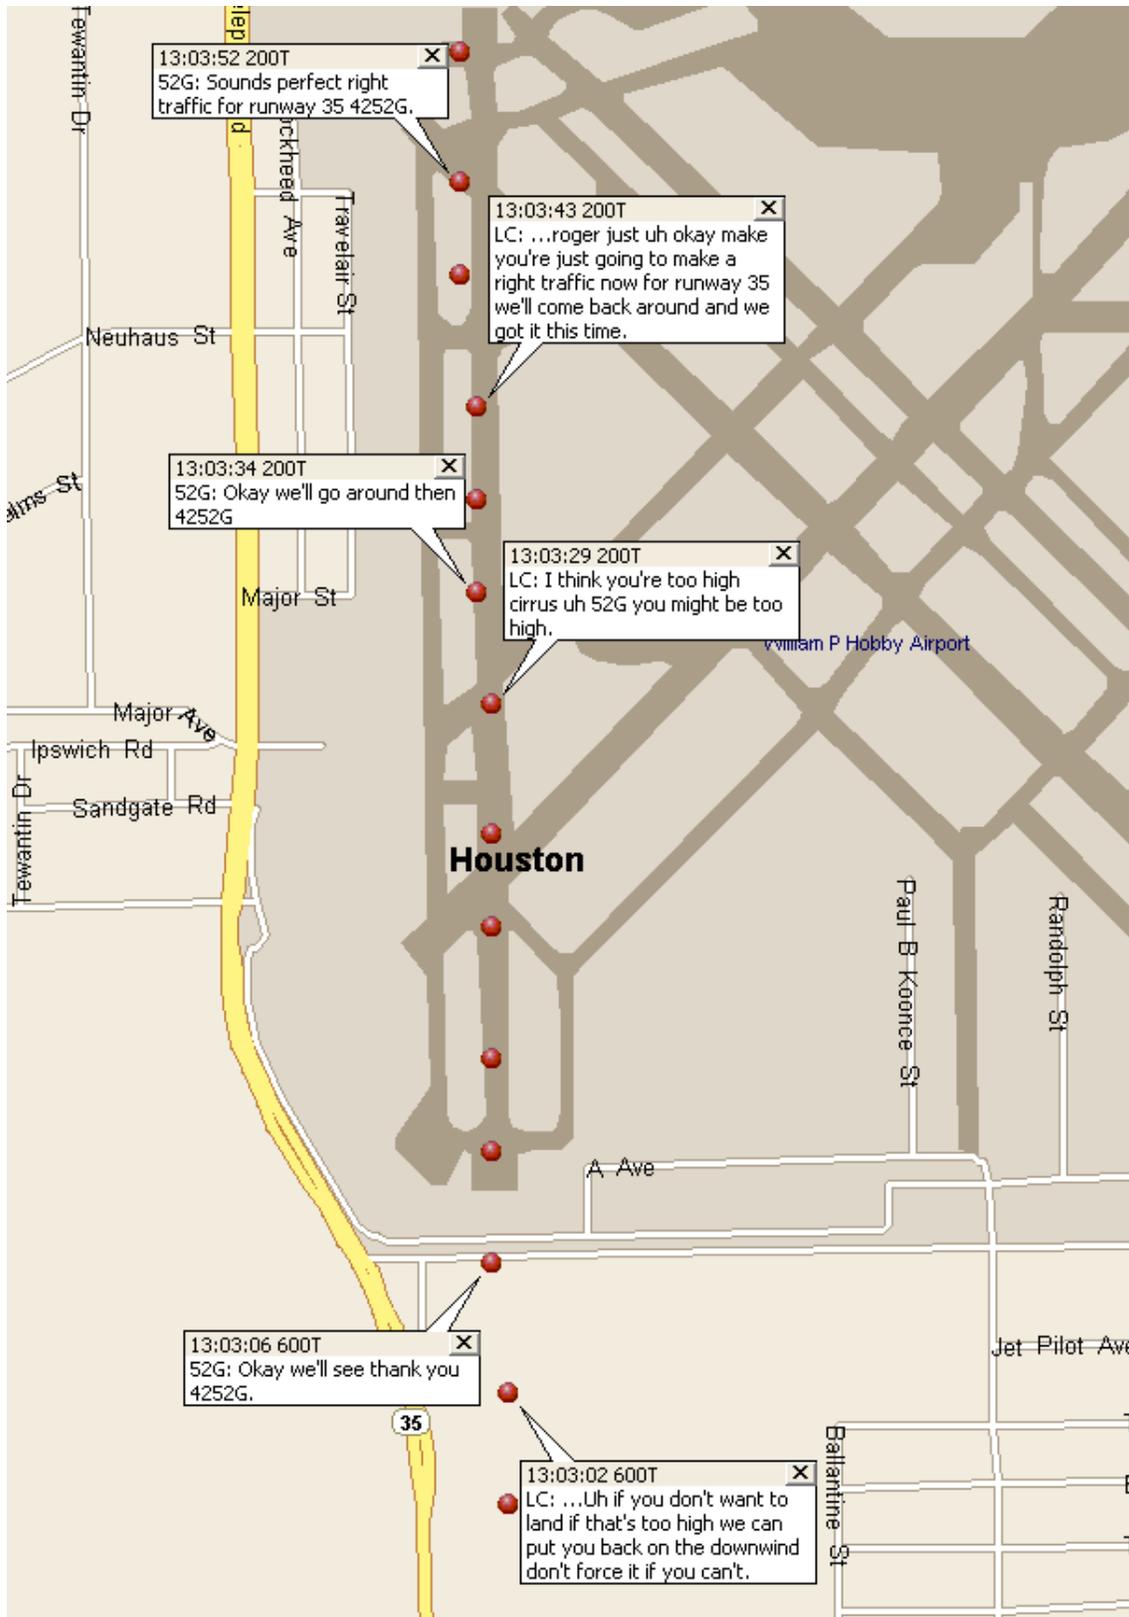
Figure 8 – Runway 35 first approach and go-around.

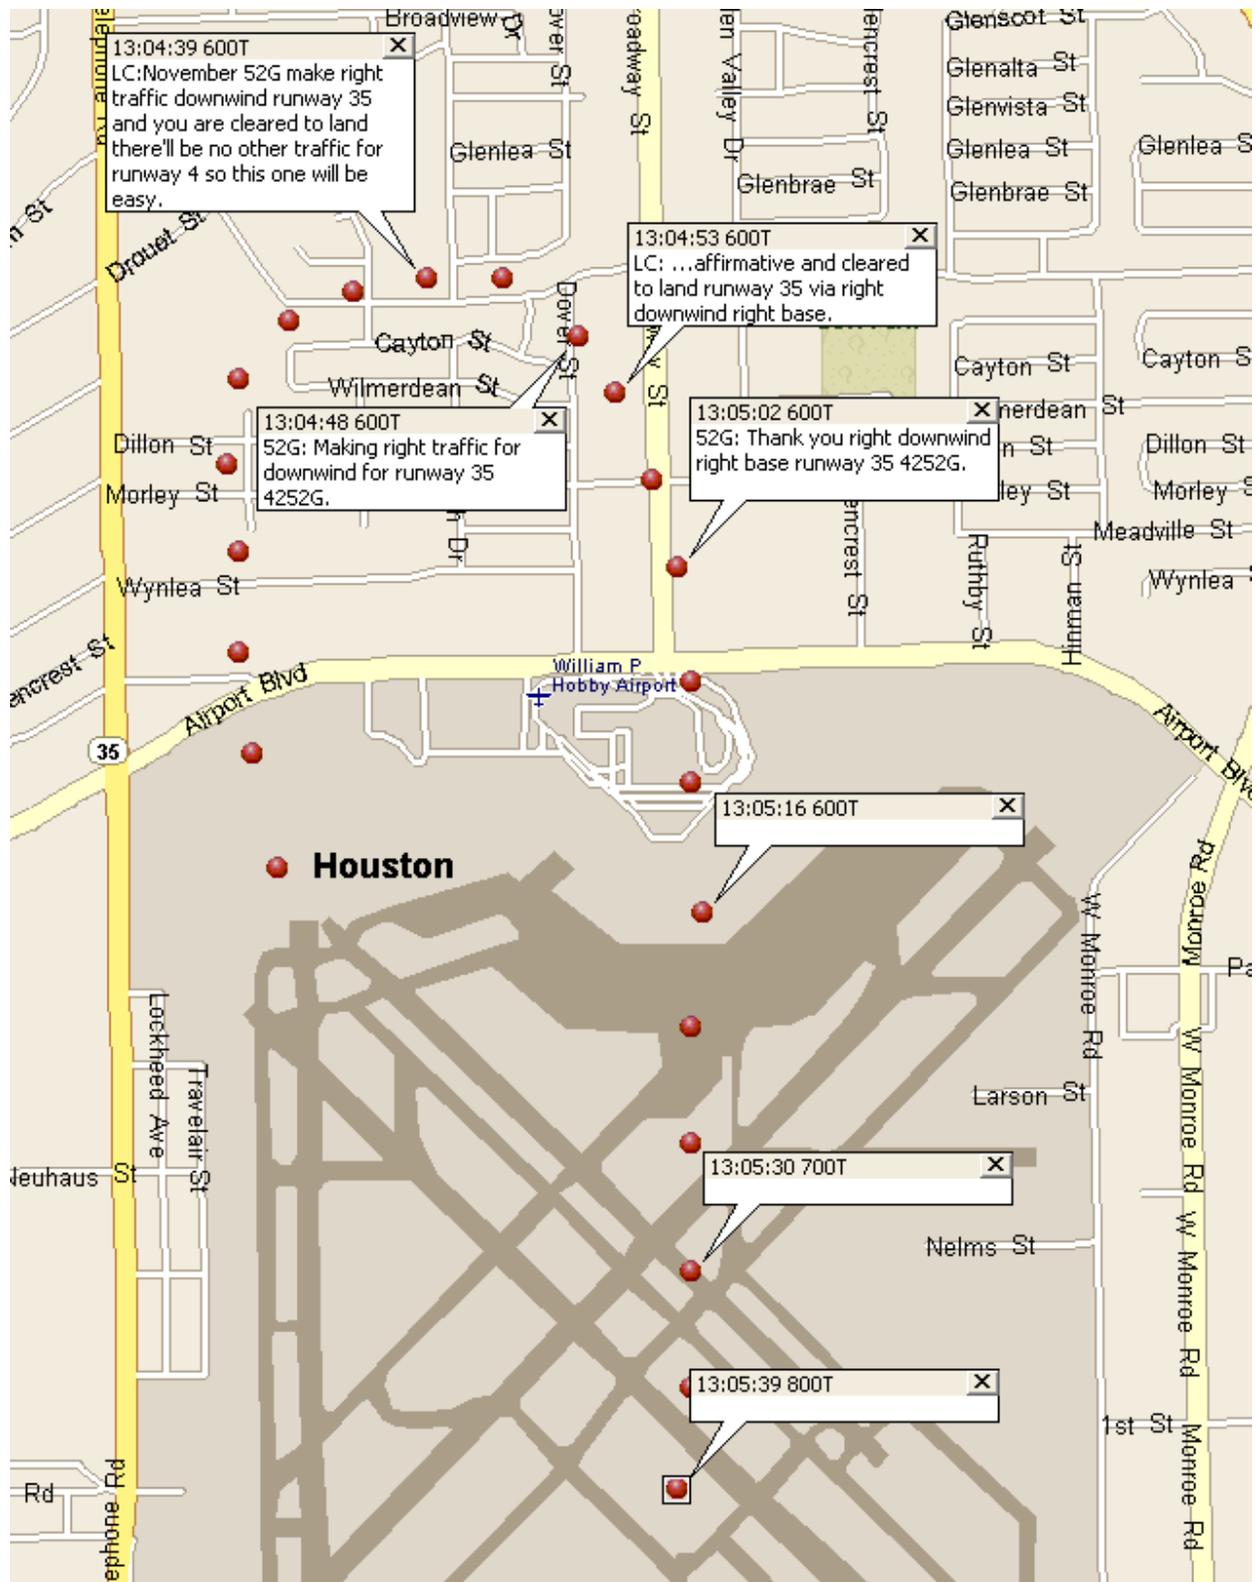
Figure 9 – Preparing for second approach to runway 35.

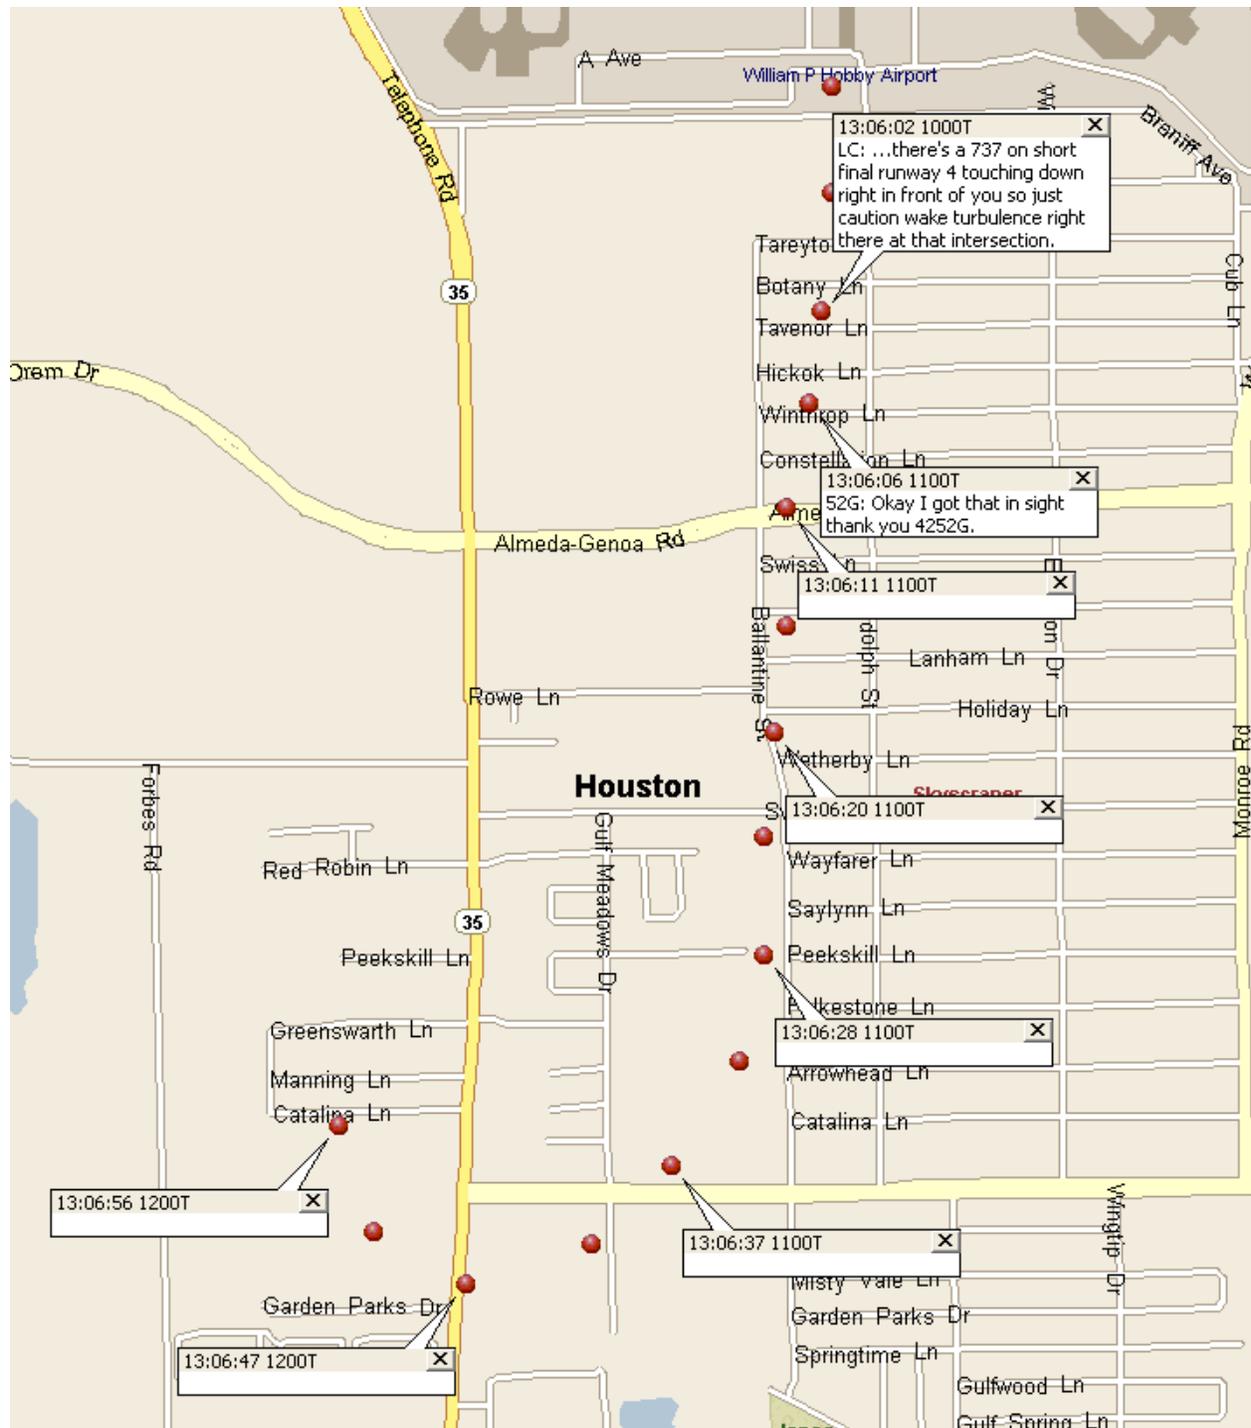
Figure 10 – Downwind to final turn, second approach to runway 35.

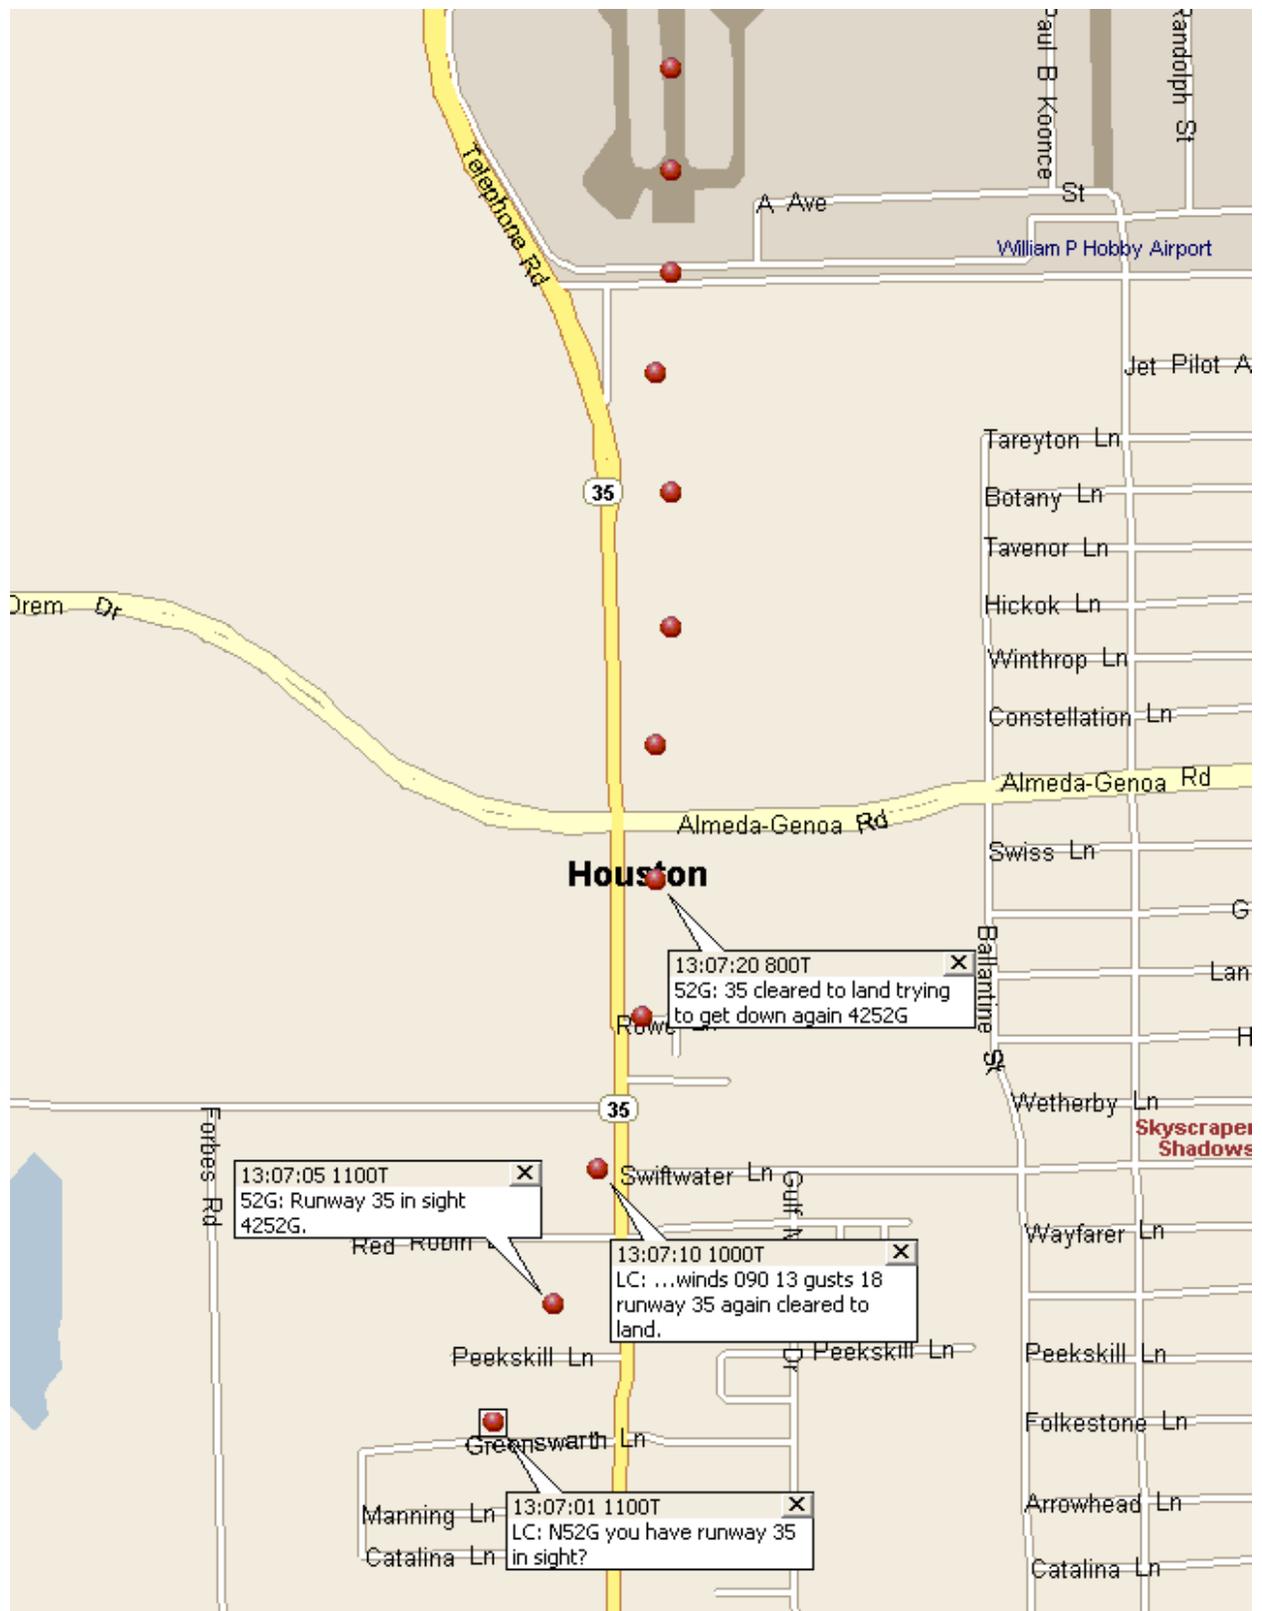
Figure 11 – Second approach to runway 35.

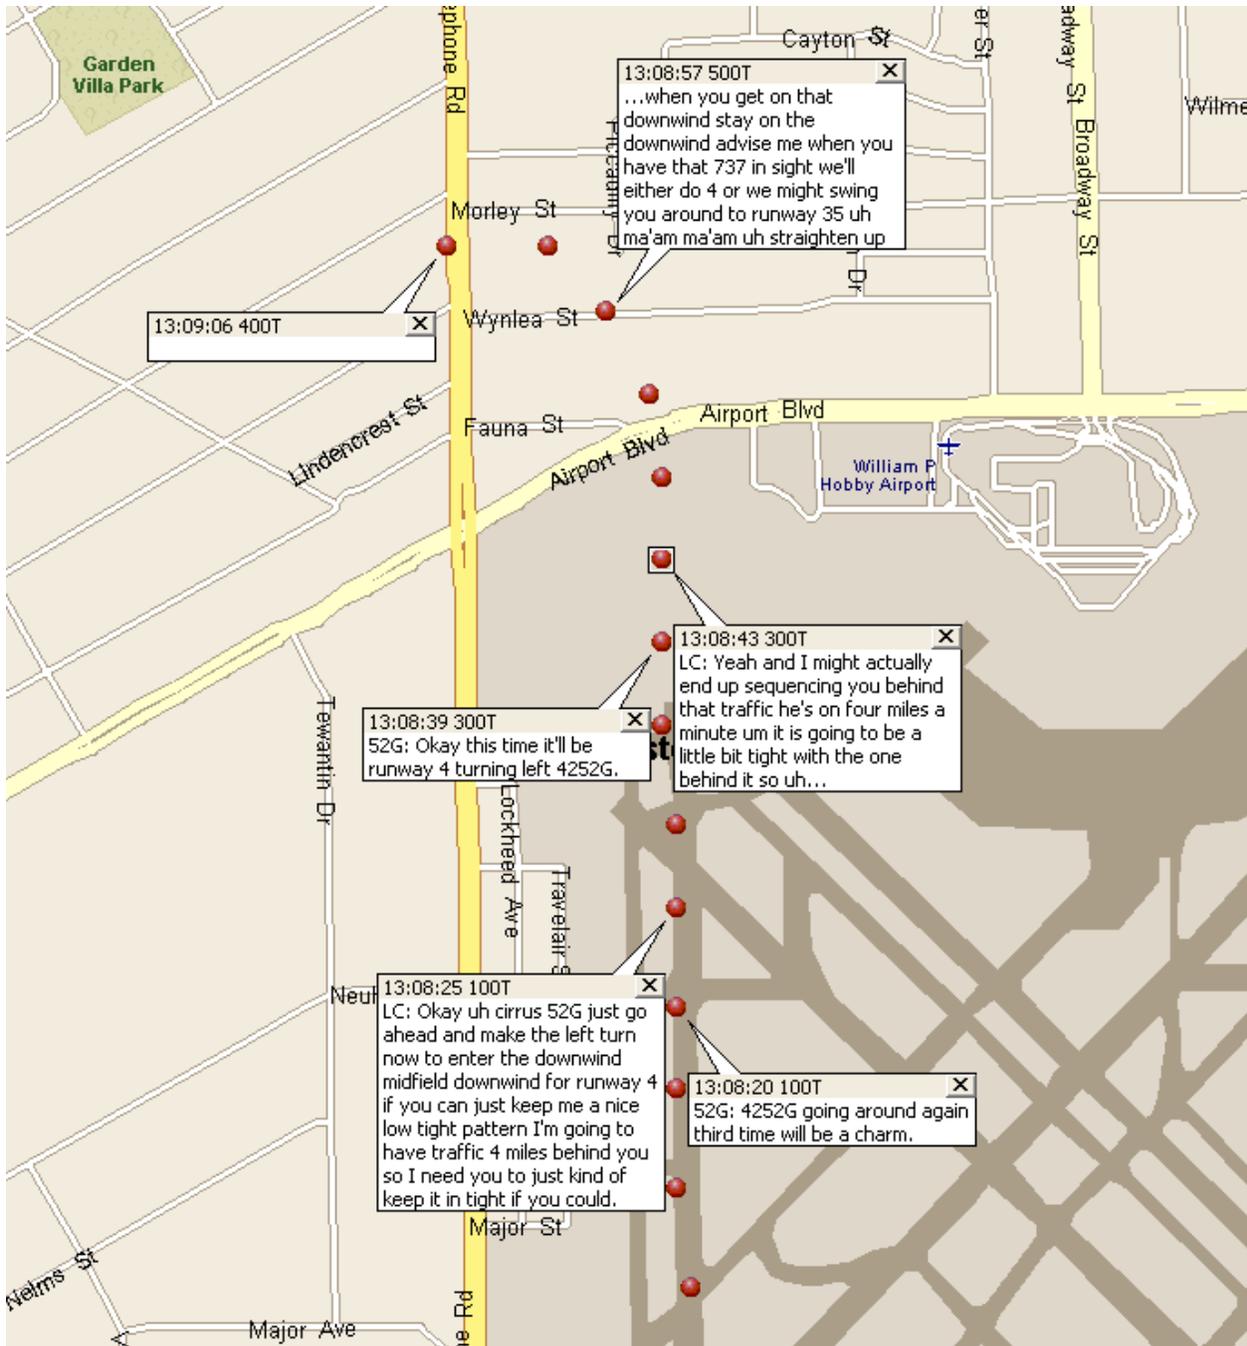
Figure 12 – Go-around following second approach to runway 35 and loss of contact.
