NATIONAL TRANSPORTATION SAFETY BOARD

Group Chairman's Factual Report

AIR TRAFFIC CONTROL

DCA17IA148

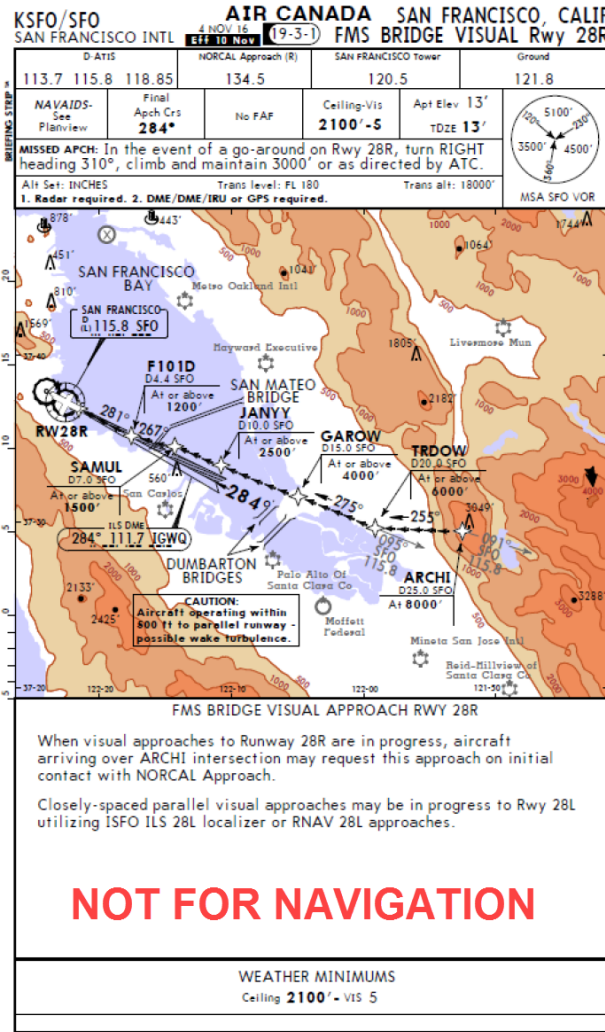
Figure 1. Air Canada FMS Bridge Visual runway 28R approach chart.

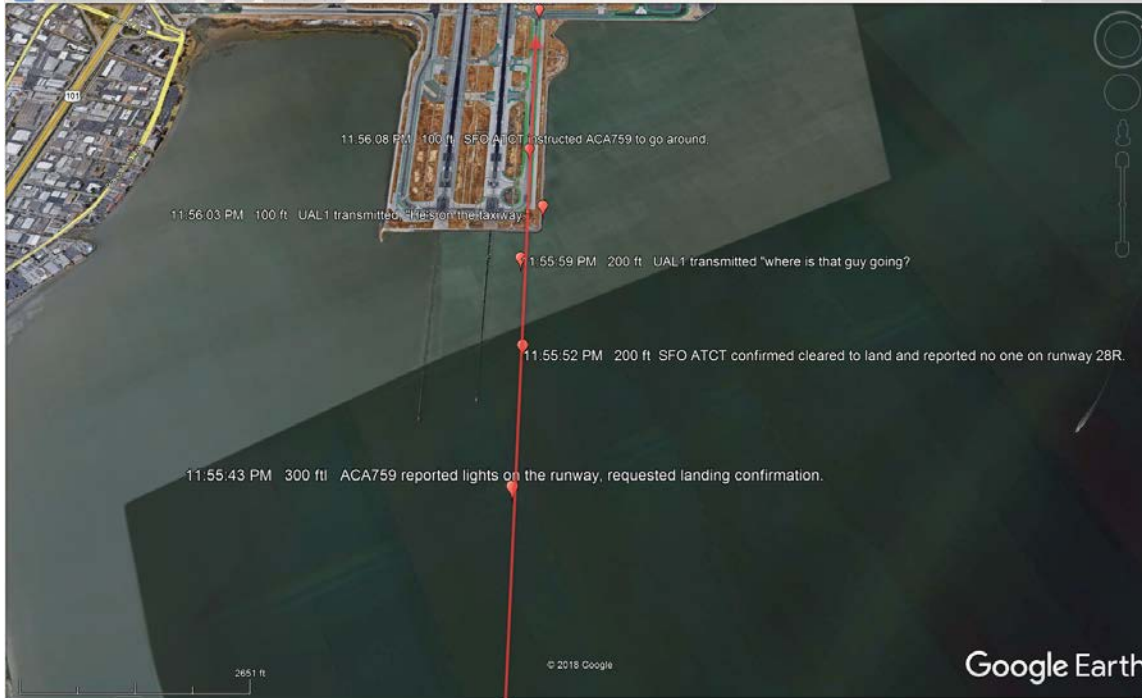
At 2356:09, the LC/CIC controller instructed ACA759 to go around. The pilot acknowledged that he was going around. The LC/CIC controller advised the pilot that he appeared to have been lined up for taxiway C.

Figure 2. Radar plot that depicts the location of ACA759 from the time the flight reported lights on the runway until the flight was issued a go around by SFO ATCT.

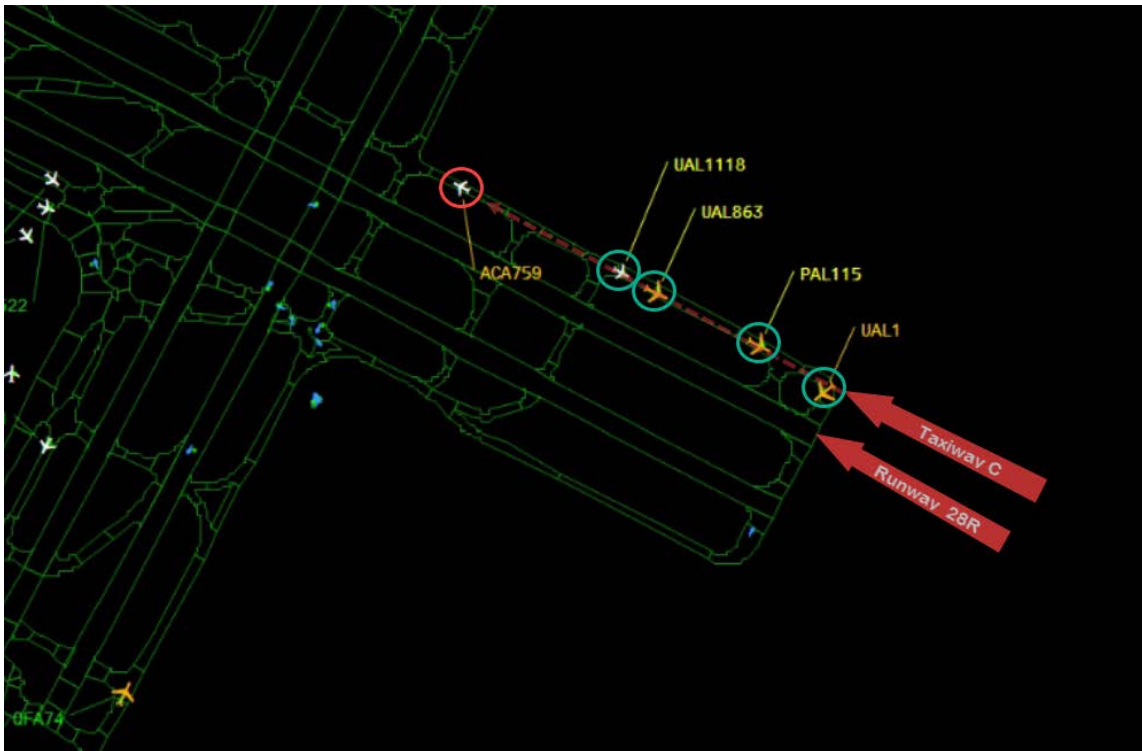
Radar data indicated that four aircraft occupied taxiway C when ACA759 over flew the taxiway. The four aircraft, in sequence for takeoff on runway 28R were United Airlines flight 1 (UAL1), a Boeing 787-900, Philippine Airlines flight 115 (PAL115), an Airbus A340-300, United Airlines flight 863 (UAL863), a Boeing 787-900, and United Airlines flight 1118 (UAL1118), a Boeing 737-900. (Figure 3 is a radar screen shot that depicts the positions of the airplanes on the taxiway at the time of the incident.)

Figure 3. Radar screen shot that depicts the positions of the airplanes on the taxiway at the time of the incident.

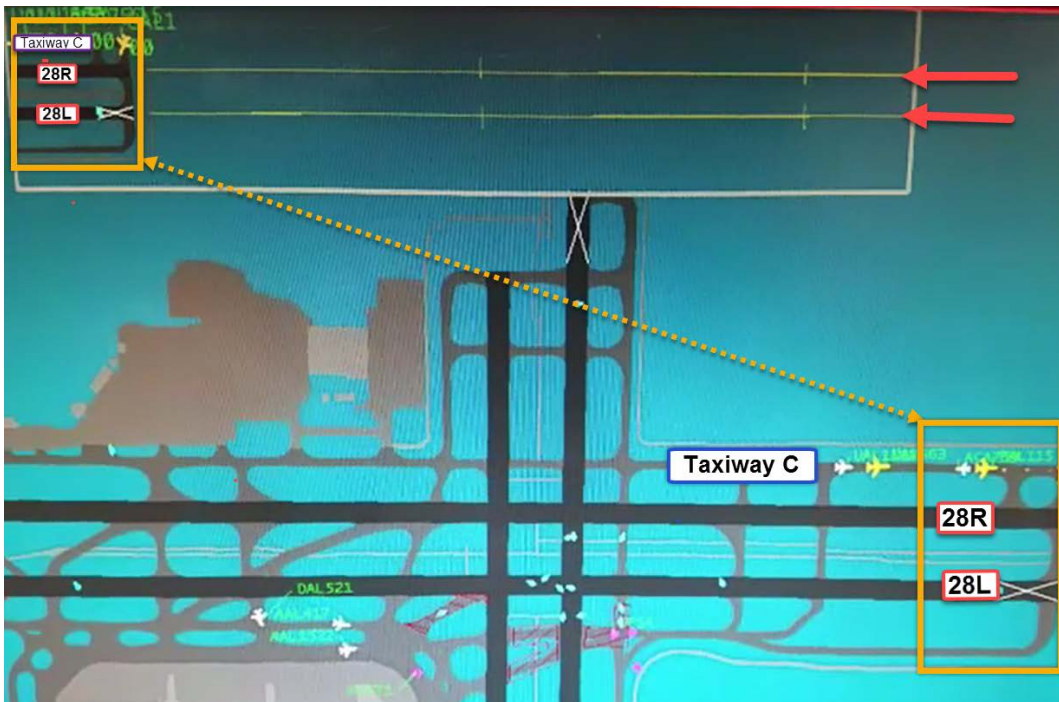
The SFO ATCT ASSC display presented aircraft and vehicle positions overlaid on a map of the airport's runways, taxiways and approach corridors. The ASSC display included a two-dimensional display of the extended runway centerlines, which extended out to about 2 1/2 nautical miles (nm). (Figure 4 is a photo of the ASSC display at SFO. The bottom portion of the photo shows the airport movement areas, and the top portion of the photo shows the extended runway centerlines for runway 28R and 28L.)

Figure 4. Photo of the ASSC display at SFO.
