## **NATIONAL TRANSPORTATION SAFETY BOARD**

### **Group Chairman's Factual Report**

# **AIR TRAFFIC CONTROL**

OPS17IA010

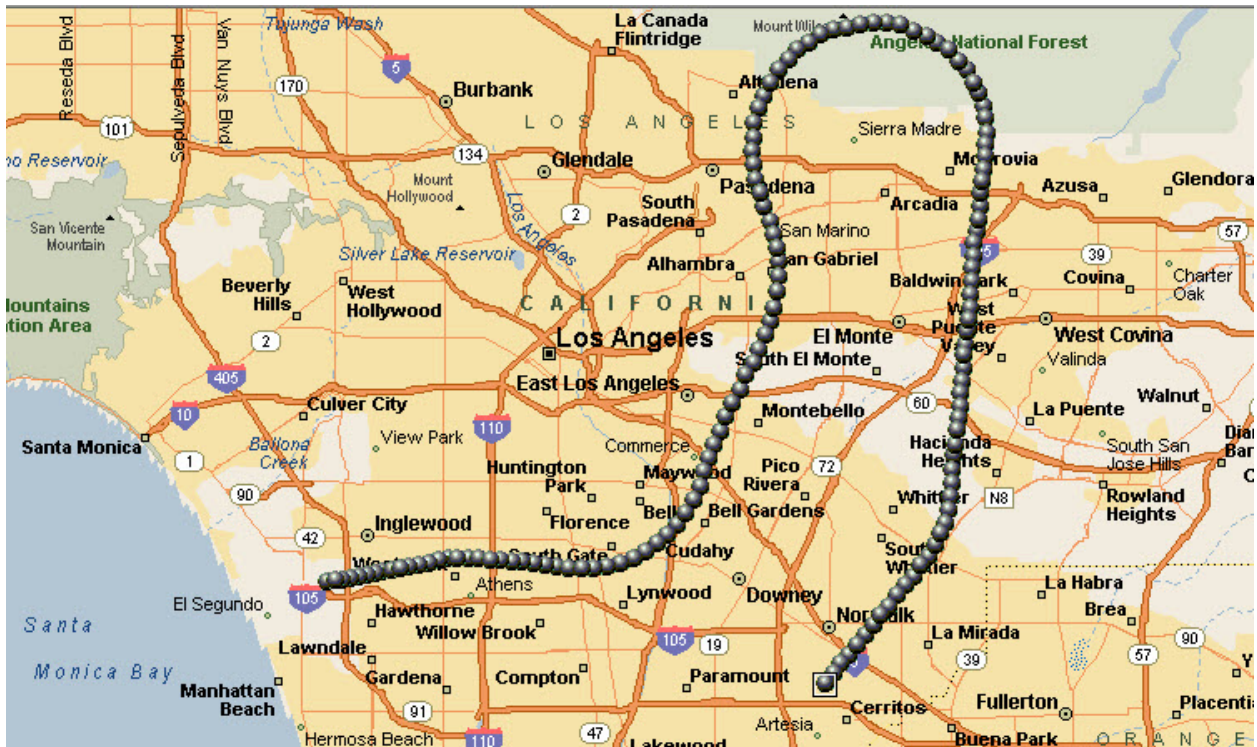
Figure 2 - Radar data showing EVA015 departing LAX and being turned northbound toward Mount Wilson.

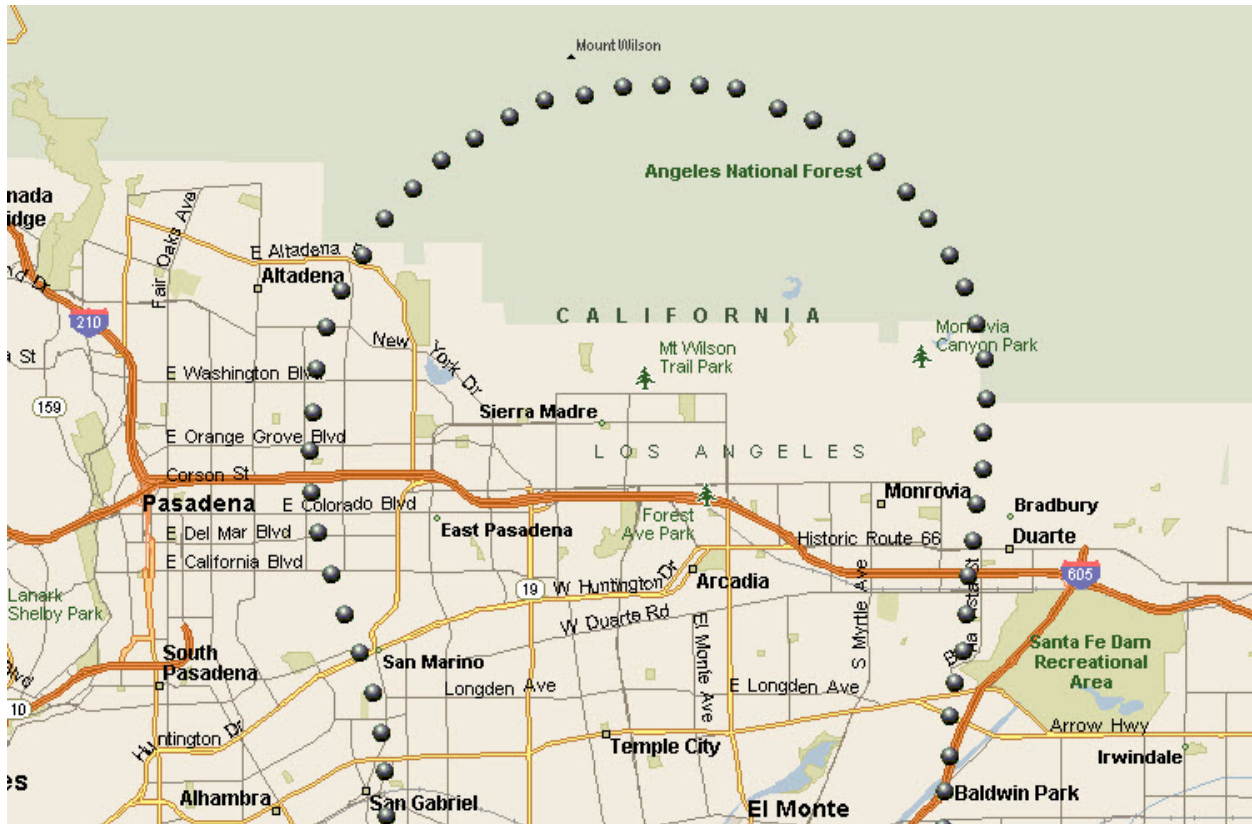
Figure 3 - Radar data showing EVA015 making a right turn just south of Mount Wilson.

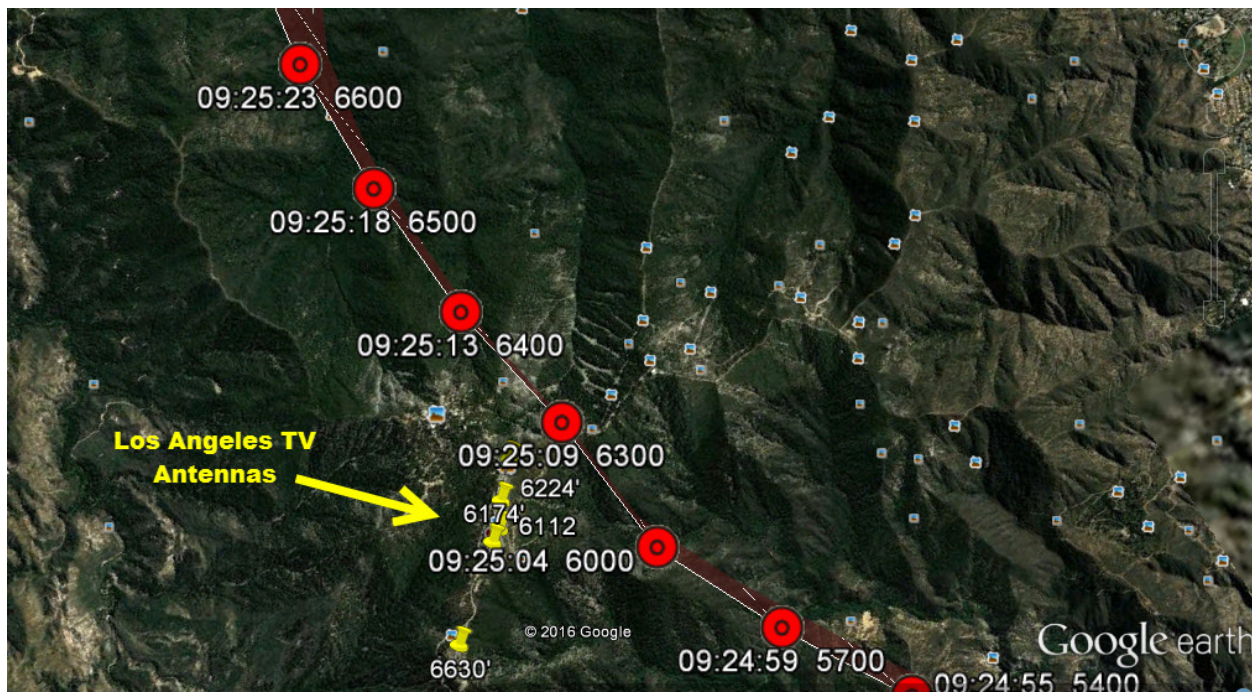
Figure 4 - Radar data overlaid on a Google Earth image with the TV antennas and the associated heights plotted.

flew within “0.5 nm laterally, and below the published and charted altitude of a displayed obstruction.”<sup>10</sup>
