NATIONAL TRANSPORTATION SAFETY BOARD

Group Chairman's Factual Report

AIR TRAFFIC CONTROL

CEN19LA074

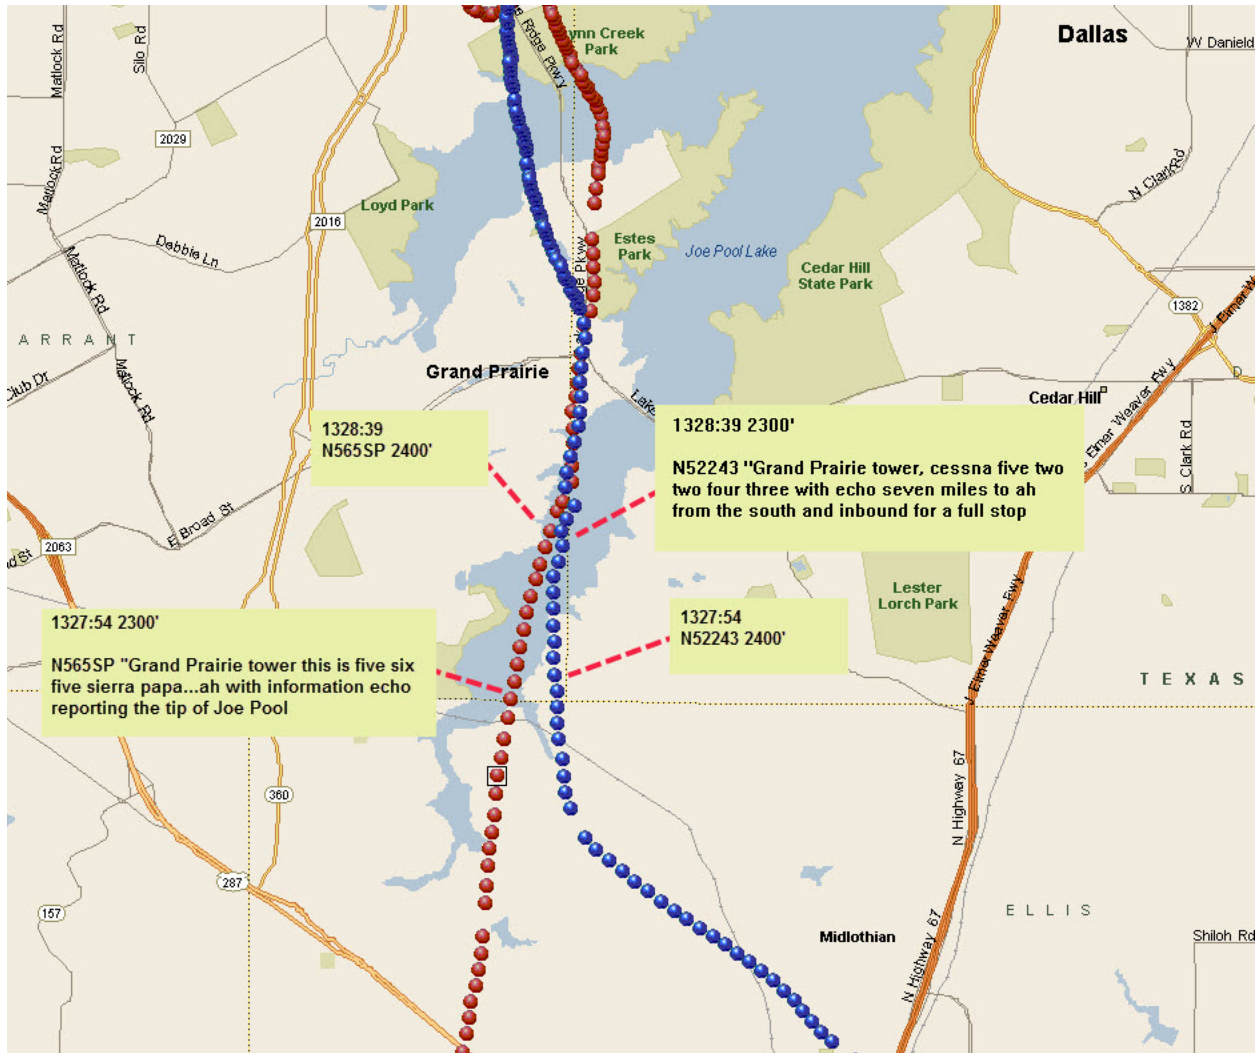
At 1327:54, the pilot of N565SP contacted the GPM LC stating “grand prairie tower this is five six five sierra papa ... ah with information echo² ... reporting at the tip of Joe Pool”. Joe Pool was a lake located south of GPM and used by pilots and air traffic controllers as a visual flight rules (VFR) reporting point for entry into the GPM class D airspace. The GPM LC instructed the pilot to enter a left downwind for runway 17 and to squawk 0457. The pilot read back the instructions. N565SP was transmitting a mode C³ indicating 2,300 feet mean seal level (msl). At that time, N52243 was about 0.3 nautical miles (NM) east of N565SP at an altitude of 2,400 feet msl.

At 1328:39, the pilot of N52243 contacted the GPM LC stating “Grand Prairie tower Cessna five two two four three with echo seven miles to ah from the south and inbound for a full stop”. The GPM LC instructed the pilot to squawk 0435 and to enter a left downwind for runway 17. The pilot read back the instructions. At that time, N565SP was about 0.1 NM west of N52243 at 2,400 feet msl.

Figure 1 - Illustrates the location of both aircraft when N565SP first contacted GPM LC and when N52243 first contacted GPM LC.

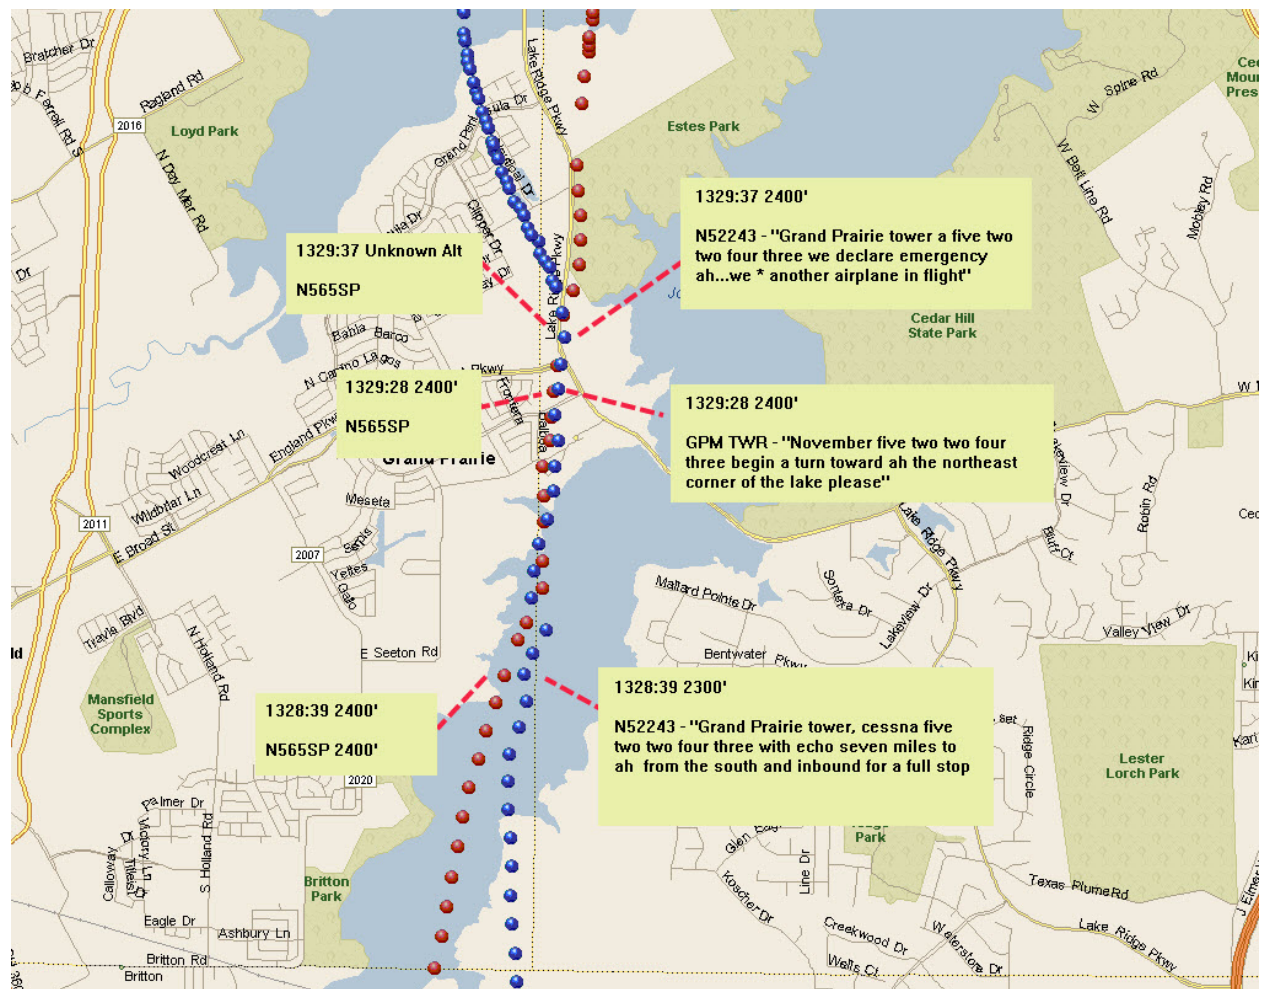
At 1329:28, the GPM LC instructed the pilot of N52243 to start a turn to the northeast corner of the lake. About 10 seconds later, the pilot of N52243 responded they were declaring an emergency; the nature was unintelligible. The GPM LC responded “understand you are declaring an emergency and say the uh nature of the emergency please”. The pilot of N565SP responded “...just had an airplane uh hit us from the back”. The GPM LC responded by asking the pilot of N52243 for the nature of the emergency. The pilot of N565SP responded the engine was still operating and they would report in the downwind. The GPM LC responded “I keep stepping on you who is declaring the emergency five two four three correct”. About 7 seconds later, the pilot of N565SP asked the GPM LC to inspect the aircraft landing gear. The GPM LC instructed the pilot of N565SP to make a straight in for runway 35. The pilot acknowledged and read back the instructions.

Radar data for this report was obtained from the FAA at Dallas Ft. Worth (D10) terminal radar approach control and were derived from ASR sensors. The radar data was displayed in the GPM tower cab via a Terminal Display Workstation (TDW) and had alerting capability for collisions and low altitude. The D10 plot playback (.PPB) data was of good quality and was part of the STARS⁴ utilized by ATC. Figure 1 illustrates the location of both aircraft when N565SP first contacted GPM LC and when N52243 first contacted GPM LC. Figure 2 illustrates the likely area of the midair collision based on the time of the GPM LC directed turn for N52243 to the northeast.

Figure 2 - Illustrates the probable location of the midair collision based on the GPM LC directed turn for N52243 to the northeast.
