EMERGENCY ALERT SERVICE BULLETIN

SUBJECT: ENGINE CONTROLS - Twist grip

Functional check and installation of a protection for microswitches 53Ka and 53Kb and 65K (IDLE / FLIGHT mode)

Corresponds to modification 074699
ATA 76

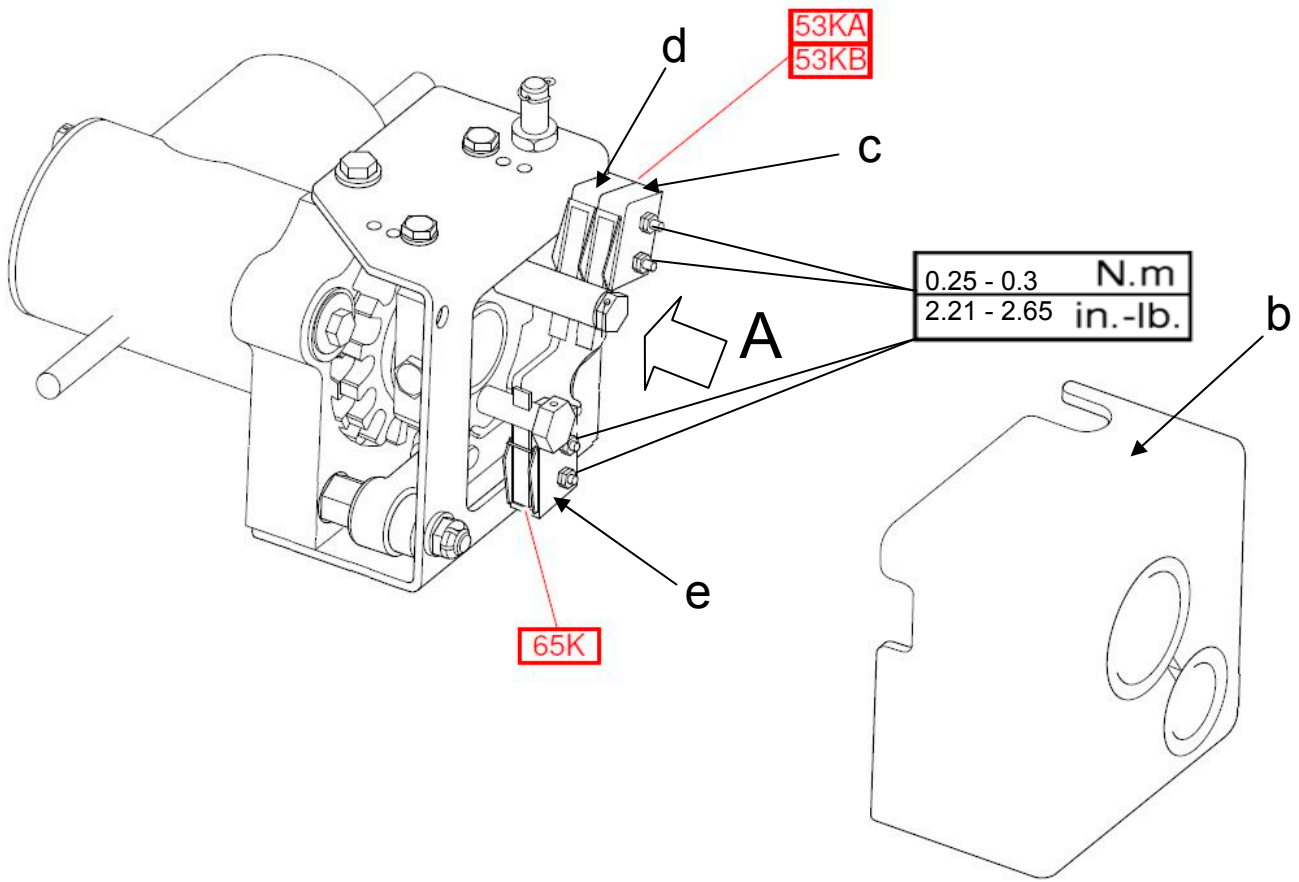
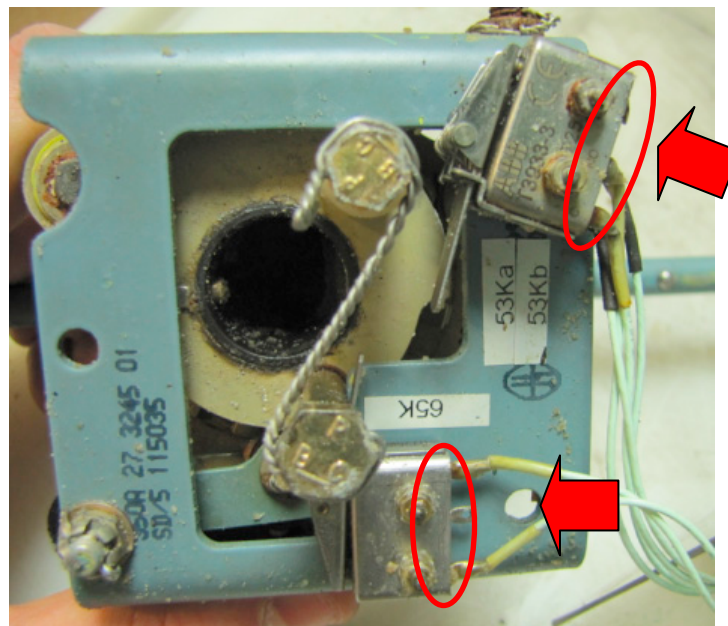
Figure 1

Following a recent incident (significant loss of power in flight) which occurred during an offshore flight, the subsequent investigations and tests revealed that the operation of the implicated microswitches could be altered due to environmental constraints (malfunction related to the possible presence of salt water on the microswitch terminals).

- Inspect the wiring side of microswitches (c), (d) and (e) in order to ensure that there are no marks, residues, corrosion or flaky varnish (DETAIL A - Figure 1).
- If there are marks, residues, corrosion or flaky varnish, comply with paragraph 3.B.2.
- If there are no marks, residues, corrosion or flaky varnish, comply with paragraph 3.B.3.

- Disconnect electrical connector 87DELTA P1 (a).
- Loosen and remove microswitches (c, d) and (e) as per AMM Task 76-12-03, 4-1 (AS350 and AS550) or 76-12-03, 4-1b (EC130).
- For each microswitch, note the position of the wires on the terminals.
- Remove and discard the sheath.
- Remove any varnish present.
- Unsolder the wires.
- Clean the wire side as per MTC Work Card 20.04.03.401 or 20.04.03.103.
