Aviation Safety Department
2701 N. Forum Drive, D10
Grand Prairie, Texas 75052

Vehicle Engine Multifunction Display (VEMD) Summary for U.S. CBP AS350B3 S/N 3592

NTSB Accident #: CEN15TA017
Aircraft Model & S/N: AS350B3 S/N 3592
Aircraft Registration: N852BP
Operator: U.S. Customs Border Protection
Location: Lordsburg, New Mexico
Date: 18 October 2014

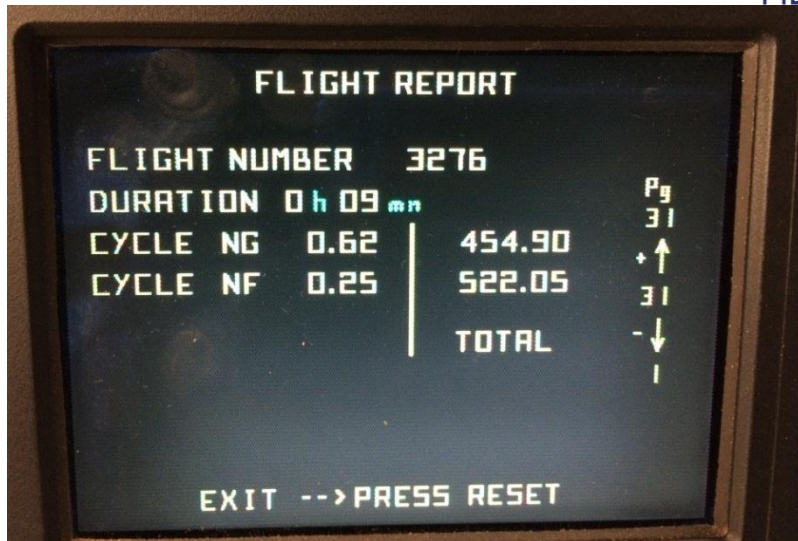
Most Recent Completed Flight Report (no failures)

The last complete flight recorded by the VEMD was #3276 with a duration of 9 minutes. It should be noted that the VEMD “flight” begins when gas generator speed (NG) reaches 10% and ends when NG falls below 10% and NR (main rotor RPM) falls below 70. However, failures are recorded when the NG reaches 60% and ends when NG falls below 50%.

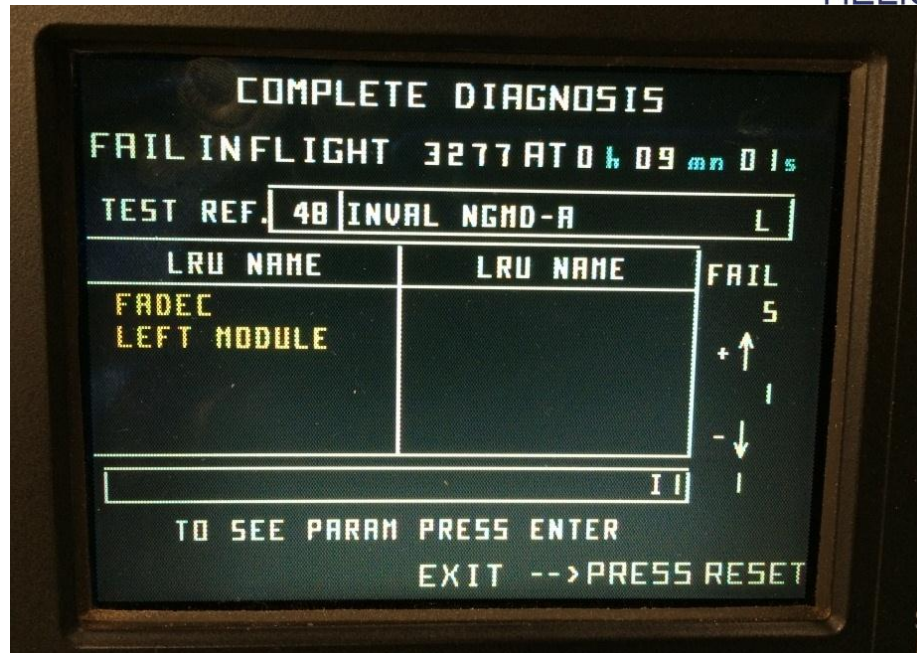
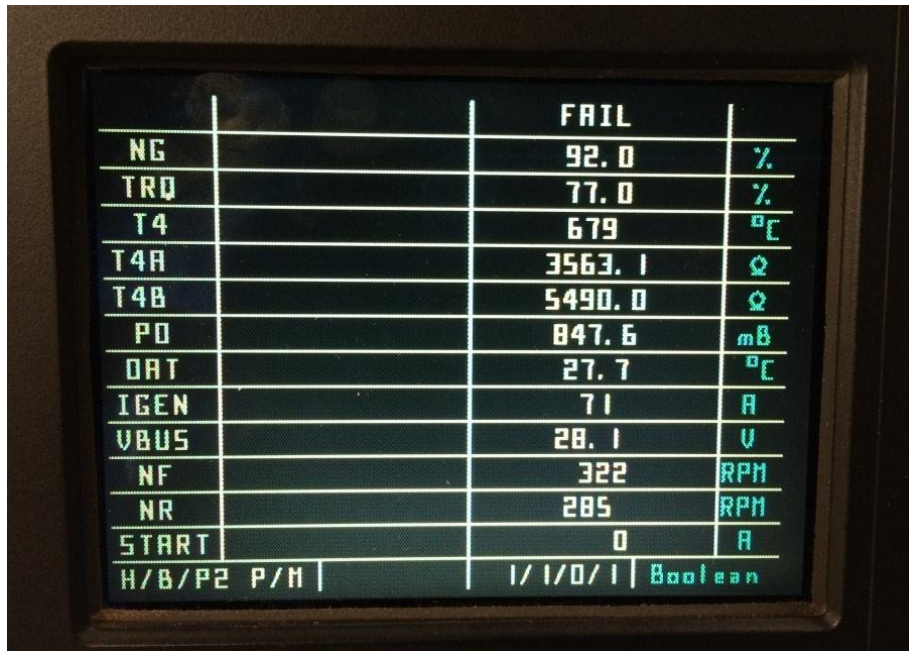
Test Reference 48 “INVAL NGMD – A” recorded on left module at 09 mn 01 s.

This failure code is raised when one of the NG values is declared invalid or is not available (the DECU of the B3 is a single channel).

FAIL	
NG	92.0	%
TRQ	77.0	%
T4	679	°C
T4A	3563.1	°C
T4B	5490.0	°C
PO	847.6	mB
OAT	27.7	°C
IGEN	71	A
VBUS	28.1	V
NF	322	RPM
NR	285	RPM
START	0	A
H/B/P2 P/M	1/1/0/1	Boolean

The parameters above indicate that the free turbine speed (NF) was higher than the main rotor speed (NR) and lower than the nominal speed which is consistent with the failure of the engine / main gear box coupling consistent with the main rotor blade impact with the ground.

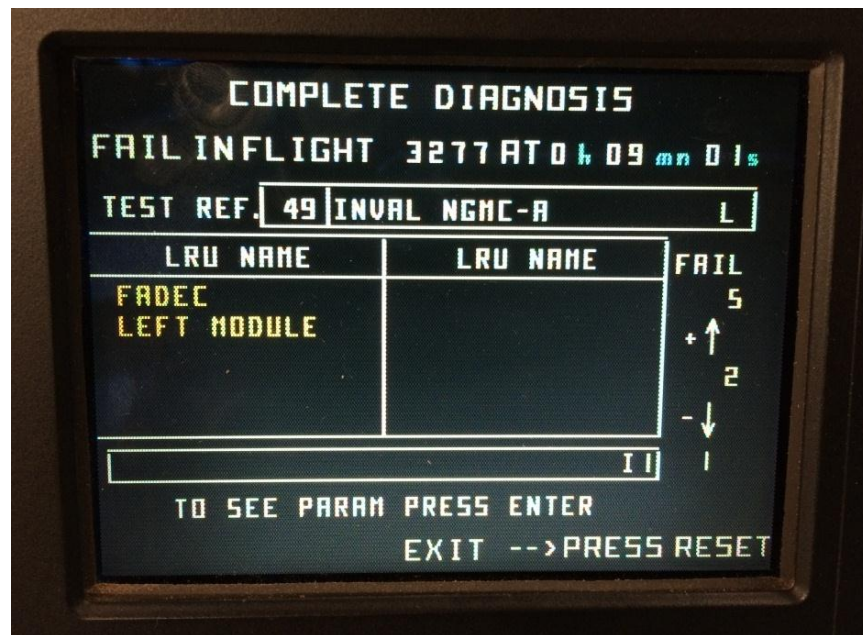
Test Reference 49 “INVAL NGMC – A” recorded on left module at 09 mn 01 s.

This failure code is raised when the second NG measurement is declared invalid or is not available.

FAIL	
NG	92.3	%
TRQ	71.3	%
T4	684	°C
T4A	3563.1	°C
T4B	5490.0	°C
PD	847.6	mB
QAT	27.7	°C
IGEN	71	A
VBUS	28.1	V
NF	322	RPM
NR	261	RPM
START	0	A
H/B/P2 P/M	1/1/0/1	Boolean

The parameters above don't provide any additional information except that the torque (TRQ) and the main rotor speed (NR) decreased as a consequence of the main rotor blade impact with the ground.

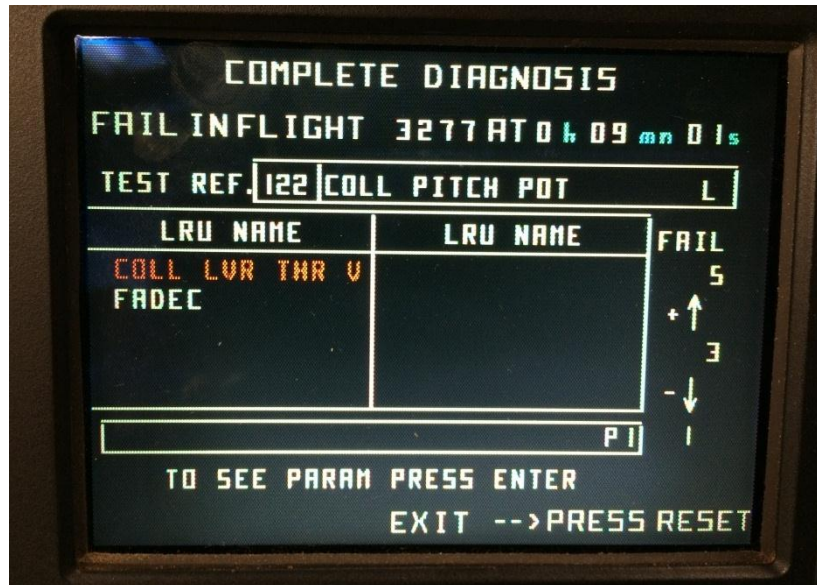
Test Reference 122 "COLL PITCH POT" was recorded on left module at 09 mn 01 s.

This failure corresponds to a collective pitch potentiometer anticipator failure.

Airbus Helicopters has noted that this failure is usually one of the first failures recorded during a crash sequence due to the ground contact and resulting structural deformation or/and main rotor blade contact with the ground.

FAIL	
NG	92.8	%
NG FR.	91.8	%
TRQ F.	5.3	%
T4	714	°C
T4 FR.	706	°C
NF	466	RPM
FAIL1	0010	HEX
FAIL2	0000	HEX
LOG 1	4204	HEX
LOG 2	4020	HEX

These associated parameters indicate that the free turbine speed (NF) increased beyond its nominal value and the torque (TRQ) was very low and close to zero which is consistent with the failure of the engine / main gear box coupling compatible with the main rotor blade impact with the ground.

These codes indicate that when the failure was recorded, the aircraft was in flight mode and that the twist grip was out of the flight detent.

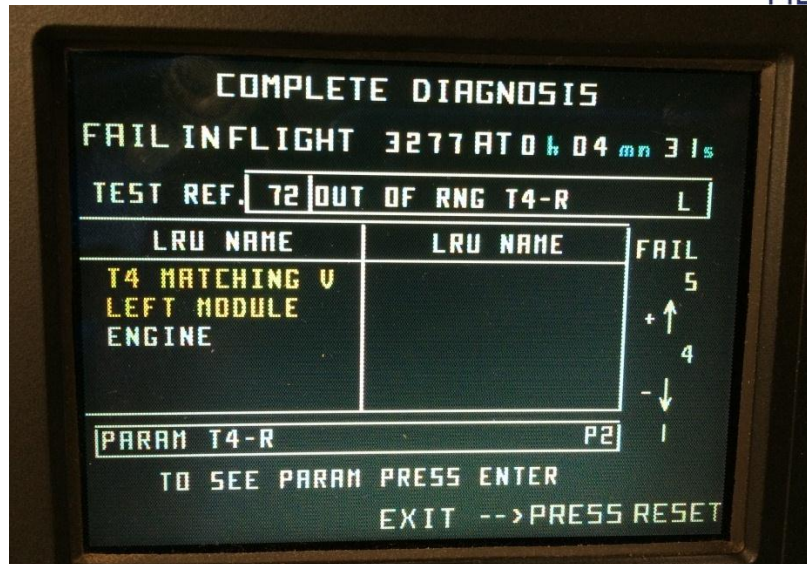
Test Reference 72 “OUT OF RANGE T4-R” was recorded on left module at 04 mn 31 s.

FAIL	
NG	0.0	%
TRQ	0.0	%
T4	0	°C
T4A	16129.9	°C
T4B	10937.7	°C
PO	0.0	mB
OAT	0.0	°C
IGEN	0	A
VBUS	0.0	V
NF	0	RPM
NR	0	RPM
START	0	A
H/B/P2 P/M	0/0/0/0	Boolean

This fourth failure appears after the first ones but with a lower flight time.

Moreover, the associated parameters show an excessively high value of T4A and B (out of range) with all other parameters equal to zero. This indicates the failure was most likely recorded during the power up on the training bench.

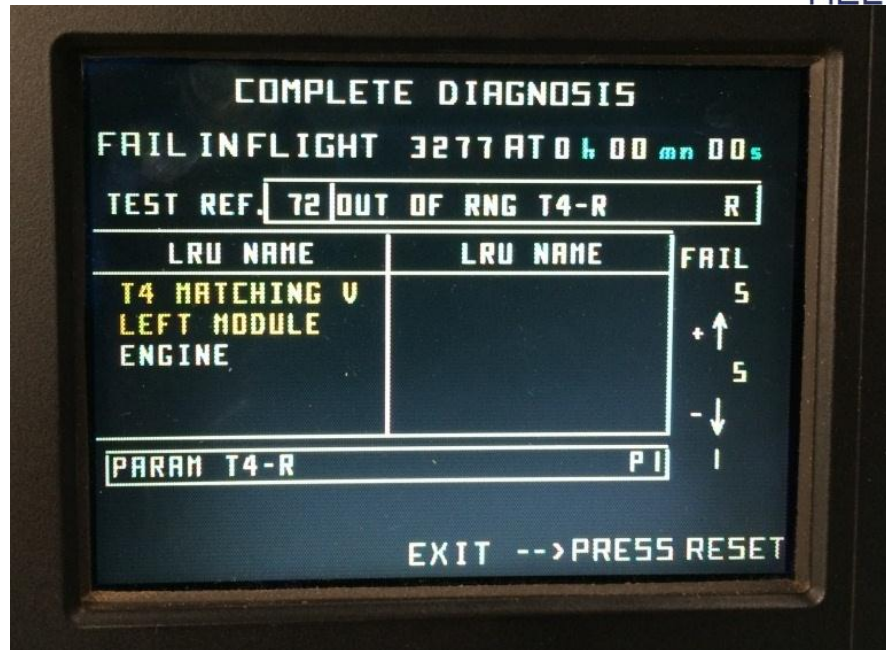
Test Reference 72 “OUT OF RANGE T4-R” was recorded on right module at 00 mn 00 s.

The failure code is raised when the VEMD has detected that the T4 value cannot be measured or is out of tolerances.

For the reason explained in the previous recorded failure, this failure was most likely not recorded during the crash sequence but during the power up on the training bench.

Furthermore, this failure is the same as the previous one but on the other module of the VEMD.

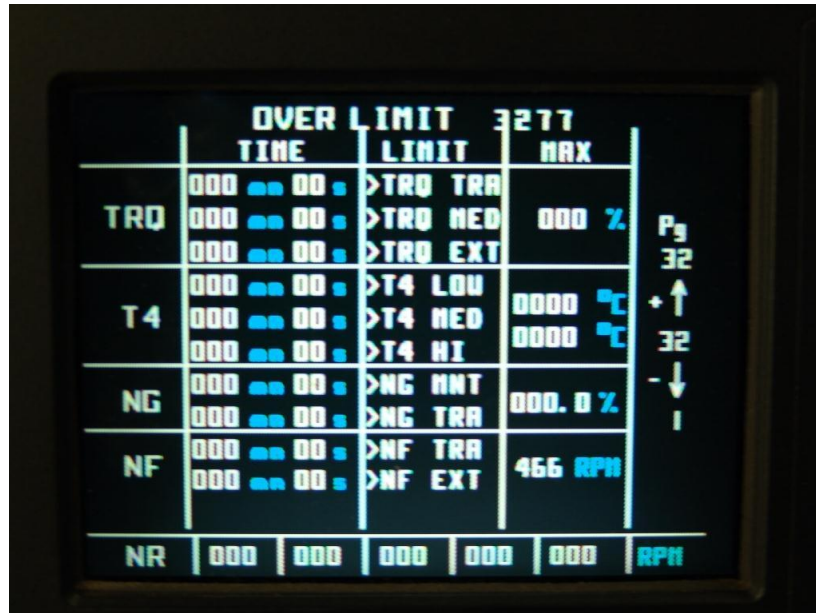
OVER LIMIT 3277			
	TIME	LIMIT	MAX
TRQ	000 00	>TRQ TRA	000 %
	000 00	>TRQ MED	
	000 00	>TRQ EXT	
T4	000 00	>T4 LOU	0000 °C
	000 00	>T4 MED	0000 °C
	000 00	>T4 HI	
NG	000 00	>NG HNT	000.0 %
	000 00	>NG TRA	
NF	000 00	>NF TRA	466 RPM
	000 00	>NF EXT	
NR	000	000	000 RPM

An NF over-limit of 466 RPM was recorded during flight # 3277, however, there is no time, level, or duration associated with this value.

This over-limit is in accordance with the failures recorded during the accident flight and is consistent with the failure of the engine / main gear box coupling compatible with the main rotor blade impact with the ground.
