National Transportation Safety Board Washington, D.C. 20594

Aircraft Accident Brief

Accident Number: DCA11PA075
Operator/Flight Number: Omega Aerial Refueling Services, Flight 70
Aircraft and Registration: Boeing 707, N707AR
Location: Point Mugu Naval Air Station, California
Date: May 18, 2011
Adopted: January 2, 2013

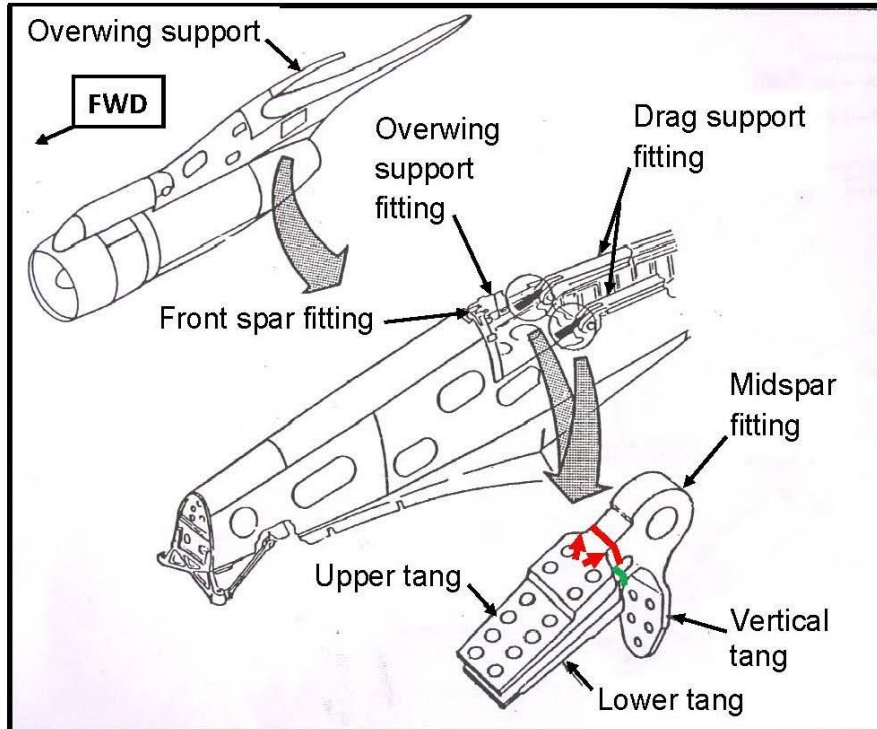
The No. 2 engine nacelle strut attaches to the wing at four primary locations: an upper connection, which consists of the overwing support fitting and the front spar fitting; lower connections, which consist of the lower spar fitting, diagonal brace (thrust link), and the wing aft drag fitting; and two middle connections, which consist of the midspar and wing drag support fittings and the vertical attach fittings. As shown in figure 1, the midspar fitting is of a right-angle configuration in which the vertical tang attaches to the pylon bulkhead and the horizontal upper and lower tangs sandwich the midspar of the pylon. The lug at the center of the fitting is attached to the forward drag support fitting on the underside of the wing. Fractures of the midspar fitting were observed at the upper and lower horizontal tangs (as indicated by the red and green lines in figure 1) at the radius (indicated by the red arrows), where the tangs merge with the lug at the fitting's center.

Figure 1. Diagram of a Boeing 707 engine nacelle strut, showing the fracture area on the midspar fitting.

The upper tang of the No. 2 pylon inboard midspar fitting failed in the reduced section between the lug where the drag support fitting was normally attached and the chromium-coated radius, with the fatigue initiating at its upper inboard corner and occupying approximately 15 percent of the fracture surface. Corrosion product covered the fatigue fracture surface, consistent with it being exposed to the atmosphere for a significant time. Chemical cleaning of the fatigue fracture surface revealed that mechanical damage had obliterated any fatigue fracture features that may have been generated in the upper inboard corner and the corrosion product had obliterated any fine fatigue features, such as striations, leaving only vestiges of crack arrest marks. The lack of striations prevented a striation count analysis. The cleaning procedure also revealed surface fissures on the fatigue fracture surface that were oriented parallel to arc-shaped crack arrest marks and are consistent with high-stress, low-cycle fatigue propagation.

The lower tang of the No. 2 pylon inboard midspar fitting failed in the inboard chromium-plated radius with the fatigue initiating at multiple locations in the upper portion of the inboard edge and occupying approximately 1 percent of the fracture face.

The plated radii in the No. 2 pylon midspar fittings were measured at a nominal 0.38 inch, identifying them as the older style fittings that should have been replaced in accordance with the effective AD. The new midspar fittings have radii of 1.0 inch.

Boeing Alert Service Bulletin (ASB) 707-00A3537-00, issued on January 30, 2012, gives instructions to inspect for the correct engine No. 2 and 3 nacelle strut midspar fittings and to perform immediate replacement if the wrong fitting is found. The ASB also calls for application of a droop stripe, inspection of the engine Nos. 1, 2, 3, and 4 nacelle struts for droop, and a high-frequency eddy current inspection for any crack of the visible lug area of the inboard and outboard strut midspar fittings (new design) on the No. 2 and 3 engines. A drooped nacelle strut indicates that a midspar fitting may have fractured. Installation of an incorrect midspar fitting can result in a fatigue crack, which can cause the fitting to fracture. A fractured midspar fitting can result in a separation of the nacelle strut and engine from the airplane in flight. On August 17, 2012, the FAA published AD 2012-16-12, effective September 21, 2012, requiring the provisions of ASB 707-00A3537-00.

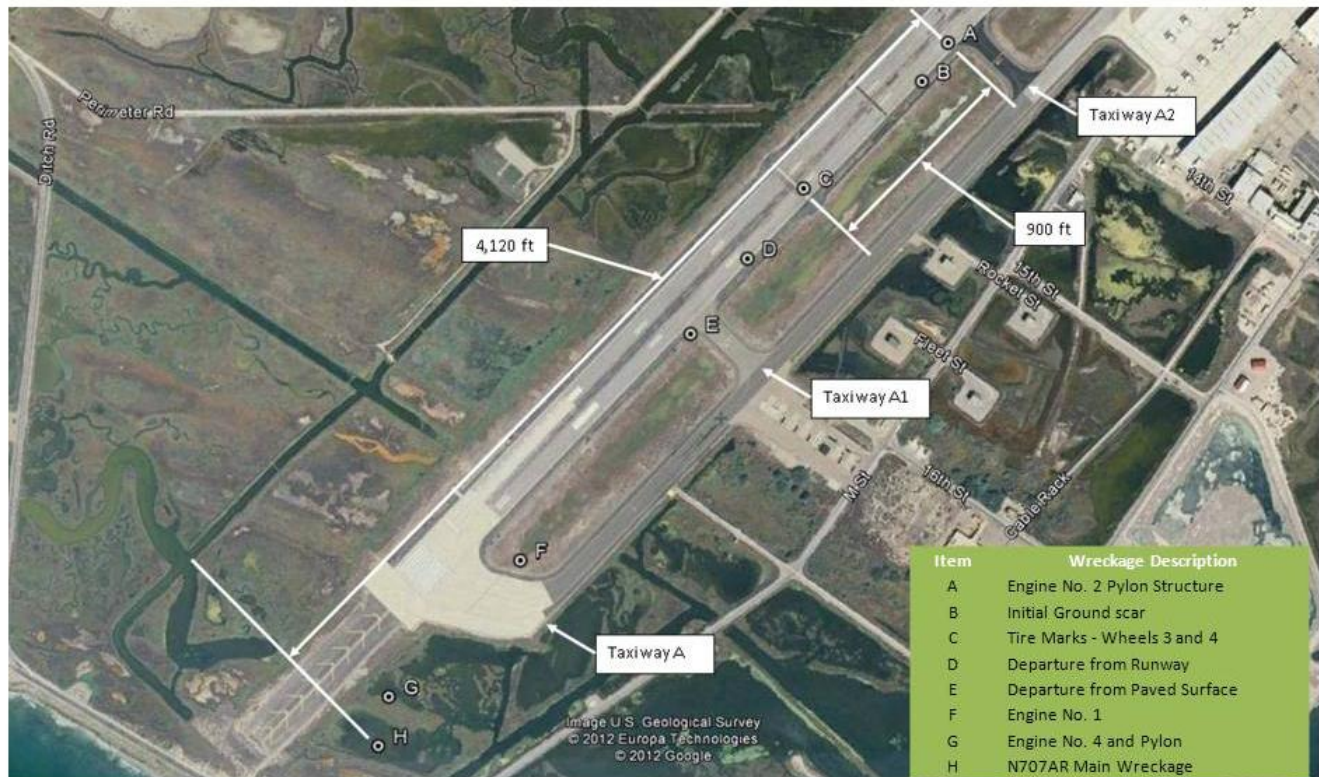
As shown in figure 2, a 4,120-foot debris field began about 7,500 feet from the approach end of runway 21, near taxiway A2. Main landing gear tire marks indicated that the airplane regained contact with the runway about 900 feet into the debris field, departed the runway on a 218° heading near taxiway A1, and continued across the grass infield and taxiway A before coming to rest in a saltwater marsh where it caught fire. The first pieces of wreckage found along the debris path were a fragment of the No. 2 engine pylon torque bulkhead and a piece of the No. 2 pylon overwing fitting, located just past taxiway A2. The No. 1 engine nose cowl was found in the grass infield near taxiway A about 450 feet further into the debris field and left of the runway surface; it exhibited crush damage consistent with contact with the No. 2 engine. The No. 2 engine nose cowl was located near the runway arresting gear on the left side of the runway at the 8,500 foot point. The No. 2 engine was found about 230 feet further, on the left side of the runway surface. Intermittent scrape marks leading to the No. 2 engine were observed on the runway beginning about 7,800 feet, consistent with the engine tumbling after separating from the wing.

Figure 2. Aerial photograph of the debris field.

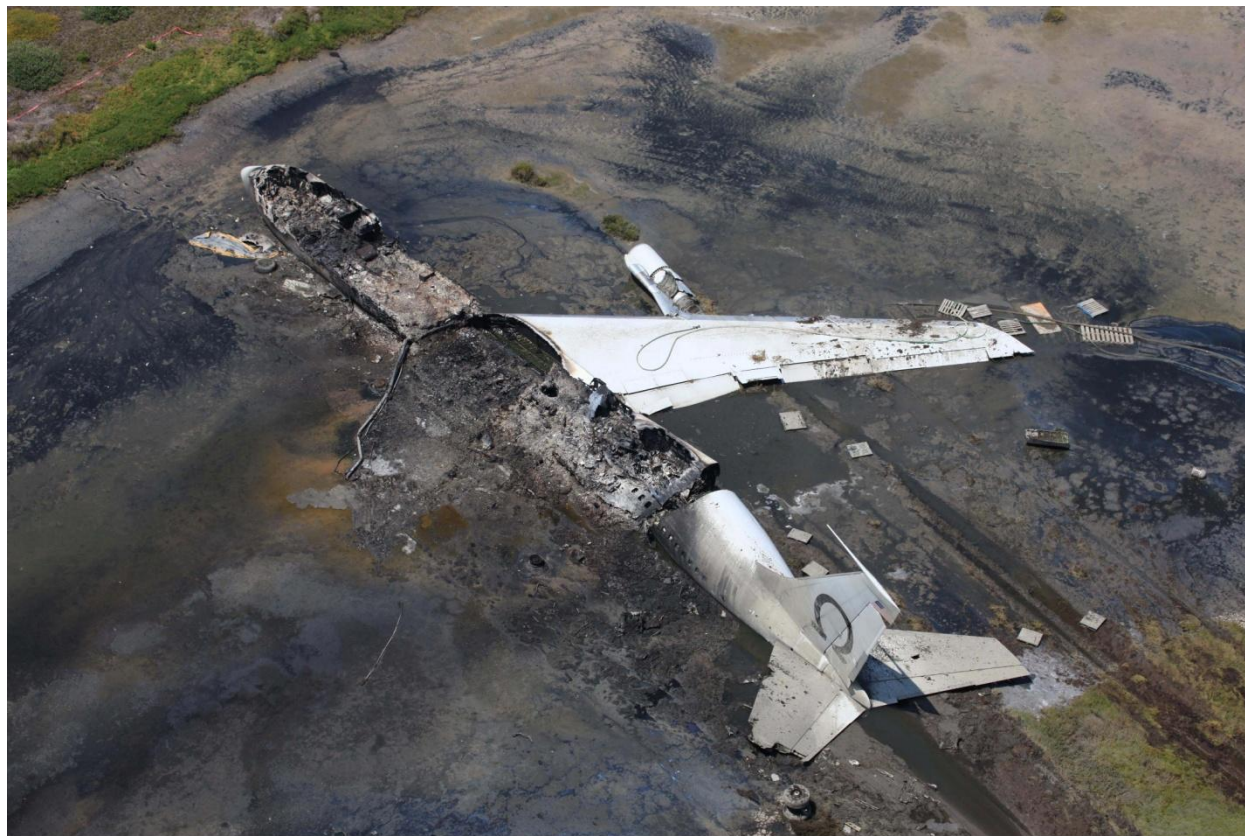
Fire consumed the top of the cabin and the cockpit (see figure 3). The main wreckage, which came to rest in the wetland marsh, consisted of the cockpit and cabin; the right wing with the No. 3 (right inboard) engine partially attached; the empennage; and the inboard half of the left wing, which sustained thermal damage and was submerged in water. Scattered debris aft of the main wreckage included the nose gear, remnants of the burned outboard left wing, right main landing gear truck, and No. 4 (right outboard) engine.

Figure 3. Aerial photograph of airplane wreckage.
