Steep Climb and Uncontrolled Descent During Takeoff  
National Air Cargo, Inc., dba National Airlines  
Boeing 747 400 BCF, N949CA  
Bagram, Afghanistan  
April 29, 2013

**Accident Report**

NTSB/AAR-15/01  
PB2015-104951

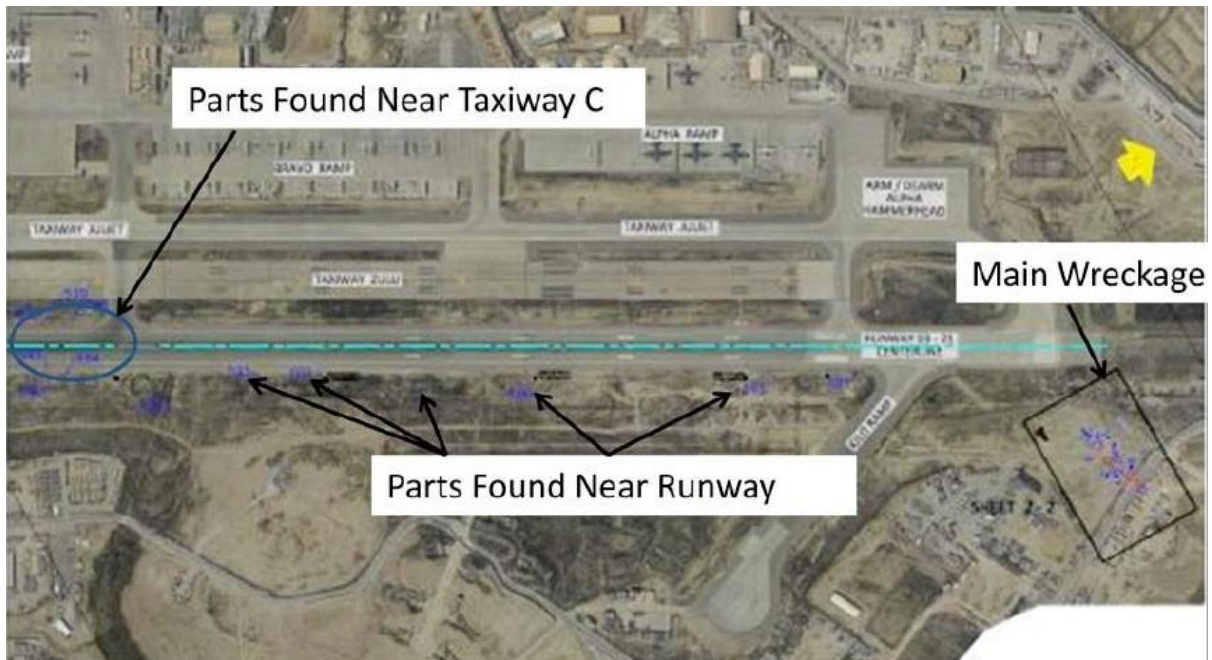
**Figure 5.** Overview image of runway 3 with locations of parts debris and the main wreckage noted.

The airplane struck the ground about 590 ft northeast of the departure end of runway 3. A sweep of the runway after the accident found pieces of debris on runway 3 in the area of taxiway C that included small pieces of airplane fuselage skin, a segment of hydraulic return tubing, a piece of the E8 rack (which provides a shelf for the airplane's CVR and flight data recorder [FDR] inside the back of the airplane), and part of a M-ATV antenna assembly. These debris pieces are discussed further in section 1.7. Other pieces of debris were found along the length of the runway (see figure 5).

The debris found on runway 3 in the area of taxiway C included two small pieces of blue-and-white painted airplane fuselage skin, a segment of white-painted hydraulic return tubing, a section of the E8 rack support stanchion (colored green), a reinforcement bracket (for a hydraulic line pass-through a fuselage frame), and part of a M-ATV antenna assembly.

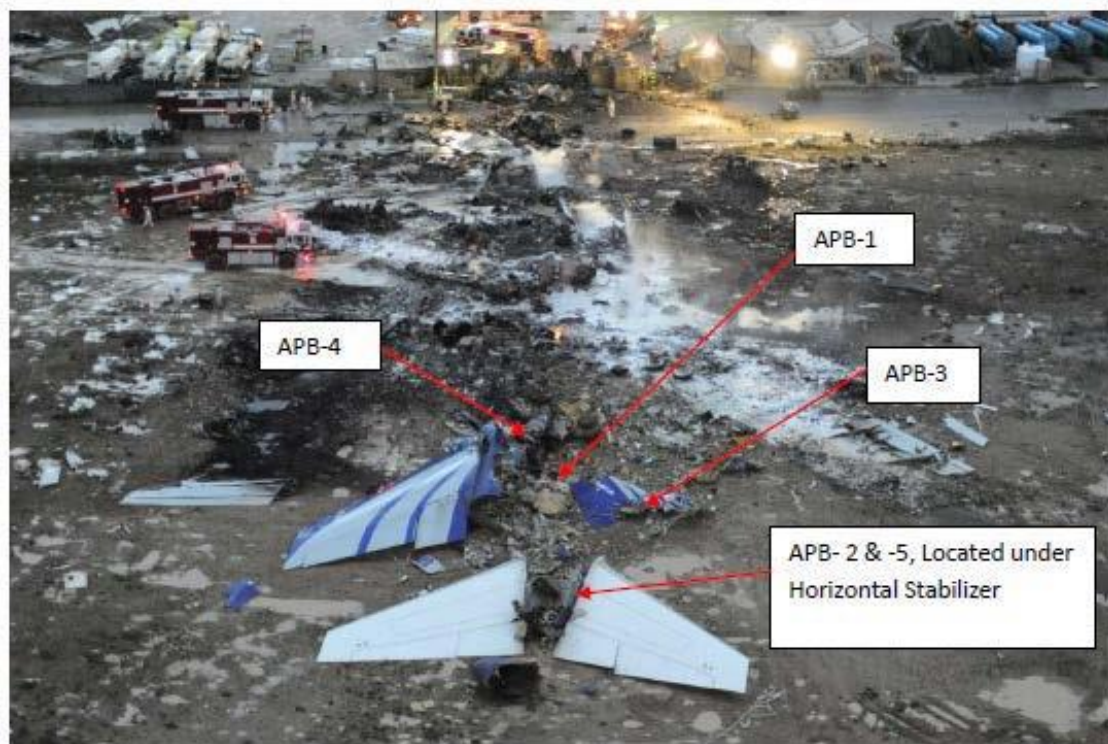
**Figure 8.** Photograph showing where five sections of the APB were found at the accident site.

The APB, the installed location for which was in the back of the airplane (aft of the cargo) at BS 2360, was found in five main sections, labeled APB-1 through -5 by investigators. Sections APB-3, -4, and -5 were found attached to corresponding fuselage structures and skin panels. Sections APB-1 and -2 were not connected to any fuselage structure. Sections APB-2 and -5 were found under the horizontal stabilizer. Figure 8 shows where each APB section was found at the accident site.

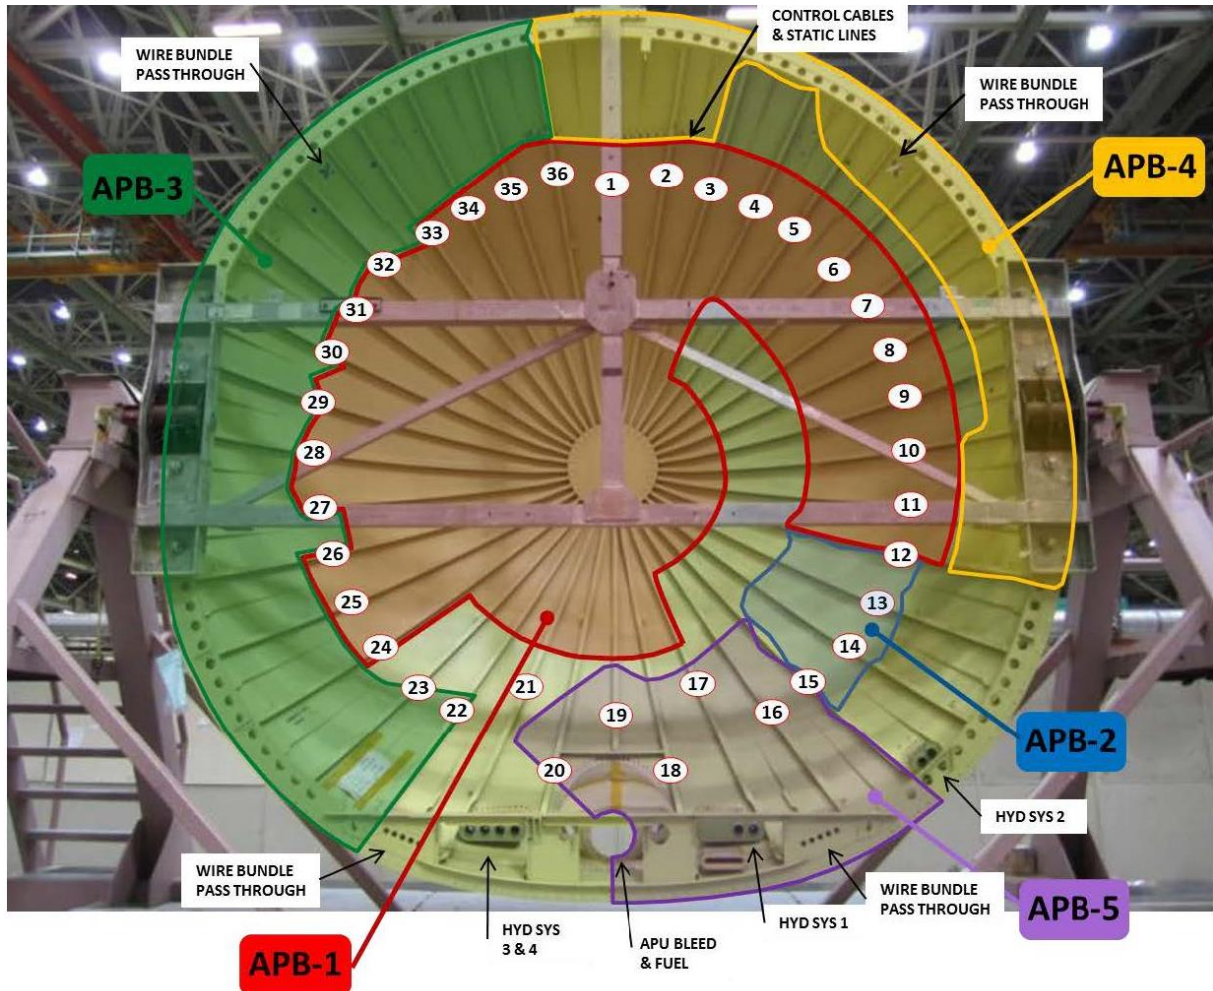
**Figure 9.** Photograph of an intact APB, looking aft, superimposed with color-shaded and labeled areas showing the installed location of each of the APB sections.

Figure 9 shows the relative installed location of each APB section using a photograph of an intact APB (without the liner), looking aft, as well as the locations where hydraulic system tubing, wire bundles, control cables, and static lines pass through the APB. (The installed location of the liner is on the forward face of the APB.)

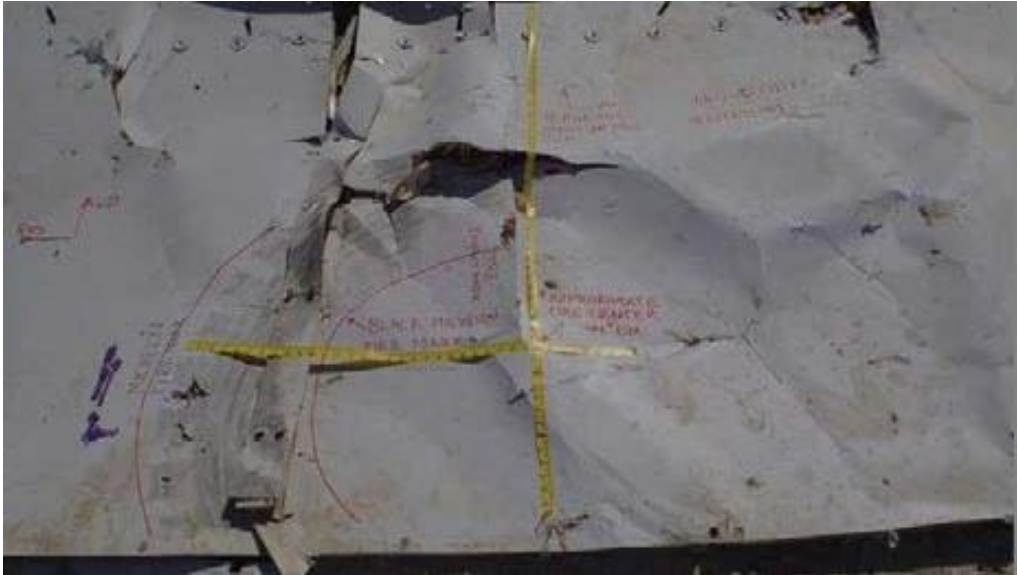
**Figure 10.** Photograph of M-ATV tire mark on the upper left quarter panel of the APB liner.

The upper left quarter panel of the APB liner showed a black mark from a 44-inch-diameter tire from a M-ATV. The installed location of this APB liner upper left quarter panel is immediately aft of and adjacent to the E8 rack. The tire imprint was consistent with a tire being parallel to the APB and the tire center located 81.5 inches above the main deck cargo floor (see figure 10).

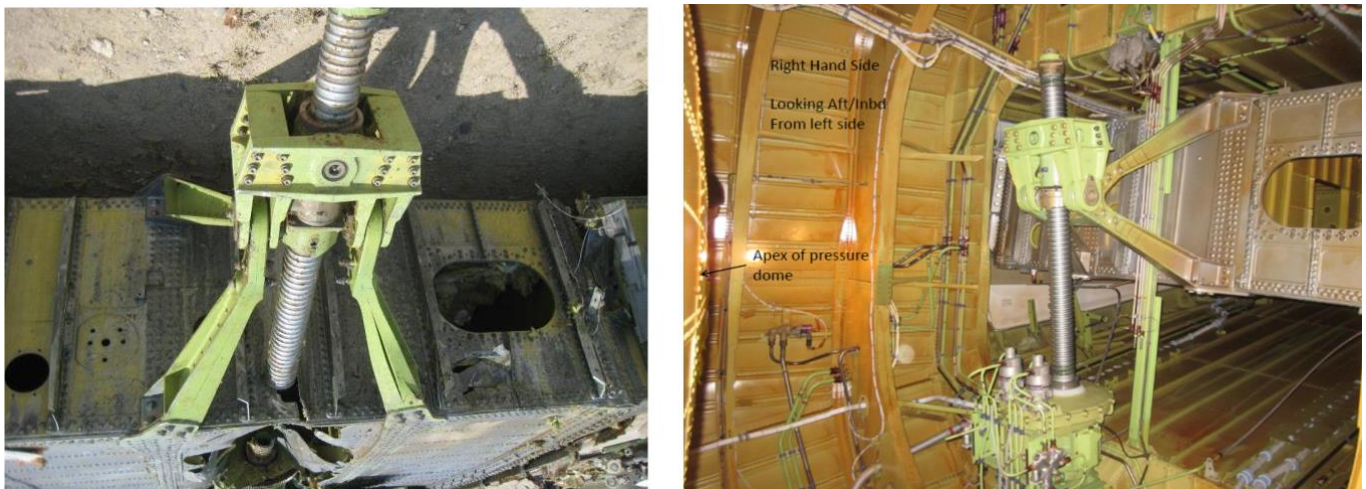
**Figure 11.** Photographs (left) showing the accident airplane's jackscrew and horizontal stabilizer in the wreckage and (right) showing an exemplar jackscrew in its installed position aft of the APB and forward of the horizontal stabilizer.

the APB was found at the stabilizer actuator. (The APB and insulation were installed forward of the stabilizer actuator.) The horizontal stabilizer jackscrew (also known as the ballscrew) was severed on its lower end about 1.5 inches above the drive assembly. A crack about 4 inches long extended longitudinally from the jackscrew's fractured end toward the upper gimbal support structure. The jackscrew drive assembly was aft of its installed location and was embedded in the lower horizontal stabilizer structure (see figure 11). The hydraulic drive motors were broken away from their housing and dislodged but were connected to brackets and tubing. The length of exposed jackscrew threads from the upper stop to the end of the threads was about 9.56 inches.

The horizontal stabilizer trim drive assembly, associated attachment hardware, and components were recovered from the accident site for examination. The origin of the fracture that separated the jackscrew into two pieces was on the forward side, and the longitudinal crack was on the aft side. The jackscrew showed an aft bend. The location of the jackscrew separation corresponded with an installed location of about 2 ft above the airplane's floor surface. The measured jackscrew nut travel was consistent with the recorded takeoff stabilizer position of about  $-1^{\circ}$ .

One of the legs of the upper gimbal support structure that attaches the horizontal stabilizer jackscrew to the forward side of the stabilizer structure was distorted and fractured. The yoke of upper gimbal support structure was gouged and showed material smearing on the forward surface. The installed location of yoke upper gimbal support structure is about 8 ft above the main cargo deck floor.

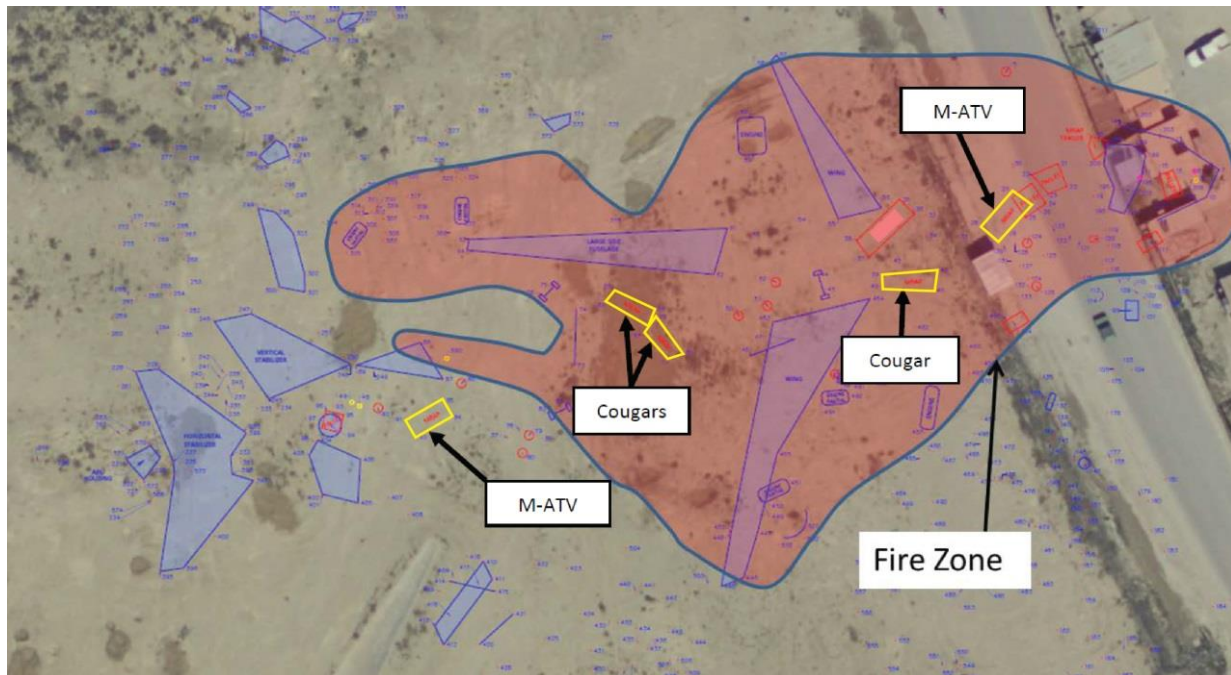
**Figure 12.** Overview of the accident debris field showing the respective locations of the MRAP vehicles and fire zone.

The M-ATV that was loaded in the back of the airplane was found in the wreckage in the area not consumed by fire; this area included other structure from the empennage, including the horizontal stabilizer and the vertical stabilizer (see figure 12).

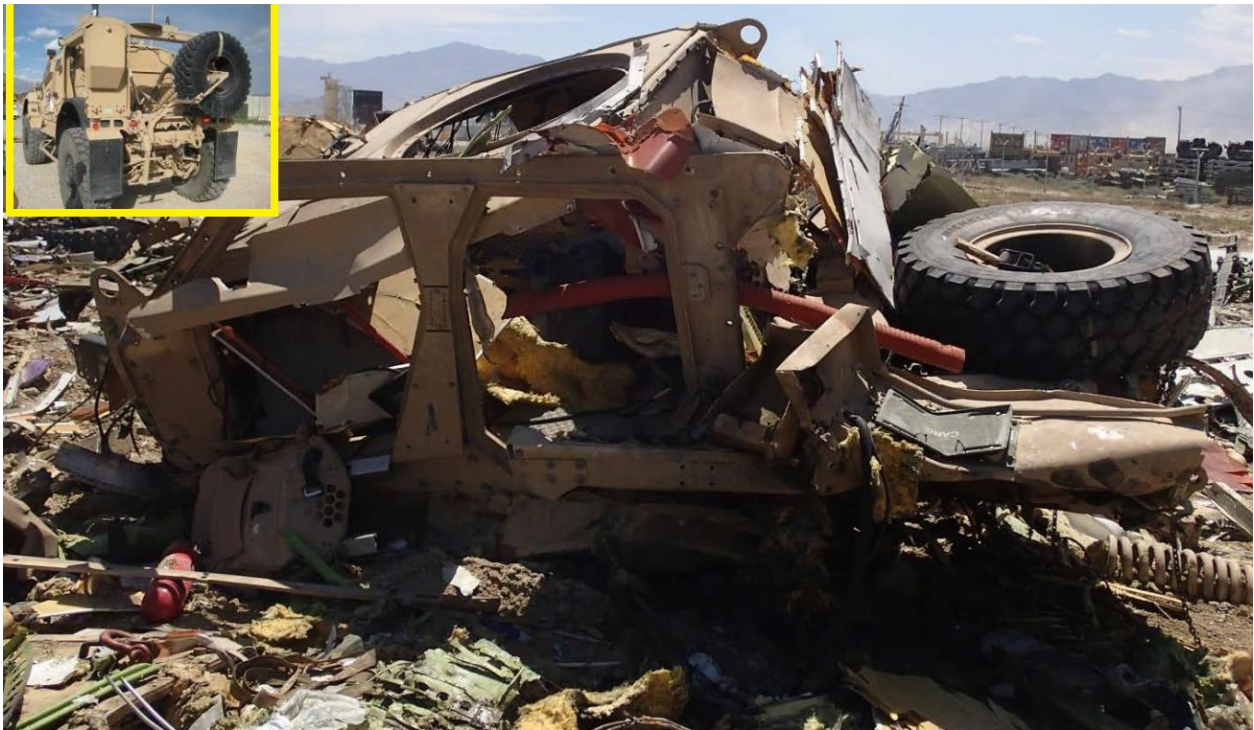
**Figure 13.** Photograph of the left side of the rear M-ATV as found in the wreckage and an inset diagram showing the installed position.

Pieces of airplane main deck interior panels were found inside the rear M-ATV, and the vehicle was missing its antenna assembly (which had been located on its rear, upper left corner). Sections of the APB's interior lining material from the right side of the airplane were found impinged in the right side of the M-ATV, such that the lining material was trapped in and pinched by the collapsed M-ATV structure.

The M-ATV's spare tire, as installed, is mounted on the back of the vehicle on the upper right side, parallel to the rear bumper. For a M-ATV shored and secured on a pallet, the bottom of the spare tire is about 59.5 inches above the floor (making its center about 81.5 inches above the floor). The rear M-ATV's spare tire was found positioned forward of and at a 90° angle to its installed position (see figure 13), which shows the spare tire as found in the wreckage and an inset diagram depicting the spare tire's installed position.

An orange transfer mark was noted on the back of the M-ATV on the antenna mounting structure on the upper left side (the location of the orange transfer mark was about 104 inches from the ground on an intact M-ATV). A comparative analysis of the orange transfer mark, which was performed using an infrared microspectrophotometer, determined that the spectrum of the transfer mark on the M-ATV was similar to other spectra of paints, indicating that the transfer was likely paint. A comparison of the transfer mark with a paint sample from the FDR chassis found that the spectra shared three similar peak patterns; however, the origin of the orange paint transfer could not be determined by spectral analysis.

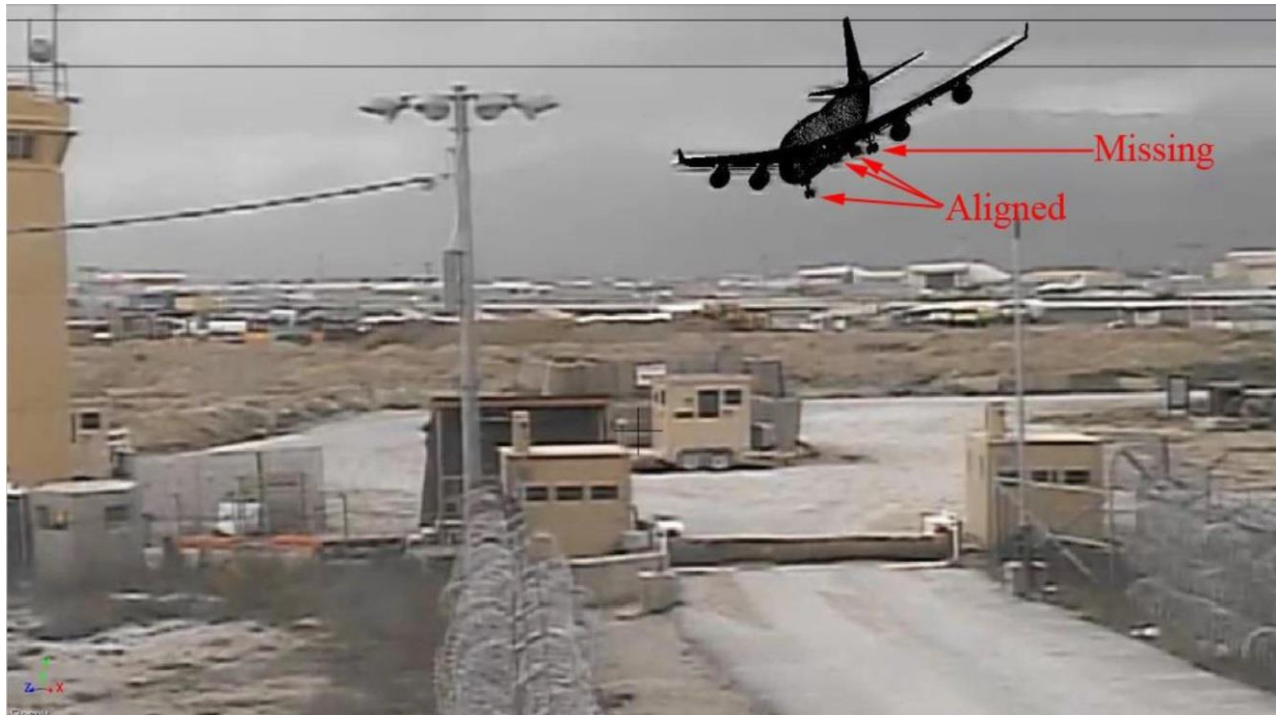
**Figure 15.** Still image from a security video of the accident airplane with a superimposed three-dimensional model airplane. (The model has all landing gear extended.)

The image study used Autodesk Softimage 2013 to compare the image data to a three-dimensional model of the airplane. The study found that, during the portions of the flight captured by one or more cameras, the airplane's left wing landing gear was not visible, consistent with it being in the retracted position. The right body landing gear, left body landing gear, and nose landing gear were visible (captured by one or more cameras), consistent with them being in the extended position. The study also found that the nose landing gear door was visibly protruding, consistent with the fully open position (see figure 15).

**Note:** Red arrows indicate which of the accident airplane's landing gear appear to be missing when compared to the model (consistent with the retracted position) and which appear to be aligned (consistent with the extended position).

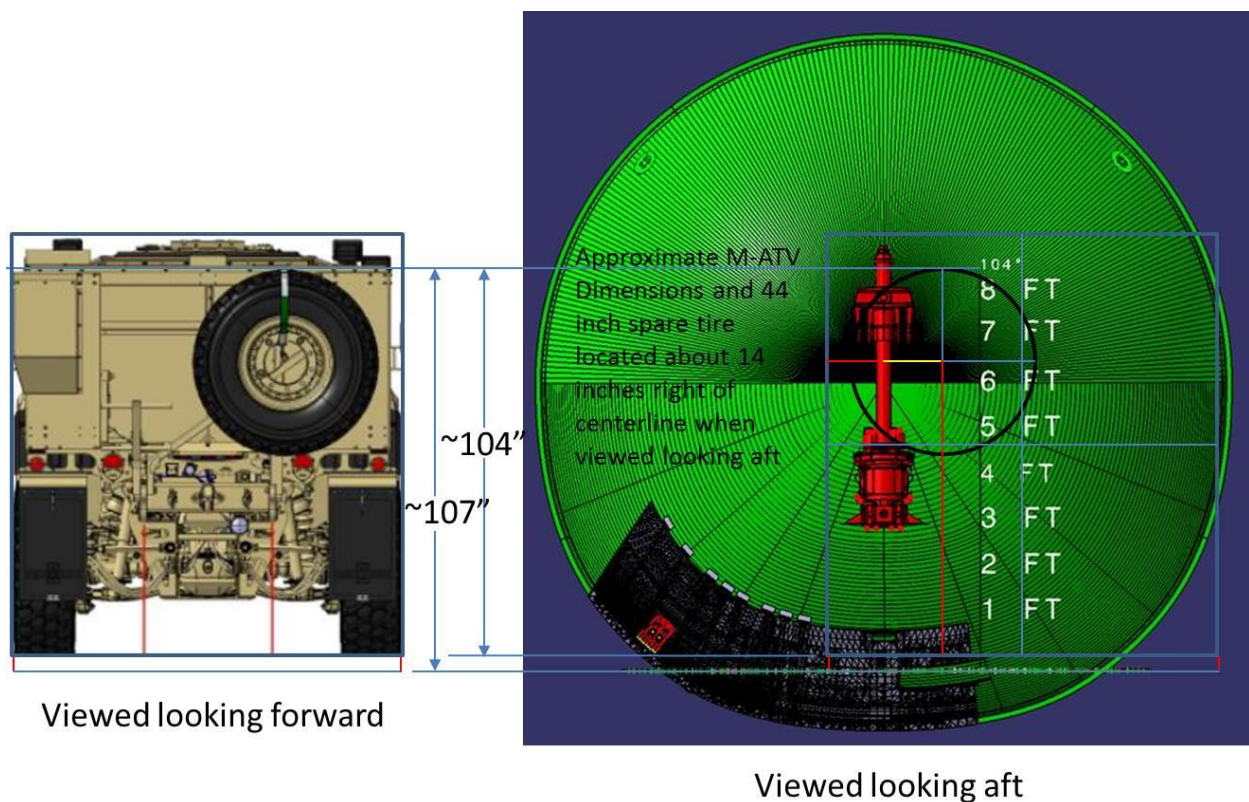
**Figure 17.** Illustration showing how the dimensions of the M-ATV align with the APB and jackscrew structures. On the image at right, the jackscrew components are shown in red, and the location of the tire imprint found on the APB is depicted with a black circle.

was consistent with the M-ATV structure becoming crushed around the liner material during the ground impact sequence. All of this evidence suggests that the rear M-ATV moved aft through the APB before the airplane struck the ground. In addition, damage on the underside of the M-ATV's pallet, damage to the aft floor locks, and the premature cessation of the CVR and FDR (which are powered by separate alternating current buses and stopped recording almost simultaneously) further support the scenario that the rear M-ATV moved aft shortly after the airplane's rotation.

Damage observed on the horizontal stabilizer jackscrew assembly and support structure and the presence of tire marks on structure aft of the APB provide further evidence that the rear M-ATV moved aft until it struck these components (see figure 17). Also, the displacement of the M-ATV's tire 90° from its original position and the presence of tire marks on the green dorsal fairing support structure for the vertical stabilizer are consistent with the M-ATV having been located aft of its original loaded location when the airplane struck the ground; that is, the tire displacement and the tire mark evidence is consistent with the M-ATV having been positioned beneath the vertical stabilizer at the time of the airplane's ground impact, and the vertical stabilizer collapsed down onto the rear portion of the M-ATV at ground impact.
