Collision with Terrain
Hageland Aviation Services, Inc.
dba Ravn Connect Flight 3153
Cessna 208B, N208SD
Togiak, Alaska
October 2, 2016

NTSB/AAR-18/02
PB2018-100871

Aircraft Accident Report

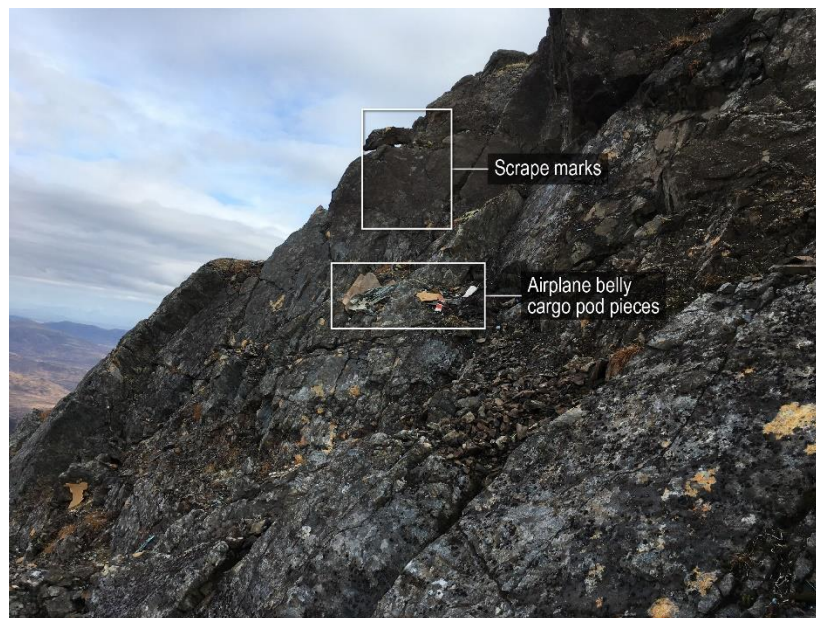
Evidence of the airplane's initial impact, which included scrape marks and pieces of the airplane belly cargo pod, was at an elevation of about 2,300 ft msl on the northwest side of a steep, rock-covered ridge about 9 nm southeast of the airplane's last Spidertracks position (see figure 2).

Figure 2. Photograph of the northwest (initial impact) side of the mountain ridge showing scrape marks and pieces of the airplane belly cargo pod.

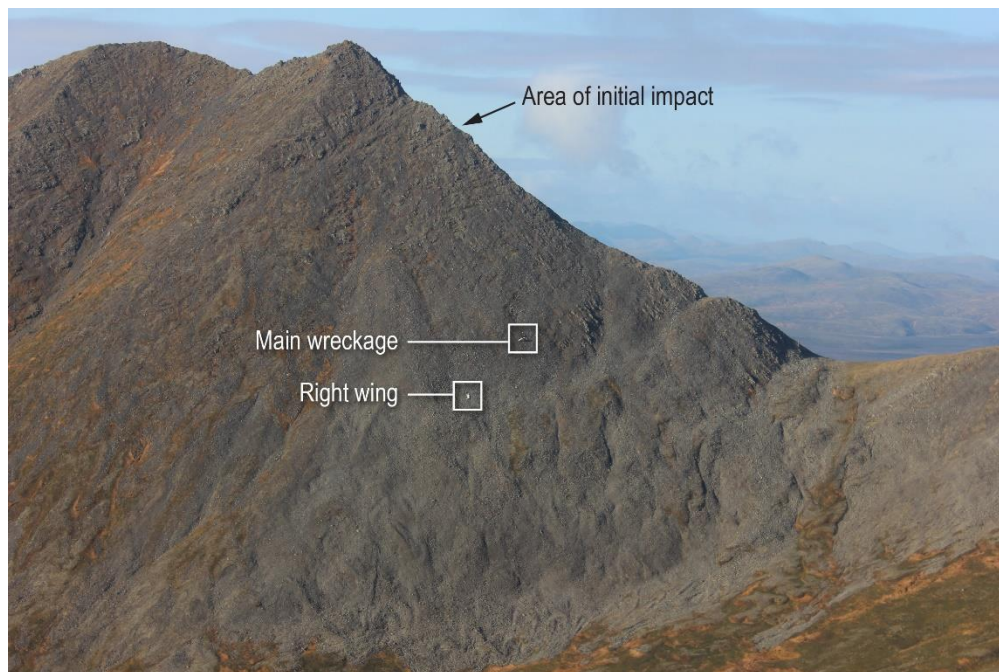
The main wreckage was located on the opposite (southeast) side of the ridge from the initial impact. The main wreckage was found at an elevation of about 1,500 ft, and the right wing was found about 200 ft below the main wreckage. (See section 1.5.1 for more wreckage and impact information.) The ridge peak adjacent to the initial impact location was about 2,500 ft msl and sloped sharply toward a saddle of lower terrain (see figure 3).

Figure 3. Photograph of wreckage location showing the southeast side of the ridge.

Note: The accident airplane's initial impact was on the opposite side of the ridge (approximate location indicated by the black arrow), and the main wreckage and right wing were found on the southeast slope.

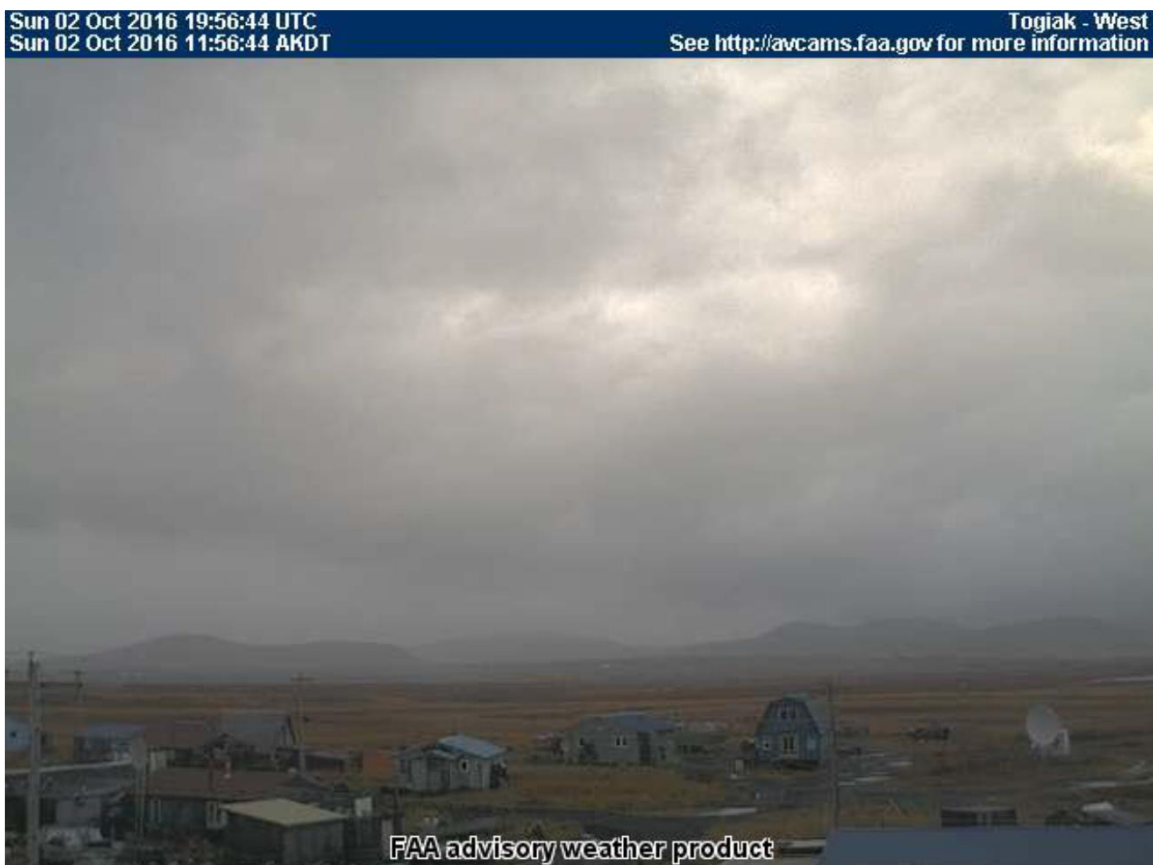
accident site location. The west-facing camera captured an image at 1156 that showed that low clouds partially obscured the top of a 1,300-ft mountain located 7 miles away (see figure 5).

Figure 5. View from the PATG west-facing FAA weather camera at 1156.

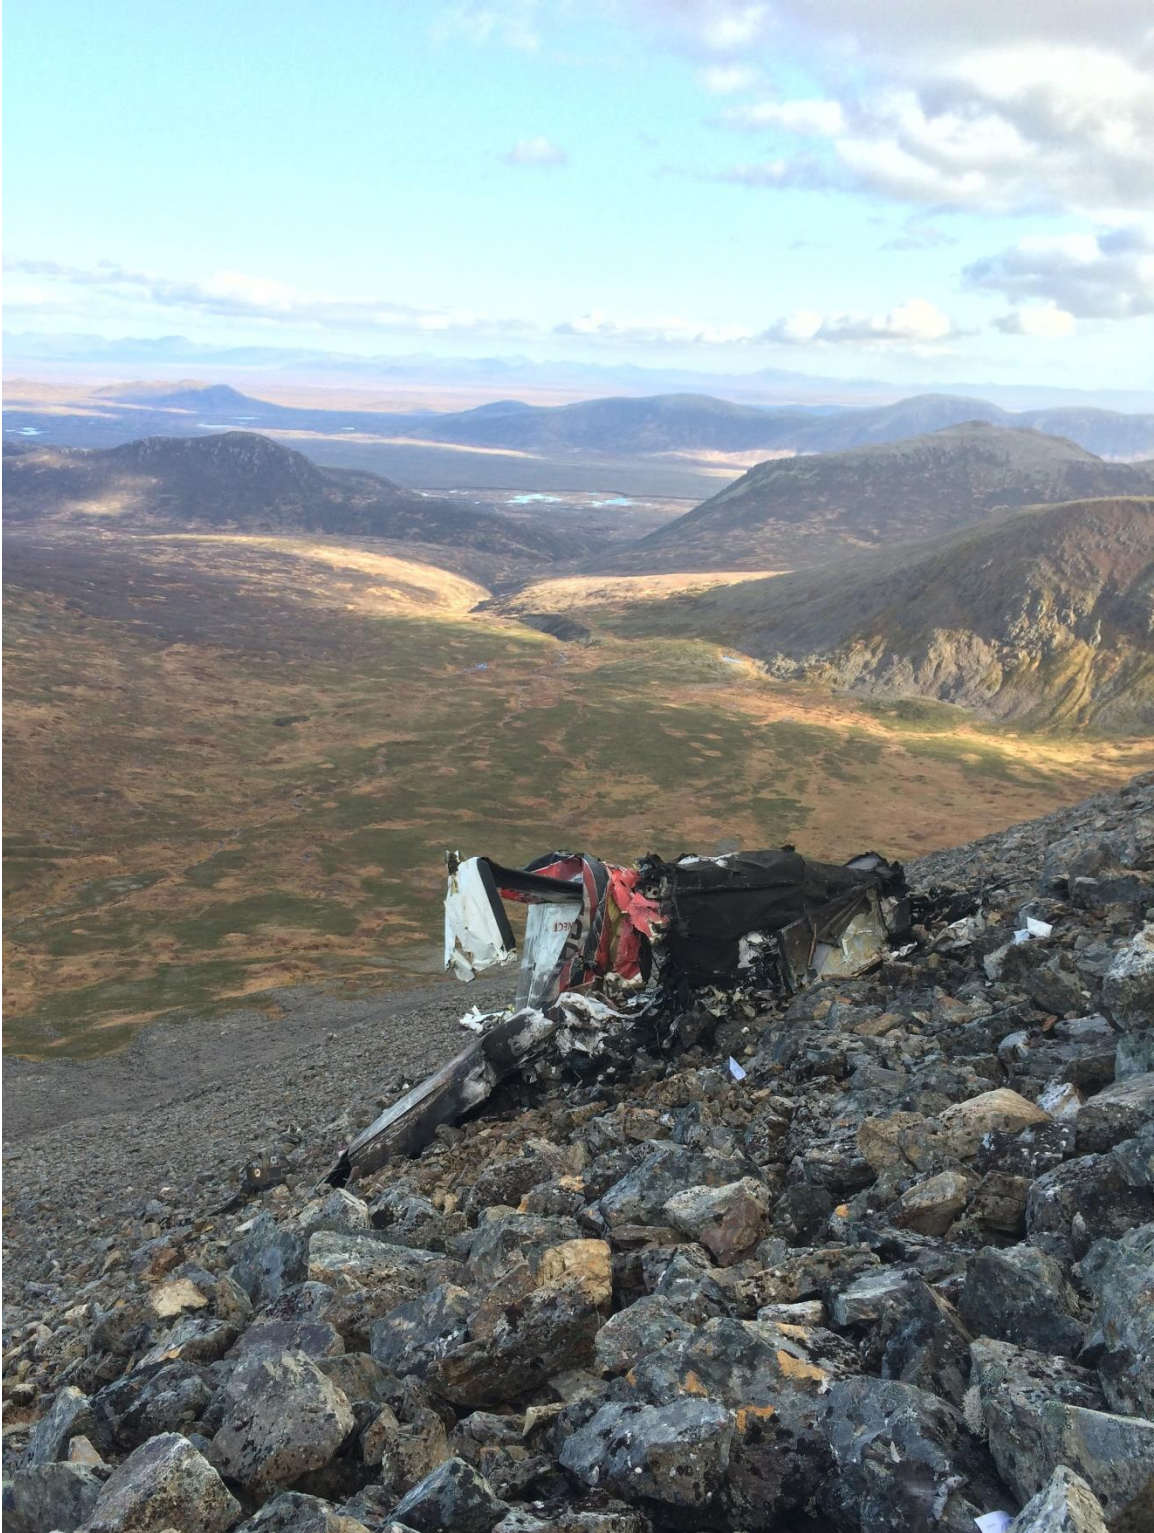
Evidence of the airplane's initial impact was found on the northwest side of the ridge and included scrape marks on the rock face (consistent with propeller blade strikes), propeller blade fragments, and pieces of the airplane's belly cargo pod. The remainder of the wreckage was found on the opposite (southeast) side of the ridge, separated into several sections and scattered down the steep slope. The fuselage and cockpit showed evidence of crush and thermal damage with portions largely consumed by fire. Both wings were separated from the fuselage and each showed leading-edge crush damage. The left and right flaps remained attached and were in the up position. The empennage was separated with the vertical stabilizer, rudder, and horizontal stabilizers attached (see figure 6). The elevator showed crush damage. Examination of the recovered flight control components for the rudder, elevator, ailerons, aileron trim, and flaps identified no evidence of any preimpact mechanical anomaly.

Figure 6. Separated section of empennage with vertical and horizontal stabilizers and rudder attached.

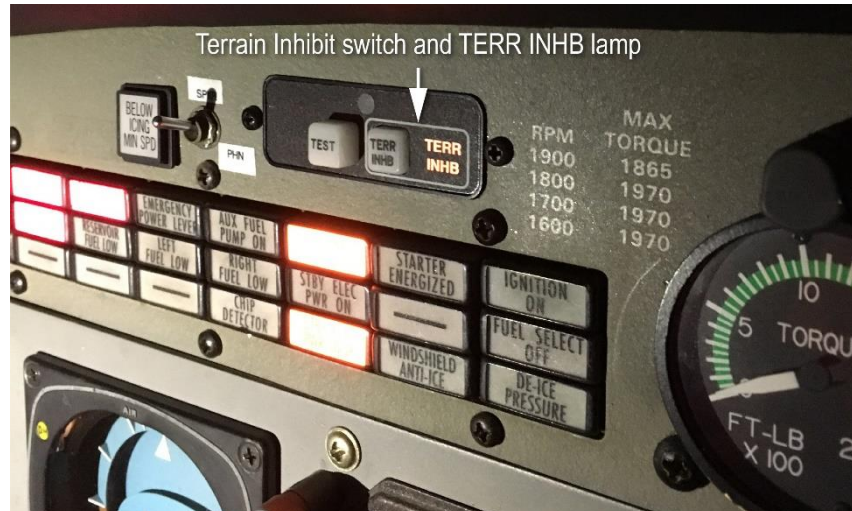
As described in section 1.3.3, at all times the terrain inhibit switch was engaged to inhibit the alerts, a white TERR INHB lamp was illuminated on the terrain awareness annunciation control unit (see figure 10). According to the Hageland chief pilot, when asked if this cue were conspicuous, she stated, "Extremely. It's directly in front of the pilot and it's in their line of sight." When asked how difficult it would be to ignore, she stated, "It's a really bright white light. I won't use the word impossible, but it's very, very difficult to ignore." A check airman also described it as "very bright," stating that "it can be obnoxious if we don't un-inhibit it."

Figure 10. Photograph of the terrain inhibit switch engaged and the TERR INHB lamp illuminated in an exemplar Cessna 208B.
