National Transportation Safety Board

SIDESLIP STUDY

CEN15FA034

Location: Wichita, KS Mid-Continent Airport
Date: October 30, 2014
Time: 0948 CST
Vehicle: Raytheon Super King Air 200, BB-1686, N52SZ,
Engine: Pratt Whitney PT-6A-42, 850 SHP
Propeller: Hartzell Propeller, Inc.

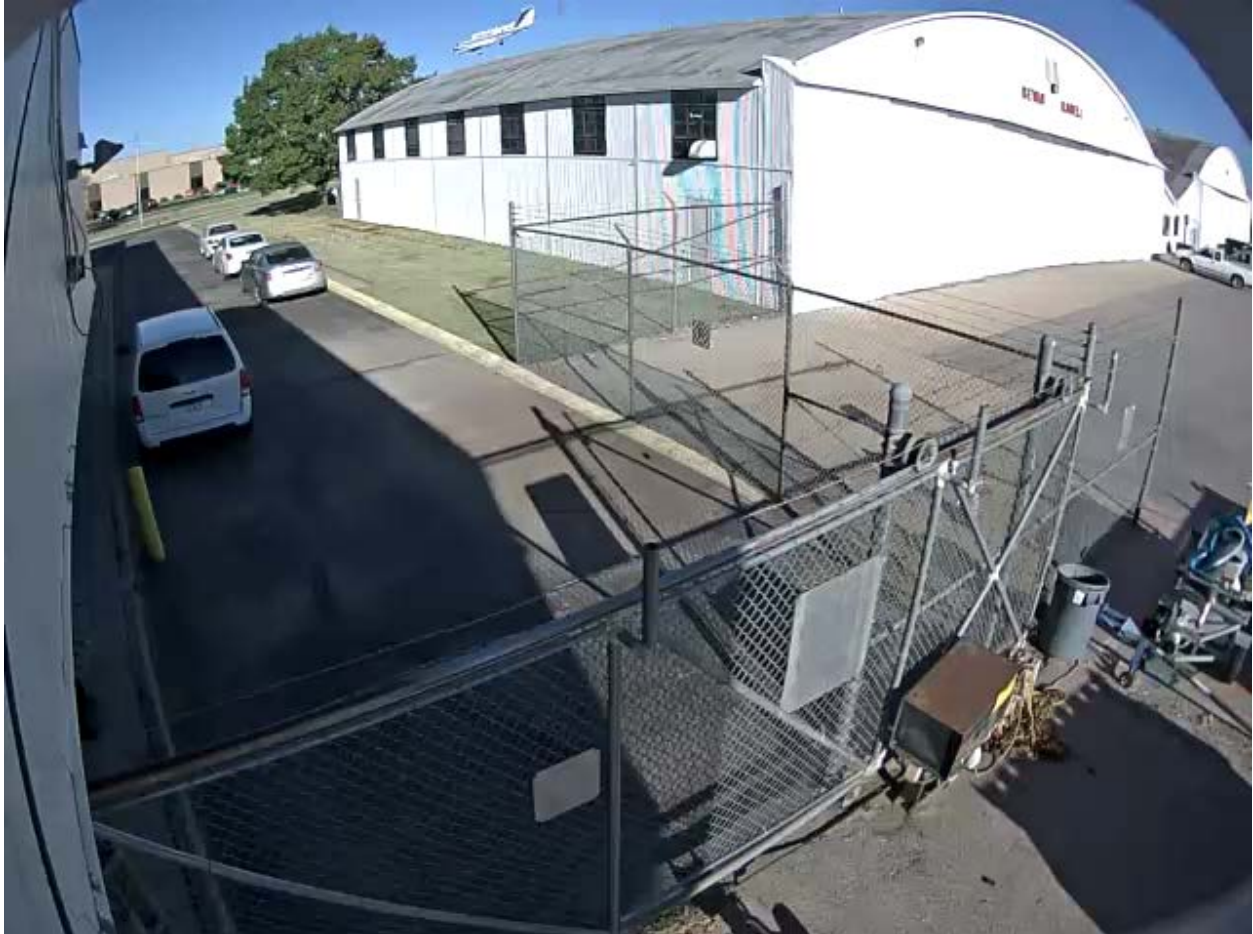
Image 1 – The airplane is within one second of impacting the building behind the tree. From the camera position, it is aligned with the corner post and left side of the 3rd window.

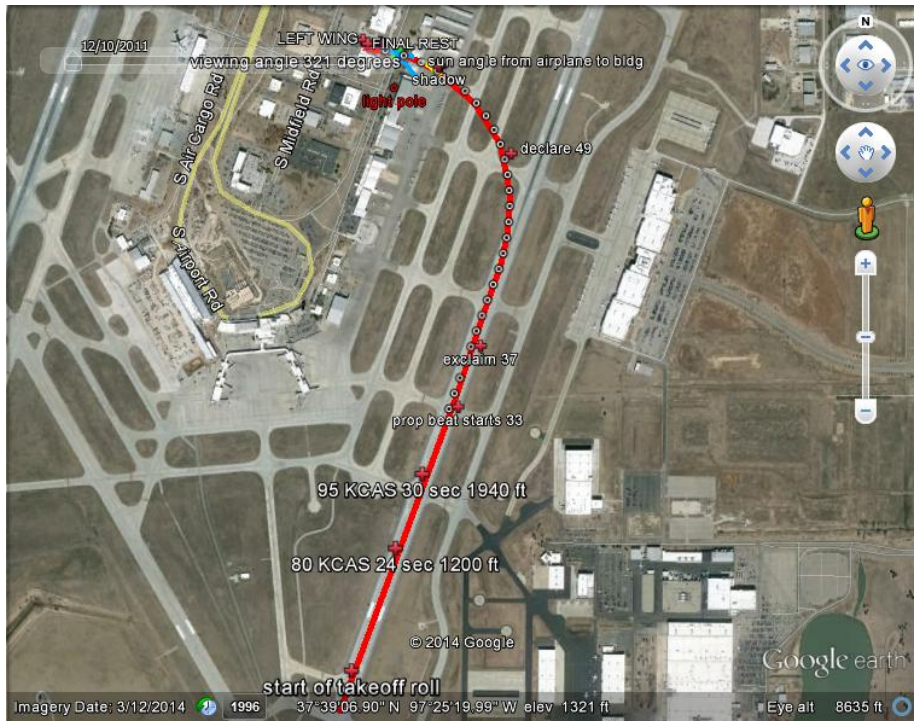
Image 2 – A representative flight path was established for the airplane.¹

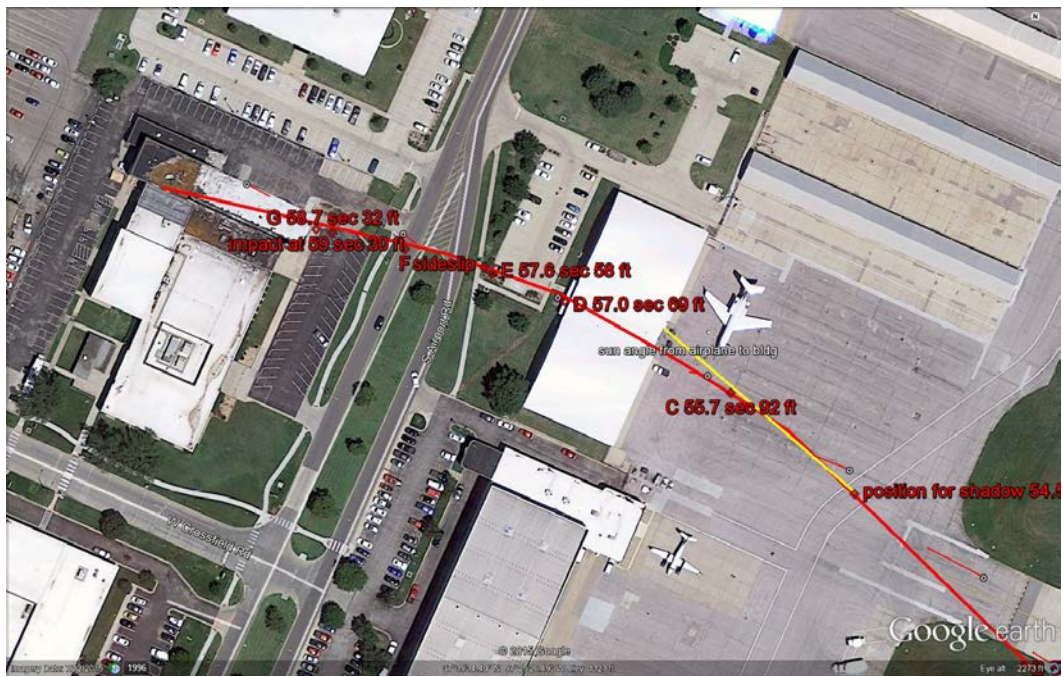
Image 3 – The final flightpath was established by using a simple flight simulation, a shadow on the building to the right (yellow line), the impact point on the building to the left, and the angle of the wreckage scatter across the building.

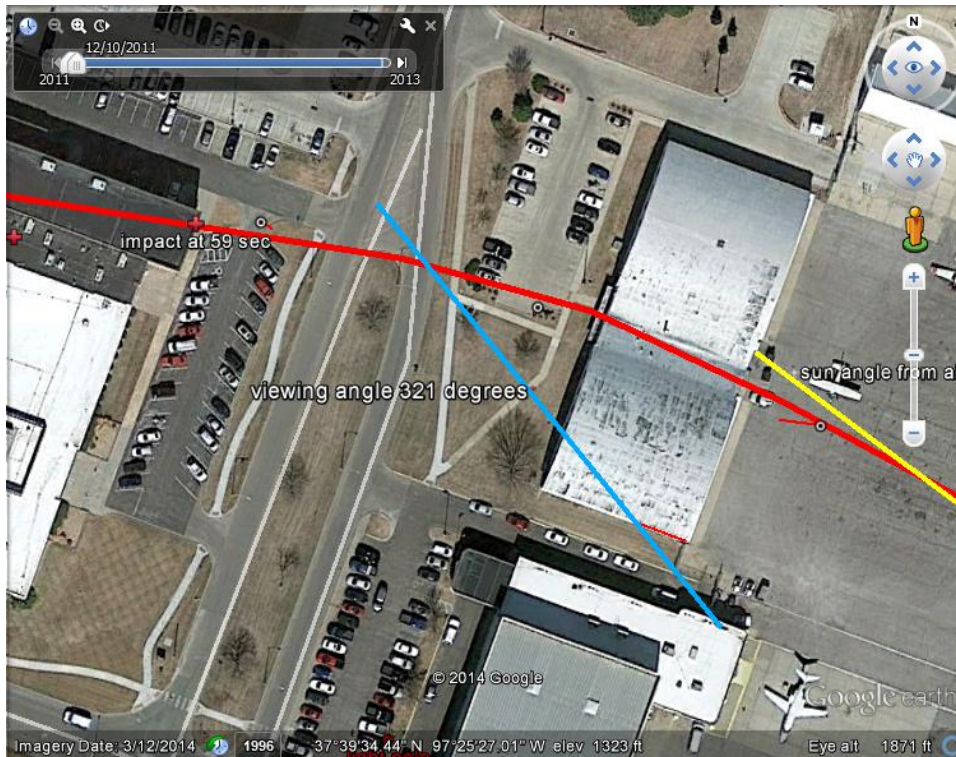
Image 4 – The viewing angle from the camera to the airplane in Image 1 was established as 321 degrees true (blue line). The blue line is aligned with the camera, the corner post and left side of the 3rd window (see Image 1).

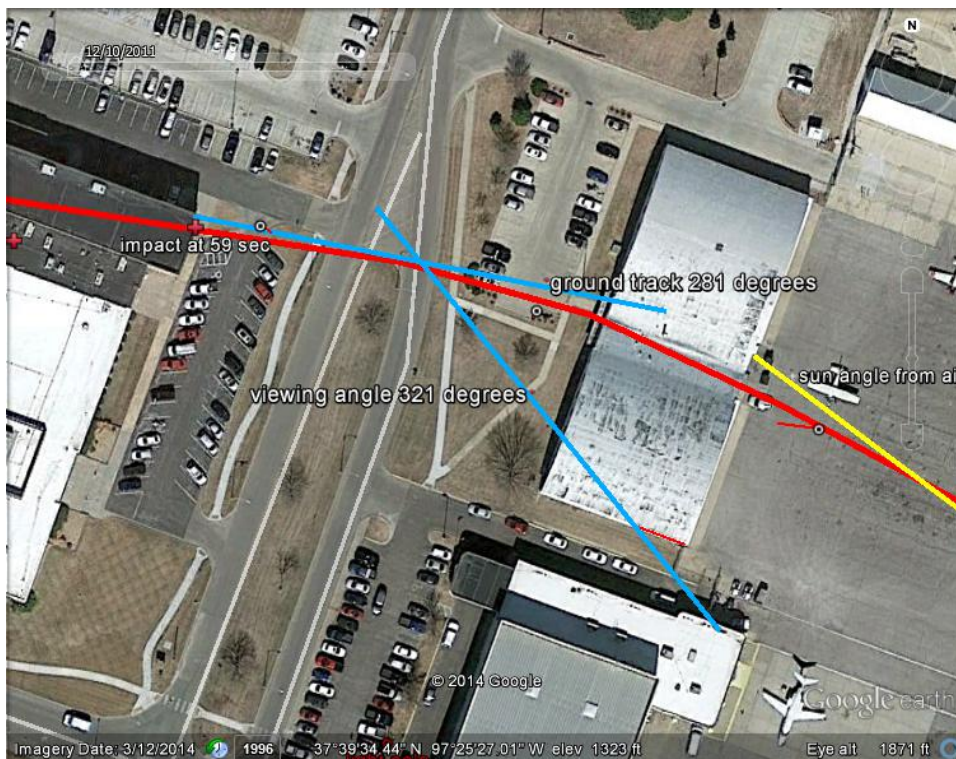
Image 5 – The second blue line represents the ground track vector when Image 1 was recorded. The ground track was established as 281 degrees true.

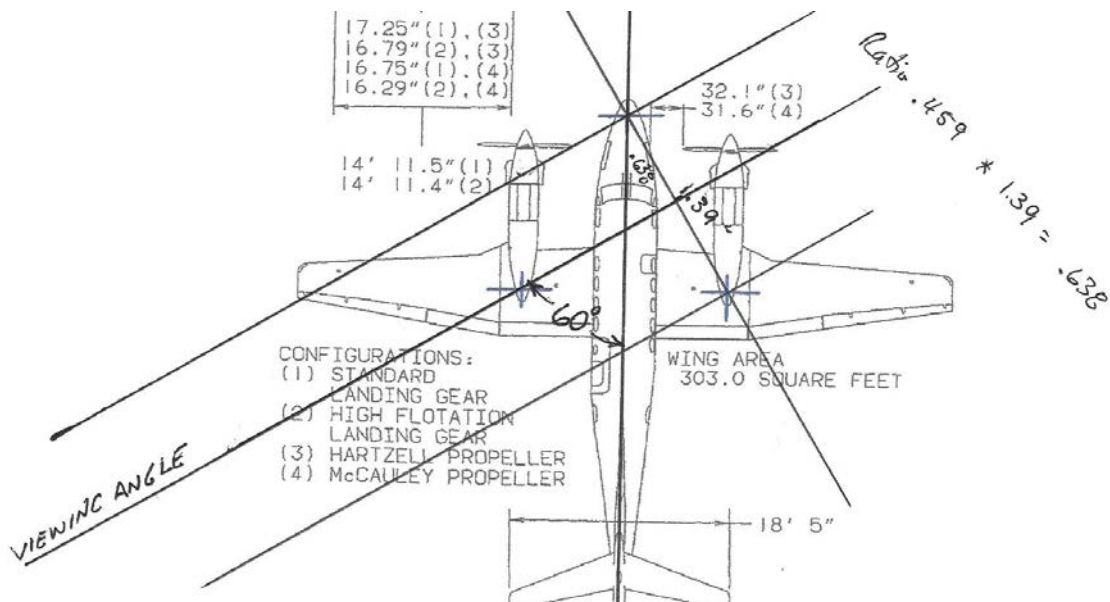
Image 6 – The the heading of the airplane relative to the viewing angle was established by measuring the relative positions of the three landing (Image 1). The airplane is pointed 60 degrees to the left of the viewing angle or 261 degrees true.

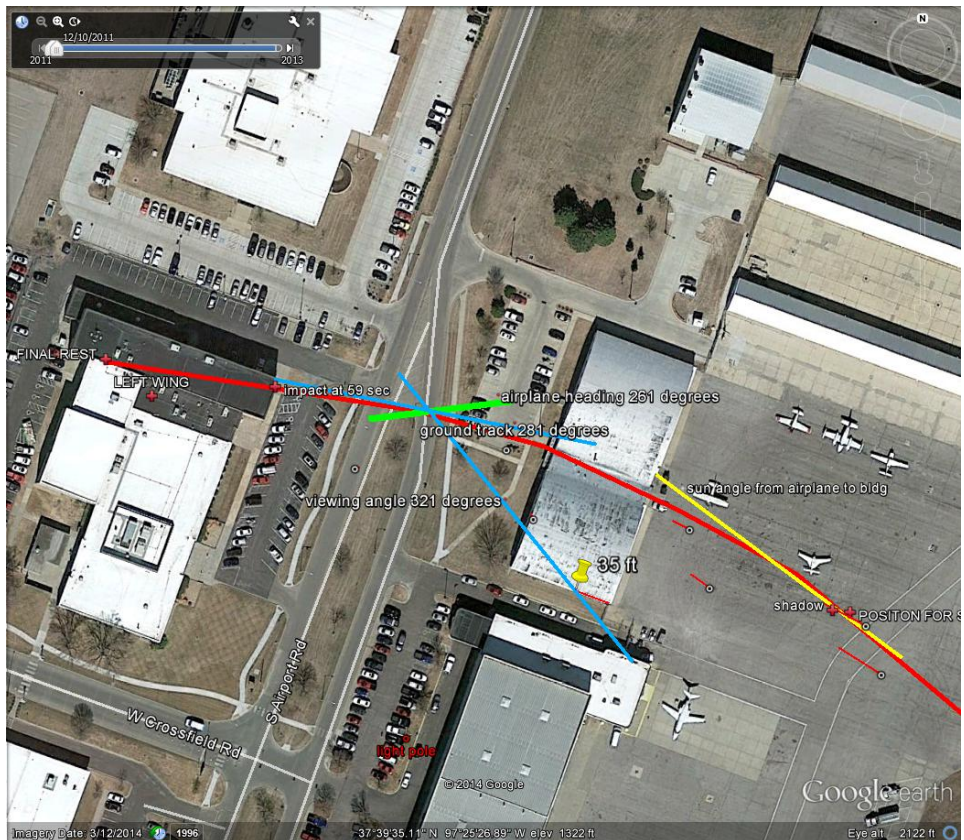
Image 7 - The difference between the heading of the airplane (261 degrees) and its ground track (281 degrees) is 20 degrees.

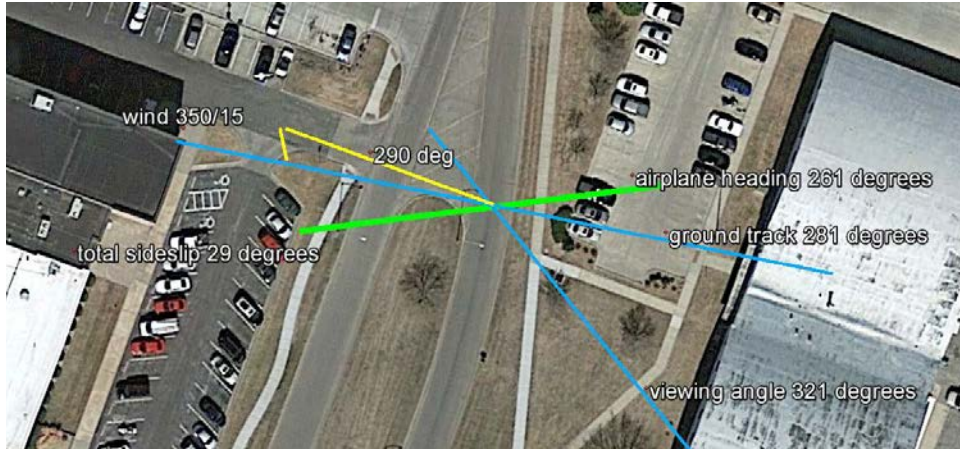
Image 8 – The wind was from 350° at 15 knots. The wind changes the airplane ground track 6 degrees. The “apparent” ground track would be 290 degrees (yellow line). The sideslip angle is the difference between the apparent ground track and the heading, or 29 degrees.
