**NATIONAL TRANSPORTATION SAFETY BOARD
Office of Research and Engineering
Washington, D.C. 20594**

Aircraft Performance Study

A. ACCIDENT: DCA11IA015

Location: Jackson Hole, WY
Date: December 29, 2010
Time: Approximately 18:38 GMT
Airplane: Boeing 757-200

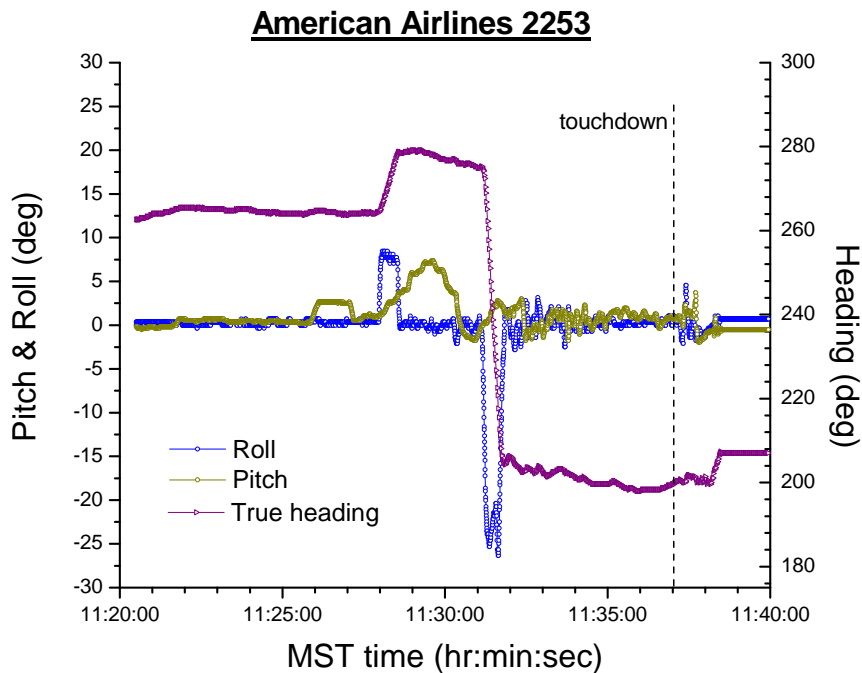
Figure 1 Pitch, Roll, and Heading

Flight data recorder (FDR) data were available for the incident aircraft. The FDR shows that the aircraft approach was relatively routine with pitch, roll, and heading recordings showing no unusual events. Figure 1 indicates that during the final approach and landing there was no more than a $\pm 5^\circ$ change in heading and a $\pm 2^\circ$ change in pitch and roll.

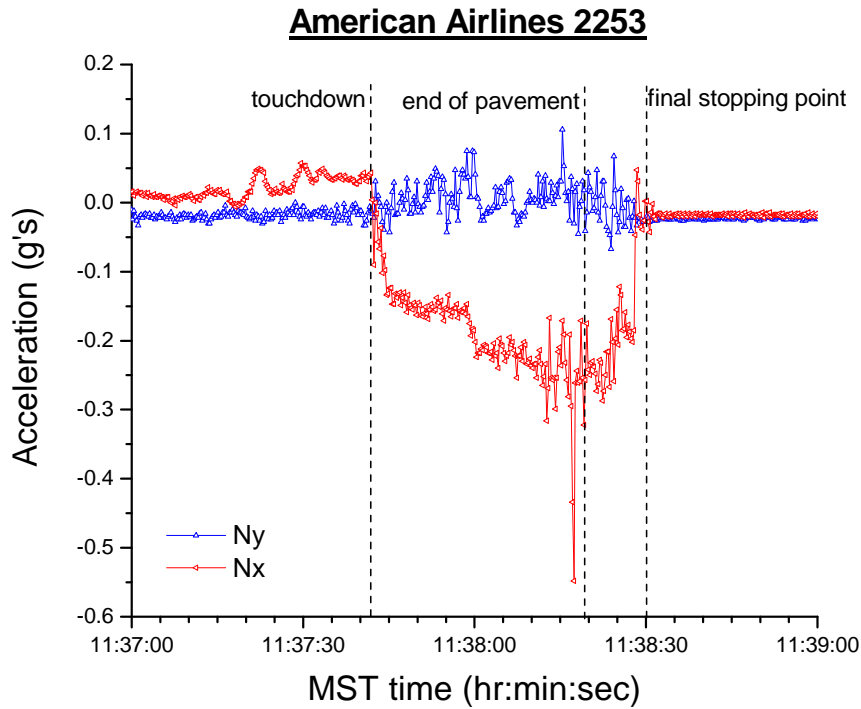
Figure 2 Longitudinal and lateral load factors.

The FDR failed to record correct vertical load factor, N_z , during the approach and landing. The lateral and longitudinal accelerations show little acceleration in the lateral plane. The expected deceleration in the longitudinal plane upon landing and are shown in Figure 2.

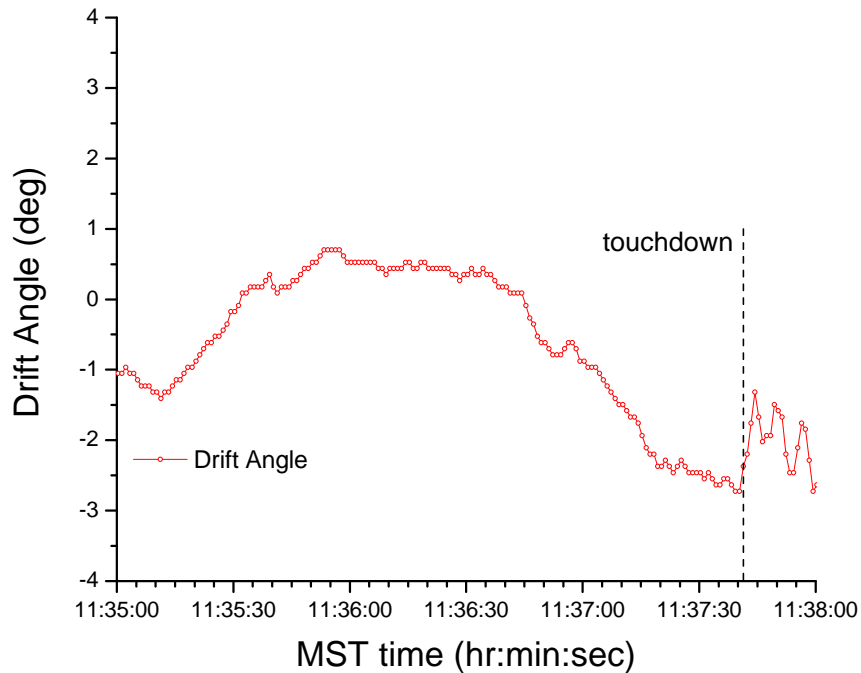
Figure 3 Drift angle on approach and landing.

Weather at the time recorded light winds and the drift angle in Figure 3 shows little drift.

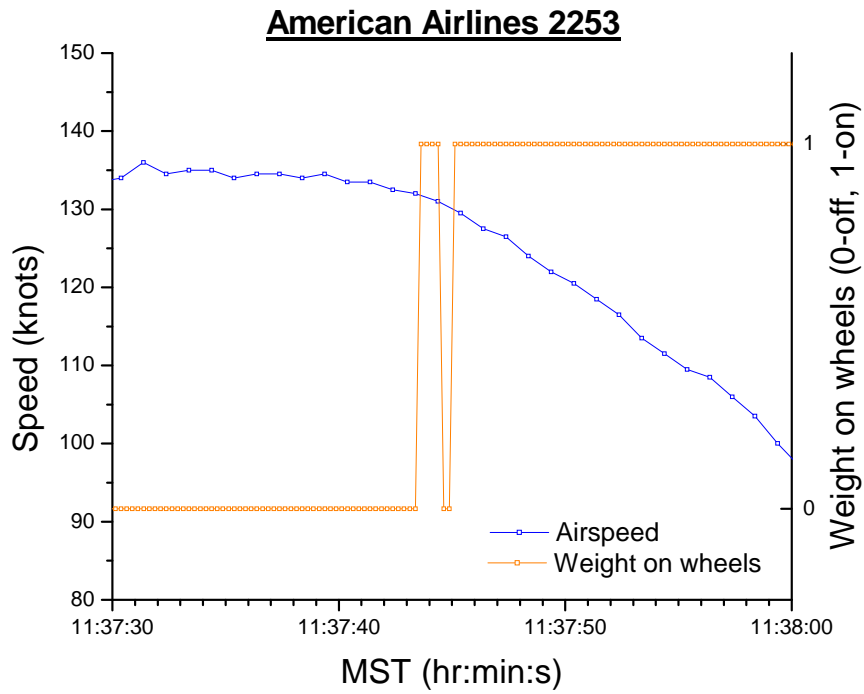
Figure 7 Airspeed and weight on wheels.

The aircraft touched down at 11:37:43MST at an airspeed of 132 knots, shown in Figure 7. The aircraft came to rest 350 feet beyond the end of the paved runway overrun at 11:38:31MST. Integration of the FDR data shows that the aircraft landed within the first 600 feet of runway as shown in Figure 8 and Figure 9. At the point the aircraft landed it had 5700 feet of runway and 300 feet of overrun ahead of it. The aircraft's approach glide path was 3 degrees.

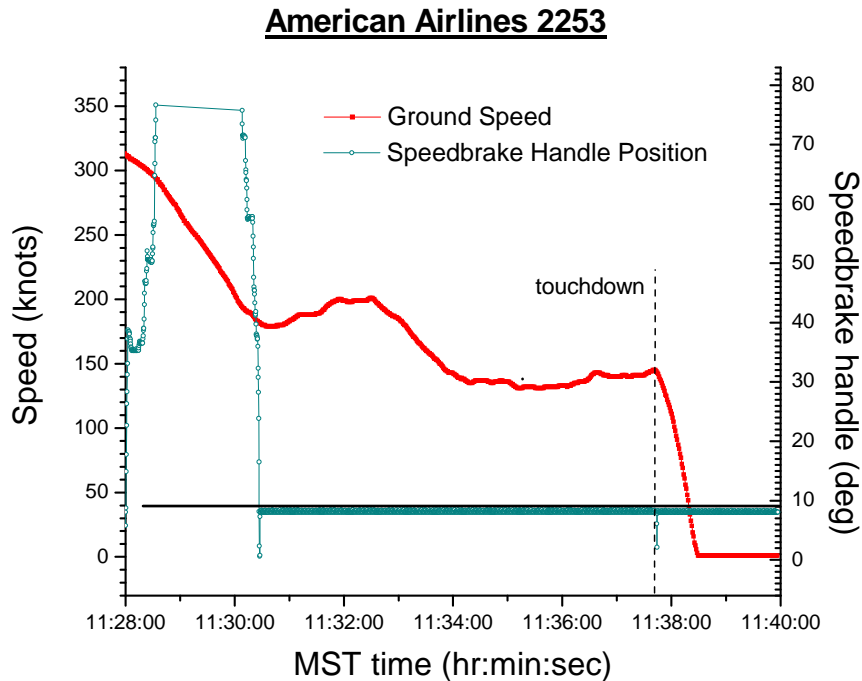
Figure 10. Speedbrake deployment.

During landing the speedbrakes are deployed to disrupt the aircraft's lift in order to maximize the weight on the landing gear. This increases the friction between the landing gear tires and the runway surface allowing the brakes to function at their maximum effectiveness. On the 757-200, the speedbrake handle deploys the ground and flight spoilers. As seen in Figure 10, the speedbrakes did not deploy after touchdown, though the flight spoilers did deploy seven minutes

earlier during the approach. If the speedbrakes are not deployed, the aircraft will not fully load the landing gear and the braking action is significantly less effective.

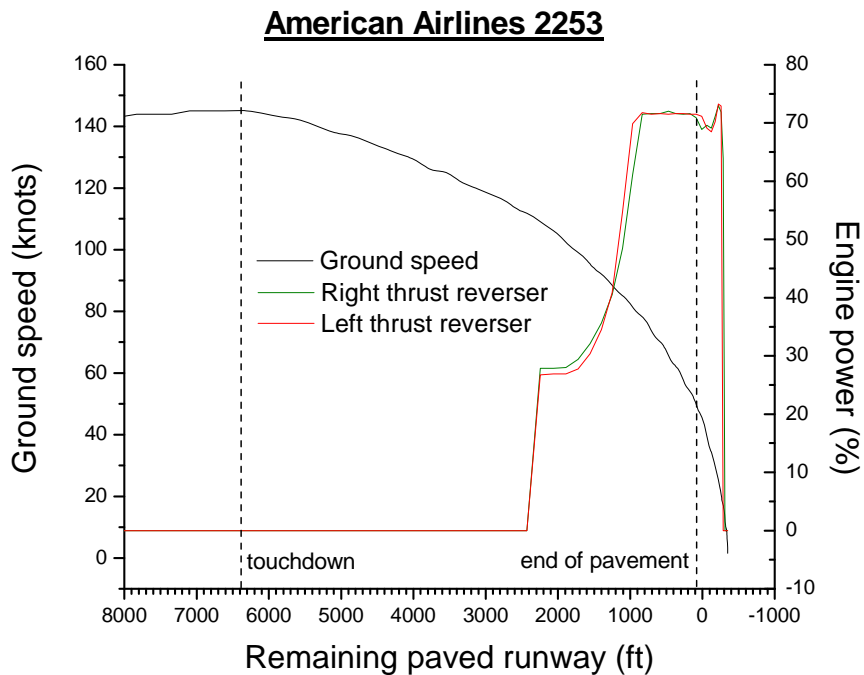
Figure 11 Speed and thrust reversers

The thrust reversers were deployed 18 seconds after touchdown with 2100 feet of runway left ahead of the aircraft as shown in Figure 11. The speed of the aircraft when the thrust reversers were deployed was 110 knots, down from 145 knots groundspeed at touchdown. Furthermore, the engines did not ramp up to 70% power until the aircraft had slowed to 80 knots. Thrust reversers are most effective at higher speeds.

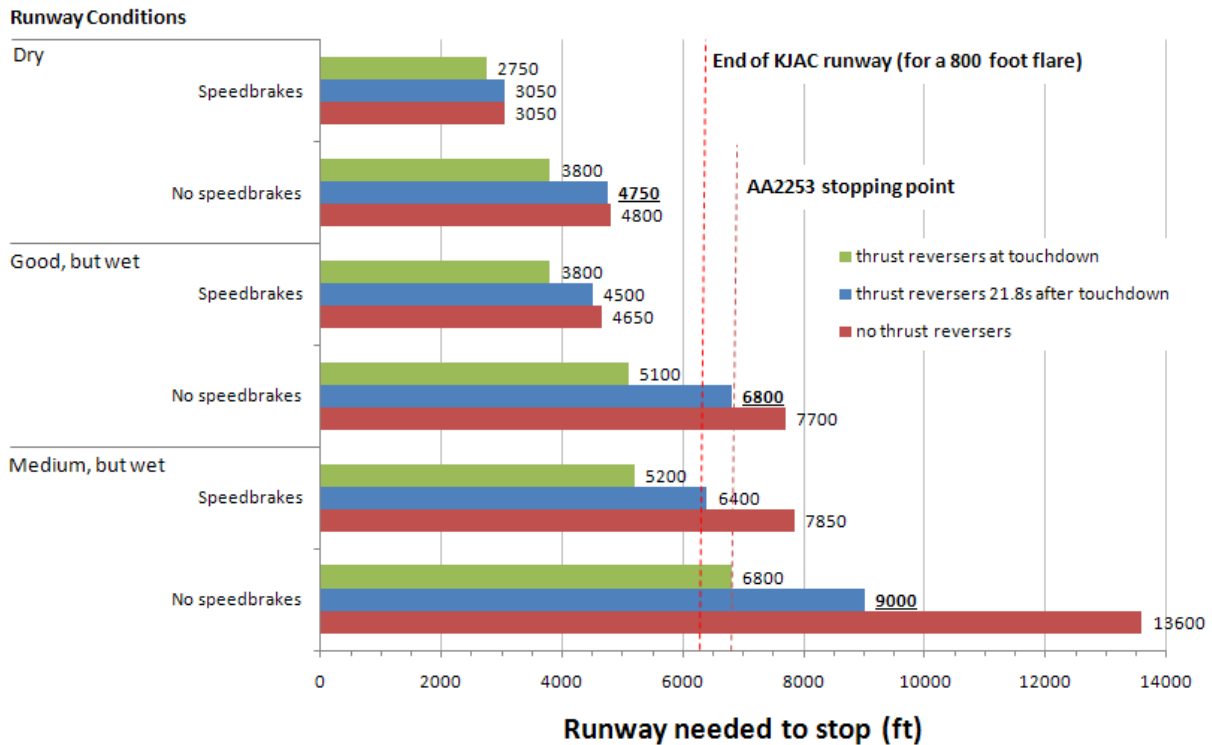
Figure 12 Boeing-calculated required runway lengths.

For dry runway braking, neither speedbrakes nor thrust reversers are needed for the aircraft to stop before the end of the runway. For a good but wet runway braking, the aircraft can be stopped without deploying the thrust reversers, but if the ground speedbrakes are not deployed and the thrust reversers are late it will not stop in time. For a medium but wet runway braking, the aircraft will stop before the end of the runway if the speedbrakes and thrust reversers are deployed at touchdown. If the speedbrakes are not deployed or the thrust reversers are late, the aircraft does not stop by the end of the runway.

According to these calculations, if the KJAC runway was dry, the aircraft could have stopped before the end of the runway without deploying the speedbrakes or thrust reversers. However, the wet weather conditions necessitated that the speedbrakes and thrust reversers be deployed in a timely manner. The calculation that most closely matches the AA2253 incident is for good but wet runway braking, no speedbrakes, and a delayed thrust reverser deployment. This condition

results in a stopping distance of 6800ft, 500ft beyond the end of the paved runway and within 150ft of the aircraft's final resting point. The same performance parameters with medium but wet runway braking condition would have resulted in a much longer overrun.
