Docket No. SA-521

Emery 17 Airplane Performance Study

Emery Flight 017 Airplane Performance Study

Location: Rancho Cordova, California
Date: February 16, 2000
Time: 1951 Local Time
Aircraft: Douglas DC-8-71, N8079 U
Operator: Emery Worldwide Airlines, A CNF Company (FAR Part 121
Supplemental)
NTSB#: DCA-00-MA-026

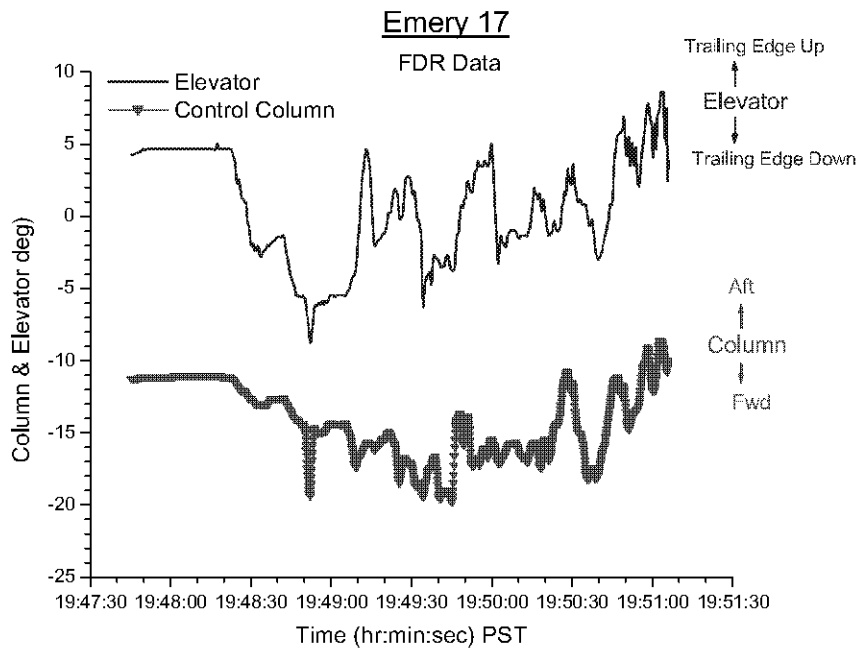
Figure 6: Uncorrected Column & Elevator

The FDR recorded elevator deflection was 11 degrees when the gust lock was engaged. Since the gust lock system requires the elevator to be faired (deflected zero degrees) to be engaged, it was concluded that the FDR elevator trace was offset 11 degrees¹. To help validate this conclusion, the Kinsurf program was used to extract a time history of estimated elevator deflection from aircraft motion during the accident flight. The control extraction process assumes no ground reaction forces. Accordingly, this study extracts estimated controls from just after liftoff until just before impact and does not extract controls during ground roll and rotation.

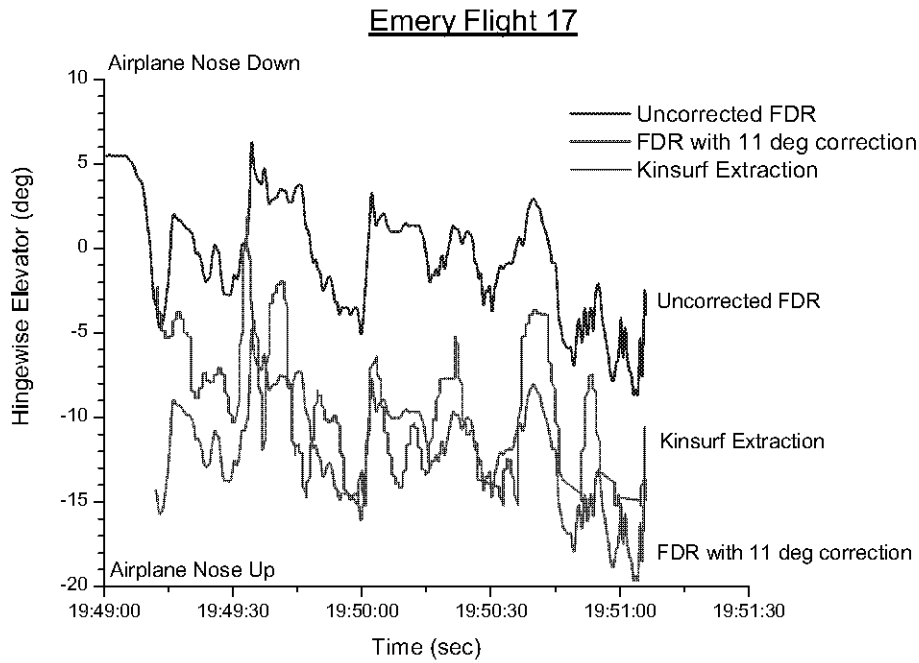
Figure 8: Hingewise elevator comparison

The weight and c.g. for the accident flight was obtained from the operations group as 279231 lb @ 27.2 % mean aerodynamic chord (%mac). The gear was down and flaps were 15 deg for the entire flight. The estimated elevator deflection extracted from the aircraft motion with Kinsurf is compared to the FDR elevator with and without the 11 deg offset in figure 8. Note that the sign

The elevator required for the aircraft motion during the accident flight is consistent with the FDR elevator offset by 11 degrees as indicated by the gust lock position.

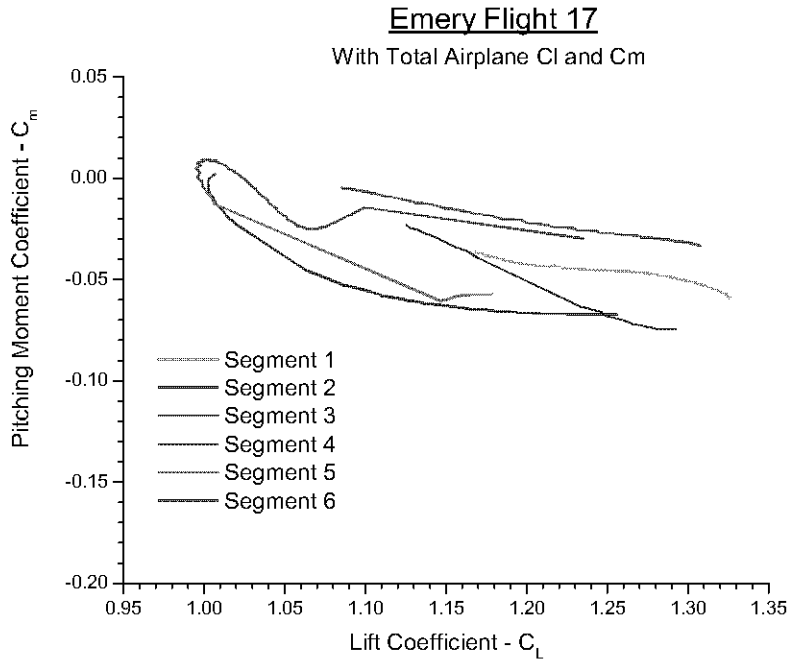
Figure 11: Total Airplane C_m vs. C_L

According to Boeing², the neutral point for this configuration and flight regime is 48.5% mac. Using this neutral point and the $\delta C_m / \delta C_L$ slopes obtained from figure 11, the center of gravity based on the total airplane measured stability is summarized in table 1.

Segment	$\delta C_m / \delta C_L$	Center of Gravity
Segment 1	-0.143	34.2 % mac
Segment 2	-0.289	19.6 % mac
Segment 3	-0.143	34.2 % mac
Segment 4	-0.308	17.6 % mac
Segment 5	-0.311	17.4 % mac
Segment 6	-0.129	35.6 % mac

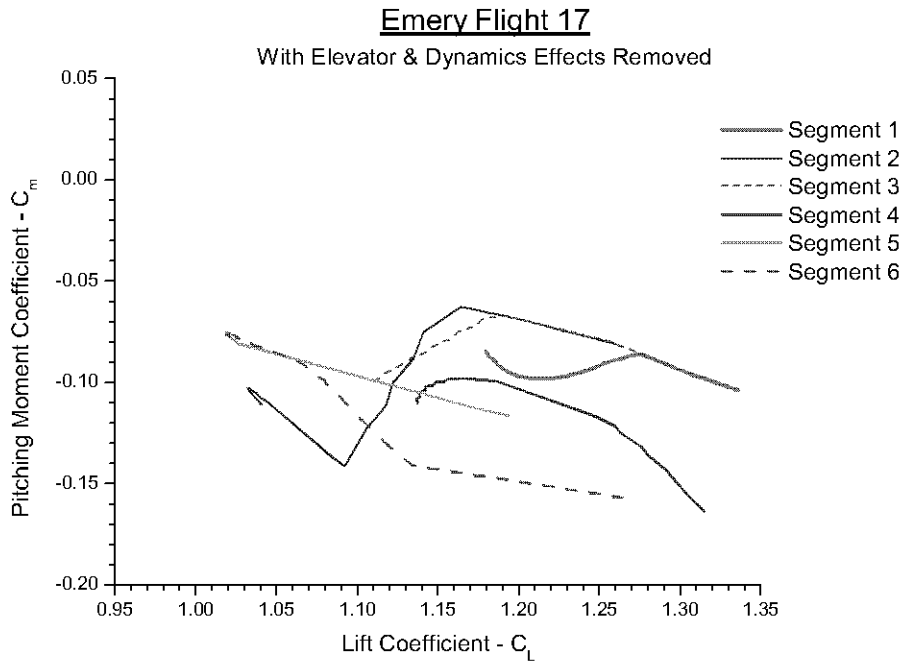
Figure 12: Corrected C_m vs. C_L

Using the 48.5% mac neutral point and the $\delta C_m / \delta C_L$ slopes obtained from figure 12, the center of gravity based on the corrected (dynamic and elevator effects removed) measured stability is summarized in table 2.

Segment	$\delta C_m / \delta C_L$	Center of Gravity
Segment 1	-0.243	24.2 % mac
Segment 2	-0.243 to -0.086	24.2 to -0.086 % mac
Segment 3	-0.243	24.2 % mac
Segment 4	-0.308	17.6 % mac
Segment 5	-0.223	26.2 % mac
Segment 6	-0.314	17.1 % mac

The basic stability of the aircraft during the accident flight is consistent with a c.g. within the cg limits. The stability is not consistent with a shift aft out of the cg limits.

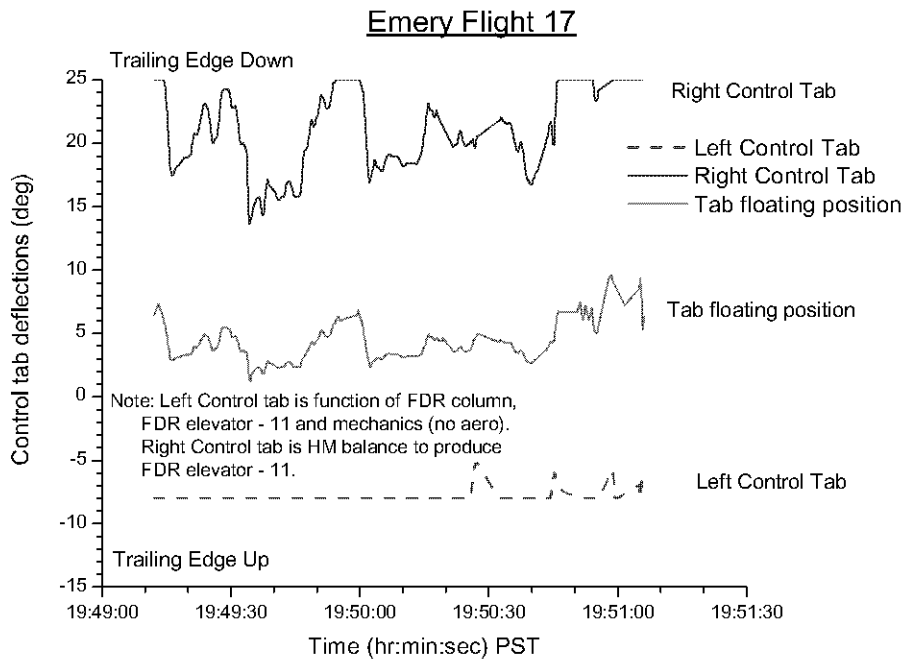
Figure 13: Extracted Control tab deflections (nominal FDR)

For initial runs, the trailing edge down control tab limit was set at 15 deg, the limit of the hinge moment data table. This resulted in a 15 deg trailing edge down right control tab output from Kinsurf. However, the trailing edge down mechanical stop is at 25 degrees streamwise. Accordingly, since the data table range could have limited the initial runs, the hinge moment data table was linearly extrapolated to 25 deg trailing edge down and the program was re-run. The resulting streamwise right control tab deflection (for elevator hinge moment balance) is plotted together with the streamwise left control tab deflection (from mechanical linkage with column and elevator) in figure 13. A trace of floating position for the control tab is also included for comparison. This floating position is the position that the tab would assume with no mechanical force input from the tab linkage. It is the tab position where the aerodynamic hinge moment is zero with the recorded elevator position and the tail angle of attack derived with Kinsurf as input.

Using FDR recorded column and elevator and the known mechanical tab function of elevator and column shows that during the accident flight the left control tab was at its negative (trailing edge up) stop. The study has shown that the right control tab necessary to obtain the recorded elevator was near the positive (trailing edge down) stop. The study has also shown that the flight crew maintained a significant column push force (airplane nose down command). The exact push force that was exerted on the column(s) cannot be determined since the control tab was against the stop.

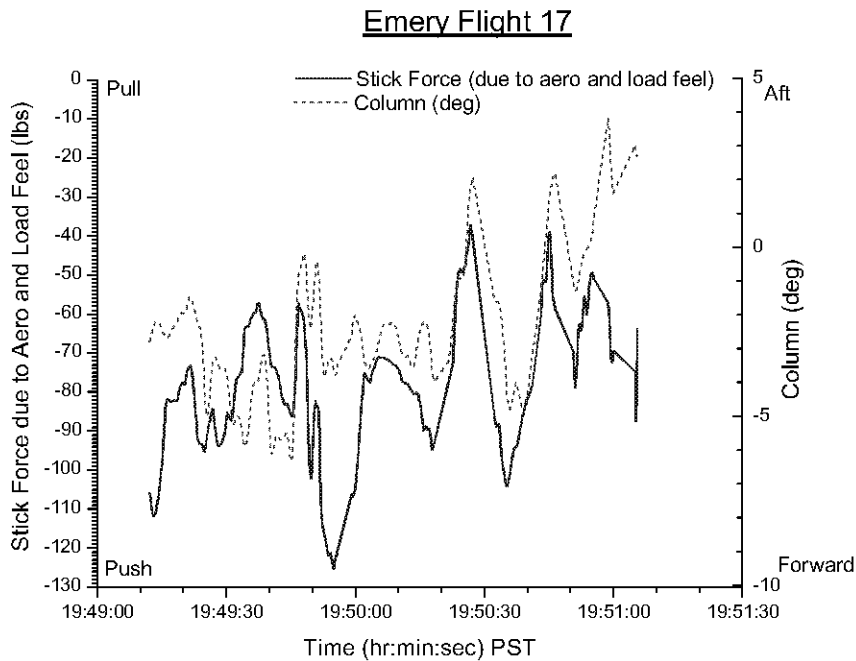
Figure 14: Stick force from aerodynamics and load feel (nominal FDR)

The estimated column force that accompanies the tab deflections shown in figure 13 is shown in figure 14. The estimated column force contribution from the load feel system is combined with the estimated column force due to aerodynamic load and plotted with column position. Note that when the left tab is at the tab trailing edge up stop, this force represents just the force necessary to reach that tab stop. The plotted column force does not include any extra push force against that tab stop.

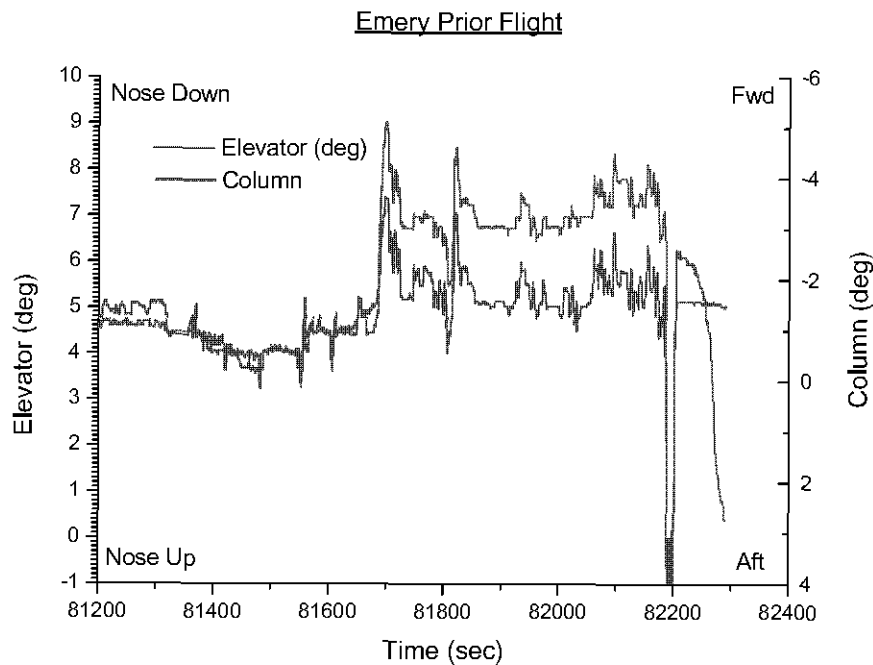
Figure 17: Sacramento Landing Control Anomaly

Examination of the FDR data for the landing at Sacramento prior to the accident flight showed a change in the character of the column and elevator data at about 81700 sec elapsed FDR time. This is shown in figure 17 with the corresponding airspeed and altitude shown in figure 18. A cross-plot of elevator vs. column in figure 19 shows the change in effective column to elevator gain at the time of the anomaly. Note that the 11 deg elevator and 13.5 deg column correction have been applied to these plots.

As can be seen in figure 17, the recorded elevator was between 4 ½ and 5 deg trailing edge down before the control anomaly. The DC-8 Flying qualities report shows elevators generally between 1 ½ and 2 ½ degree trailing edge down for trimmed flight. The Kinsurf program was run iterating on column offset and elevator offset to find the trim condition during the period before the control anomaly. That is, the offset to the elevator trace was found that produced zero column force while the offset to the column trace was used to make sure that the control tab obtained from mechanical gearing and linkage (modeled with the left tab) matched the control tab required to get the elevator deflection (modeled with the right tab). Kinsurf calculated a stabilizer for each offset elevator trace. The Zero column Force, aircraft equilibrium trim condition was satisfied with a 3.2 deg trailing edge up offset to elevator and with no offset to column. Figure 26 shows the elevator with the offset required for column force trim and the stabilizer required for equilibrium. The trim elevator approaching the anomaly is within the 1 ½ to 2 ½ degree range. The control tab deflections extracted through the anomaly are shown in figure 27. The accompanying stick force is plotted with column deflection in figure 28. A trace of floating position for the control tab is also included in figure 27 for comparison. As discussed before, this floating position is the position that the tab would assume with no mechanical force input from the tab linkage. It is the tab position where the aerodynamic hinge moment is zero with the recorded elevator position and the tail angle of attack derived with Kinsurf as input.

A control anomaly has been identified about 8 1/3 minutes before landing at Sacramento. The control extraction showed that the stabilizer moved trailing edge up (airplane nose up) when the pilot pushed the airplane over to resume the descent after a brief pause. This is opposite to the airplane nose down trim one would expect at this point. A kinematic extraction shows a control tab split began at the time of the anomaly. This tab split was easily controllable with the stabilizer trim motion returning the aircraft to trim and the elevator remaining responsive to pilot input.

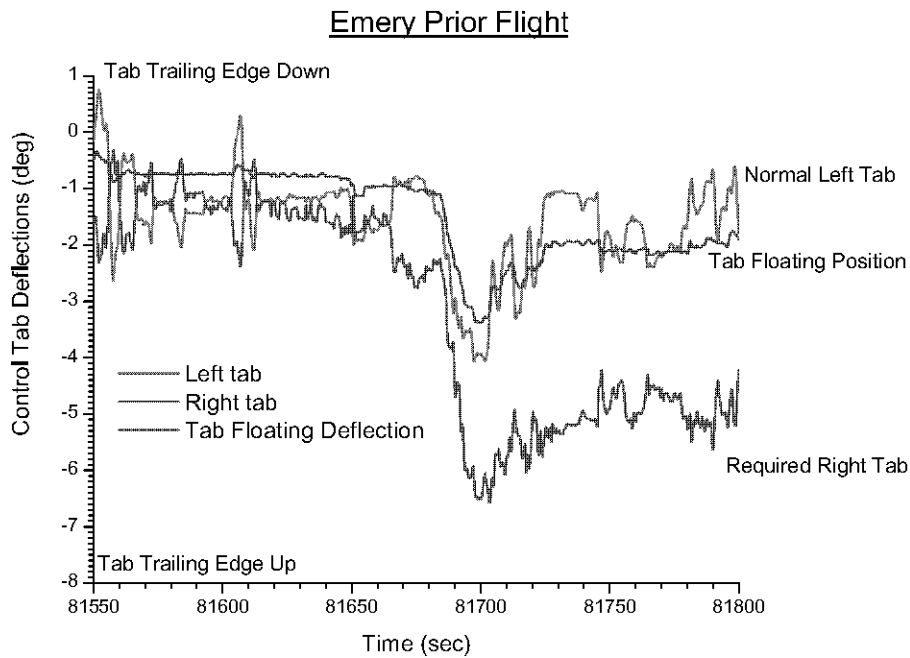
Figure 27: Control tabs for control anomaly

The Kinsurf program was used to determine the control tab deflections during the control anomaly on approach to Sacramento for the flight previous to the accident. As before, the left tab operates normally as a function of column and elevator position. The right tab is calculated to provide the hinge moment required to balance the elevator at the elevator deflection.
