Airplane Performance Group Chairman's Factual Report

**American Airlines Flight 1420
Little Rock, Arkansas
June 1, 1999**

DCA99MA060

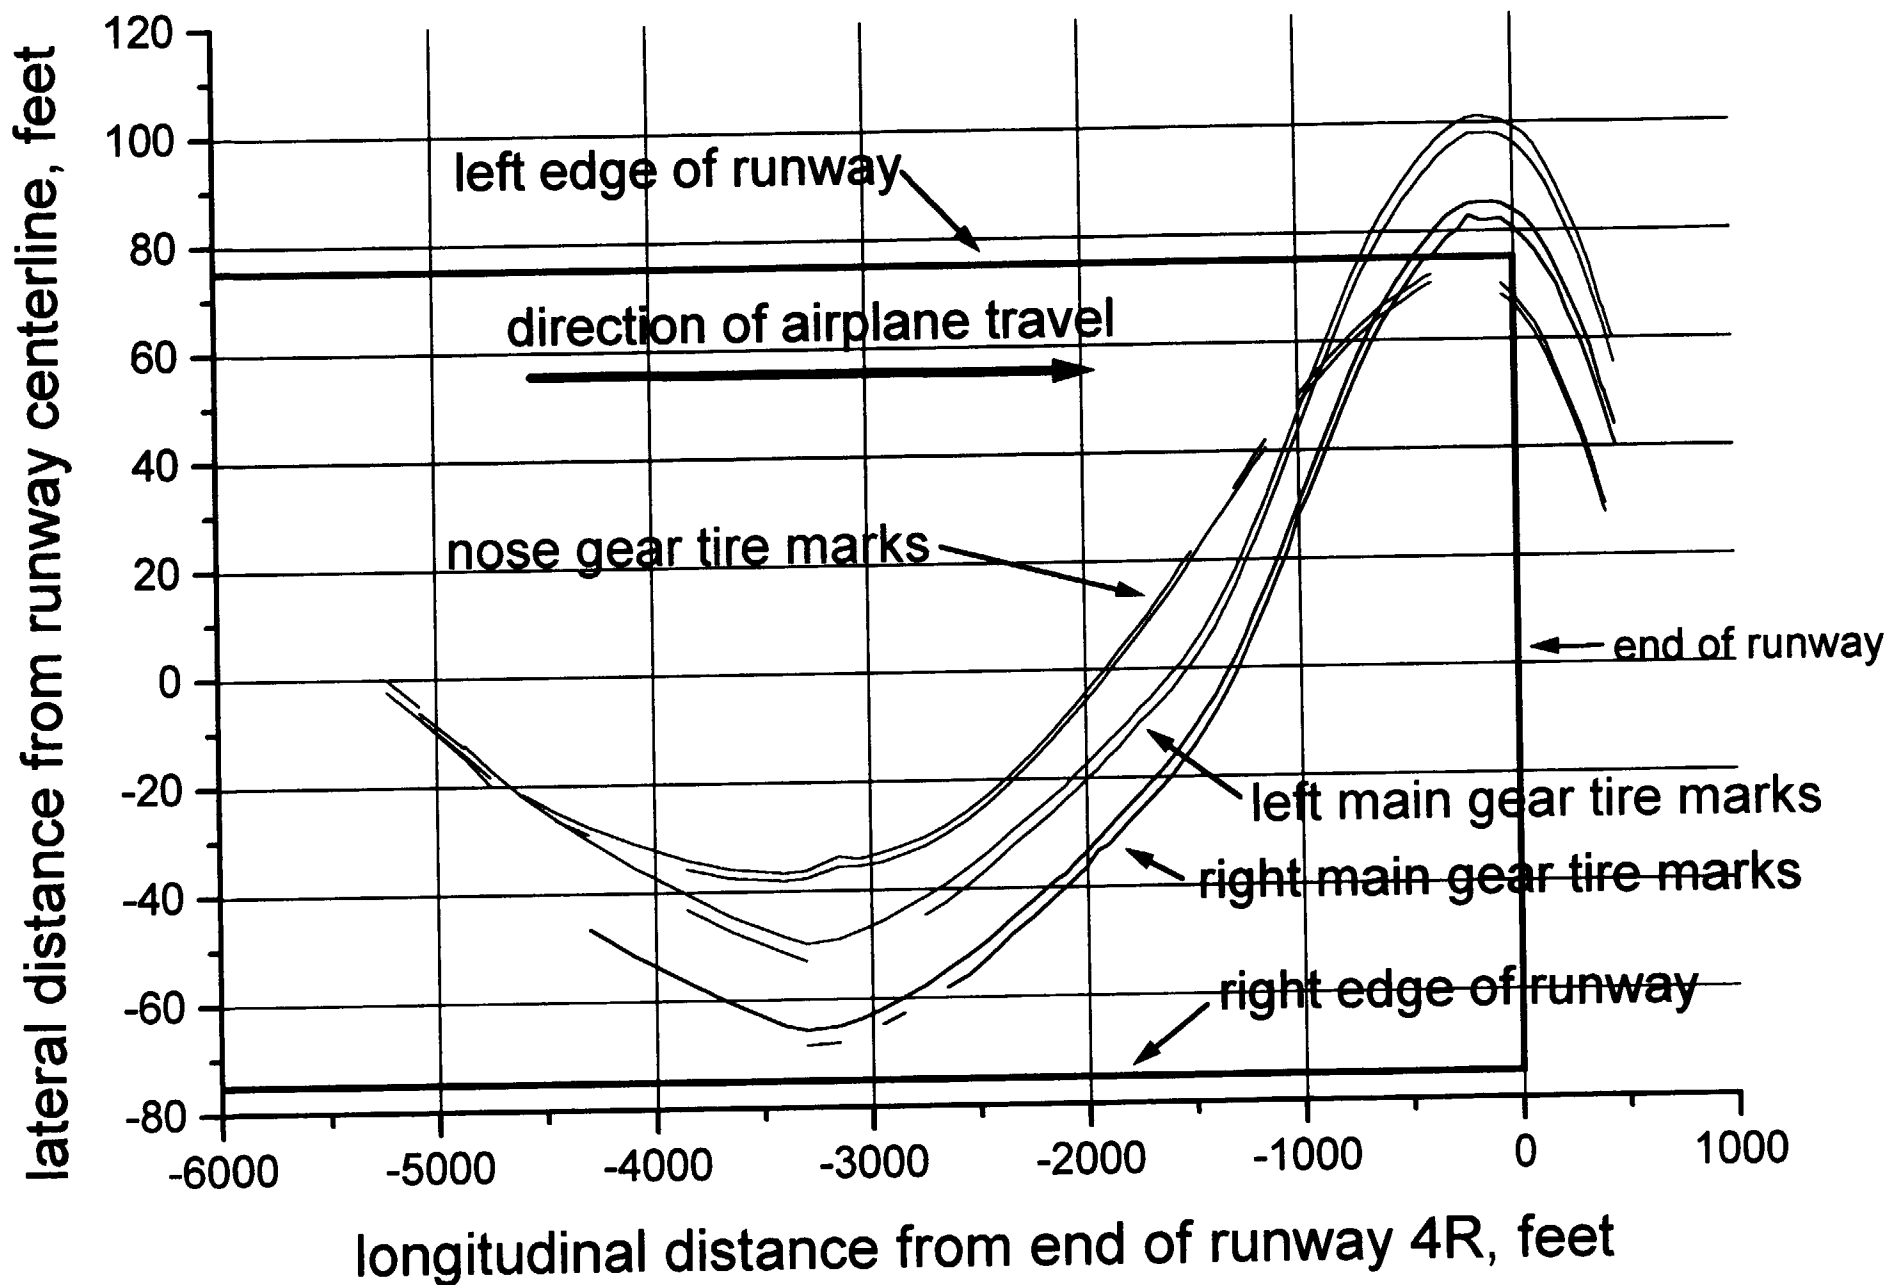
AAL 1420 Runway Tire Marks

Tire marks consistent with those of the left main landing gear began 5,228 feet from the end of the runway's concrete surface. These tire marks continued for 149 feet before ending. Tire marks consistent with those of the left main landing gear began again at 4,872 feet from the end of the runway's concrete surface. These marks continued without further interruption until ending at the edge of a gravel downslope 459 feet beyond the end of the runway's concrete surface. The left main gear tire marks began crossing into the grass on the left edge of the runway about 710 feet before the end of the runway concrete surface.

Tire marks consistent with those of the nose landing gear began 5,079 feet from the end of the runway's concrete surface. These marks continued for 207 feet before ending. Tire marks consistent with those of the nose landing gear began again at 4,753 feet from the end of the runway's concrete surface. These marks continued with occasional interruptions until ending at the edge of the concrete ILS array pad 411 feet beyond the end of the runway's concrete surface. The nose gear tire marks remained on the runway concrete surface until reaching the end of the runway concrete surface approximately 67 feet left of runway centerline.

Tire marks consistent with those of the right main landing gear began 4,303 feet from the end of the runway's concrete surface. These marks continued without further interruption until ending at the edge of a gravel downslope 459 feet beyond the end of the runway's concrete surface. The right main gear tire marks began crossing into the grass on the left edge of the runway about 465 feet before the end of the runway concrete surface. The left and right main gear tire marks were approximately 98 and 82 feet left of runway centerline, respectively, when they crossed the end of the runway/taxiway concrete surface.

note that x and y axes are not to same scale

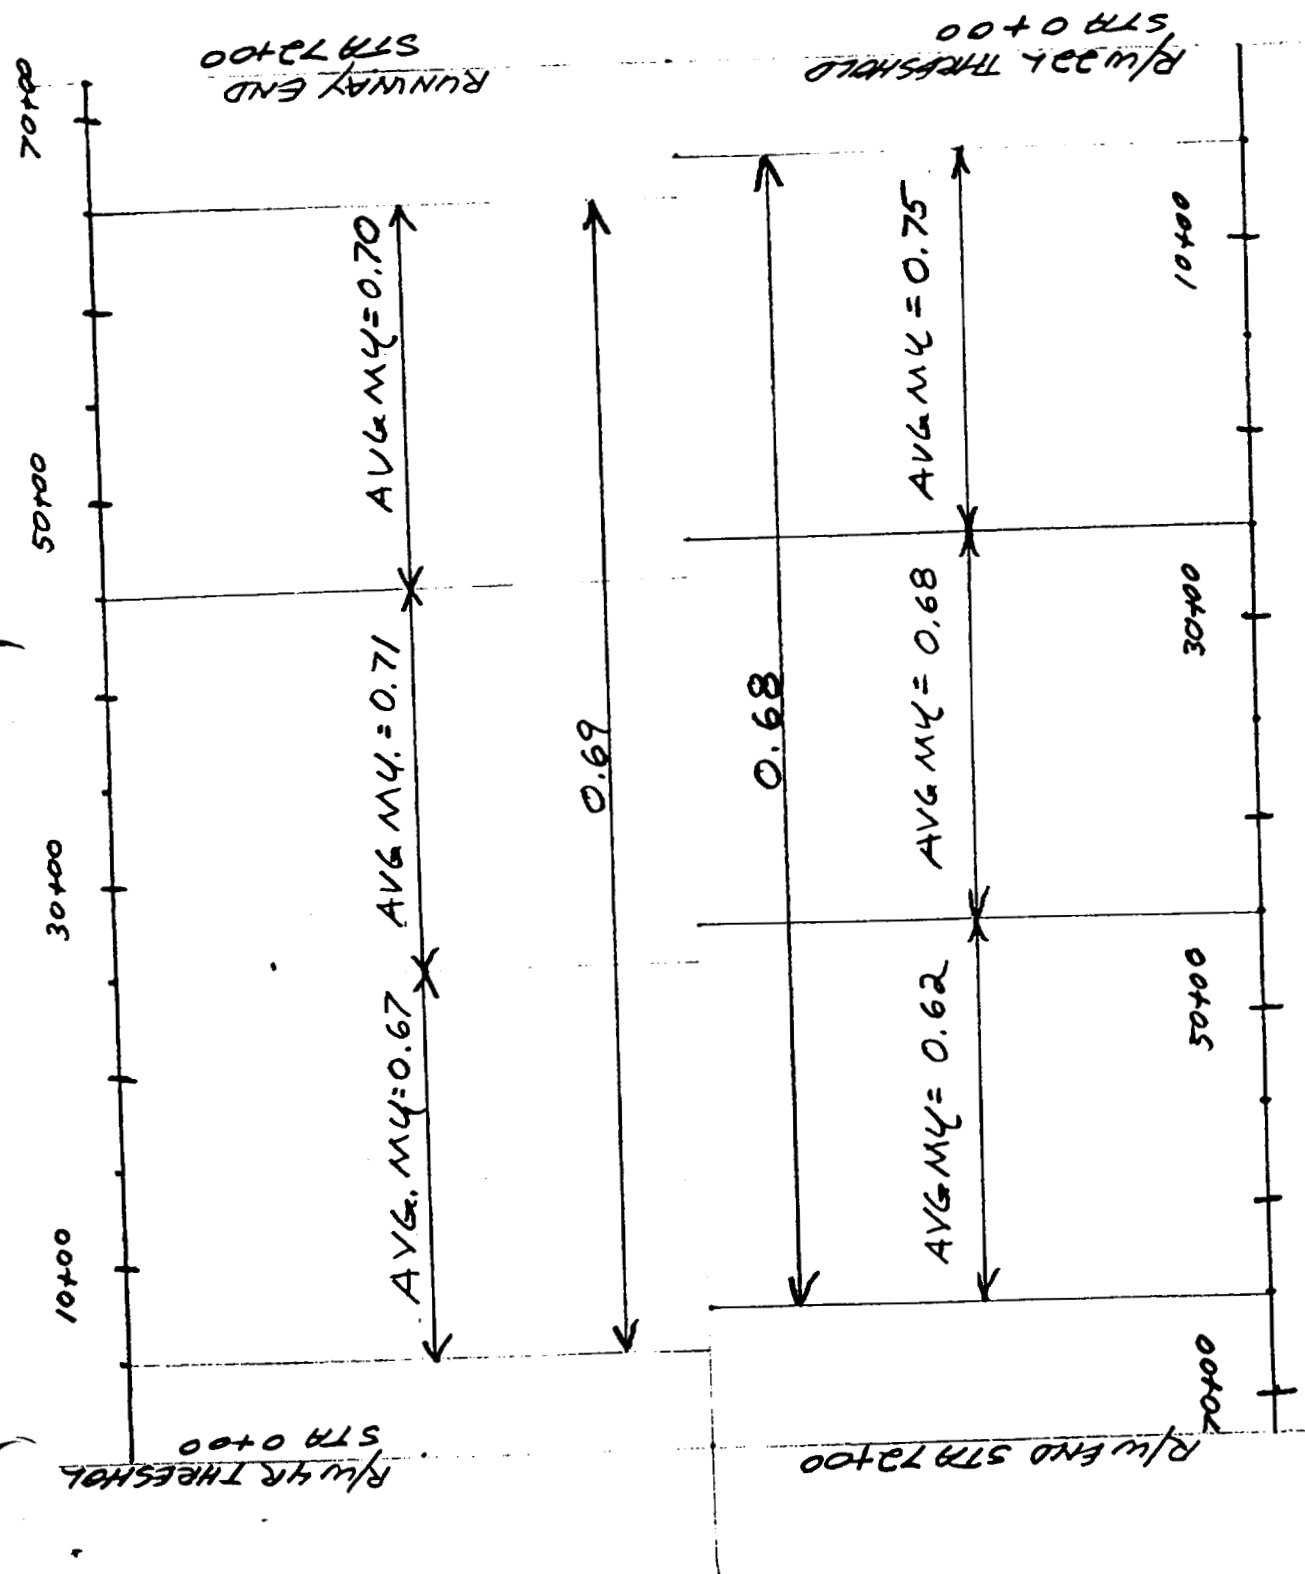
Runway 4R's wet friction coefficients were measured using Dallas-Fort Worth Airport's SAAB test vehicle at 40 and 60 mph speeds. The average friction coefficient was 0.685 at 40 mph and 0.555 at 60 mph.

R/W 4R/22L CFME (SFT) @ 40 MPH WATER ON 10' L RIGHT

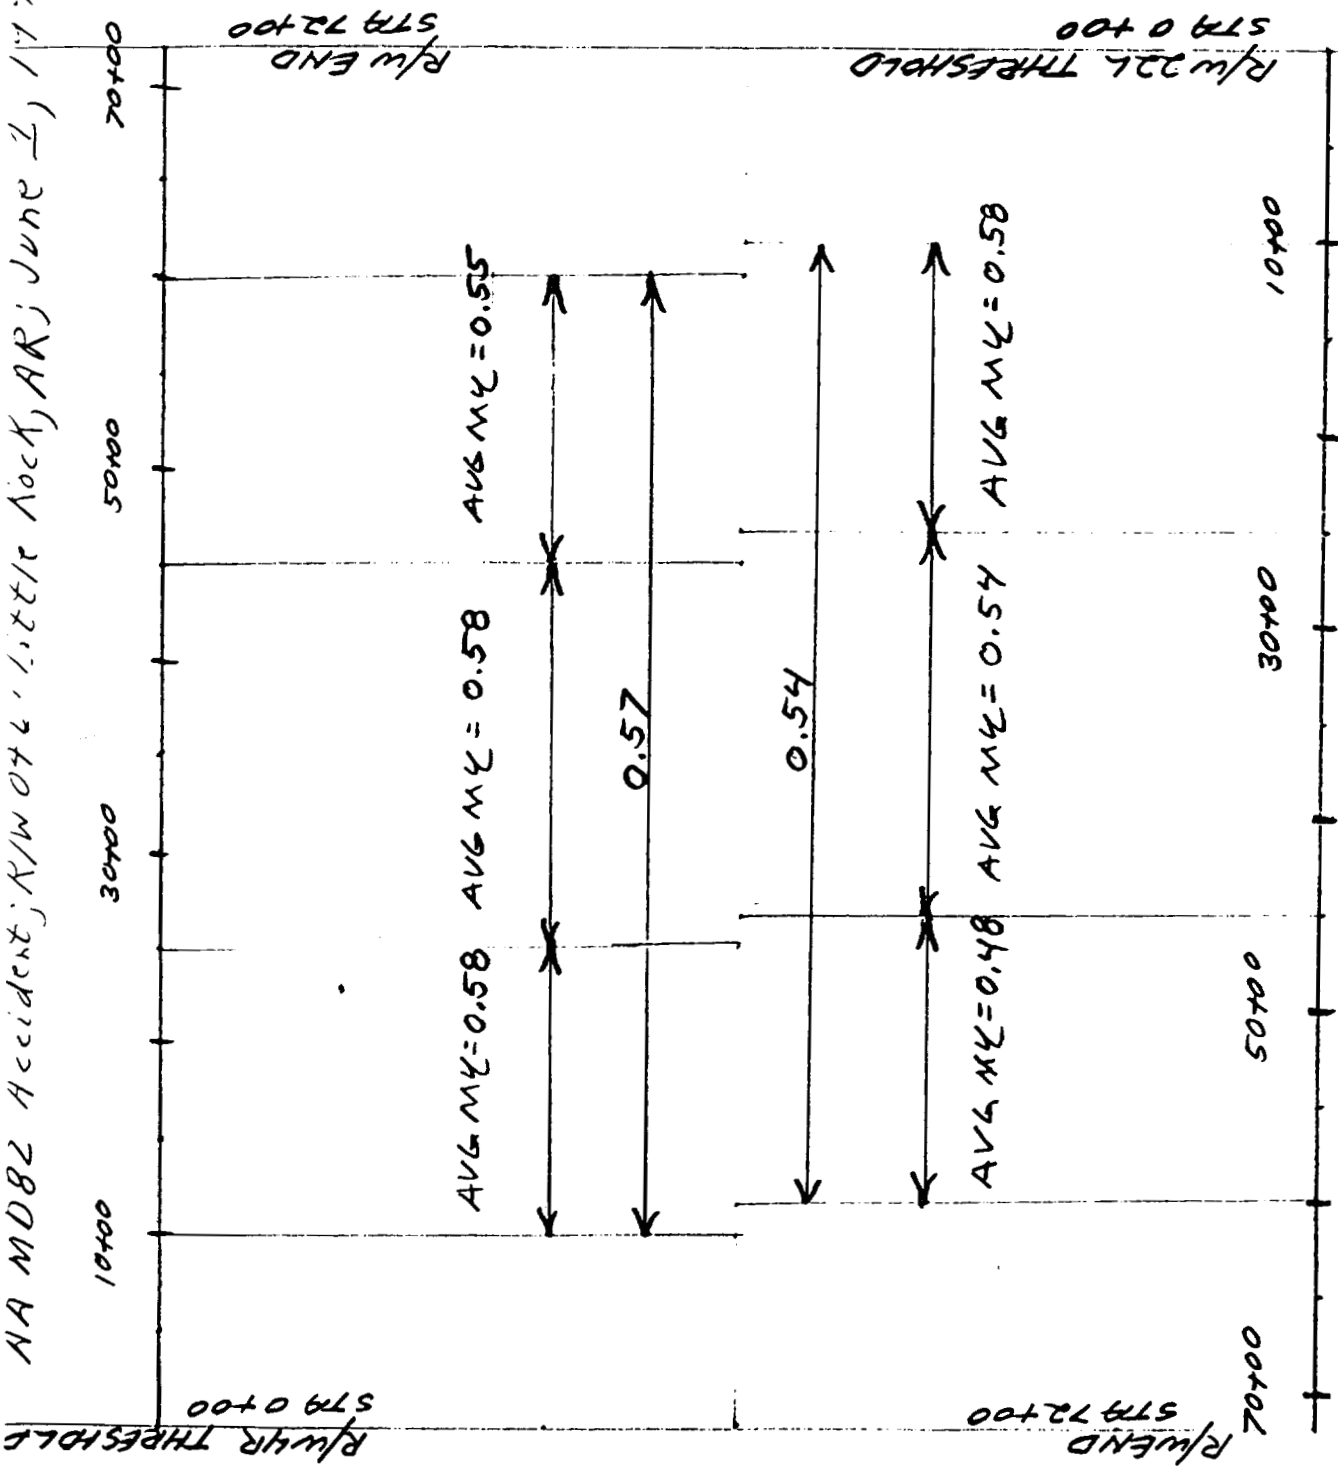
Fig 2

R/W 4R/22L CFME(SFT) @ 60 MPH WATER ON 10 L RIGHT
