**DOCKET No.: SA-521**  
**EXHIBIT No. 13B**

**Emery 17 Airplane Performance Study – Addendum 1**

**Addendum 1**

Location: Rancho Cordova, California  
Date: February 16, 2000  
Time: 1951 Local Time  
Aircraft: Douglas DC-8-71, N8079 U  
Operator: Emery Worldwide Airlines, A CNF Company (FAR Part 121  
Supplemental)  
NTSB#: DCA-00-MA-026

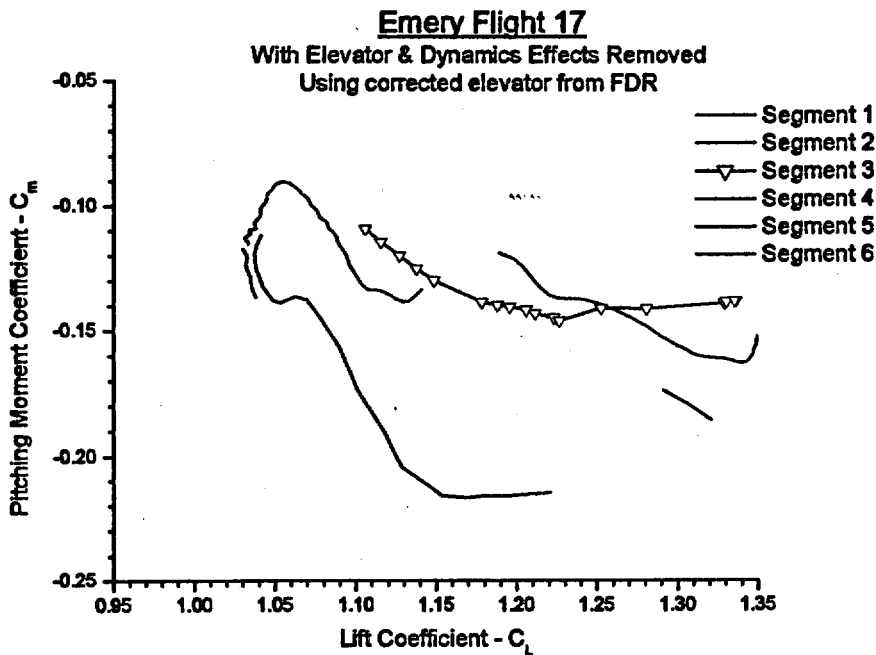
**Figure 1: Corrected  $C_m$  vs.  $C_L$  using FDR elevator**

For this addendum, the effect of the elevator and the effect of dynamics in the aerodynamic coefficient build-up equations were summed and removed from the total airplane stability using the FDR elevator with the 11 deg offset discussed in the original report. The resulting stability is presented in figure 1 for the six flight segments.

Using the 48.5% mac neutral point and the  $\delta C_m / \delta C_L$  slopes obtained from figure 1, the center of gravity based on the stability with offset FDR elevator and dynamic effects removed is summarized in table 2.

The Kinsurf code was modified to use of the corrected FDR elevator rather than the Kinsurf derived elevator when removing the effect of elevator from longitudinal stability. The use of the corrected FDR elevator has resulted in a larger derived center of gravity scatter than the Kinsurf extracted elevator method but also shows no indication of an aft center of gravity.

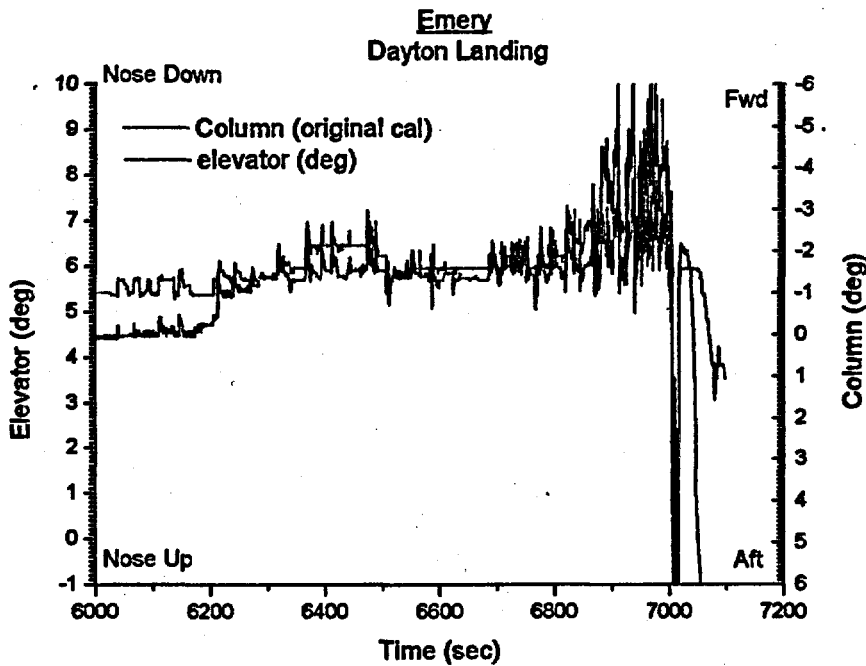
Figure 2: Dayton Landing Controls

In their post docket additional comments, Boeing suggested that the shift in the elevator trace at 6210 sec during the Dayton landing be investigated. Figure 23 from the original report showed this shift and is reproduced below as figure 2.

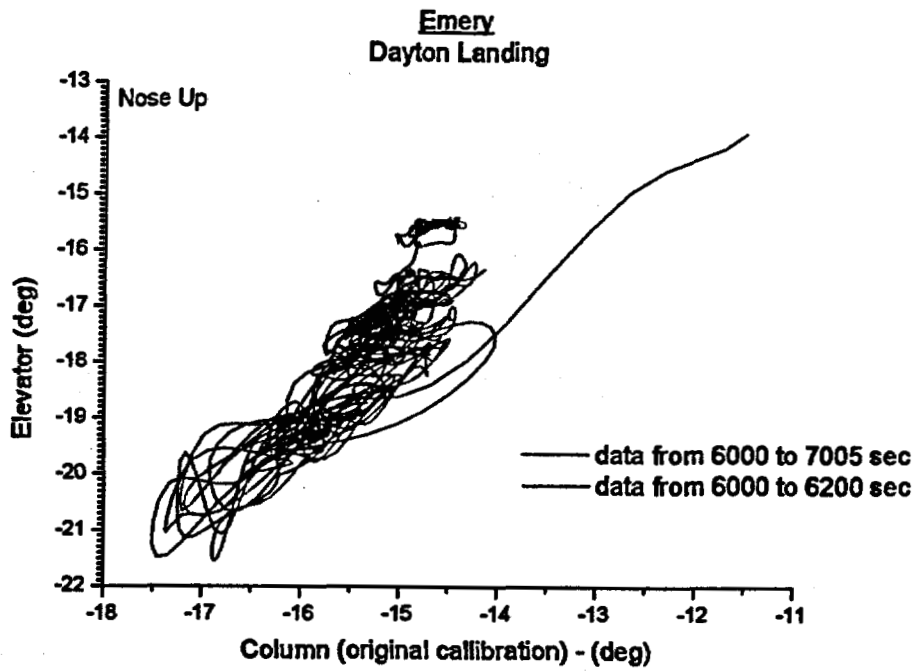
**Figure 3: Dayton Landing Cross-plot**

The cross-plot in Figure 25 of the original report is reproduced below as figure 3 with data before the 6210 sec elevator shift highlighted in red.

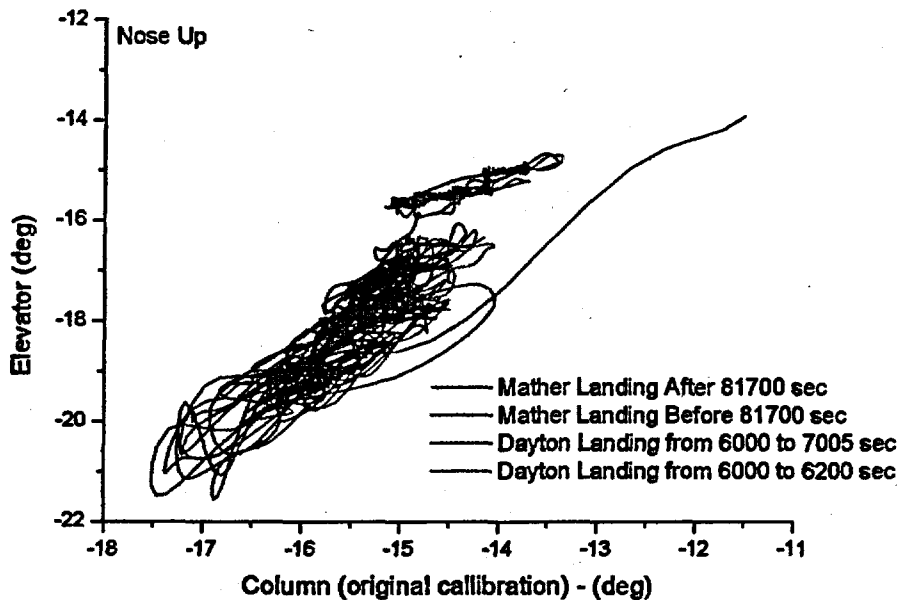
**Figure 4: Comparison of Dayton and Mather approaches**

The cross-plot of the Dayton approach is compared to the cross-plot of the approach into Mather field in figure 4.

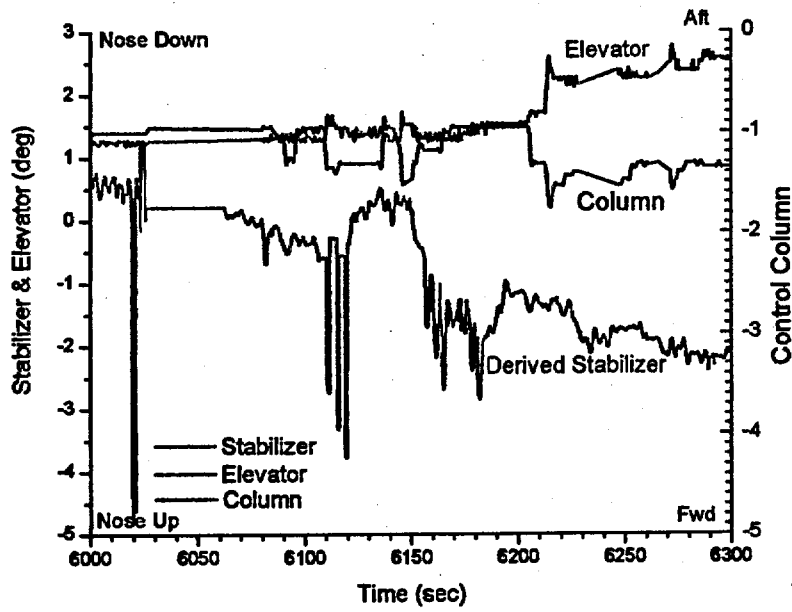
Figure 5: Extracted Stabilizer and pitch controls.

Kinsurf was first run to extract stabilizer from aircraft motion using elevator as input. The extracted stabilizer is shown in figure 5 together with elevator and column. Note that the analysis assumed zero winds and turbulence. Winds and turbulence actually present will be reflected in noise in the extracted stabilizer trace.

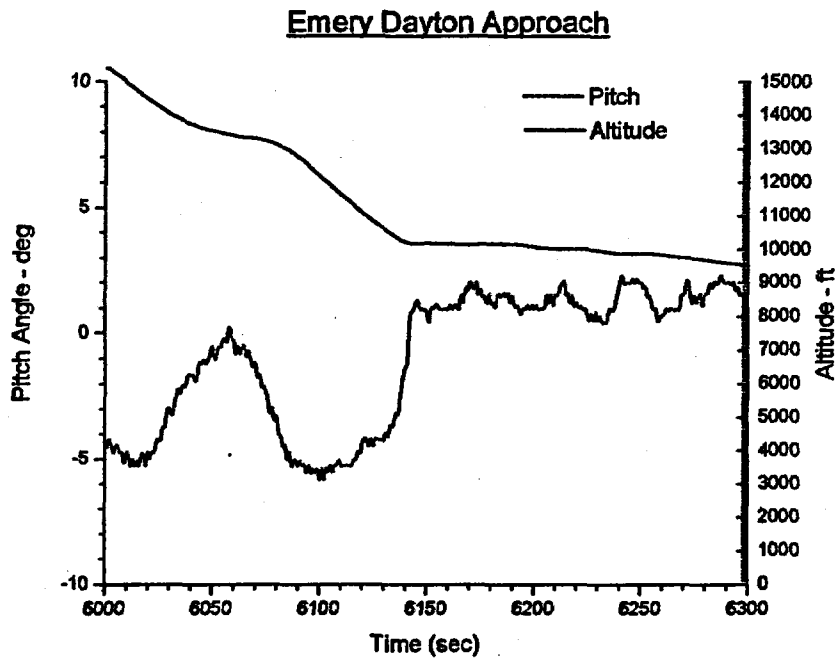
**Figure 6: Flight path profile**

As can be seen in figure 6, the aircraft had leveled out just before the trim change that began about 6150 seconds.

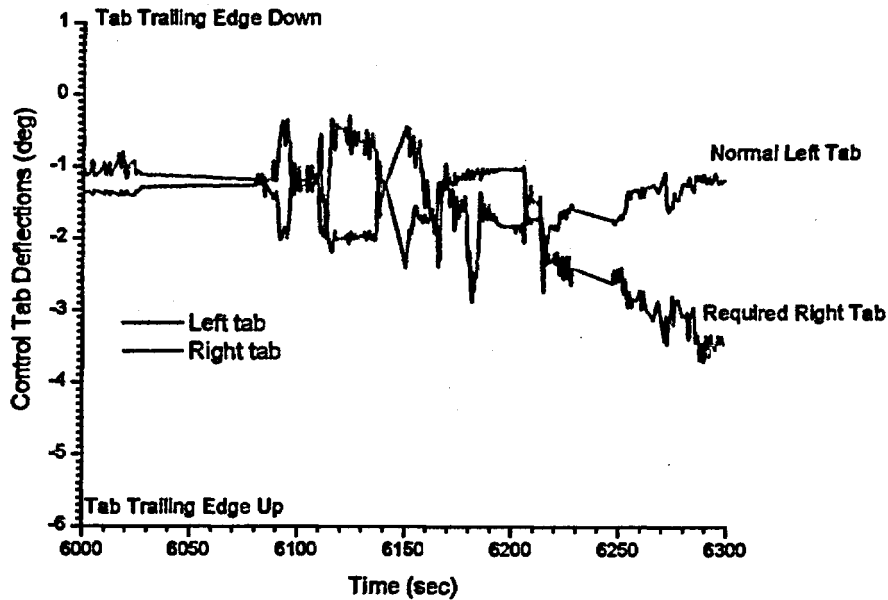
**Figure 7: Control tabs**

With the stabilizer trace established, Kinsurf was then run in the mode to extract control tab deflection. As before, the left tab operates normally as a function of column and elevator position. The right tab is calculated to provide the hinge moment required to balance the elevator at the elevator deflection. The resulting control tab deflections are shown in figure 7.

The shift in the elevator trace at 6210 sec during the Dayton landing has been investigated. The shift in derived tab at this point is less than one degree.

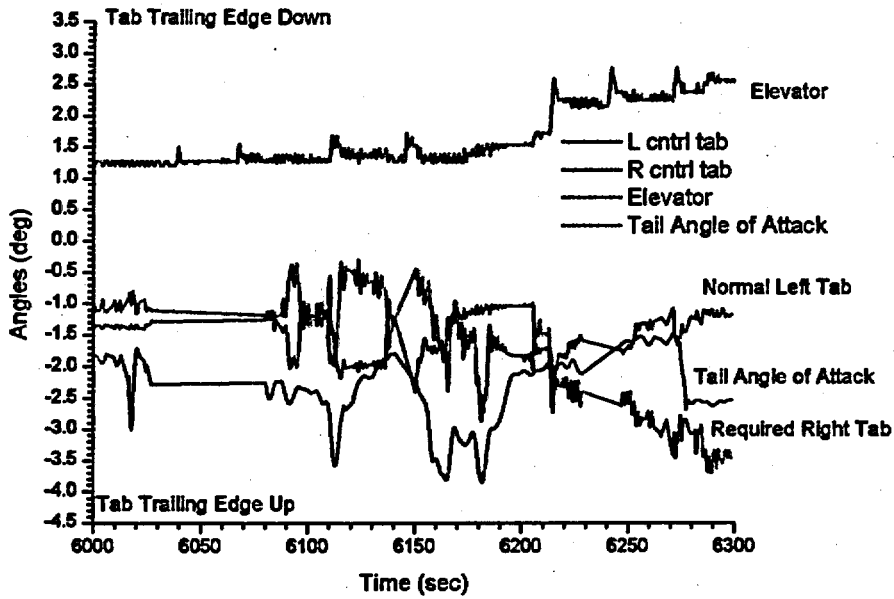
**Figure 8: Control tabs with elevator**

The right control tab required to balance the elevator is primarily a function of the left control tab deflection and the elevator deflection<sup>1</sup> and horizontal tail angle of attack. To aid in the understanding of the extracted right tab, the right tab is plotted together with the left control tab, elevator deflection and tail angle of attack in figure 8. Note that a flap extension to 5 deg is assumed to occur when the aircraft slows through 210 kts (at 6274 sec). With the weight unknown, this flap extension could have occurred earlier.

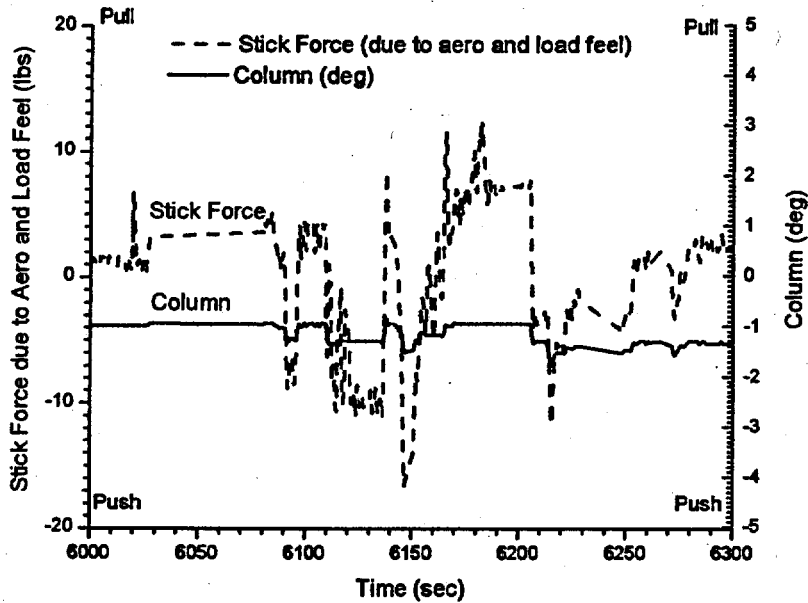
Figure 9: Column Force

The stick force is plotted in figure 9. Note that the control system motion at 6210 sec relieves the 7 lb pull stick force held before the movement. Note also that the stick force indicates proper trim at the beginning of the event.
