National Transportation Safety Board
Office of Research and Engineering
Washington, D.C. 20594

Wreckage Site Factual Report

Location: Denver, CO
Date: December 23, 2008
Time: 0018 GMT (6:18 pm MST)
Airplane: Boeing B-737-500, N18611
NTSB Number: DCA09MA021

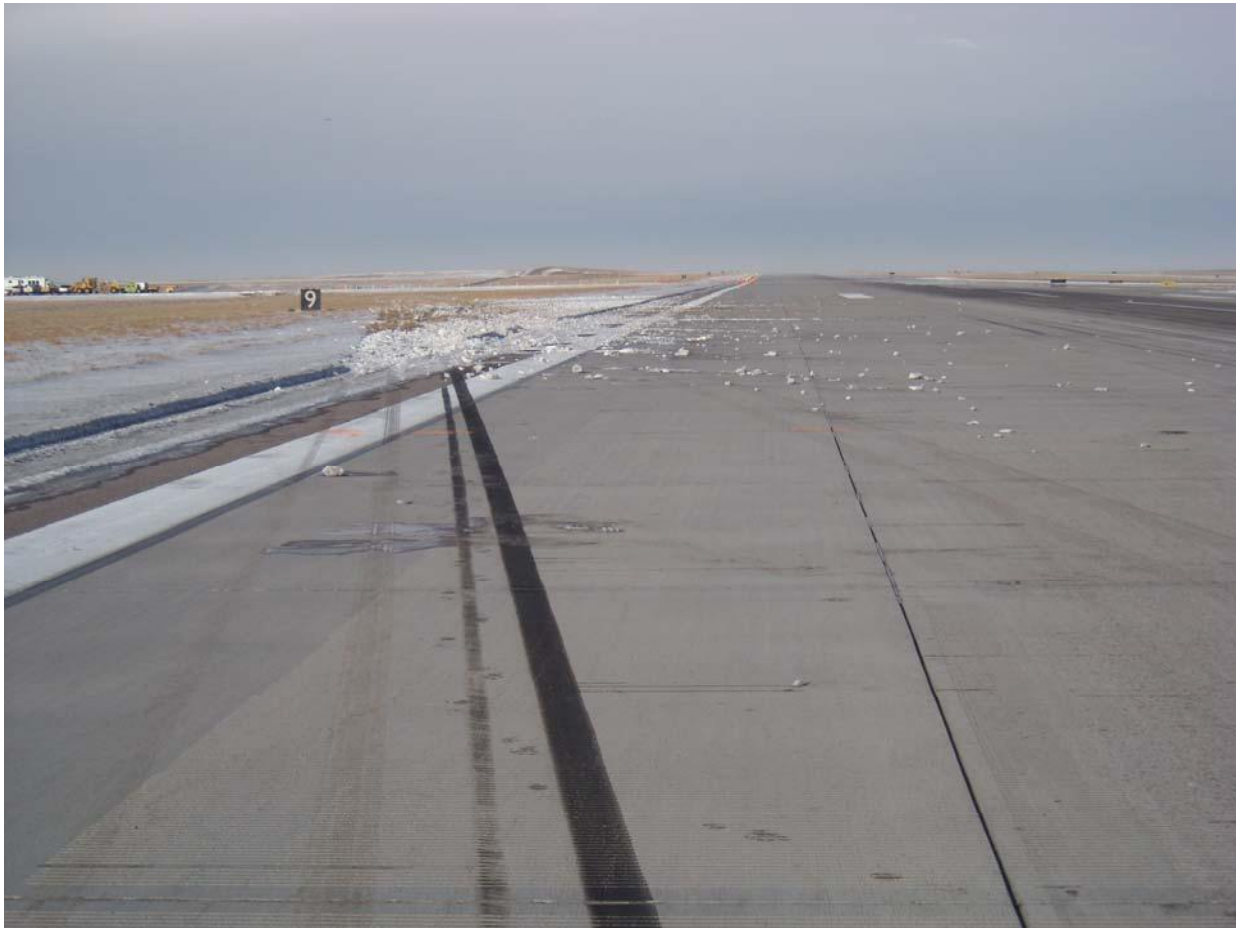
Upon arriving at the accident scene the next morning, the group noted that there were visible tire marks from the main and nose gear on runway 34R that veered off approximately 2500 ft down the runway. See Figure 1.

Figure 1: The Airplane Departed Approximately 2500 ft from 34R Threshold

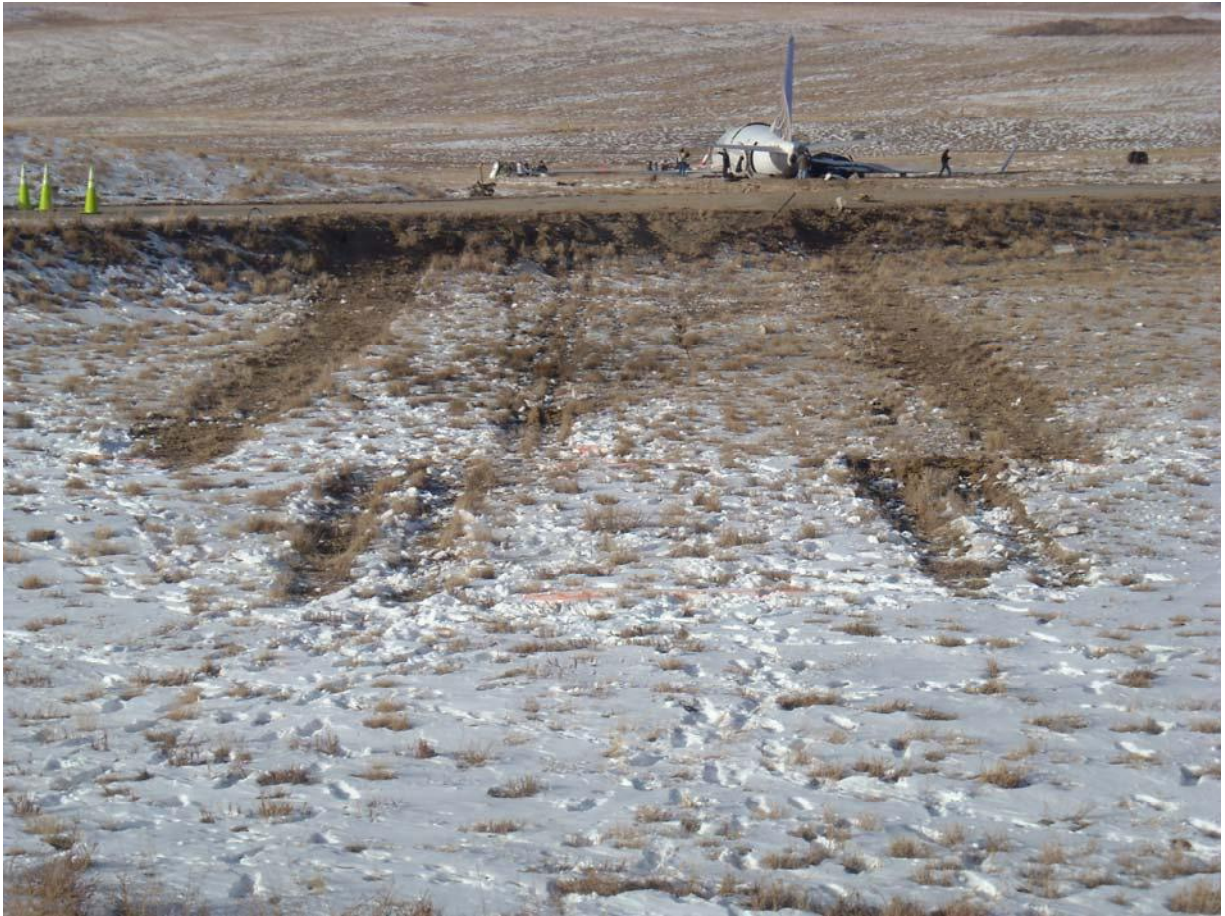
The main gear tire marks continued through a grassy area at approximately 10° to the left of the runway centerline, with no nose gear mark visible. The tracks then crossed taxiway (WC) where they were momentarily lost just beyond the taxiway. All three gear tracks then reappeared. In addition, this area showed what appeared to be heavy scrapping from the engine nacelles on the ground. There was a black fluid deposit in the nose gear track shortly beyond where the nose gear tracks reappeared. The main gear tracks disappeared just prior to the engine nacelle scrapes. See Figure 2.

Figure 2: All Gear Tracks Reappear Beyond Taxiway Along with Engine Nacelles

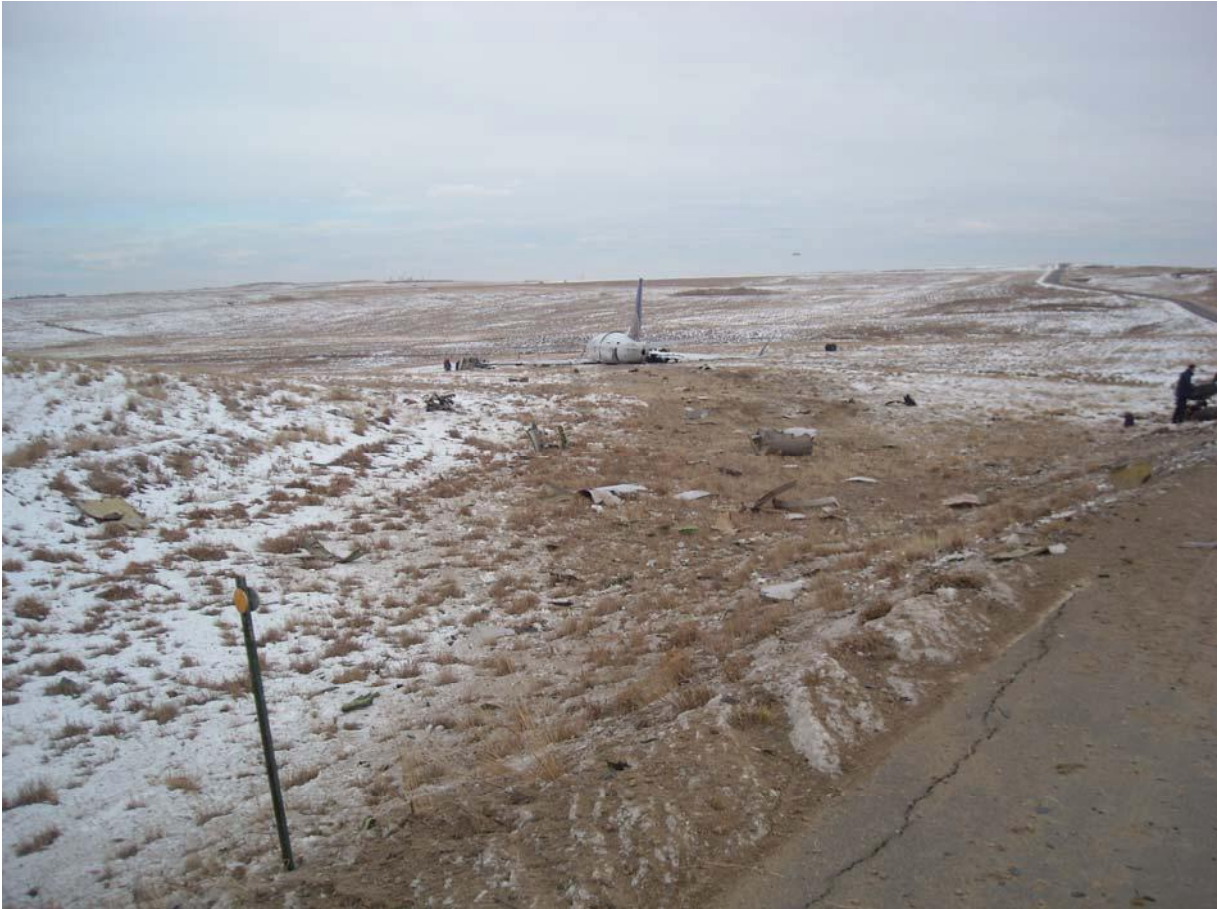
Engine nacelle and fuselage scraping proceeded over a service road and continued to the final resting place of the airplane. See Figure 3

Figure 3: Final Resting Location of Airplane

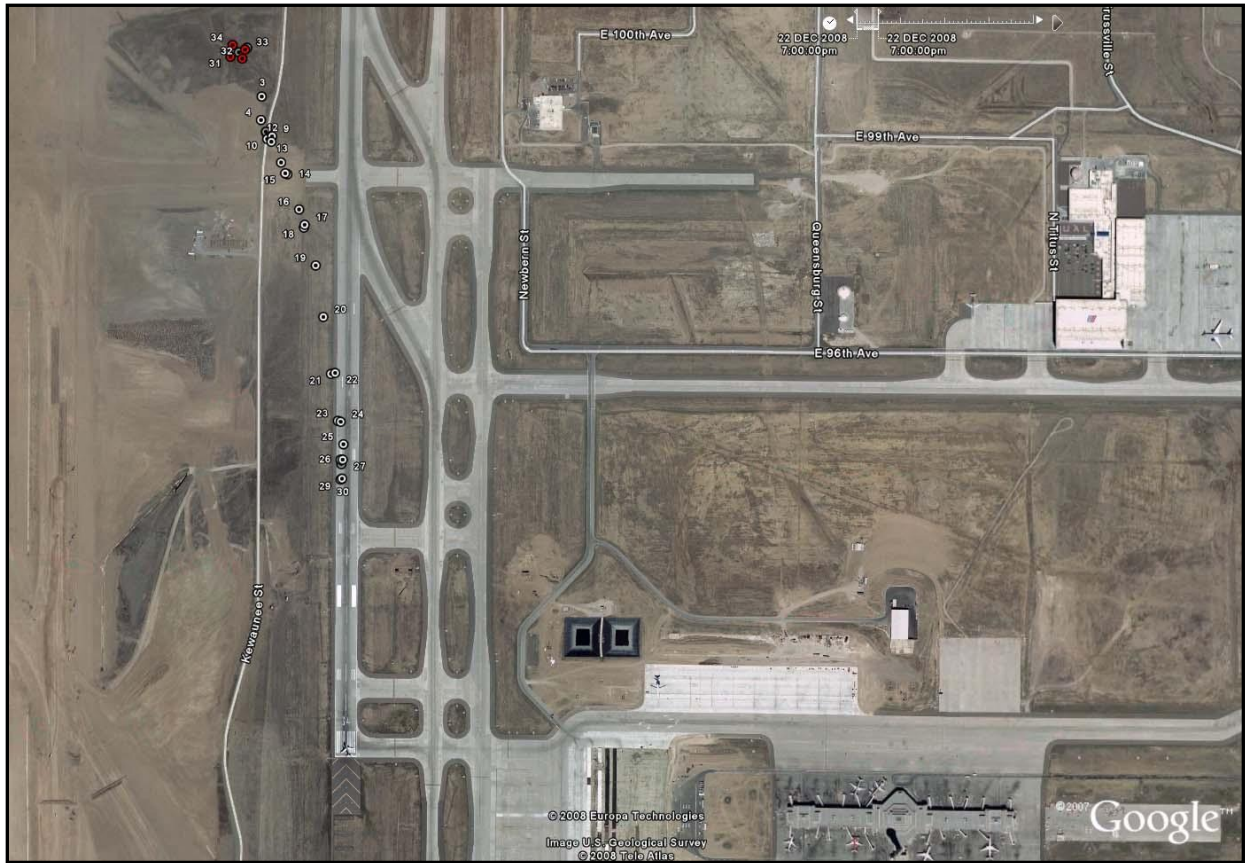
Figure 4: GPS Placemark Overlay

The GPS data were processed and over-layed on a satellite image of DEN Runway 34R. These data are depicted in Figures 4 and 5. The numbers in the figures correspond to the NTSB numbers in Table 1. The red placemarks in the figures indicate the four corners of the airplane. A compass measurement indicated that the airplane came to rest on a magnetic heading of approximately 315°.
