National Transportation Safety Board
Office of Research and Engineering
Washington, D.C. 20594

Group Chairman's Aircraft Performance Study

Location: Lexington, KY
Date: August 27, 2006
Time: 1007 GMT (6:07 am EDT)
Airplane: Bombardier CRJ-100, N431CA
NTSB Number: DCA06MA064

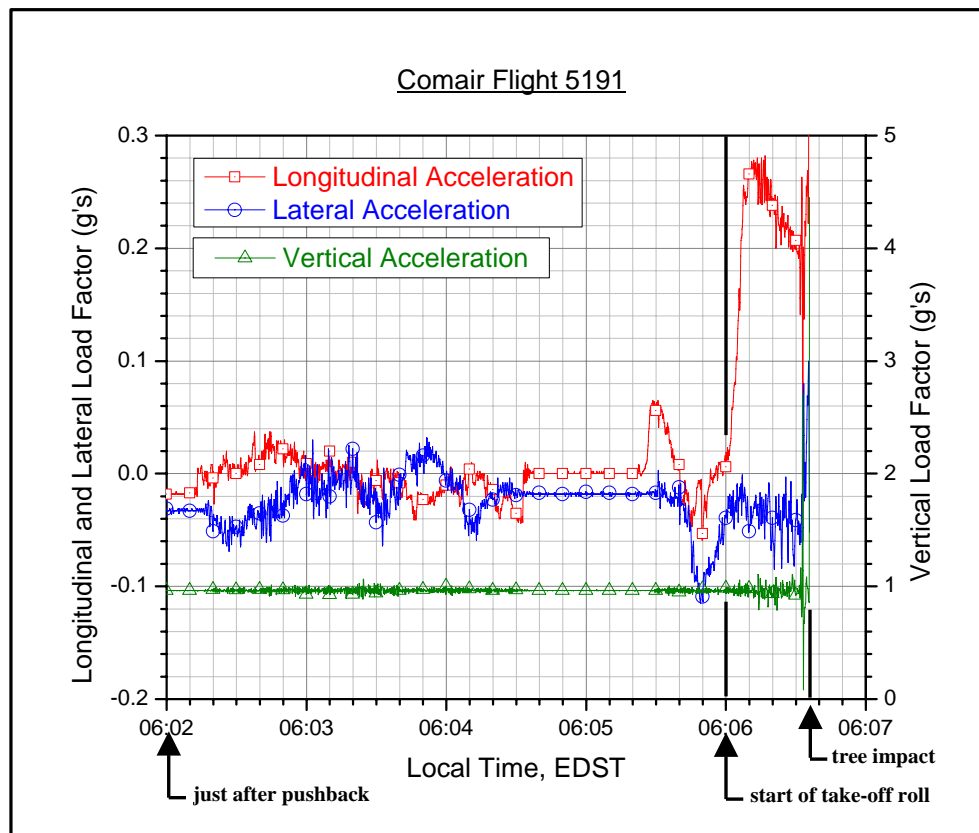
Figure 1: FDR Acceleration from Pushback

The accelerations and attitudes recorded on the FDR and used in the study are shown in Figures 1 and 2, respectively. The time segment that was used in the study begins shortly after the aircraft tug released Comair 5191 from the pushback and ends when the aircraft impacted the first tree and the FDR stopped recording.

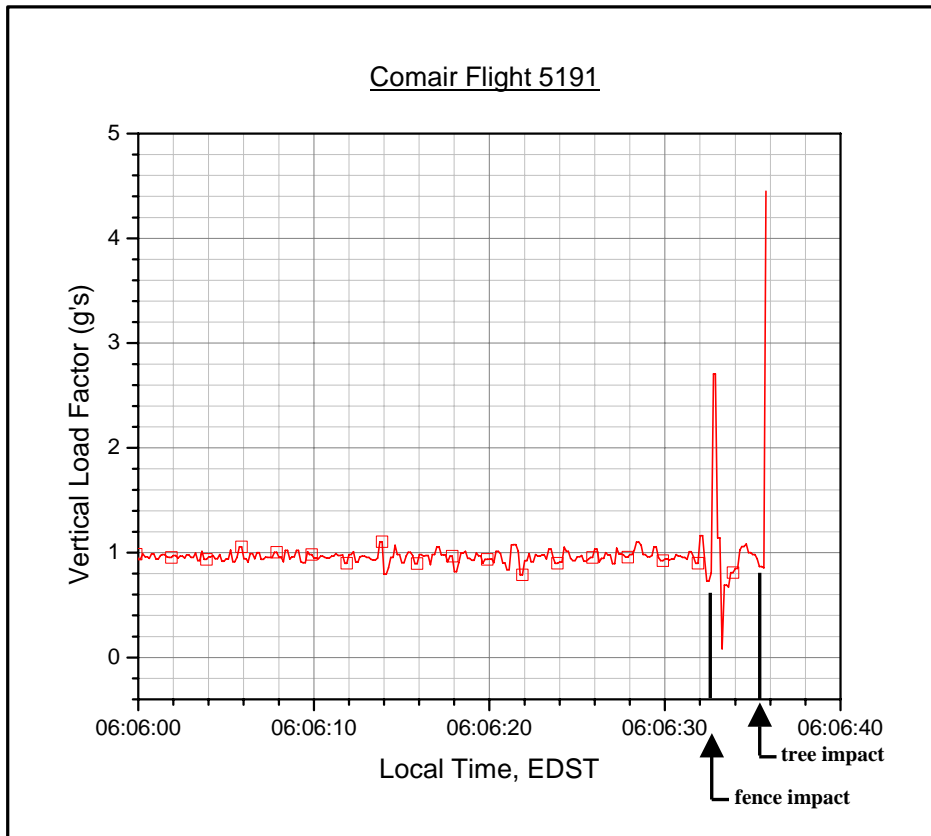
Figure 3: FDR Vertical Acceleration during Take-off Roll

The time scale is expanded to just the take-off roll for vertical load factor in Figure 3. This highlights the impact with both the perimeter fence and the first tree. Figure 3 shows that Comair Flight 5191 impacted the fence around 6:06:32 EDT and experienced approximately a 2.5 g spike in vertical load factor. At 6:06:35, the FDR data show approximately a 4.0 g spike in vertical load factor when the aircraft impacted the first tree. These two impact points are supported by the FDR speed data and the distance measurements taken at the accident site: average speed calculations indicate that it would take approximately 2.5 sec for Flight 5191 to travel the 530 ft from the fence to the first tree at an average speed of 126 kt. The FDR speed and altitude data are shown in Figures 4 thru 7. These data show that Comair Flight 5191 had a positive acceleration of approximately 4.3 kt/sec until impacting the fence and that the aircraft never climbed more than about 20 ft off of the ground.

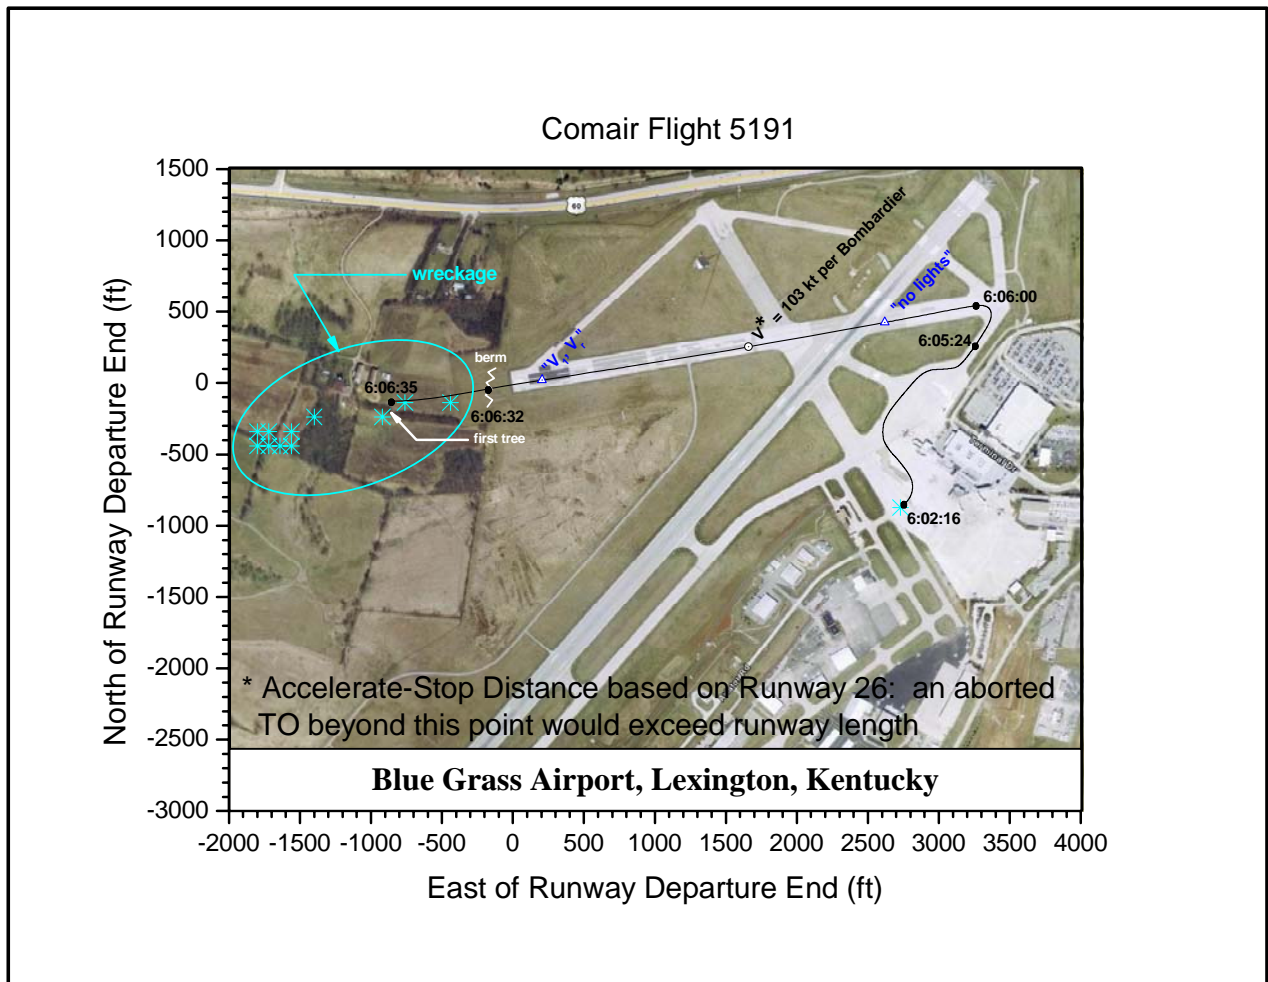
Figure 8: FDR Load Factor Integration Results

In order to obtain meaningful integrations results, boundary conditions were required to constrain the integration output and to refine the initial conditions. One set of boundary conditions in the Comair integration came from the airport geometry (e.g., gate information, taxiway and runway locations, hold-short line, etc.) The second set of boundary conditions came from the wreckage documented during the on-scene investigation. Details of the wreckage can be found in the Aircraft Performance Wreckage Site Factual Report. The final integration results and the associated boundary conditions are shown in Figure 8 in an overhead image of the Blue Grass Airport.

The integration result (shown in black in Figure 8) represents the aircraft track. The integration started shortly after push-back from gate at 6:02:16. The integration stopped at the end of the FDR data that, as previously mentioned, occurred when the aircraft impacted the first tree approximately 920 ft off the end of runway 26. Various pieces of the left winglet and other debris are highlighted in cyan (*) in the figure around the first tree. The wreckage cluster located furthest from the runway is where the cockpit and fuselage were found. As indicated in Figure 8, the bulk of the wreckage was found approximately 1820 ft off the departure end of runway 26.

Figure 8 also shows the location beyond which an aborted take-off would exceed the length available on LEX runway 26 (black circle). It represents the point beyond which a CRJ-100

aircraft could not be stopped on the available runway, even with maximum braking applied. Prior to this point, a CRJ could be stopped before reaching the end of the runway. Beyond this point, a CRJ would overrun the runway. The speed calculated at this critical point (assuming a normal Airplane Flight Manual take-off) for the accident aircraft configuration and the atmospheric conditions reported the morning of the accident is 103 kt. This speed would be reached 1834 ft down the runway (approximately five seconds beyond the lighted runway 22 at LEX), leaving 1667 ft for stopping. However, because these calculations are based on runway 26 and not the intended take-off runway 22, Comair Flight 5191 would not have known of this limit. Comair 5191 would not have knowingly taken off on runway 26 based on published CRJ performance. Flight 5191 was appropriately using take-off performance numbers based on runway 22.

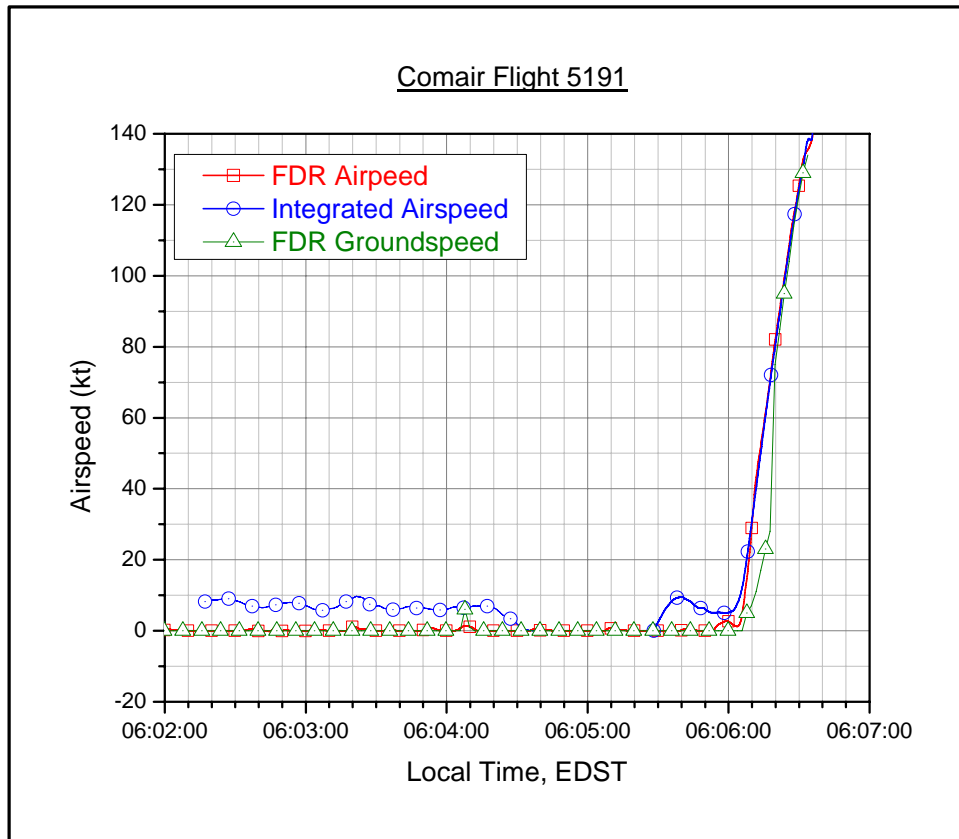
Figure 9: Comparison of FDR Speed with Integration Result

Figure 9 shows a comparison of the speeds recorded on the FDR and the speed that resulted from the integration. The comparison shows a good correlation above approximately 10 kt. Below 10 kt the FDR speed was reported as invalid by the FDR group.

Figure 9 also highlights that the integration was done in two segments to avoid “integrator wind-up” when the aircraft was not moving. As a result, the integration starts just into the taxi at approximately 6:02:17 EDT and pauses while Comair Flight 5191 sat on the runway hold line between 6:04:33 and 6:05:24 EDT. (Note: The centerline to runway 26 was captured at approximately 6:06:00.)
