National Transportation Safety Board
Office of Research and Engineering
Washington, D.C. 20594

Performance Study

Specialist Report
Marie Moler
August 30, 2013

Location: Soldotna, AK
Date: September 5, 2012
Time: 18:42 UTC (10:42 Alaska Daylight Time)
Aircraft: DHC-8-100, N886EA, ERA Flight 874
NTSB Number: DCA12IA141

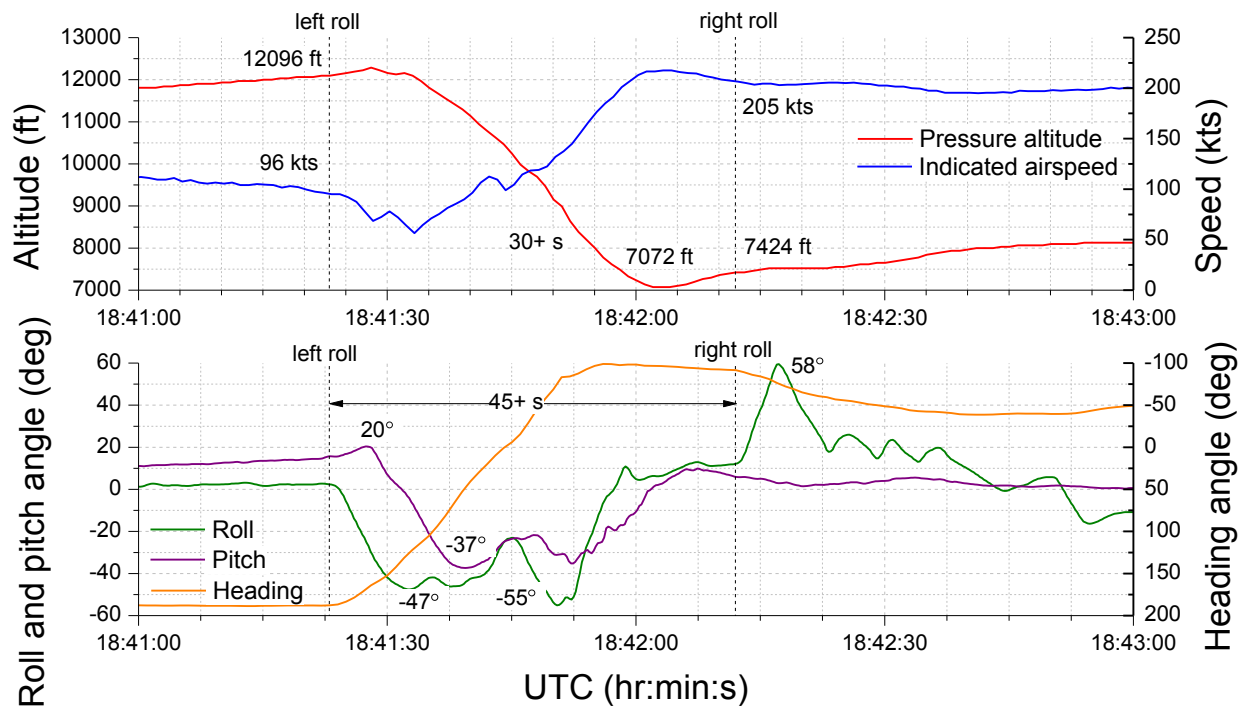
Figure 6. Altitude, speed, roll, pitch and heading for loss of control event.

Figure 6 details the loss of control event. At 18:41:23, the aircraft, which during the climb was holding a right roll of approximately 2.5° , began to roll left, reaching a bank of -47° in about 11 seconds for a roll rate of $4.5^\circ/\text{s}$. The crew opposed the roll with wheel (see Figure 8, discussed in more detail later). The aircraft recovered slightly before rolling further left to -55° . During the roll event the aircraft completed a 270° turn from an initial southerly heading to a westerly heading (also illustrated in Figure 10). The aircraft initially continued to climb before descending from 12,288 ft to 7072 ft in about 30 seconds.

At 18:42:04, the aircraft reached its lowest local altitude and began to level out and stabilize. Then at 18:42:17, the aircraft began to roll right to 58° . The airspeed at the onset of the right roll was 205 kts and there was no significant loss of altitude during the right roll.

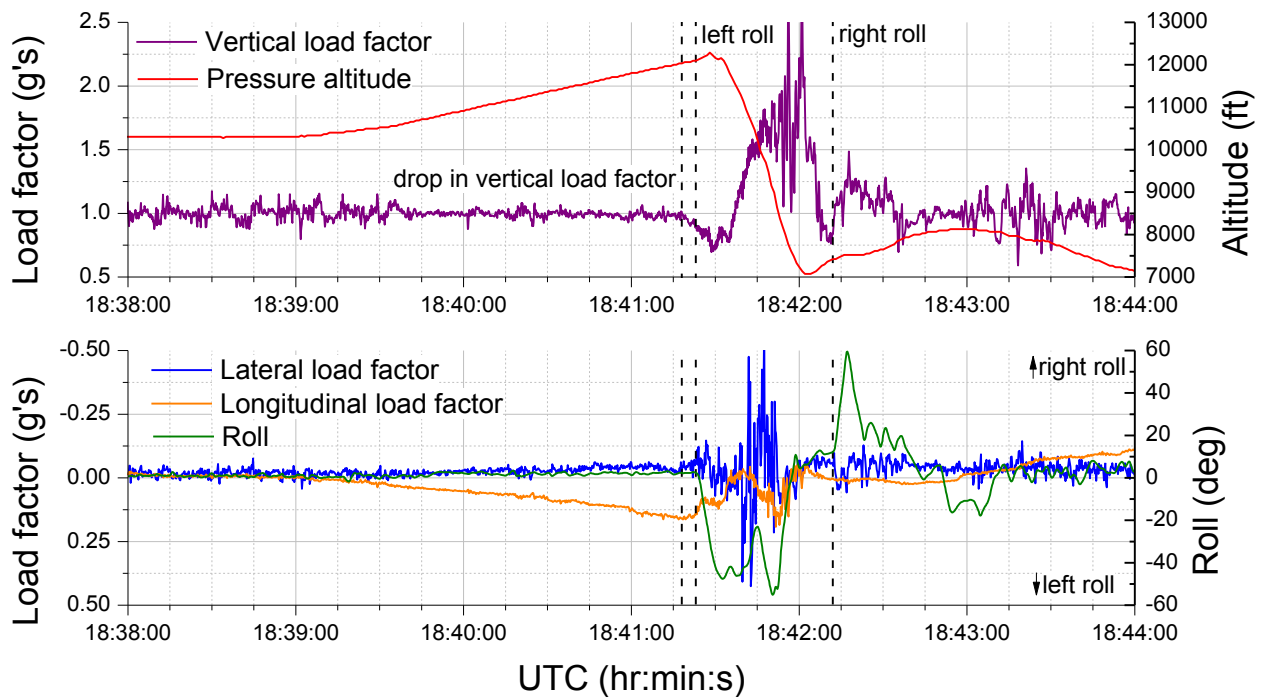
Figure 7. Load factors during climb and loss of control event.

During the climb, the aircraft's vertical load factor remained constant at 1 g, before suddenly beginning to decrease at 18:41:18 and then increase during the loss of altitude. The vertical, longitudinal, and lateral load factors are shown in Figure 7. The magnitude of the longitudinal load factor was steadily increasing during the climb as pitch attitude increased. The lateral load factor was also steadily increasing from near zero to about -0.04 g at the time of the upset. While the left roll began at 18:41:23, the onset of the loss of control event can be marked at the point when the vertical load factor suddenly decreases at 18:41:18. This loss of vertical load factor indicated a sudden degradation of lift.

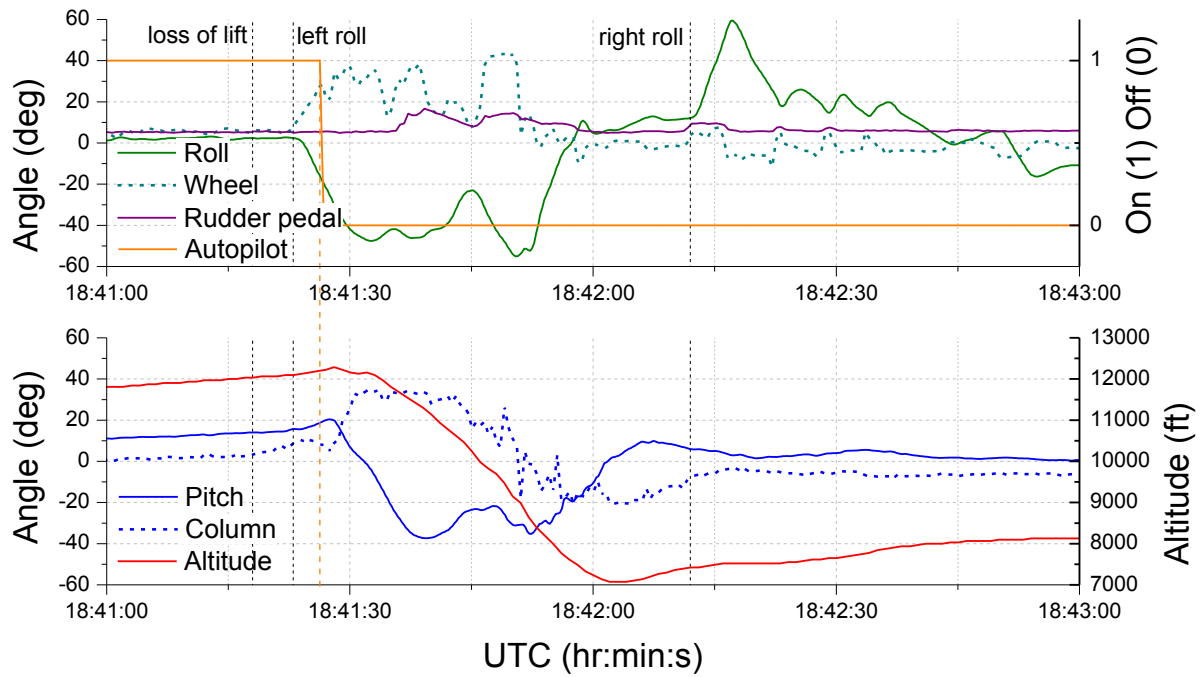
Figure 8. Roll, wheel, rudder, autopilot, pitch, column, and altitude during loss of control event.

After the vertical load factor began to drop, indicating a loss of lift, the column began to move back, briefly increasing the pitch of the aircraft as shown in Figure 8. The FDR only recorded total wheel and column position and did not distinguish between captain, first officer, or autopilot input. The constant climb rate and the smooth increase in column from 18:41:18 until the autopilot disconnect is consistent with the actions of the autopilot in vertical speed mode. At 18:41:27, the autopilot disconnected. The autopilot could have disconnected for a number of reasons: it could have been manually disconnected by the pilots, by the onset of stick shaker, or when the force on the column or wheel exceeded a set maximum. Once the autopilot disconnected, the column position increased from about 8° to 32° to nose up while the aircraft's pitch decreased from 20° nose up to -37° (nose down). The aircraft recovered when the force on the column was released.

After the airplane experienced a loss of lift at 18:41:18, the column was pulled back for a nose-up attitude gradually from 3° to 8.5° over the next 8 or 9 seconds. The FDR recorded that the autopilot disconnected at 18:41:26.7. At 18:41:27 (about the same time the aircraft reached its maximum altitude), the column was pulled back rapidly from 8.5° to 33° in three seconds. The crew held greater than 33° of aft column until 18:41:43 before beginning to release the column. During this time the aircraft lost 1600 ft of altitude. However, the column was not pushed nose down for another 7 seconds until 18:41:50. More than 3100 ft of altitude were lost over 23 seconds before the crew pushed the column forward. This sequence is shown in Figure 8.

Aerodynamic stall recovery requires the crew to reduce the aircraft's angle of attack by pushing the nose down so that proper air flow across the wing and control surfaces can be restored. Pulling on the column in an attempt to keep the aircraft pitched up would resist recovery. Additionally, the crew reduced the engine power from 90% (NH) at the time of stall to 83% for about 10 seconds before increasing the power again to the point of over-rotating the propellers (indicated in Figure 9 when Engine 2 NH levels out at 97%). Reducing engine power would also exacerbate the loss of attached airflow across the wing and resist stall recovery.

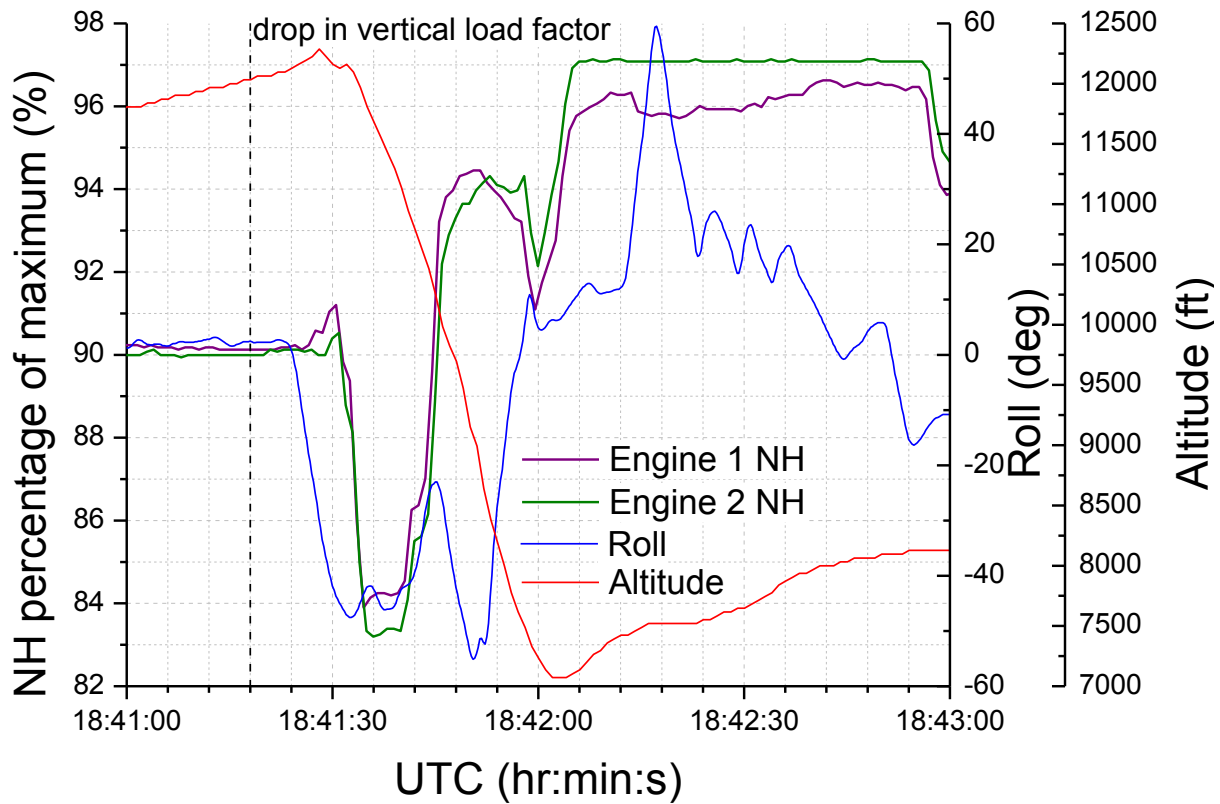
Figure 9. NH as a percentage of maximum, roll, and altitude during loss of control event.

Once the aircraft began to roll left, engine power increased until the apex of the climb, before being reduced from about 91% to 83% of the NH maximum as shown in Figure 9. The engine power was increased later in the roll upset.

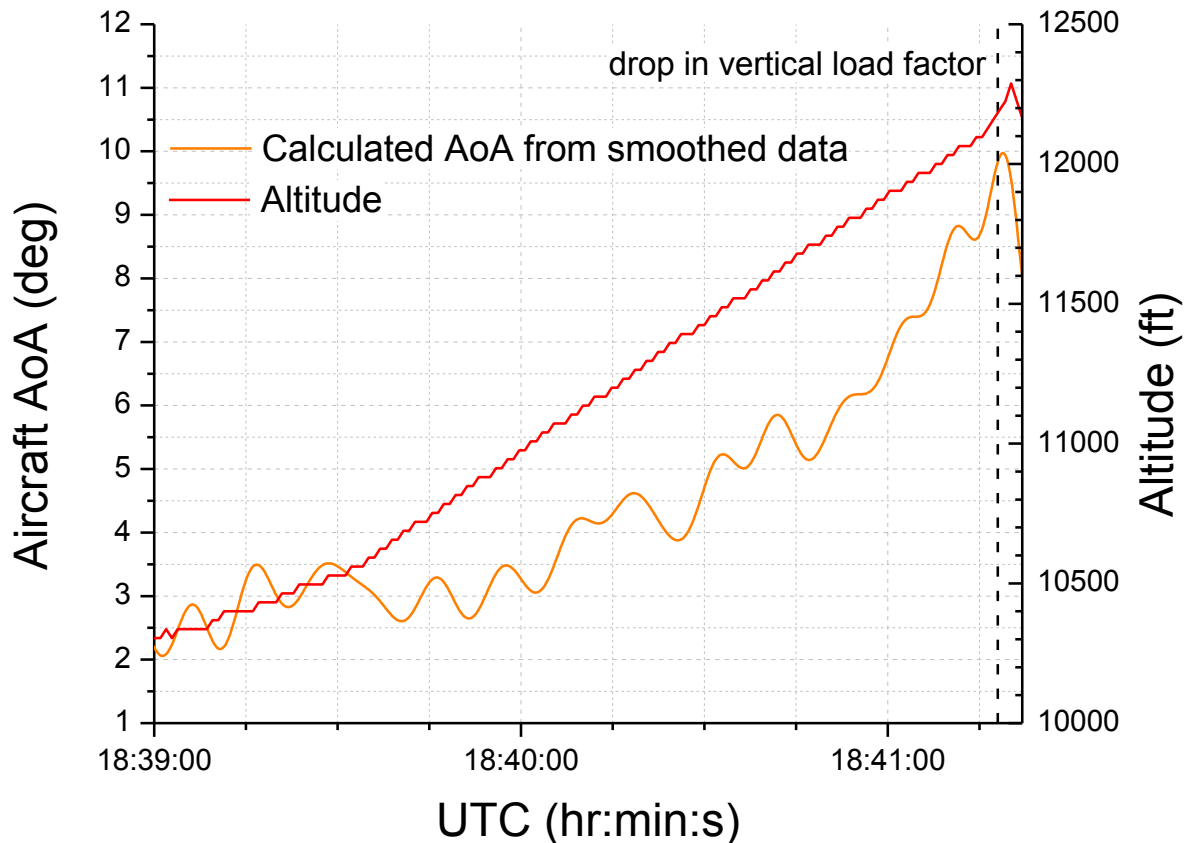
Figure 13. Calculated angle of attack (AoA) and altitude during climb.

Although the calculated AoA did exhibit fluctuations due to noise in the signal, as shown in Figure 13, the aircraft's AoA was increasing throughout the climb until the drop in vertical load factor.

The lift a wing can generate is a function of AoA and lift increases with AoA up to a point. At this point, known as the critical angle of attack, lift begins to decrease and the aircraft has suffered an aerodynamic stall. The decrease in the vertical load factor at 18:41:18 indicated a reduction in lift and the beginning of aerodynamic stall. It is important to note that a *reduction* in the rate of lift increase with AoA begins at the stall point, but for many airplanes the initial decrease in lift may be gradual. The aircraft may still be able to gain altitude after stall until the dynamics of the increase in drag and loss of lift stop the climb.

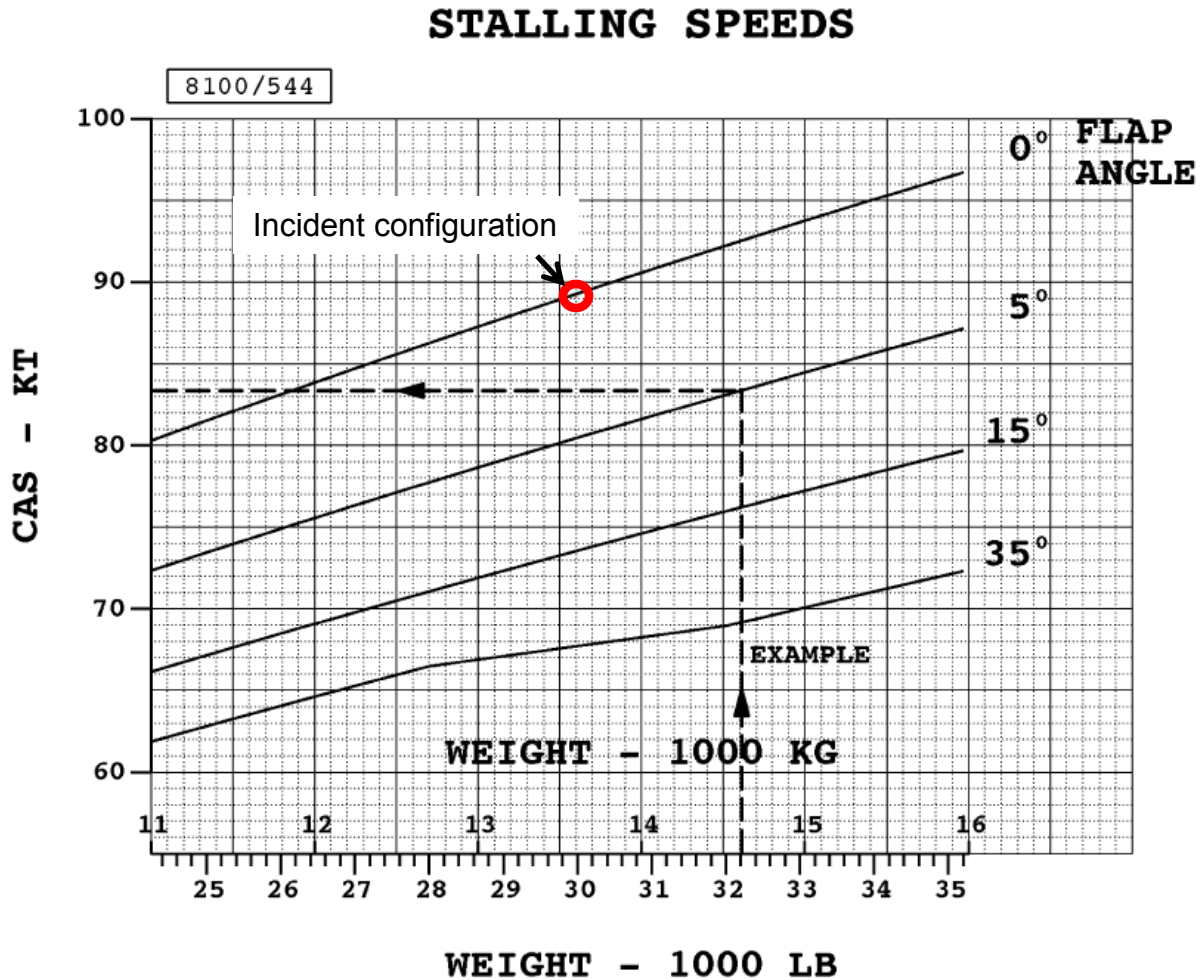
Figure 14. Power off stall speeds from de Havilland Inc. Dash 8 Flight Manual (Figure 5-1-1) [Reference 5] The incident configuration is noted with a red circle.

Bombardier provided the stall speeds for the power off condition for the Dash-8-100, shown below in Figure 14. At take-off, the aircraft's weight was reported as 30,325 lbs and its

estimated landing weight was 29,327 lbs [Reference 4]. Flaps at the time of the upset were zero. According to Figure 14, the calibrated airspeed at stall for a 30,000 lb aircraft at flaps 0° would be 89 kts. Since this is the conservative power-off condition, the actual speed at which an aircraft under power in the clean wing configuration would stall would be slightly lower. For a turboprop with wing-mounted engines, an increase in power can delay the onset of flow separation and stall in the area of the wing behind the propellers.

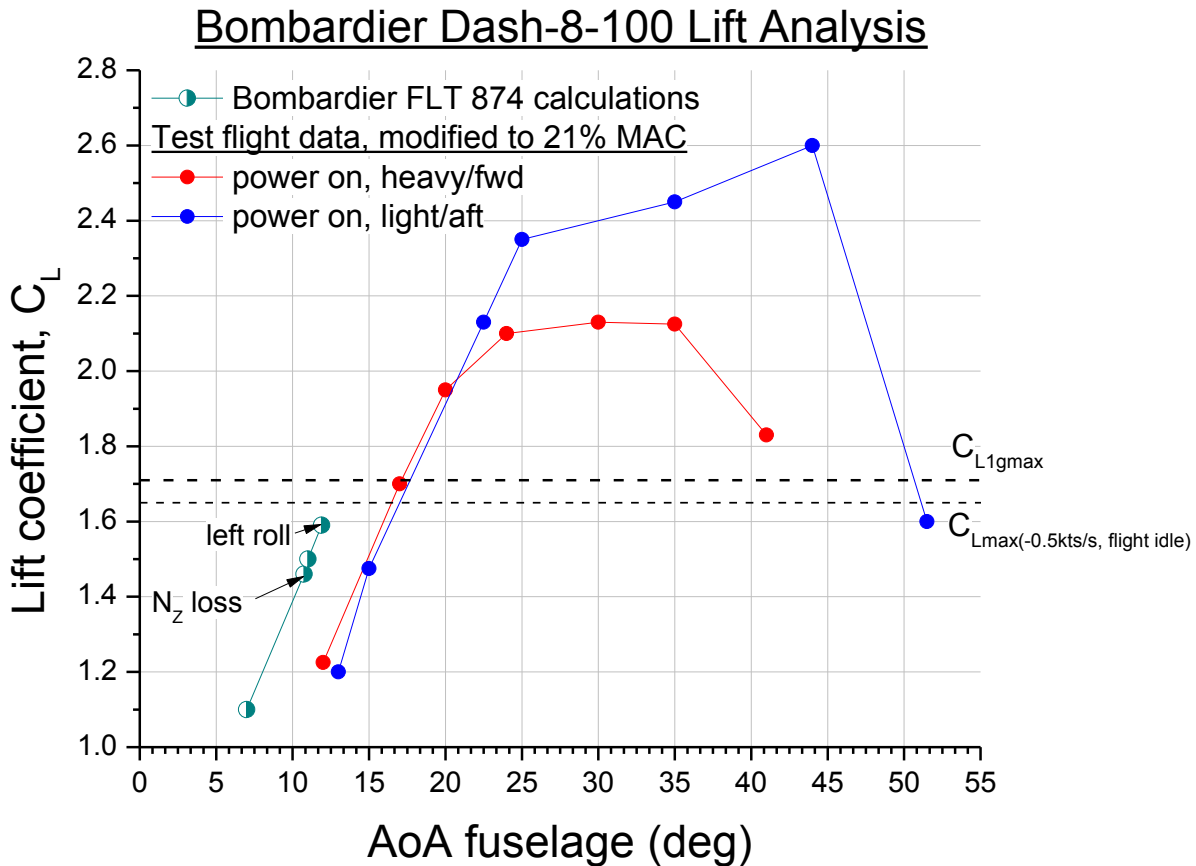
Figure 16. Bombardier Dash-8-100 lift analysis for incident flight and stall flight testing.

Bombardier reported that the declared maximum lift coefficient at 1g vertical load factor (C_{L1gmax}) with retracted flaps is 1.71 for the Dash-8-100. Bombardier also reported a maximum lift coefficient at 1g vertical load factor of 1.65 for a stall entry of -0.5 kts/s and flight idle power [Reference 7]. The stall entry rate of -0.5 kts/s is similar to the deceleration observed for ERA Flight 874, but the climb power setting during the incident would be expected to lead to a higher maximum 1g lift coefficient compared to the flight idle conditions of the test. Additionally, Bombardier analyzed previous power-on and power-off flight test stalls (from de Havilland Aircraft of Canada data) to compare to the incident flight [Reference 7]. Data was corrected for position errors and center of gravity differences but note that a number of different factors affected the accuracy of comparing the flight test data to the incident event data. Namely, that upwash may have affected the flight test measured AoA (the AoA was measured during flight testing using a wing-mounted boom), position error with power on and low airspeeds may not have been well defined, and that the incident aircraft's pitot-static system does not accurately record airspeed once the aircraft has rolled off and side slip has developed. Figure 16, below, shows Bombardier's calculations of the lift coefficient and angle of attack for the incident flight

and two power-on stall test flights. During the incident flight, the loss in vertical load factor (N_z loss) occurred at a C_L of about 1.46 and the left roll occurred at a C_L of 1.59. As a result, both the loss in N_z and the left roll occurred at C_L values below the quoted maximum C_{Ls} .

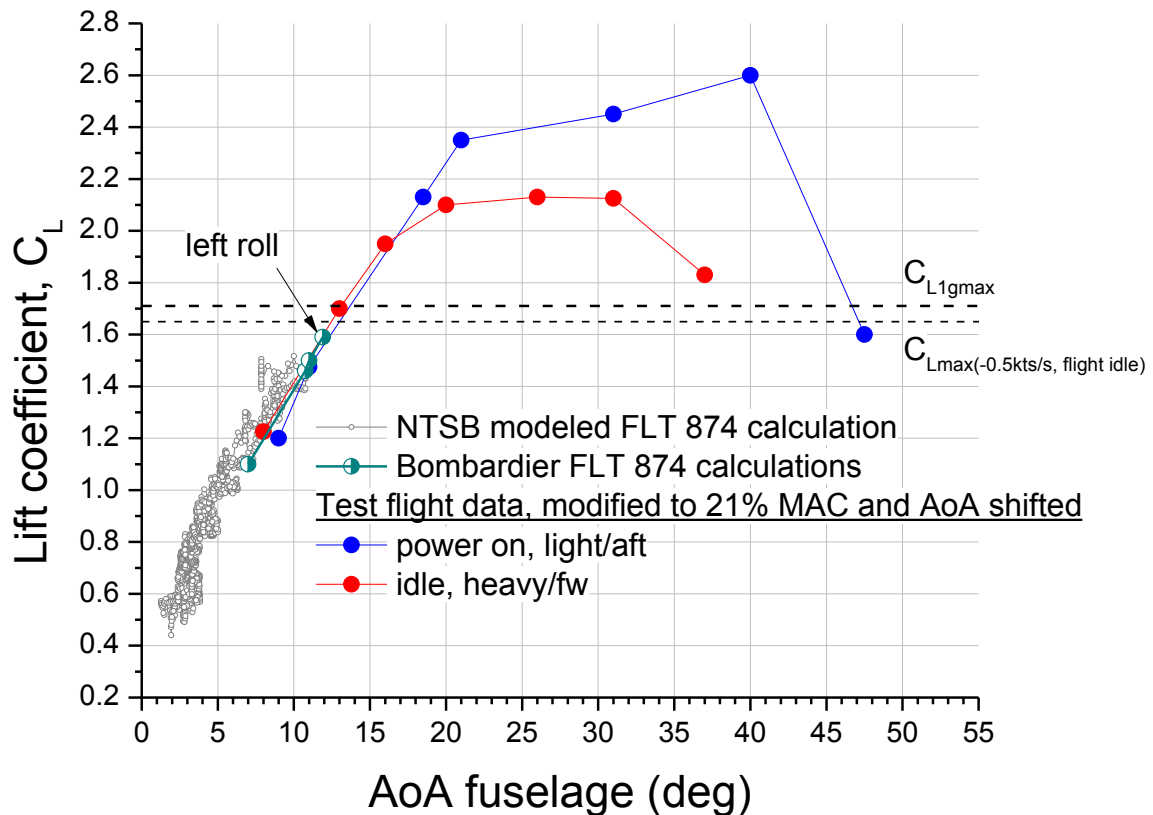
Figure 17. Shifted Bombardier Dash-8-100 lift analysis for incident flight and stall flight testing and NTSB modeling of the aircraft.

As stated earlier, the NTSB AoA calculations were for fuselage AoA while the Bombardier flight tests reported a boom measured AoA. Therefore, it was reasonable to shift the AoAs of the lift curve for the test flight data so that the gradient of the incident flight and the test data were aligned as shown in Figure 17. Also included in this figure is the lift coefficient calculated by the NTSB for the incident flight. The NTSB calculated the lift curve using the ERA provided weight and CG; Bombardier provided I_{xx} , I_{yy} , I_{zz} , I_{xz} , and geometry; and a representative engine model driven by FDR recorded torque and RPM data. This lift coefficient was calculated up to the time of the apparent aerodynamic stall. After the aircraft has rolled off data from the pitot-static system becomes too uncertain to make a reasonably accurate prediction of the lift coefficient or aircraft AoA. However, the NTSB lift curve and Bombardier's calculations for Flight 874 were in good agreement up to the time of the loss of N_z and the left roll and did not require any shifting of the AoA to align with one another.

The slope of the lift curves for the incident flight calculations and the test flights show good agreement. Both the NTSB and Bombardier calculations have the aircraft roll off at a C_L of less than 1.6, below both the 1.71 and 1.65 of the reported C_{L1gmax} and $C_{Lmax(-0.5kts/s, flight idle)}$, respectively. This corresponds to the incident aircraft experiencing aerodynamic stall (loss of N_Z) at an AoA of 10.75° from Bombardier’s calculations. Extrapolating using the flight test data leads to the $AoA_{max(-0.5kts/s, flight idle)}$ and AoA_{1gmax} being 13° and 14° respectively.

The calculations showed that the incident aircraft entered aerodynamic stall at a higher speed than the stall speed reported in the manual and at a C_L below the reported C_{Lmax} . Aircraft may stall before clean-wing stall predictions due to icing. A build-up of ice can change the aerodynamic shape of the wing and leave it susceptible to stall at a lower AoA (or a higher speed) than expected.

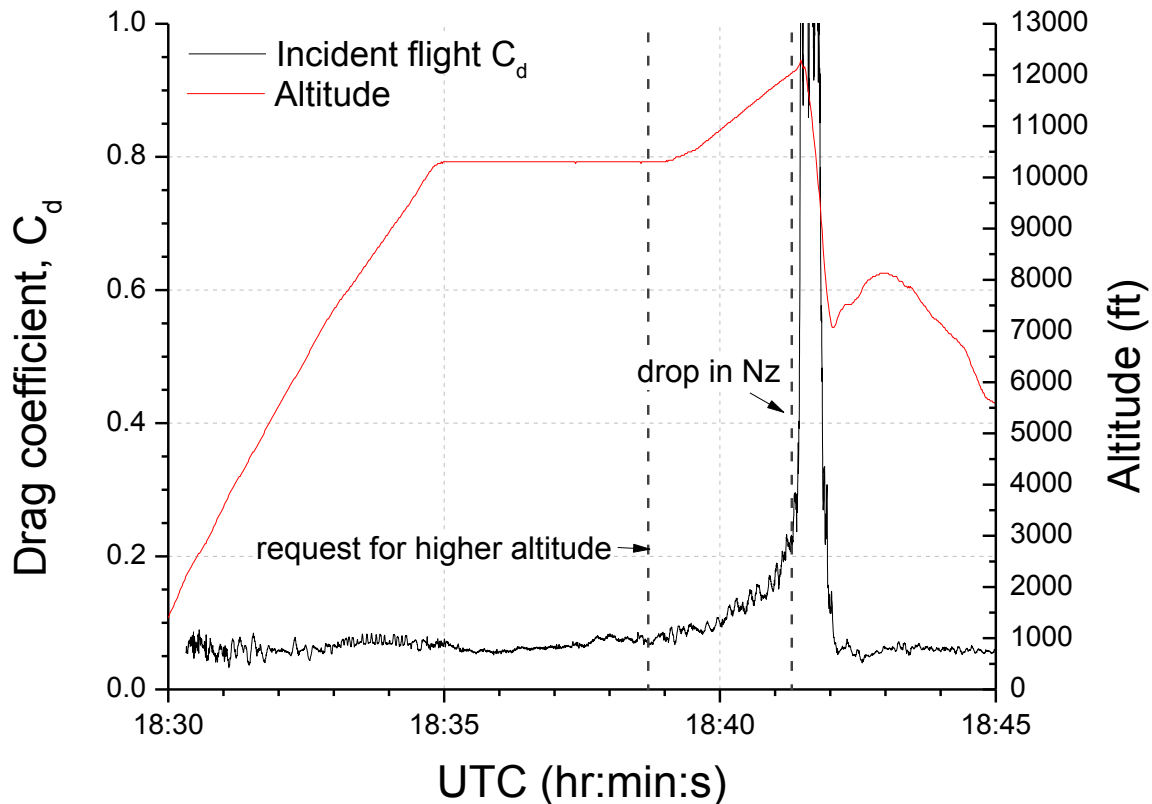
Figure 18. Drag coefficient (C_d) and altitude versus time for incident flight.

geometry; and a representative engine model driven by FDR recorded torque and RPM data. Again, the absolute value of the drag coefficient during the roll off event should not be considered as accurate due to higher uncertainty in the airspeed and altitude data during this time. Figure 18 shows how the C_d calculated for the incident flight begins to increase during the climb from 10,000 feet until it spikes after the drop in vertical load factor (N_z).

The analysis shown in Figure 18 and Figure 19 imply that the aircraft's drag characteristics changed during the climb from 10,000 feet until the upset. The changes in the aircraft's speed, thrust, and control surface positions during the climb do not explain an increase in drag. A build-up of ice can change the aerodynamic shape of the wing and cause an increase in drag compared to the clean-wing configuration. The drag analysis indicates that the aircraft entered into increased ice as it climbed above 10,000 feet.

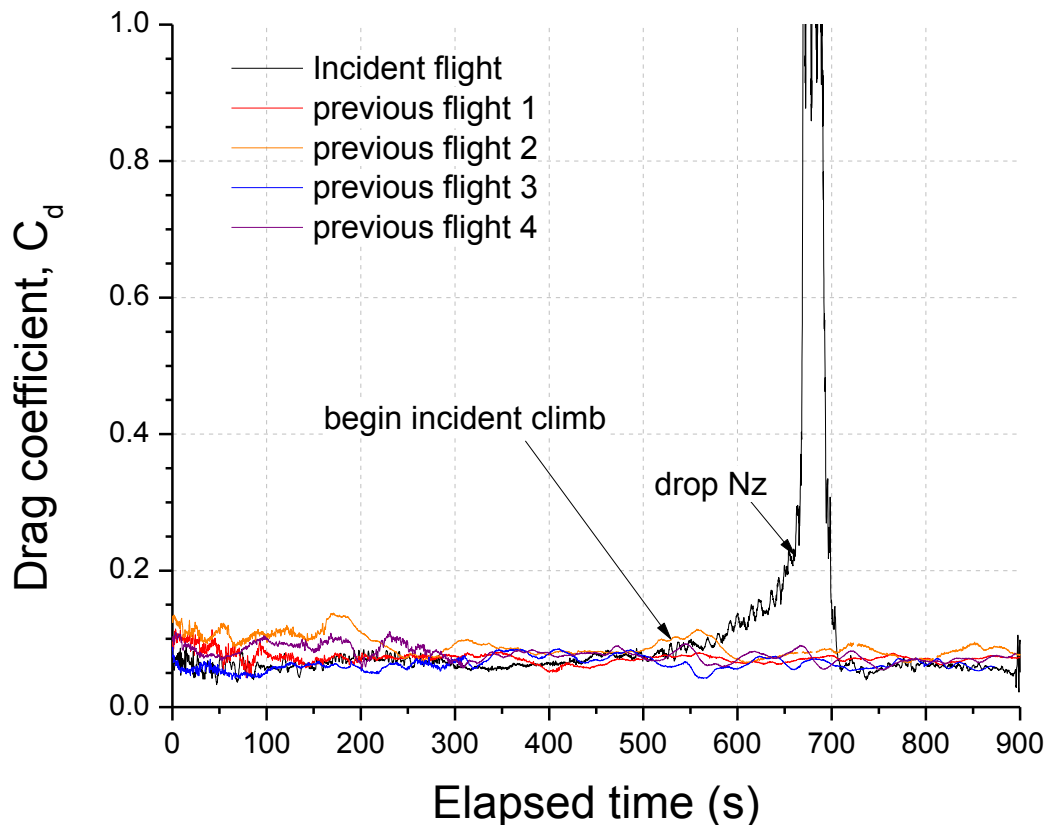
Figure 19. Drag coefficient (C_d) versus elapsed time for the incident flight and four previous flights of the same aircraft.

Additionally, the NTSB also analyzed four previous flights of the incident aircraft as shown in Figure 19. C_d is plotted against elapsed time to compare events from different times to one another. The drag coefficient for the previous flights and the incident flight generally stay in the range of 0.05 to 0.1 with some variation due to other affecting factors such as thrust and controls. However, during the climb from 10,000 feet the incident flight C_d begins to increase steadily. After the upset, the C_d returns to the original range.

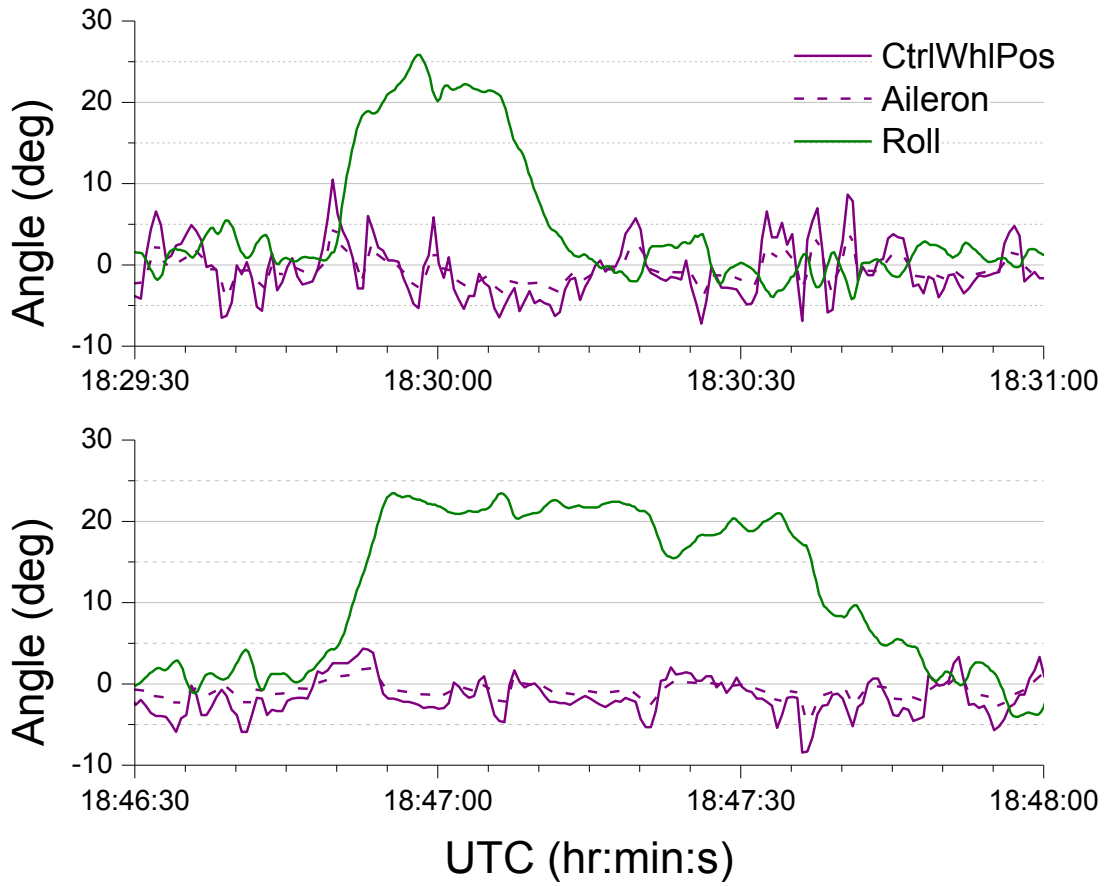
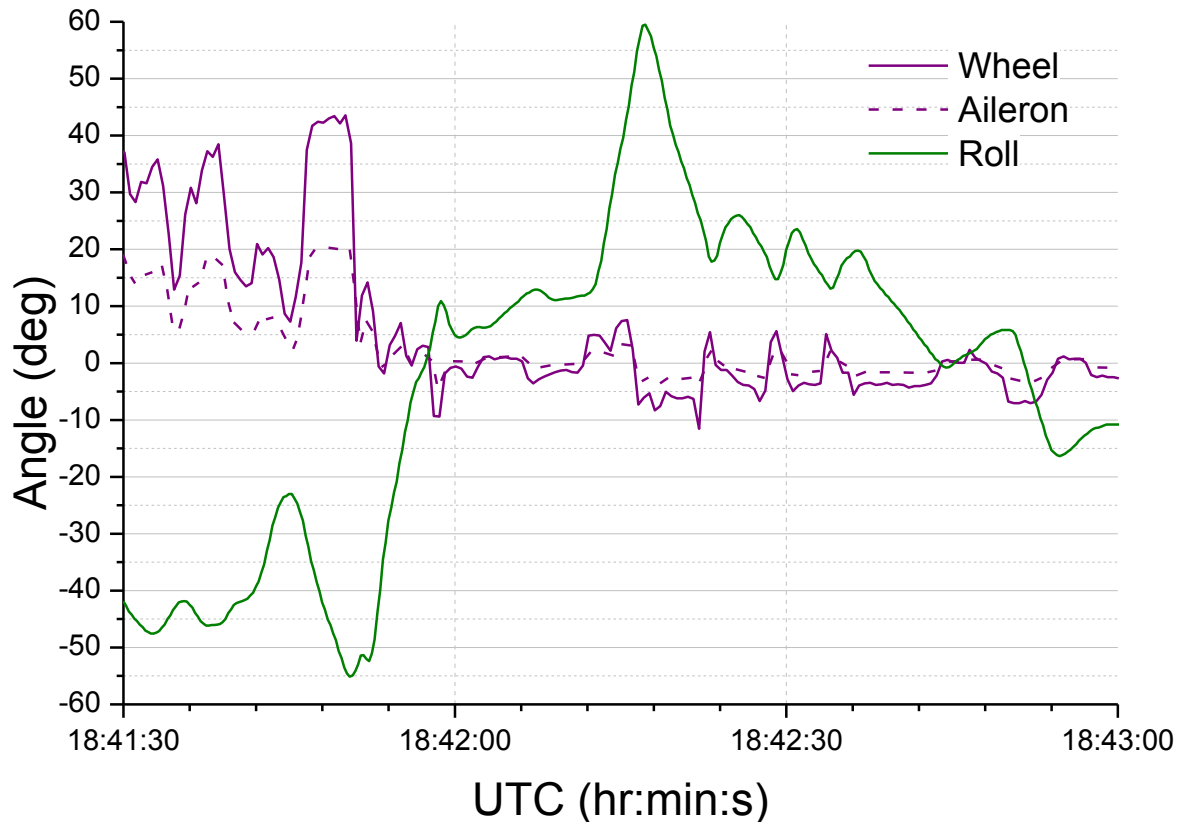
The second roll to the right at 18:42:12 was difficult to analyze due to the prior upset orientation of the aircraft which increased uncertainty of the airspeed measurements. Therefore it was not possible to create a lift curve like the one in Figure 17 for the second roll event. This roll event was not accompanied by a loss of altitude, but it was a significantly large (60° right) roll. Two other right banking maneuvers from the incident flight were analyzed to compare to the 60° right roll and are shown in Figure 20 with the right roll from the upset in Figure 21. During the two routine right wing down maneuvers, the pilot inputs about a 10° right wheel input to produce a 25° right wing down roll. However, Figure 21 shows how during the upset, the pilot entered less than 10° of right wheel but the aircraft rolled 60° right wing down.

While the pilot did put in wheel to begin the second roll to the right, the response was much too large. A 60° bank attitude falls into the Federal Aviation Administration's (FAA) definition of aerobatic flying [9] and would not be an intentional maneuver by a commercial pilot. The magnitude of the roll then indicates that the aircraft was not stable, despite gaining altitude since the initial left roll stall upset. It is possible that an accumulation of ice on the wing was still affecting the aircraft's aerodynamic response to control inputs.
