**NATIONAL TRANSPORTATION SAFETY BOARD**  
**Office of Research and Engineering**  
**Washington, D.C. 20594**

**Aircraft Performance Study**

**A. ACCIDENT: WPR11MA454**

Location:	Reno, NV
Date:	September 16, 2011
Time:	Approximately 16:26 PDT
Airplane:	North American P-51D

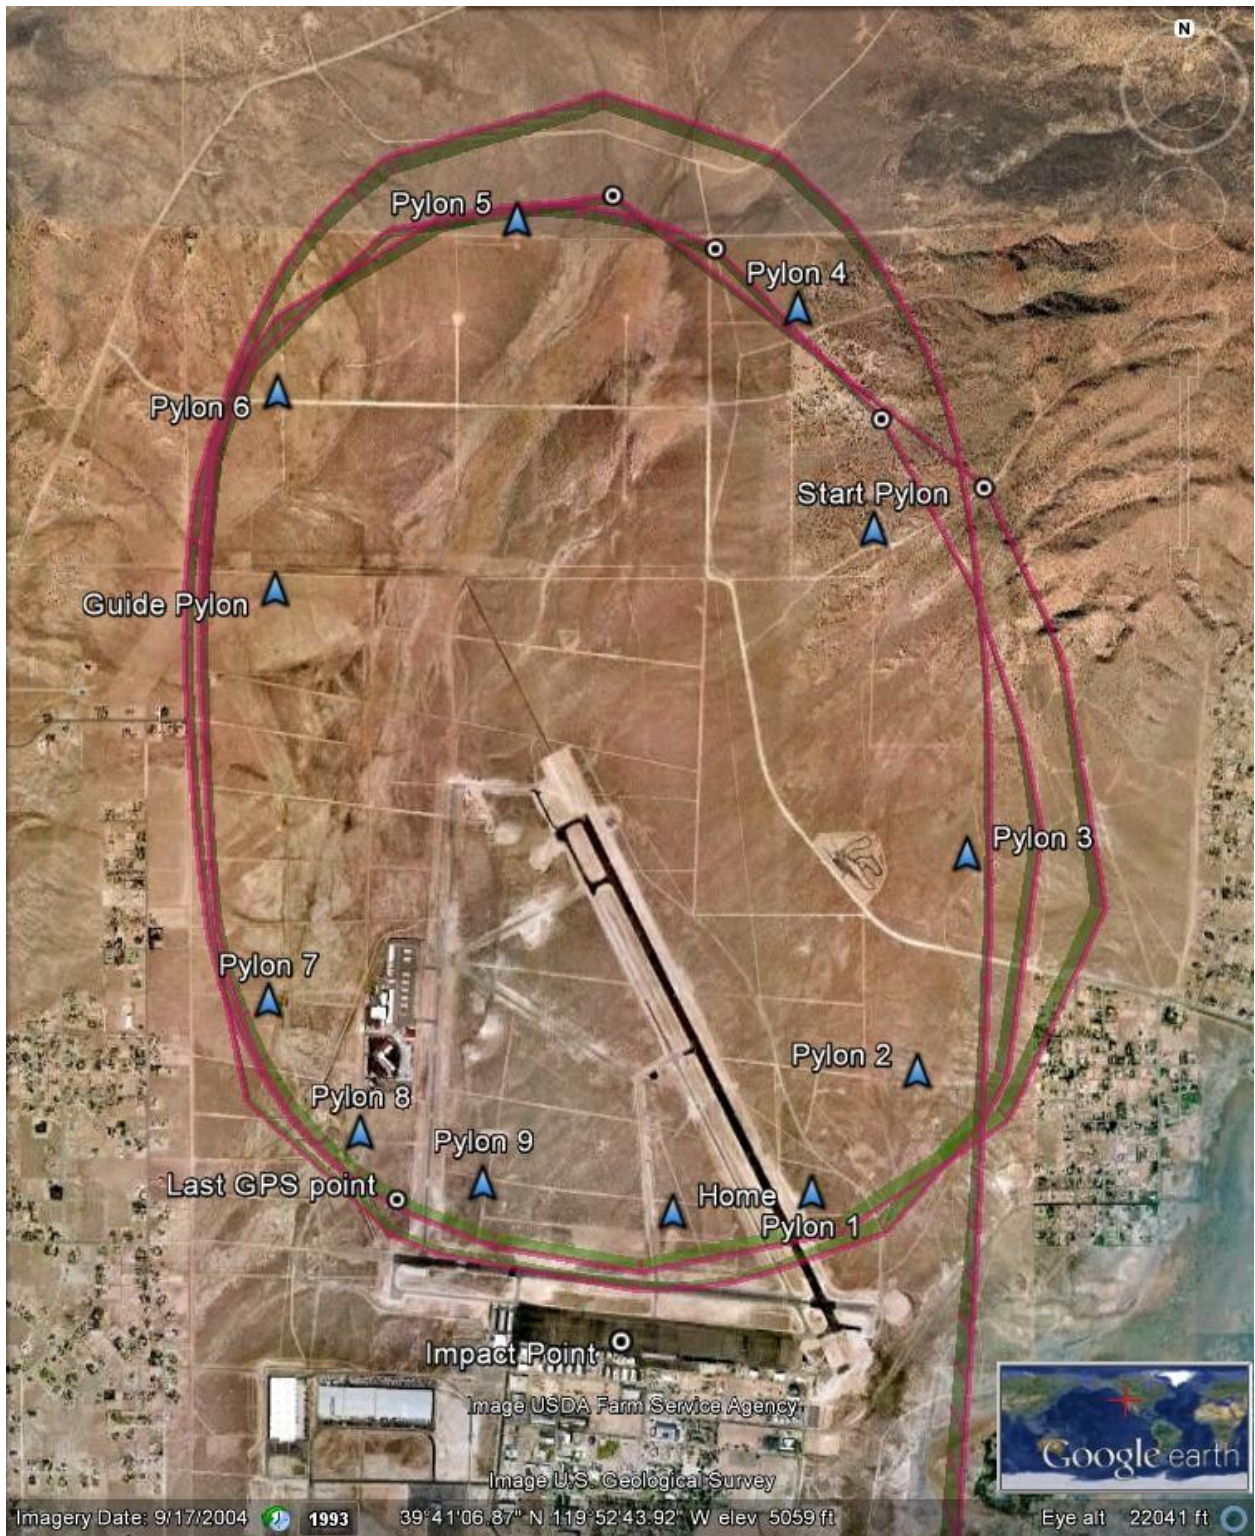
Figure 1. Galloping Ghost race flight path from GPS telemetry latitudes and longitudes.

In Figure 1, the aircraft seems to twice pass to the inside of Pylon 4. The erroneous flight path is due to gaps in telemetry data in this area. The flight path is drawn with straight lines between latitude and longitude points (shown before and after Pylon 4 as black and white circles), so missing points lead to a flight path that appears to miss the turn around the outside of the pylon. However, there were other aspects of the GPS system that contributed to the uncertainty. According to the Data Recorder Specialist Factual Report [3], the quality of the signal degraded during the race due to rapid banking to angles that obscured the antenna's view of the sky and limited access to satellites. Additionally, the manufacturer/designer of the telemetry system has noted issues with the GPS data when the load factor exceeds the operational limits (4 g's).

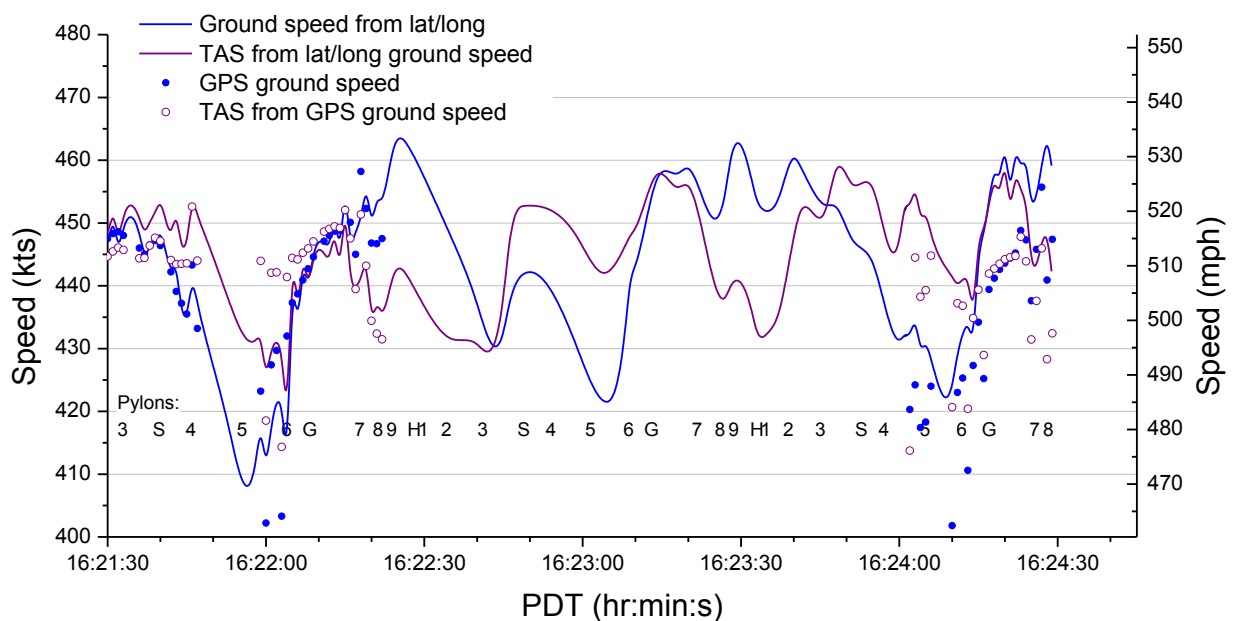
Gaps in data were common for all telemetry channels. The GPS speed record had a period of no data from 16:22:22 to 16:24:02. To compensate for the two minute loss of data, an inertial speed was calculated from the GPS altitude, latitude, and longitude. This data was then smoothed to account for timing irregularities. During the final lap of the race, the calculated ground speed is higher than the telemetry ground speed despite correlating well during the first lap (see Figure 2). It is unclear what accounts for the discrepancy, since the telemetry ground speed should use the same latitude, longitude, and time data as the NTSB calculation. There was no method available to independently verify which speed was the most accurate. This also makes the aircraft's true airspeed (TAS) (which was calculated using winds of 21 knots from 275°) different depending upon which ground speed was used to derive the airspeed. However, the maximum difference between the speeds is about 10 kts, which is less than a 3% difference from the average recorded speed. For the remainder of this report, the true airspeed determined from the GPS-position-based calculated ground speed will be used, unless otherwise noted. Using the calculated ground speed and true airspeed allowed for analysis of the second lap of the race when no telemetry speeds were available. Note that the magnitudes of the various speeds have some uncertainty, but the trends are consistent.

**Figure 2. Galloping Ghost race speeds. Symbols indicate the times when the airplane passed the numbered pylons as well as the Start (S), Guide (G) and Home (H) pylons.**

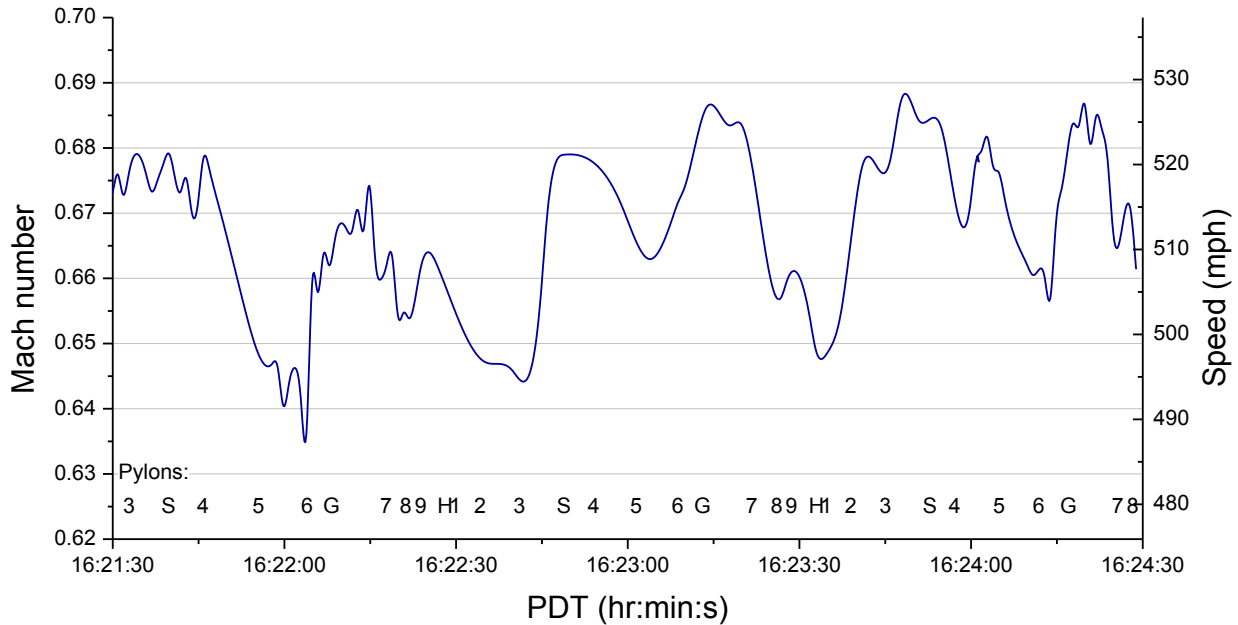
The Mach number of the aircraft was calculated using a speed of sound in air of 667 knots and the aircraft's true airspeed and is shown in Figure 3. At some points on the course, these speeds are higher than Reno Air Race Association (RARA) recorded speed values which reflect the average speed calculated from the ideal race course distance divided by the aircraft's lap times. The telemetry data was of much higher resolution recording the variations in speed around the course as well as the actual path the aircraft flew, which extended over a longer distance than the ideal race course.

**Figure 3. Galloping Ghost race Mach numbers.**

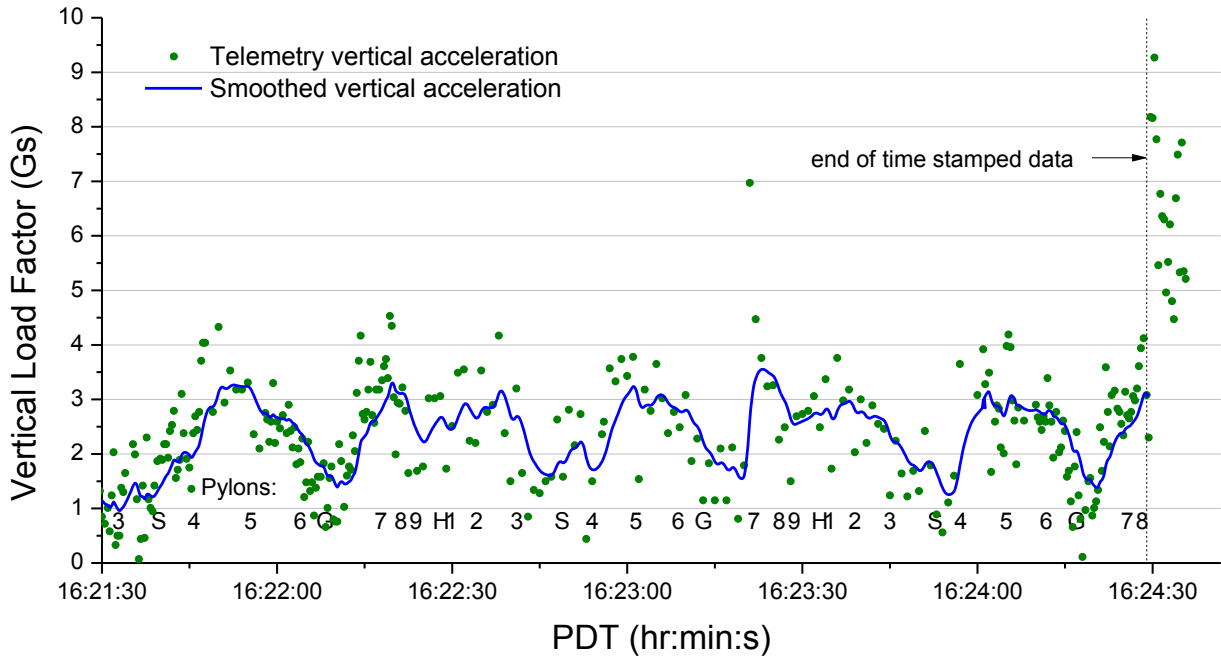
**Figure 4. Galloping Ghost race vertical acceleration.**

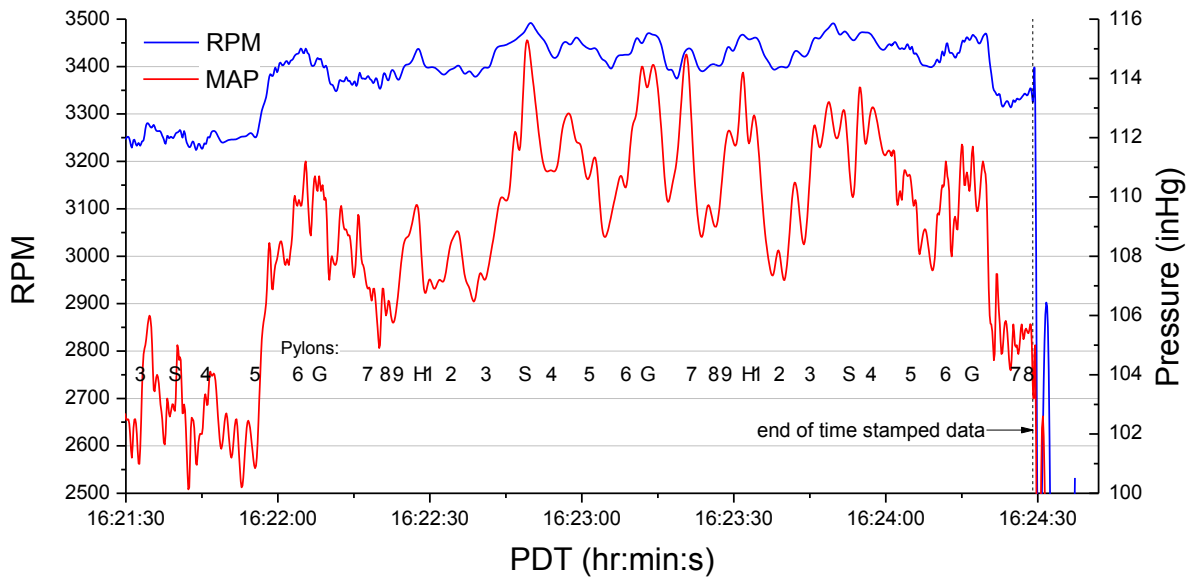
A total of nine telemetry channels were dedicated to engine and cooling system parameters. Engine speed in revolutions per minute (RPM) and engine manifold pressure (MAP) data are shown in Figure 5.

**Figure 5. Galloping Ghost race RPM and MAP.**

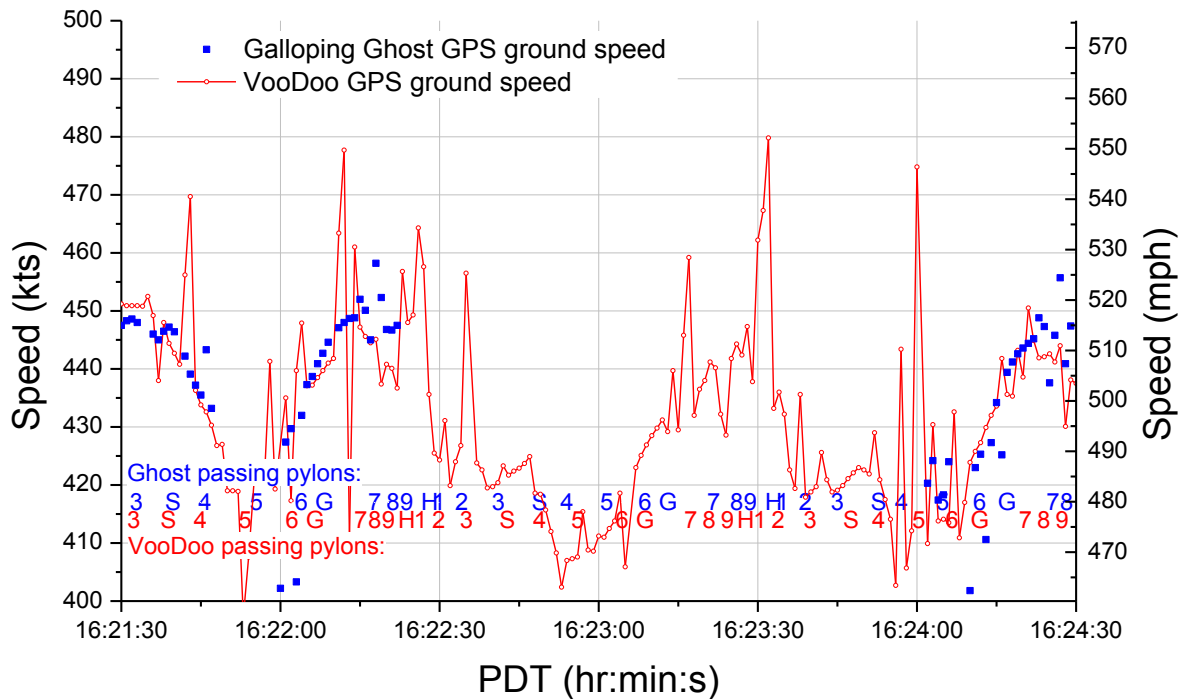
To determine if the performance of the Galloping Ghost during the race flight prior to the upset was unusual compared to other similar aircraft, the race team from Voodoo, another modified P-51, provided telemetry data from the September 16<sup>th</sup> race to the NTSB. Voodoo was a few seconds ahead of the Galloping Ghost during the accident race. Figure 6 shows the speeds of both aircraft and Figure 7 compares the vertical load factor throughout the race. Both figures show that the Galloping Ghost speed was close to that of Voodoo and that the two airplanes were experiencing similar vertical load factors.

Figure 6. Voodoo and Galloping Ghost GPS recorded ground speed.

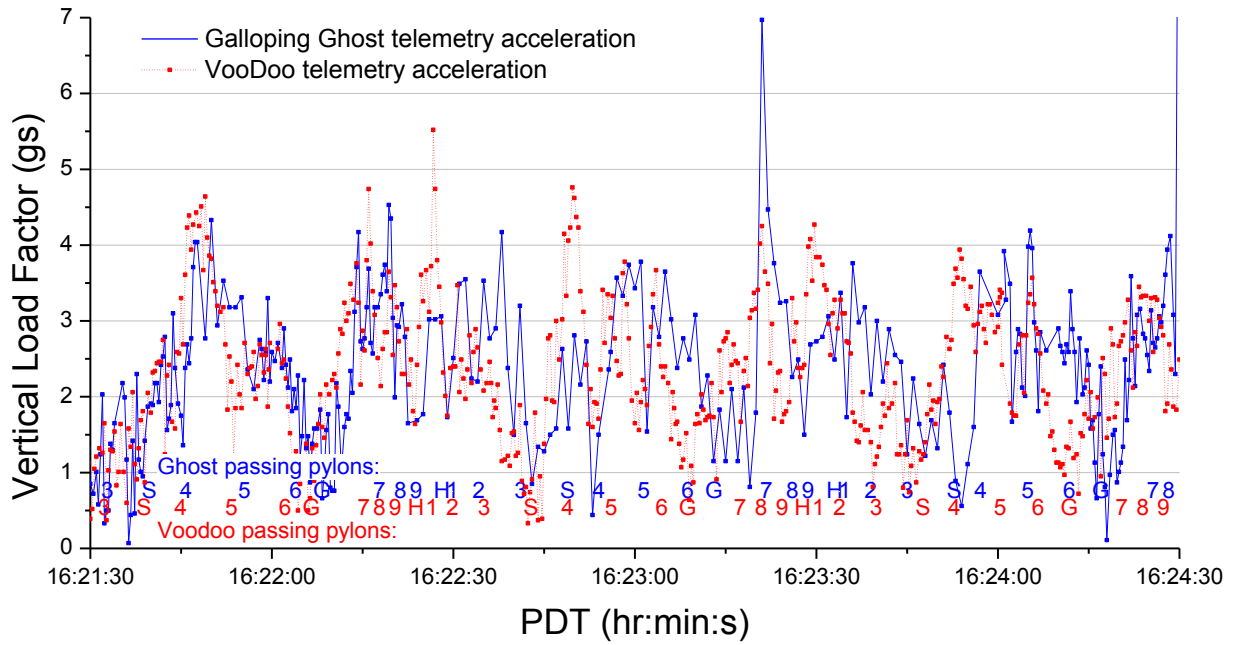
Figure 7. Voodoo and Galloping Ghost vertical load factors.

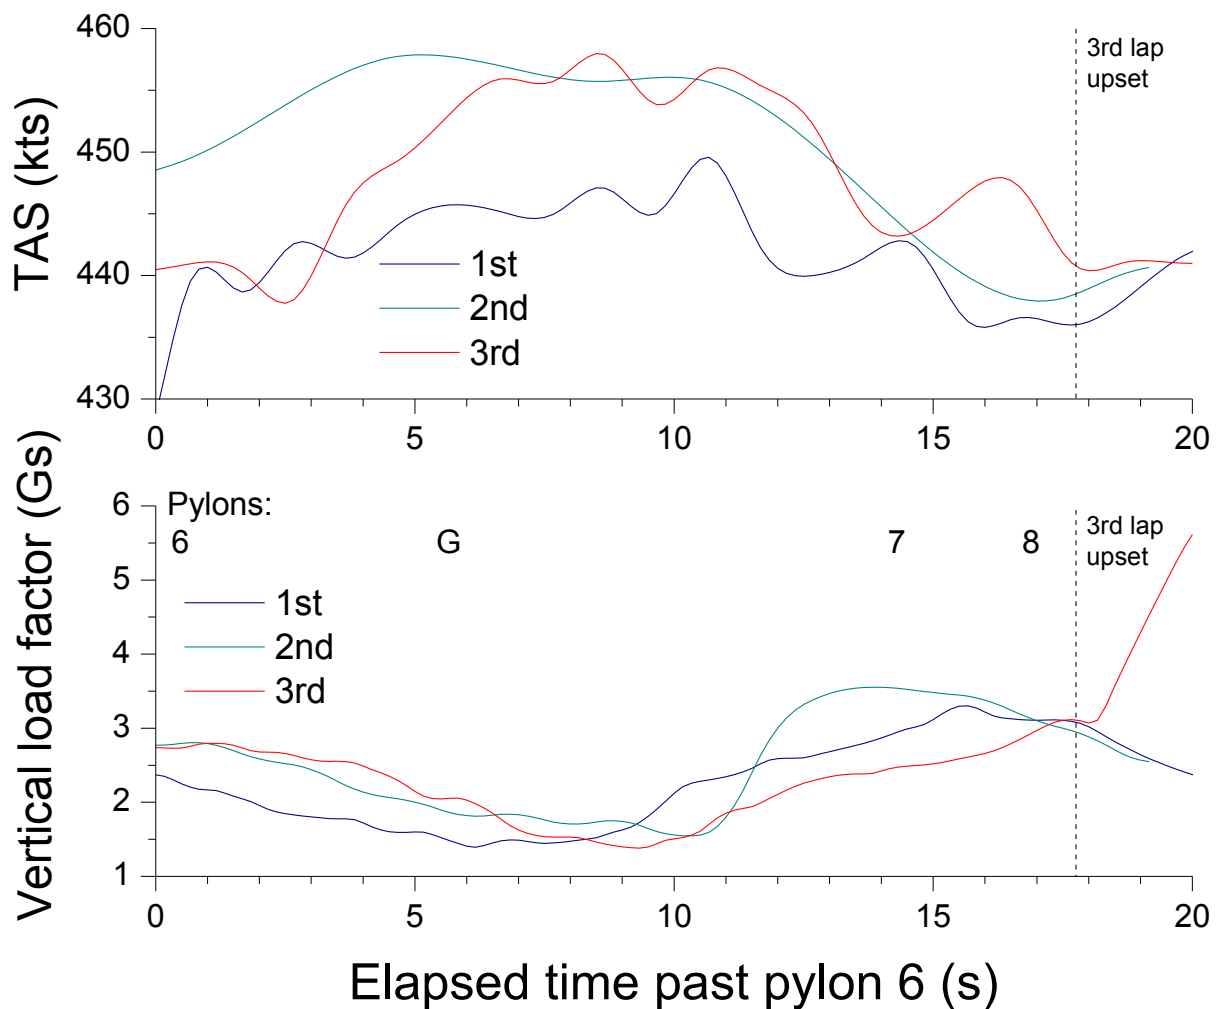
To determine if the performance of the Galloping Ghost during the portion of the flight immediately prior to the upset was unusual, the aircraft's speed, vertical acceleration, MAP, and RPM for each lap in the location of the upset were compared. The roll transient event occurred as the aircraft passed pylon 8 during the third lap of the race. Figure 8 and Figure 9 show comparisons of the first and second laps of the race to the accident lap for speed, vertical acceleration, and engine performance. The pylon numbers reflect the third lap. Figure 8 shows that the aircraft's speed and acceleration on the third lap of the race were not significantly different from those during its first two turns past Pylon 8.

Figure 8. True airspeed and vertical load factor leading into the turn round Pylon 8 on laps 1, 2, and 3.

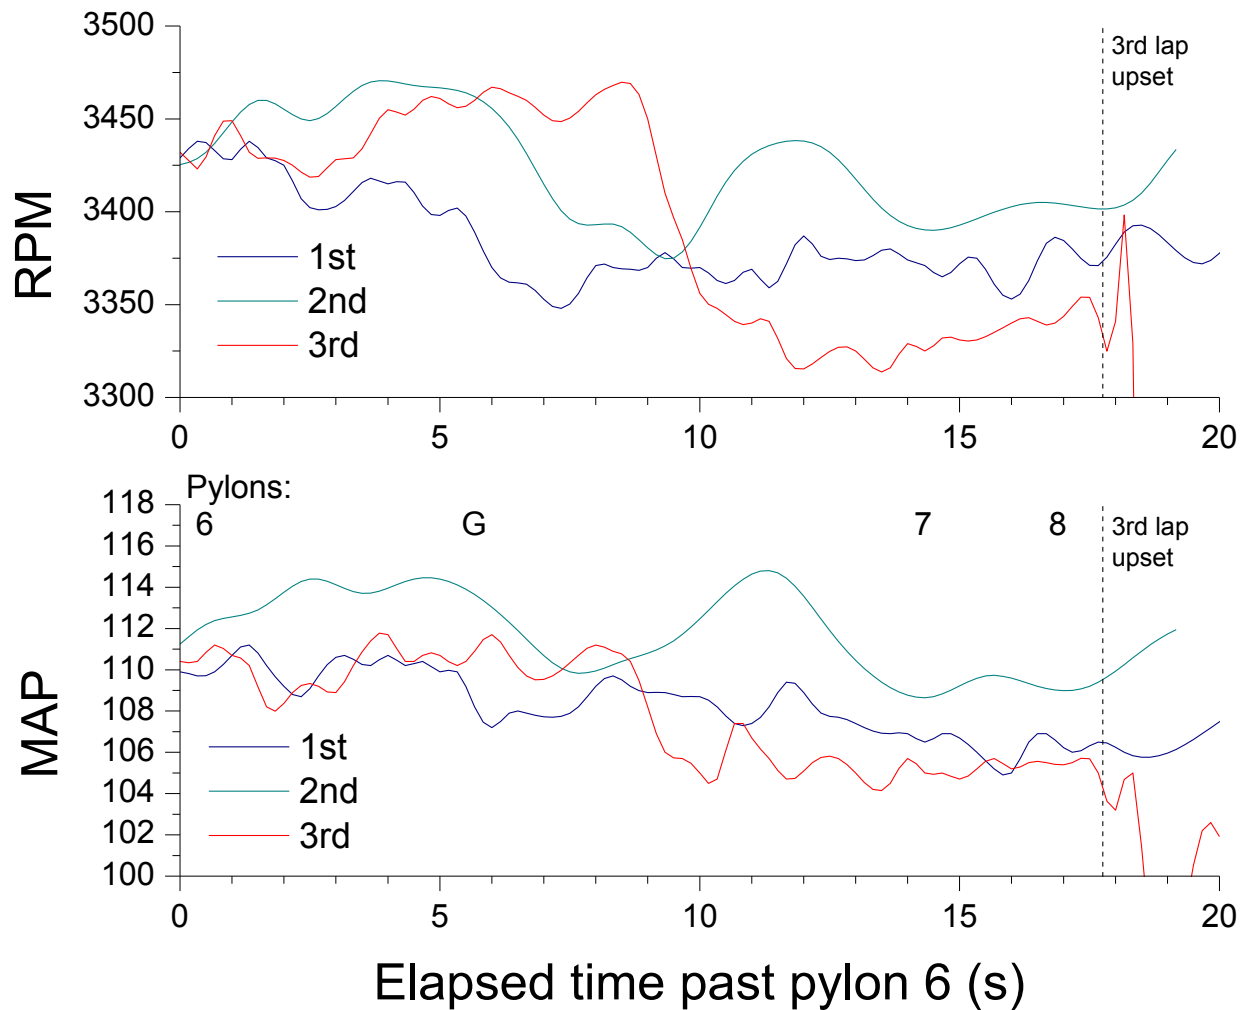
Figure 9 shows RPM and MAP for the laps. About 8 seconds before the beginning of the upset, the engine was cut back.

Figure 9. RPM and MAP leading into the turn round Pylon 8 on laps 1, 2, and 3.

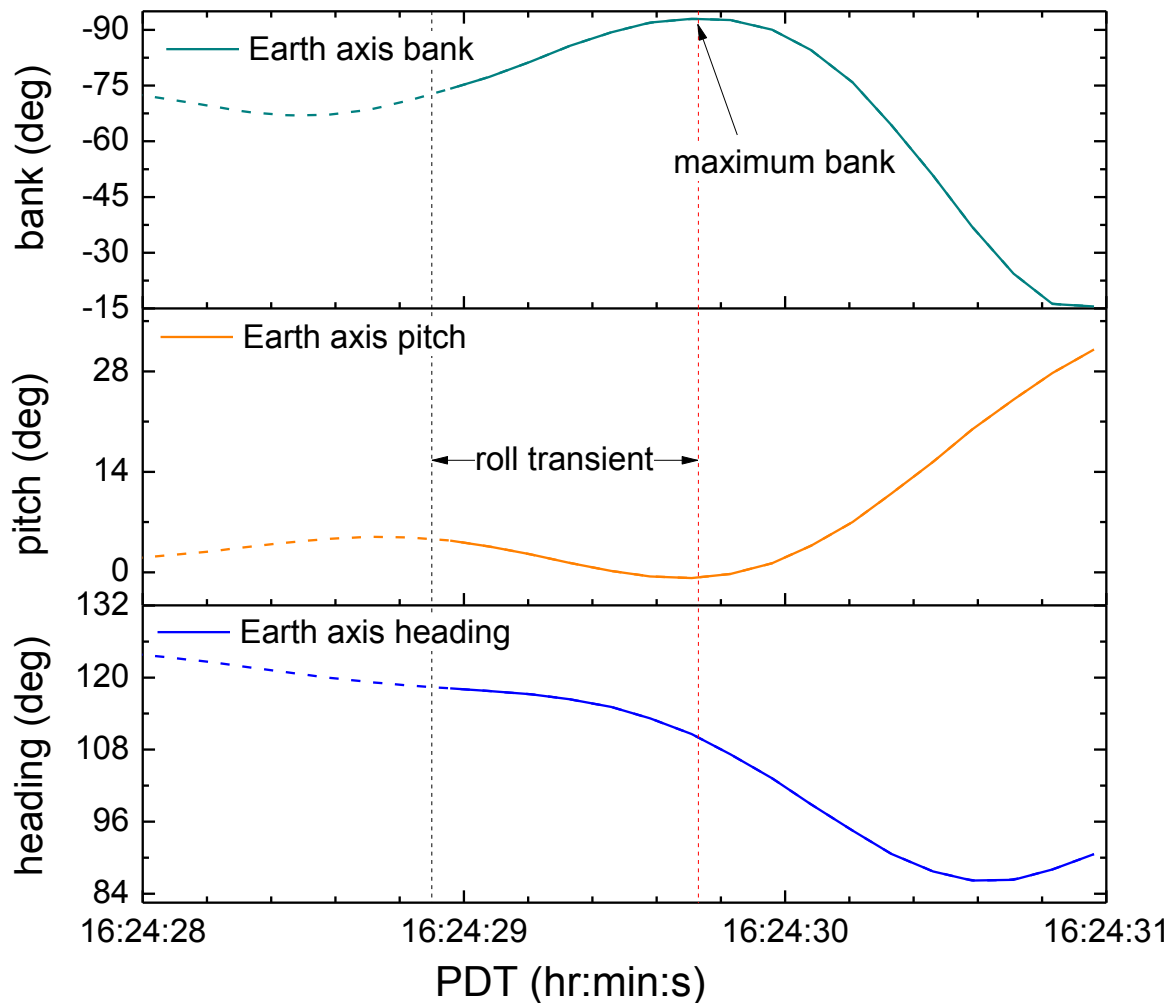
Photographs and video of the Galloping Ghost during the race and subsequent upset and accident were analyzed by the NTSB. The Video Study [5] used available video to evaluate the motion of the aircraft's flight over approximately 4 seconds. The Galloping Ghost was in a coordinated left turn at a 73° bank when it abruptly rolled to a greater than 90° bank. The aircraft then rolled back right and pitched up into a climb. The motion results of video analysis, shown in Figure 10, were time correlated to the telemetry data. Because of the difficulty in determining the motion of the aircraft with respect to the motion of the camera when the aircraft was coming towards the camera, especially for heading and pitch, the data before 16:24:28.90 is less accurate than later data. The estimation of the bank of the aircraft is dependent upon pitch and heading for transformation from camera to earth axis and is therefore also slightly less accurate during this period before the upset.

Figure 10. Motion of Galloping Ghost from video analysis of final portion of the accident flight.

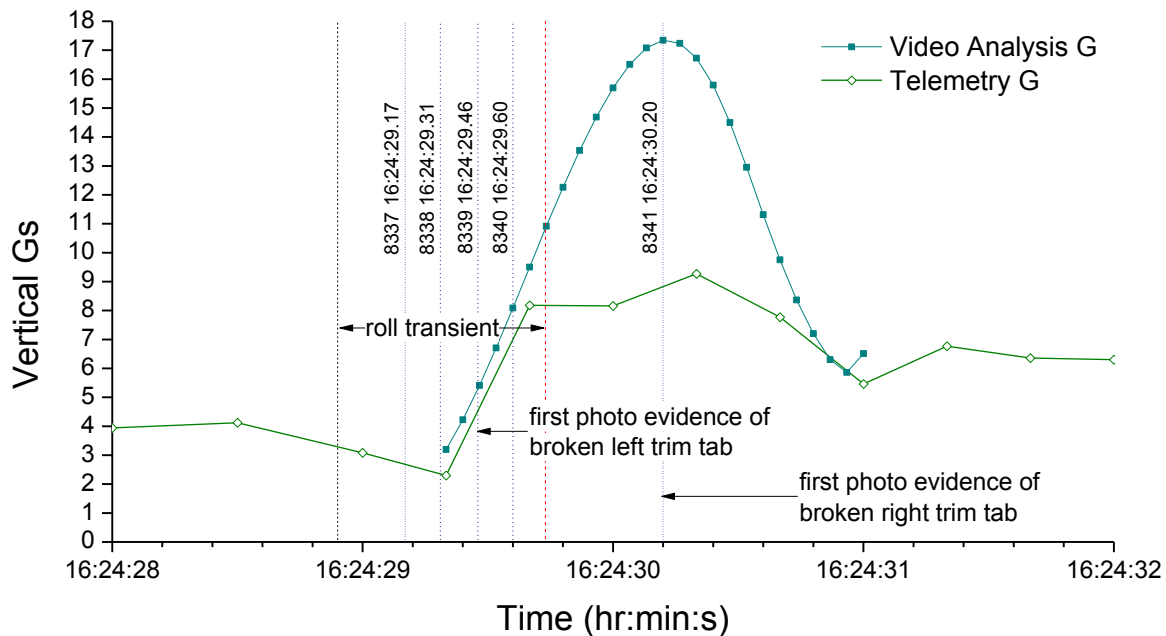
Figure 11, below, shows the vertical acceleration leading up to, during, and after the roll transient identified in photographs and videos of the accident. During the roll transient, the onboard accelerometer recorded a greater than 5 g jump in vertical acceleration in 1/3 of a second. The departure from the flight path and the sudden increase in vertical acceleration indicate that the roll transient was at the beginning of the upset that led to the accident. Figure 11 also locates when, in the photographic evidence (Image Study [1]), the right and left trim tab control rods were first definitively recorded as being visibly broken.

**Figure 11. Galloping Ghost vertical acceleration during upset. Dashed blue lines mark the time of Apfelbaum photographs. Further information on the content of each photo is in the Image Study [1].**

The earliest photographic evidence of the failure of the left trim tab control rod is at 16:24:29.46, 0.56 s after the beginning of the roll transient as shown in Figure 11. However, the quality or angle of the other photographs of the aircraft leading into and at beginning of the upset made it not possible to definitively determine if the tab was broken earlier. In the 16:24:29.46 photograph, the trim tab was deflected trailing edge up at an angle past the design constraints of the system. For a loss of trim tab effectiveness to have induced the left roll transient, it would have had to occur before the onset of the roll at 16:24:28.9.

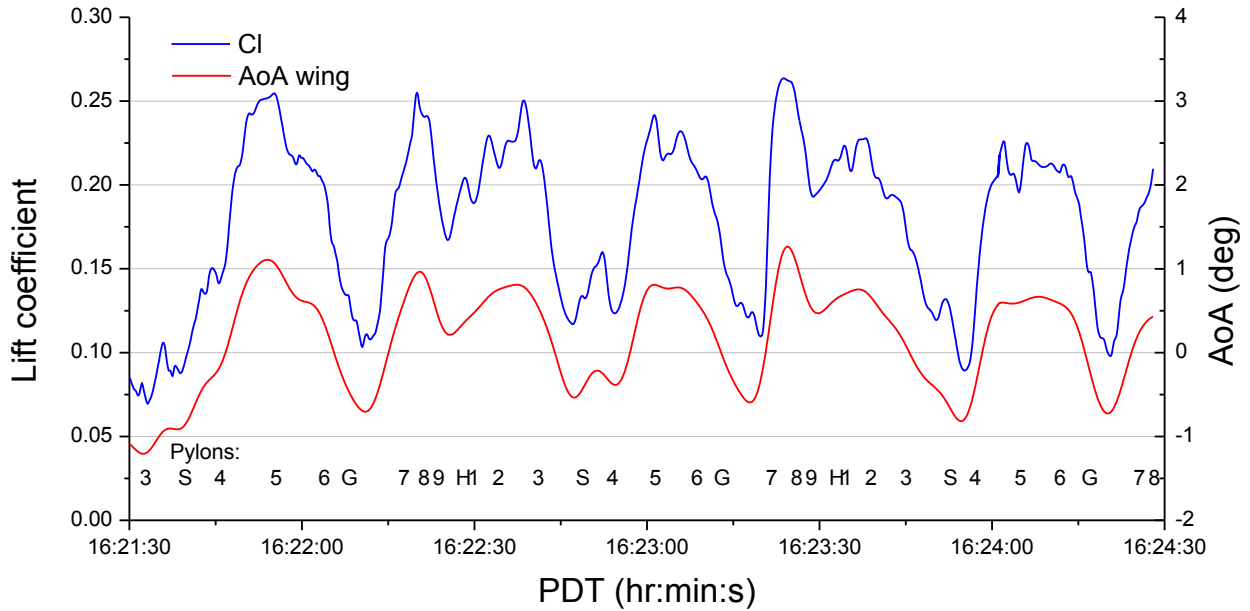
**Figure 12. Calculated lift coefficient and angle of attack of the wing.**

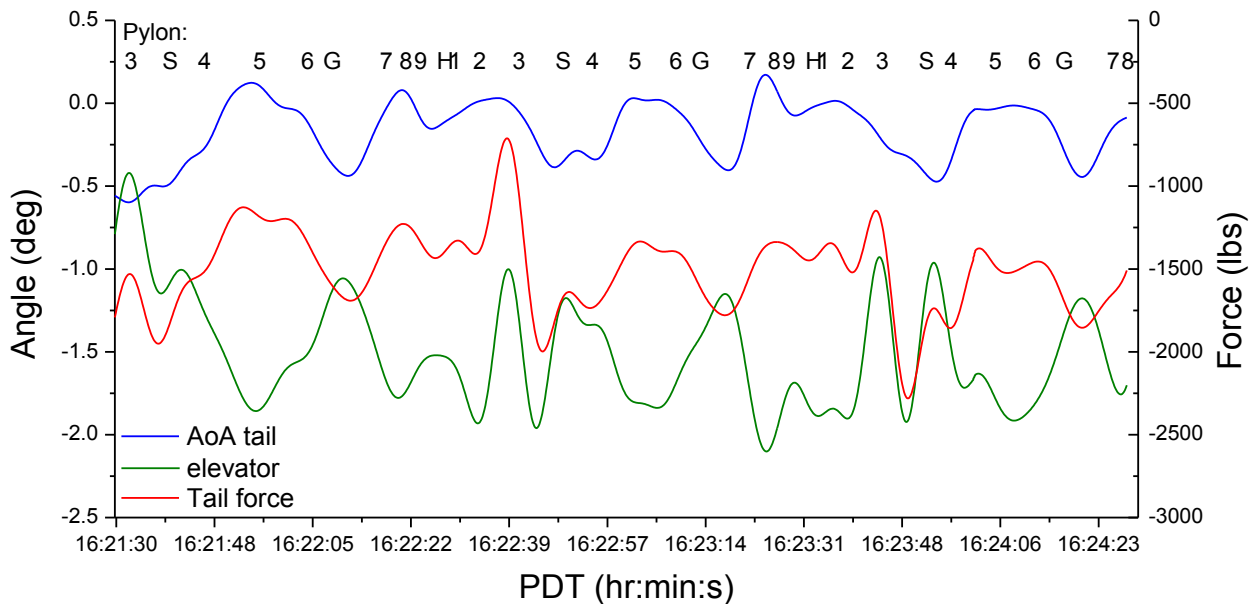
Figure 13 shows the angle of attack of the tail, the elevator deflection, and the load on the tail. Note that a negative elevator deflection equates to a trailing edge up condition, which is consistent with the photographic evidence from the race. The negative load on the tail equates to a download which is consistent with photographs showing fuselage wrinkling discussed in the Image Study [1].

**Figure 13. Angle of attack of the tail, elevator deflection, and load on the tail for the accident race from the kinematic extraction.**

It is of note that during the race the Galloping Ghost maintained a slight trailing edge up elevator deflection consistent between the photographic evidence and the kinematic extraction.

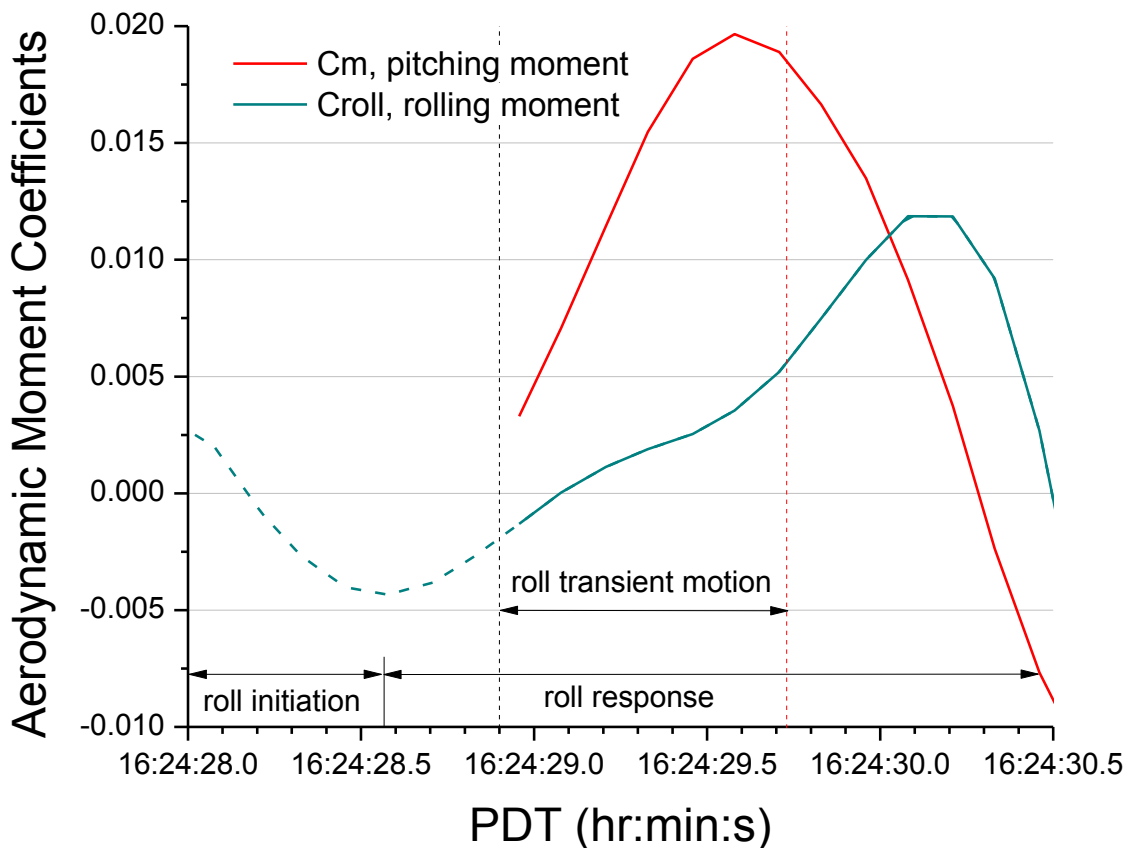
The kinematic extraction method was applied to the video data (shown earlier in Figure 10) and Figure 14 shows the pitching and rolling moments required for the aircraft to complete the roll upset. As the data before 16:24:29 has larger uncertainty, especially in pitch and heading, the rolling moment is shown as a dashed line, the pitching moment is not shown before 19:24:29, and the yawing moment is not presented at all. The change in aerodynamic moment for the initiation of roll began before 16:24:28.90, but due to inertial lags, the roll was not visible until 16:24:28.90.

**Figure 14. Pitching and rolling moment aerodynamic coefficients required for roll transient. Dashed lines indicate less reliable data.**

To be responsible for an upset, a wake vortex encounter must produce the roll coefficient time history shown in Figure 14. However, due to the uncertainty of the data during the initiation of the roll in the kinematics analysis, it is not possible to separate out the effects of a wake encounter versus a different roll initiator. It can be concluded that a wake would only have to induce a small change in the rolling moment coefficient (less than 0.005) to begin the roll transient.

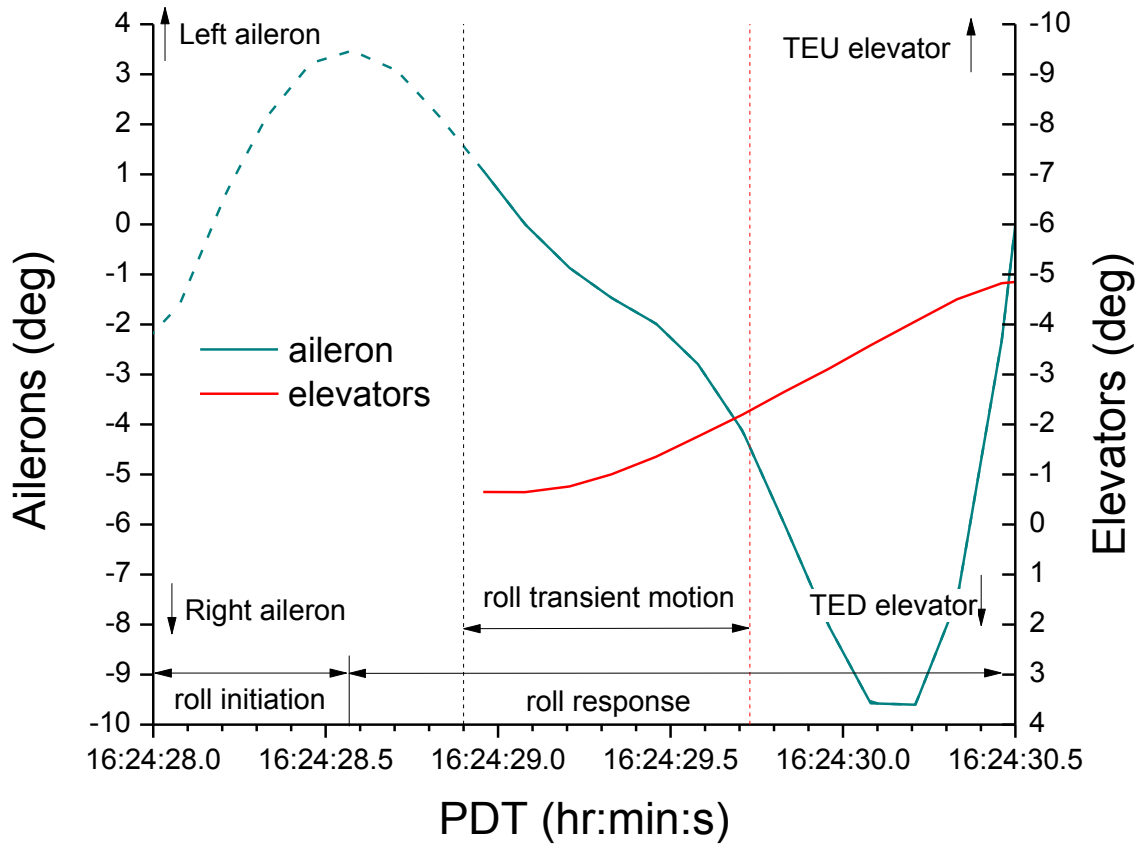
Additionally, it was determined what control inputs would be required for the aircraft to complete the roll transient maneuver. Assuming an intact airplane and no wake or wind encounters, the elevator and aileron deflections required to complete the roll transient motion are shown in Figure 15. During the roll initiation a change in aileron input of about  $3^\circ$  ( $\pm 30\%$  due to uncertainty) would be necessary for the aircraft to complete the roll transient motion. The photographs of the aircraft during the roll initiation period were at such an angle that measuring

the deflection of the ailerons to the necessary degree of accuracy was not possible. Therefore it was not possible to use the photographs to either confirm or rule out that a change in control inputs initiated the roll transient.

Figure 15. Elevator and aileron required for roll transient motion.

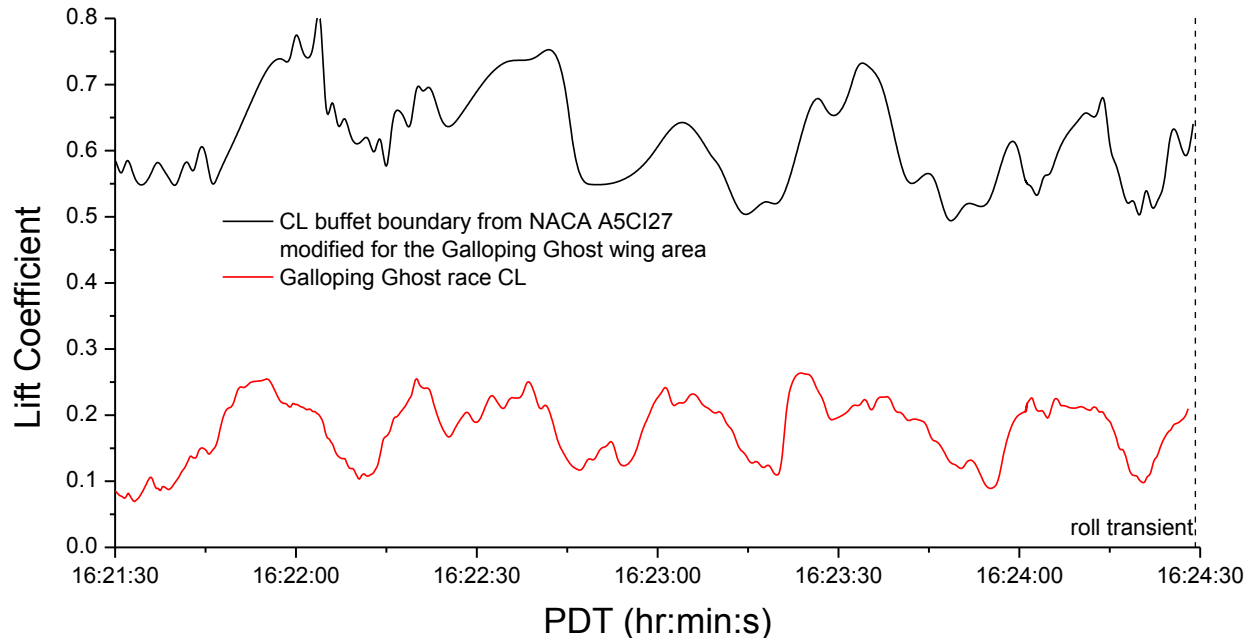
Mach buffet could have caused separation on the left wing, causing it to lose lift, and initiate the left roll. The Mach number where Mach buffet occurs is inversely related to the lift coefficient. Figure 16, below, shows the NACA defined lift coefficient marking the Mach buffet boundary (Reference [11]) for the P-51D modified for the reduced wing area of the Galloping Ghost, as calculated using the aircraft's Mach number during the race. The accident aircraft's lift coefficient (first presented in Figure 12) stays well below the buffet boundary throughout the race. Additionally, the aircraft lift coefficient was higher and closer to Mach buffet earlier in the race than at the time of the upset. It is unlikely that Mach buffet instigated the roll transient.

**Figure 16. Comparison of Galloping Ghost lift coefficient with modified P-51D Mach buffet boundary data.**

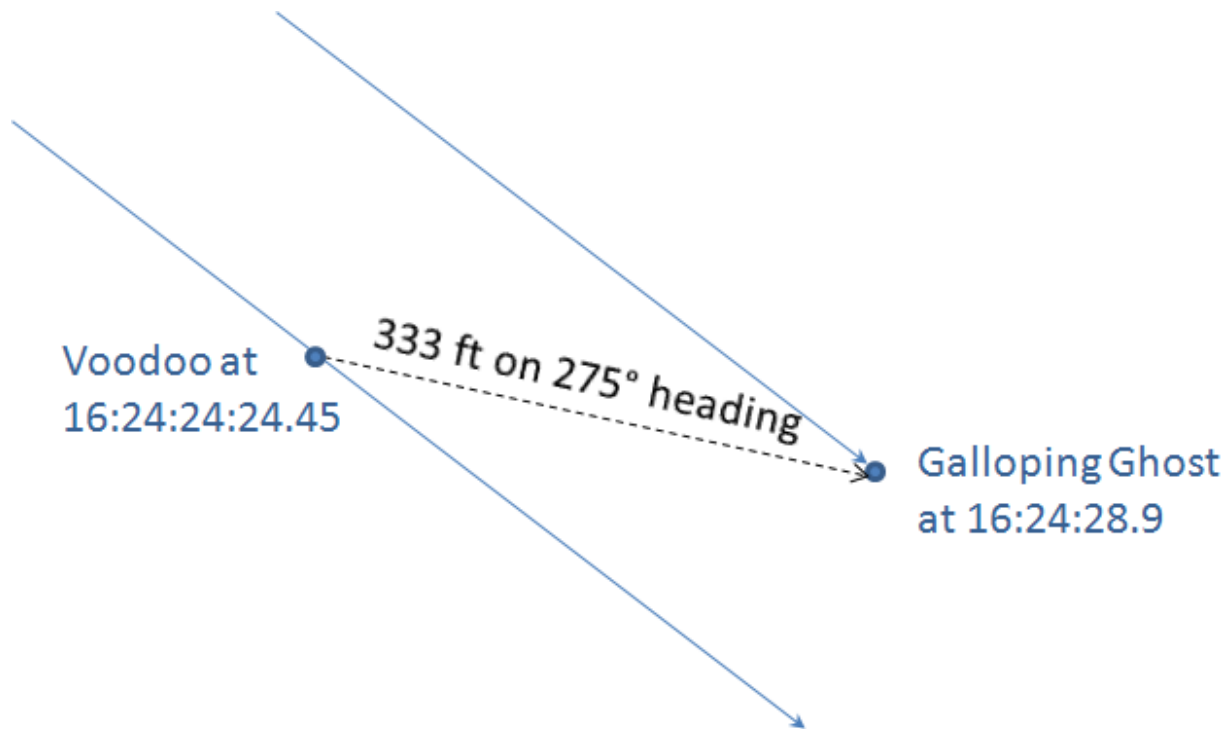
At the time of the upset, Voodoo was about 4.5 seconds ahead and Strega was about 8.8 seconds ahead of the accident aircraft. Voodoo was at a bank angle of about  $70^\circ$  (nominally  $2.9 g$ 's) when it was at the point of the Galloping Ghost upset. Strega's left bank angle was assumed to be  $70^\circ$  for calculation purposes. Image analysis determined that Voodoo and the Galloping Ghost were at about the same altitude near the point of the upset (see Image Study [1]). A wake generated by either airplane would be pushed along a heading  $275^\circ$  by the 21 kts wind. Using the GPS ground tracks of Voodoo and the Galloping Ghost it was determined that at 16:24:24.45 Voodoo would have been aligned in such a way that the wind would carry its wake towards the upset point (see Figure 17). The 21 kts (35.4 ft/s) wind could have only carried the wake 157 ft in 4.5 s, 176 ft short of the accident aircraft's location at the time of the upset. Accounting for possible increases in wind due to altitude and uncertainties in GPS locations, a second estimate was made using 4.8 s of separation and a 25 kts (42.2 ft/s) wind and it yielded a travel distance of 202 ft, still short of the distance to the Galloping Ghost. However, the GPS data for Voodoo showed a number of inconsistencies during the race, so the exact path of the airplane was not able to be determined. Therefore, it is not possible to conclude definitively whether the Galloping Ghost could or could not have encountered a wake from Voodoo.

**Figure 17. Distance between Galloping Ghost and Voodoo GPS ground paths along wind heading.**

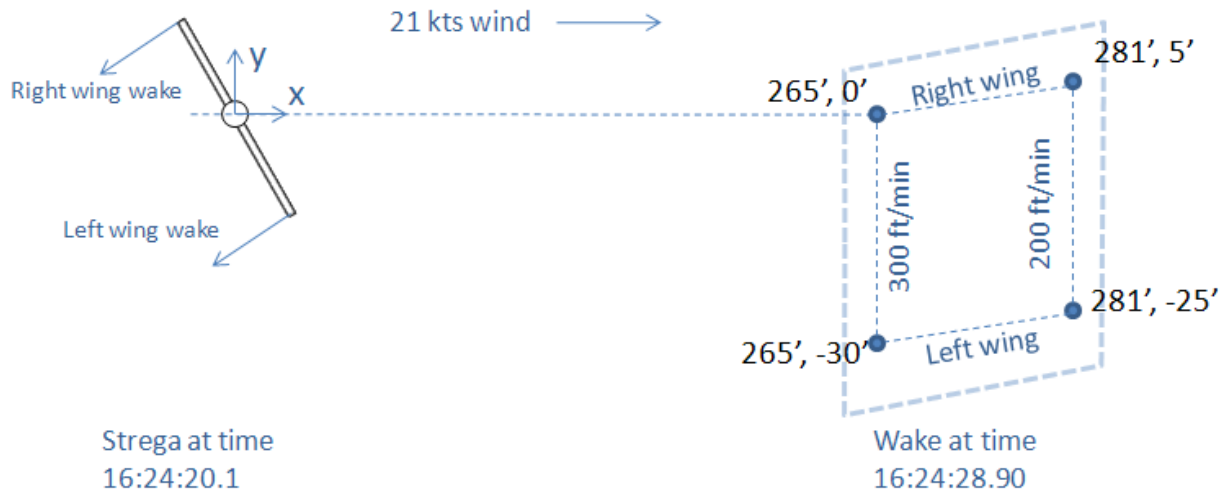
The position or altitude time history of Strega was not known from telemetry or GPS. Nominally, the position required for Strega to generate a wake to upset the Galloping Ghost is shown in Figure 18 and Figure 19. Since there are multiple encounter geometries and wake descent rates that could produce a left roll, this nominal point grows to a region about the size of the Galloping Ghost. Strega's flight path would have had to be just inside Voodoo's and its height would have to be level or just above the Galloping Ghost for the wake to intersect the accident aircraft. The tendency for wakes to depart from straight lines due to the possibility of developing Crow instability<sup>2</sup> widens the region further.

Figure 18. Horizontal and vertical distance the wake from Strega's right and left wing could move over 8.8 s.

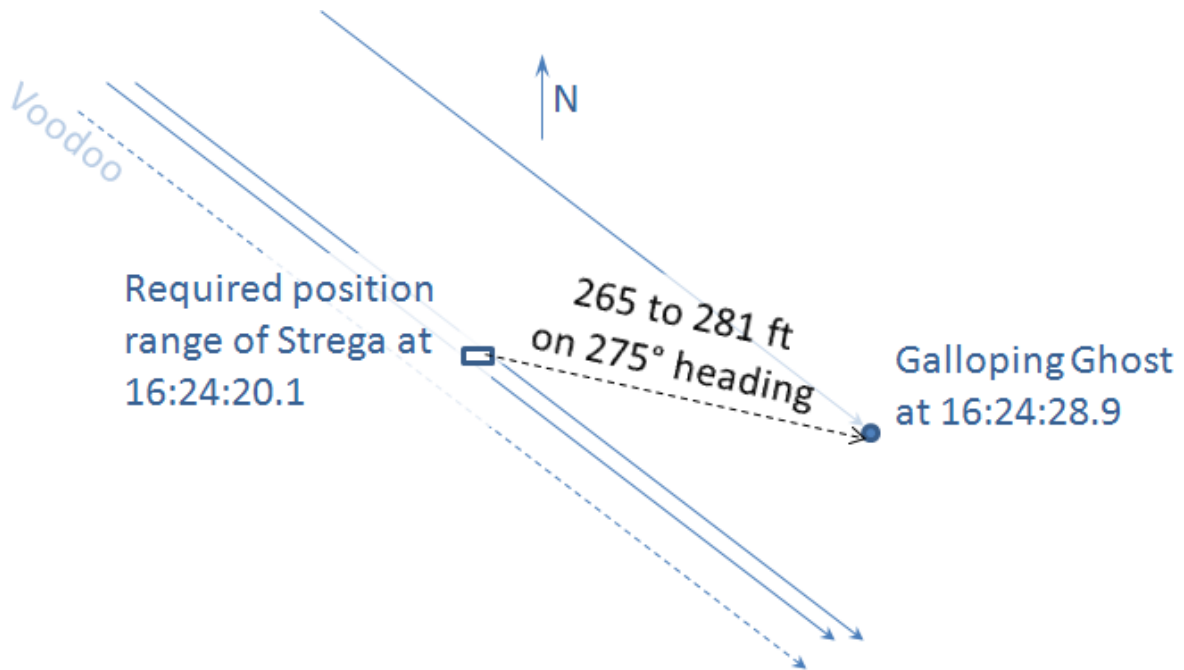
Figure 19. Required distance between Galloping Ghost and Strega ground paths along wind heading for Galloping Ghost to encounter Strega's wake.

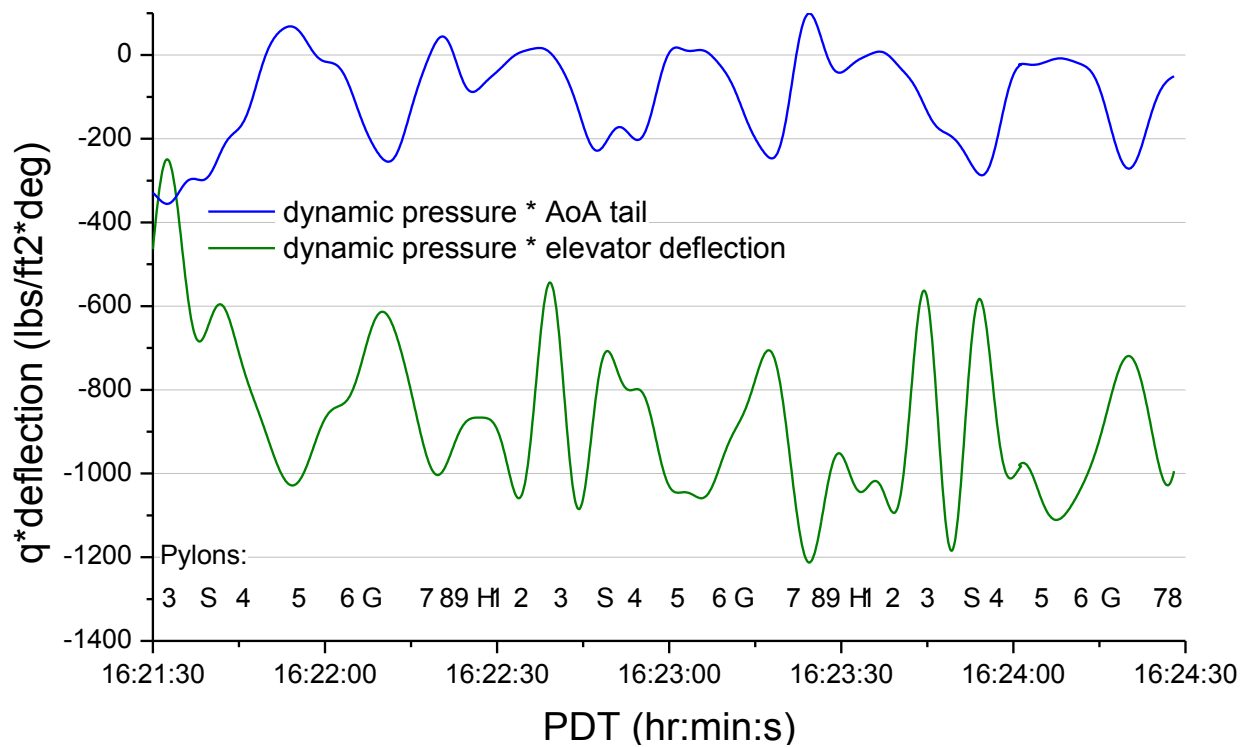
An increase in aerodynamic load could have overloaded the left trim tab and caused a failure of the control rod, leading to the extreme deflection of the trim tab seen in the photographs. Static loads on the trim tab control rods are calculated using hinge moments unique to each type of aircraft. Unfortunately due to the age of the P-51, the data for the hinge moments were not available. However, the tab loads are a function of dynamic pressure ( $q$ ) multiplied by both the angle of attack of the horizontal tail and the elevator deflection. These quantities are shown in Figure 20. From this plot it can be seen that the values for  $q \cdot A_{oA_{tail}}$  and  $q \cdot \delta_{elevator}$ , terms which are multiplied by constants and added together to yield the load on the trim tab control rod, are both lower at the point leading into the upset than they were at earlier points during the race. The deflection of the tab itself is also a factor, but is not included since the deflection is unknown and assumed to be near-constant throughout the race. Regardless of the actual hinge moment values, the combination of these two values could not have produced a greater static aerodynamic load on the trim tab leading into the upset than at points earlier. Therefore, it is not possible that a flight induced increase in static aerodynamic loads on the tab was able to break the left trim tab control system.

**Figure 20. Dynamic pressure (q) multiplied by the angle of attack of the horizontal tail and the elevator deflection.**
