**NATIONAL TRANSPORTATION SAFETY BOARD**  
**Office of Research and Engineering**  
**Washington, D.C. 20594**

**Aircraft Performance Study**

**A. ACCIDENT: WPR11MA454**

Location:	Reno, NV
Date:	September 16, 2011
Time:	Approximately 16:26 PDT
Airplane:	North American P-51D

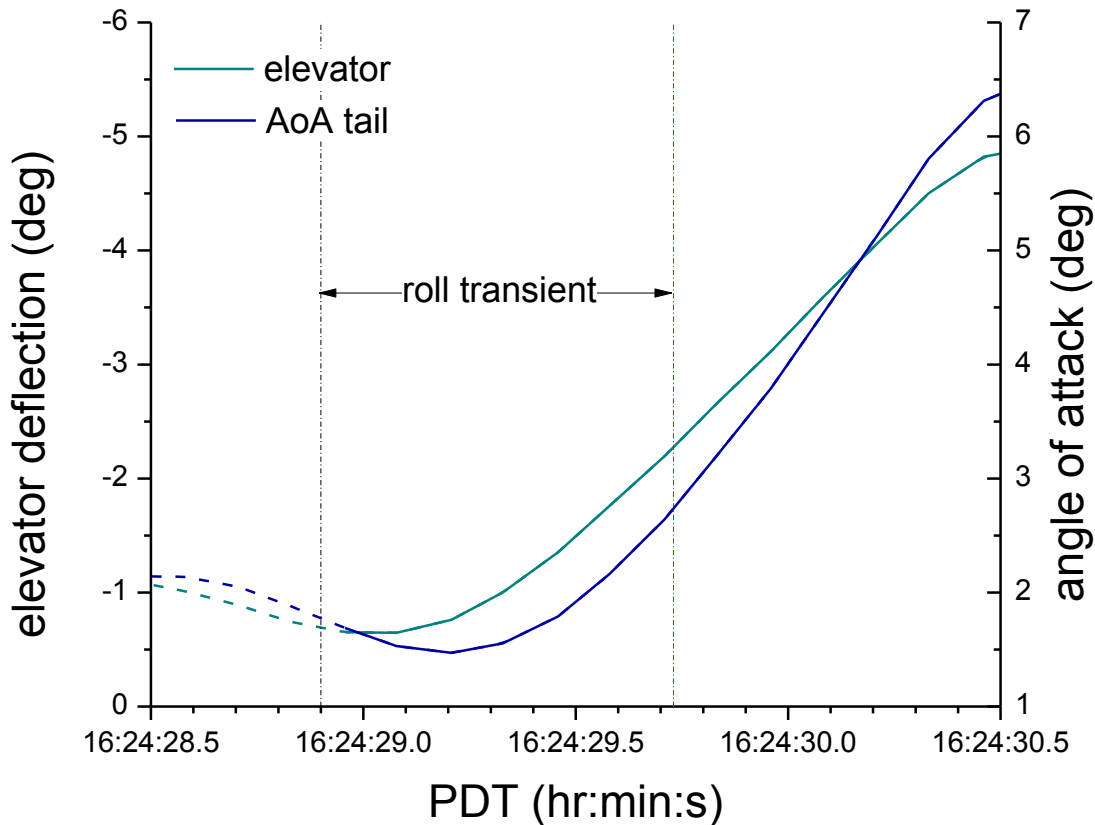
Since the pilot would be unable to hold the control stick as far forward as with an intact trim tab, the elevator would deflect slightly trailing edge up, which would pitch the aircraft upward and increase its angle of attack (pitch onset would be slightly later than roll onset due to the higher inertia about the pitching axis). The increased angle of attack would in turn increase the forces on the elevator surface and control stick according to

**Figure 21. Elevator and angle of attack of the tail during the roll transient and pitch-up.**

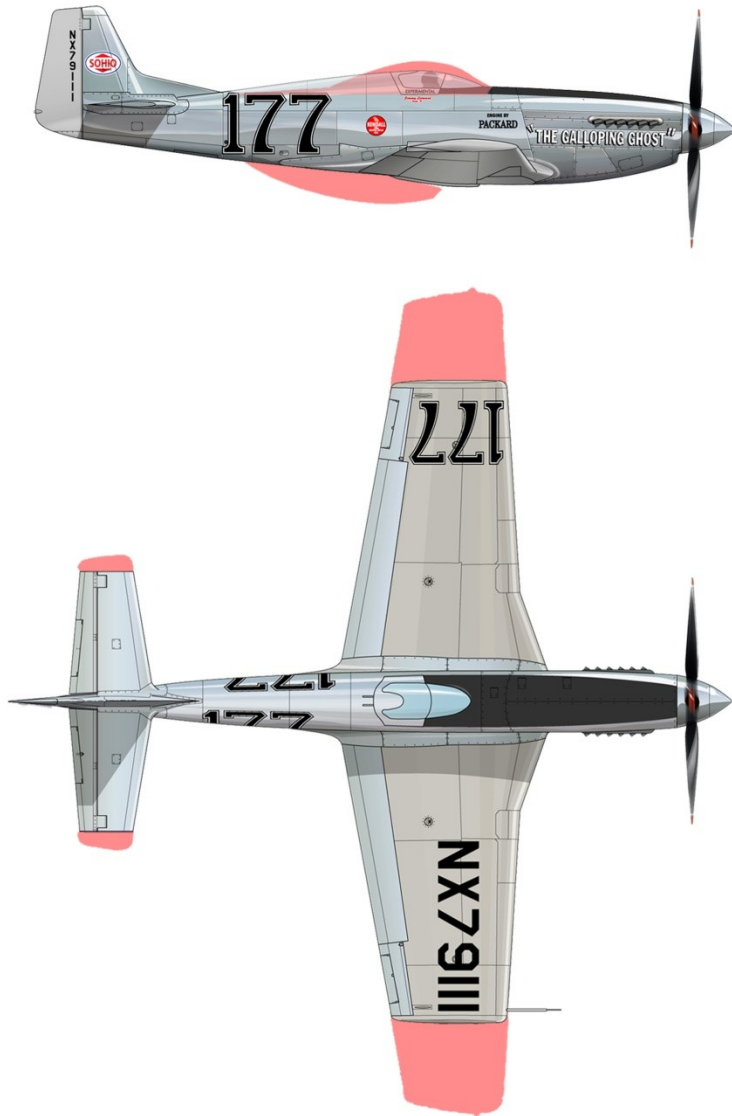
Figure 22. Galloping Ghost drawing with stock P-51D area shown in red. The aircraft featured shortened wings and tail, a low profile racing canopy, and had the fuselage scoop removed.
