National Transportation Safety Board
Office of Research and Engineering
Washington, D.C. 20594

Aircraft Performance

Wreckage Site Factual Report

Location: Lexington, KY
Date: August 27, 2006
Time: 1007 GMT (6:07 am EDT)
Airplane: Bombardier CRJ-100, N431CA
NTSB Number: DCA06MA064

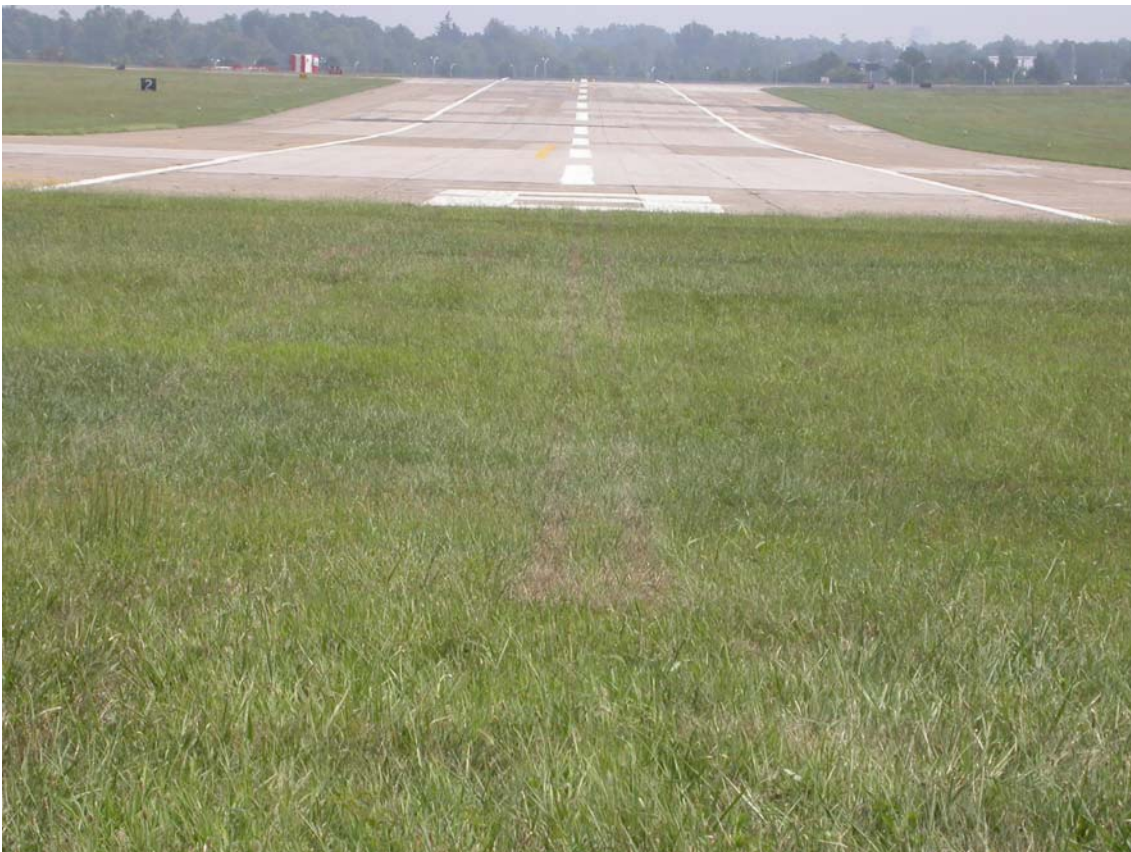
There were no obvious marks or skids found on approximately the last 2000 ft of the accident runway 26. There were three gear marks immediately off the end of the runway, two main and a nose gear. See Figures 1 and 2. Approximately 200 ft off the end of the runway, the nose gear tire mark appeared to become lighter. At approximately 265 ft past the end of the runway, on the crest of a berm, the tire marks disappeared. See Figure 3.

Figure 1: Departure End of Runway 26 Looking Back Towards the East

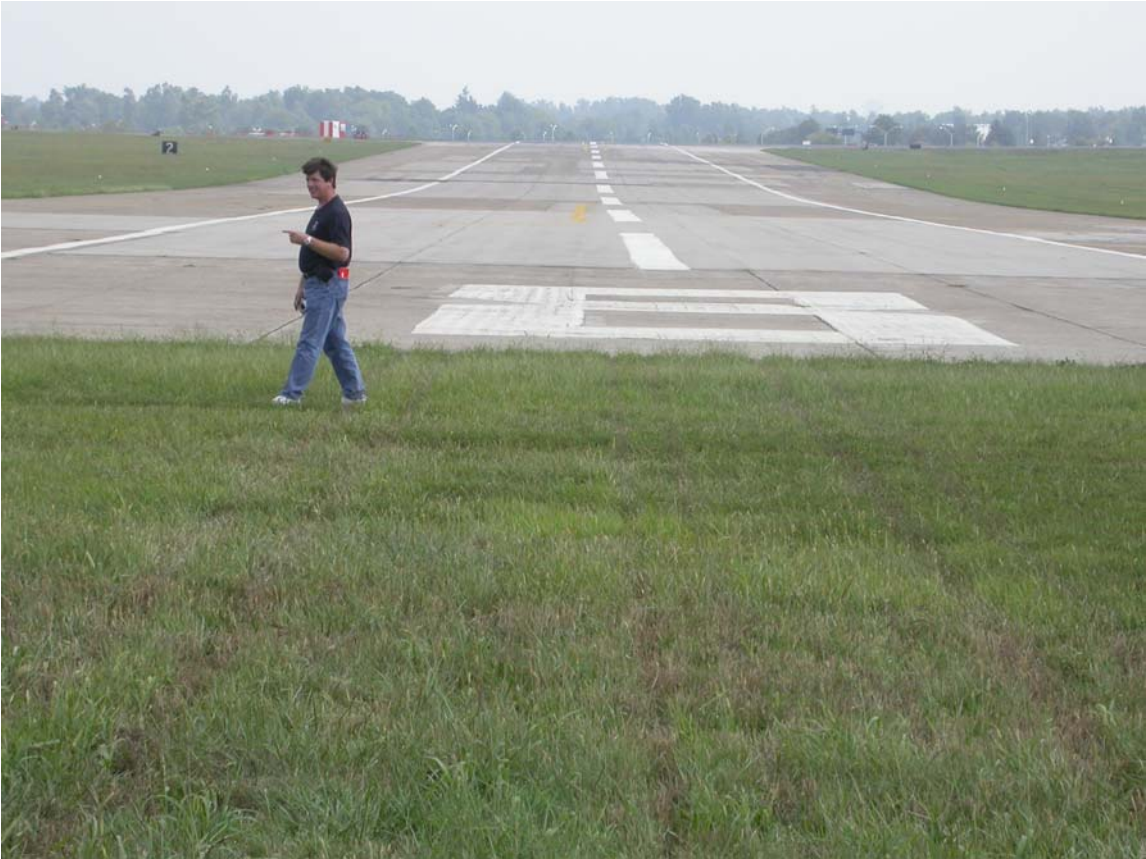
Figure 2: Departure End of Runway 26 Looking East

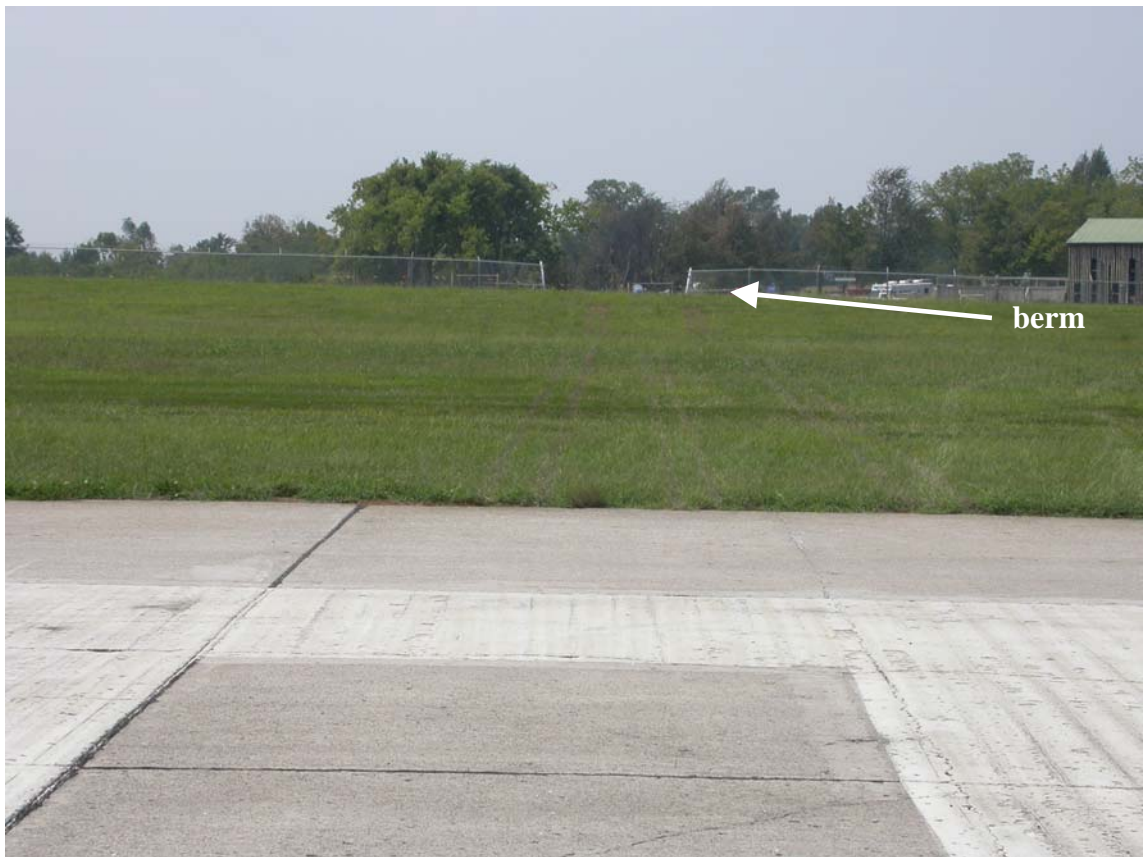
Figure 3: Departure End of Runway 26 Looking West

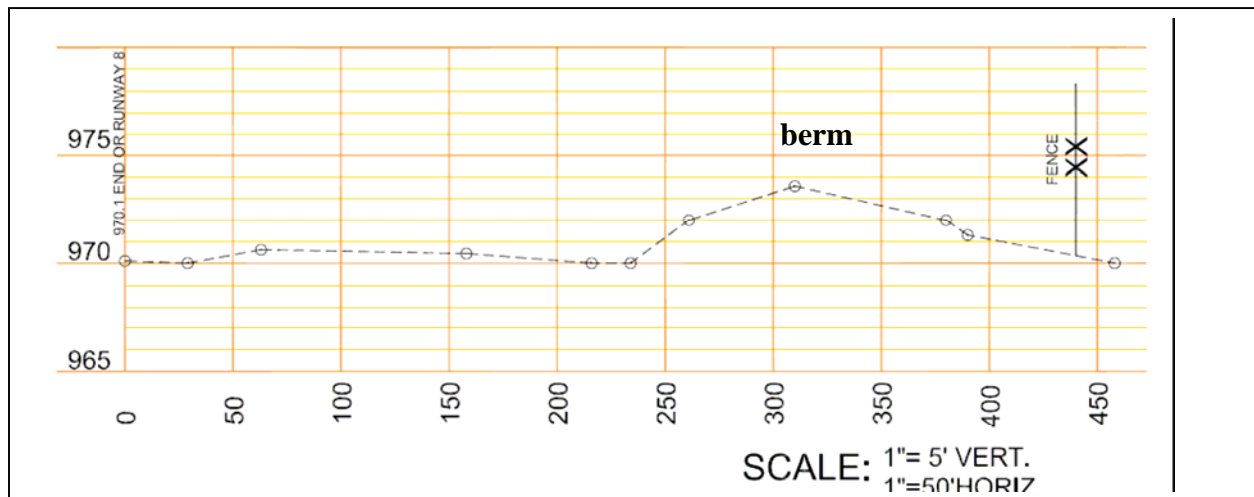
GPS measurements taken by the Systems Group indicate that the crest of the berm is about thirteen feet higher than the end of runway 26. However, a profile view provided by the airport subsequent to the accident and shown in Figure 4 indicates that the crest is only four feet higher than the end of runway 26. While there are discrepancies for the terrain height between the runway end and the berm, both measurements indicate that the height of the berm relative to the immediate terrain is approximately four feet.

Figure 4: Profile View Off End of LEX Runway 26 (view looking south)

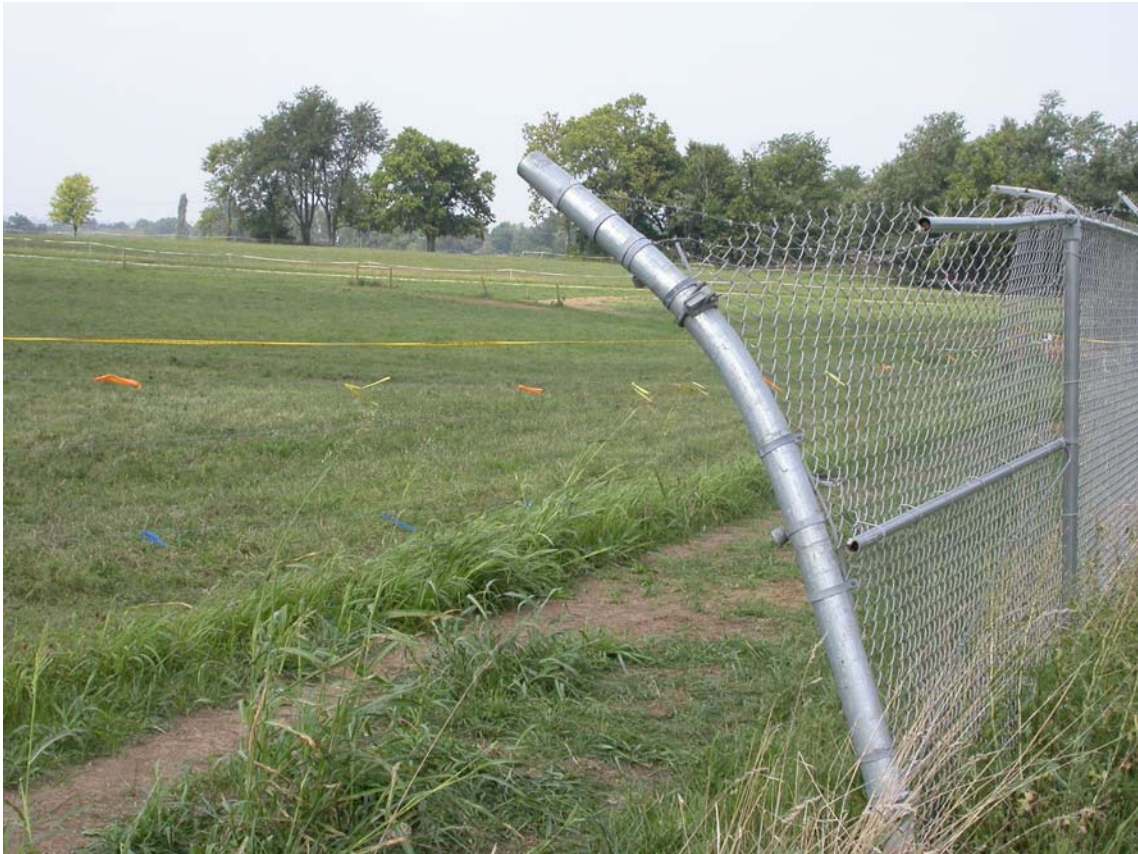
While there were a few smaller pieces of debris found just beyond the berm, no significant wreckage was observed until reaching the airport perimeter fence. The perimeter fence is located about 131 yards off the end of runway 26 and was the next point of impact for Comair Flight 5191. A 15 ft wide gate in the perimeter fence and in-line with the extended centerline of runway 26 was torn from its hinges. Black rubber was found on the top of the detached gate. See Figures 5 and 6.

Figure 5: Perimeter Fence Gate Post Impact Damage

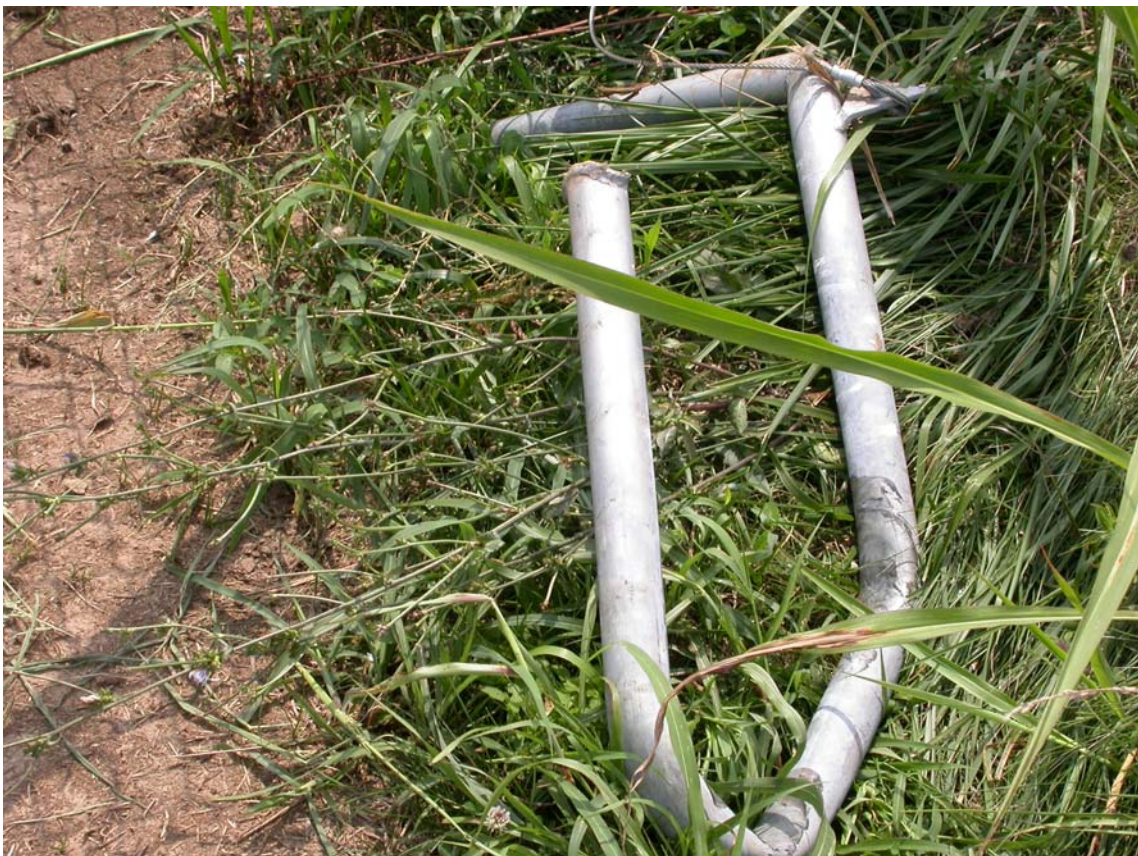
Figure 6: Perimeter Fence Gate Top with Tire Rubber Marks

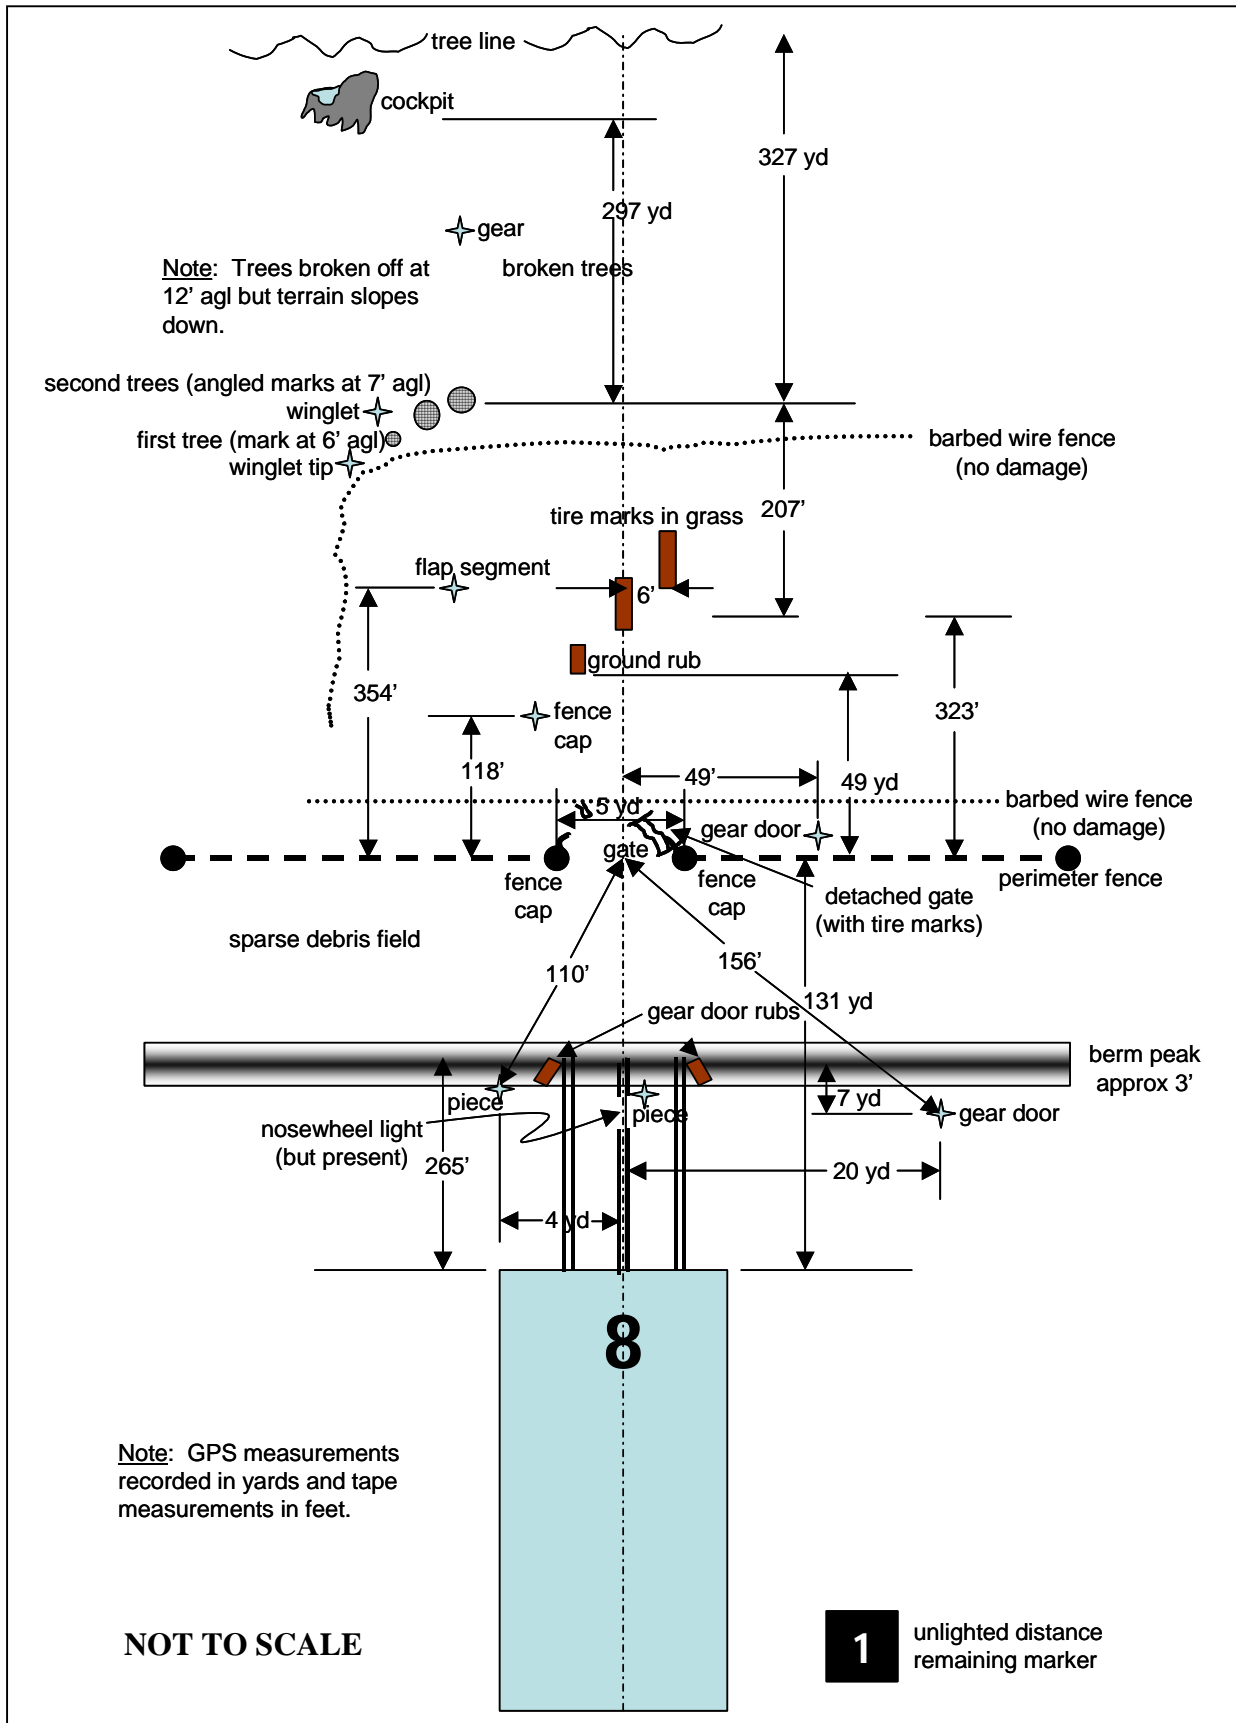
Continuing west, between the airport perimeter fence and the first tree strike, a debris field containing various aircraft pieces, a fence post, a ground rub, and two tire marks was found. The only sizeable aircraft wreckage observed was what appeared to be a segment of the wing flap found approximately 354 ft beyond the perimeter fence and about 50 ft left of the extended runway centerline. (The wreckage had Shorts Drawing No. 60|R|4002-A.) The ground rub was approximately 49 yd beyond the perimeter fence while the two tire marks were beyond that at about 108 yd. Both the ground rub and tire marks were close to the extended runway centerline. In addition, the tire marks appeared to be that of a nose and main with approximately 6 ft separating the two. See Figure 7 for a diagram of the debris field. Attachment 3 contains a copy of the original field sketch.

Figure 7: Sketch of Debris Field

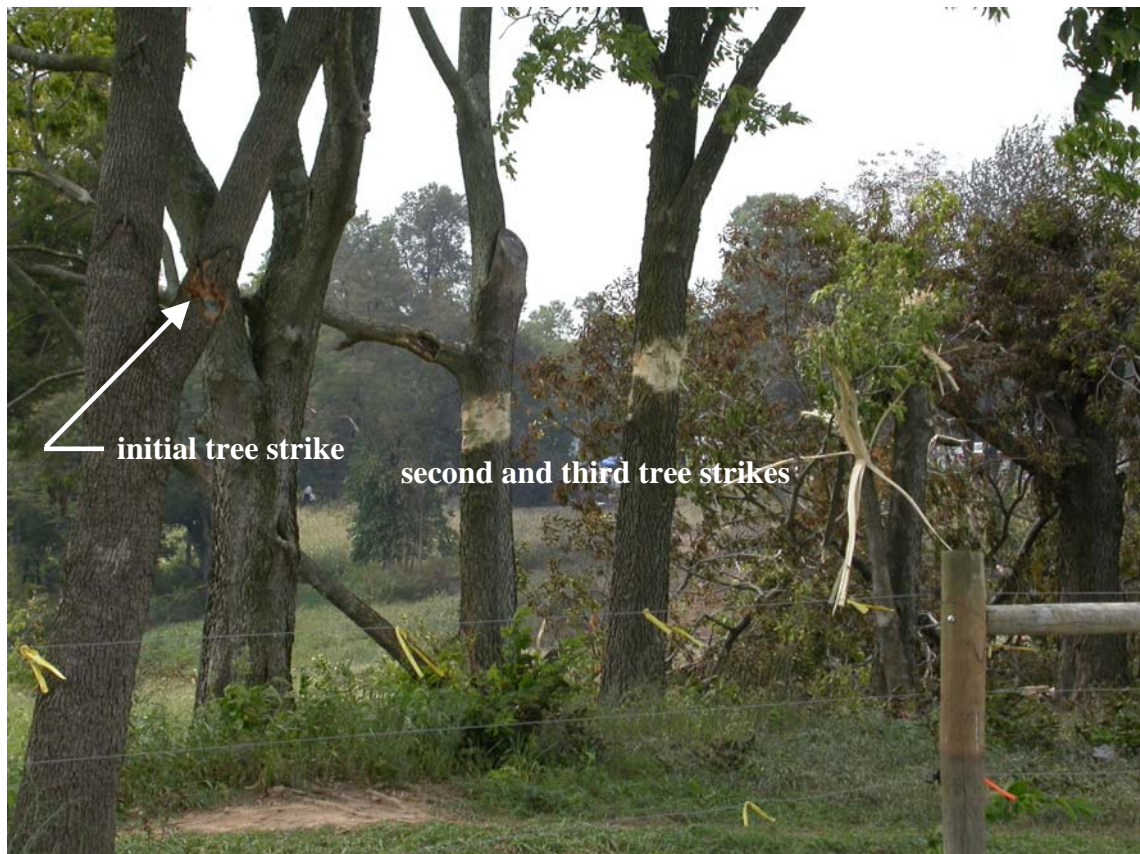
Approximately 920 ft beyond the end of the departure runway is the first observed tree strike. The tree had blue paint markings as well as small pieces of wreckage impregnated in the bark. See Figure 8. The winglet tip was found just forward and to the left of this tree. The left winglet was found just beyond the tree. See Figure 9.

Figure 8: First Tree Strikes

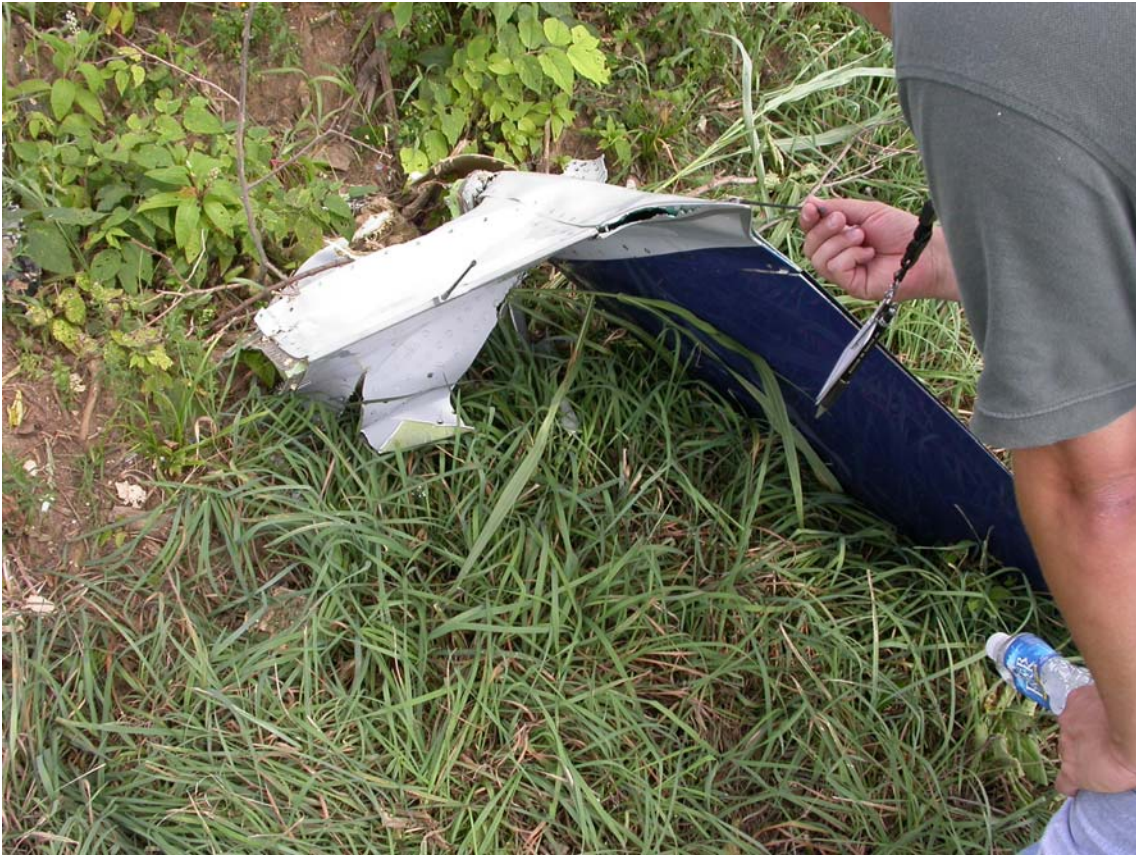
Figure 9: Left Winglet from First Tree Strike
