Boeing Memo and Letter on B-737 Lateral Stability

November 13, 1995
B-XK01-15420-ASI

Subject: Document Request- USAir 737-300 N513AU Accident Near
Pittsburgh - September 8, 1994

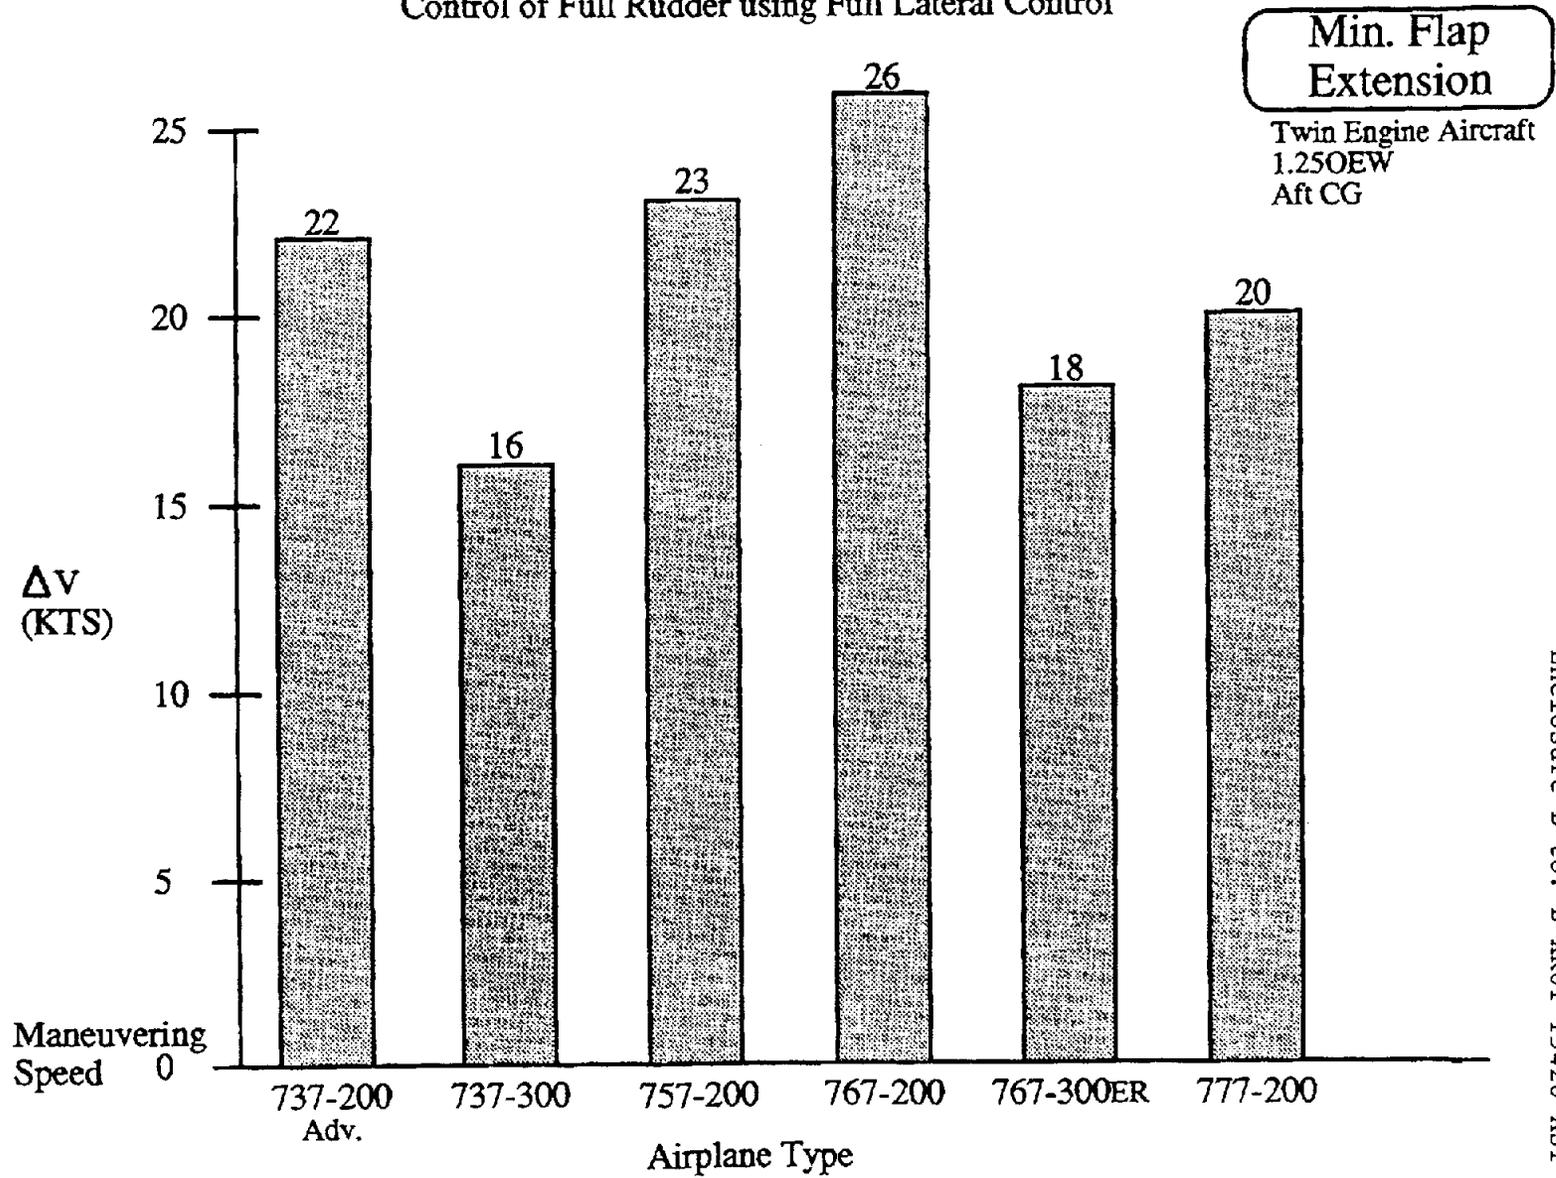
Fleet Status Relative to Static Balance

The speed margin of the 737-300 over its recommended maneuvering speed is very similar relative to the other twin engine aircraft in the Boeing fleet at their minimum flaps down setting as shown in enclosure B. While data is not available at this time for non-Boeing aircraft in this category, there is no reason to believe other aircraft are much different.

Control of Full Rudder using Full Lateral Control
