# National Transportation Safety Board

## Airplane Performance Study

Location: Gaithersburg, MD  
Date: December 8, 2014  
Time: 1041 EST  
Airplane: Embraer EMB-500 Phenom 100, Registration N100EQ  
NTSB Number: DCA15MA029

DCA15MA029, Embraer EMB-500 Phenom 100, N100EQ , 12/8/2014

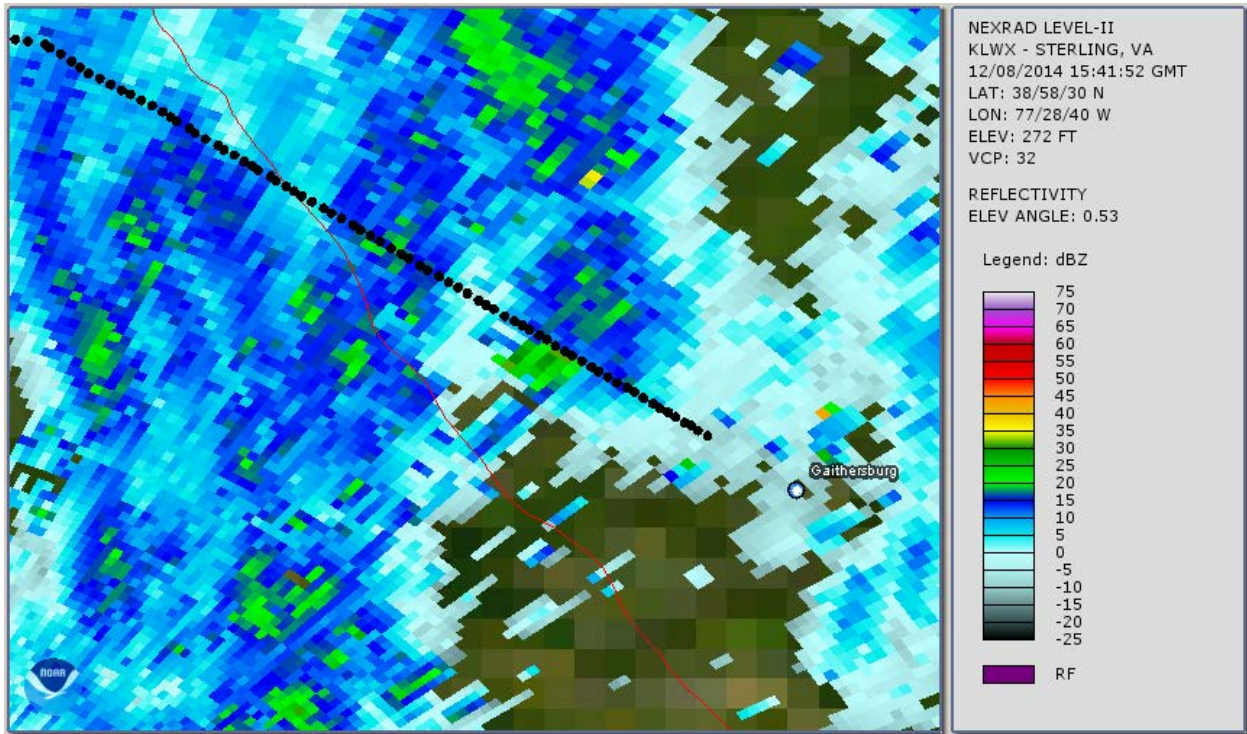
Figure 3: NEXRAD Radar Image at 1541 GMT/1041 EST

Figures 3 and 4 show weather radar at the time of or shortly after the accident. The radar echoes in the figures combined with the flight track (shown in Figures 5 and 6) indicate that N100EQ was in instrument meteorological conditions (IMC) until approximately one mile from GAI and also in conditions that were favorable for structural icing for at least ten minutes during the approach. Multiple jet air carriers in the vicinity of the accident site reported icing conditions in the clouds with cloud tops ranging from 4,300 ft to 5,500 ft above mean sea level (msl). In addition, four minutes after the accident, there was another pilot report (PIREP) from a regional turboprop pilot who was encountering moderate mixed icing between 4,000 ft and 5,000 ft msl.

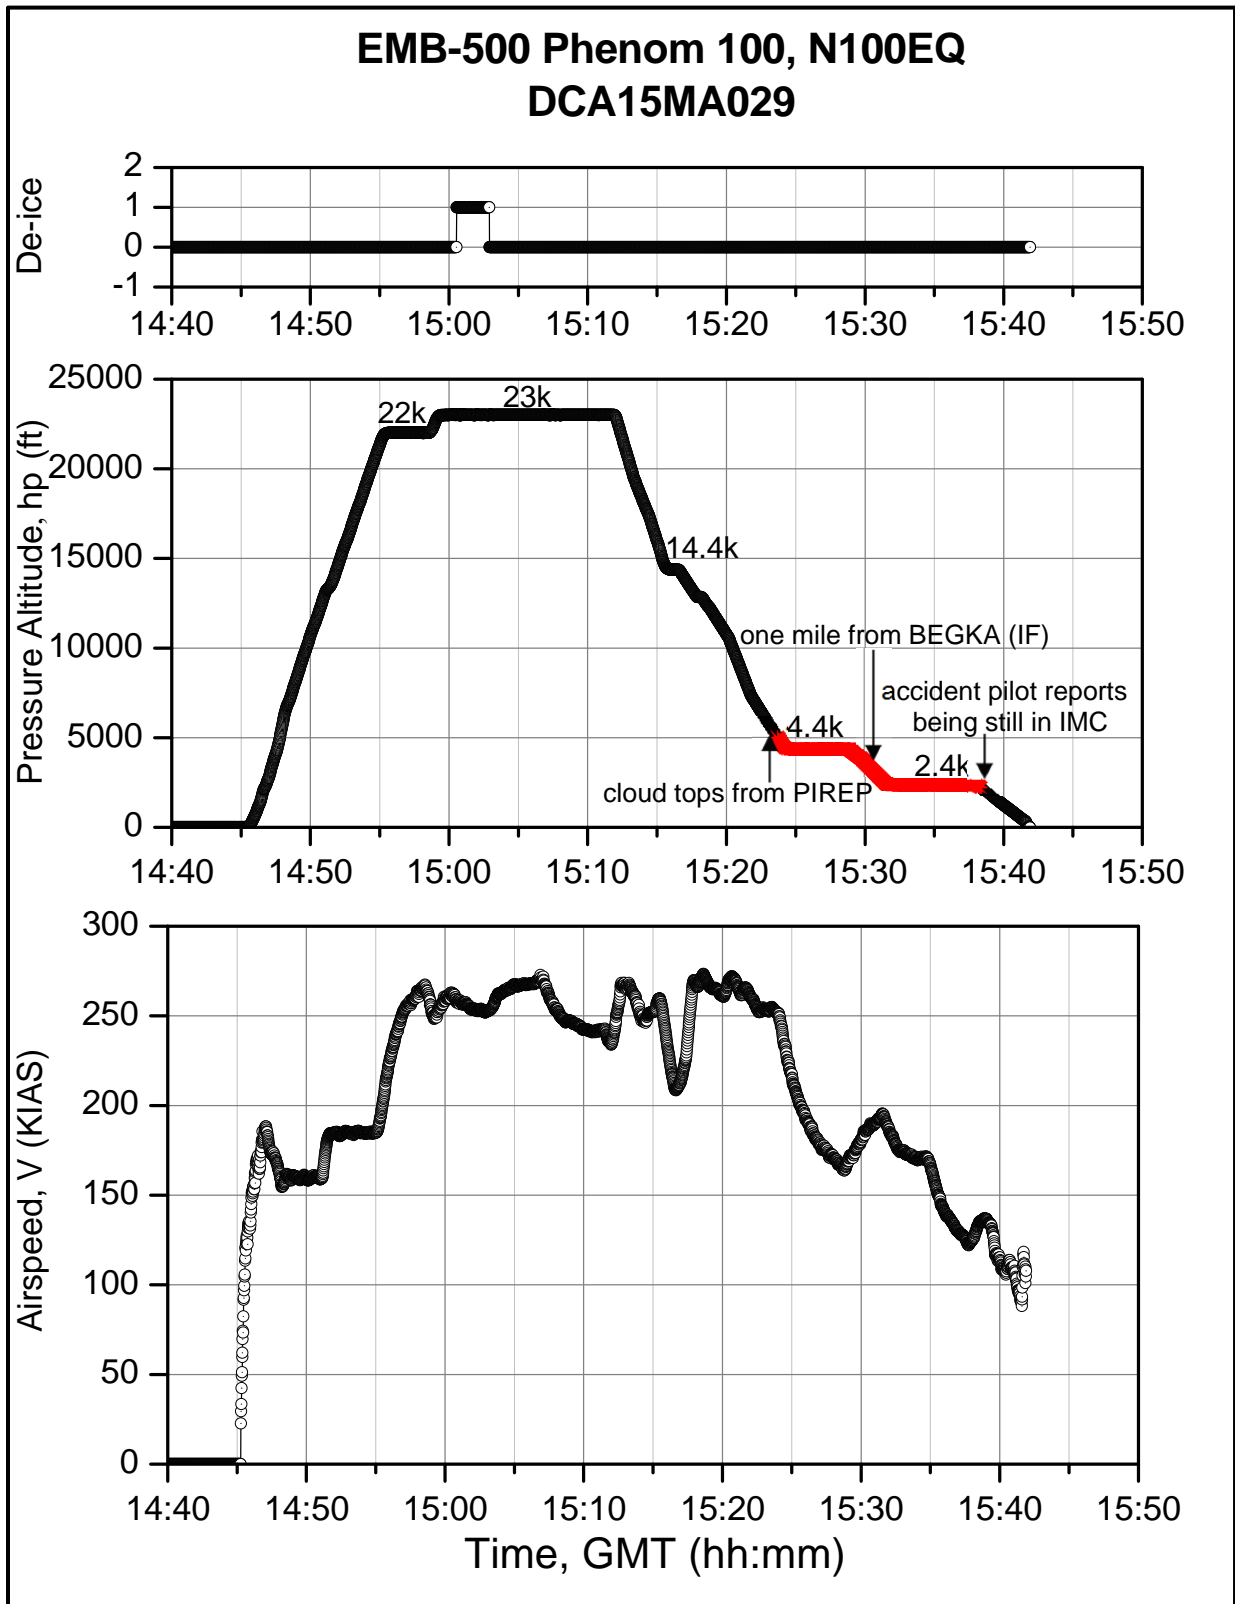
**Figure 9: N100EQ Speed and Altitude Profile with Likely Ice Encounter in Red**

Figures 9 and 10 show the speed and altitude profiles for the accident flight captured on the CVDR. The de-ice discrete from the CVDR indicates that de-ice was selected for 2 min 23 sec upon reaching a cruising altitude of 23,000 ft but then remained off for the rest of the flight. Figure 9 also highlights (in red) the portion of the flight where the airplane likely entered the clouds and encountered structural icing during the approach (based on PIREPs of cloud tops and the presence of ice). The airplane entered the clouds around 15:23:41 at 5,500 ft msl and, at 15:38:27 while descending through 2,700 ft msl, the pilot reported being in IMC. That puts the airplane in visible moisture, an essential element for ice, for approximately 15 min.

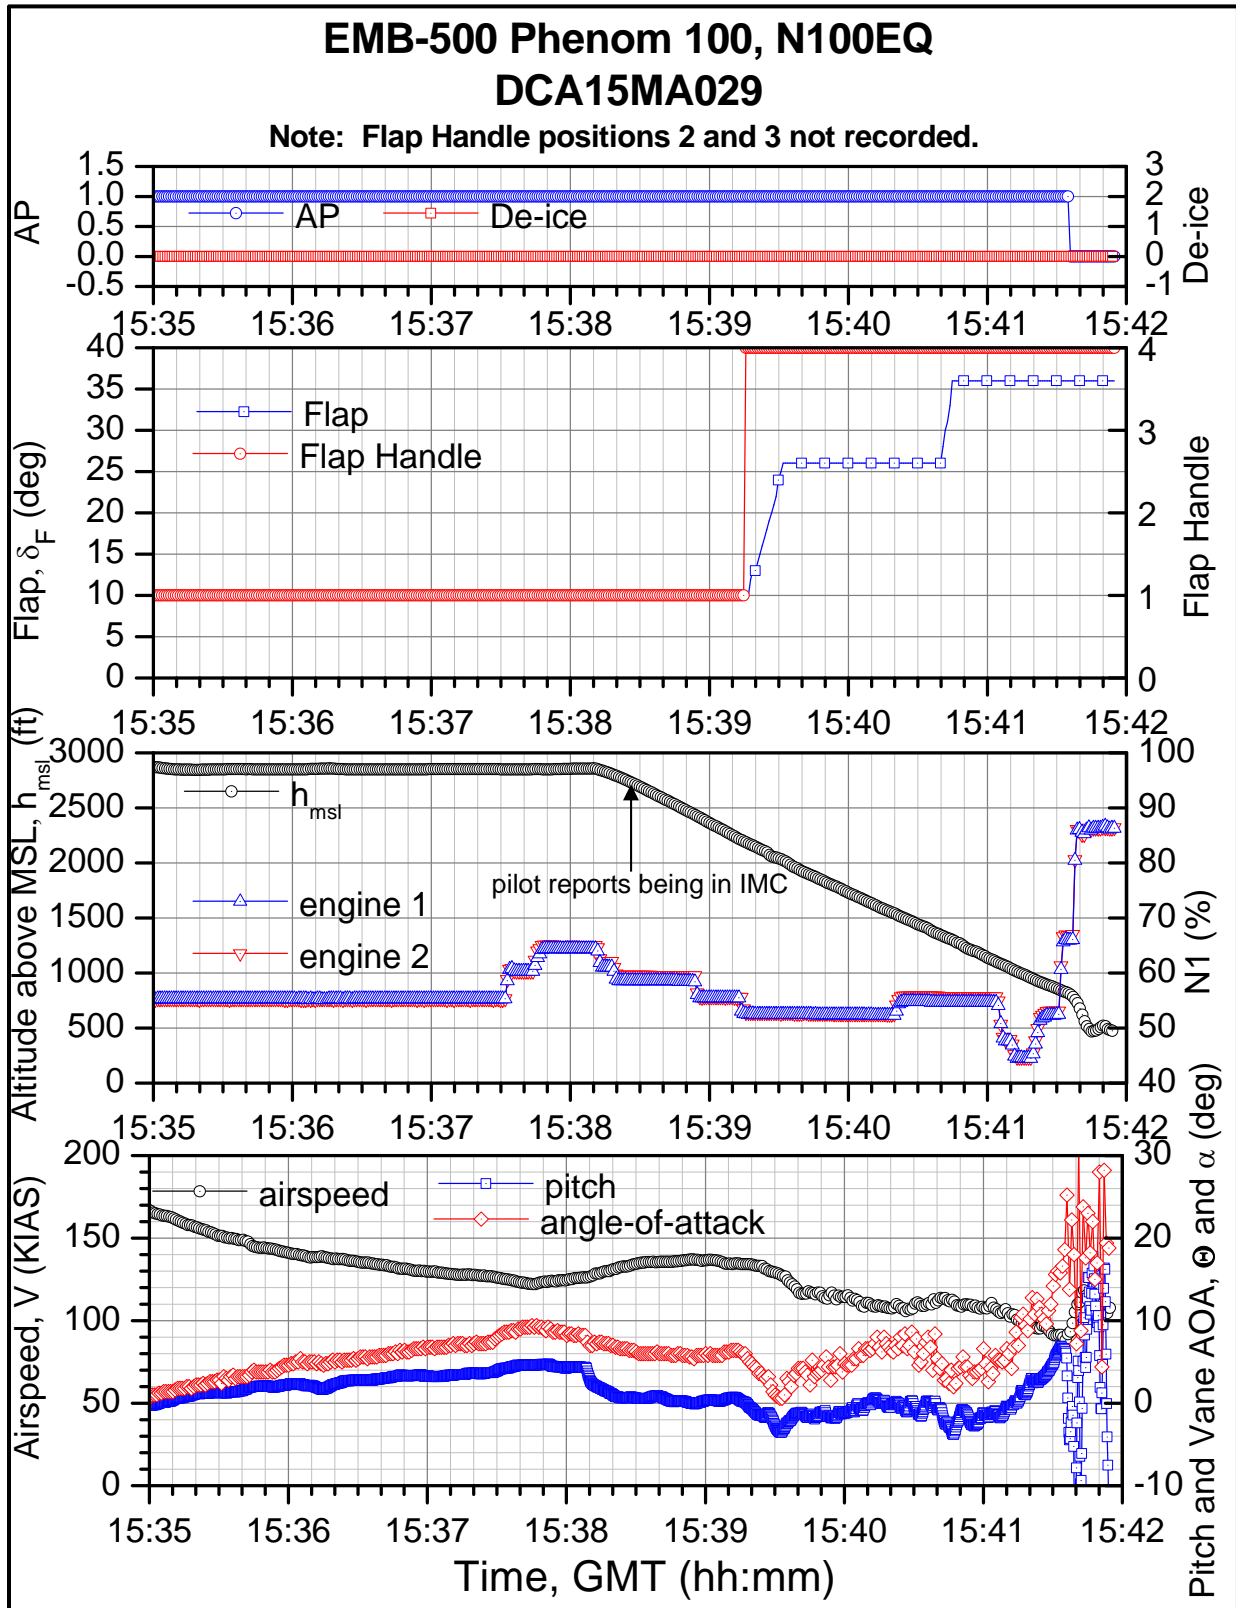
Figure 11: Altitude and Speed for Last Seven Minutes of Flight

Figure 11 indicates that the majority of the approach was uneventful with the autopilot on until the last 20 sec of the recording<sup>3</sup>. At 15:41:36, the autopilot disengaged when the aural stall warning system sounded with the airplane altitude at just over 800 ft msl. The airspeed had decayed from an initial airspeed of 166 kt at 15:35:00 to a speed of 88 kt, 6.6 min later<sup>4</sup>. Angle-of-attack (AOA) increased from 0.80 deg at 15:35:00 to 21 deg when the autopilot disengaged.

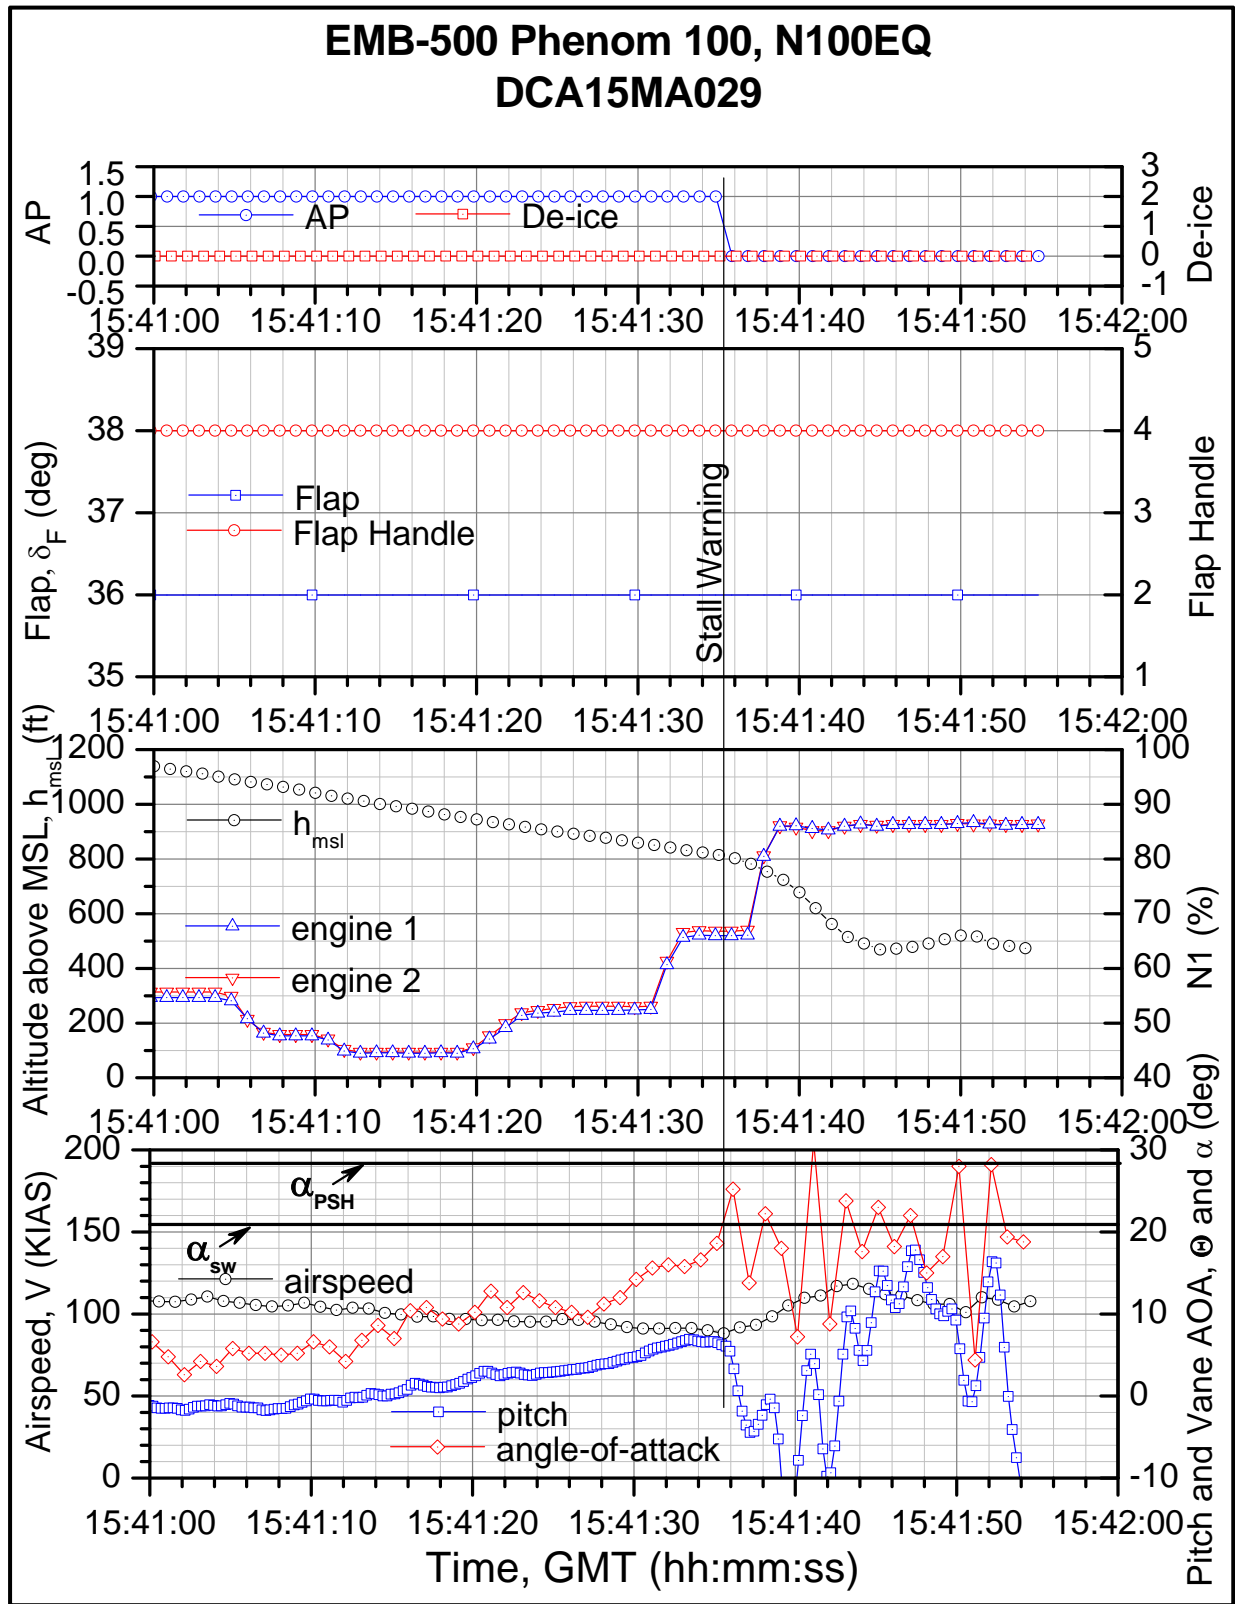
Figure 12: Altitude and Speed for Last Minute of Flight

Figure 12 highlights the last minute of recorded data for the same altitude, airspeed, and AOA parameters shown in Figure 10. The first aural stall warning occurred at 15:41:36 and at a vane AOA of 21 deg, and the data indicate that it likely sounded seven more times before the recording ended. (The figure also shows that the stick pusher AOA of 28.4 deg was reached at least once and possibly as many as three times before the recording ended; however, stick pusher is not a recorded parameter, and a final determination as to whether the stick pusher activated could not be made.) Finally, the recorded engine fan speed, N1, increased from 45% at 15:41:20 to 67% at 15:41:36 when the aural stall warning system first triggered. The fan speed continued to climb to a peak of 86% at 15:41:39 where it remained until the end of the recording at 15:41:55. (See the “Phenom 100 Stall Warning System” section below for a more complete description of the stall warning and stick pusher thresholds.)

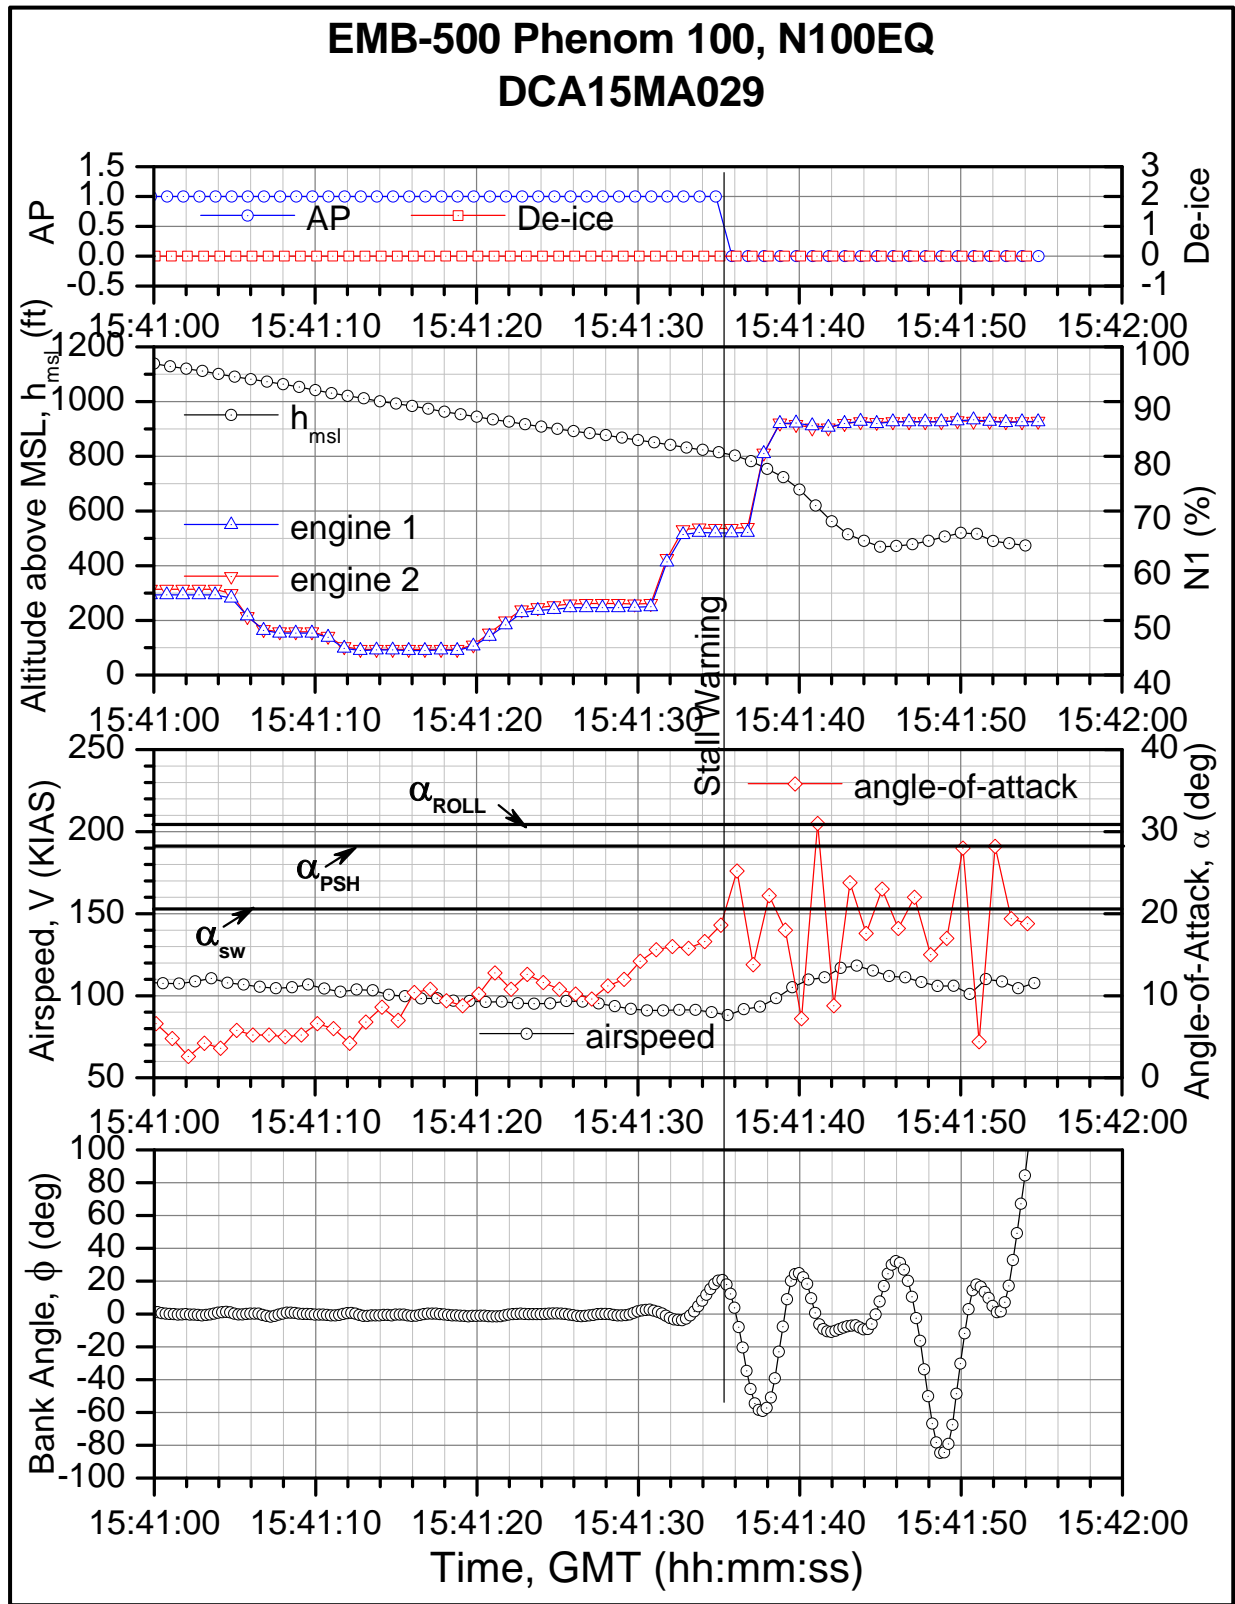
Figure 13: Bank Angle for Last Minute of Flight

Figure 13 shows the bank angle for the last minute of the recording. Two seconds before the first aural stall warning, the airplane started to bank to the right. The airplane reached a bank angle of 21° before the aural stall warning sounded, and the airplane then quickly rolled left to 59°. The airplane went through a series of (roll) oscillations over the next 14 sec before rolling to over 100° to the right when the recording ended. The CVDR did not record elevator position so the pilot’s control response to the stall warning could not be determined. However, the airplane did pitch down following the first stall warning.

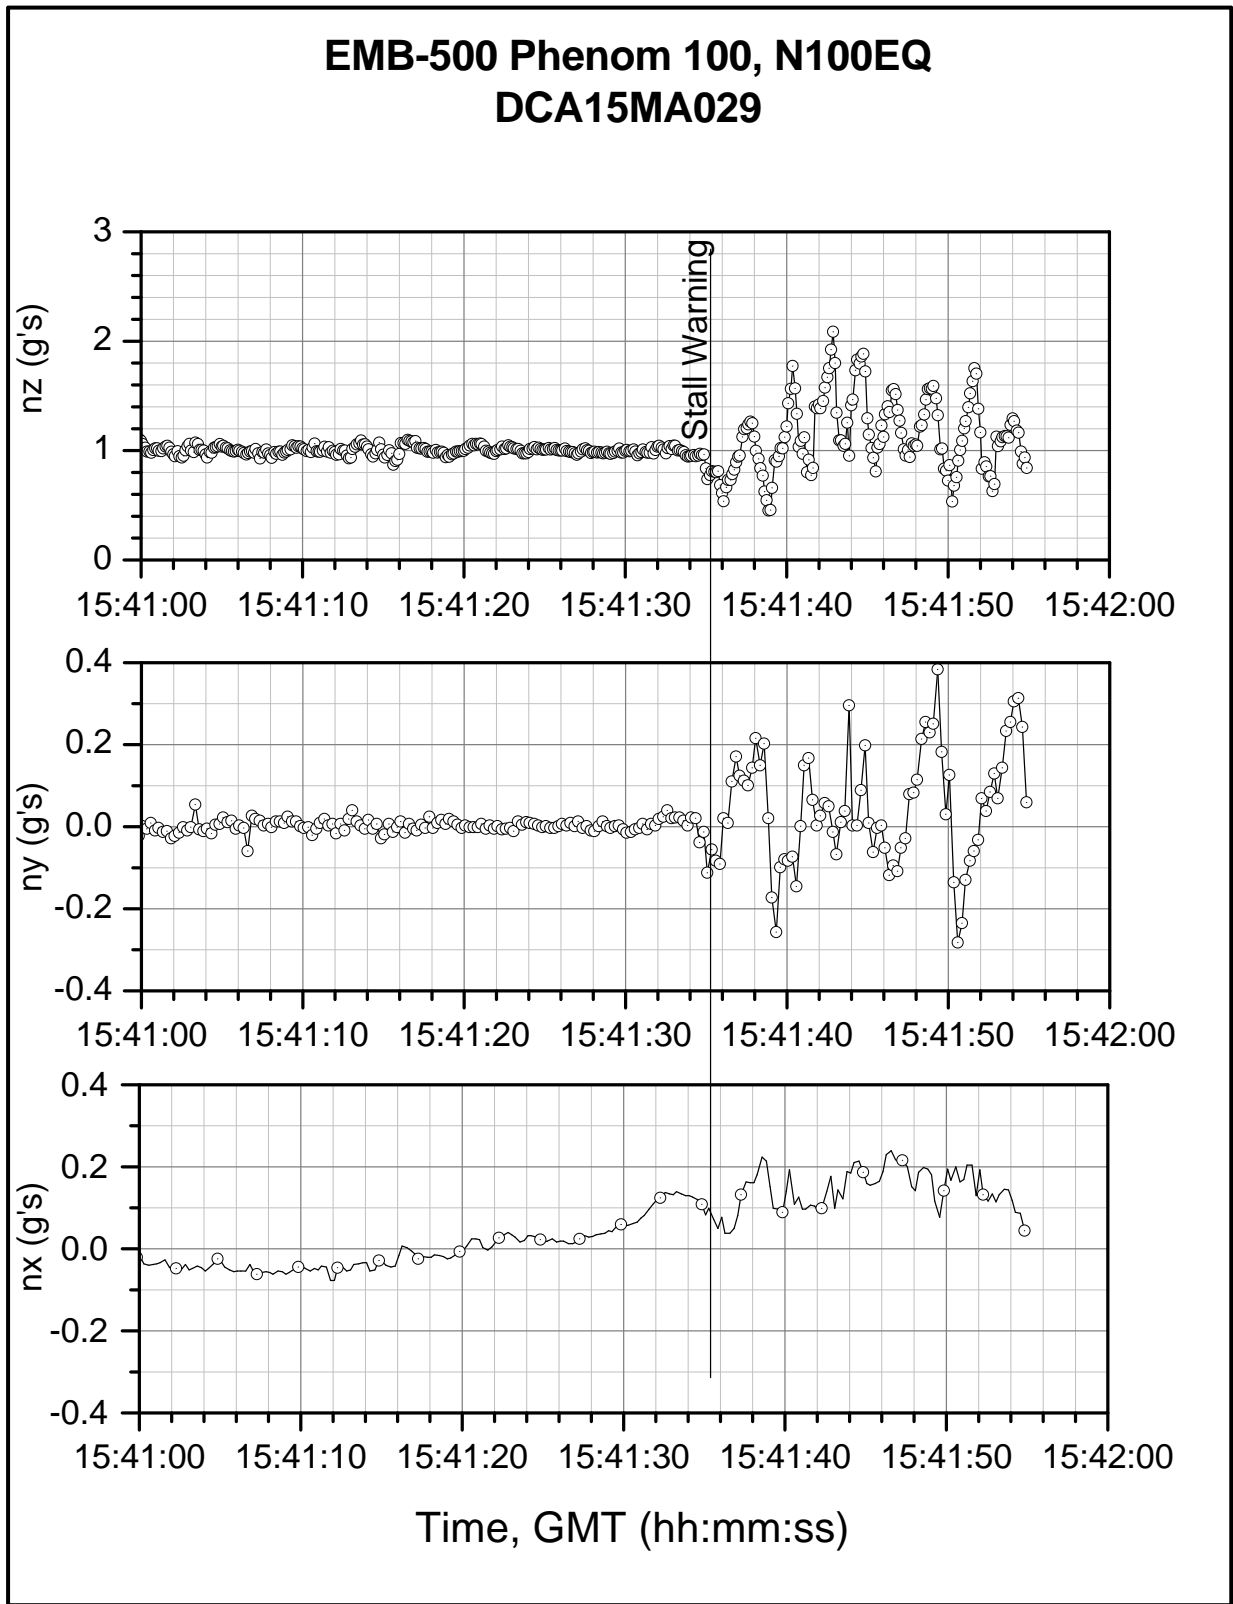
Figure 14: Load Factor for Last Minute of Flight

Figure 14 is a plot of the load factors during the last minute of recorded data. The normal load factor,  $n_z$ , shows a stall break at 15:41:35, less than one second before the aural stall warning and autopilot disconnect. Figure 15 shows the same stall break along with the pitch break that follows. (Figure 15 also highlights the difference between vane angle-of-attack, which is used by the stall warning system, and body angle-of-attack shown in blue<sup>5</sup>.)

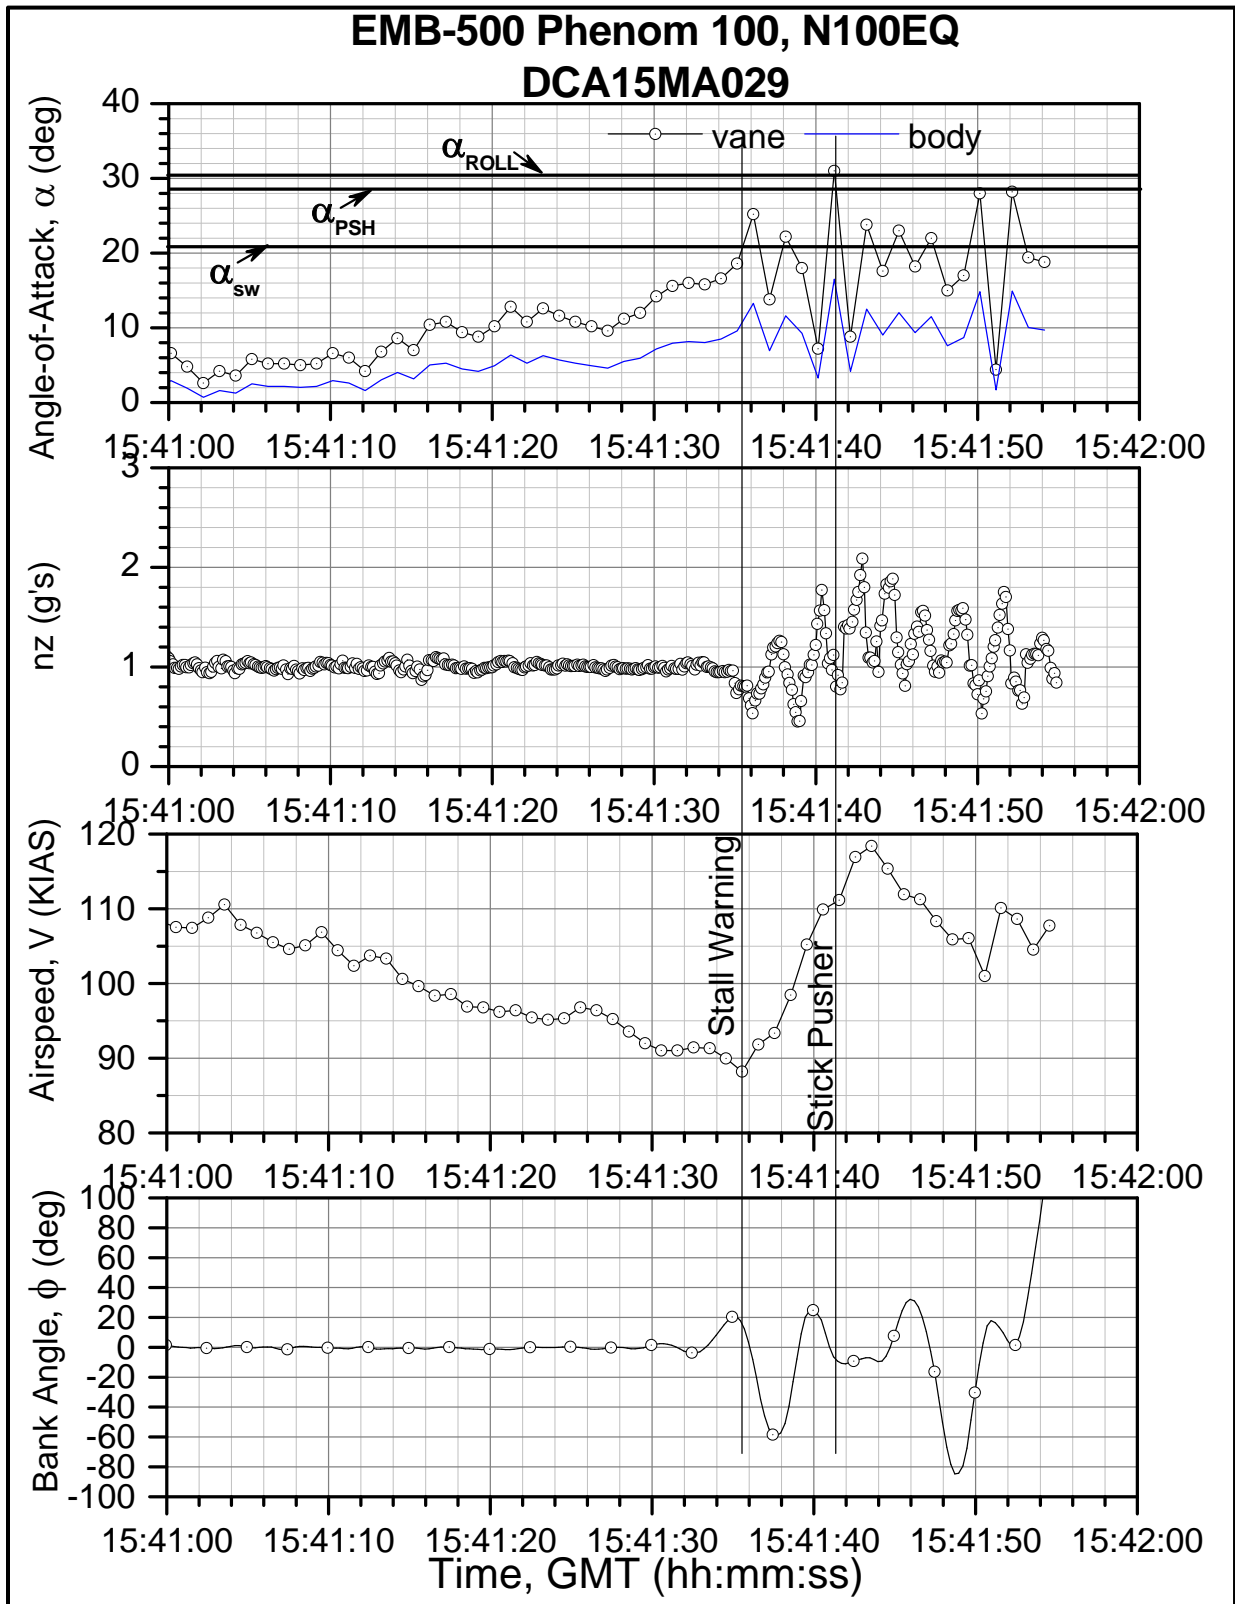
Figure 16: Bank Angle with  $n_z$  Stall Break

Figure 16 again shows the  $n_z$  stall break but with bank angle. Because of the different sample rates between load factor and bank, the exact bank angle at the break could not be determined. However, the airplane was rolling to the right with the autopilot still engaged at the stall break.

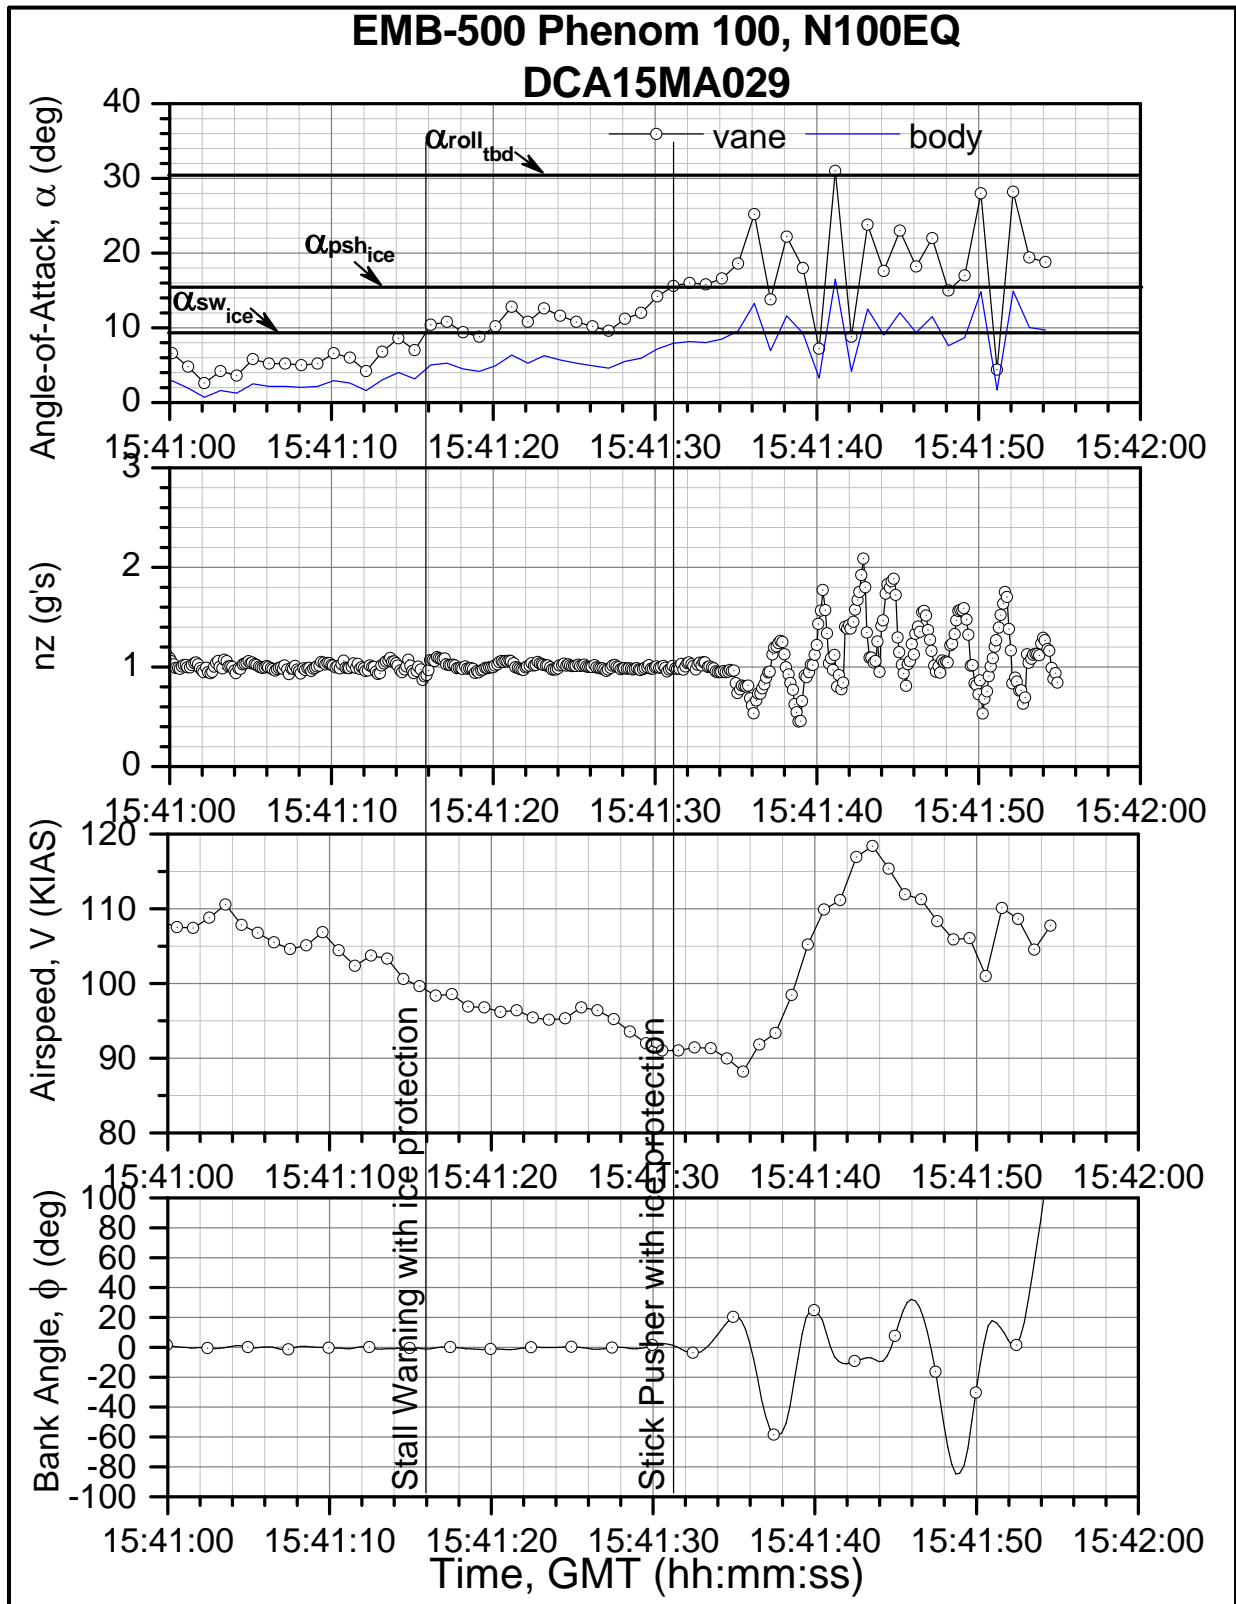
Figure 17: Bank Angle with  $n_z$  Stall Break, Wing/Stabilizer De-ice On Stall Thresholds

Figure 17 repeats Figure 16 but instead shows the stall warning and stick pusher AOA thresholds with the ice protection system turned on. This is only an estimate because the recorded data in Figure 17 are with the ice protection system turned off, and the thresholds shown in the figure are with the ice protection system turned on. Nevertheless, comparing Figures 16 and 17 shows that the aural stall warning would have sounded approximately 20 sec sooner, and the stick pusher would have activated about 10 sec sooner had the ice protection system been turned on during the approach into Gaithersburg.

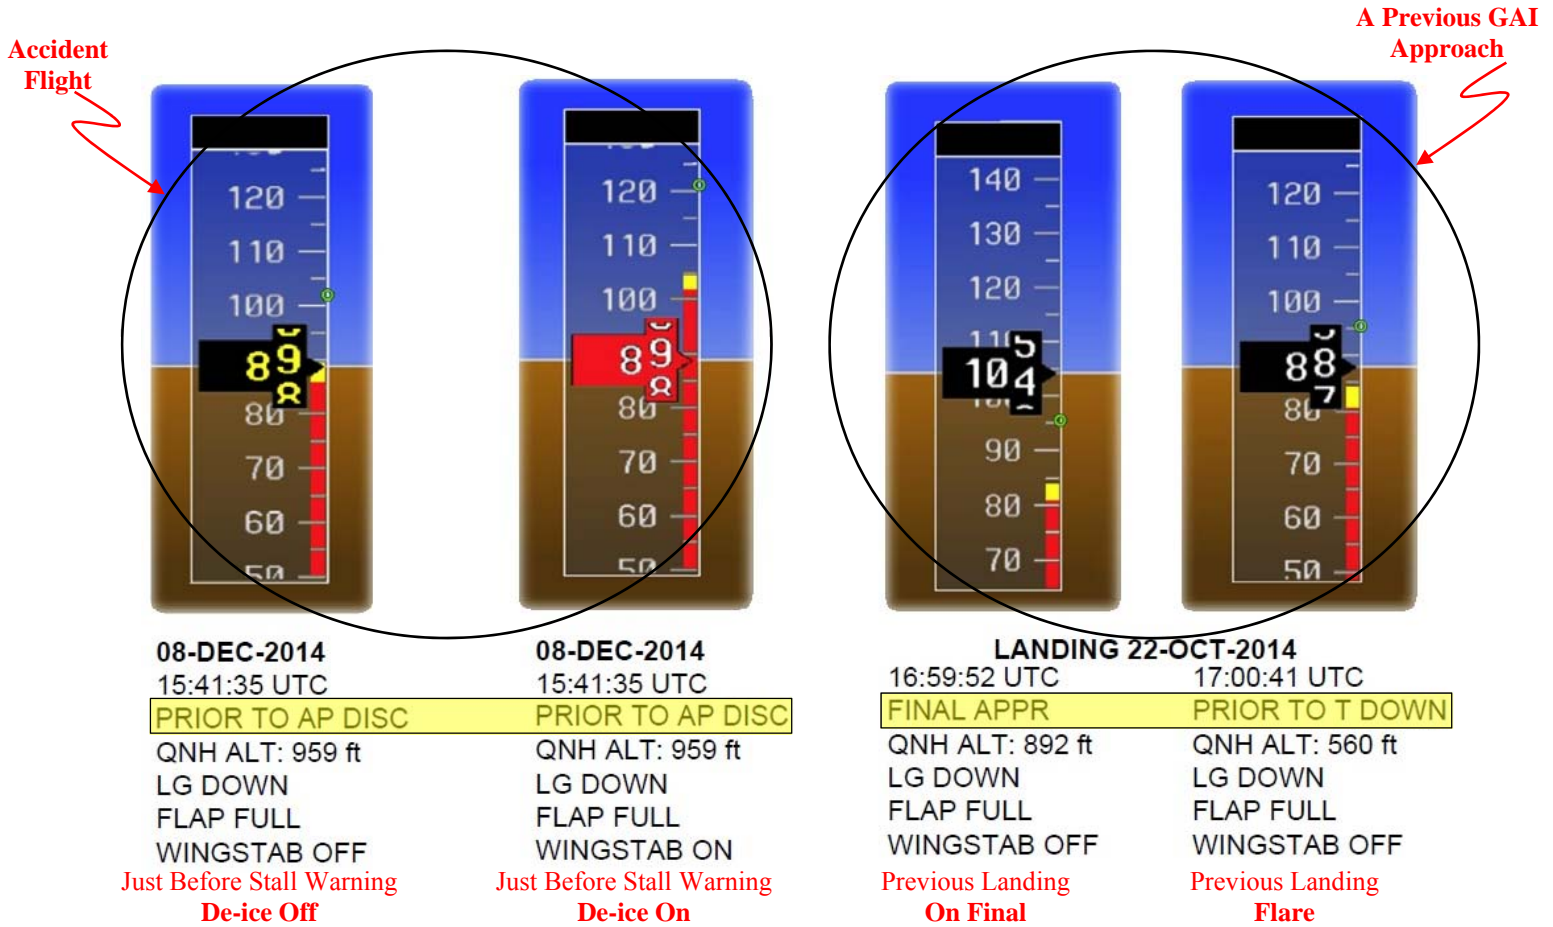
**Figure 18: Embraer EMB-500 Phenom 100 Low Speed Awareness Tape Simulations**

Figure 18 is a simulation of the Phenom 100’s low speed awareness tape for three approaches into Gaithersburg: two at the accident flight conditions, with and without ice protection (the two tapes on the left), and one from a previous landing at GAI on 10/22/14 but at different points in the approach (the two tapes on the right). Note that “QNH ALT” in the figure is the same as “MSL ALT”.

Comparing the first two tapes in the figure highlights what the low speed awareness system would have done had the ice protection system been selected during the accident approach. The first tape simulates the actual flight with the pilot slowing into the yellow (band) and close to the top of the red aural stall warning (at approximately 88 KIAS). The second tape, on the other hand, shows that the aural stall warning would have sounded earlier (at over 100 KIAS) if the ice protection system had been selected. This would have disconnected the autopilot and potentially given the pilot more time to recover.

Next in the figure, data from a 10/22/14 approach into Gaithersburg are used to simulate what might typically be seen by the accident pilot on the low speed awareness tape while landing Gaithersburg (but in the opposite direction on the 4,202 ft runway 32). The two tapes are from two different points on the approach with the ice protection system turned off. The first shows the airplane at 372 ft above the runway touchdown zone and 104 KIAS or about 23 kt above the aural stall warning. The second tape and the last one in the figure shows the airplane at an altitude of about 40 ft above the touchdown zone and approximately 7 kt above the aural stall warning.

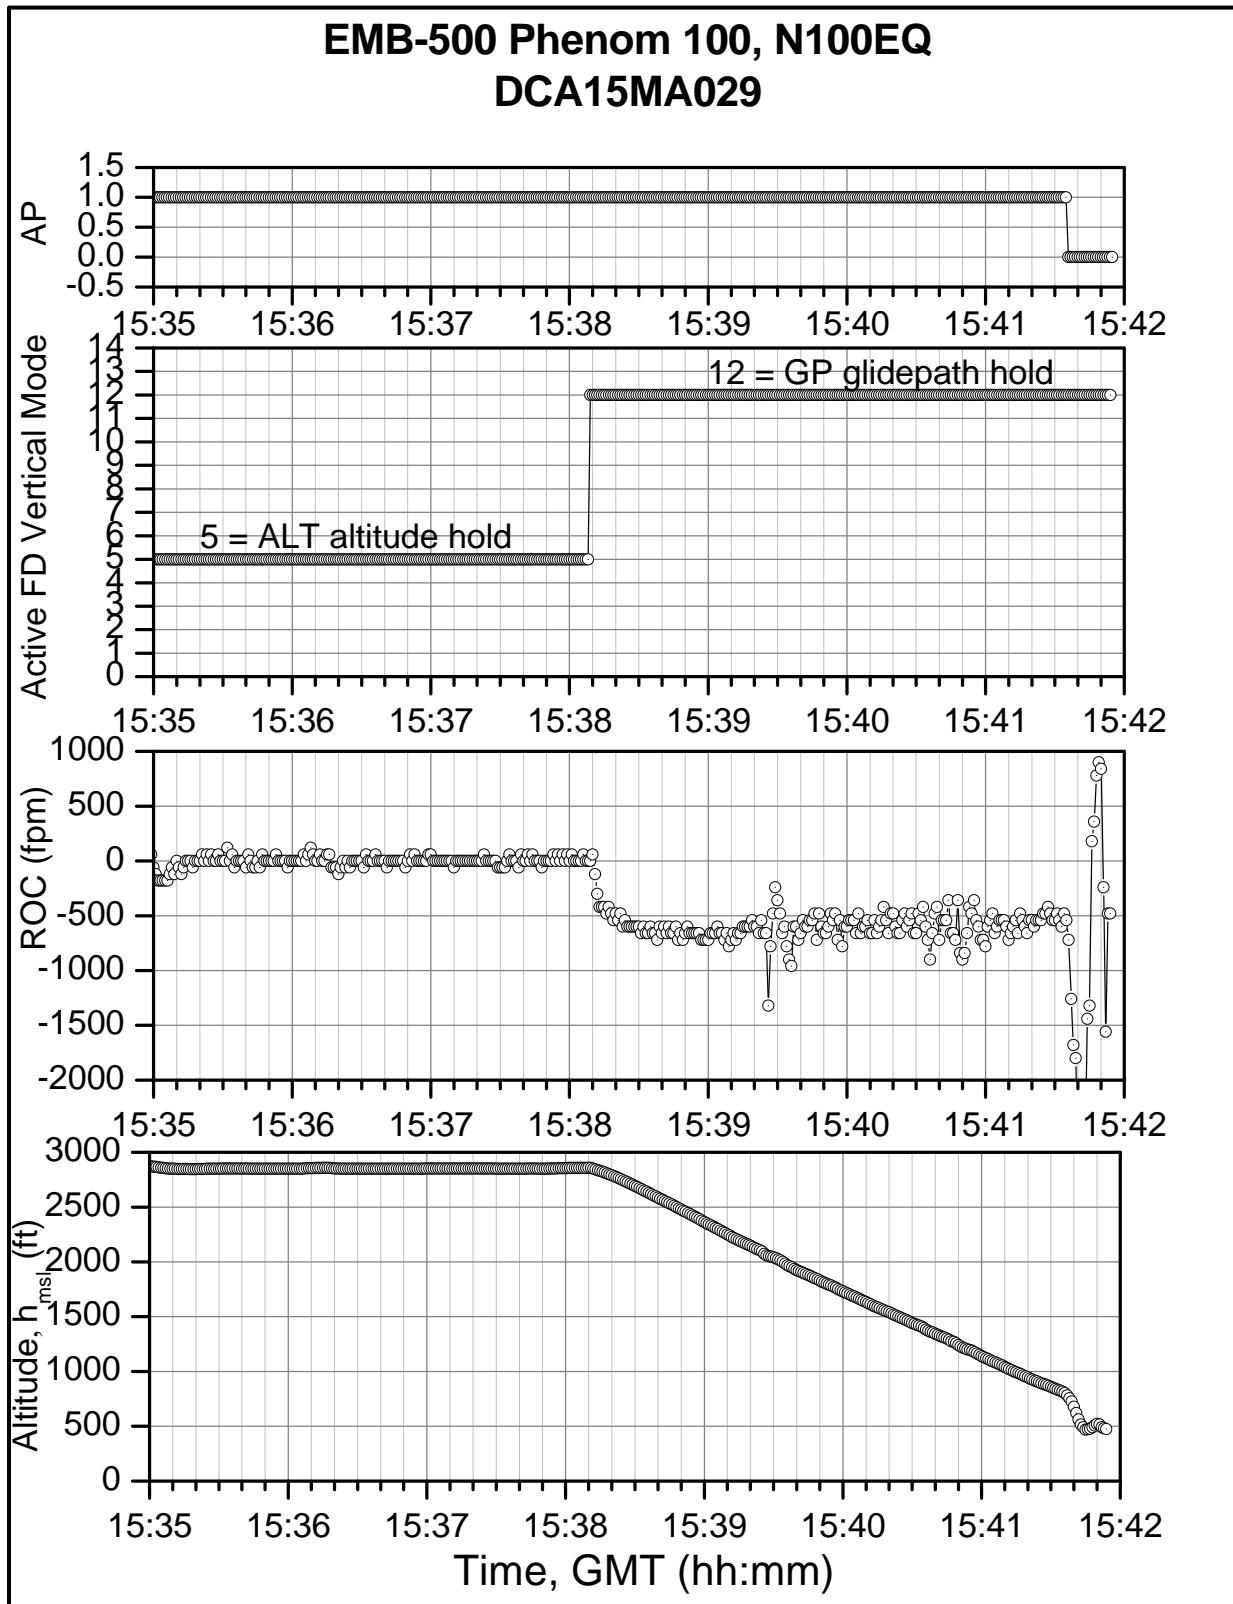
Figure 20: Active Flight Director Vertical Modes During the Approach

Figure 20 highlights the active Flight Director vertical modes during the approach. The Garmin GFC 700 was initially holding an altitude of 2,850 ft msl just outside of the Initial Approach Fix TIMBE (FD/APR/ALT). This is denoted by an Active Flight Director Vertical Mode of 5 in the figure. When the airplane intercepted the glidepath at 15:38:09, a descent rate of approximately 600 ft/min was commanded by the AFCS to track the glidepath (FD/APR/GP). This is denoted by an Active Flight Director Vertical Mode of 12 in the figure. Note: The AFCS commands elevator to control glidepath; the Phenom 100 does not have an autothrottle, and it is up to the pilot to command power as necessary to maintain the appropriate airspeed.

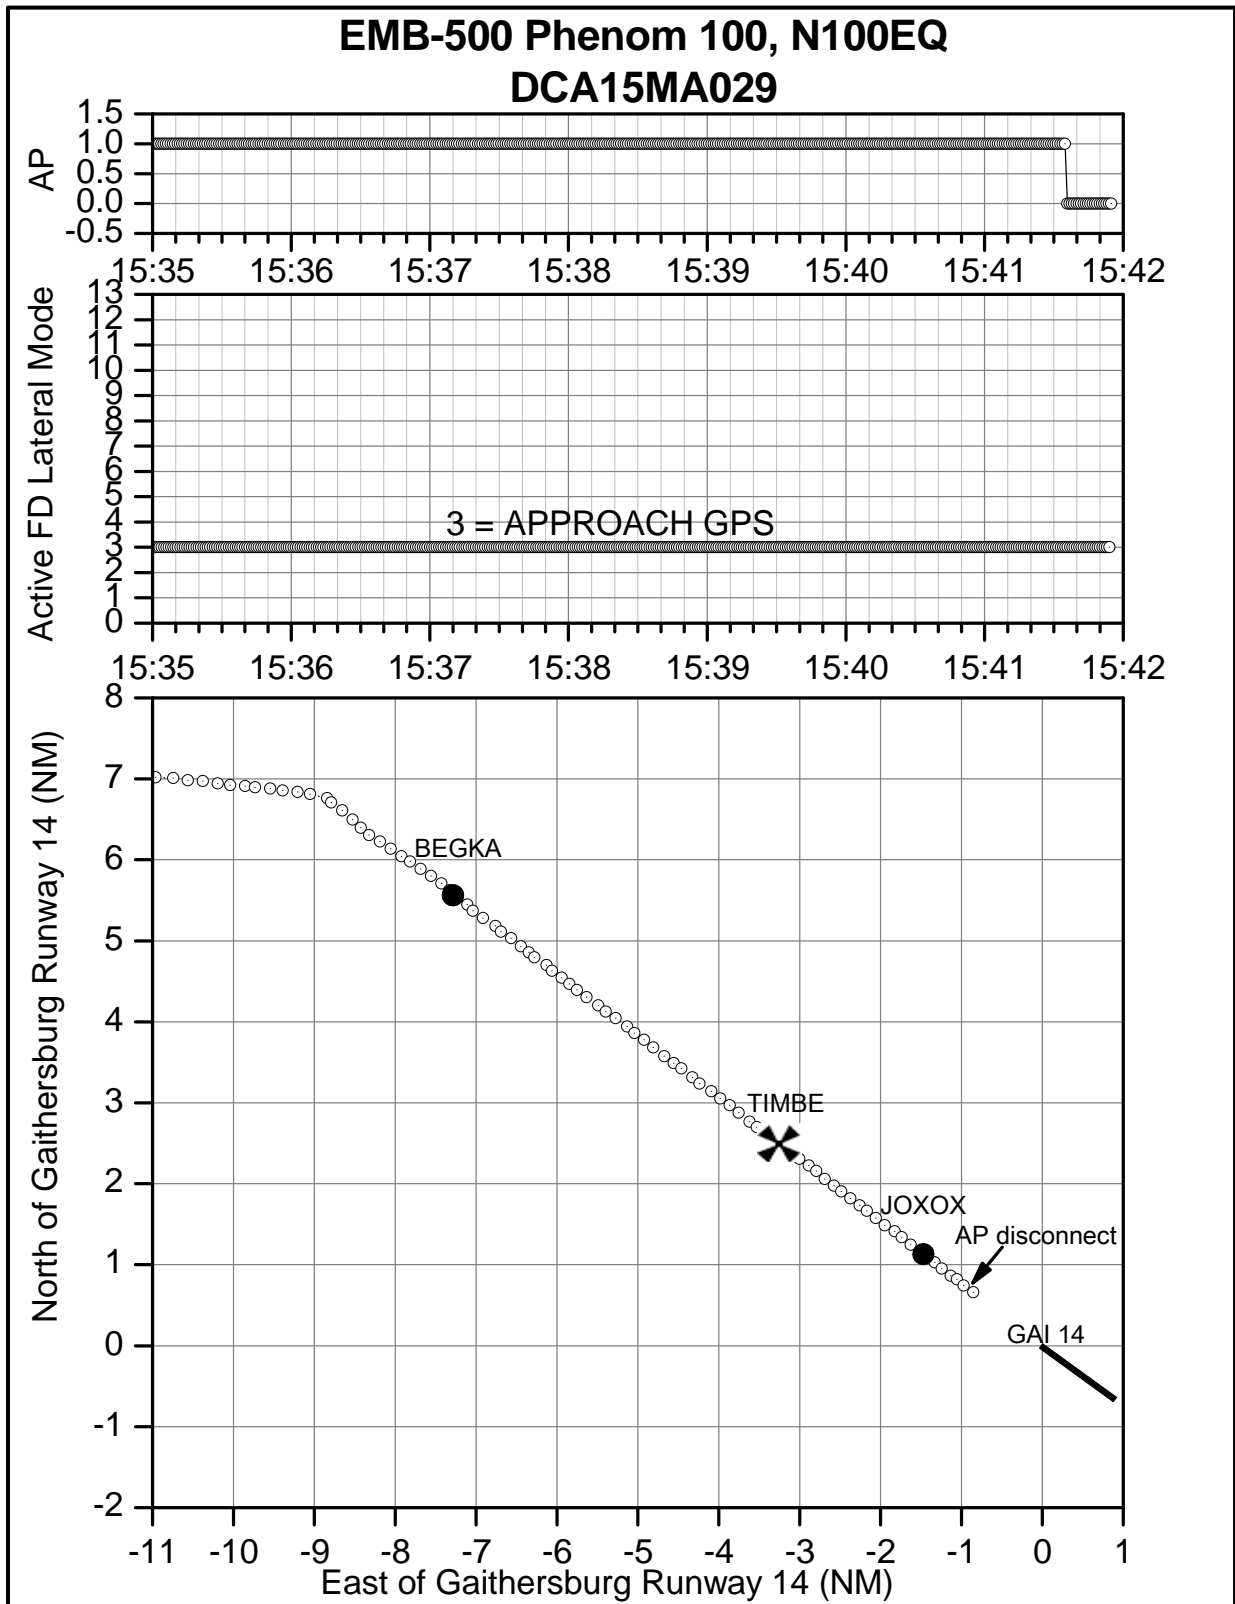
**Figure 21: Active Flight Director Lateral Mode During the Approach**  
 (note: Ground track from radar. Waypoint locations are approximate.)

Figure 21 highlights the active Flight Director lateral mode during the approach. The autopilot was tracking the GPS waypoints contained on the approach plate shown in Figure 7 (BEGKA, TIMBE, JOXOX, 50 ft threshold crossing, touchdown) using the Wide Area Augmentation System (WAAS) GPS signal (FD/APR/GPS). This is denoted by an Active Flight Director Lateral Mode of 3 in the figure.
