National Transportation Safety Board

Performance Study

Specialist Report

Location: Zaleski, Ohio
Date: January 29, 2019
Time: 0650 EST
Airplane: Bell 407, N191SF
NTSB Number: CEN19FA072

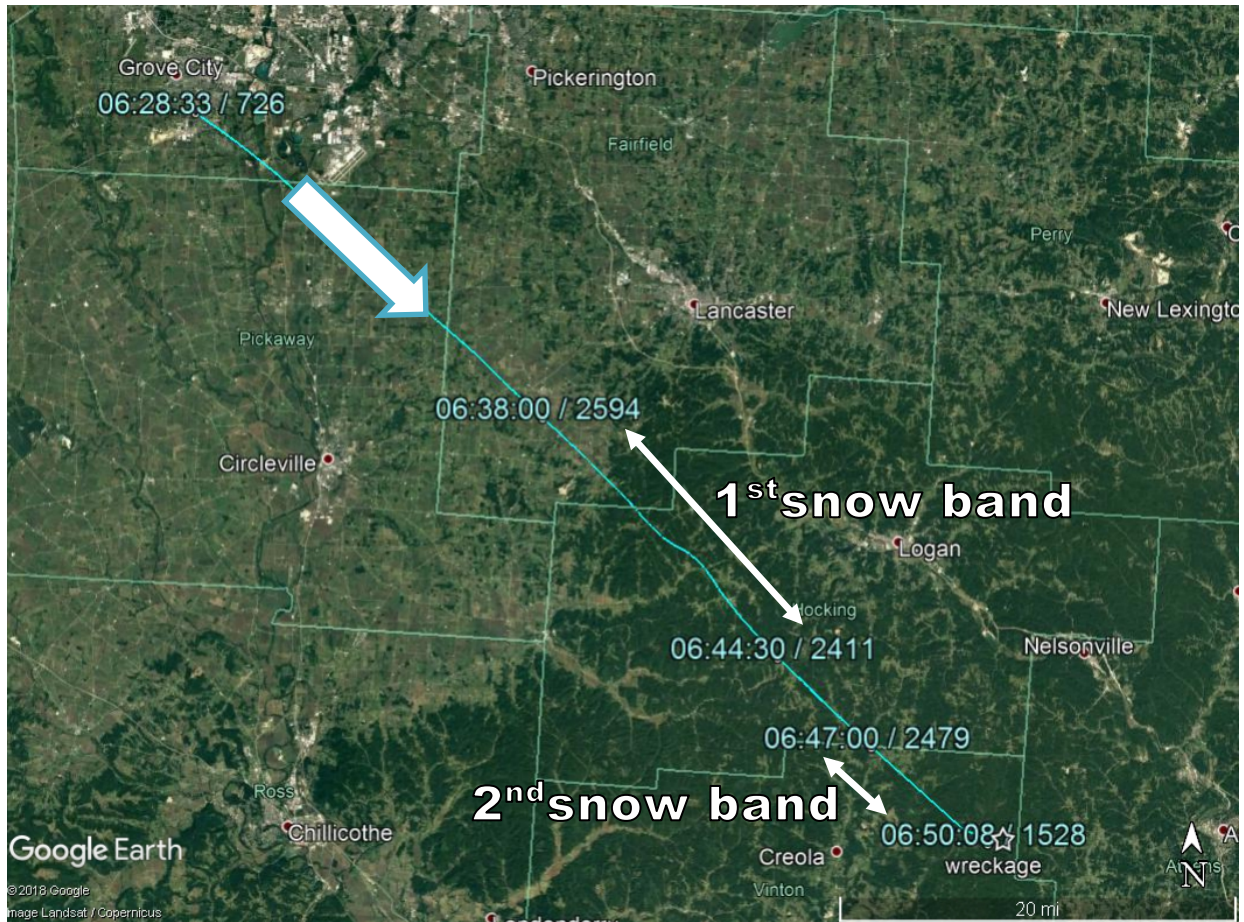
Figure 1 shows the accident flight path with the portions of the flight when snow was encountered annotated. The flight path was approximately 55 miles long and lasted about 22 minutes.

Figure 1. Accident flight path. The annotations indicate the time and the altitude (MSL).

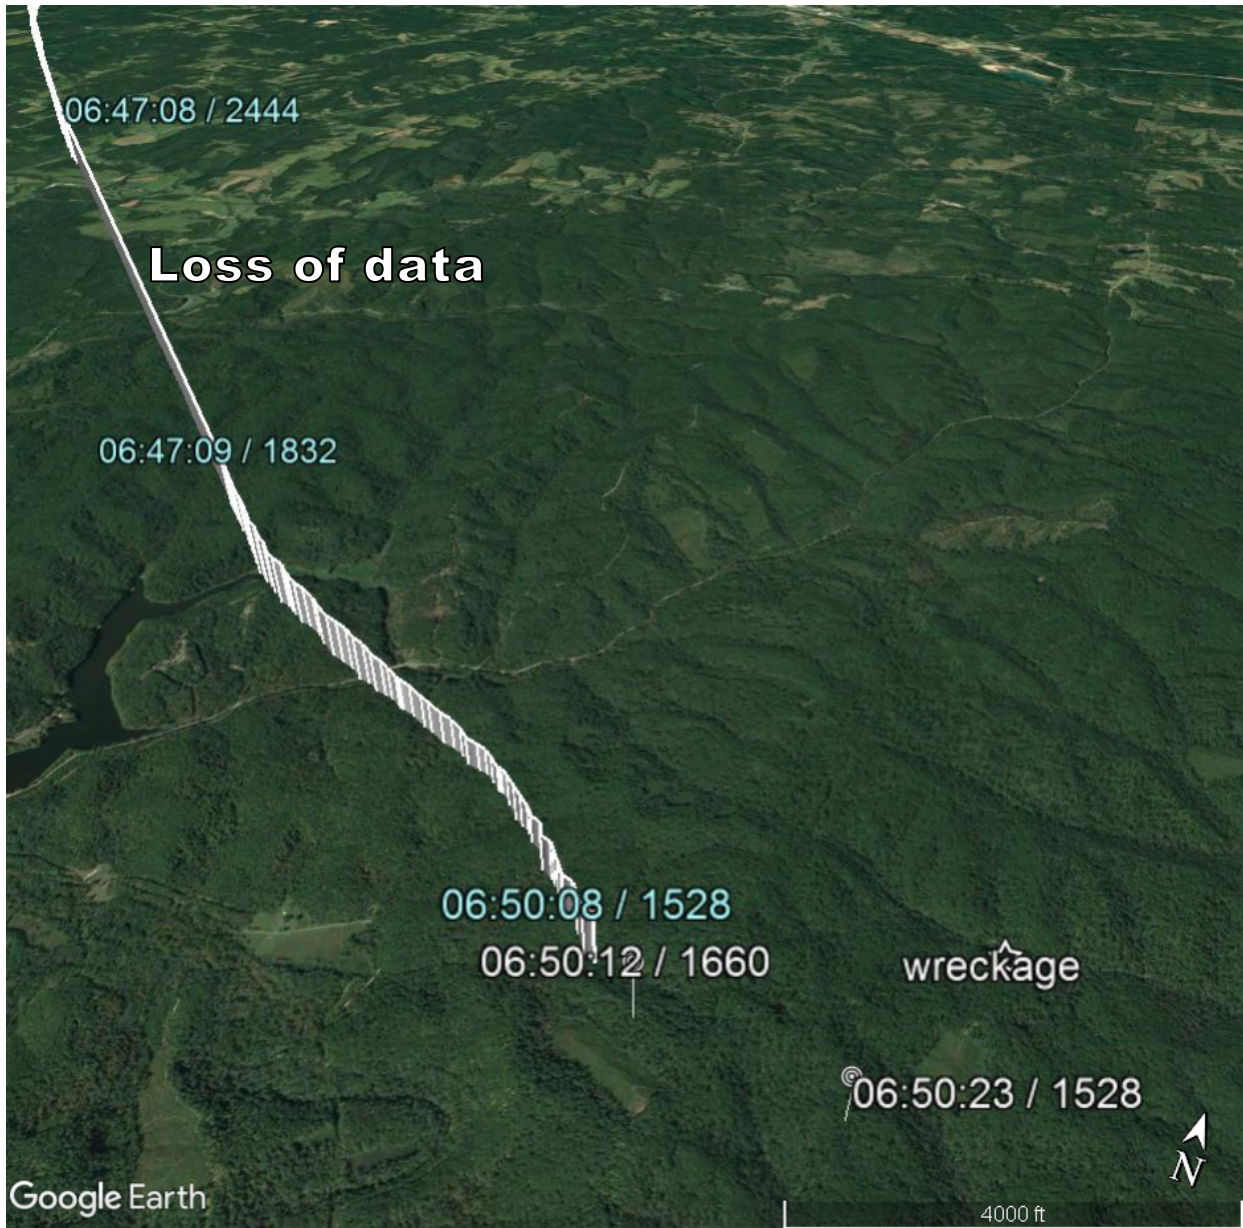
The onboard device recorded all parameters as expected from take-off until 0647:09, when no data was recorded for two minutes. From 0649:09 to 0650:08, an additional minute of data was recorded, and then the data ended. The NTSB Flight Data Monitoring Device factual report [2] discusses the loss of data. The location of the last data point was 4,400 ft from the wreckage location. The ADS-B data from the accident flight ended about 40 seconds before the Outerlink data, so only the Outerlink data will be used in describing the accident flight. The Outerlink device also sent position and altitude data to a satellite every eleven seconds. Two satellite altitude and location points were sent after the end of the onboard data. Figure 2 shows the end of flight, loss of data, additional satellite points, and wreckage location. However, Figure 3 shows a comparison of the flight path recorded by the satellite uplink versus the onboard position recorded. The satellite data tracked a saw-toothed approximate path compared to the onboard position data, so satellite position data must be considered as having a larger uncertainty.

Figure 2. End of accident flight. The blue data record is from the onboard data recorder. The two circular points are from the satellite record. Annotations indicate the time and the altitude (MSL).

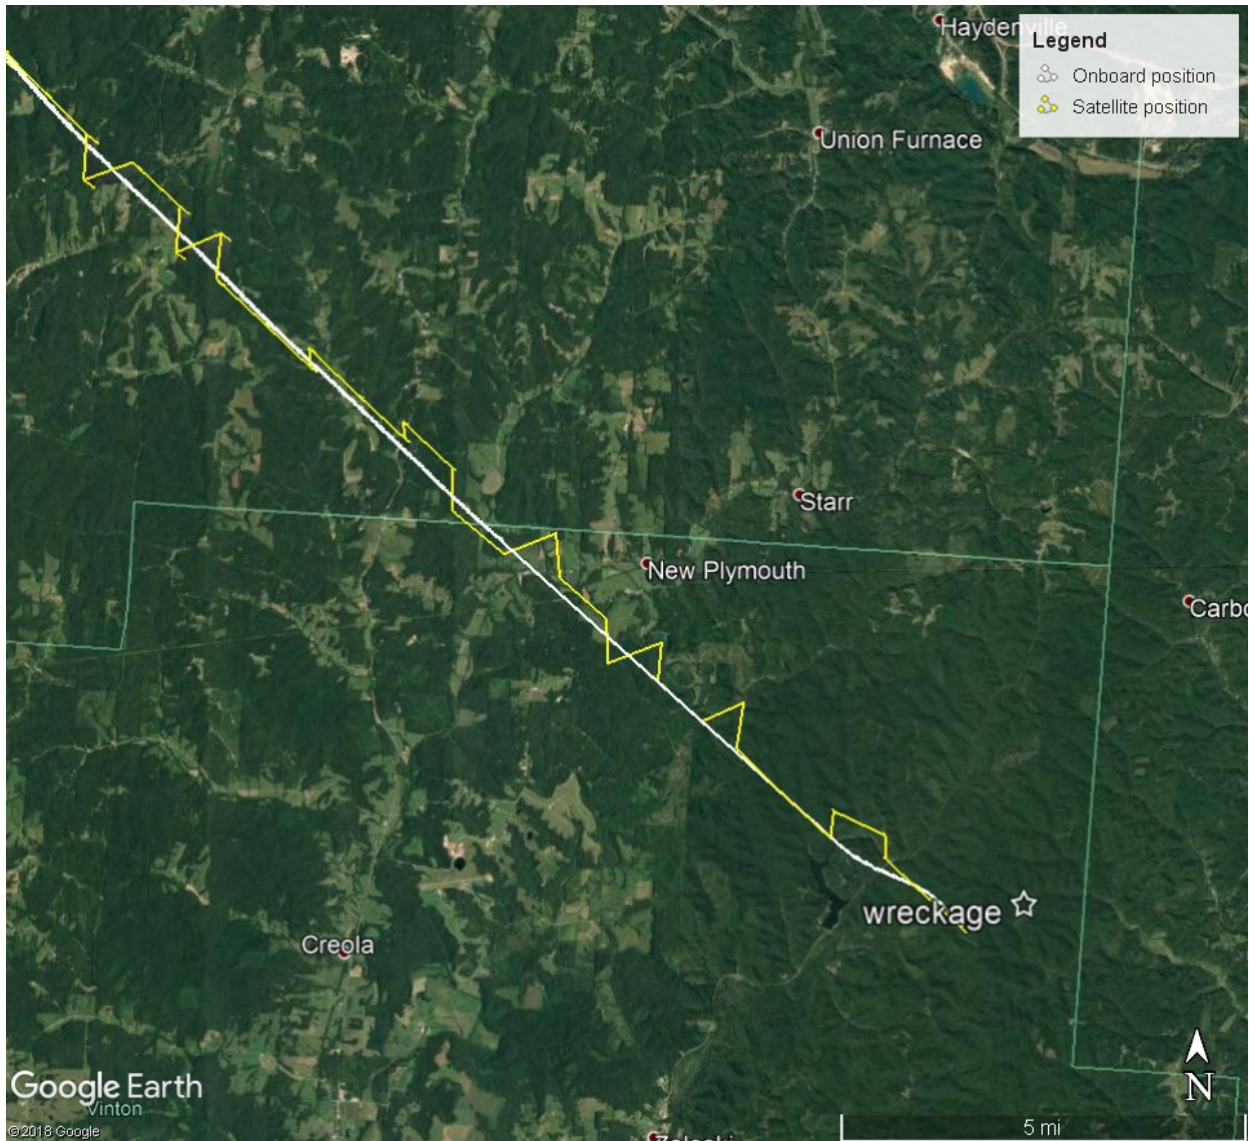
Figure 3. Satellite received flight track (yellow) versus onboard flight track (white).

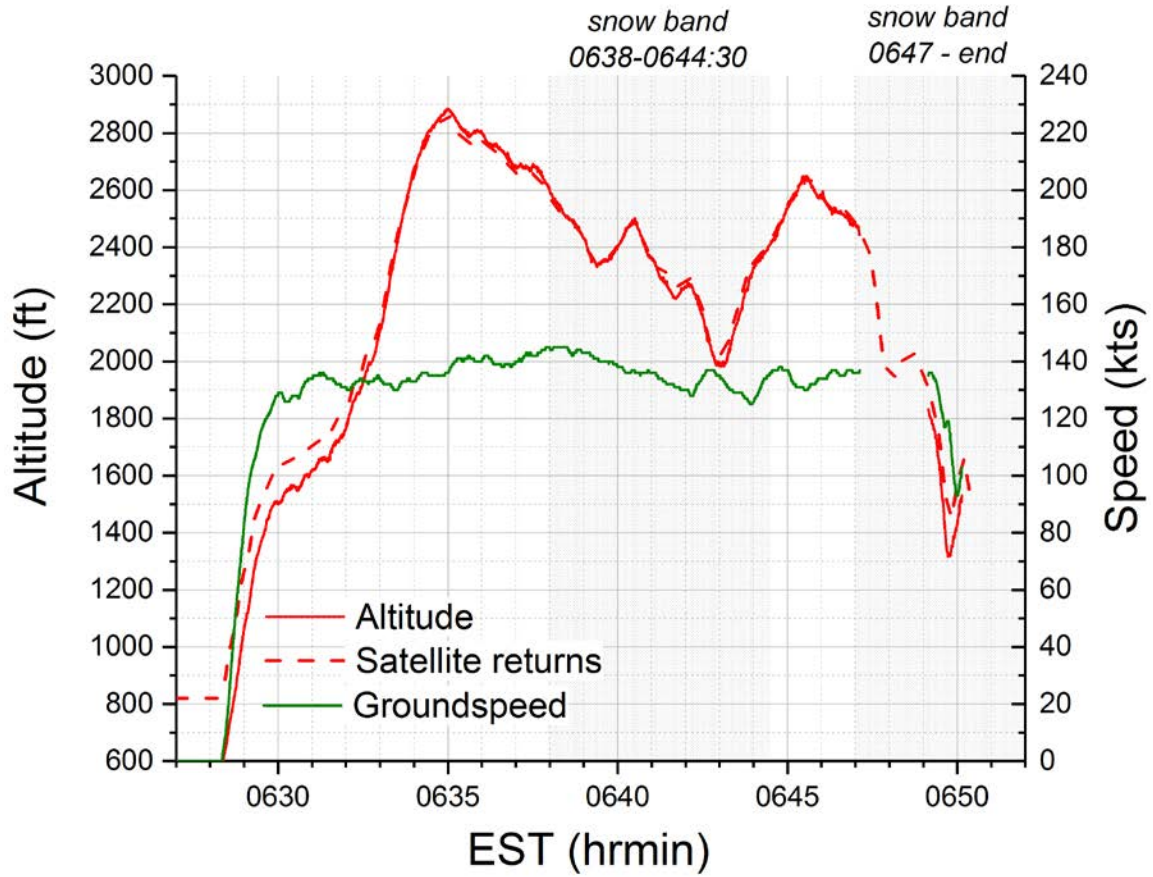
Figure 4 shows the altitude and groundspeed of the helicopter from the onboard device and the altitude data from the satellite. Above 2,000 ft MSL, the satellite altitude shows good agreement with the onboard altitude record. Below 2,000 ft, they diverge so that during that last minute of the record, the satellite recorded altitude was about 120 ft higher than the onboard recorded altitude. Figure 5 shows the altitude with the terrain elevation beneath the flight path. The helicopter gained altitude from the beginning of flight, 0628, to 0635, reaching a maximum altitude just below 3,000 ft, about 2,000 ft AGL (an overcast cloud ceiling was reported at 3,100 ft, MSL). The aircraft's speed throughout the flight was between 120 and 140 kts. From 0635 to 0643 the aircraft descended about 1,000 ft, before climbing again to an altitude of 2,600 ft at 0643:30. The terrain below the helicopter during the flight varied between 700 ft and 1,100 ft of elevation. By 0647 the helicopter was descending and at an altitude of 2,400 ft. No data was recorded onboard

for the following two minutes but satellite altitude data is shown. At the same time the helicopter entered the second band of snow.

Figure 4. Altitude (MSL) and groundspeed versus time.

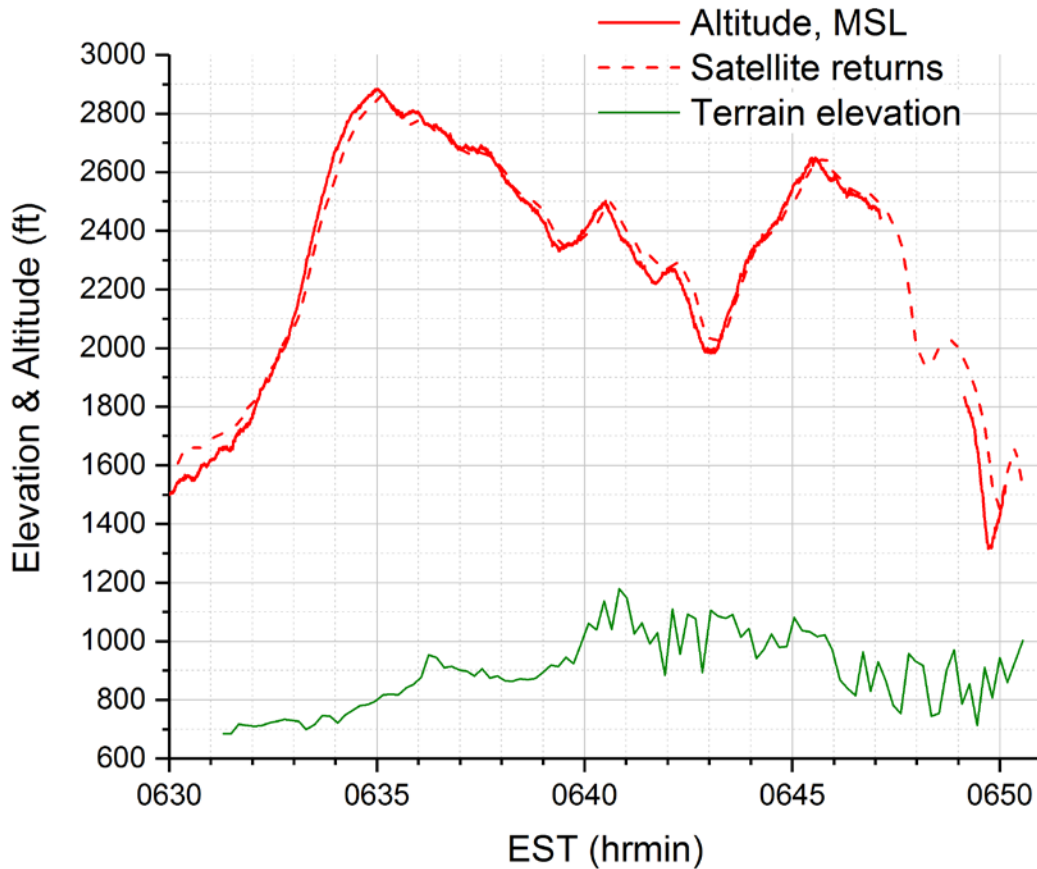
Figure 5. Altitude (MSL) and ground elevation versus time.

Satellite altitude data showed that the helicopter continued to descend until 0647:58. It briefly regained about 80 ft of altitude before descending at a rate of about 900 ft/min. At 0649:45, the aircraft had descended to 1,300 ft and then began climbing. At 0650:07.8 the helicopter was at 1,500 ft and climbing when the data ended. During the loss of onboard data, groundspeed was not recorded, but the recorded speed before and after the loss was about 135 kts. During the final recorded portion of flight the groundspeed slowed to near 100 kts.

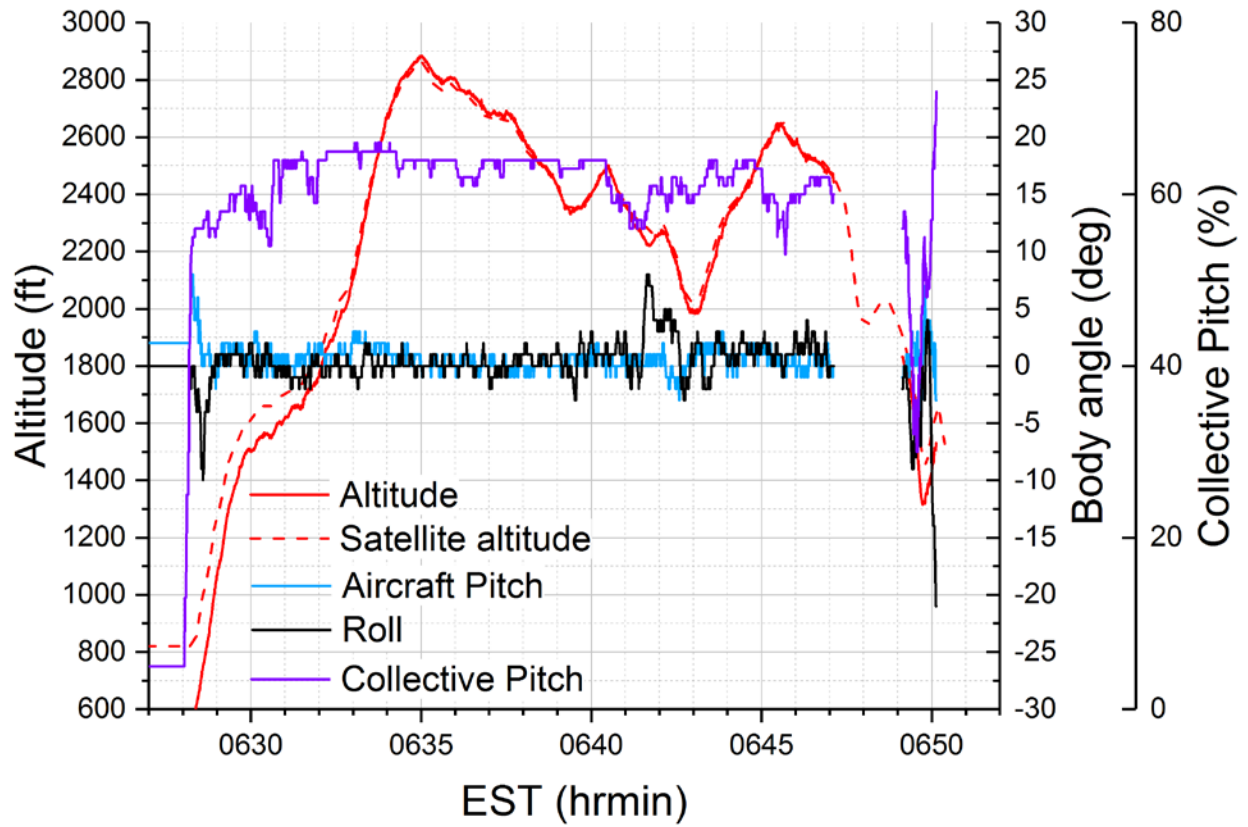
Figure 6 and Figure 7 show the aircraft's recorded pitch and roll attitude and the collective pitch (cyclic was not recorded). Figure 6 shows the entire length of the flight. Collective was generally between 55% and 65%, aircraft pitch was $\pm 2.5^\circ$, and roll was also $\pm 2.5^\circ$ other than a turn at 0642. During the final minute of recorded flight, collective was dropped from about 60% to 30% over the course of 20 seconds. The collective was then increased to 72% over the next 25 seconds. The aircraft was 9° left side down at 0649:25, righted itself by 0650, but then banked to 20° left side down as the data ended. Pitch went briefly 7° nose up at 0649:48 before ending 3° nose down. The recorded helicopter attitude after the data loss was more dynamic and larger control inputs were recorded than in the earlier portion of the flight, but the helicopter tracked the pilot's inputs, so the data were not indicative of a loss of control.

Figure 6. Altitude (MSL), aircraft pitch and roll, and collective pitch versus time.

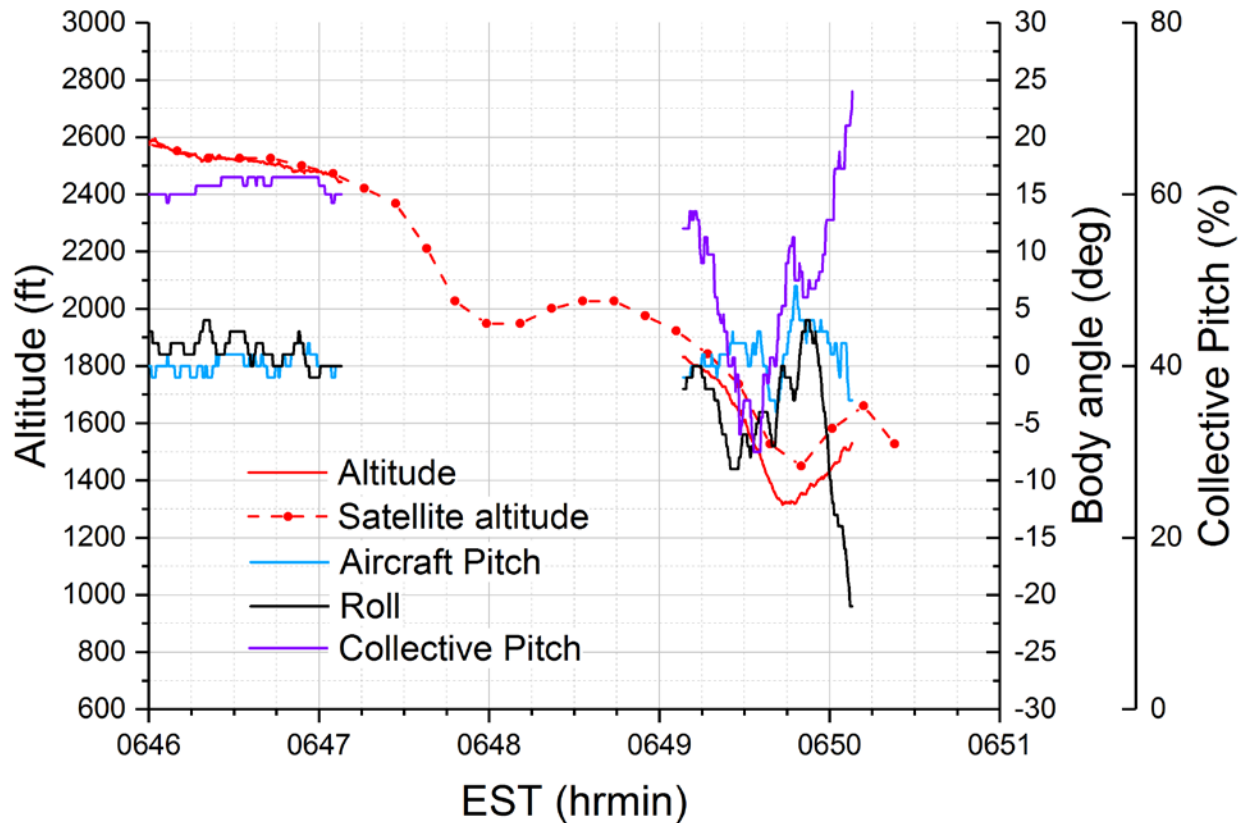
Figure 7. Altitude (MSL), aircraft pitch and roll, and collective pitch versus time for the end of flight.

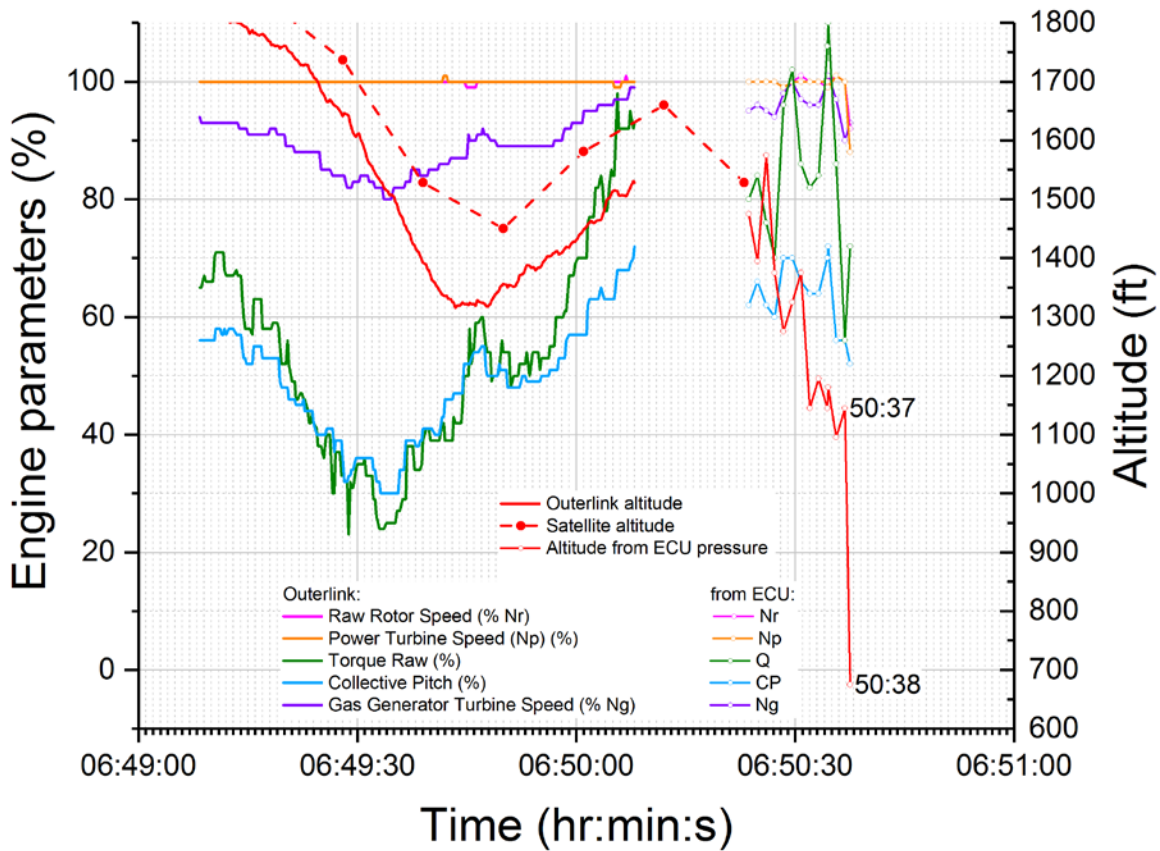
Figure 8. Engine parameters from Outerlink and ECU devices with altitude.

Collective pitch was between 60 and 70% during the final 14 seconds. The aircraft recorded two overtorques (Q greater than 100%) before the data ended. Torque exceeding 100% while the collective was about 70% indicates that the rotor was additionally loaded likely from lateral maneuvering (which was not recorded by the ECU). After each overtorque, the collective was lowered in response, while the absolute pressure reflected a decrease in altitude.

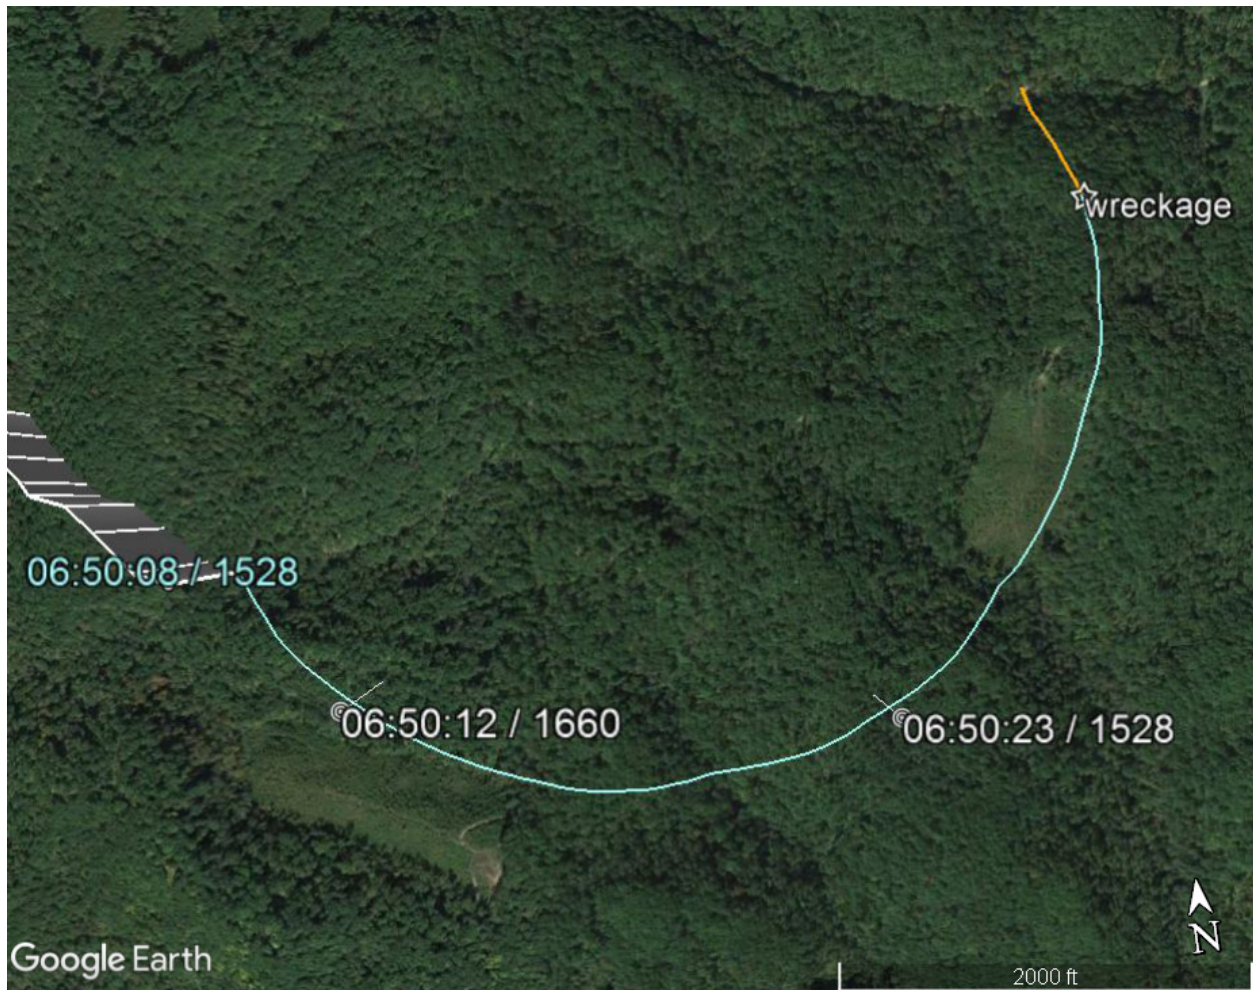
The onboard data ends 4,400 ft and likely 30 s of flight time from the wreckage location. Two additional satellite points were recorded (Figure 9), but as shown in Figure 3, the ground path locations were unreliable. However, the end of onboard data, the satellite points, and the wreckage location do lie roughly along the arc of a circle 0.7NM (4,400 ft) in diameter. In the equation below, θ is the bank angle to complete a level turn of radius R at constant groundspeed V , neglecting winds (g is the gravitational constant, 32.2 ft/s^2),

An aircraft at a speed of 100 kts (last onboard recorded groundspeed), would need a 22° bank angle to complete a turn along the described arc. This track would be consistent with both the final roll record from the onboard device (20° left bank) and the direction of the debris field which was recorded along a heading of 345° (see Figure 9). Additionally, the distance along the arc path was about 5,900 ft and to cover it in 30 s would require an average groundspeed of 116 kts, also consistent with the above-mentioned speeds.

Figure 9. End of flight path, wreckage location, and debris field orientation (orange line).

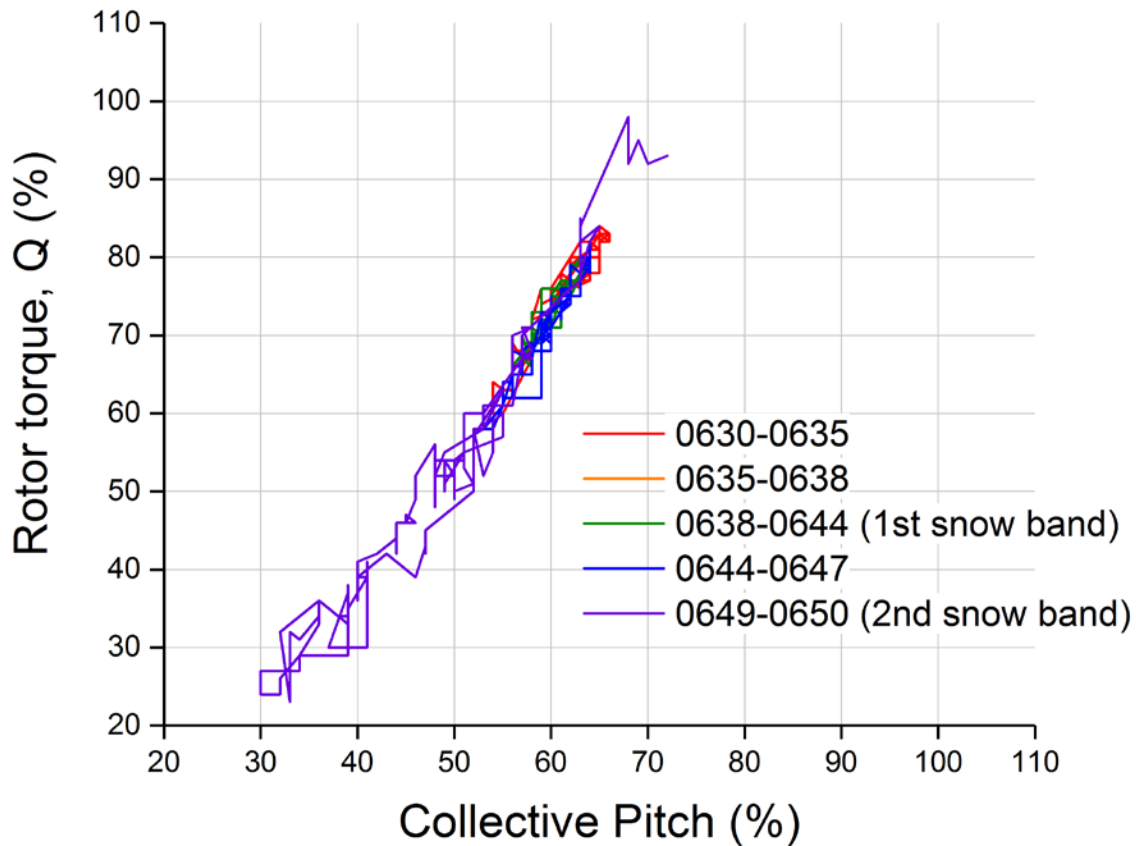
increase in collective produces an increase in torque. If ice accretion on the rotor blades occurs, the helicopter would record higher torque values without requiring more collective pitch. Figure 10 shows collective pitch versus rotor torque, divided into timed sections. Most of the flight (red, orange, green, and blue) lay along a continuous curve of torque versus pitch. The purple section (0649-0650) represents the end of the data which coincided with the second snow band. The lowering of collective during the last minute of data differentiates that data from the rest of the flight, but the relationship between collective pitch and rotor torque does not change and does not indicate that icing affected rotor performance.

Figure 10. Rotor torque versus collective pitch at different times throughout the flight.

The onboard data ended approximately 30 seconds before the helicopter's impact with the ground. Bell reported that the development of severe rotor icing conditions would require three to four minutes of ice accretion. While there was no evidence of rotor icing, the presence of airframe icing could not be determined from the data available.

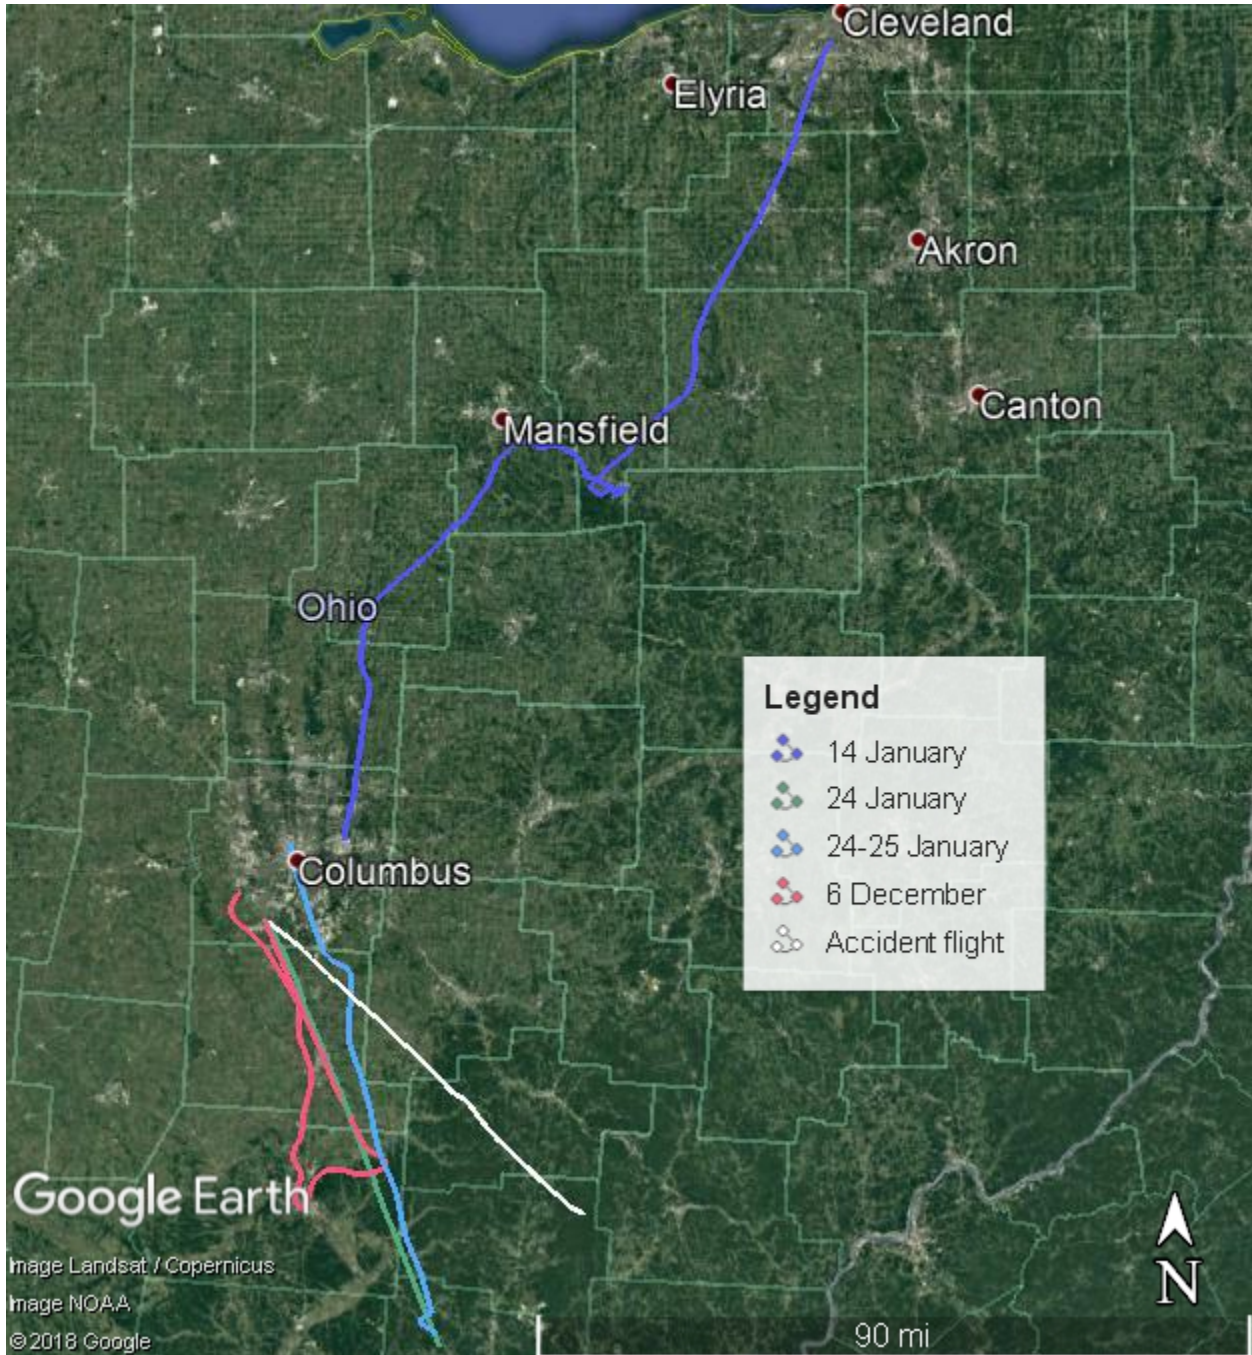
ADS-B for four days of prior flights were provided to the investigation. Figure 11 shows the prior flight paths in addition to the accident flight path.

Figure 11. Four prior flights and accident flight path (white).

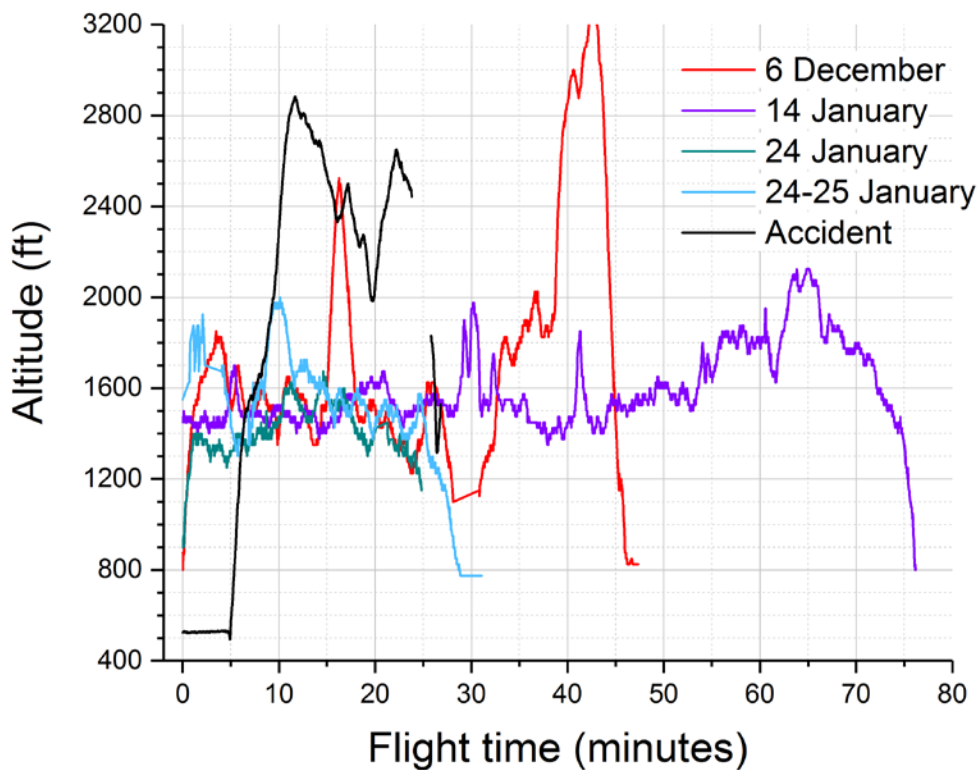
Figure 12 and Figure 13 show the altitudes, MSL, and height above ground of the four flights and the accident flight. Three of the flights showed flight profiles between 400 and 1,000 ft above the ground at altitudes near 1,500 ft MSL for most of the flight. The accident flight and the December flight were flown at greater heights above ground and with more variation in altitude than the other three flights.

Figure 12. Altitude (MSL) versus flight time.

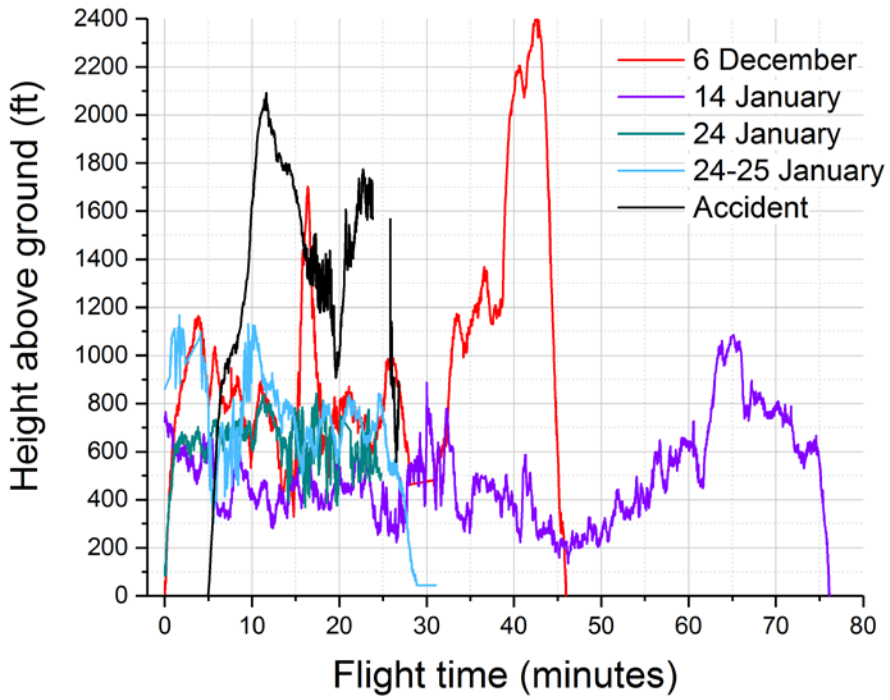
Figure 13. Height above ground versus flight time.

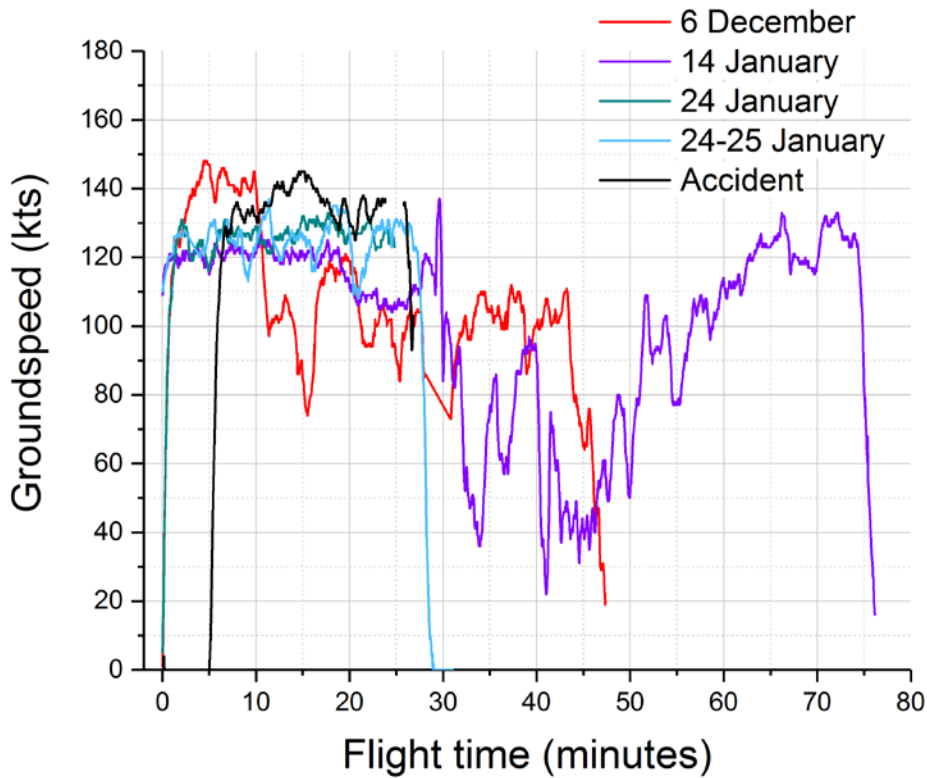
Figure 14 shows the groundspeeds for all the flights. The accident flight was ten to 15 kts faster than some of the other flights, but not all. This data from the prior flights is discussed in additional detail in the Human Performance report [3].

Figure 14. Groundspeed versus flight time.
