**National Transportation Safety Board**  
Office of Research and Engineering  
Washington, D.C. 20594

**Performance Study**

Location:	Hazelhurst, Wisconsin
Date:	April 26, 2018
Time:	2250 CDT
Airplane:	Airbus AS 350 B2, N127LN
NTSB Number:	CEN18FA149

**Performance Study**  
**CEN18FA149, Airbus AS 350 B2, N127LN**

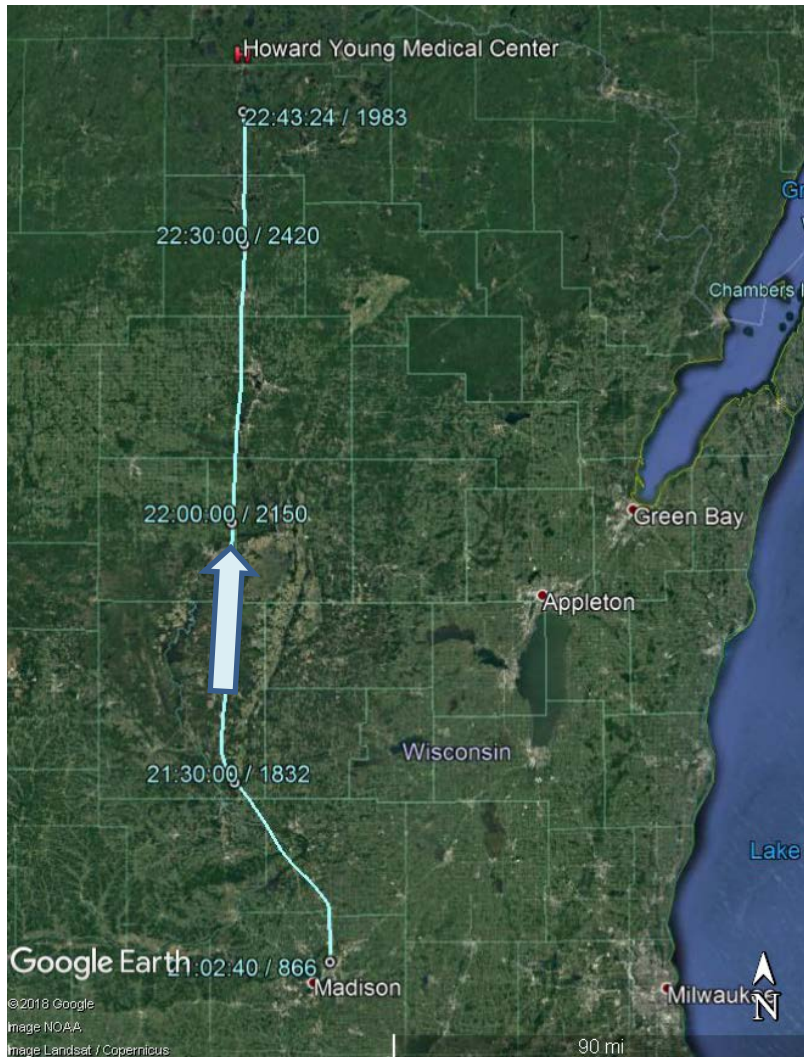
Figure 1 shows the accident flight path. The helicopter left MSN north of Madison, Wisconsin at 21:02 CDT and flew for one hour and 40 minutes. The flight ended less than 10 miles short of its destination of the Howard Young Medical Center helipad.

**Figure 1.** Accident flight.

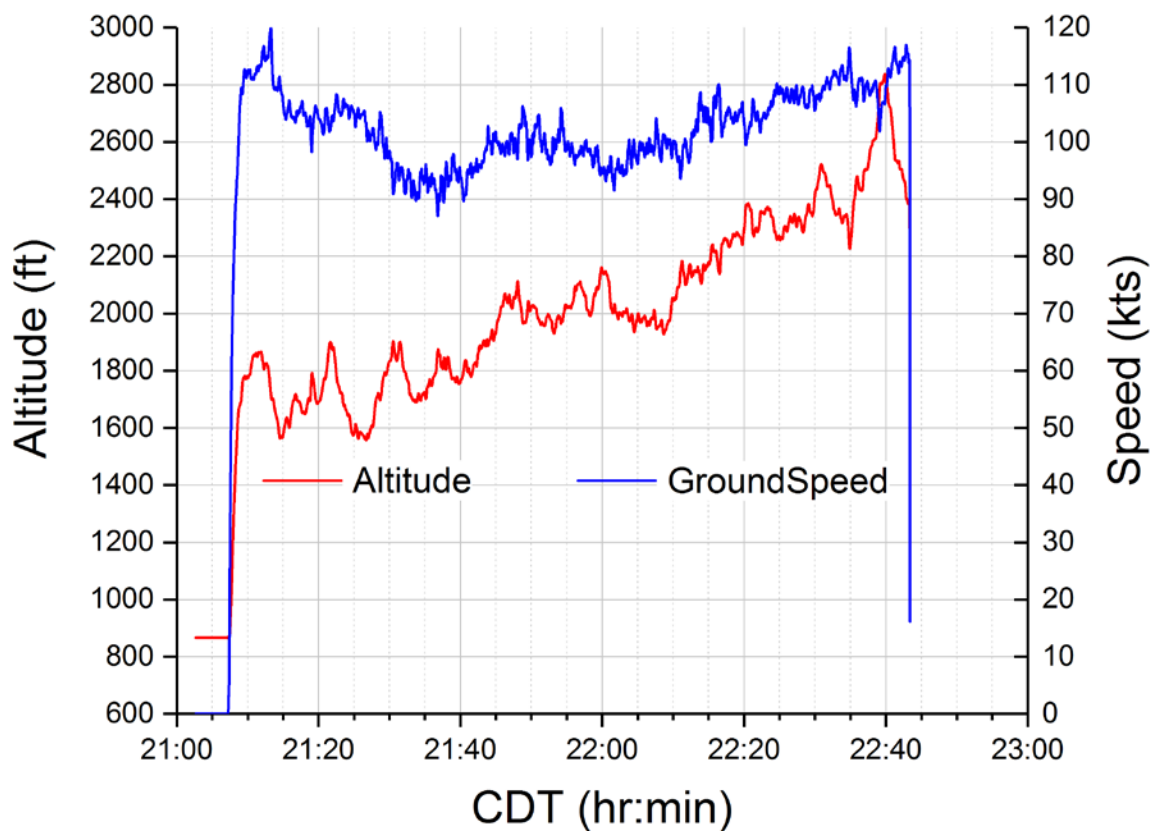
The helicopter's altitude and groundspeed are shown in Figure 2. The groundspeed was between 90 and 120 kts for the flight and the altitude was generally increasing from 1,600 ft MSL to 2,800 ft MSL. Near the end of the flight, the aircraft climbed from 2,220 ft at 22:35 to 2,800 ft at 22:40, while airspeed remained about 110 kts. After 22:40 the aircraft began descending while groundspeed increased to about 115 kts.

**Figure 2.** Accident flight altitude and groundspeed.

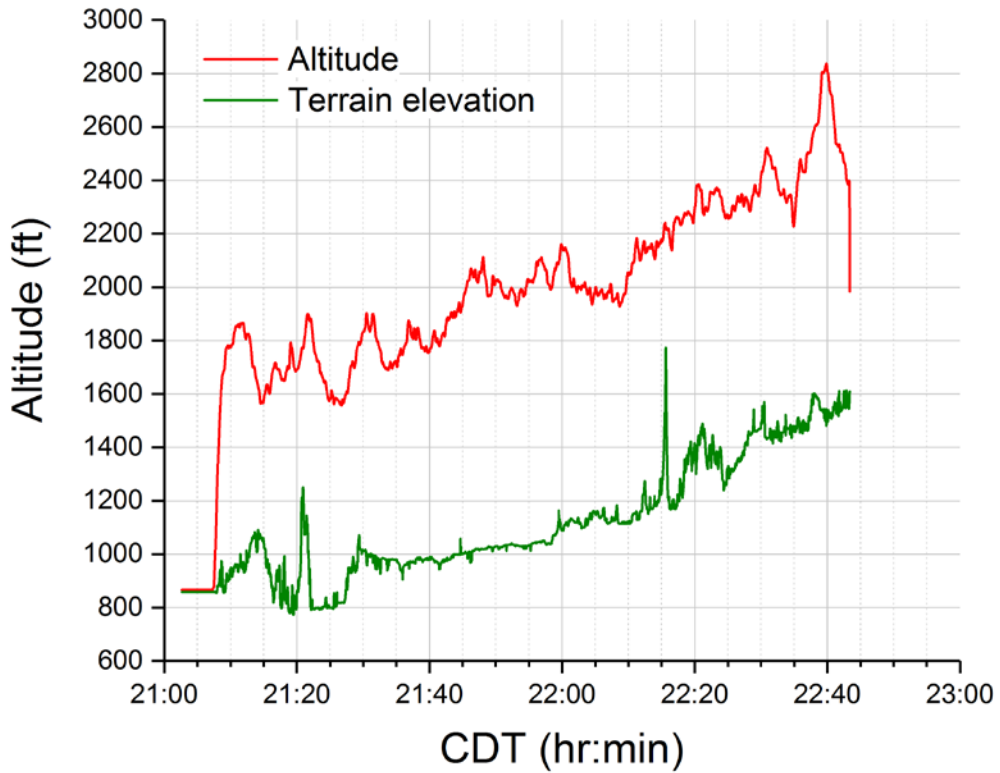
The increase in altitude coincided with an increase in the terrain elevation as the helicopter flew north as shown in Figure 3. For most of the flight, the aircraft was between 800 and 1100 feet above the terrain. At about 22:35, the helicopter began to climb, reaching an altitude over 2,800 ft by 22:40, which was over 1,300 feet above the terrain.

**Figure 3.** Accident flight altitude and terrain elevation.

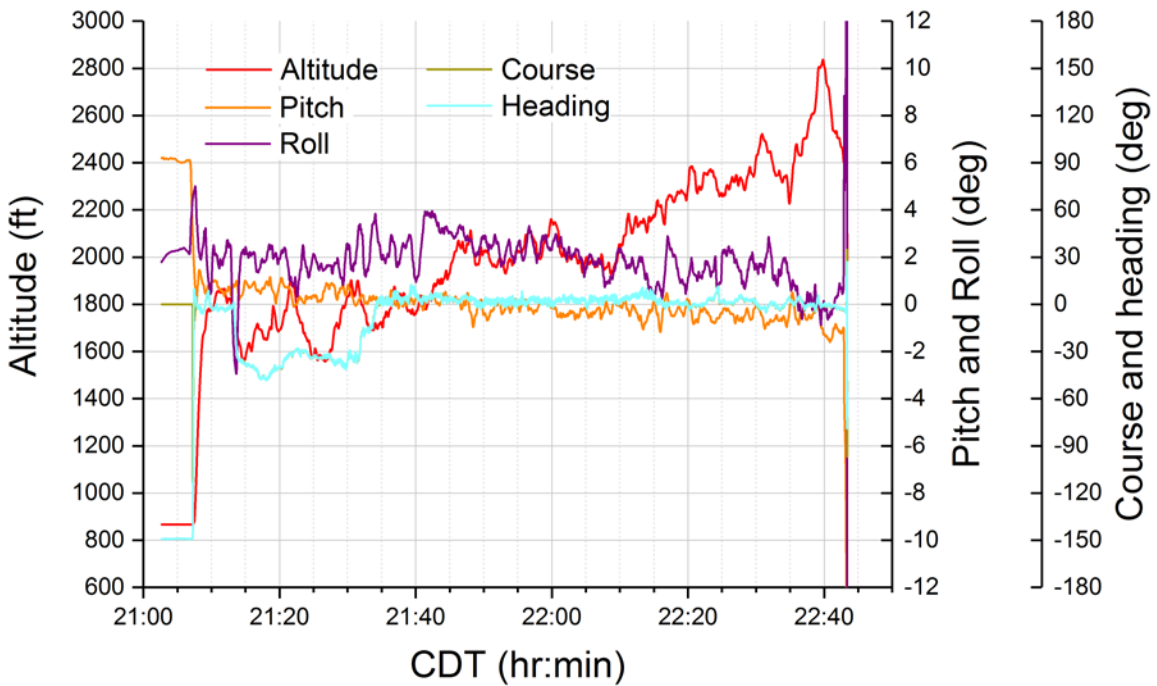
Figure 4 shows the recorded pitch, roll, course, and heading of the aircraft throughout the flight. Pitch and roll stayed relatively constant throughout most of the flight and heading tracked course.

**Figure 4.** Accident flight altitude, pitch, roll, course and heading. Course and heading overlap for most of the flight. Positive roll is right side down.

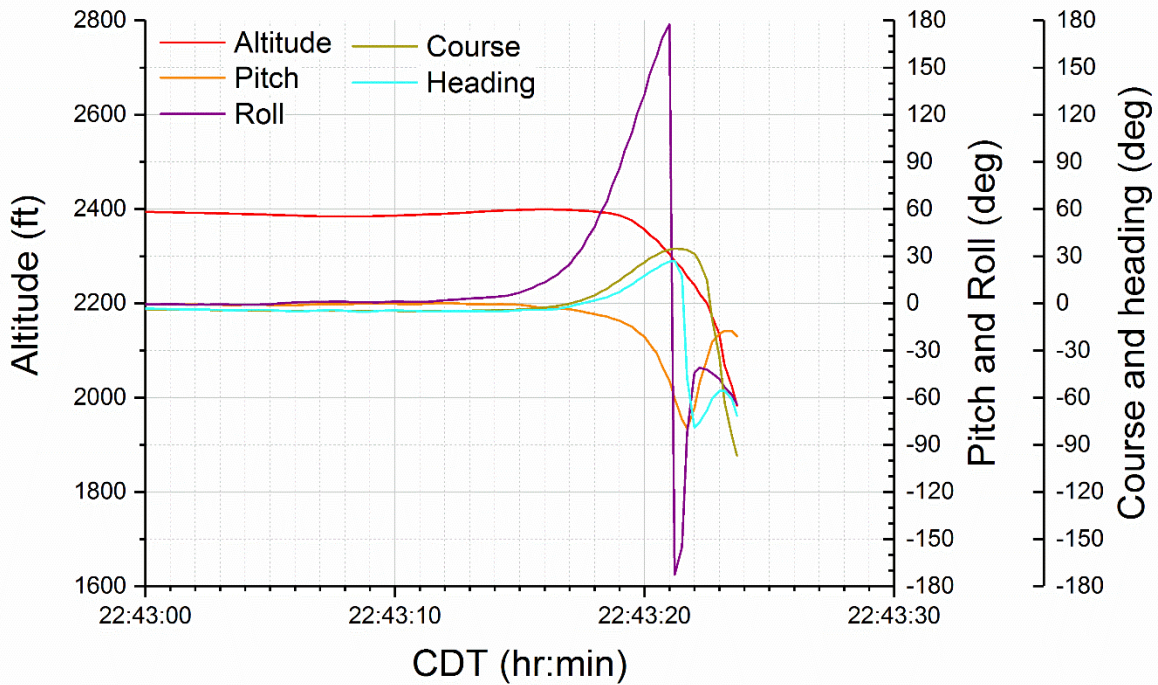
As stated earlier, from 22:40 until 22:43, the helicopter descended to 2,400 ft at a rate near 100 ft/min and the groundspeed was steady at about 115 kts. At 22:43:12, pitch and roll began to increase with the helicopter's heading deviating from its course around 22:43:16 (Figure 5). The helicopter rolled right 30° in five seconds and by 22:43:21 was recorded fully inverted. The aircraft pitched down and at 22:43:18 began to rapidly lose altitude at a rate of near 5,000 ft/min before the recording ended at 22:43:23.7 at an altitude below 2,000 ft.

**Figure 5.** End of accident flight altitude, pitch, and roll. Positive roll is right side down.

The accident flight averaged groundspeeds between 90 and 115 kts for the flight and flew at an altitude between 800 and 1100 feet above the terrain. At 22:43:12, 11 seconds before the end of the recording, the attitudes change and roll records the helicopter inverting and losing altitude. The recording ends at 22:43:23.

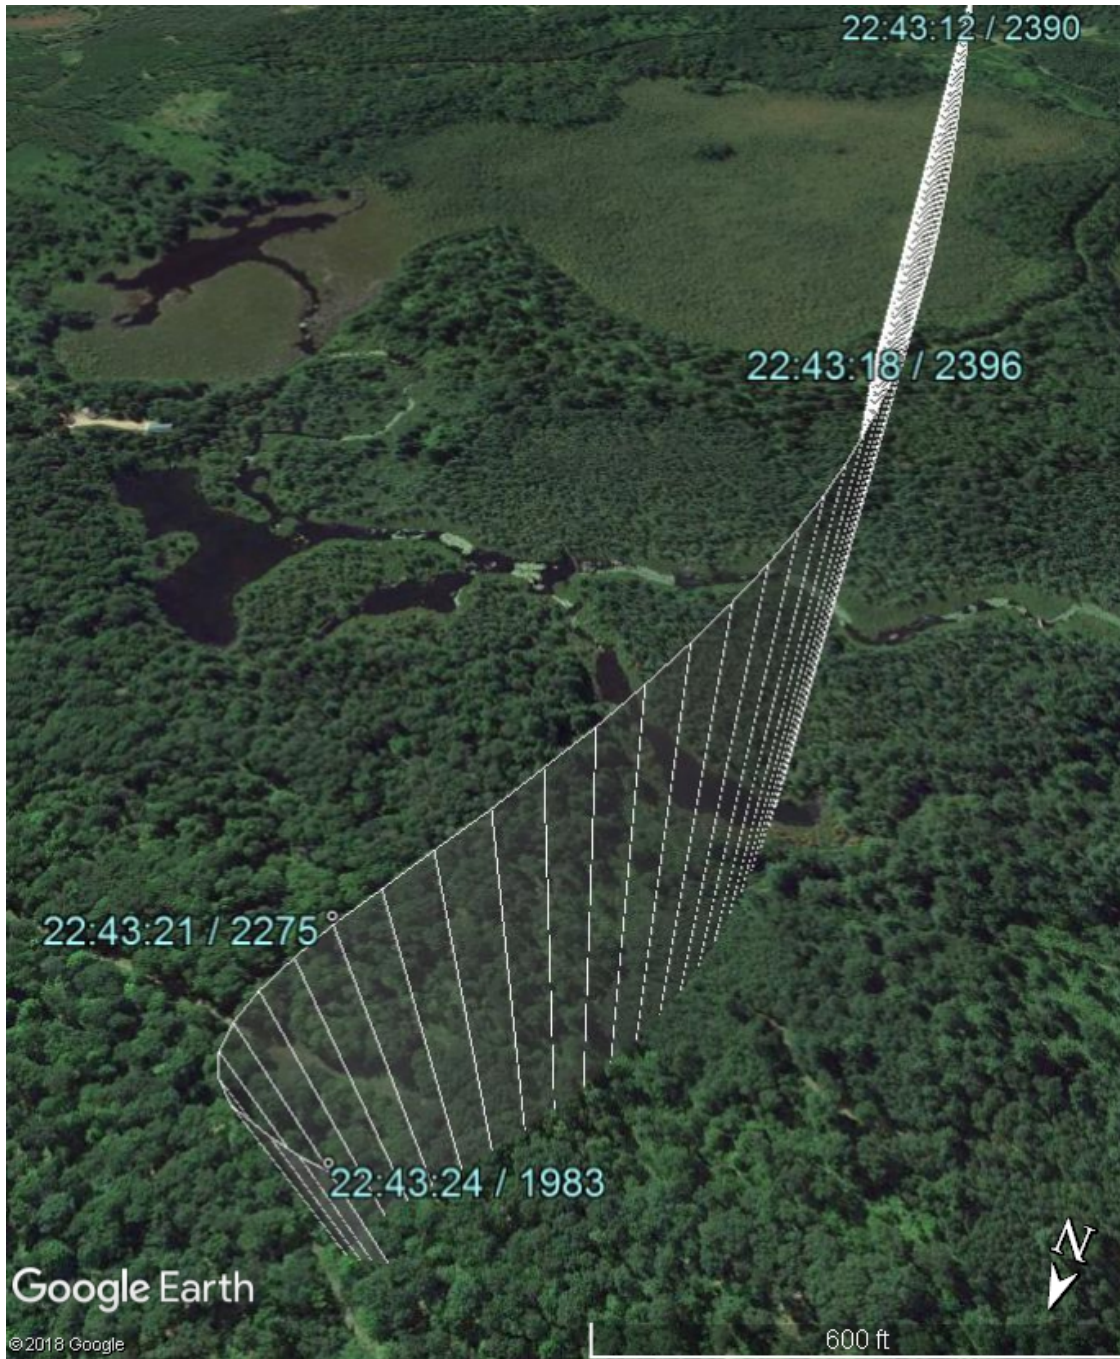
**Figure 6.** End of accident flight.

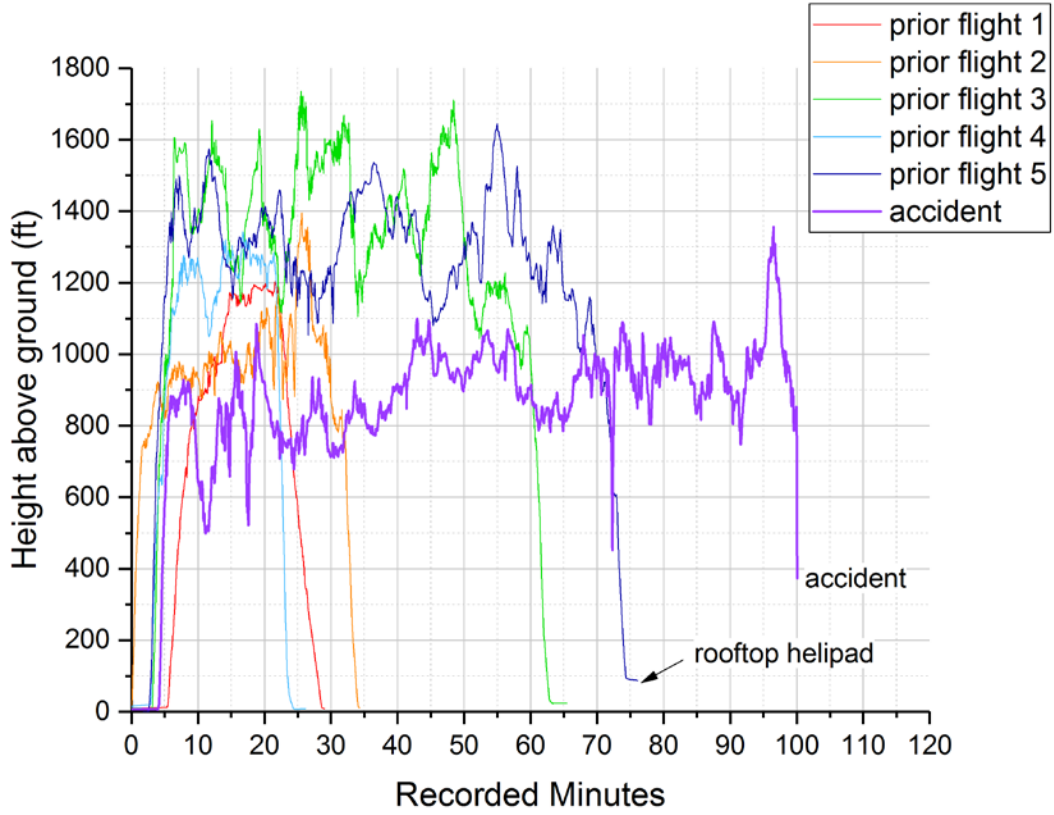
Of interest was the aircraft's prior flights. Appareo data from the helicopter for five prior flights is shown in Figure 7 and Figure 8. The accident flight's height above ground was 200 to 600 feet lower than the many of the five prior flights and the groundspeed was 20 to 40 kts slower.

**Figure 7.** Height above ground for accident flight and five prior flights.

The accident flight was 200 to 600 ft lower and 20 to 40 kts slower than five prior recorded flights.

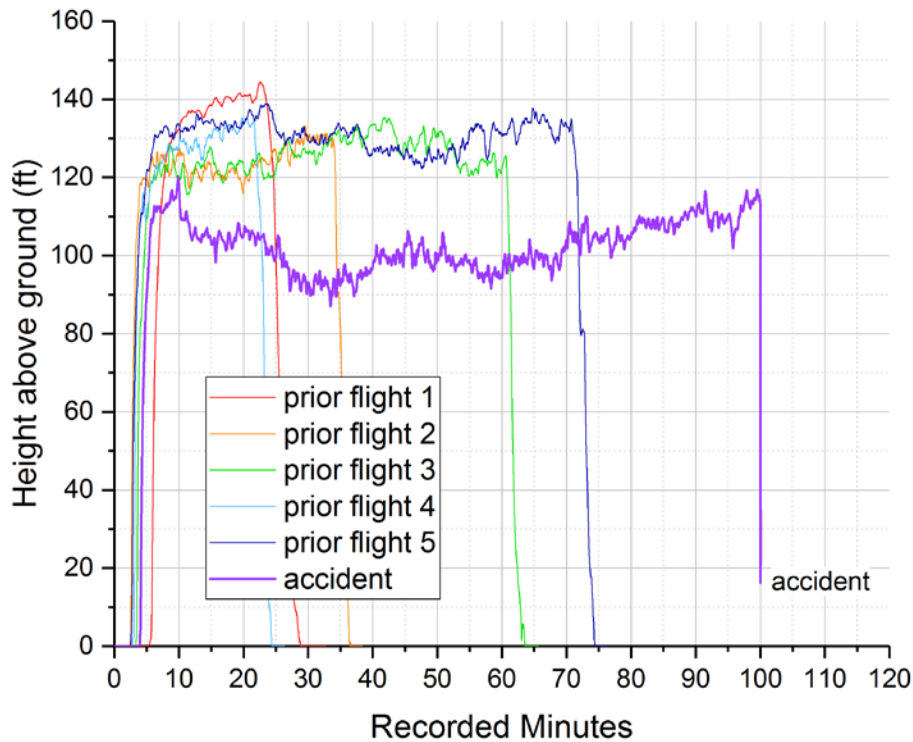
**Figure 8.** Groundspeeds for accident flight and five prior flights.
