National Transportation Safety Board
Office of Research and Engineering
Washington, D.C. 20594

Airplane Performance Study *gtr*

NTSB #: DCA97MA055
Location: Newark, New Jersey
Date: July 31, 1997 0131
Time: Approximately 0132 local time
Operator: Federal Express
Aircraft Type: McDonnell Douglas MD-11, N611FE

Federal Express MD-11
Newark, N.J. (EWR) 7/31/97

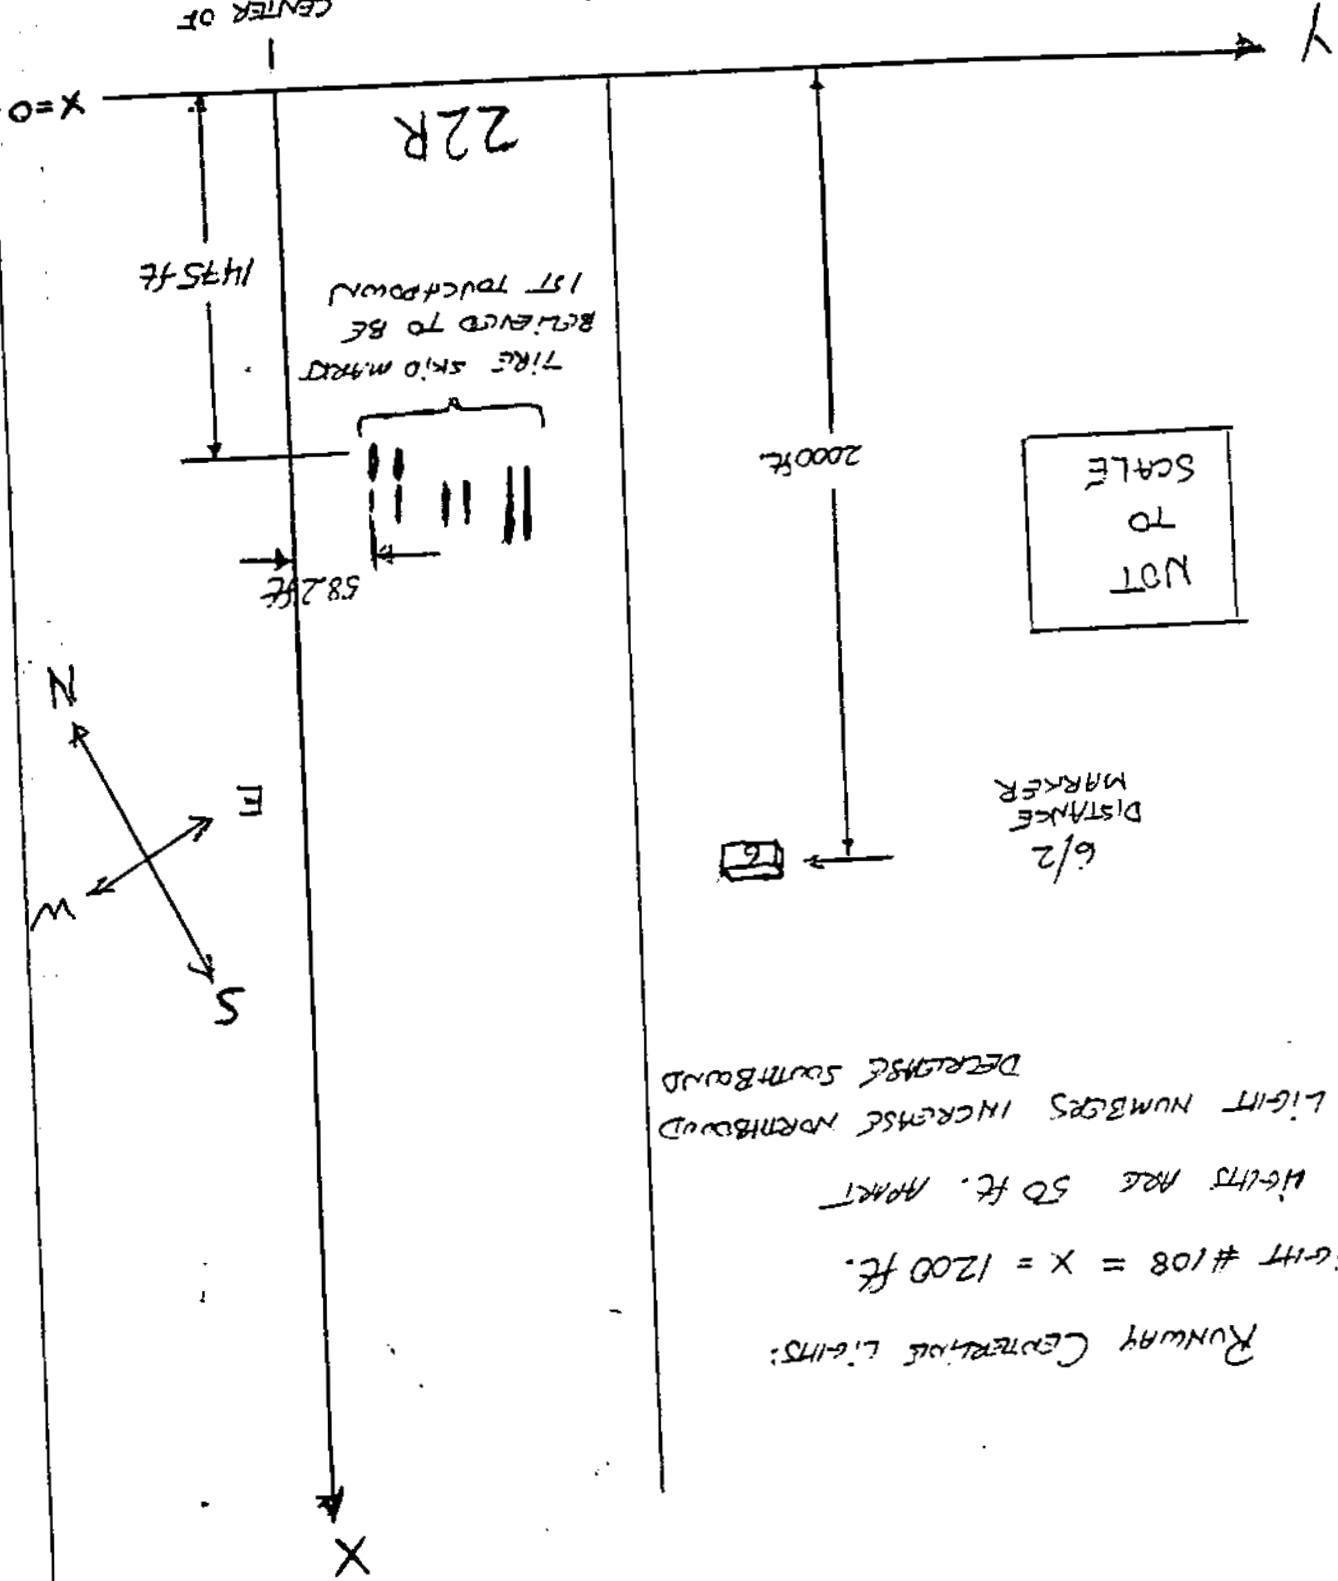
Attachment I

Tire rubber marks consistent with touchdown of the accident airplane's right main landing gear tires were first visible approximately 1,126 feet from the runway 22R displaced threshold. Tire rubber marks consistent with touchdown of the left main gear tires and center main gear tires became visible shortly thereafter at 1,151 and 1,160 feet from the displaced threshold, respectively (gear and tire spacing and tread diameter are consistent with those of an MD-11). These tire marks are dark and intermittent up to 1,222 feet from the displaced threshold, then they become less dark and continue with very light outlines off and on until ending about 1,301 feet from the threshold. The tire marks indicate the airplane was near the center of the runway on the first touchdown.

Tire rubber marks consistent with the second touchdown of the accident airplane's right main landing gear became visible approximately 1,924 feet from the displaced threshold (798 feet after tire marks consistent with first touchdown), and those of the center main gear became visible shortly thereafter at 1,983 feet from the displaced threshold. The tire marks indicate the airplane was near the center of the runway on the second touchdown. The right main landing gear tire marks then swerve to the right starting at 1,995 feet from the displaced threshold, with the center main landing gear tire marks also moving to the right but not as rapidly as those of the right main landing gear.

Ground scars consistent with the right (#3) engine nacelle contacting the runway surface began at 2,164 feet from the displaced threshold and end approximately 3,476 feet from the displaced threshold. Small pieces of composite structure and hard foam from the right inboard trailing edge flap were found 2,226 feet from the displaced threshold. Runway ground scars consistent with impact of the right inboard trailing edge flap began 2,299 feet from the displaced threshold, and continued to the location of the right inboard trailing edge flap 2,376 feet from the displaced threshold. Soot marks consistent with burning fluid began 2,506 feet from the displaced threshold and continued to the end of the wreckage path (5,126 feet from the displaced threshold).

Scrape marks and purple paint consistent with the accident airplane's tail striking the ground began 2,644 feet from the displaced threshold and ended 3,060 feet from the displaced threshold (the accident airplane was painted with FedEx's new paint scheme, in which the tail cone, #2 engine, and vertical stabilizer are painted purple). A gouge in the runway surface consistent with the location of an antenna on the underside of the MD-11 tail began 2,676 feet from the displaced threshold and ended 2,711 feet from the displaced threshold. At 2,826 feet from the displaced threshold, all of the scrapes, soot marks, and gouges on the runway surface start to turn right. Approximately half of one of the center main landing gear tires was found 3,084 feet from the displaced threshold at the far left edge of the runway.

A scrape mark with purple paint consistent with the right side of the top of the vertical stabilizer was found 3,342 feet from the displaced threshold, and corresponding scrape marks were found on that area of the vertical stabilizer. A change in the shape of the right engine scrape mark began approximately 3,351 feet from the displaced threshold, and a large, white, purple, and orange scrape mark consistent with the right side of the forward fuselage began 3,376 feet from the displaced threshold just to the right of the runway (corresponding scrape marks were found on the right side of the forward fuselage).

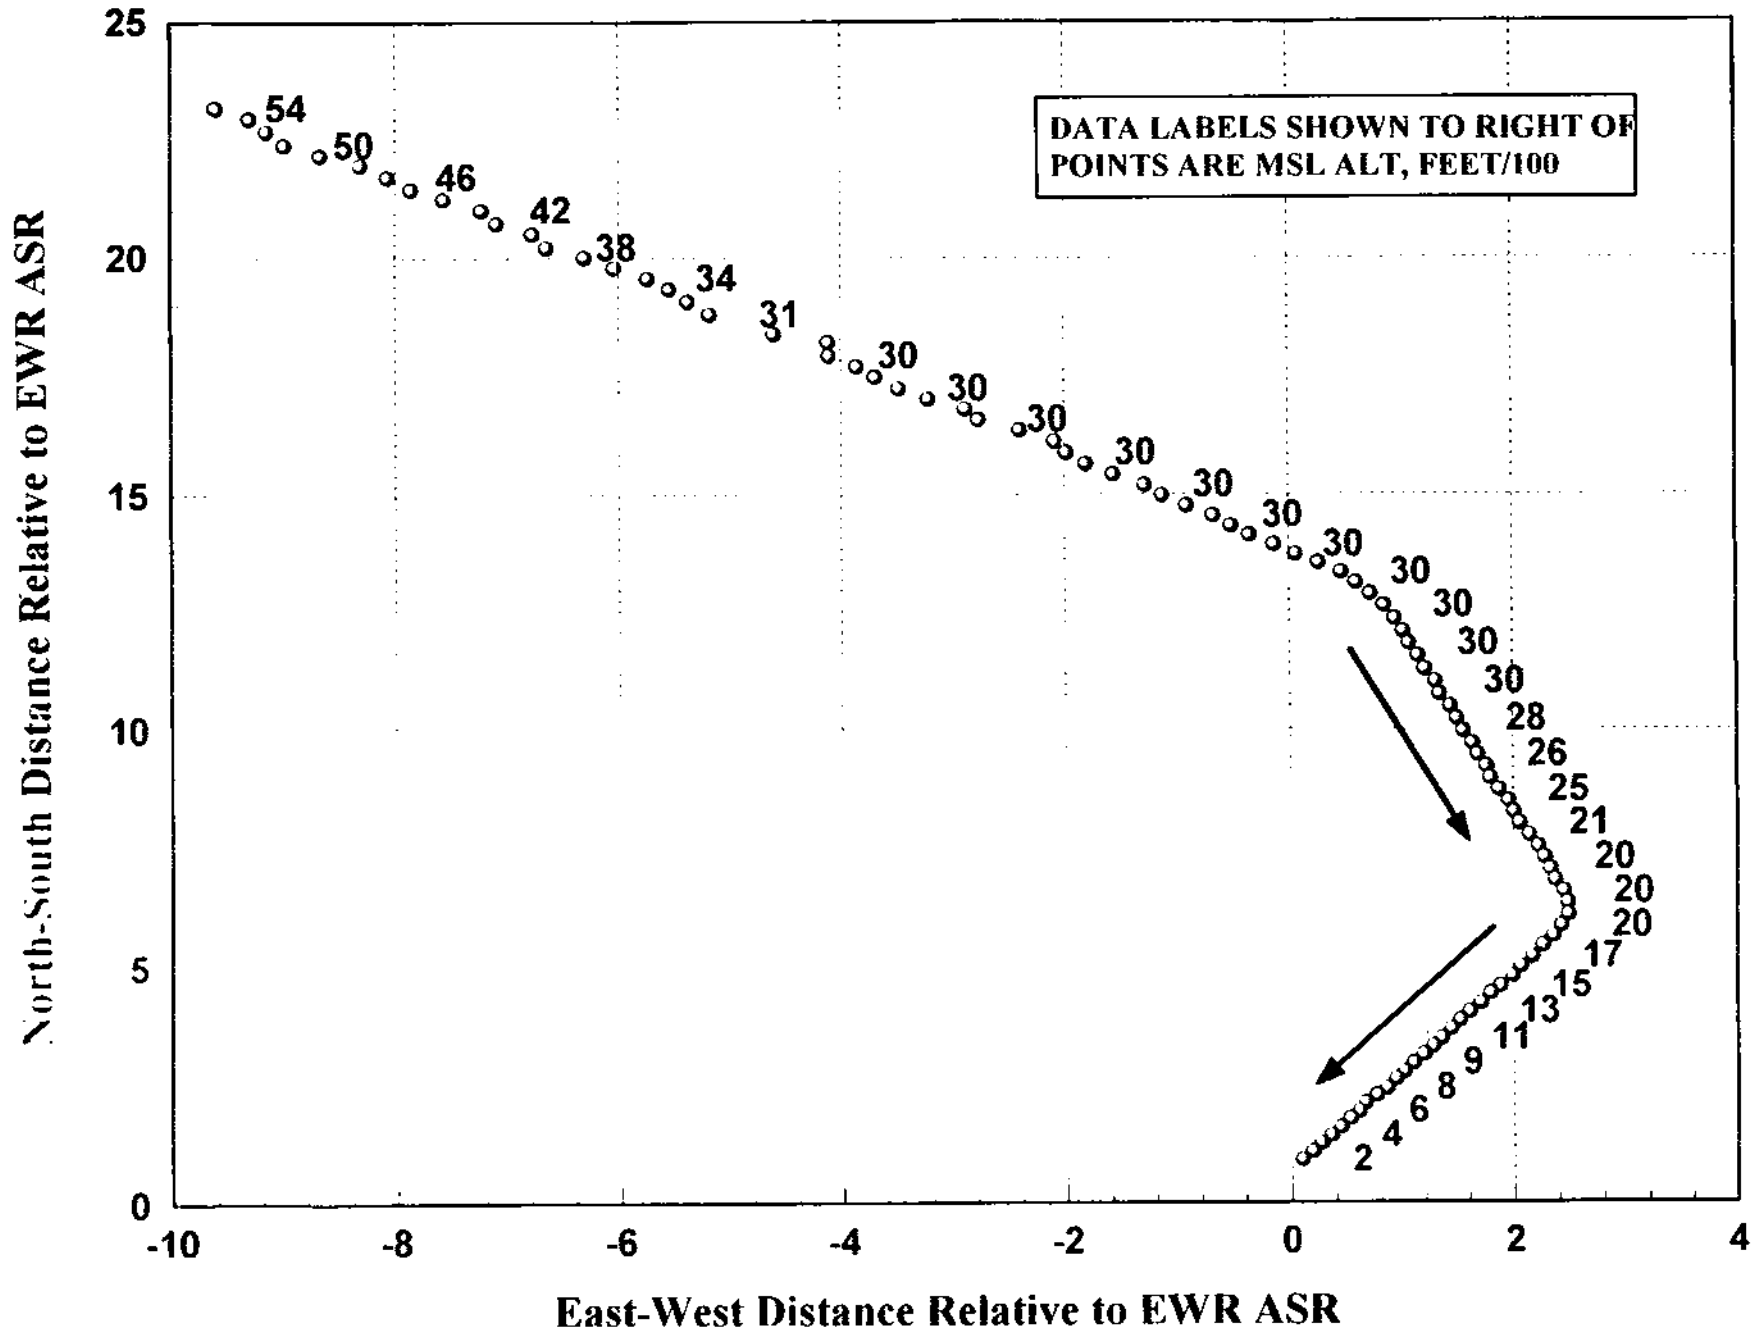
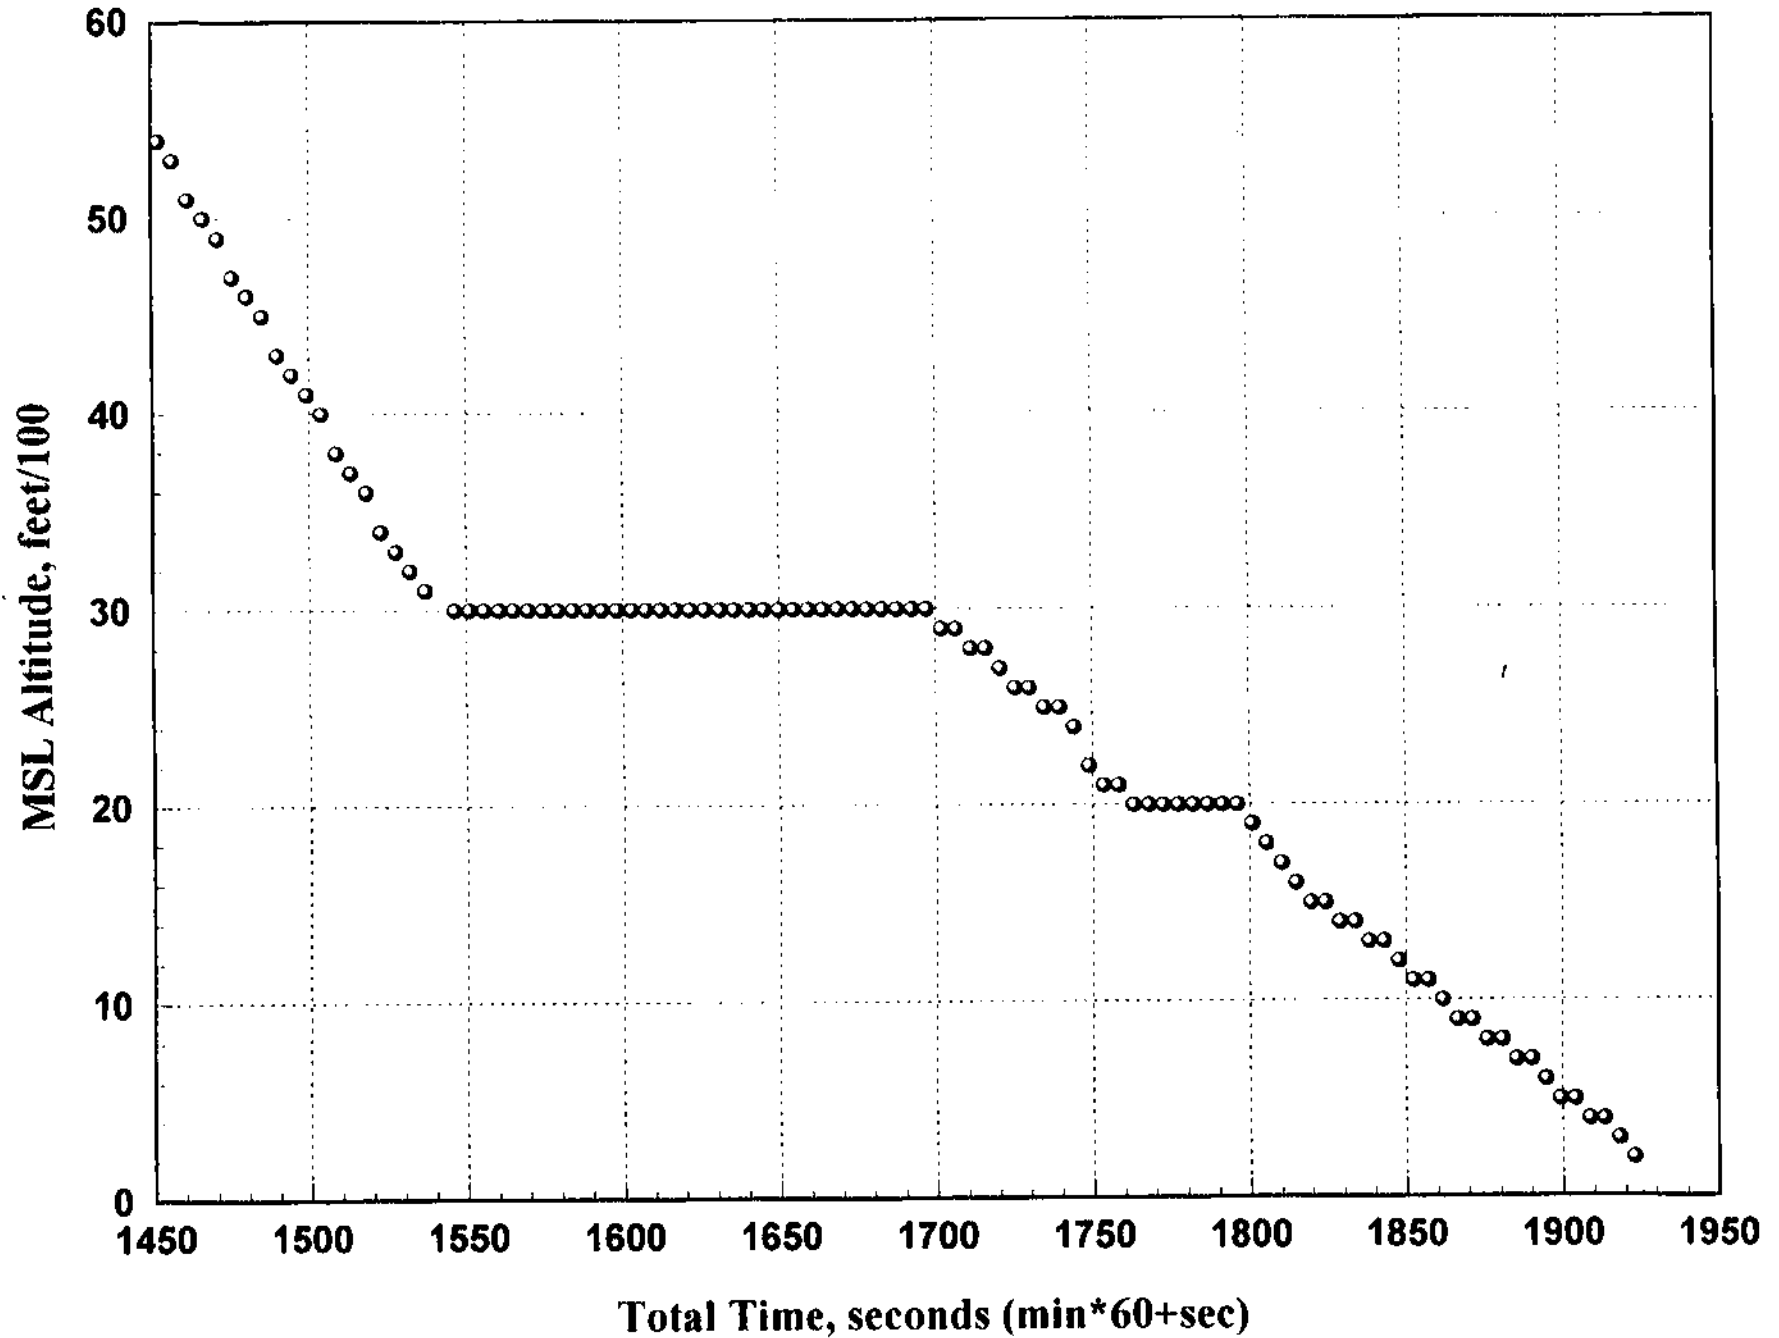
Federal Aviation Administration (FAA) radar data from the Newark Airport Surveillance Radar (ASR) indicate that the accident airplane's descent from 1500 feet MSL to 200 feet MSL was conducted at an average vertical speed of 790 feet per minute. The last secondary radar return shows the airplane at an altitude of approximately 200 feet MSL (secondary radar data are rounded to the nearest hundred feet). The EWR runway 22R field elevation is 11 feet MSL. Attachment II contains tabular and graphical radar data.

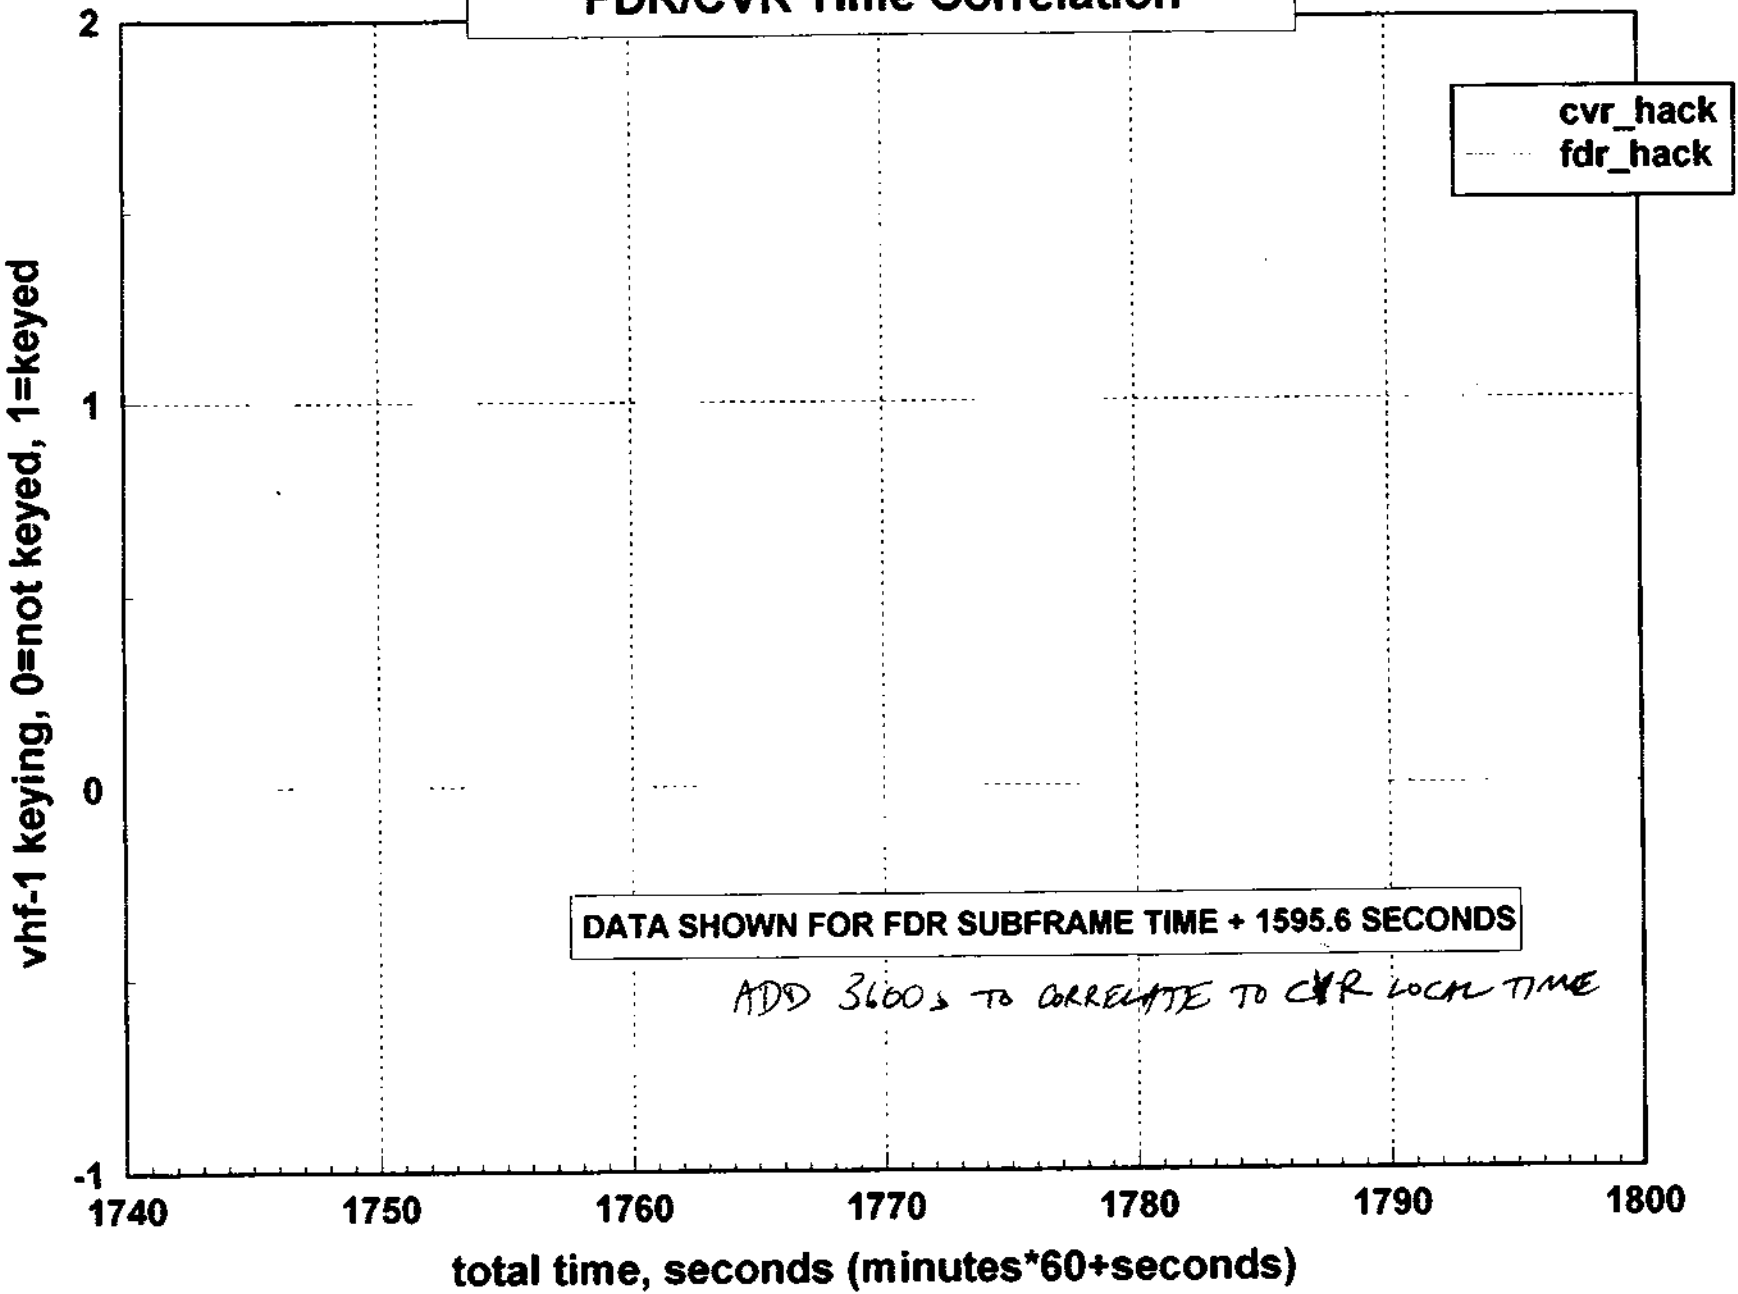
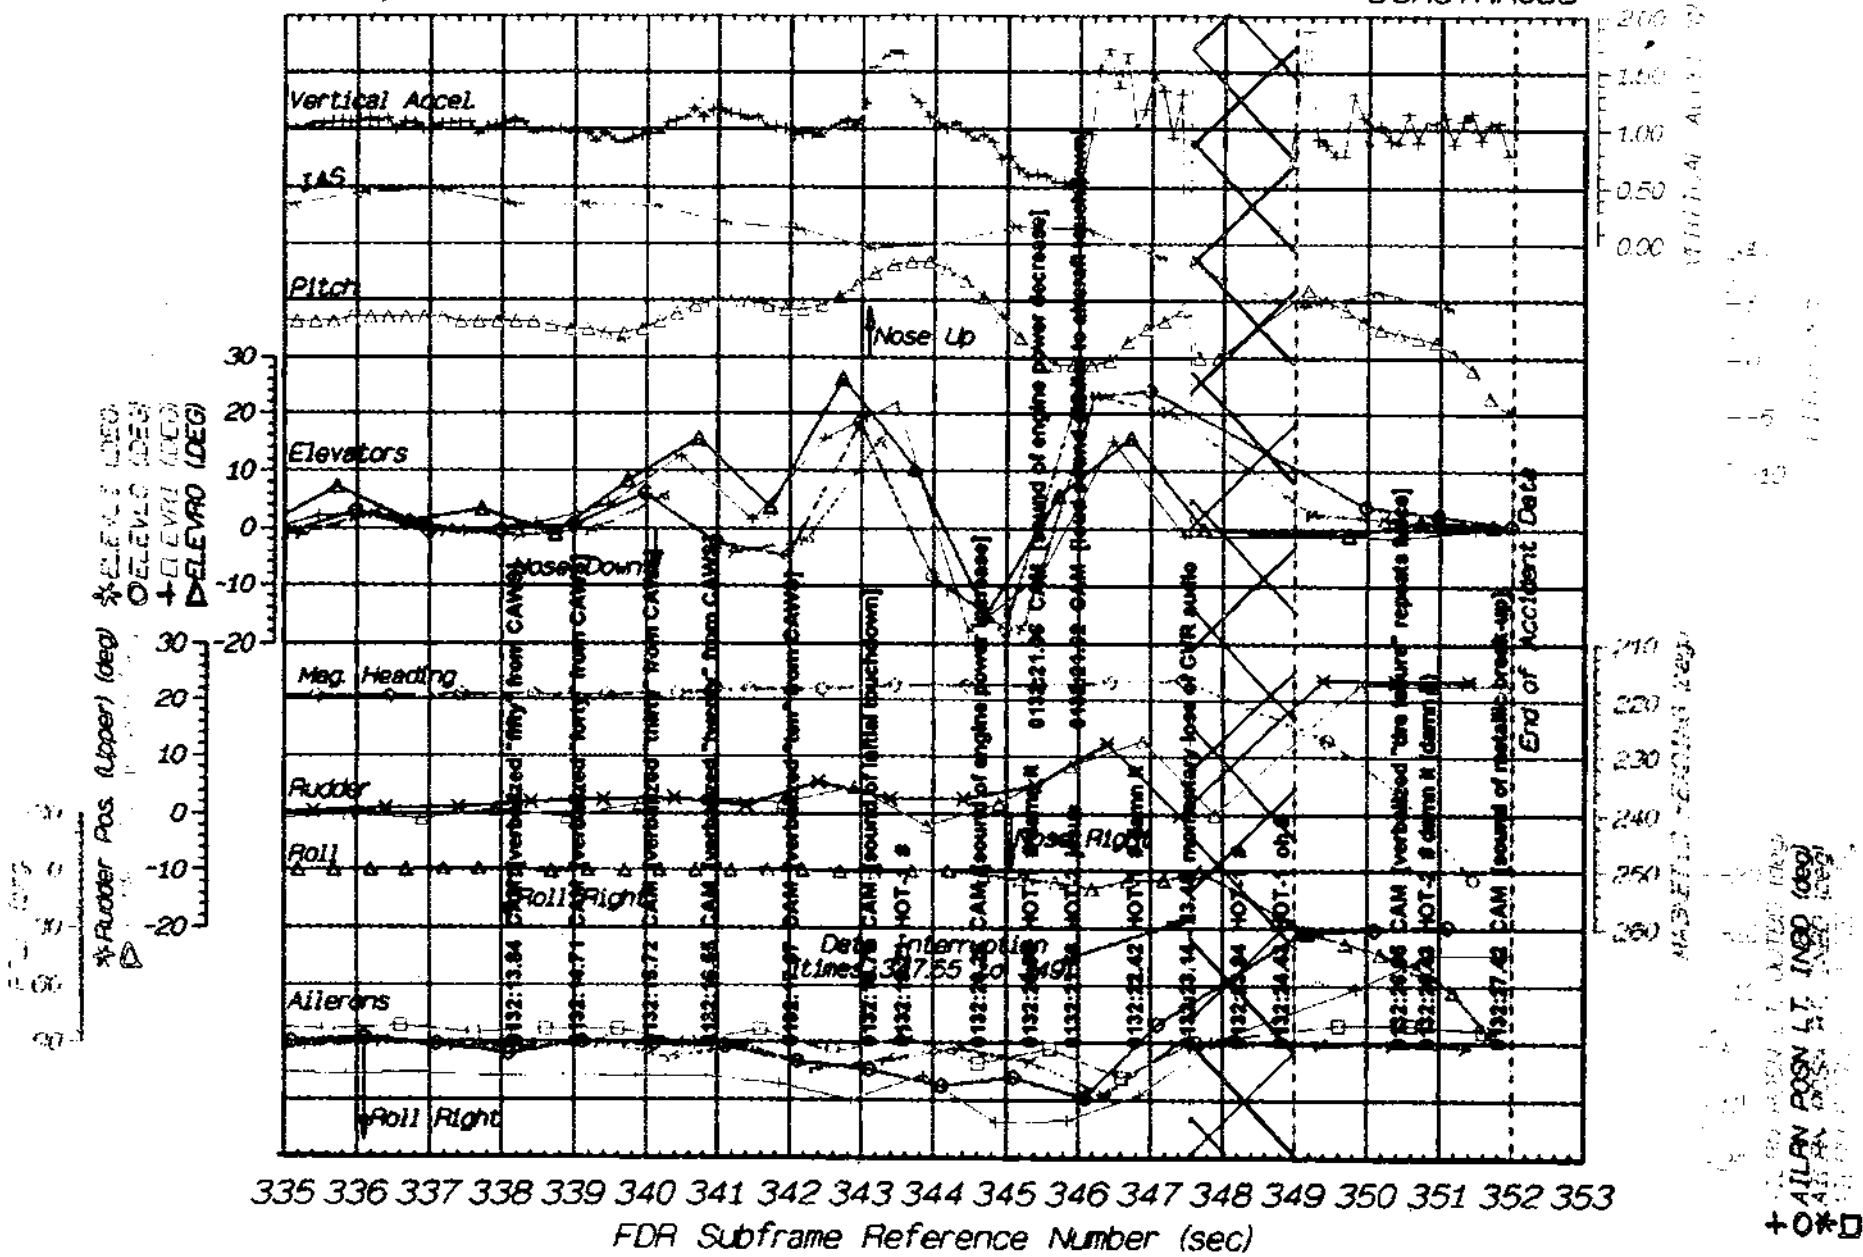
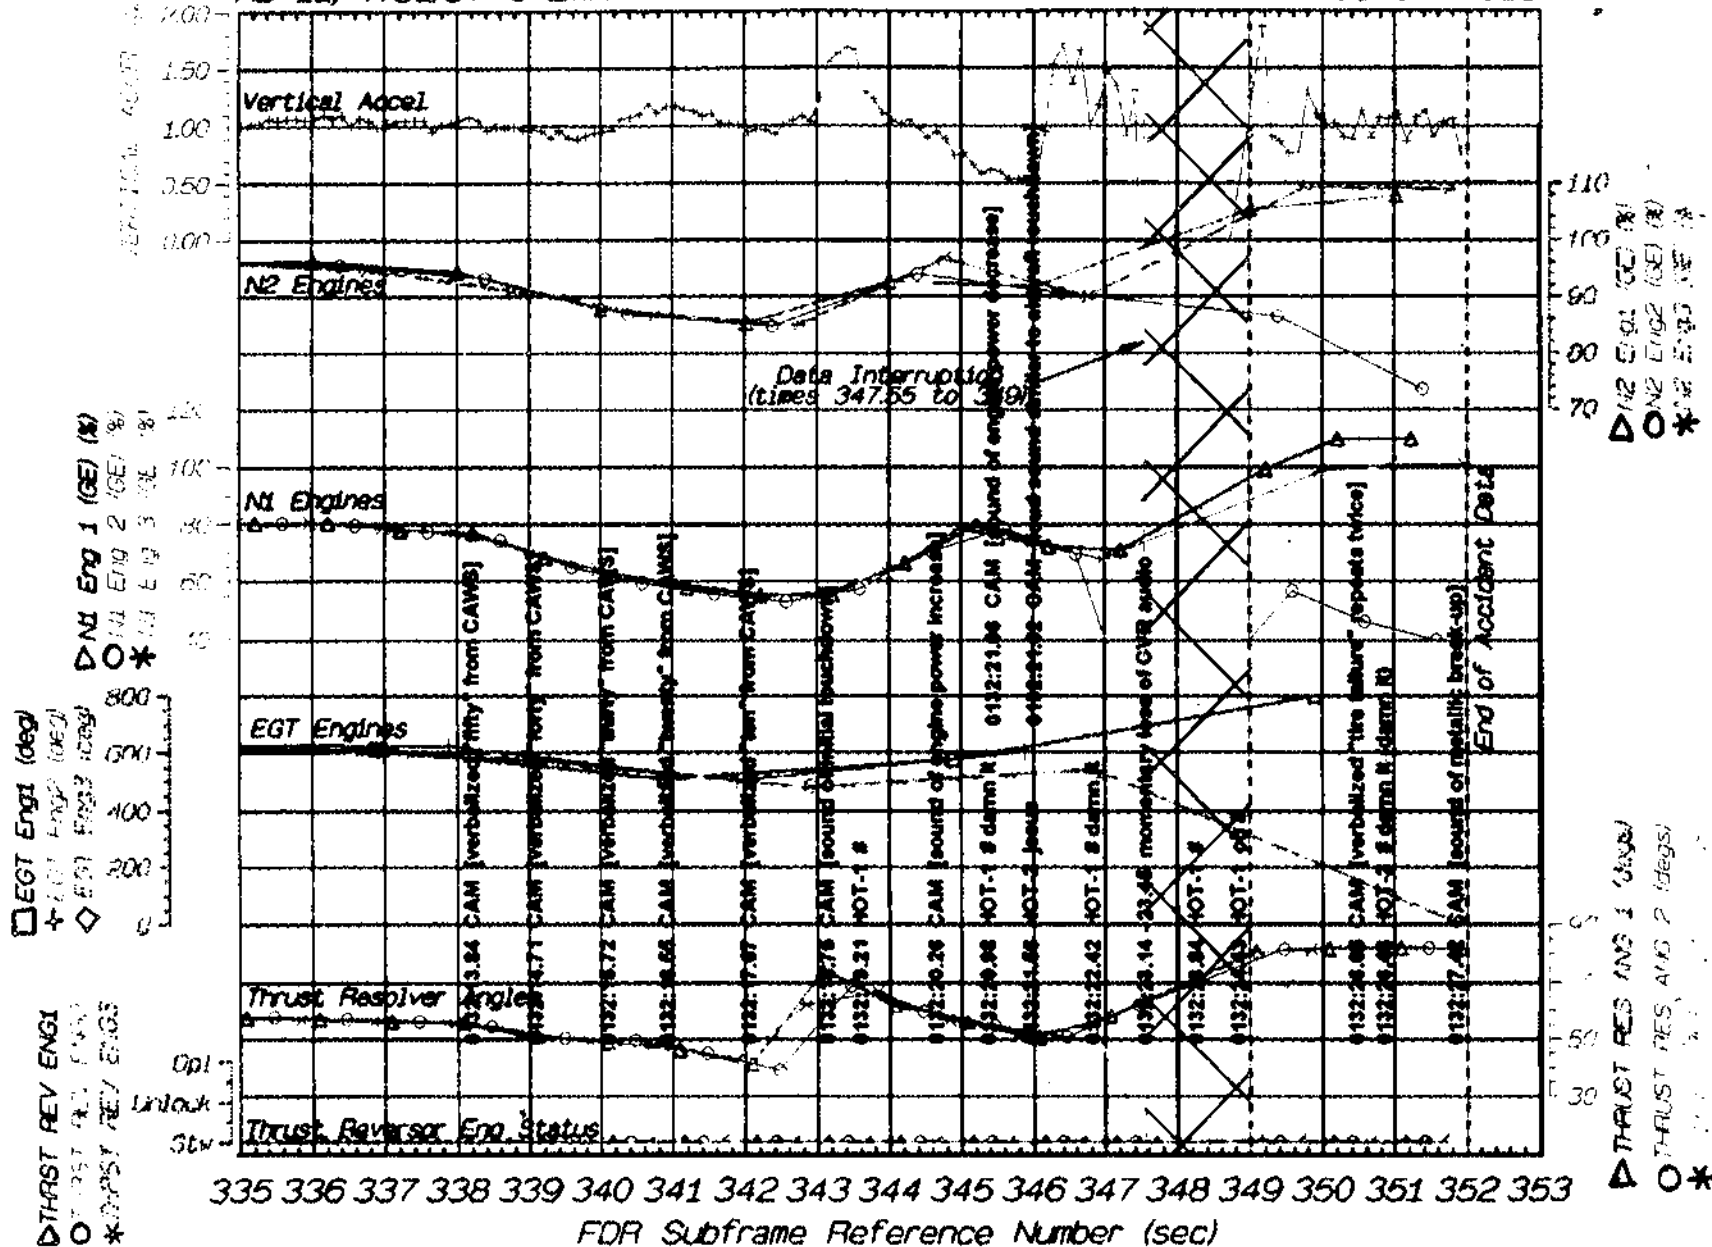
Attachment III

The FDR and CVR data are presented in the FDR and CVR group factual reports. FDR and CVR microphone keying data were aligned in order to establish a time correlation between the FDR and CVR. The alignment established that 5195.6 seconds must be added to the FDR subframe reference number (the readout elapsed time in seconds shown in the FDR Factual Report) in order to correlate with the CVR transcript local time. For example, FDR subframe time 335 correlates to the CVR transcript time of 5530.6 seconds, which is 01:32:10.6 local time. Overlays of CVR transcript excerpts

onto graphs of the FDR data are shown in Attachment III. The overlays show good correlation of key FDR and CVR events.

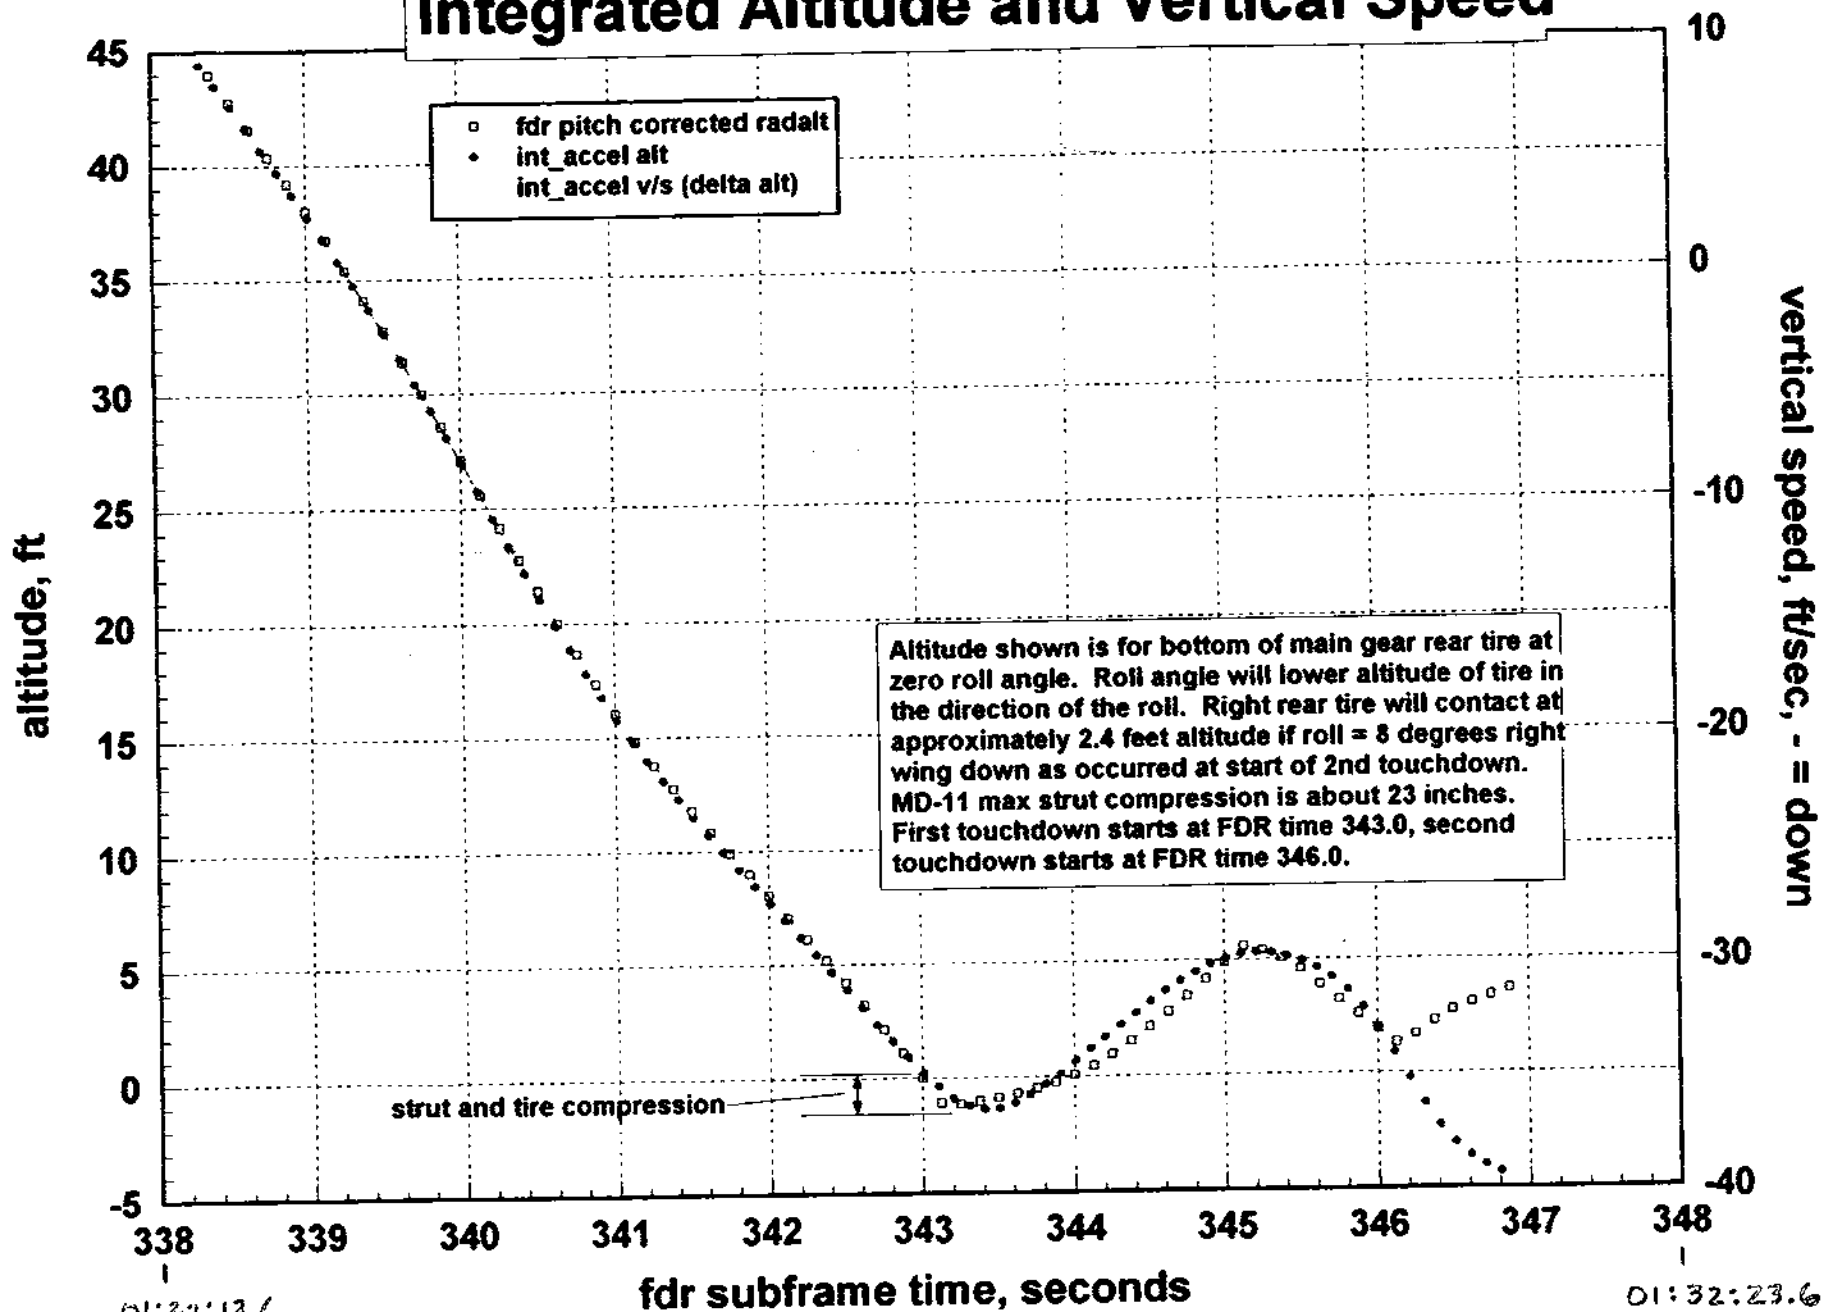
Attachment V

An NTSB computer program was used to calculate airplane vertical speed and position using FDR 3-axis acceleration data and meteorological data. The integrated output (see Attachment V) provides a good match of the FDR pitch-corrected radio altitude⁸ and the times and distances between the 1st and 2nd touchdowns compared to the FDR data and ground scar measurements.

For example, the ground scar data indicate tire marks from the 2nd touchdown were visible 798 feet after the beginning of the tire marks from the first touchdown. The FDR and integration data show about 768 feet and 763 feet, respectively, between the first and second touchdown tire contacts⁹. It is possible that the absolute beginning of the tire marks was not discernable on scene and/or sampling rate limitations or sensor inaccuracies existed, thus the small differences.

The integrated vertical speed of the CG at the first touchdown was 6.6 ft/sec and decreasing rapidly due to the large nose-up elevator input just prior to touchdown. The first touchdown occurred at about 1 degree right wing down (rwd) with 1.4 deg/sec rwd roll rate and 4.2 deg/sec nose-up pitch rate, so the vertical speed at the right main gear at the first touchdown was approximately 7.6 ft/sec. Pitch and roll rates affect vertical

The integrated vertical speed of the CG at the beginning of the 2nd touchdown was 9.7 ft/sec and increasing due to a large nose-down elevator input just after the first touchdown. The beginning of the second touchdown occurred at about 8 degrees rwd with 7.0 deg/sec rwd roll rate and zero pitch rate, so the vertical speed at the right main gear at the beginning of the 2nd touchdown was approximately 11.7 ft/sec. Vertical speed at the CG peaked about 0.2 seconds later at 11.5 ft/sec and assuming that the roll rate remained at 7.0 deg/sec until this point (the twice per second roll angle sample rate of the FDR limits knowledge of roll rate to half second intervals), the result is a peak vertical speed of approximately 13.5 ft/sec at the right main gear.

Within 0.25 seconds of the peak right main gear vertical speed, lateral acceleration increased 0.3 g and the roll angle decreased to 4.6 degrees rwd. This corresponds in time and distance to the point on the runway where the right main landing gear tire marks oscillate and swerve rapidly to the right, followed immediately by contact of the right engine nacelle with the runway, loss of wing/flap structure, and spilling of fuel. Thus, the right main landing gear and/or wing structure experienced some form of structural failure within approximately 0.45 seconds of the beginning of the second touchdown and within 0.25 seconds of the calculated peak vertical speed. The right engine cowling then contacted the runway, and the right wing began breaking away from the fuselage.
