National Transportation Safety Board
Office of Research and Engineering
Washington, D.C. 20594

Airplane Performance Study *gtr*

NTSB #: DCA97MA055
Location: Newark, New Jersey
Date: July 31, 1997 0131
Time: Approximately 0132 local time
Operator: Federal Express
Aircraft Type: McDonnell Douglas MD-11, N611FE

Federal Express MD-11
Newark, N.J. (EWR) 7/31/97

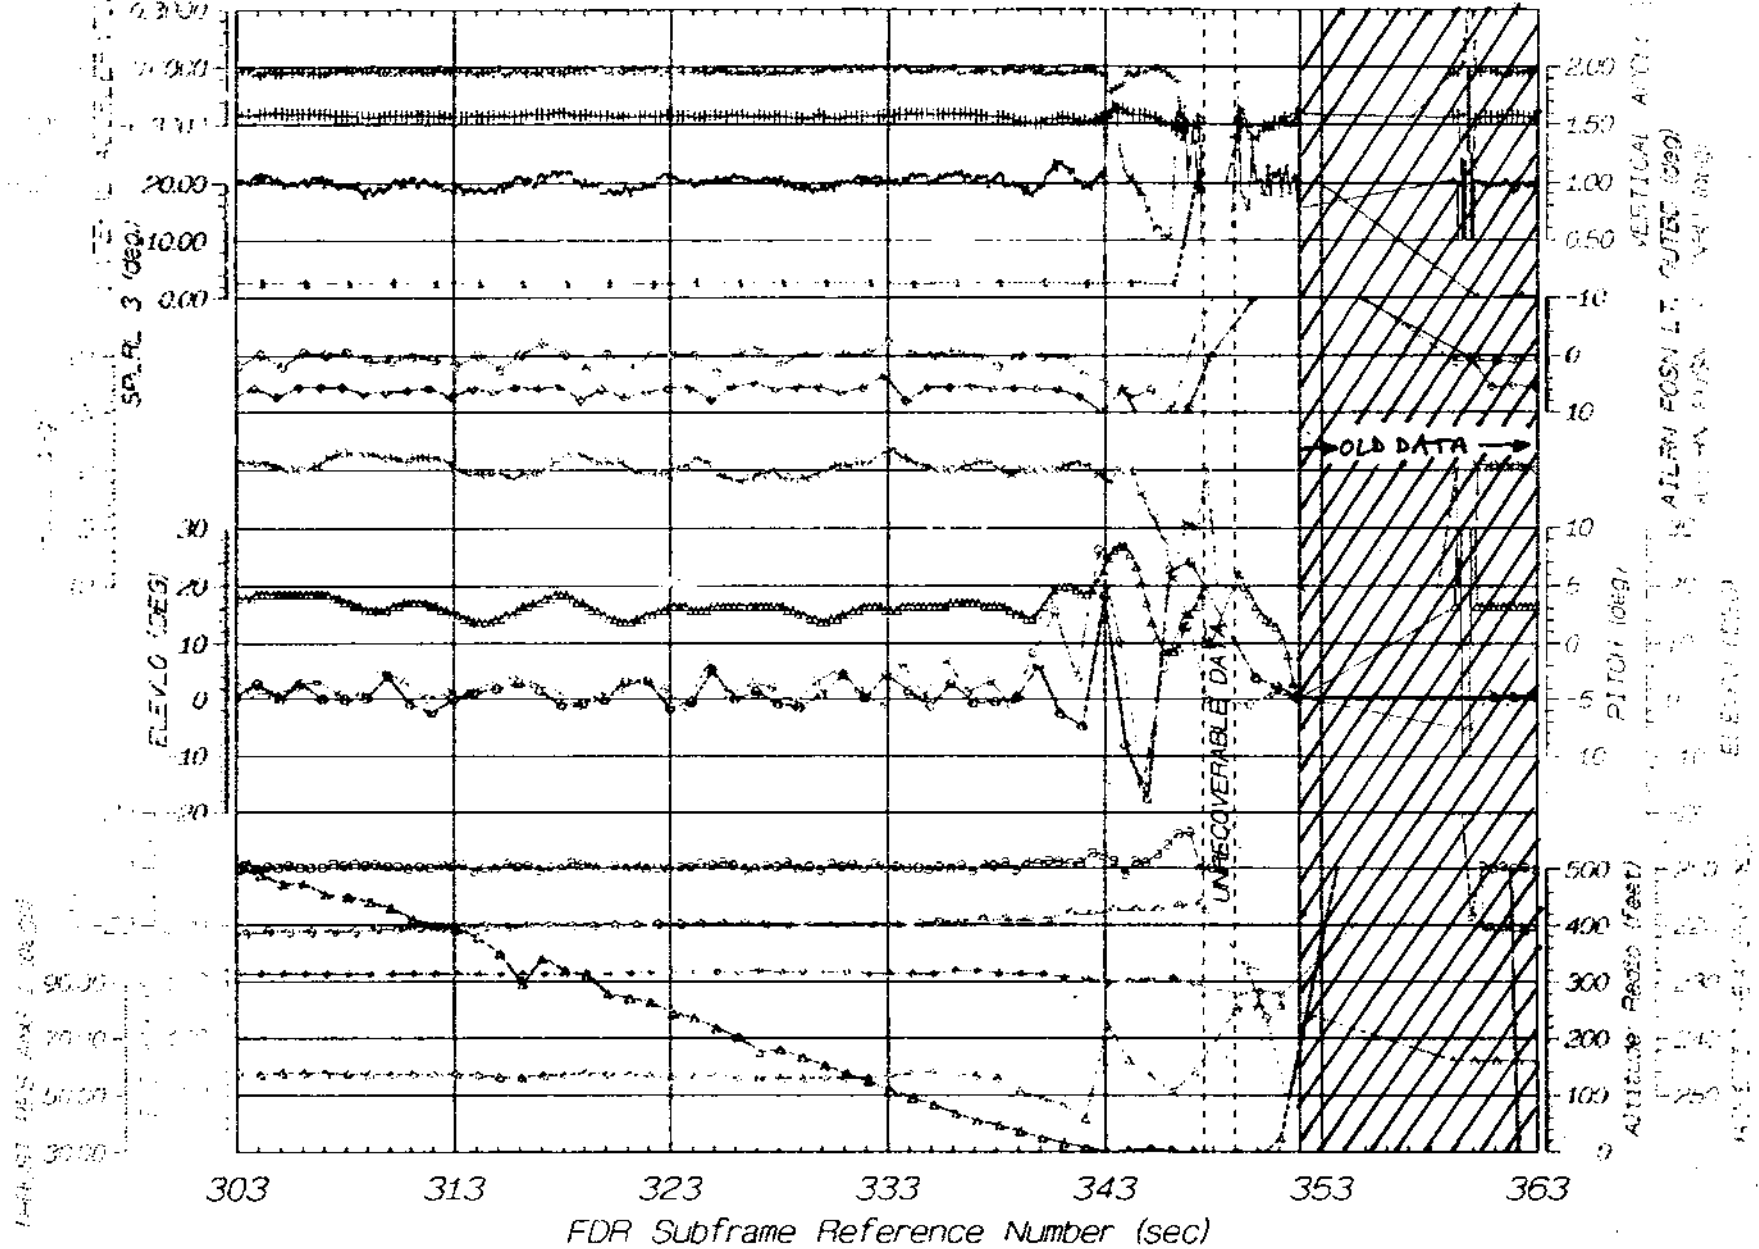
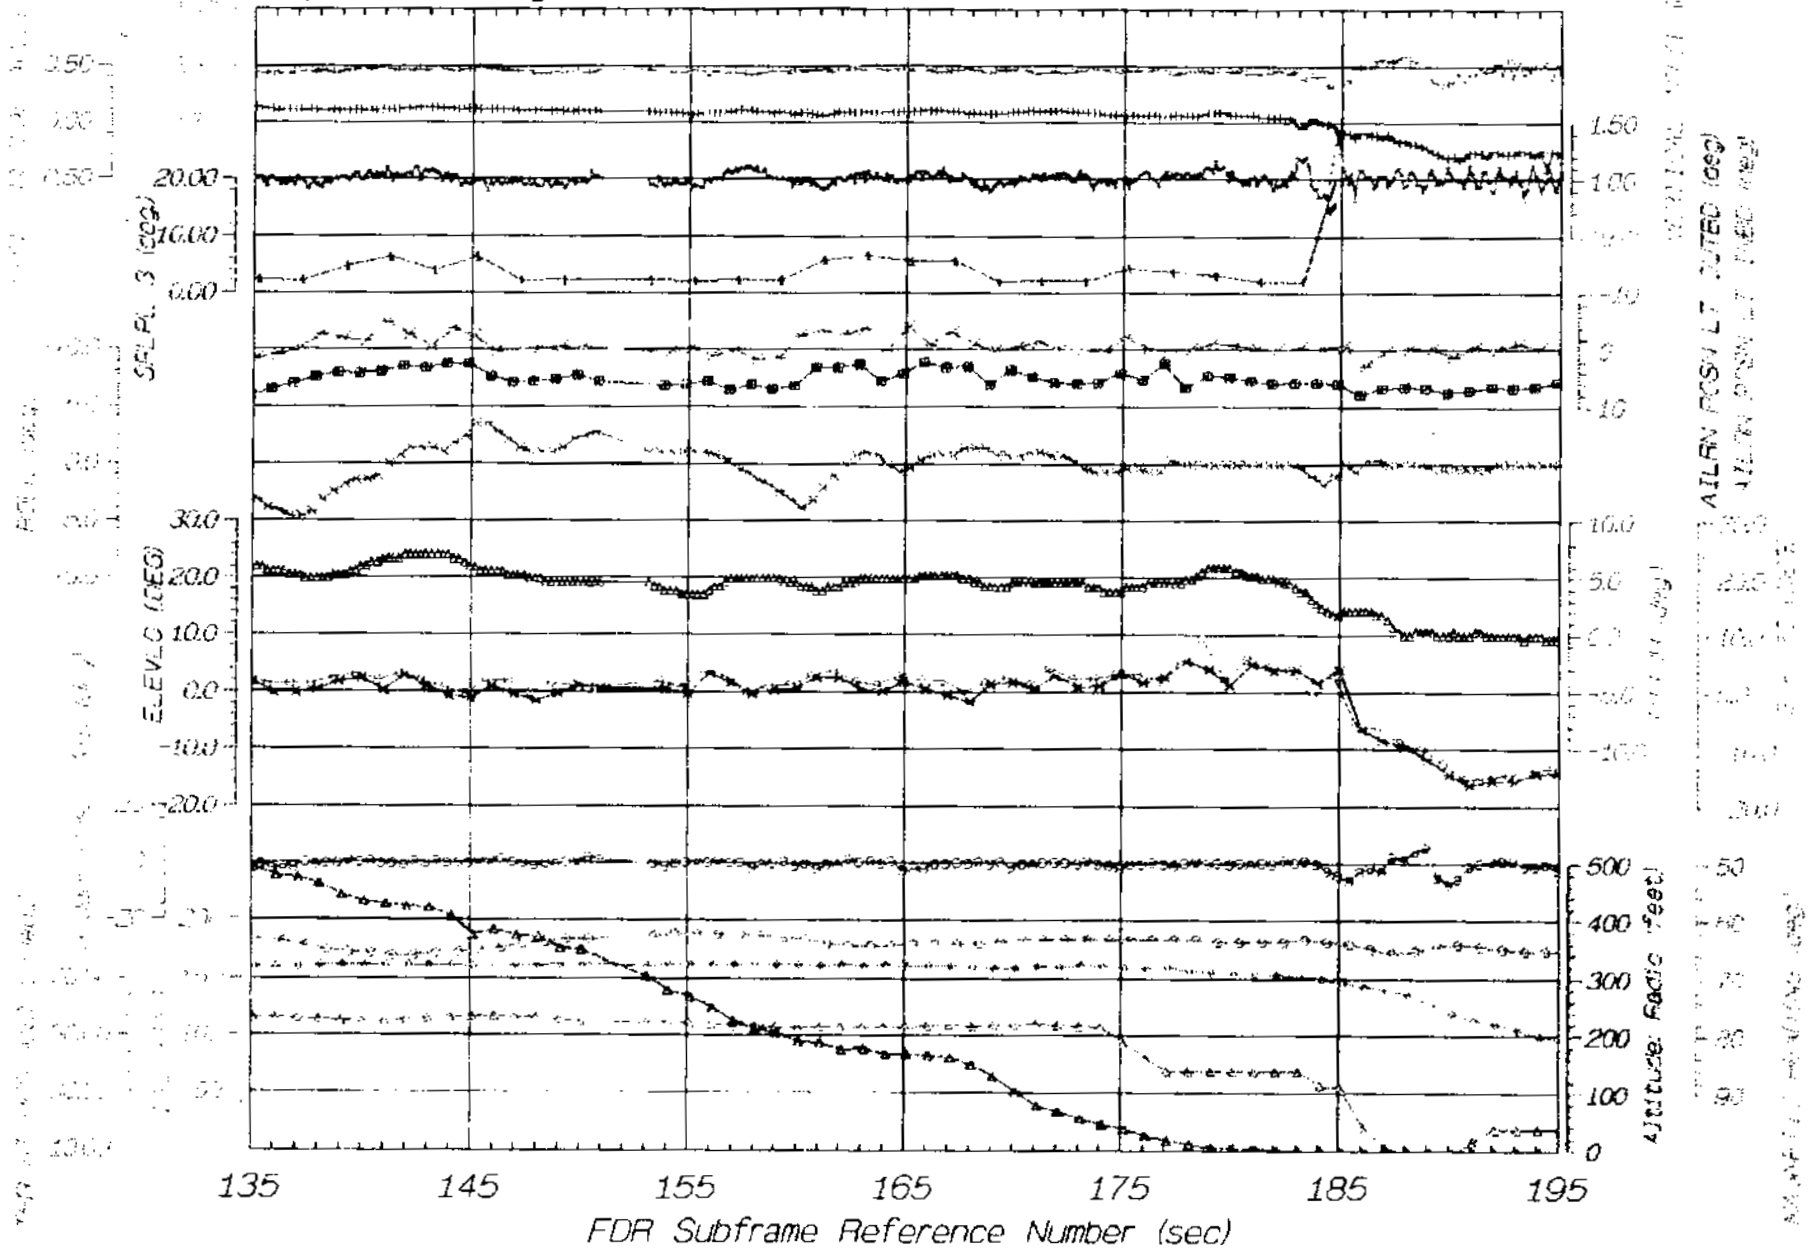
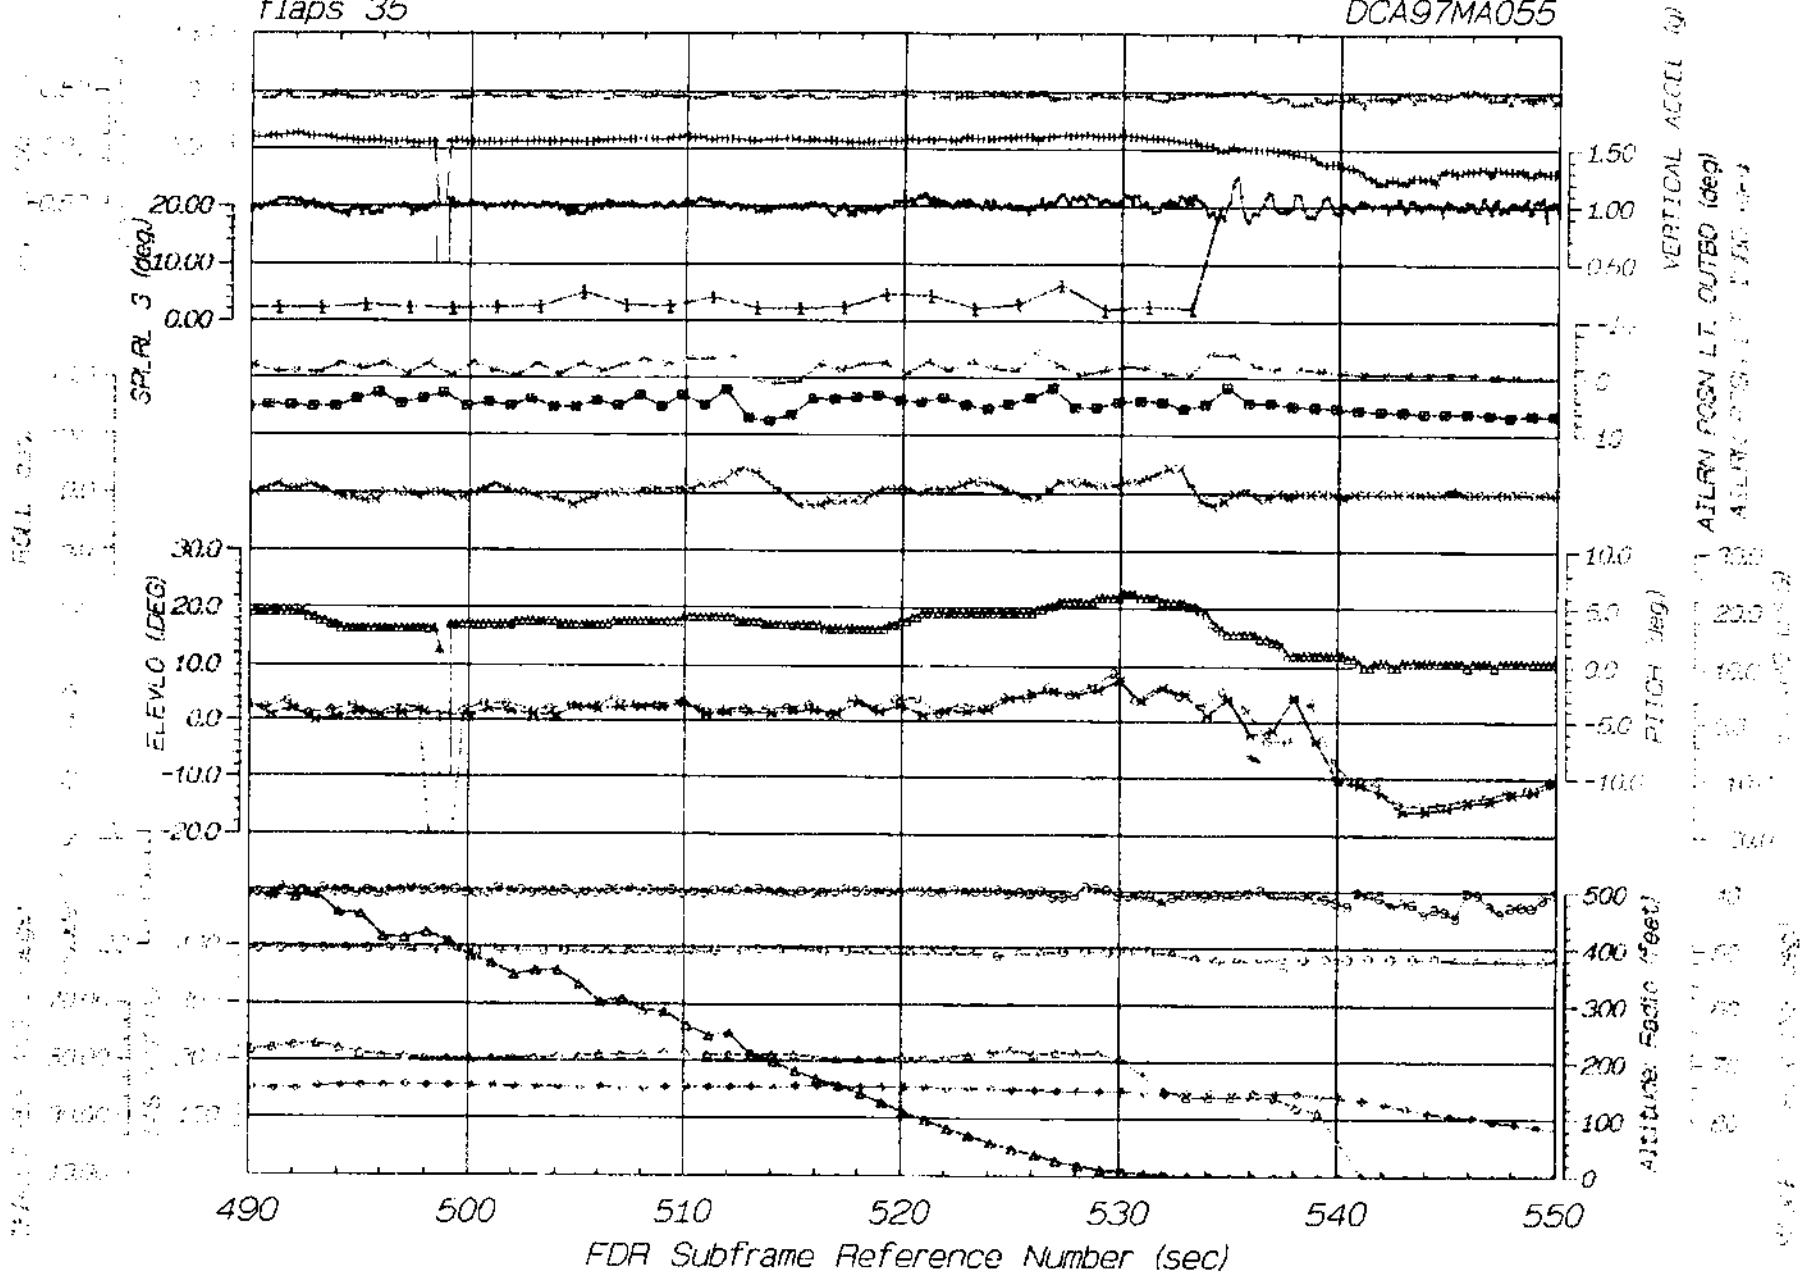
Attachment VI

Graphs of FDR data for the accident landing and the 2 previous landings are presented in Attachment VI. The data for the 2 previous landings show less than 40% of the pre-touchdown elevator deflection magnitude seen in the accident landing, less than 20% of the pre- and post-touchdown elevator deflection rates seen in the accident landing, and no throttle resolver angle and thrust increases just prior to or after touchdown. Thus, the previous successful landings show much smaller, slower control inputs than the accident landing. Additionally, the previous successful landings do not show any control inputs consistent with an attempt to rapidly decrease vertical speed just prior to touchdown.
