National Transportation Safety Board
Office of Research and Engineering
Washington, D.C. 20594

Performance Study

Location: Santa Monica, California
Date: September 29, 2013
Time: 1820 PDT
Airplane: Cessna 525A Citation, N194SJ
NTSB Number: WPR13FA430

Performance Study
WPR13FA430, Cessna 525A Citation, N194SJ

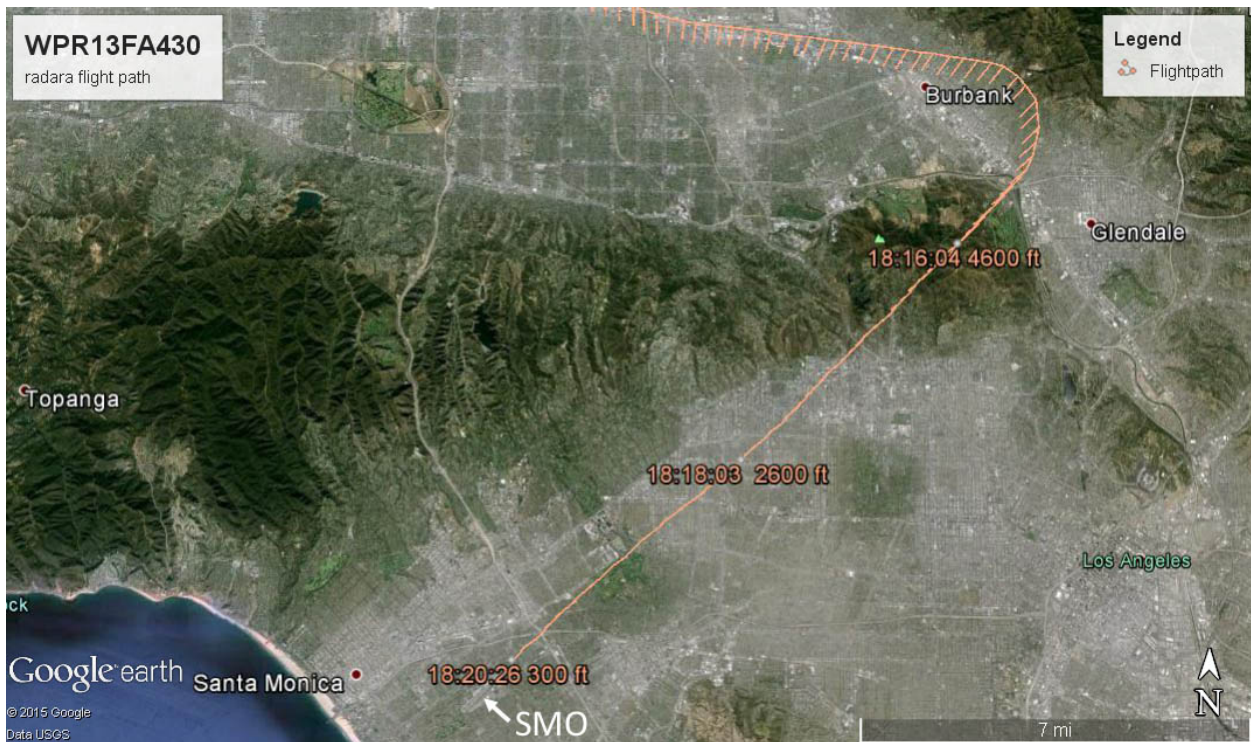
The aircraft’s flight on approach into SMO is shown in Figure 1. The last radar return was recorded at 18:20:26 PDT, about 1500 ft before the airport threshold.

Figure 1. Aircraft approach flight path from LAXA radar.

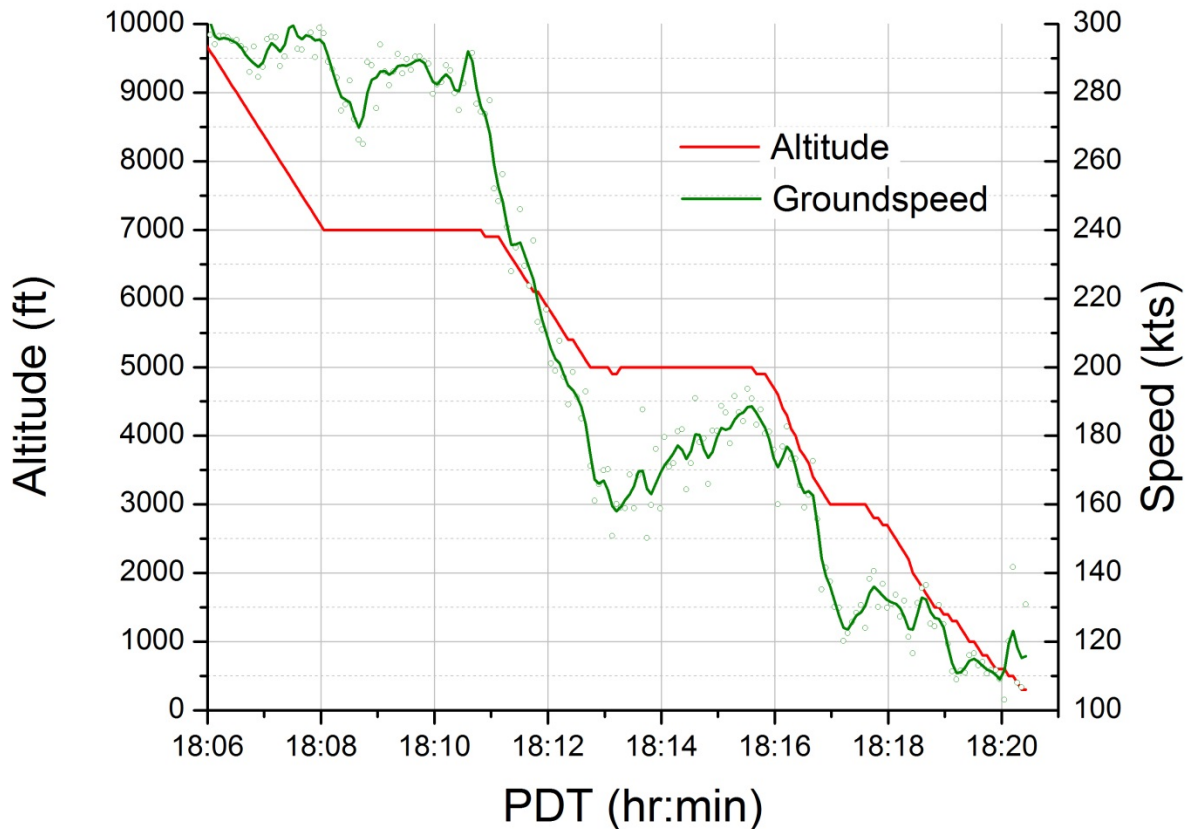
The aircraft's groundspeed was calculated from radar and is shown versus time in Figure 2. Its final groundspeed was about 115 kts. Wind was, as stated above, 4 kts from 240°, which would have added a slight headwind when landing on runway 21. The approach speed (V_{APP}) for the 525A for 15° of flaps is between 98 kts indicated airspeed (for 8000 lbs landing weight) and 122 kts (for 12375 lbs landing weight) [1].

Figure 2. Aircraft altitude and groundspeed for final 14 minutes of flight.

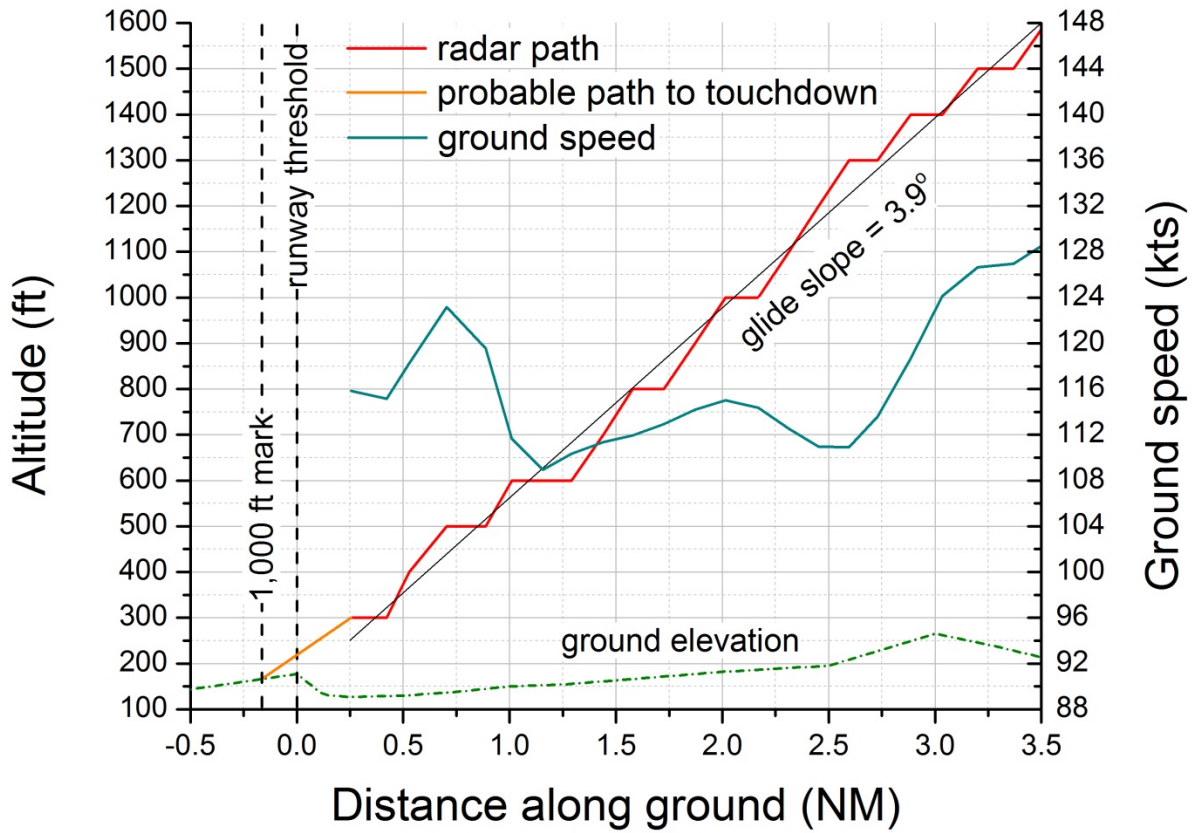
Figure 3 shows the altitude and groundspeed versus ground distance for the final 3.5 NM of the flight. The aircraft's glide slope was 3.9°. Runway 21 at SMO has a four light precision approach path indicator (PAPI) for a 4.00° glide slope. The tower controller reported that the airplane landed normally in the designated touchdown zone, abeam the tower and 1000 ft from the threshold [2]. The path from the last radar return to the 1000 ft mark is shown in orange on Figure 3. The glide slope of this last 2500 ft of flight was about 3°.

Figure 3. Aircraft altitude and groundspeed for final 3.5 NM of approach.

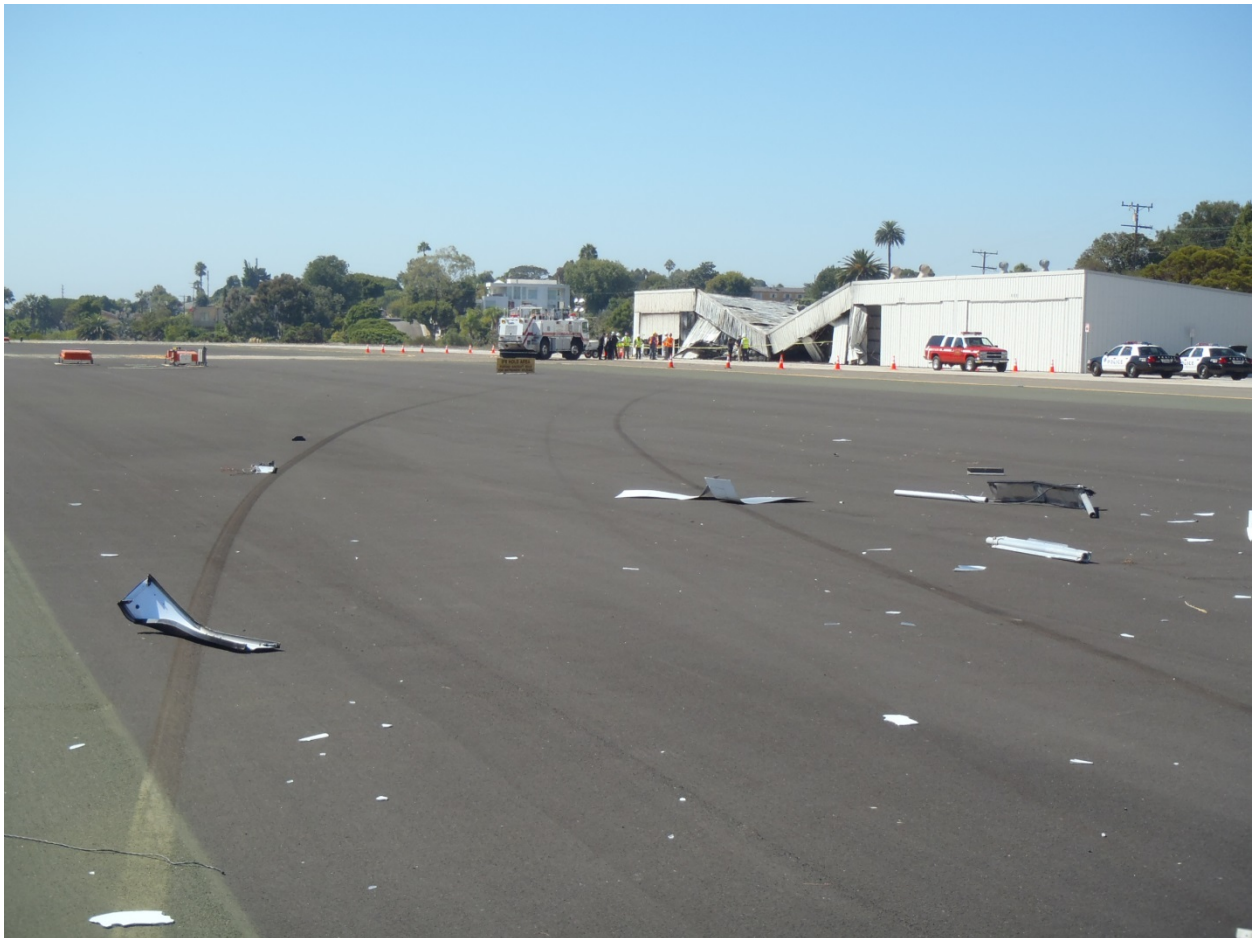
The rubber tire marks left by the aircraft on the runway and other paved surfaces were photographed and their locations recorded. The first tire mark was found about 2800 ft from the threshold of runway 21 and 35 ft right of the centerline. Figure 4 shows a photograph of one set of tire marks left by the accident aircraft. The aircraft's path was determined by connecting the recorded tire marks and is shown in Figure 5. Aircraft braking causes rubber from the tires to be deposited onto the runway.

Figure 4. Tire marks from the left and right main gears. The nose gear mark is lighter and closer to the right main tire mark. The hanger the aircraft impacted is in the top right of the picture.

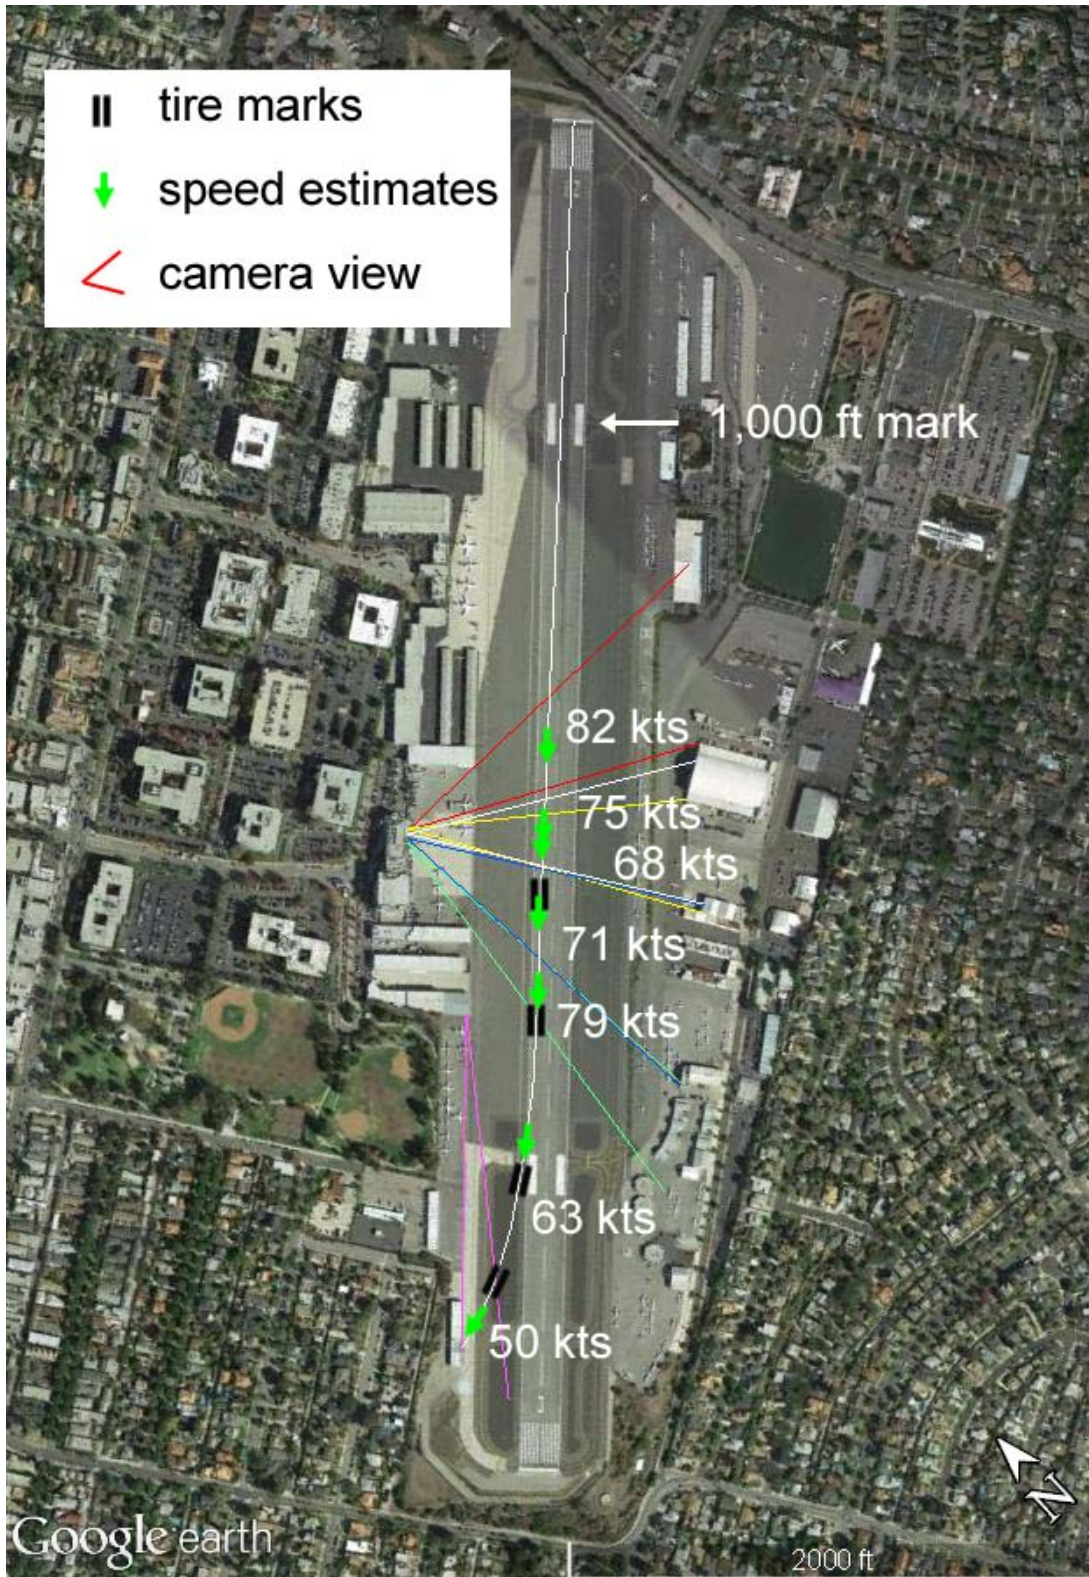
Six security cameras at the Santa Monica Municipal Airport recorded the accident aircraft. The aircraft was first recorded on video approximately 2000 ft from the runway threshold. The average speed of the aircraft was estimated for each camera recording and once for between camera views. The estimated speeds in knots are shown in Figure 5, below. The details of the speed calculations can be found in the NTSB Video Study [3]. The calculated speeds in Figure 5 do not uniformly decrease due to the uncertainty of estimating the speed from video. Additional configuration information, such as flap or spoiler settings or thrust reverser deployment could not be determined from the video due to low resolution.

Figure 5. Recorded tire marks shown (not to scale) in black. Speed estimates from the Video Study are shown in knots next to green arrows. The projected ground roll path is shown as a white line. The arc of the camera views are shown as colored lines.

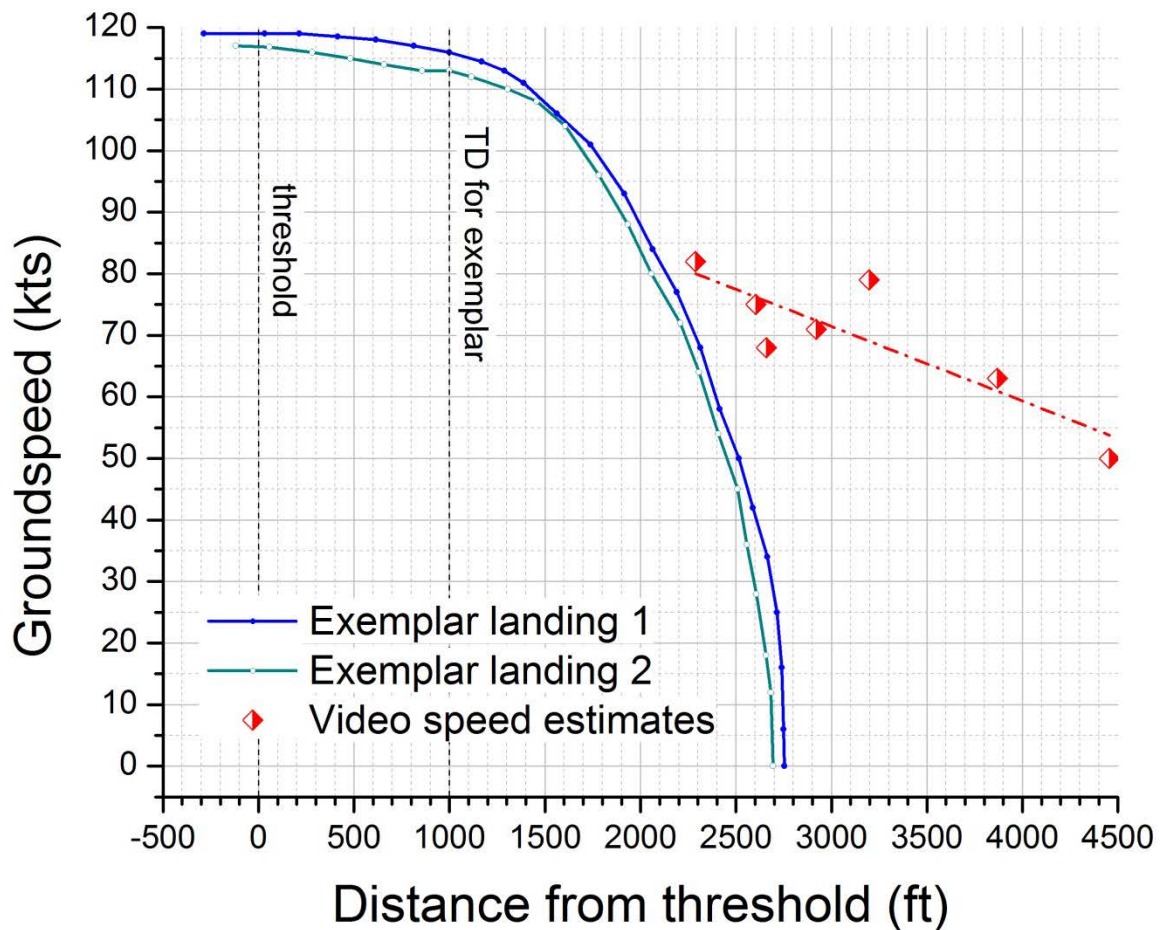
Cessna Aircraft Company provided data from two exemplar landings and ground rolls for a Citation 525A. The data included distance along the runway, calibrated airspeed, GPS speed, left and right brake pressures, brake pedal inputs, and flaps. To compare the exemplar and the accident aircraft landings and ground rolls, it was assumed that all aircraft touched down at the 1000 ft mark, as reported by the tower controller. Figure 6, below, shows the ground speed versus runway location for all three ground rolls.

Figure 6. Groundspeed versus distance from threshold for two exemplar landings and ground roll (blue and green lines) and the accident aircraft speed estimates (red points). Also included are the tire marks along the accident aircraft ground roll.

The first speed estimate is about 10 kts faster than the exemplar ground rolls at the same location. This may indicate that during the first 1000 ft of the ground roll, the accident aircraft was decelerating near as expected. The exemplar aircraft slowed to a stop more than 1700 ft before the accident aircraft impacted the hanger.
