**National Transportation Safety Board**  
Office of Research and Engineering  
Washington, D.C. 20594

**Performance Study**

Location: New York, New York  
Date: March 5, 2015  
Time: 1102 EST, 1602 UTC  
Airplane: MD-88, N909DL, Delta Flight 1086  
NTSB Number: DCA15FA085

**Performance Study  
DCA15FA085, MD-88, N909DL, Delta Flight 1086**

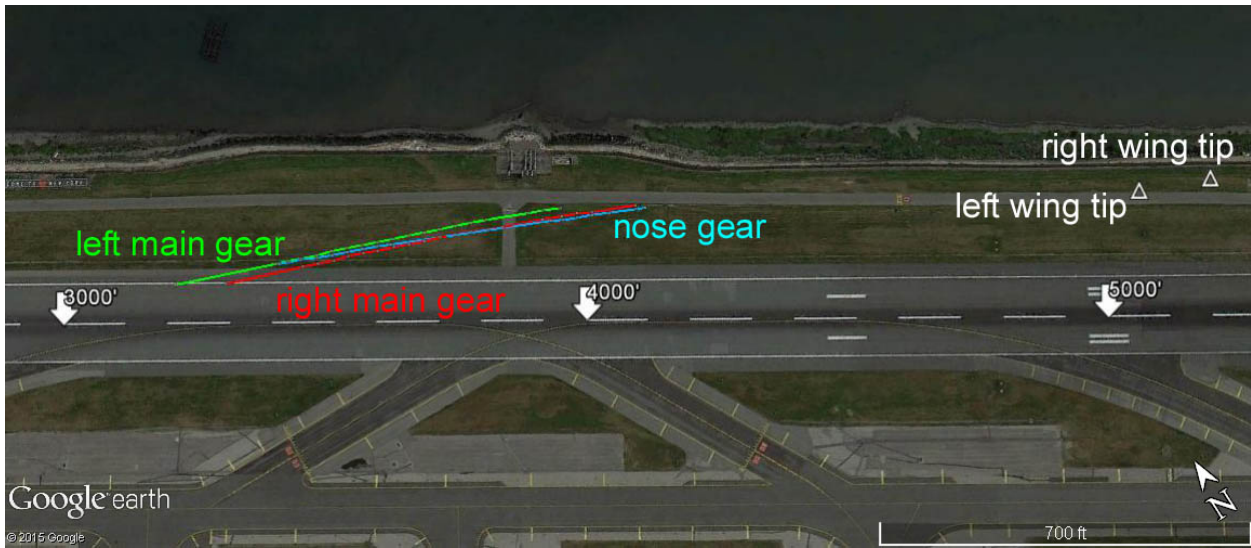
The aircraft left a series of witness marks on the tarmac and through the soft ground between runway 13 and the access road along the sea wall. The witness marks were surveyed and are shown in Figure 3. Figure 4 overlays the SMR path with the ground marks and the aircraft's final resting point. The SMR ground track, the ground marks, and the aircraft location showed good agreement.

**Figure 3.** Ground marks from left main gear (green), right main gear (red), and nose gear (blue). The 3000, 4000, and 5000 ft points on the runway are shown by white arrows.

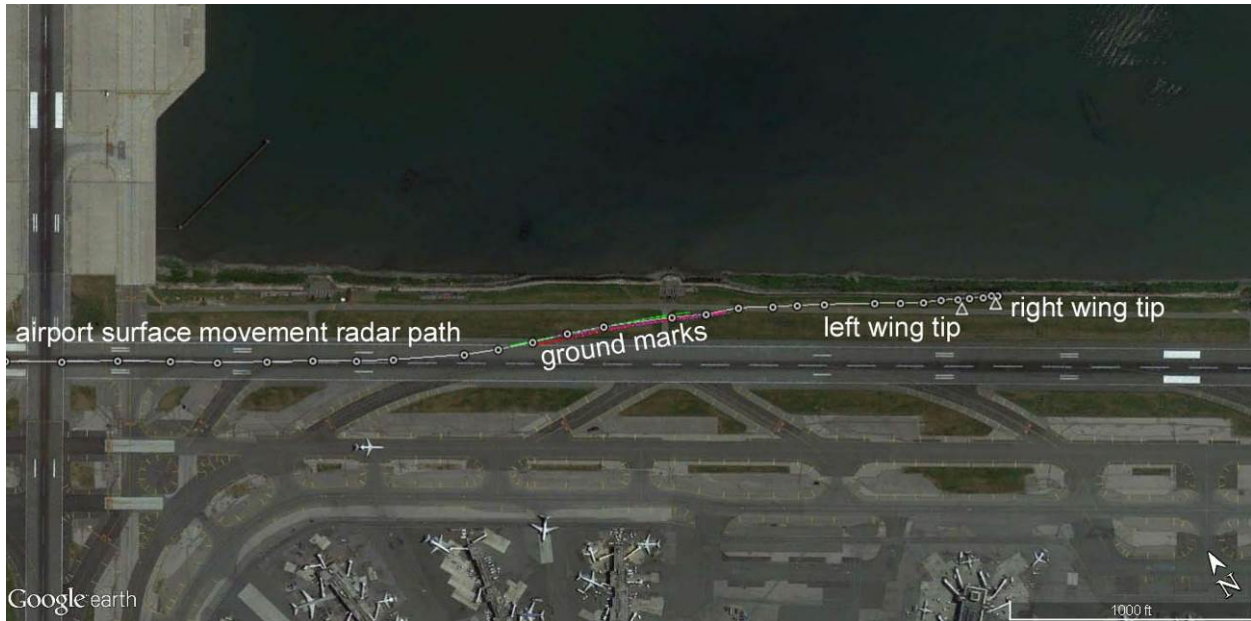
**Figure 4.** Airport surface movement radar path, recorded ground marks (pink and green), and final location of aircraft.

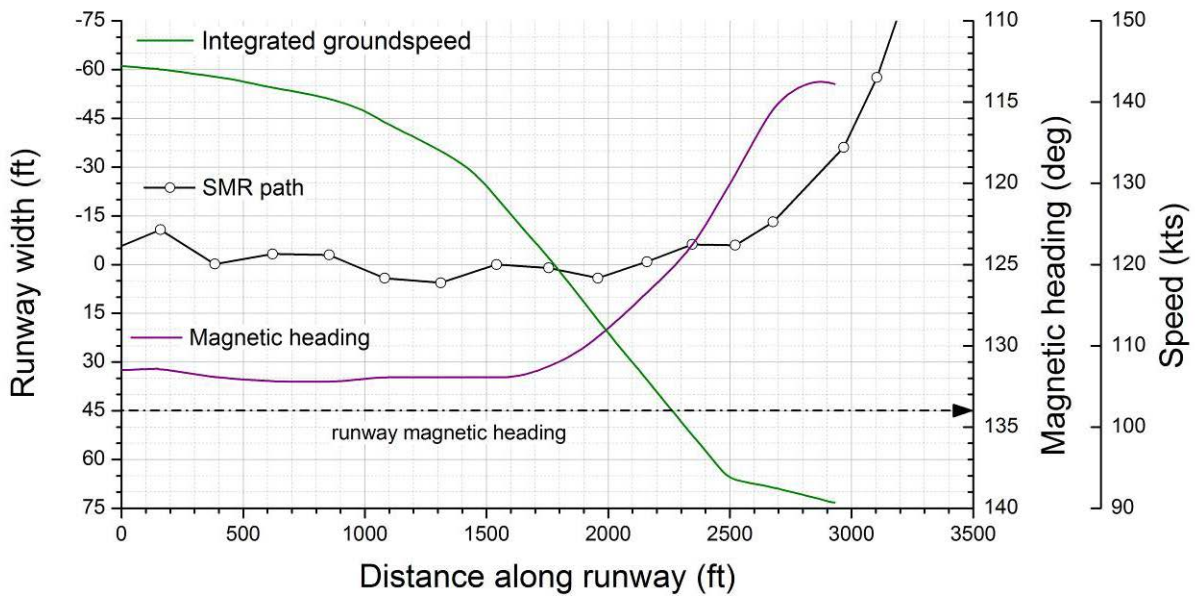
The aircraft touched down within 5 ft of the runway centerline according to SMR shown in Figure 18 and Figure 19. The aircraft did not deviate from the centerline more than  $\pm 5$  ft until 2300 ft down the runway (1700 ft and 8 seconds after main gear touchdown). At 1600 ft the heading began to move further left, leading the centerline departure by 700 ft and four seconds. The aircraft’s ground speed at touchdown was about 140 kts. Its groundspeed at 2500 ft was 93 kts. The aircraft left the runway 3200 ft from the threshold.

**Figure 18.** Radar path on runway and magnetic heading versus distance. The aircraft's main gear touched down 600 ft from the threshold.

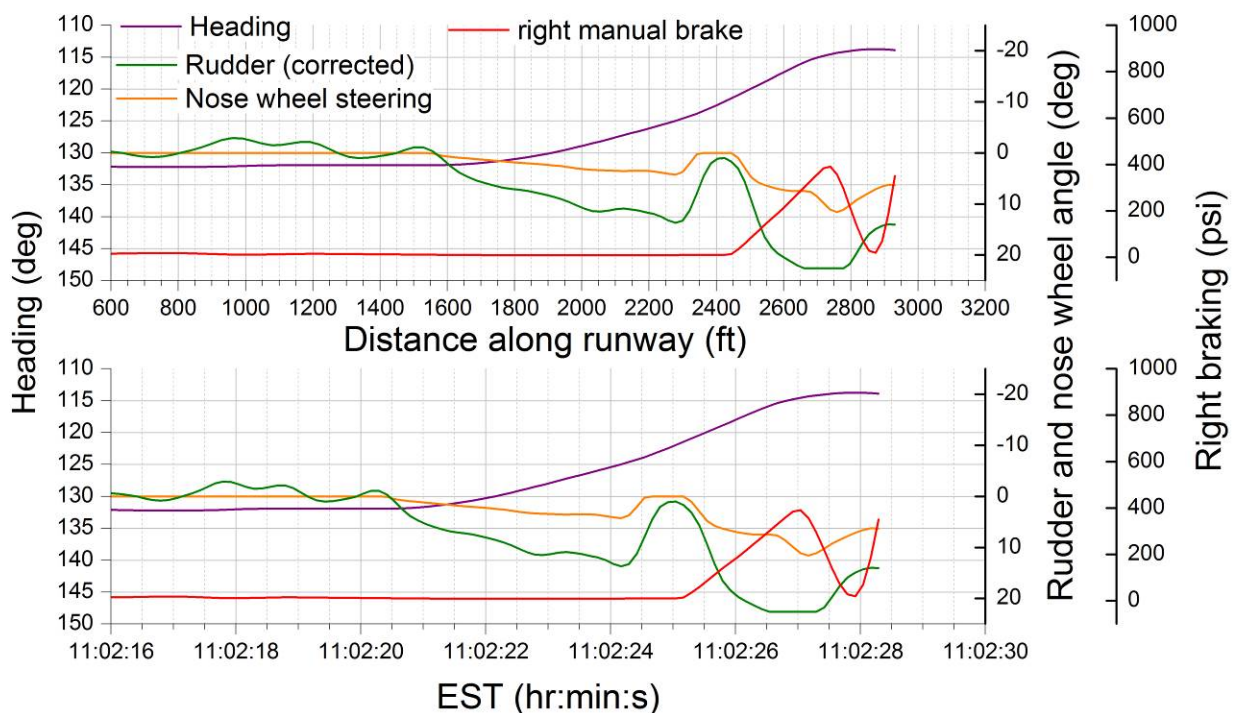
The crew began applying right rudder at 1600 ft and 11:02:20.5 as shown in Figure 20. Due to an intermittent electrical issue [1], the rudder deflection parameter on the FDR had numerous drop-outs during the landing roll and had to be corrected. The corrected data is shown in Figure

20. The crew applied increasing opposing rudder as the aircraft turned to the left, briefly releasing the rudder at about 11:02:24, before applying maximum rudder deflection (23°).

**Figure 20.** Aircraft rudder application, nose wheel steering, right manual braking, and heading versus distance and time.<sup>2</sup>

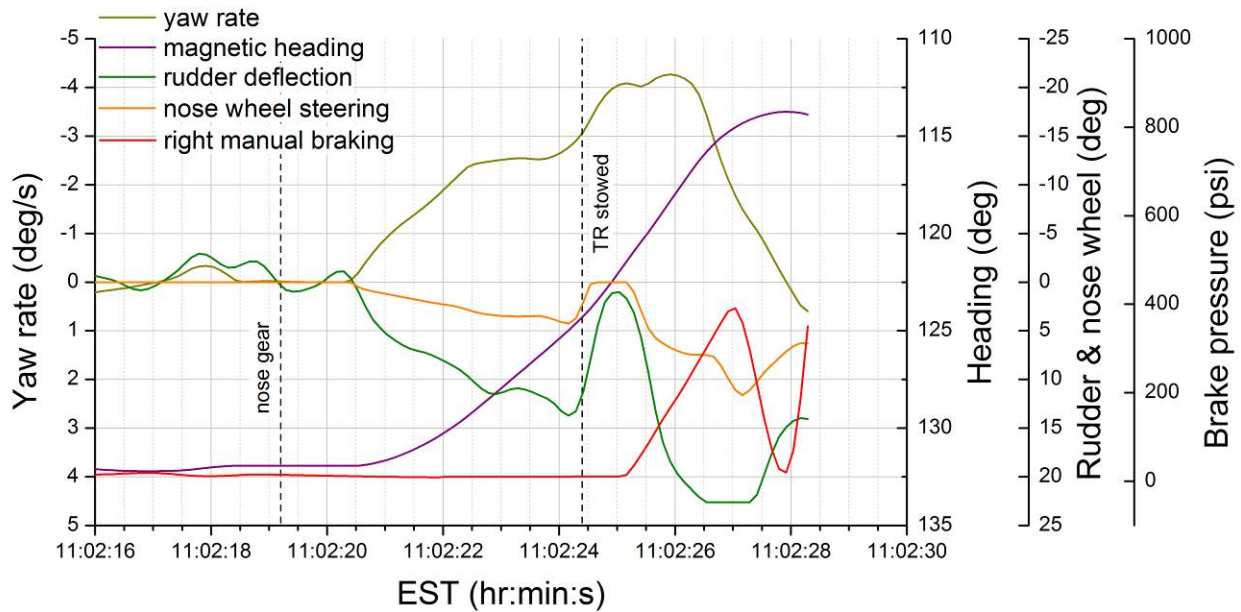
As discussed in the *Deviation from Runway Heading* section, the FDR recorded the crew inputting right rudder and differential right braking during the heading deviation. Figure 26 shows the calculated aircraft yaw rate during the landing roll. The left yaw rate began at about 11:02:20.5 and the pilot applied right rudder simultaneously. Calculated nose wheel steering increased with the increase in rudder pedal, plateauing at about 3.5° before 11:02:24 when the rudder pedal was released, causing both rudder deflection and calculated nose wheel steering to drop. At approximately the same time, thrust reversers were stowed. At about 11:02:25, right rudder pedal returned and right rudder increased to its maximum deflection by 11:02:26.5. Right manual braking was also applied at 11:02:25. The data was truncated at 11:02:28 in the figure as discussed earlier, but right manual braking continued to increase to about 1100 psi (Figure 13) as the aircraft left the paved runway by about 11:02:30.

**Figure 26.** Calculated aircraft yaw rate, heading, rudder and nose wheel steering, and right manual braking during heading deviation.

As noted previously in Figure 26, there was an arrest of the left yaw rate during the landing roll with the right rudder and the right nose wheel steering were applied, but before any differential braking was applied (autobrakes were still active). The rudder would have been considered ineffective because of the high EPR in reverse thrust at the time. The arrest of the yaw rate at that time suggests that the nose wheel was reacting to the rudder pedal input as expected and providing a counteracting yawing moment. It seemed unlikely that the nose wheel steering contributed to the initial left yaw.

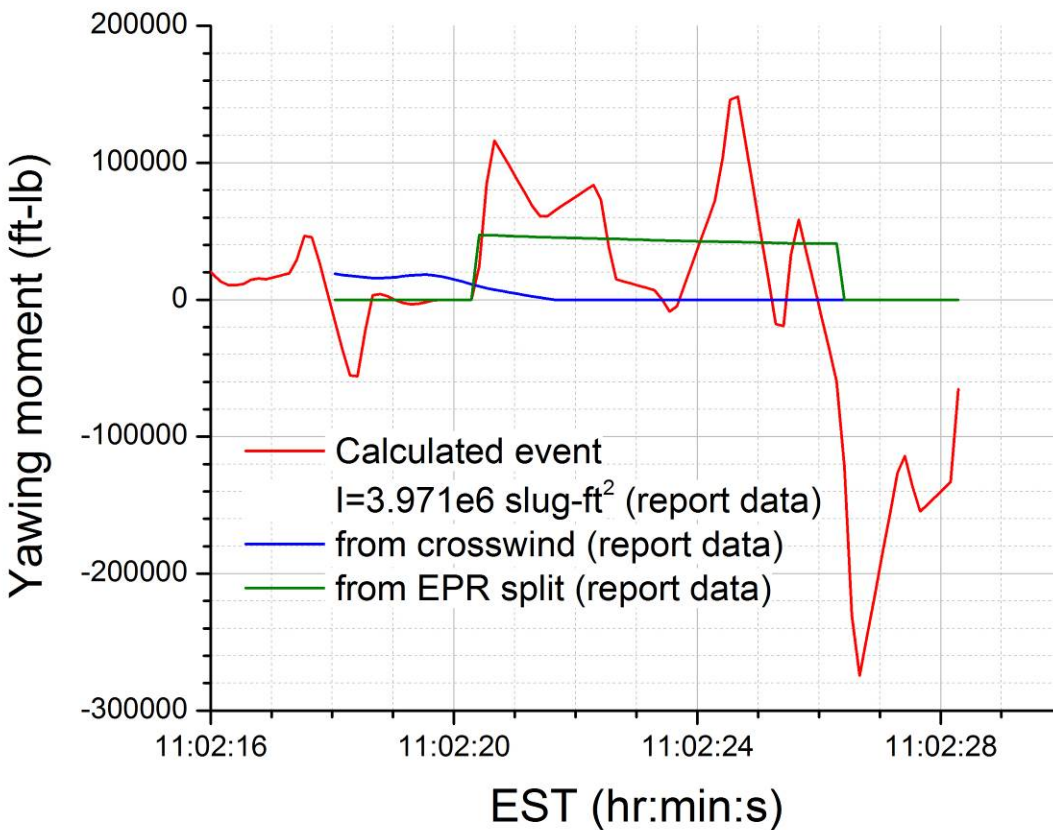
**Figure 29.** Calculated yawing moment (red line) and possible yaw moments from crosswind (blue) and EPR split (green).

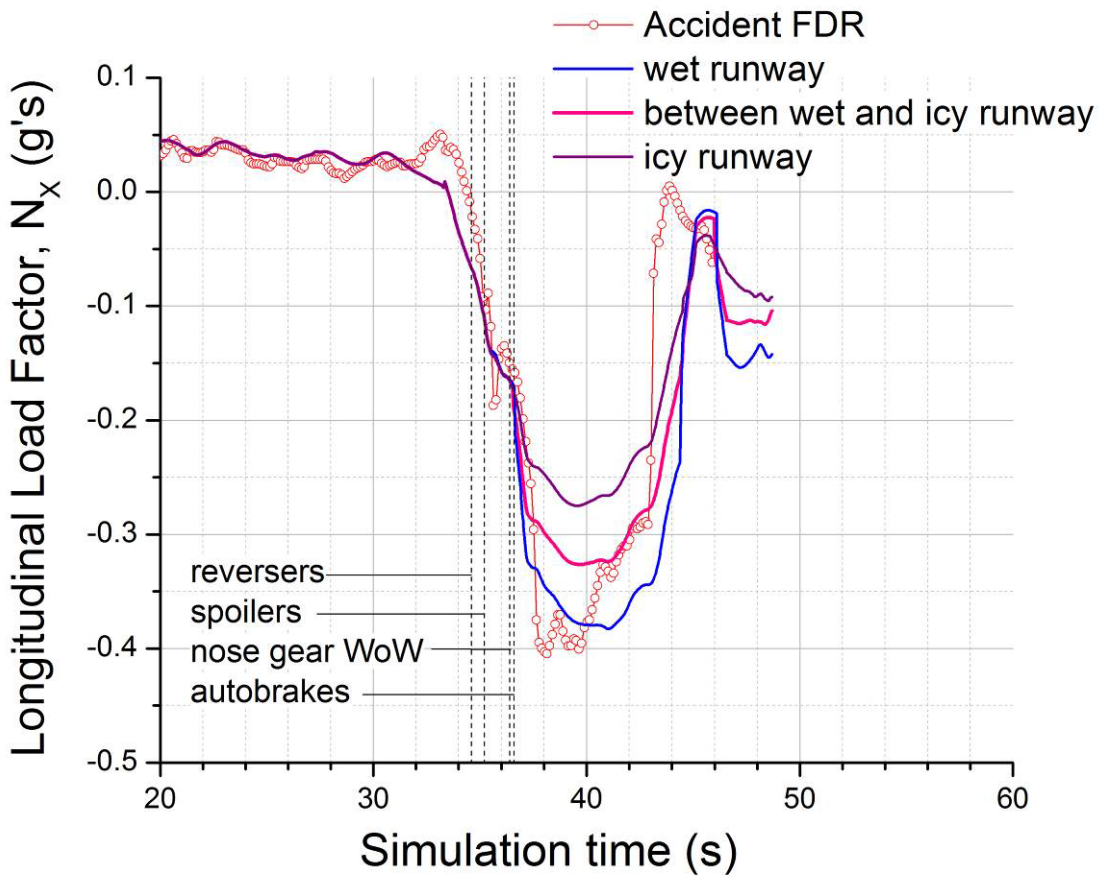
Figure 31 shows the accident landing with the same three runway conditions. Here, the FDR deceleration is greater than what the simulations predict for any of the three runway conditions (wet, icy, or intermediate) from time 38 s to 40 s, implying better than wet runway performance. After that time, the longitudinal acceleration was approximately consistent with the intermediate runway performance value.

**Figure 31.** Longitudinal acceleration for accident flight and three landing simulations for different runway frictions.
