**National Transportation Safety Board**  
Office of Research and Engineering  
Washington, D.C. 20594

**Performance Study**

Location: Aspen, Colorado  
Date: January 5, 2014  
Time: 1222 MST  
Airplane: Bombardier CL-600-2B16, N115WF  
NTSB Number: CEN14FA099

### **CEN14FA099, Bombardier CL-600-2B16, N115WF**

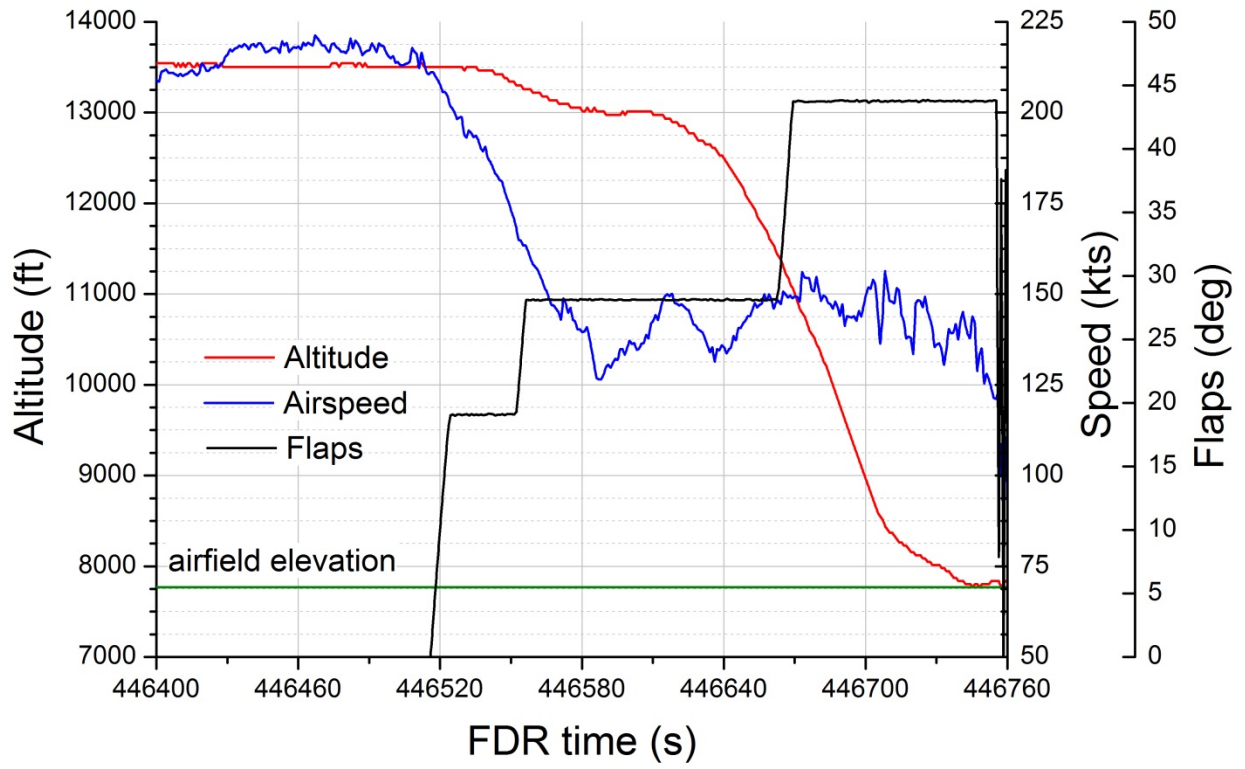
During the last six minutes of flight, the aircraft descended from 13,500 ft and slowed from an airspeed of 220 kts (Figure 1). The aircraft's descent angle for the last nautical mile of flight was approximately 4° and its airspeed was about 140 kts (Figure 2).

**Figure 1.** Aircraft recorded altitude, airspeed, and flaps for the last six minutes of flight.

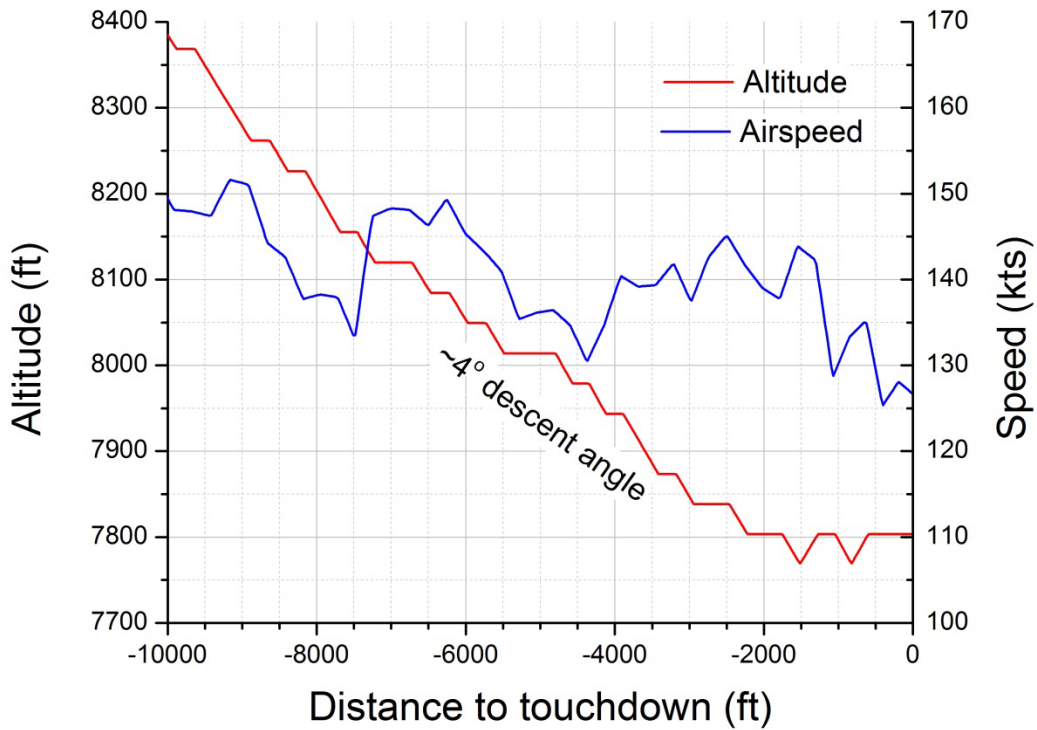
**Figure 2.** Aircraft altitude and airspeed for the last 10,000 ft of flight.

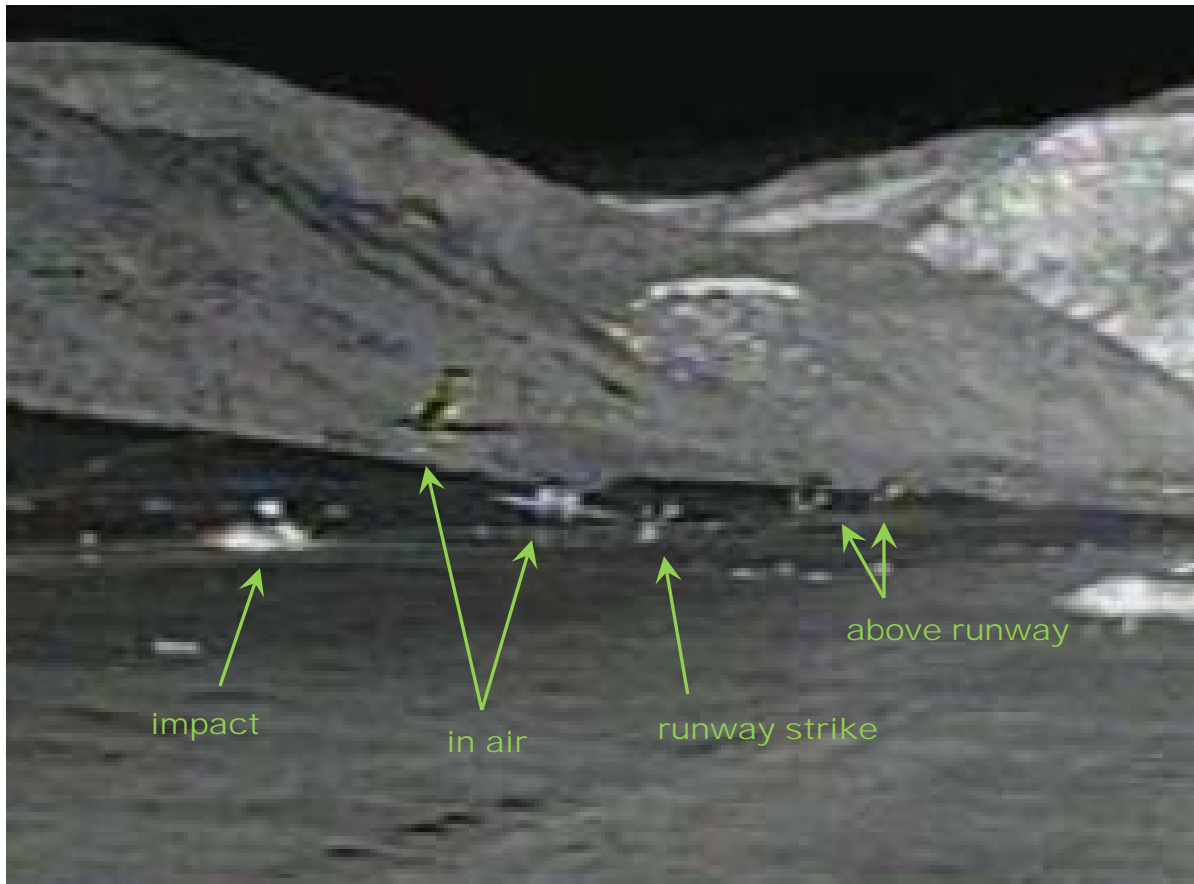
Video of the runway showed the accident aircraft landing at KASE. The sequence of events in the video was: the aircraft above the runway in a slightly nose down configuration, a flash of light indicating a runway strike, the aircraft in the air above the runway and nose down, and then the aircraft impacting the runway nose down and being engulfed in light. In Figure 3, six stills from the video are overlaid to show these events. The motion is from right to left. Approximately four seconds elapse between the runway strike and the final impact.

**Figure 3.** Overlaid stills of landing from runway video.

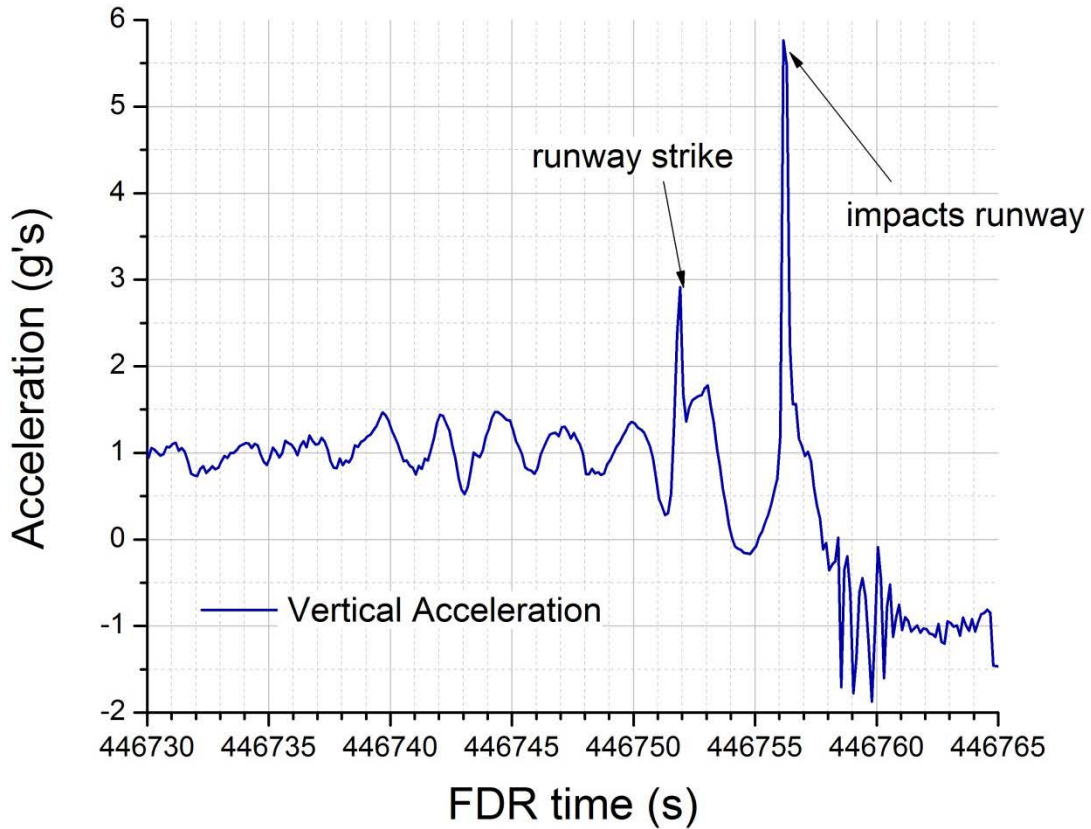
The vertical acceleration ( $N_z$ ) from the FDR (Figure 4) was consistent with the video. At 446752 s FDR time there was a spike in  $N_z$  from 1g to 3g's followed by a second spike to nearly 6g's about four seconds later. These points likely are the runway strike and final impact seen in Figure 3. The touchdown  $N_z$  is typically between 1.1 and 1.5g's depending on the landing. Figure 4 shows five  $N_z$  peaks to just below 1.5g that occurred before the runway strike. The  $N_z$  data indicates that the aircraft oscillated above the runway a number of times before the 3g runway strike.

**Figure 4.** Aircraft vertical acceleration for last 30 seconds of flight.

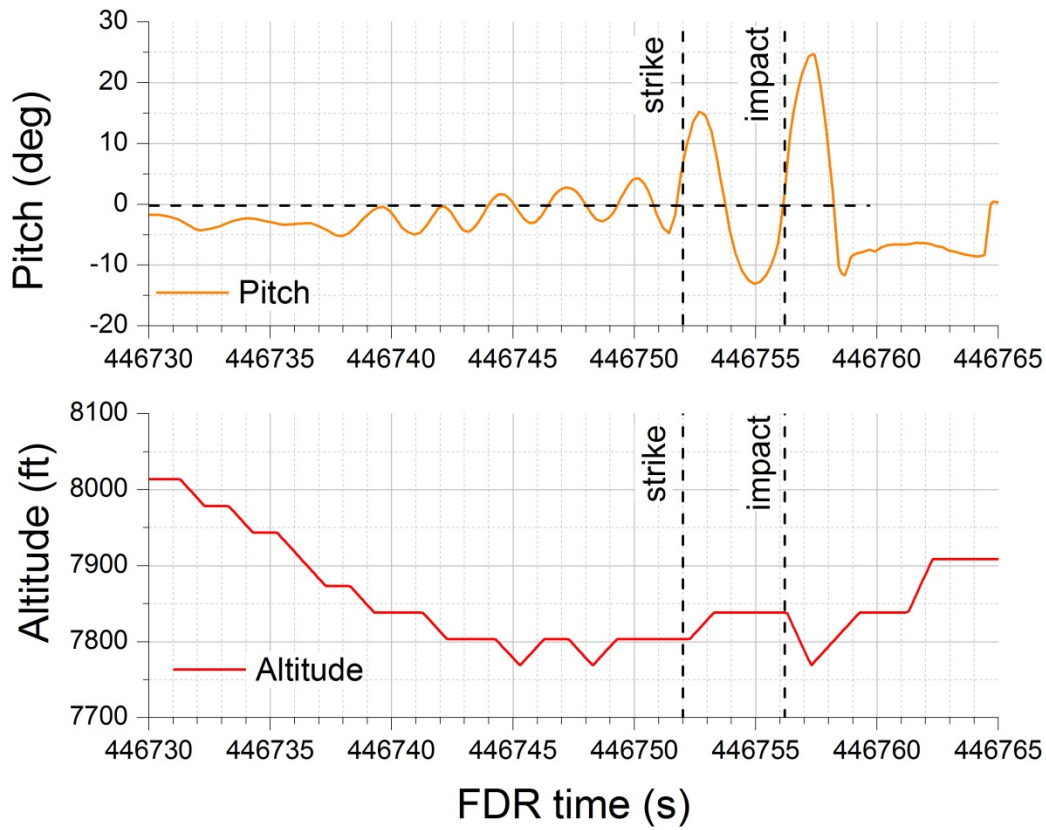
Figure 5 shows the aircraft's pitch and altitude for the final 200 ft of descent. The aircraft remained nose down (negative pitch value) until the third  $N_z$  oscillation. Figure 6 shows both  $N_z$  and pitch. The recorded pitch indicates that the aircraft did not rotate into a nose up position for the main gear to touchdown first.

**Figure 5.** Aircraft pitch and altitude. The horizontal black dotted line corresponds with 0° pitch.

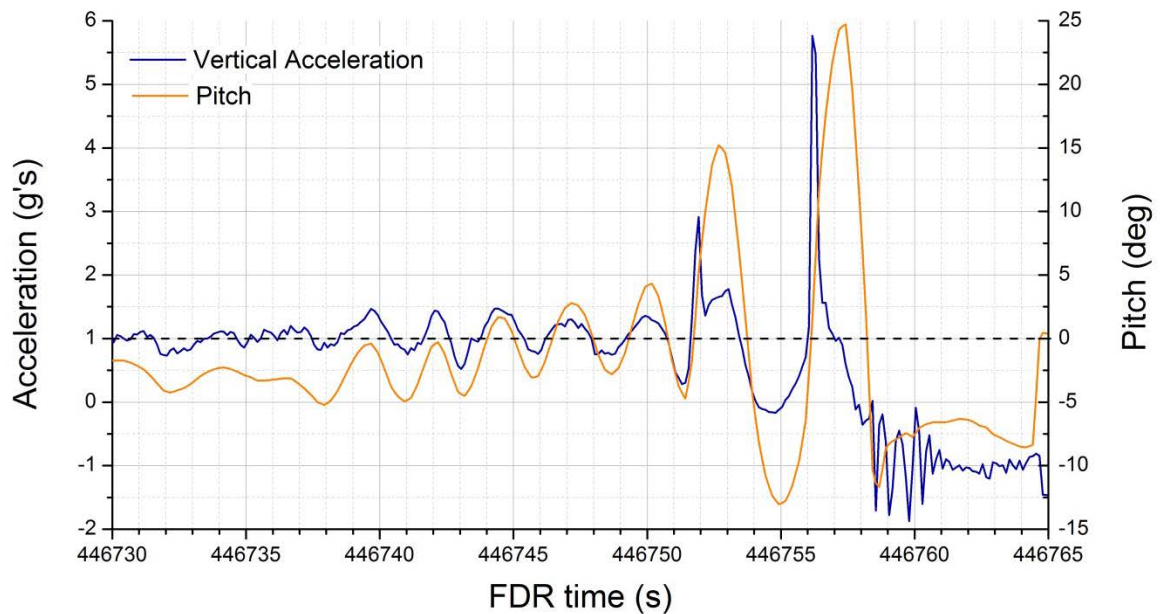
**Figure 6.** Aircraft vertical acceleration and pitch during touchdown and impact. The black dotted line corresponds to 1 g of vertical acceleration and 0° of pitch.

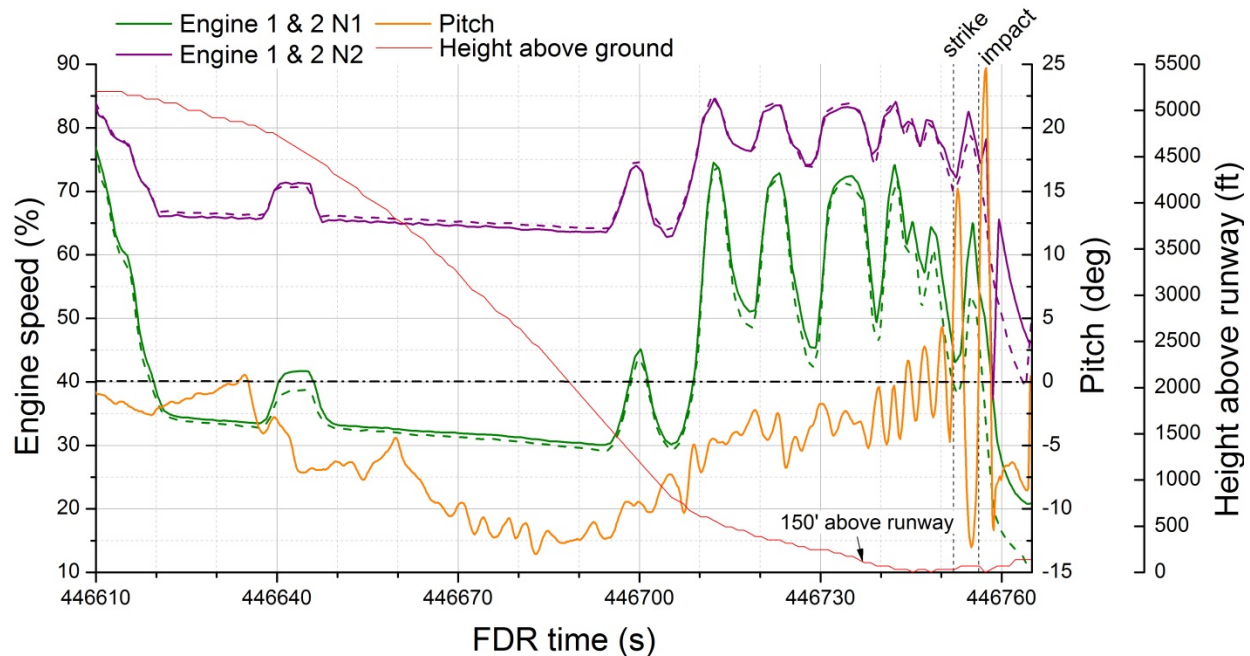
During the last minute of flight, the aircraft's engines were advanced and pulled back five times (Figure 7). N2 begins at about 65% at 446690 s, then transitions between 75% and 85%. N1 begins at about 30%, then transitions between 45% and 75%.

**Figure 7.** N1 and N2 speeds, and pitch and height above ground for approach.

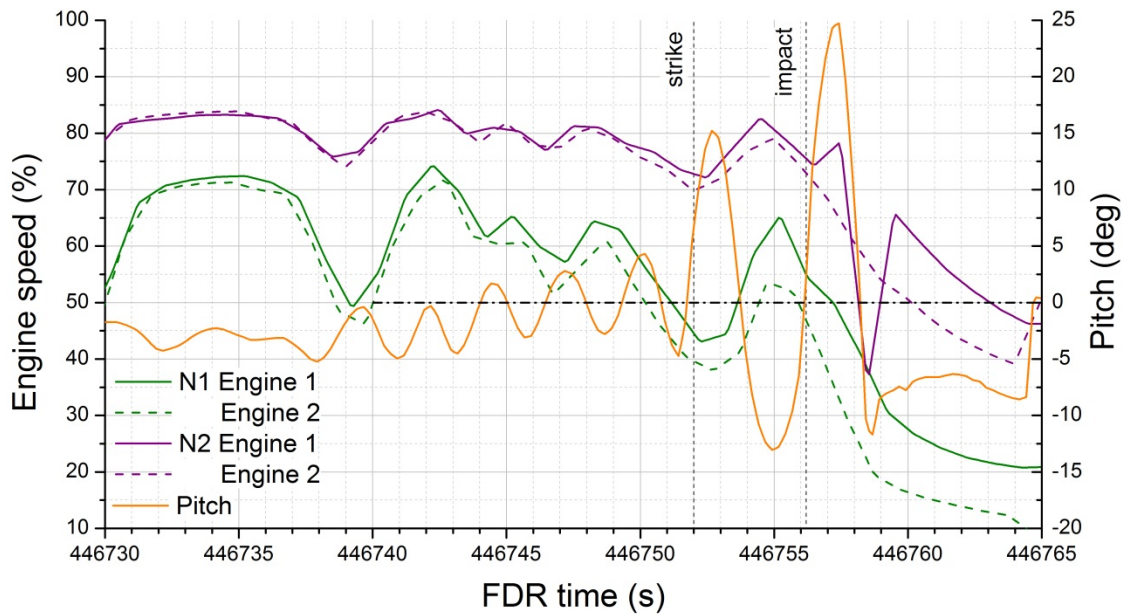
As the oscillation in pitch began, the engines were retarded to 70% for N2 and 45% for N1 (Figure 8). After the strike the engines were briefly advanced. GE Aviation, Inc. commented that the CF34-3 engines installed on the accident aircraft are mechanically controlled and do not have a FADEC (full authority digital engine control). For the speeds of both engines to vary together as recorded by the FDR, it would have had to have been commanded at the throttle.

**Figure 8.** N1 and N2 speeds and pitch for the final seconds of flight and runway impact.

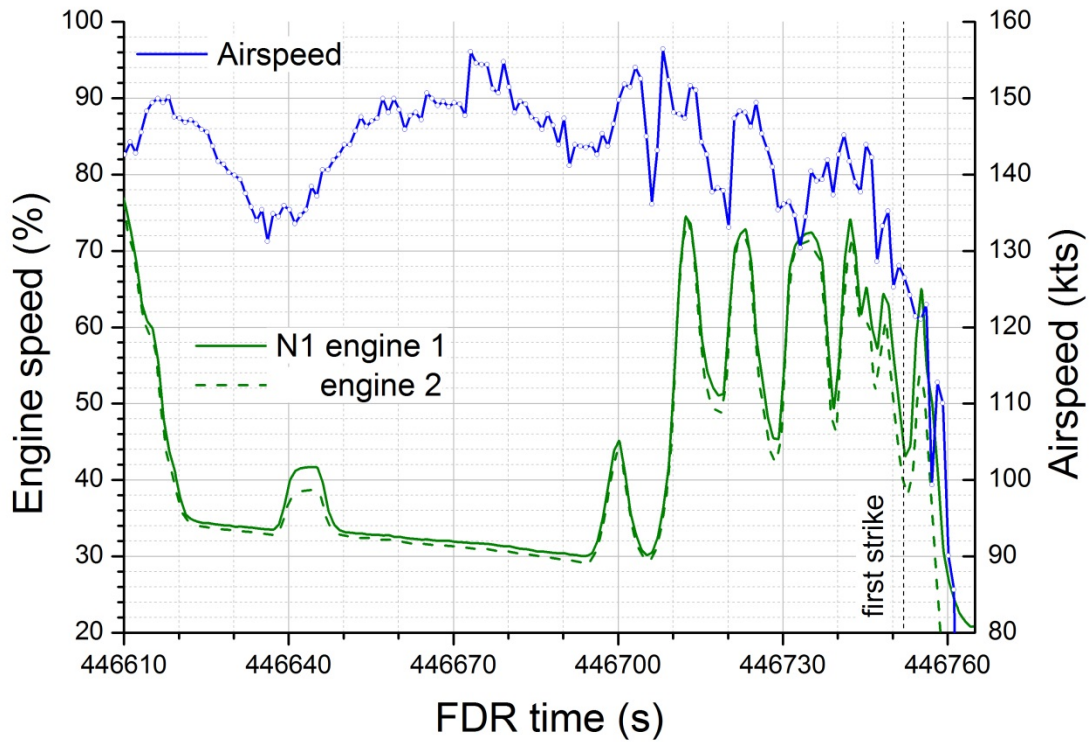
Figure 9 shows N1 and airspeed during the final approach (same time scale as Figure 7. At 446675 s to 446695 s the aircraft lost about 15 kts of airspeed and the engine speed was briefly advanced. The engine speed then led changes in airspeed (engine speed was reduced, airspeed dropped, engine speed was increased, airspeed increased) for about 40 s before the pitch oscillation began.

**Figure 9.** N1 speeds and recorded airspeed on final approach.

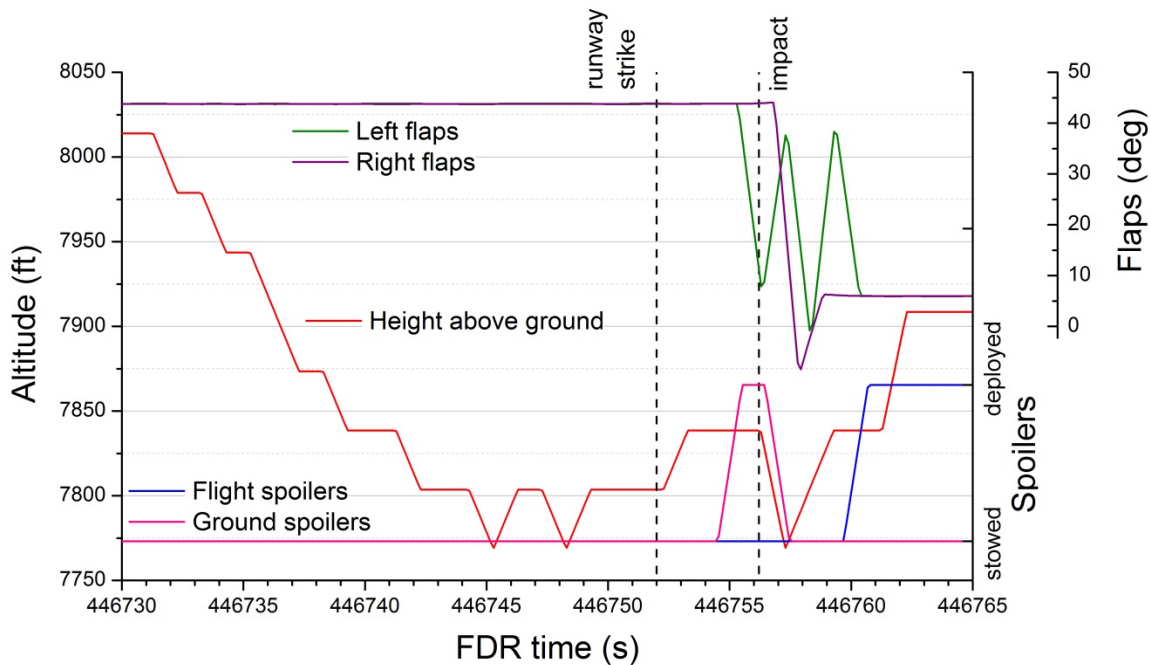
Figure 10 shows that flaps were at 45° during the approach and landing. Three seconds after the runway strike the ground spoilers deployed. After the 6 g impact, the flaps and spoilers moved out of position, possibly due to the force of the impact. The flap and spoiler positions were as expected for this aircraft during approach and landing. The FDR did not record elevator or aileron positions. Thrust reversers were not deployed.

**Figure 10.** Aircraft altitude, flaps, and spoilers during approach and landing.

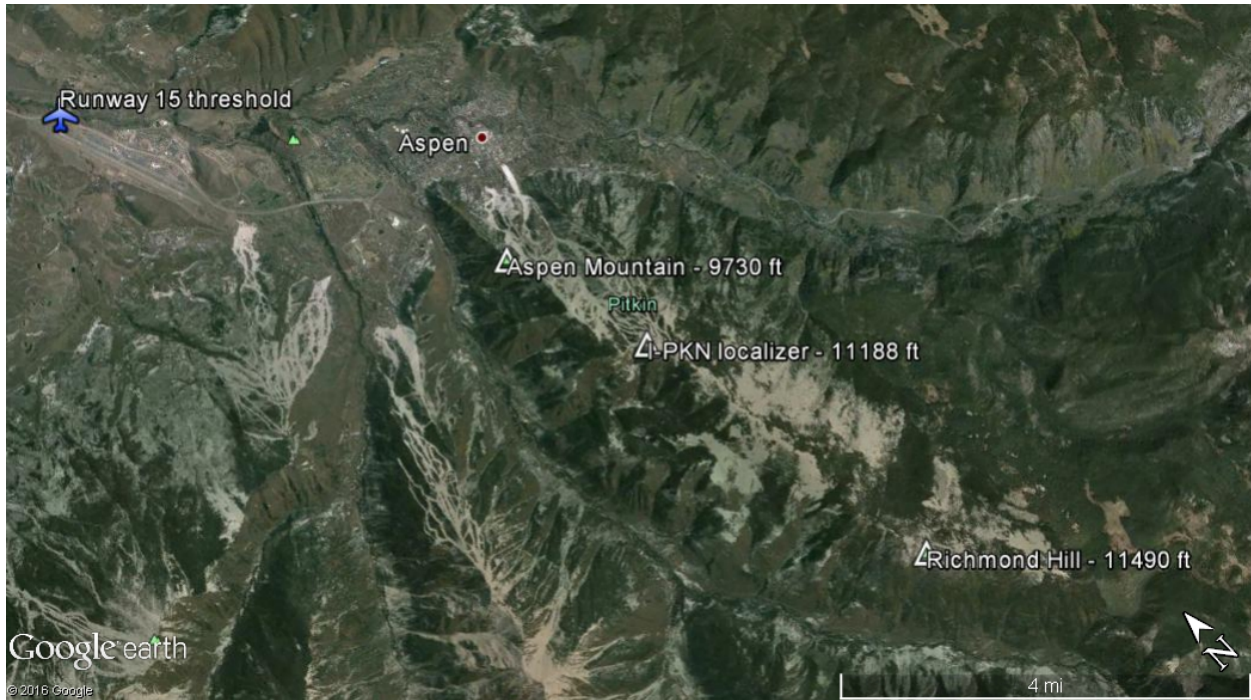
It was requested to determine if the aircraft could have completed a go-around while over the runway and continued along the heading of runway 15 (151° magnetic, 160° true) and cleared the mountainous terrain beyond the airport. Figure 11 and Figure 12 show three selected points of high terrain beyond the end of runway 15.

**Figure 11.** Runway 15 at KASE and three points of high terrain: Aspen Mountain, the I-PKN localizer location, and Richmond Hill.

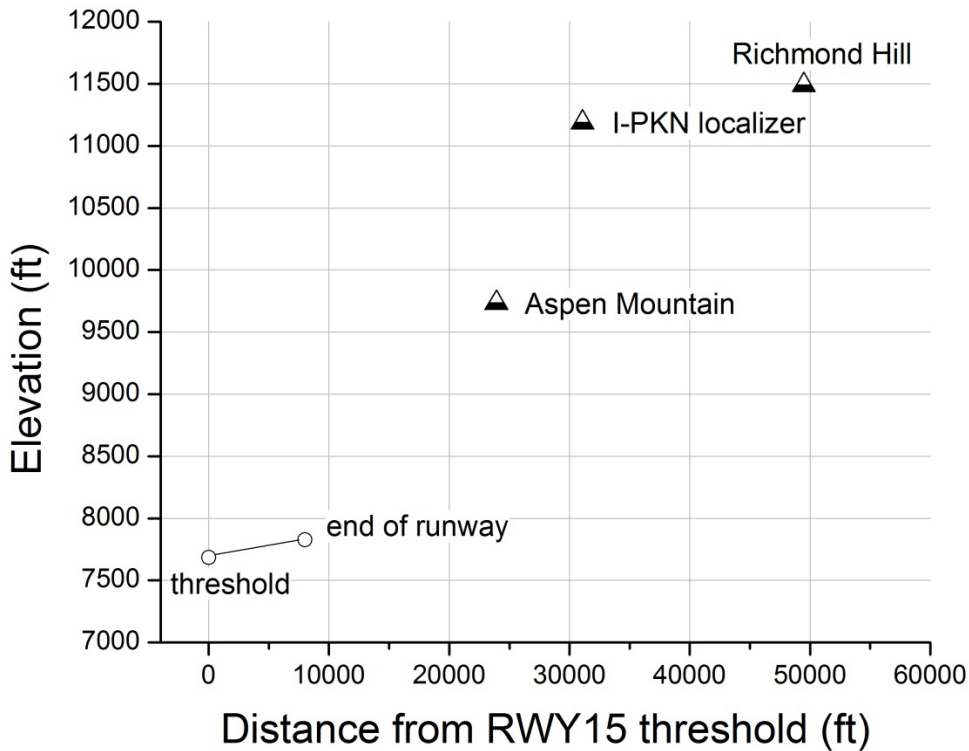
**Figure 12.** Elevation and distance from runway 15 at KASE for three points of high terrain: Aspen Mountain, the I-PKN localizer location, and Richmond Hill.

Figure 12 shows the elevation of these three points of terrain (Aspen Mountain, the location of the I-PKN localizer, and Richmond Hill) and the distance of each from the threshold of runway 15. Of the three, the location of the I-PKN localizer requires the steepest climb gradient from the runway threshold. To clear the I-PKN localizer, an aircraft has 31,000 ft (5.1 NM) of horizontal distance to climb 3,500 ft to an altitude above 11,188 ft.

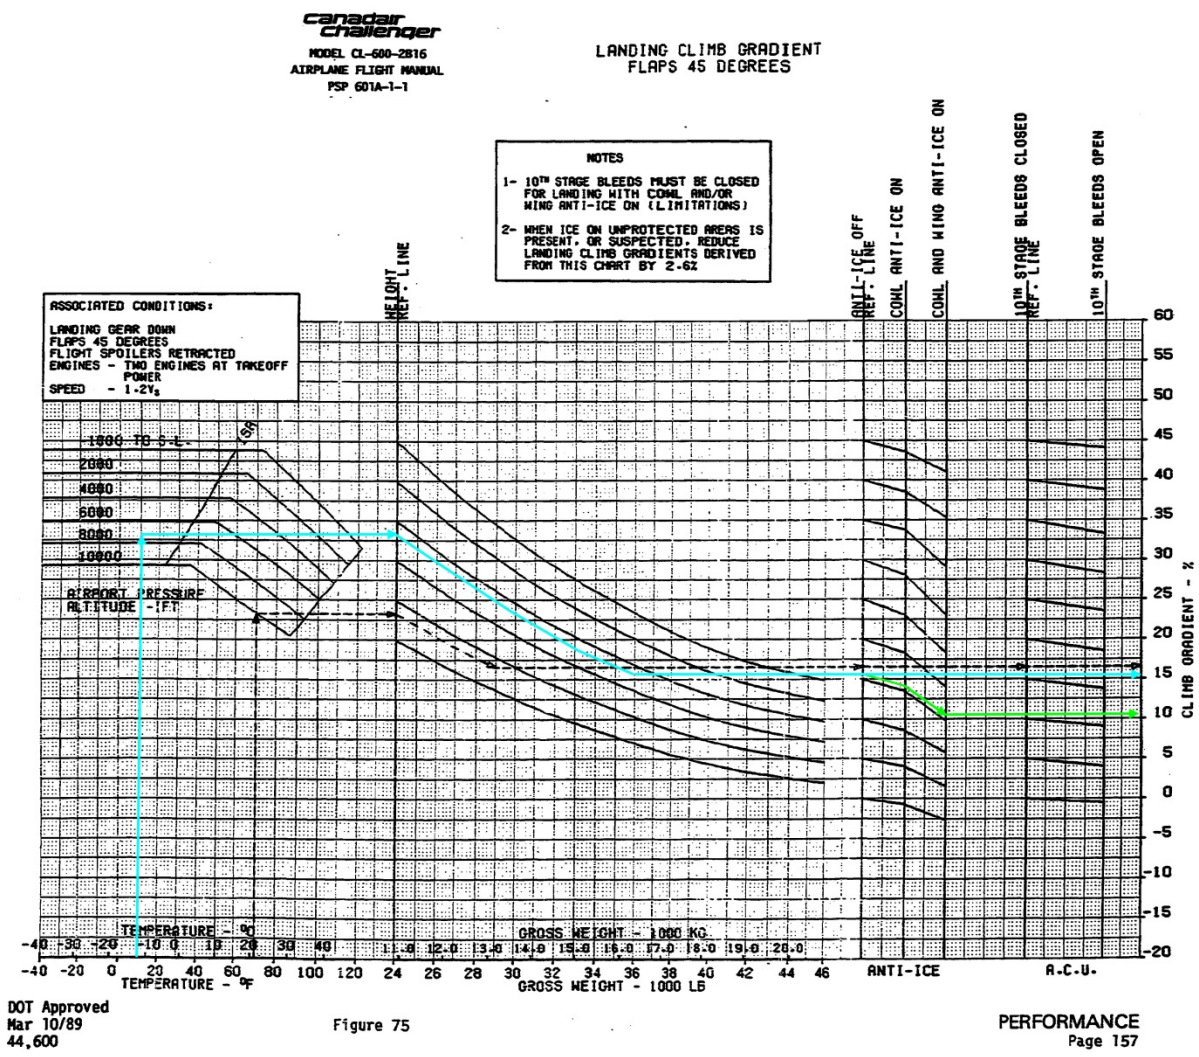
Figure 13 shows the landing climb gradient for the approximate temperature, altitude, and weight of the accident aircraft [2]. This plot is for landing climb gradients with flaps 45 and landing gear down and applies to the first portion of flight. For cowl and wing anti-ice on, the landing climb gradient is about 10.5%. If the anti-ice is off, the climb gradient is about 15%. Cowl and wing anti-ice degrade the climb performance by 30%. This data assumes no wind component.

Figure 13. Landing climb gradient for -12°C, 7,600 ft, 36,000 lbs is approximately 10.5% for cowl and wing anti-ice on (green line) and 15% for anti-ice off (blue line).

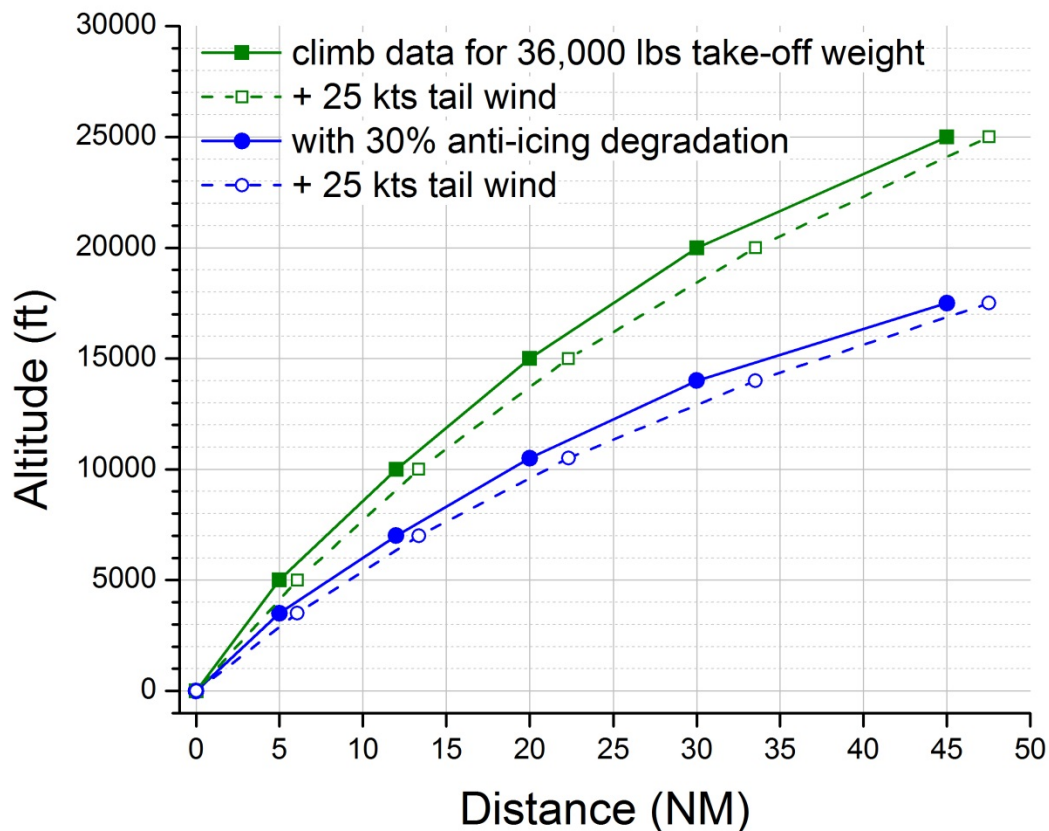
The data from Figure 13 only applies to the earliest portion of a climb when the landing gear are still down and take-off flaps are used. The Aircraft Operating Manual [3] provided climb data from sea level to various altitudes for different take-off weights for international standard atmospheric conditions (ISA). The temperature on the day of the accident was colder than ISA, so climb performance would have been better than this data indicates, making the following evaluation conservative. Data provided were the altitude gain, time, ground distance, and fuel burn for conditions with both engines operating; no information was provided to indicate the change in climb performance with the anti-icing systems on. The solid green line in Figure 14 shows the altitude versus ground distance from the manual. The solid blue line shows a 30% degradation in altitude gain with cowl and wing anti-ice use, assuming a similar performance penalty as was found in the landing climb gradient chart. The average ground speed was determined from the provided data to be 311 kts. The dotted green and blue lines show the climb performance with an added worst case tailwind of 25 kts.

**Figure 14.** Climb data from sea level to various altitudes for 36,000 lbs take-off weight.

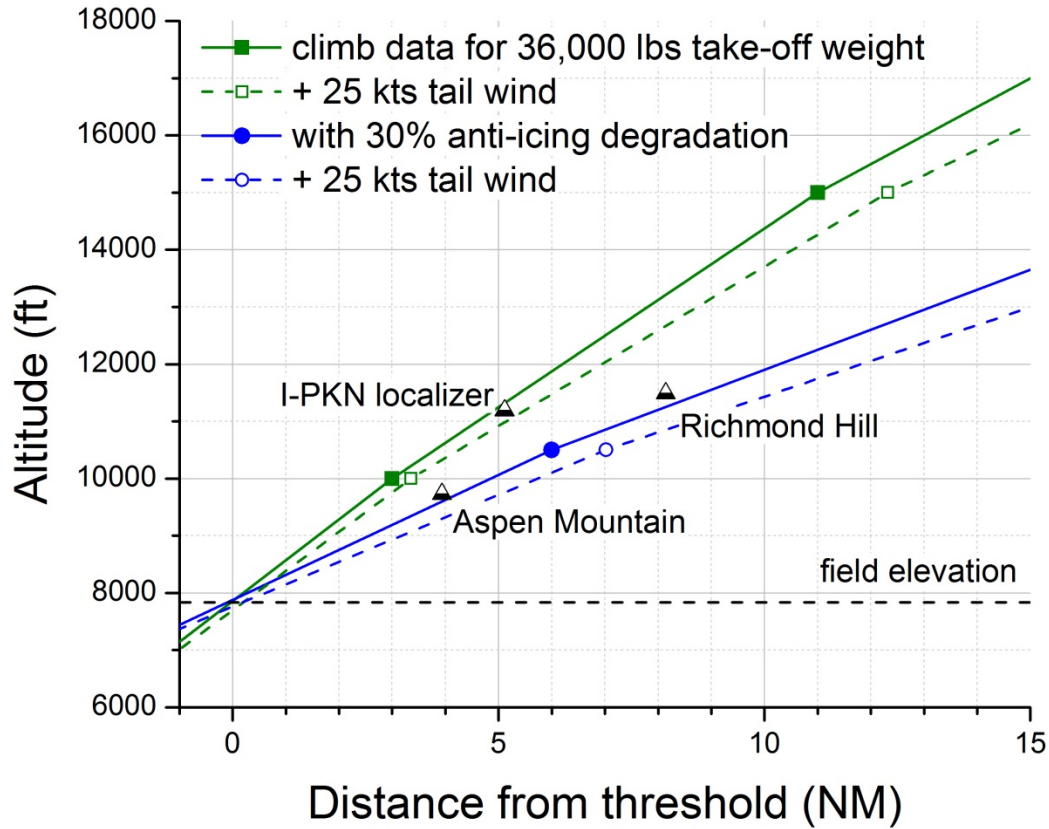
The field elevation at KASE was 7,837 ft. Shifting the plots from Figure 14 and adding in the obstacles to be cleared from Figure 12 yields Figure 15. Zero on the horizontal axis is the threshold to runway 15. If the anti-ice protection was not used during the climb, the aircraft

should be able to clear both Aspen Mountain and Richmond Hill. Clearing the I-PKN localizer would require a more optimal climb performance and less than a 25 kts tailwind.

**Figure 15.** Climb data for 36,000 lbs take-off weight and terrain obstacles.
