National Transportation Safety Board

Performance Study

Location:	Bahama, North Carolina
Date:	October 21, 2014
Time:	1044 EDT
Airplane:	Beech D95A, N64GM
NTSB Number:	ERA15FA023

Performance Study
ERA15FA023, Beech D95A, N64GM

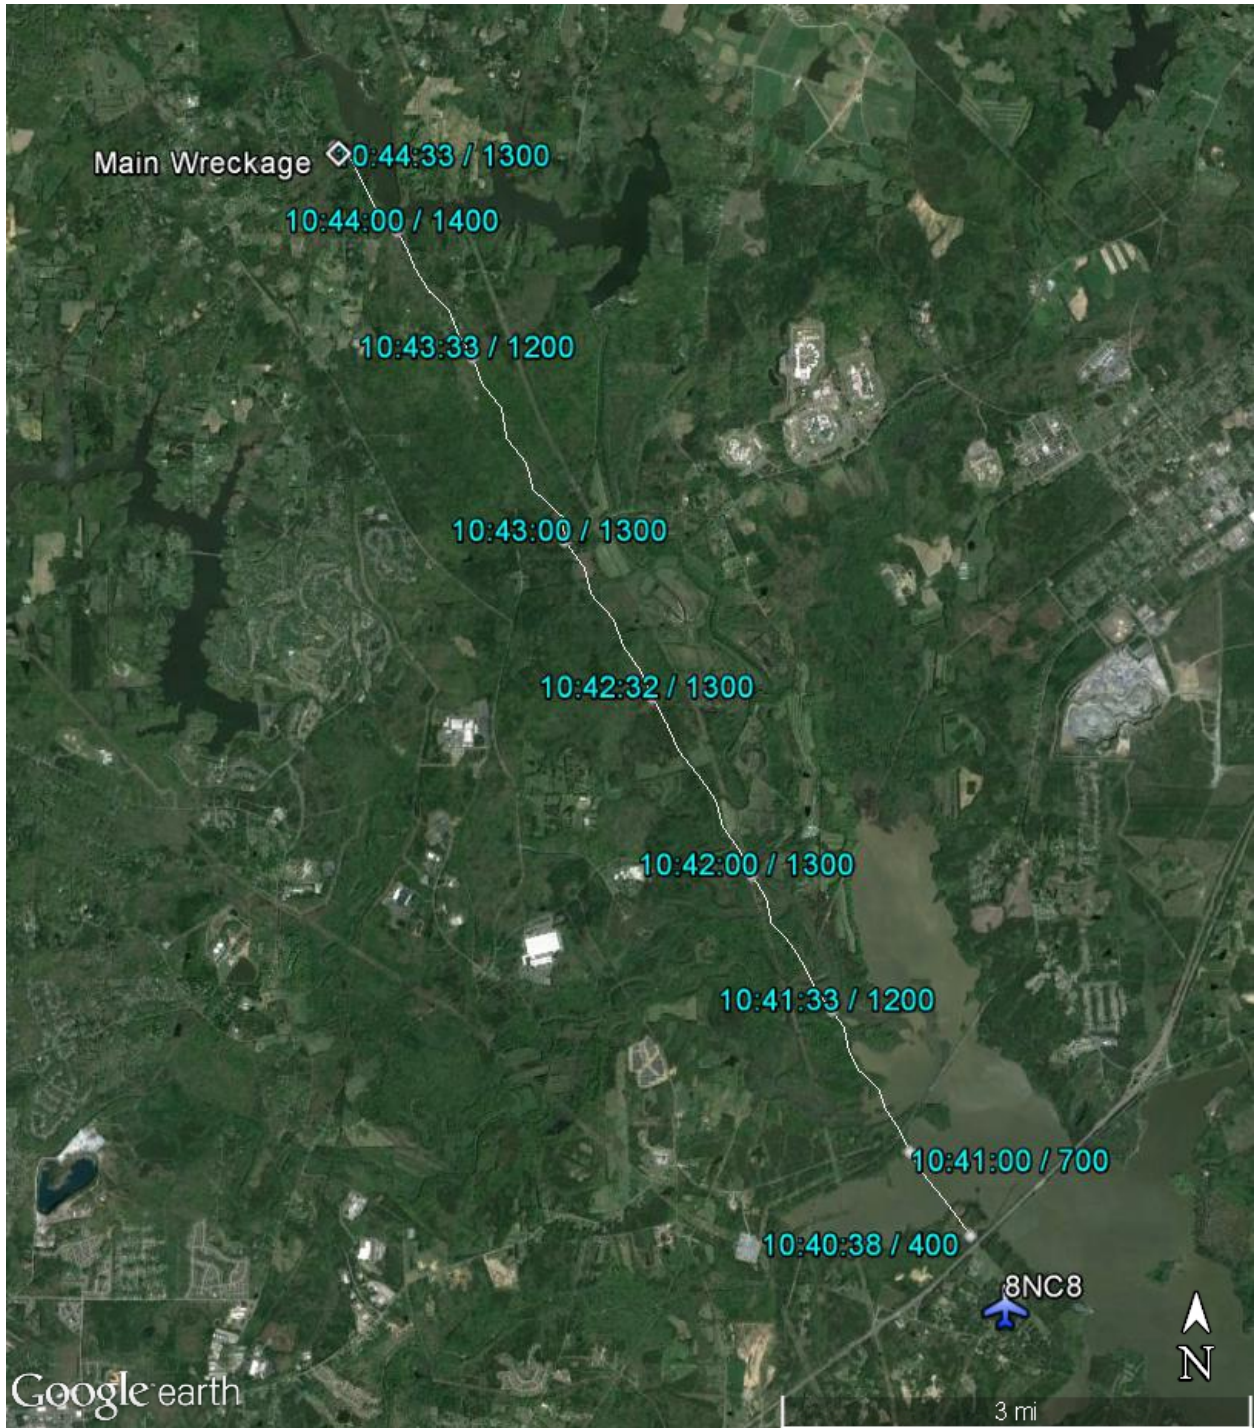
Figure 1. Radar flight path.

The flight path is shown in Figure 1. The aircraft took off from Lake Ridge Aero Park (8NC8) at about 10:30 EDT and traveled northwest on a track of about 330° . The length of the flight path based on the radar returns was about 7 NM. Figure 2 shows the final five radar returns and the wreckage location. The second to last radar return was at 1700 ft msl and on a track of 331° . The final radar return was 400 ft lower and on a track of 270° . Wreckage elevation was about 400 ft.

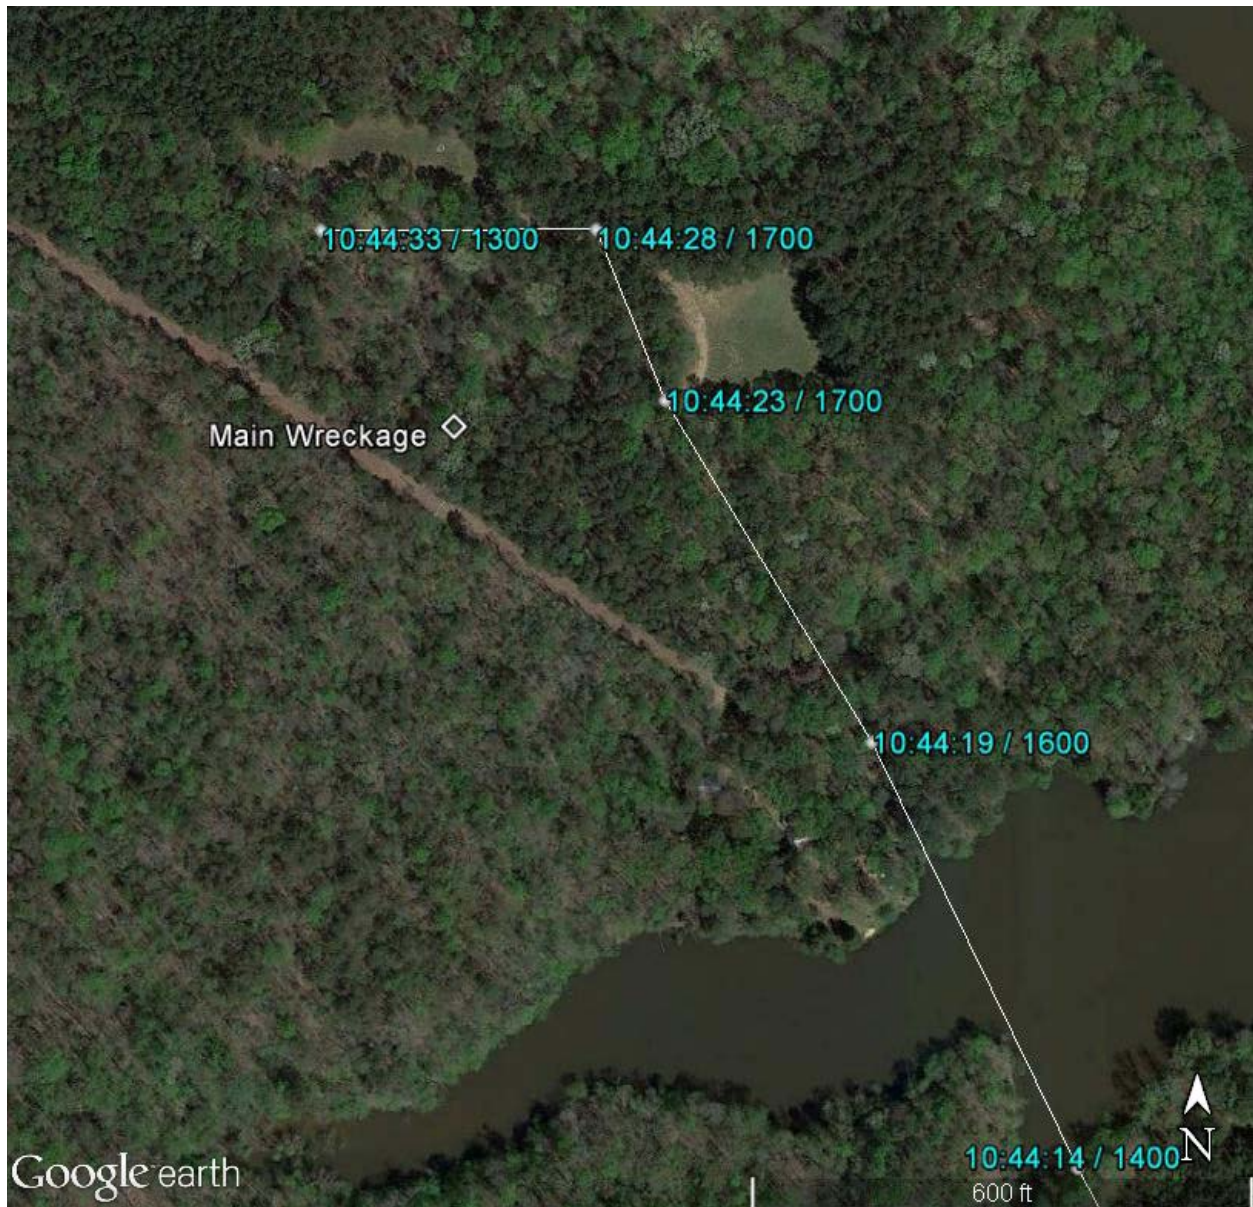
Figure 2. End of radar flight path.

From 10:43 until the end of flight, the aircraft gained altitude while losing airspeed. The calculated equivalent airspeed was close to the aircraft's expected stall speed before losing altitude. The rapid loss of altitude and subsequent track deviation to the left is consistent with aerodynamic stall.

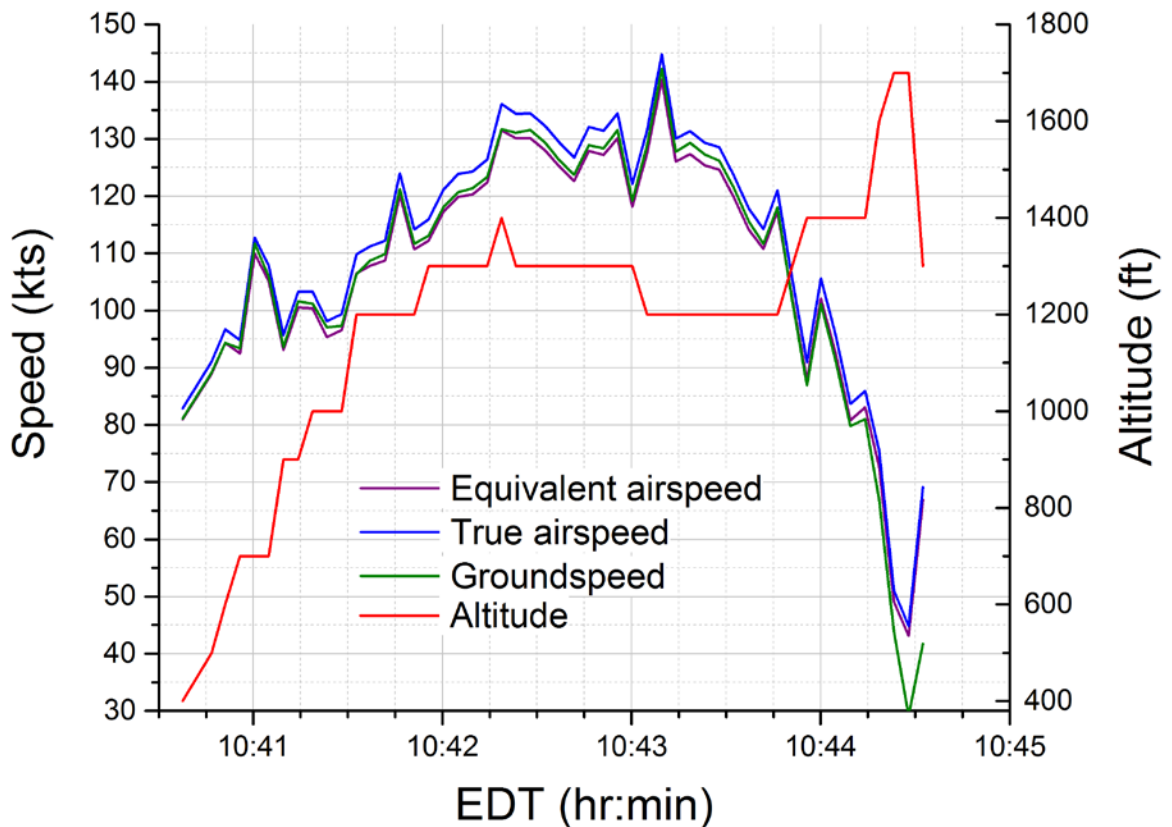
Figure 3. Calculated air and groundspeeds and recorded altitude for flight.

The aircraft climbed and gained speed from takeoff to about 10:42 when the altitude leveled off at about 1300 ft (Figure 3). At about 10:43 the aircraft's altitude dropped to 1200 ft for about 45 seconds before climbing again to 1700 ft by 10:44:23. From 10:43 until near the end of the flight the aircraft lost speed from an airspeed of about 130 kts to an airspeed of 45 kts at 10:44:27, when the aircraft rapidly lost altitude.

At 10:44:23, the peak of the aircraft's final climb, the equivalent airspeed was calculated to be less than 50 kts and slowing. Figure 4 shows the stall speeds for the Beech D95A [1] in indicated airspeed (within one or two knots of equivalent airspeed). For a gross weight of 4200 lbs (maximum take-off weight), 50 kts was below any of the gear and flaps up stall speeds. The empty weight of the airplane is listed as 2555 lbs; at that weight, the power-on stall speed would be expected to be reduced from 53 kts to 41 kts. The accident aircraft only had two people aboard with light baggage and was likely considerably lighter than maximum take-off weight.
