National Transportation Safety Board
Office of Research and Engineering
Washington, D.C. 20594

Performance Study

Location: Marco Island, Florida
Date: March 1, 2015
Time: 1615 EST
Airplane: Bombardier Challenger CL-600-2A12, N600NP
NTSB Number: ERA15LA140

Radar Study
ERA15LA140, Bombardier Challenger CL-600-2A12, N600NP

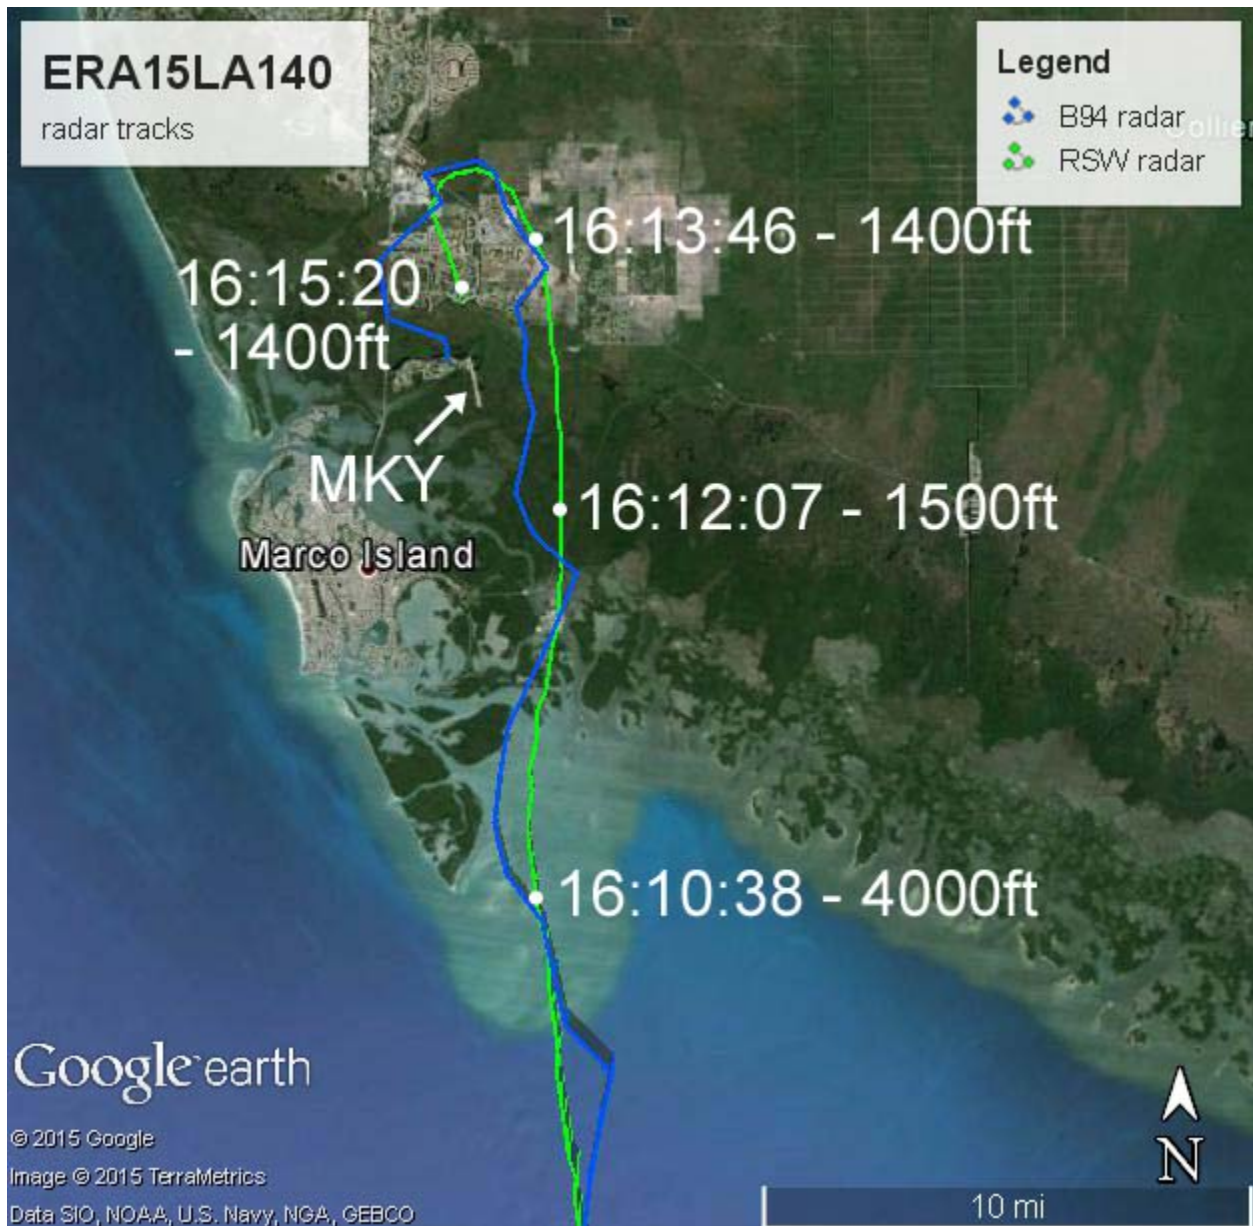
The radar data for the aircraft is shown in Figure 1. The aircraft passed east of Marco Island at about 1612 before turning west and heading south for runway 17 at Marco Island Executive Airport. The radar data from Fort Meyers, Florida (labelled RSW) is shown in Figure 1 in green and the TARS radar data (labelled B94) in blue.

Figure 1. Aircraft flight path from RSW and B94 radar. Select altitudes and times are marked on the RSW track.

The RSW radar path in green had location accuracy of approximately ± 560 ft in the east-west direction and ± 380 ft in the north-south direction, but due to altitude and line of sight limitations, the last recorded radar location was about 1 NM from the runway threshold. Since the B94 radar data was from a TARS, it recorded the aircraft for longer at lower altitudes, but the location data was much less accurate.

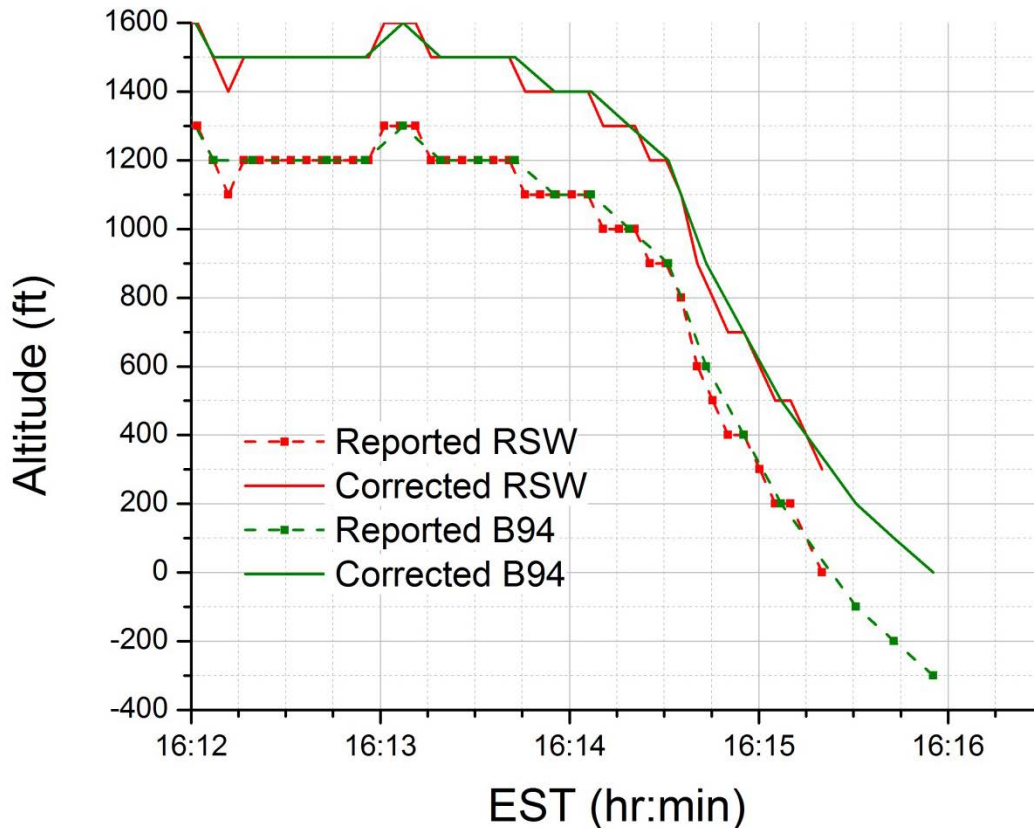
Altitude was reported by the aircraft transponder. The altitude was corrected for both sets of radar data using an altimeter setting of 30.22 inHg and is shown in Figure 2. The data was

aligned using altitude and time. The last radar return from B94 was at 0 ft of corrected altitude. MKY is at 1ft of elevation and the altitude uncertainty was ± 50 ft.

Figure 2. Aircraft pressure and corrected altitude from RSW (red) and B94 (green) radar.

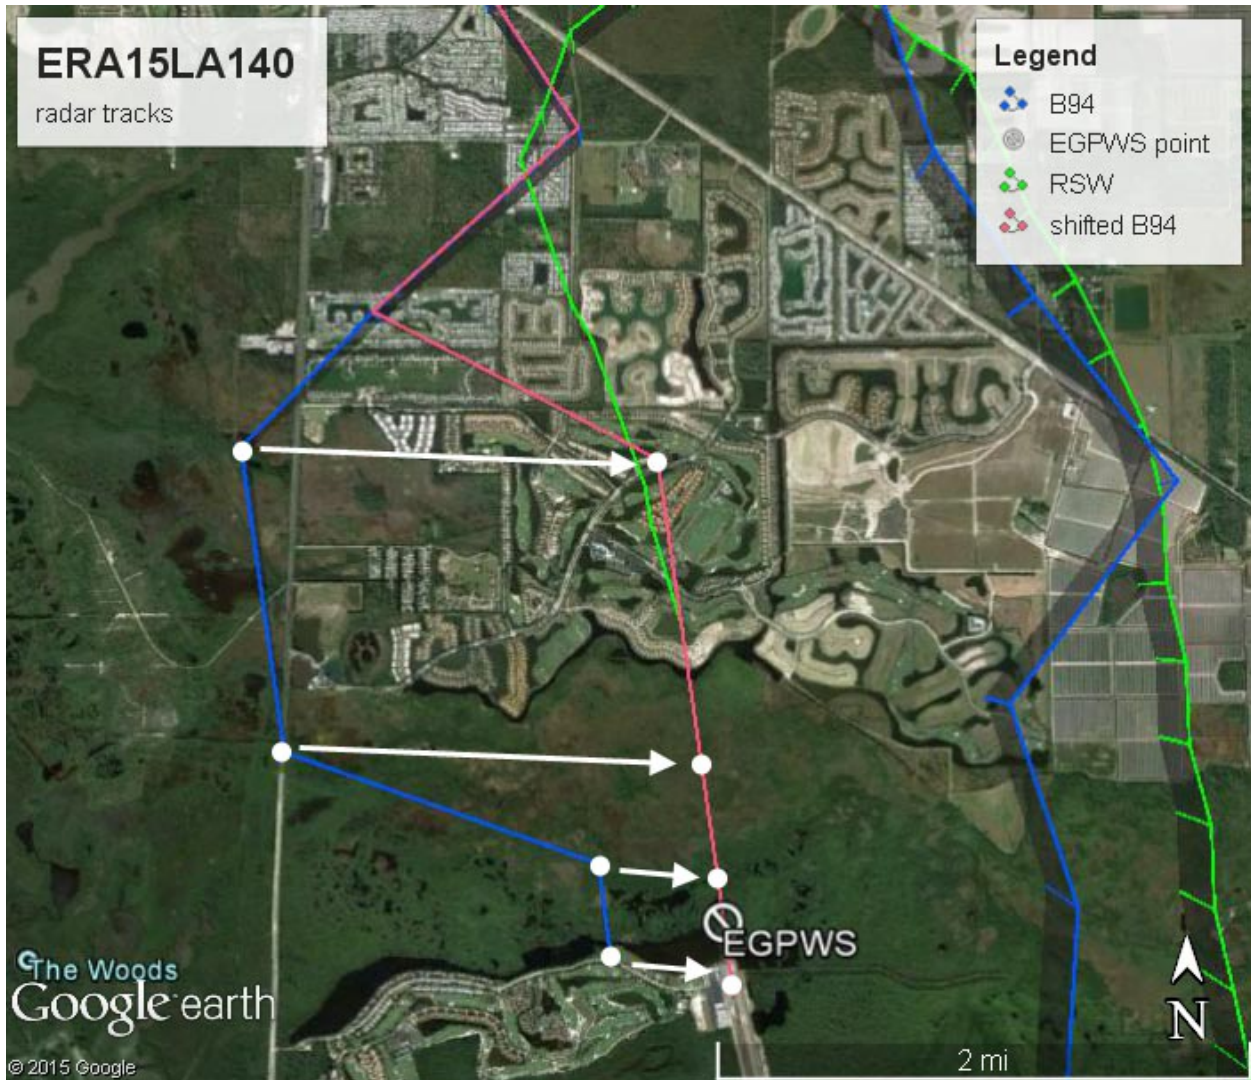
The aircraft was equipped with an enhanced ground proximity warning system (EGPWS). While the terrain inhibit was not active during this flight, the device did record the aircraft's take-off and landing [1]. The landing record reported that the aircraft was at a GPS height of 68 ft (geometric height 58 ft) at a point 800 ft before the runway threshold. The reported uncertainty of the GPS location from the EGPWS was 0.0032 NM, or ± 20 ft. The GPS location was along the runway centerline and is shown in Figure 3.

The last four B94 radar returns were shifted to align with the runway centerline, the RSW radar data, and the EGPWS altitude and location. The track between the two points farther from the runway was parallel to the runway, as was the track between the two points closer to the runway. The two points farther from the runway were shifted together so their locations relative to each other were maintained. The two points closer to the runway were moved in a similar manner. These two segments of B94 data were shifted such that the aircraft's track and altitude were consistent with the other data. Figure 3 and Figure 4, below, show how the B94 data was shifted. Shifting the data adds additional uncertainty.

Figure 3. Aircraft radar paths from RSW (green) and B94 (blue) with the final points of B94 shifted (red) to align with RSW and EGPWS point.

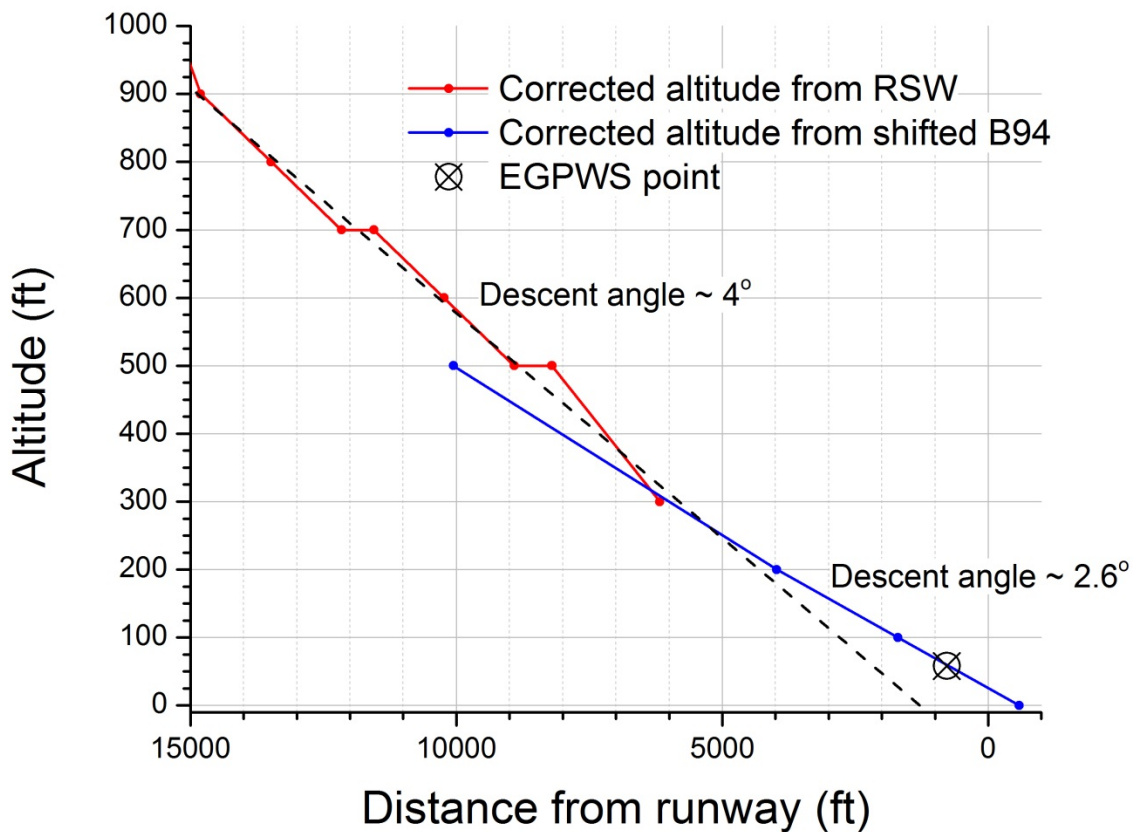
Figure 4. Descent angles for final RSW radar returns and shifted B94 radar data. The shifted B94 data was matched to the altitude of the final RSW data point and to the EGPWS point.

Figure 4 shows the aircraft's descent angle from 2.5 NM to 1 NM out from the threshold to be about 4°. The EGPWS and shifted B94 data show a final descent angle of 2.6°. MKY runway 17 has a four light precision approach path indicator (PAPI) set for a glide slope of 3.00° [2].

The shifted B94 data has the aircraft touching down 600 ft past the threshold. However, since the altitude uncertainty is ± 50 ft, the aircraft at this point could have been 50 ft above the runway. If the aircraft was at + 50 ft and the same angle of descent was assumed, the aircraft would have touched down 1700 ft past the threshold. Using these two points as boundaries, the B94 radar indicated the aircraft touched down between 600 and 1700 ft past the threshold of runway 17. Security camera video showed the aircraft touching down just past the 1,000 ft mark (see Figure 5) which agreed with pilot and passenger interviews [3].

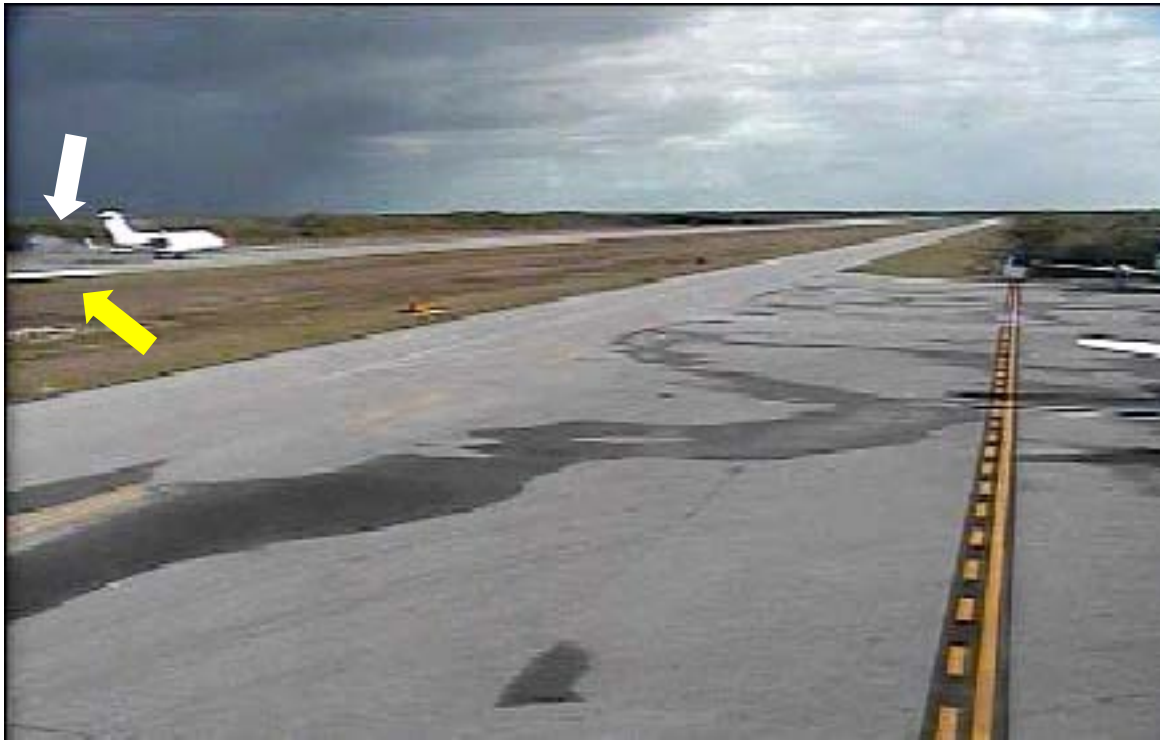
Figure 5. Security camera still from MKY of the accident aircraft on runway. The white mark to the extreme left behind the aircraft is the 1,000 ft mark (yellow arrow). The small cloud of smoke behind the aircraft (white arrow) visible in this frame was indicative of touchdown.

Video was collected from 10 different security cameras that captured the aircraft flight or landing. Due to either the angle of the image, a lack of necessary background reference points, or the frame rate of the video (nine of the cameras, including the one in Figure 5 sampled at 1 frame per second) a reliable groundspeed was unable to be calculated. It was also not possible to conclusively determine the configuration of the aircraft from the images.

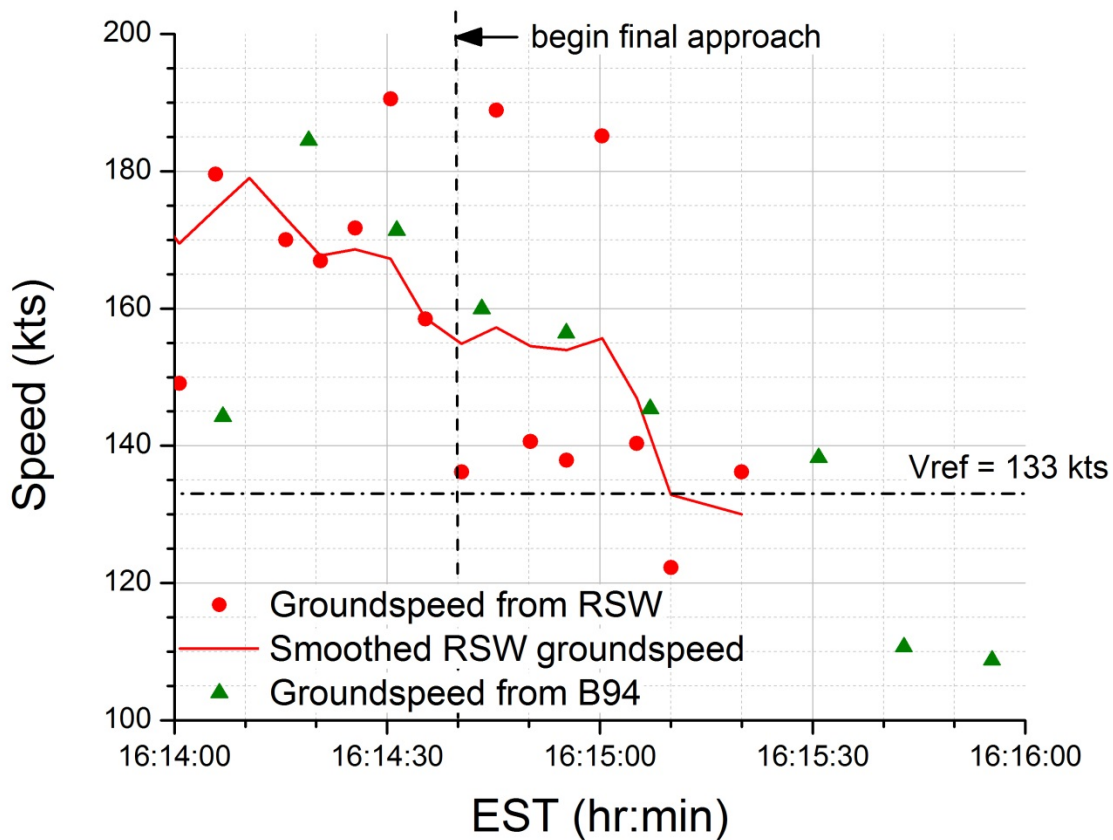
The calculated groundspeed from radar is shown in Figure 6, below. The aircraft began its final approach on the heading for runway 17 at 16:14:40. The final calculated groundspeed was just below 110 kts. This number has a large amount of uncertainty from the B94 radar position and the shifting of the points, but earlier points tracked the RSW calculated groundspeed well.

Figure 6. Calculated groundspeed from RSW and B94 radar.

The pilot and copilot reported the aircraft was at or a few knots above the V_{ref} speed of 133 kts as they crossed the runway threshold. The final RSW groundspeed calculations, approximately 1 NM from the threshold, were in agreement with the V_{ref} speed. The final calculated groundspeed from the shifted B94 was more than 20 kts slower than V_{ref} . The wind, from between 250° and 280° was mostly a crosswind and would have had little effect on the aircraft's airspeed. Despite this disagreement in calculations, the pilot reports and the RSW and B94 groundspeeds indicate that the aircraft did not touchdown faster than recommended.
