**National Transportation Safety Board**  
Office of Research and Engineering  
Washington, D.C. 20594

**Performance Study**

Location: Italy, Texas  
Date: July 6, 2016  
Time: 1148 CDT  
Airplane: Bell 525, N525TA  
NTSB Number: DCA16FA199

## **Performance Study DCA16FA199, Bell 525, N525TA**

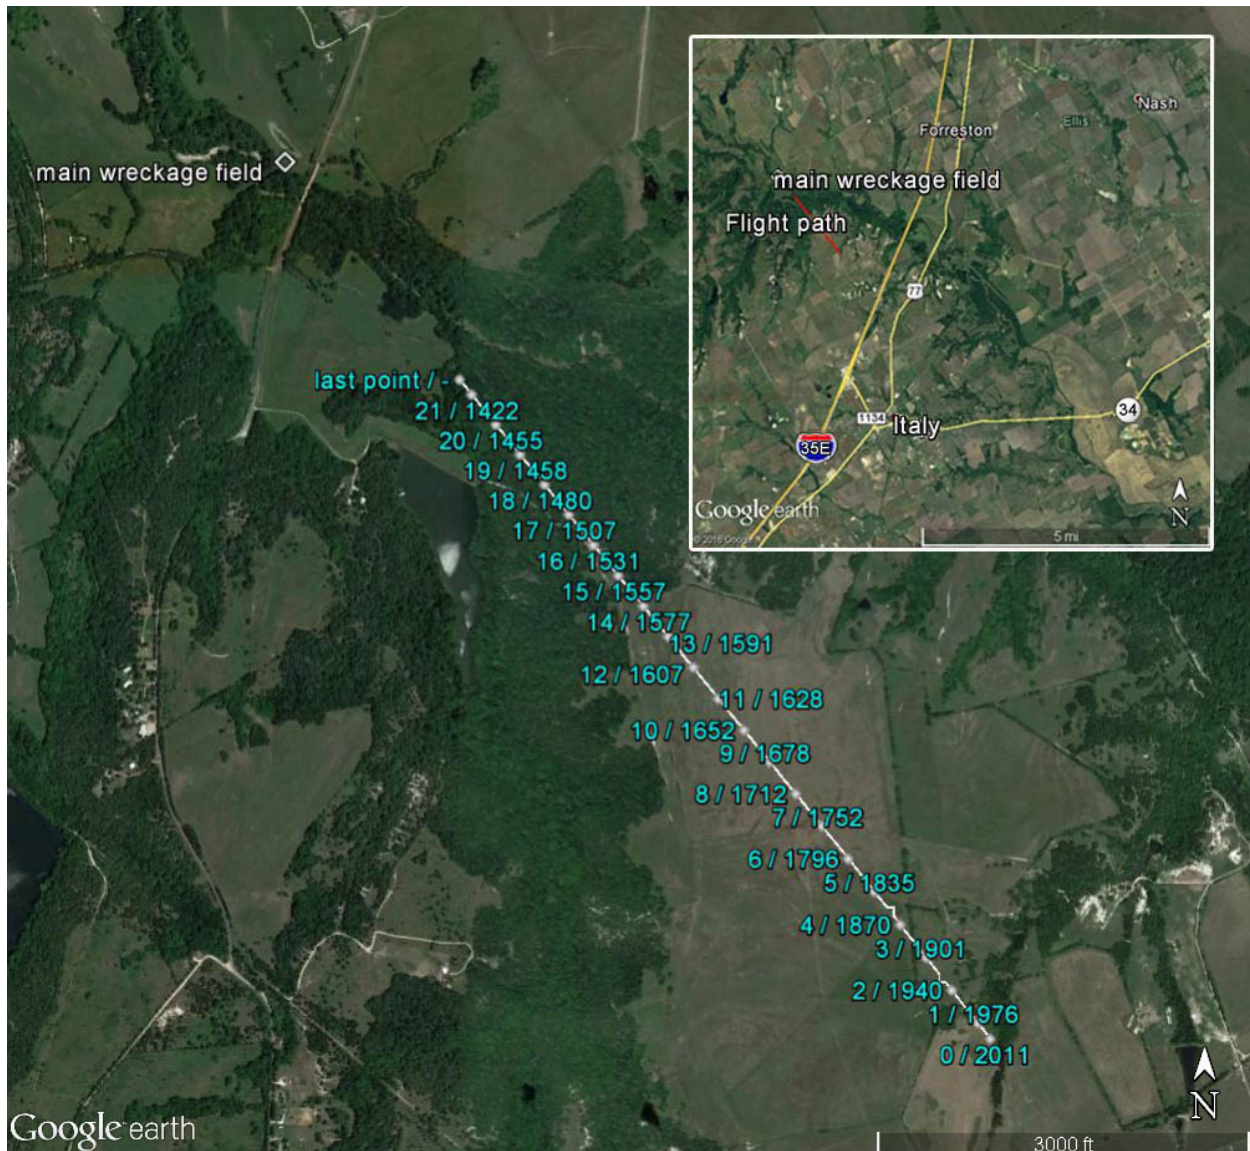
Figure 1 shows the aircraft's flight path for record 51 with locations based on Global Positioning System (GPS) satellite data. Each point is annotated with the time shown as test time in seconds, and with corresponding height above ground in feet. The test record began at time zero, in the lower right of the figure. The aircraft's flight path was along a track of 320°. The telemetry system stopped recording data just after the 21 second mark. The location of the last verified data point is shown as 'last point' in Figure 1.

**Figure 1.** Aircraft flight path and main wreckage location. The last point occurs at 21.18s.

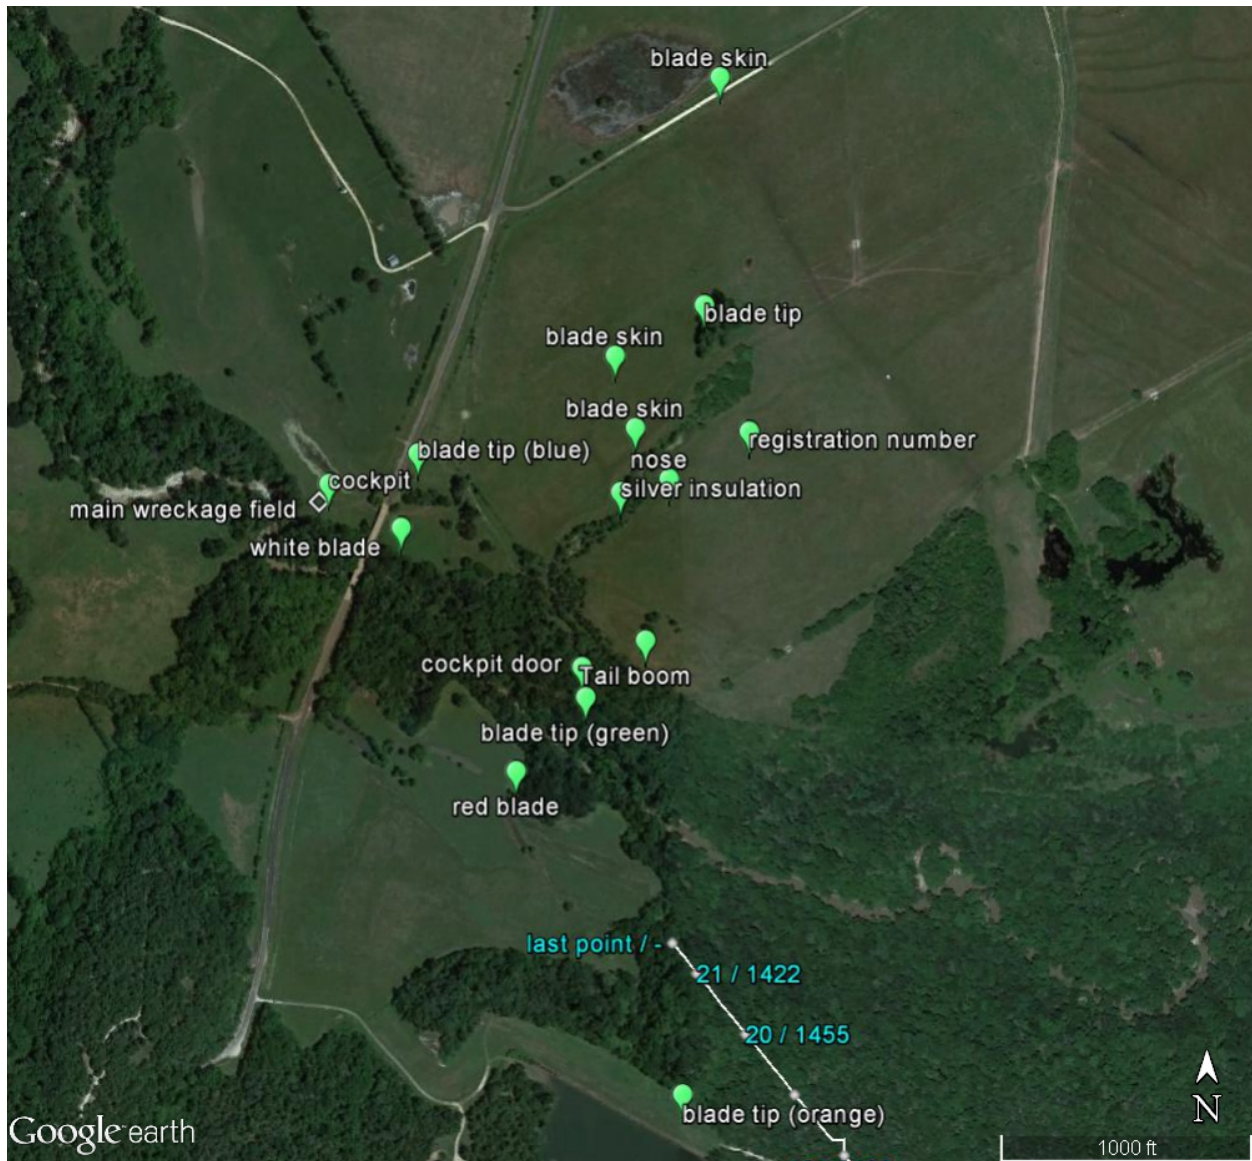
the blue and green main rotor blades<sup>1</sup>. A debris field (Figure 2) extended between the last data point and the main wreckage covering approximately 4,000 ft (north to south) by 1,700 ft (east to west). The debris field indicates an inflight breakup of the aircraft that was confirmed by witness statements from the pilots of the chase helicopter. The tail boom and the orange, white, and red main rotor blades were in the larger debris field while the root ends of the blue and green blades were with the main wreckage of the aircraft.

**Figure 2.** Aircraft flight path and main wreckage field.

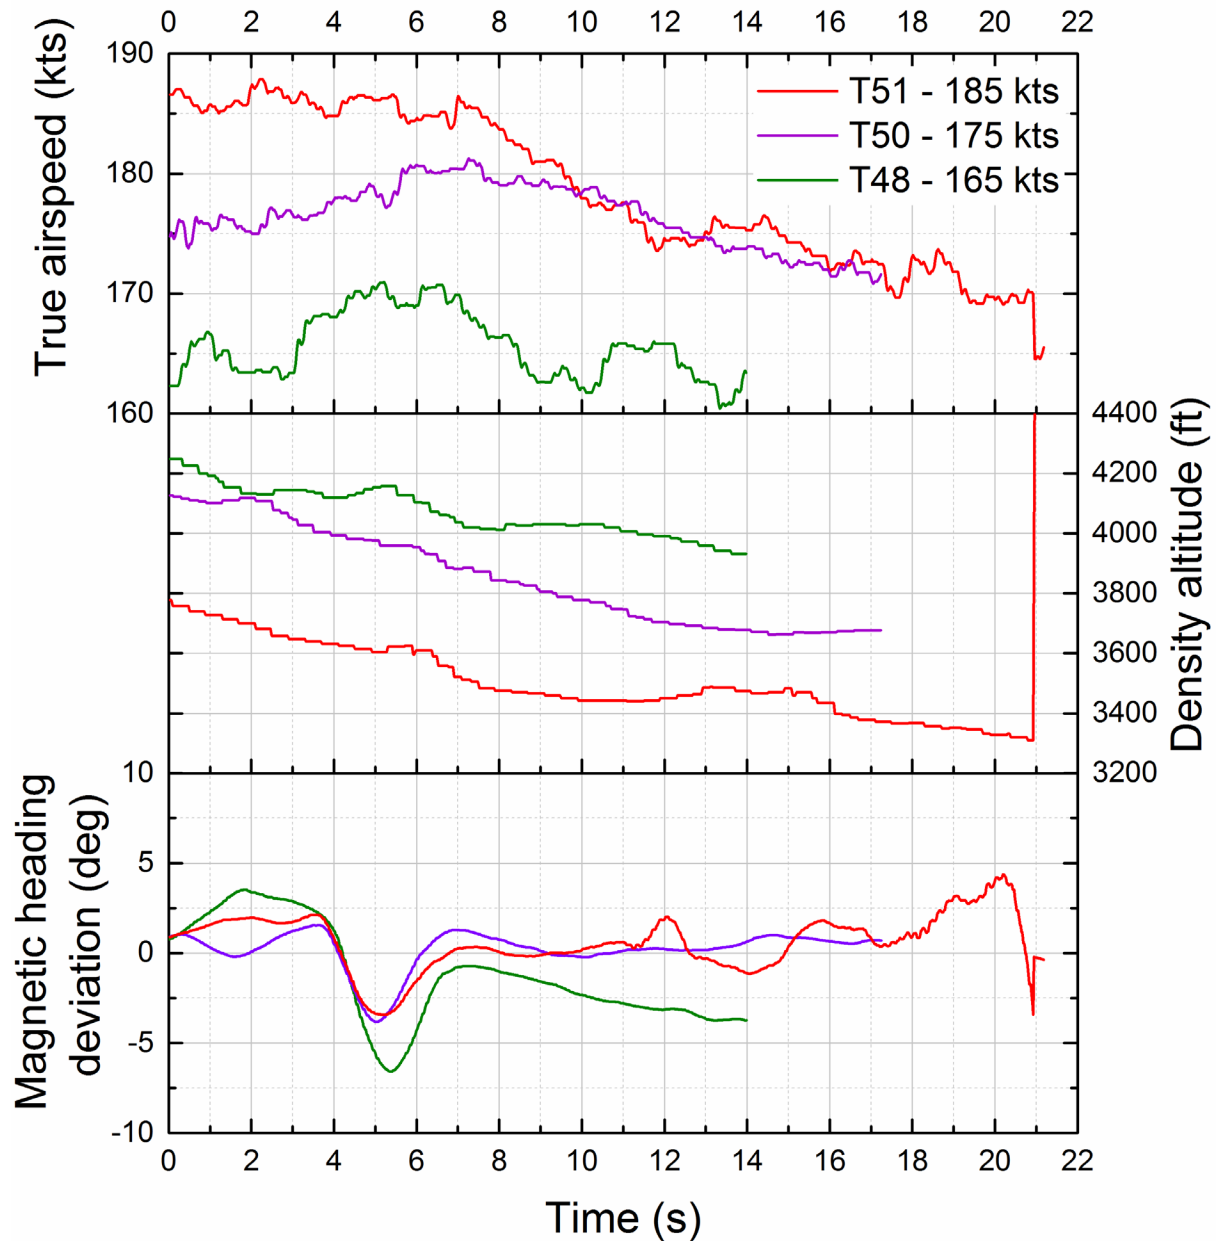
OEI records where airspeed was increased in 10 kts increments. Figure 3 shows the airspeed, altitude, and heading of accident flight and two prior successful OEI tests<sup>3</sup>. The entry conditions for this test point had been previously evaluated with regard to the aero-servo-elasticity stability (ASE). ASE refers to the dynamic stability of the airframe, rotors, and control system in flight.

**Figure 3.** Accident flight and prior two successful OEI test records. In each test, the OEI condition was initiated at about the 4 second mark.

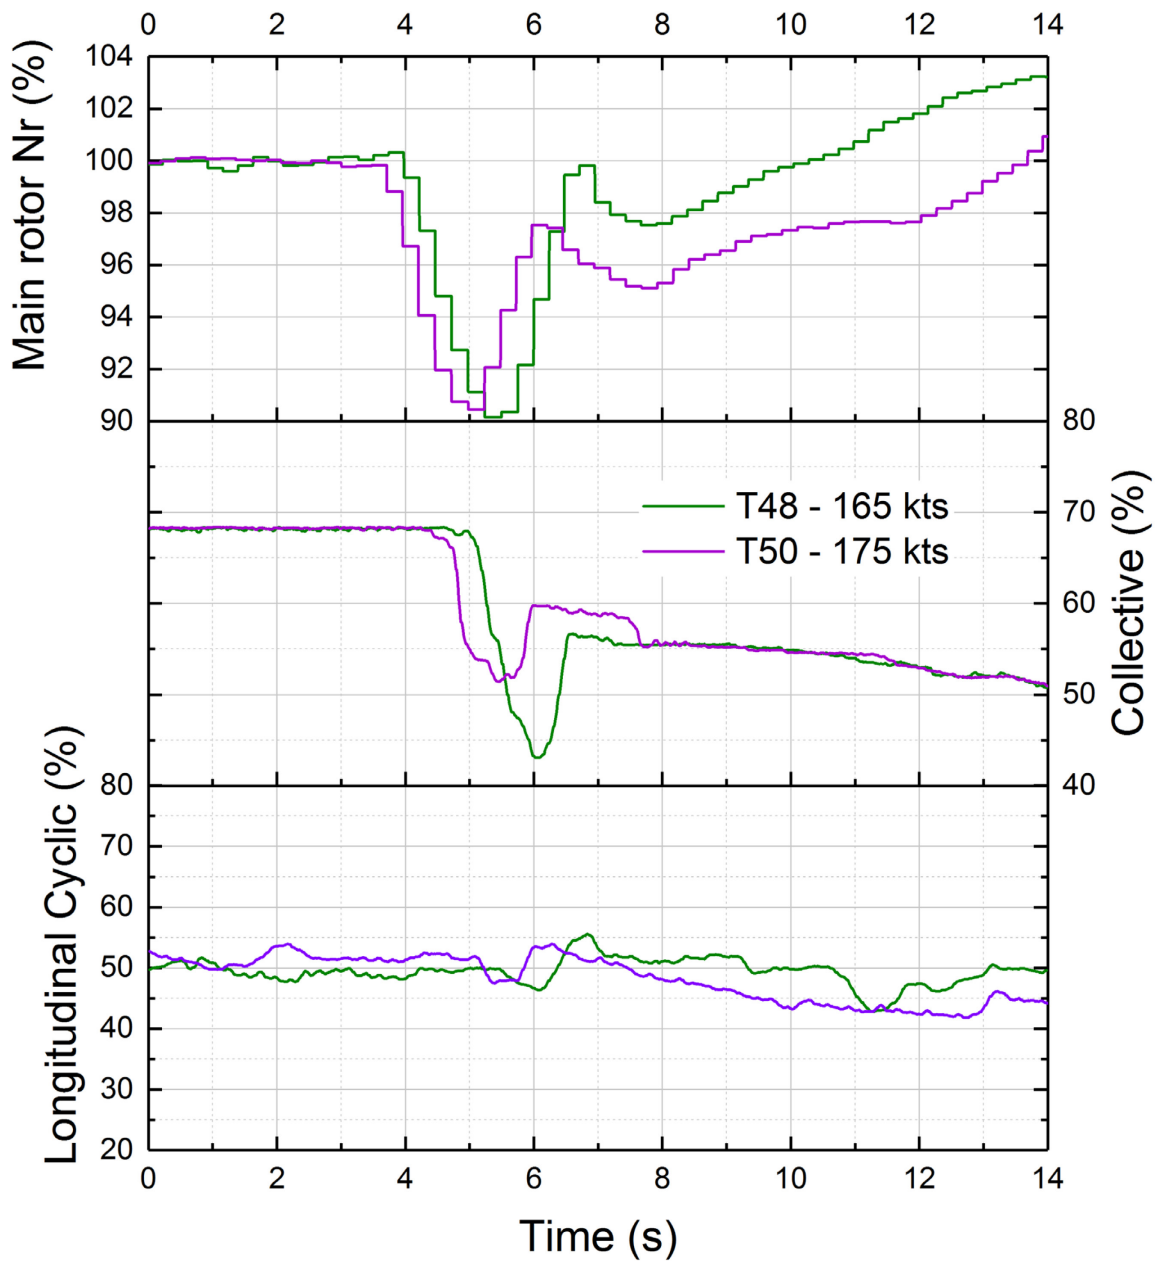
Figure 4 shows the two prior successful OEI test records at 175 kts airspeed (labeled T50 for record 50) and 165 kts airspeed (labeled T48 for record 48). For both tests, the main rotor  $N_r$  degraded from 100% at about 3.5 to 4 s, consistent with initiation of the OEI test. Collective was reduced to 51% for T50 and 43% for T48. The  $N_r$  stopped decreasing at around 90% before recovering by ten seconds to 97% for T50 and nearly 100% for T48 before continuing to rise to the 103% completion point. The time from  $N_r$  decay to initial  $N_r$  recovery for both tests was between two and three seconds.

Figure 4. Prior two successful OEI test records.

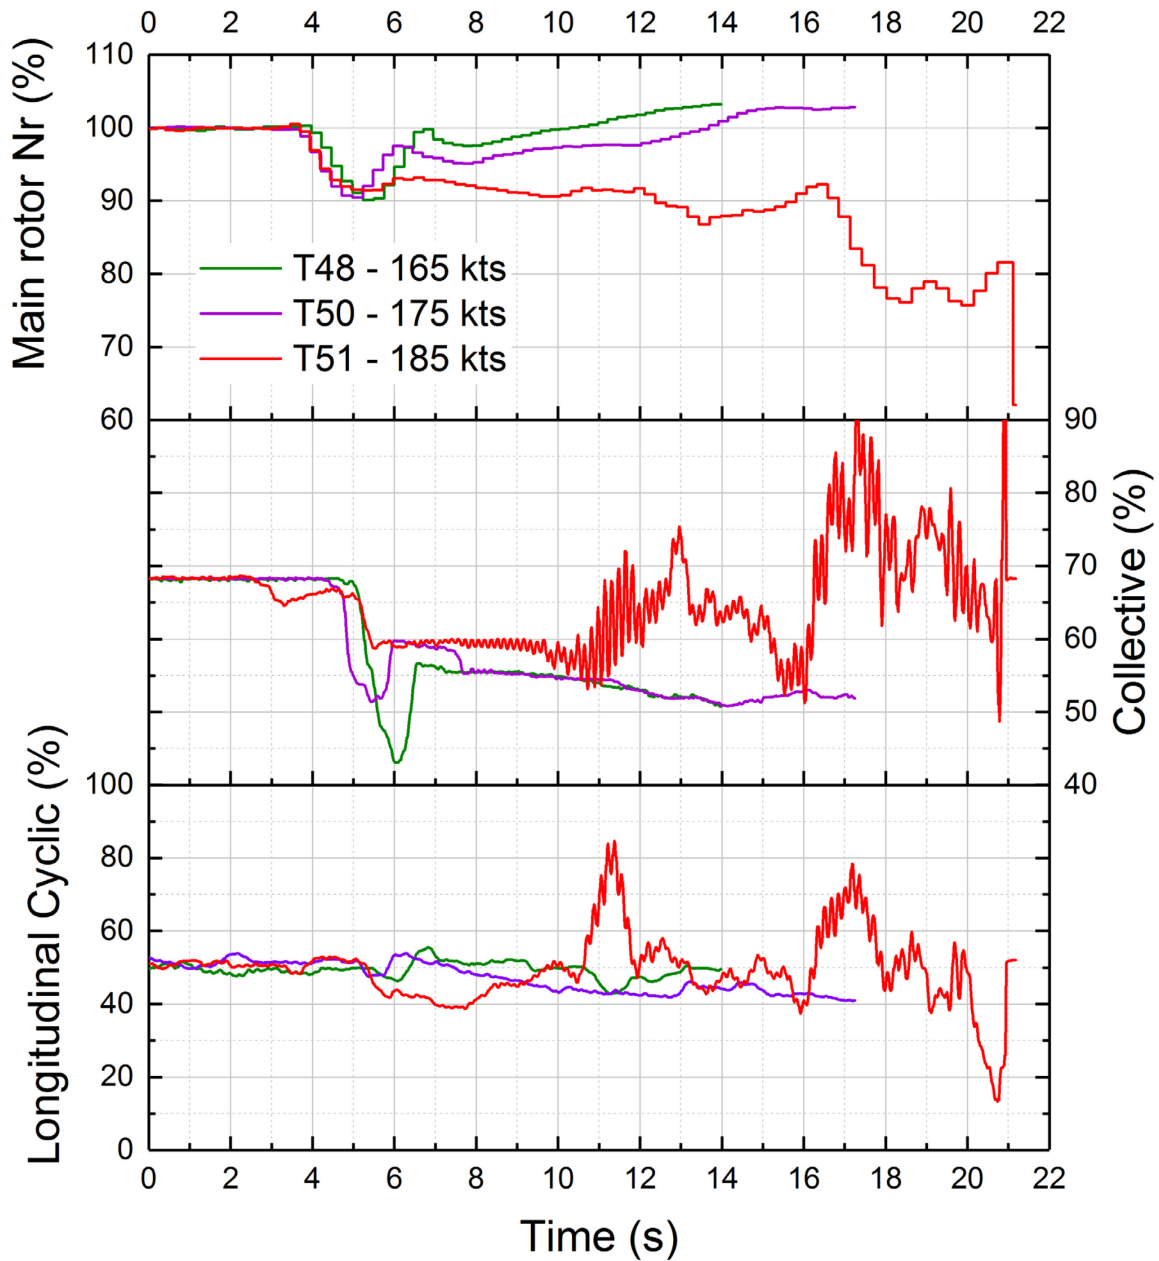
For comparison, Figure 5 shows the same Nr, collective, and longitudinal cyclic parameters for the accident record compared to the prior tests. For record 51, Nr began to decay at about 3.5 s, similar to the prior tests. Collective was reduced to 58% and the Nr stabilized near 92% but did not return to 97% or higher as in the previous tests. After 6 s, higher frequency components can be seen in the collective and longitudinal cyclic inputs that were not present in the earlier tests. After 7 s, the Nr stopped recovering and by 18 s, it had decreased to below 80%.

**Figure 5.** Accident Nr and control input with earlier flight test records.

Figure 5 shows an oscillation in the collective and cyclic control inputs during the accident record, sometime after 6 s. The oscillation was not present during the previous test records. The oscillation indicates a vibration in the structure and controls near 6 Hz. This vibration, which will be referred to as ‘the 6 Hz’ vibration throughout this report, was not a single mode of vibration at exactly 6 Hz throughout the flight. The frequency of the vibration changed slightly through the record as rotor speed changed and various airframe and rotor modes were excited. The 6 Hz vibration was introduced at a very low amplitude and it became apparent in many data channels sometime between 6 and 8 s. This 6 Hz vibration was distinctive, grew in amplitude, and affected the entire helicopter and the crew.

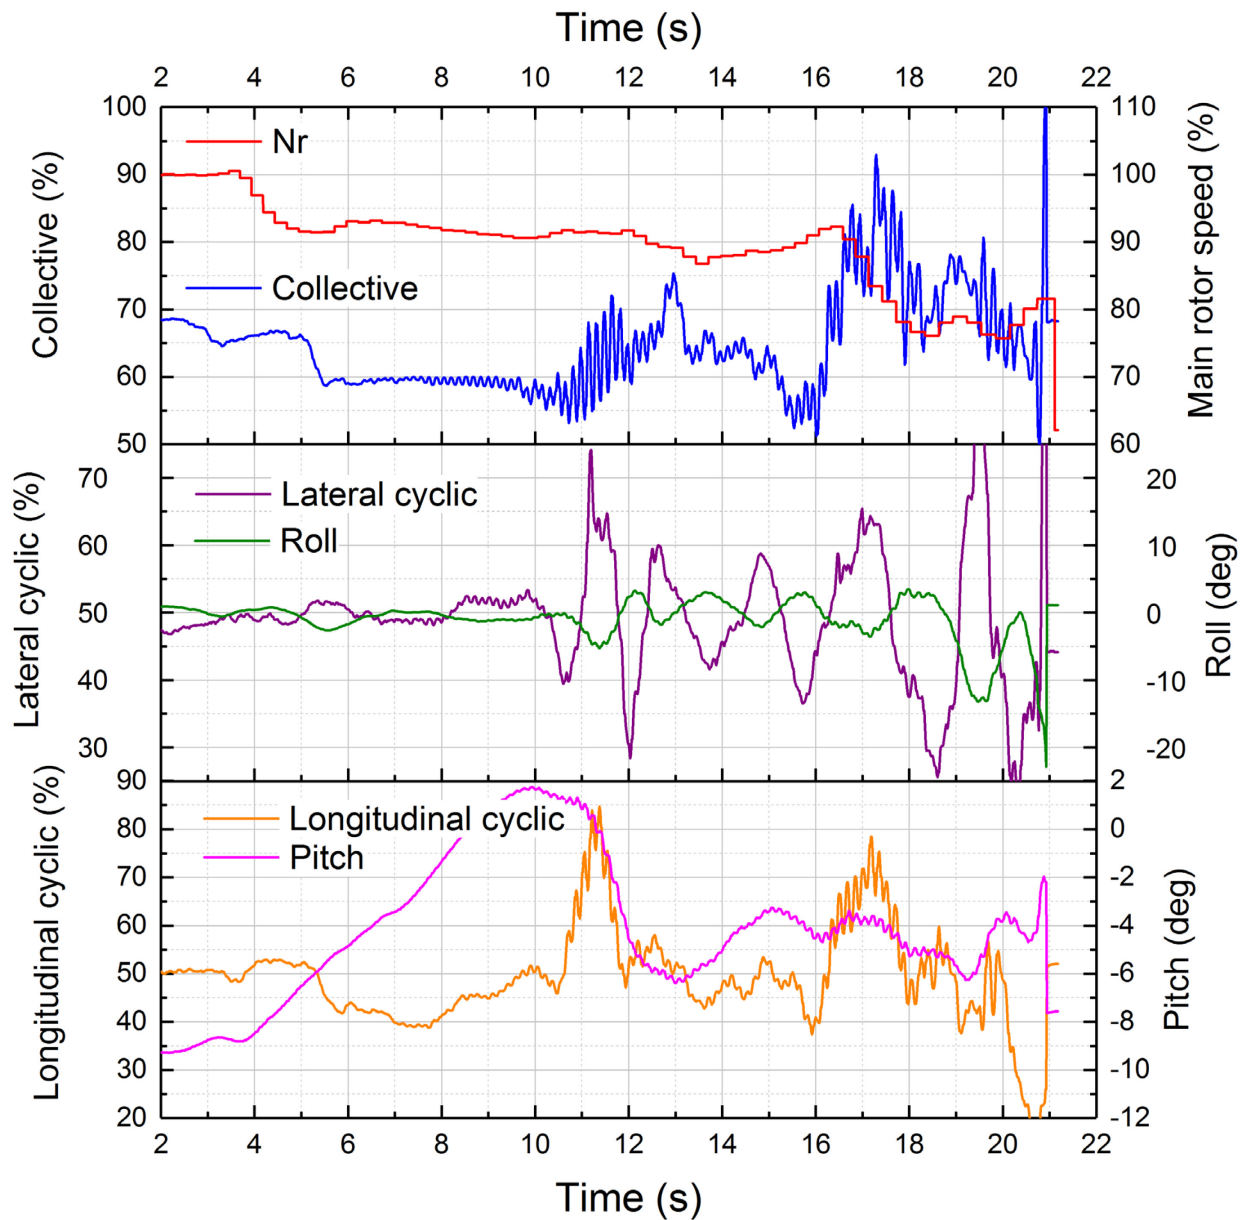
Figure 6 shows the control inputs from the collective and cyclic and the aircraft's response and orientation during the accident test point. When collective was increased between 10 and 13 s and again between 16 and 17.5 s, the main rotor rotational speed slowed. The middle plot shows lateral cyclic and roll. After 10 s, cyclic input activity increased as did the roll response. The bottom plot shows longitudinal stick and pitch. The aircraft's roll and pitch responded to cyclic input throughout the accident flight.

**Figure 6.** Control input and aircraft response during the accident test record.

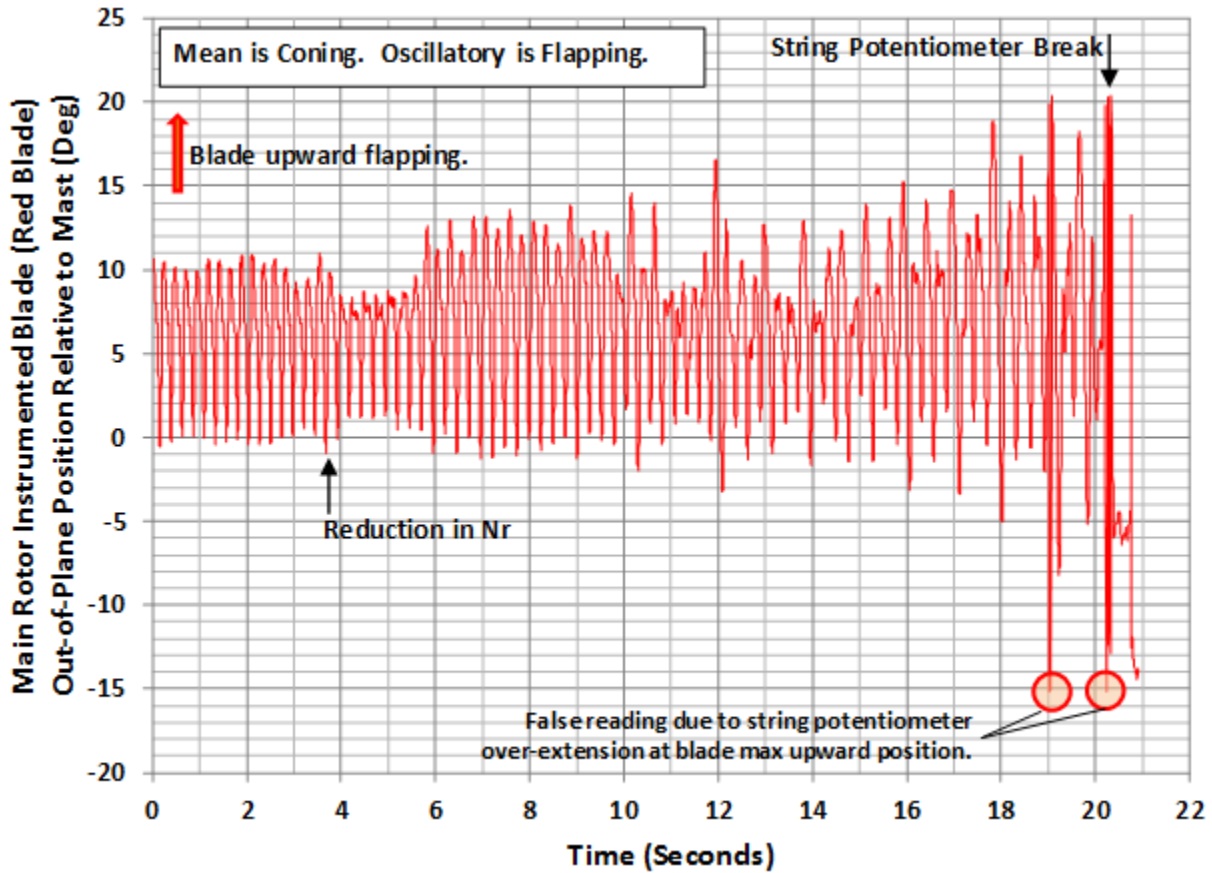
Increasing the collective increases the torque load on the main rotor. However, in the high speed flight with OEI mode active, the engine power is insufficient for the load and therefore the main rotor rotational speed decreases. The red blade was instrumented to record flapping and the blade's out of plane flapping motion is shown in Figure 7. As the rotational speed decreased after 16 s, the out of plane flapping motion increased. At approximately 20.7 s, a large aft cyclic input reached peak value. At 20.4 s, the string potentiometer that measured blade flapping motion stopped functioning due to excessive flapping. Within two rotations of losing the flapping signal, one or more of the main rotor blades severed the tail boom from the aircraft and all data recording

**Figure 7.** Red blade out-of-plane position during the accident test record. Plot courtesy of Bell Helicopter.

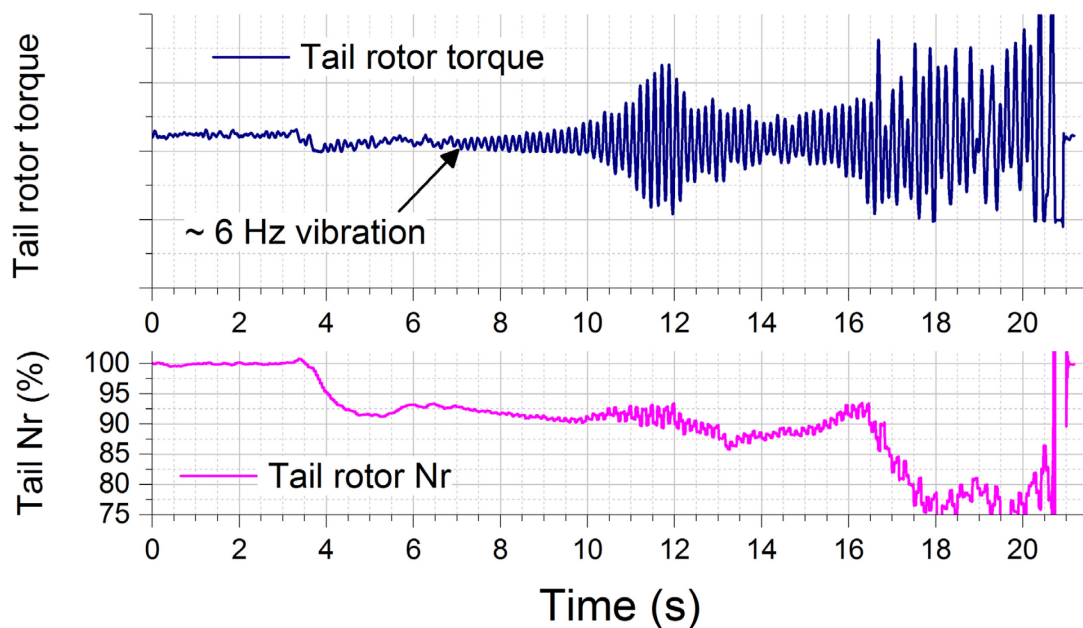
Figure 8 shows the recorded tail rotor torque and tail rotor Nr (the tail rotor is mechanically linked to the main rotor so tail rotor Nr tracks main rotor Nr). After 7 s, the vibration was well defined and the amplitude began to grow. At 10 s, the amplitude grew before decaying again after 12 s. This growth was described as a ‘blossom’ in the vibration and the term will be used throughout this study. The appearance of the 6 Hz torque oscillation corresponded with a rotor Nr of about 92%. Since the collective was oscillating at 6-Hz, the control laws would send a corresponding (6-Hz) command to the tail rotor as anti-torque compensation.

**Figure 8.** Tail rotor torque and tail rotor Nr during the accident test record.

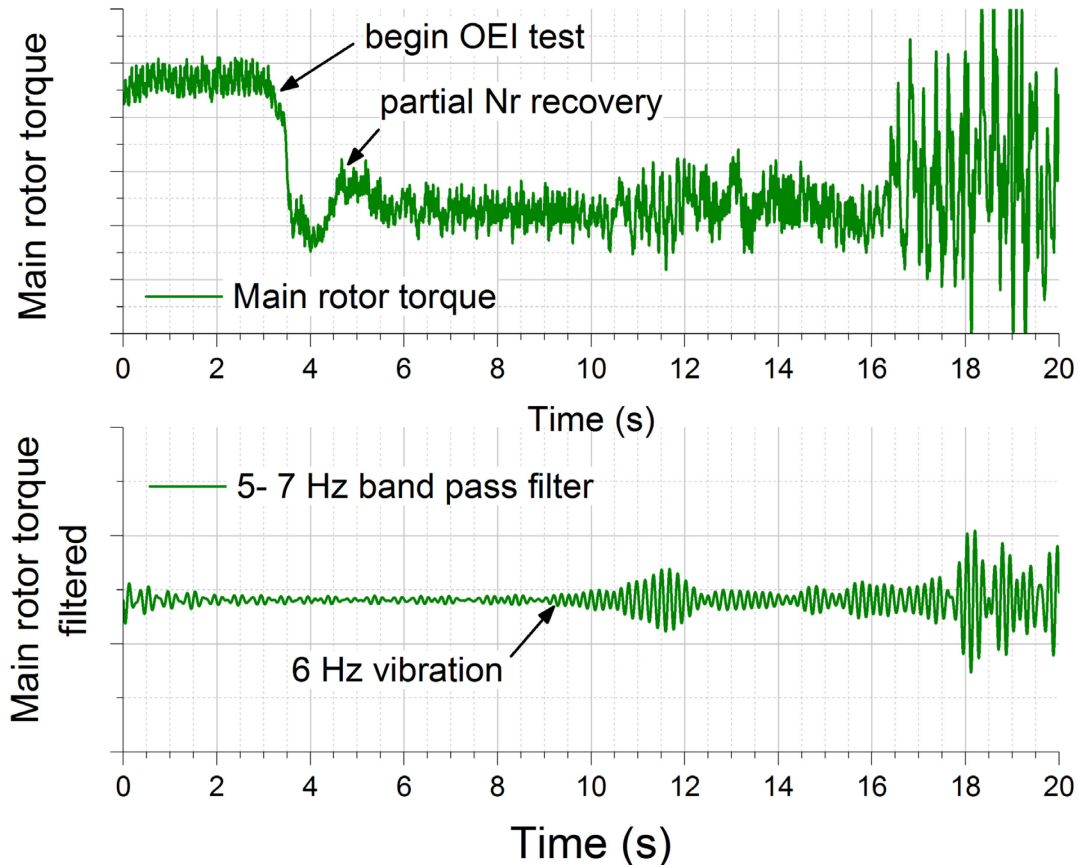
The torque on the main rotor is shown in Figure 9. The filtered sub-plot is used to better differentiate the 6 Hz vibration, and highlights the vibration at 10 s.

**Figure 9.** Main rotor torque during the accident test record.

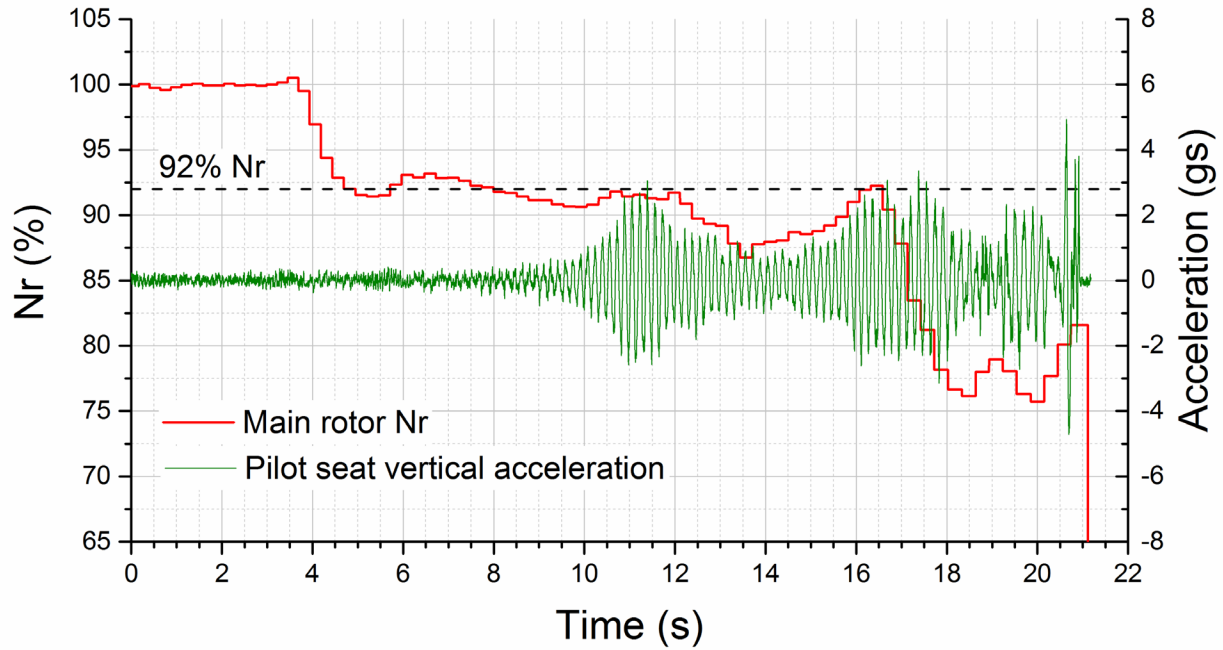
Figure 10 shows main rotor Nr and pilot seat vertical acceleration<sup>5</sup>. As the rotor speed stayed near 92%, the 6 Hz vibration grew in amplitude from around 7 s until 11 s. At 11 s the Nr slowed below 90% and the 6 Hz amplitude decreased. At 13.5 s, the Nr began to increase from 86%. As the Nr again approached 92% the 6 Hz amplitude increased. The amplitude of the vertical oscillation was near  $\pm 2.5$  g at 6 Hz around 11 s and again after 16 s. For comparison, earlier test records showed variations in vertical acceleration no greater than  $\pm 0.3$  g. The 6 Hz vibration appeared in the control inputs, especially the collective, starting before 7 s (Figure 11). The effects of this vibration on the pilots is discussed in the Human Performance Report [3].

Figure 10. Main rotor Nr and pilot seat vertical acceleration during the accident test record.

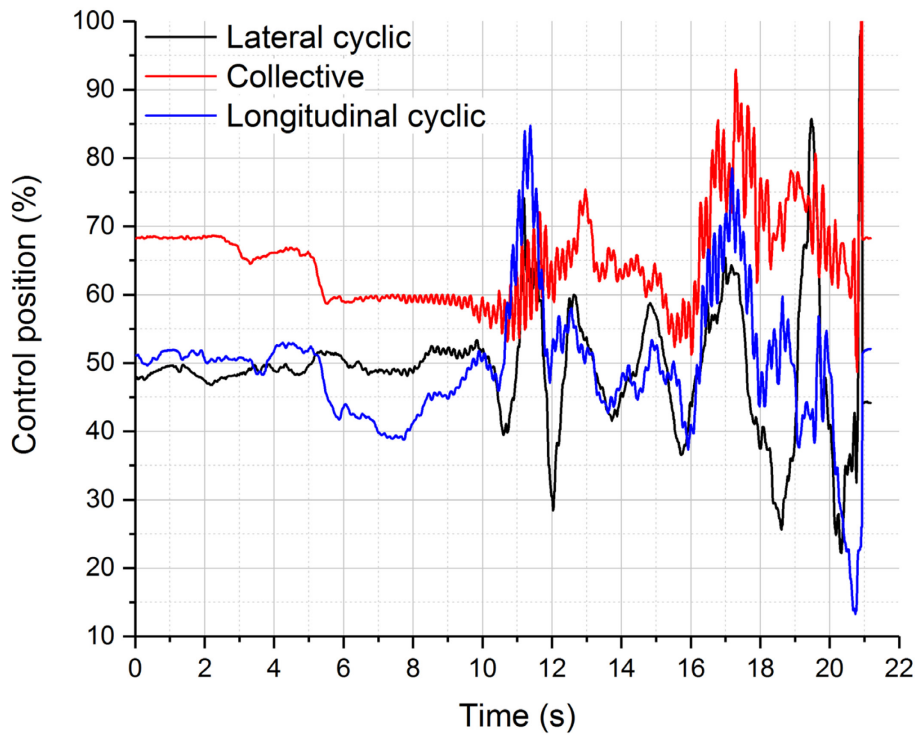
Figure 11. Control inputs during the accident test record

As shown in Figure 11, the 6 Hz vibration also manifested in the control inputs, starting around 6.5 s. The scissors mode through aerodynamics produces a fore-aft motion of the main rotor mast. The airframe responded to this forcing frequency with an oscillatory ~6 Hz vertical motion at the pilot seat.

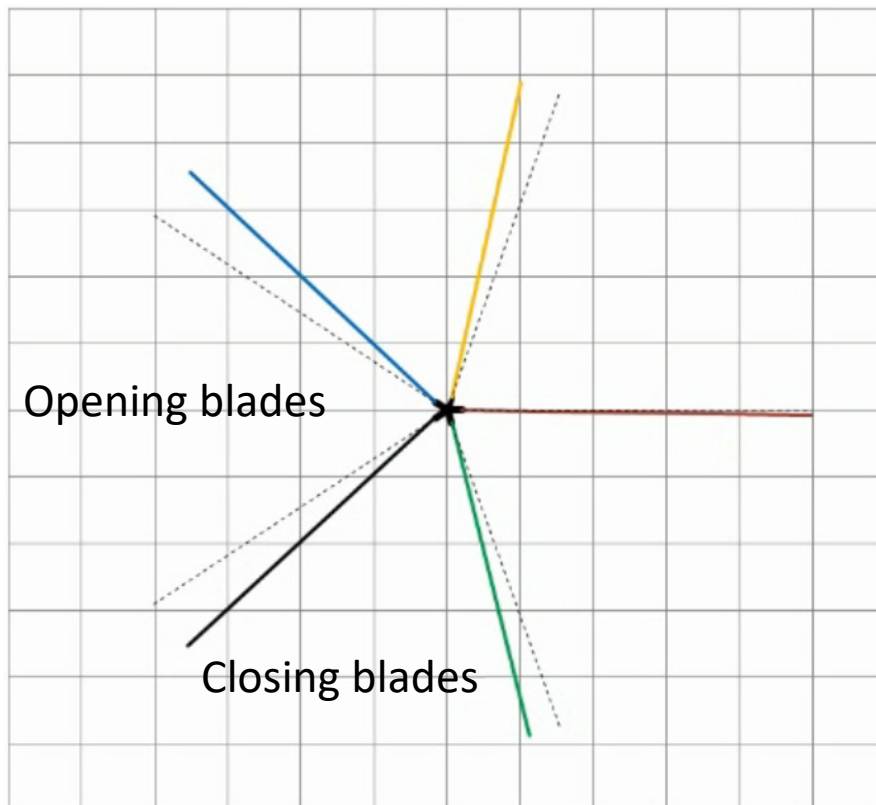
The focus of much of the investigation was on the source of the 6 Hz vibration. The predicted frequency of the main rotor 1<sup>st</sup> in-plane scissors mode is 6.8 Hz at 100% Nr and drops to 6.2 Hz at 92% Nr. These values are reported as fixed-system (non-rotating) frequencies. For a rotor mode, this is the frequency at which the rotor hub conveys motion into the fixed system. An illustration of the in-plane scissors mode in the main rotor system is shown in Figure 12. The lead-lag motions of the blades act in such a way that adjacent blades move together and apart in a scissoring motion. The excitation of the scissors mode was confirmed by plotting the relative lag angle between the red and green blades as a function of azimuth. The scissors mode produces a fore-aft motion of the main rotor mast due to aerodynamic forces.

**Figure 12.** Scissors mode in main rotor system. Illustration courtesy of Bell Helicopter.

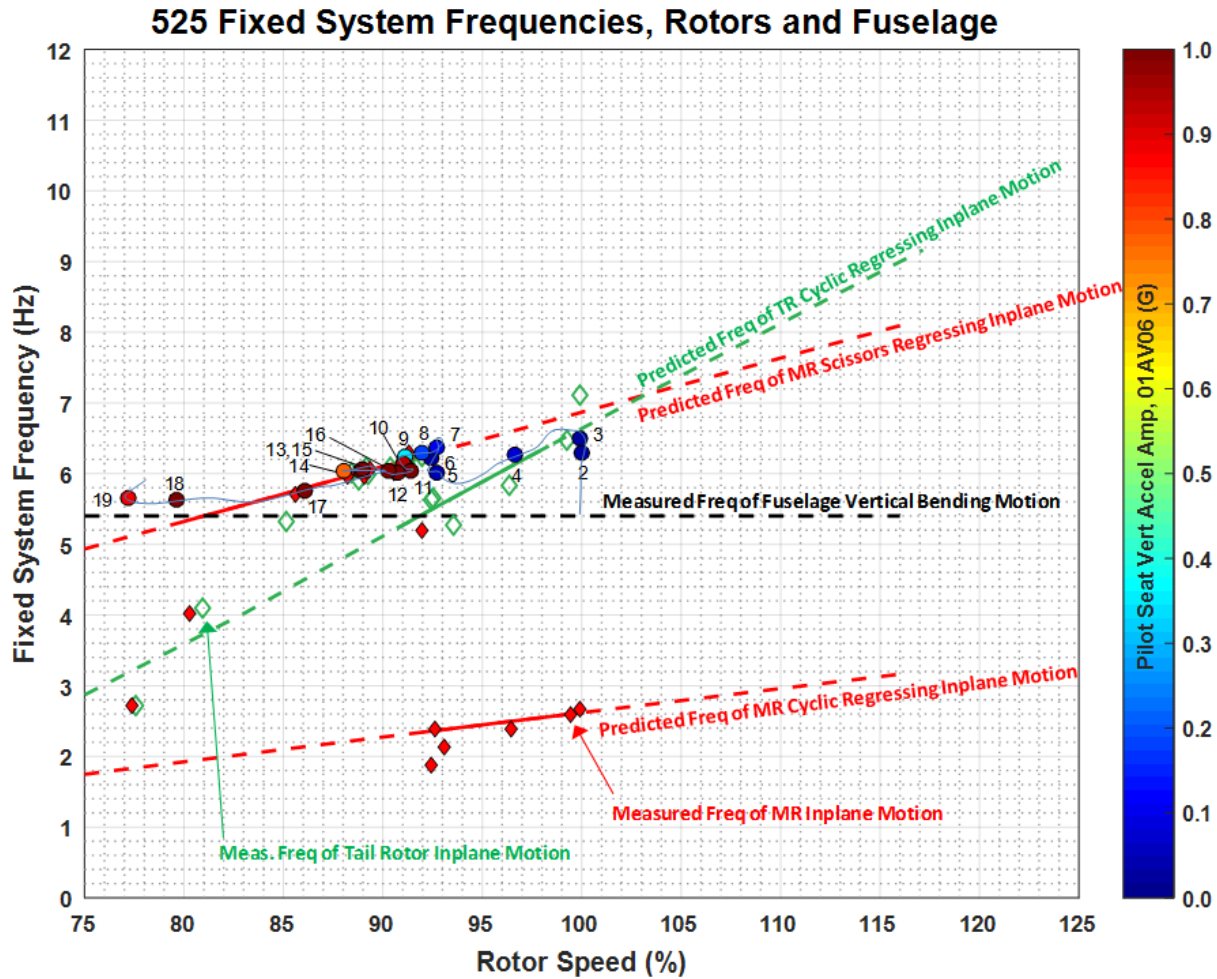
Figure 13 shows the frequency of the main rotor scissors mode (upper red line), the first vertical bending mode<sup>7</sup> (black line), the main rotor cyclic regressing mode<sup>8</sup> (lower red line), and the tail rotor cyclic regressing mode (green line). The frequencies of the rotor modes vary with rotor speed. The existence of a mode at a given frequency on this plot is not indicative of vibratory amplitude at that frequency. The cyclic regressing modes of the rotors and vertical bending mode of the fuselage have small amplitude responses prior to the main rotor scissors mode becoming the dominant mode.

The frequency and amplitude of the vertical oscillations of the pilot seat during the accident test flight are shown as a series of colored circles. Each circle is labeled with the test time in seconds (from 2 to 19 s) and the color of the circle reflects the amplitude of the frequency response. The amplitude color scale is shown to the right of the figure.

Figure 13. Fixed system frequencies versus rotor Nr. Plot courtesy of Bell Helicopter.

Early in the test record, the frequency of the main and tail rotor systems followed their cyclic regressing modes as shown by the green diamonds (tail rotor in-plane motion) and red diamonds (main rotor in-plane motion). Initially, as the rotor speed was between 100% and 93%, the pilot seat vertical vibration frequency followed the frequency of the tail rotor cyclic regressing mode. The amplitude of this response was quite low: less than 0.2 g's and consistent with prior tests.

As the rotor speed decreased towards 92% Nr, the measured in-plane motion of the main rotor blade shifted from a dominant cyclic regressing mode to a dominant scissors regressing mode (upper red dotted line) and by 6.5 s the pilot seat vertical acceleration responded at the main rotor scissors mode frequency, indicating that the fuselage of the aircraft was responding to the scissors mode. The main rotor's shift to the scissors mode produced a frequency around 6 Hz that began dominating the vibratory signature of the tail rotor, the fuselage, and by 7 seconds (referring to Figure 5) affected the controls.

The tail rotor cyclic regressing mode and the first vertical bending mode of the aircraft (black line) coalesce near 5.4 Hz at 92% Nr. This coalescence coincides with the shift in pilot seat vertical vibration frequency to the main rotor scissors mode frequency. It is possible that the coalescence at 5.4 Hz initiated the main rotor scissors mode response. However, the growth in aircraft vibration at 92% Nr is not a response to the tail rotor or airframe modes (at 5.4 Hz), but is a response to the scissors mode at near 6Hz. Two sources were determined to have increased the amplitude of the aircraft's 6 Hz frequency response:

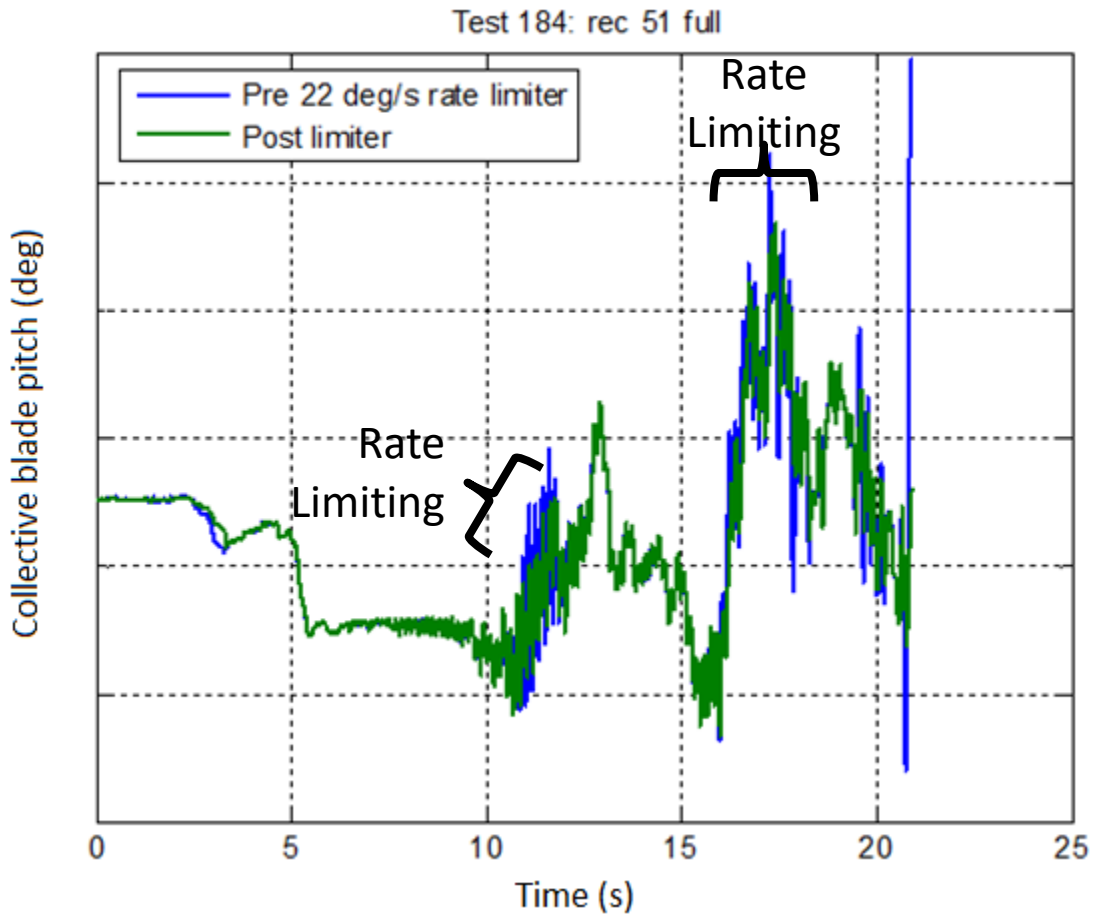
The evidence for biomechanical feedback is seen in the trace of pilot collective control after 6.5 seconds, which shows the pilot's control stick moving at the 6-Hz scissors mode frequency. The pilot's collective control oscillations result in further amplification of the main rotor scissors mode, further amplifying the vertical seat vibration, and further increasing the collective stick oscillation. The biomechanical feedback loop appears to attenuate after 10 s (and again at 16 s as seen by reductions in the pilot seat vertical vibration and collective control oscillation at those times. The command between the collective input and the actuators was governed by a control law that limited inputs greater than 22°/s. The control law rate limit in the collective control is seen as the difference between the pre-limit and post-limit collective command signal shown in Figure 14. Further discussion of the biomechanical feedback is in the Human Performance Report [3].

**Figure 14.** Rate limiting evidence in collective blade pitch angle parameter. Plot courtesy of Bell Helicopter.

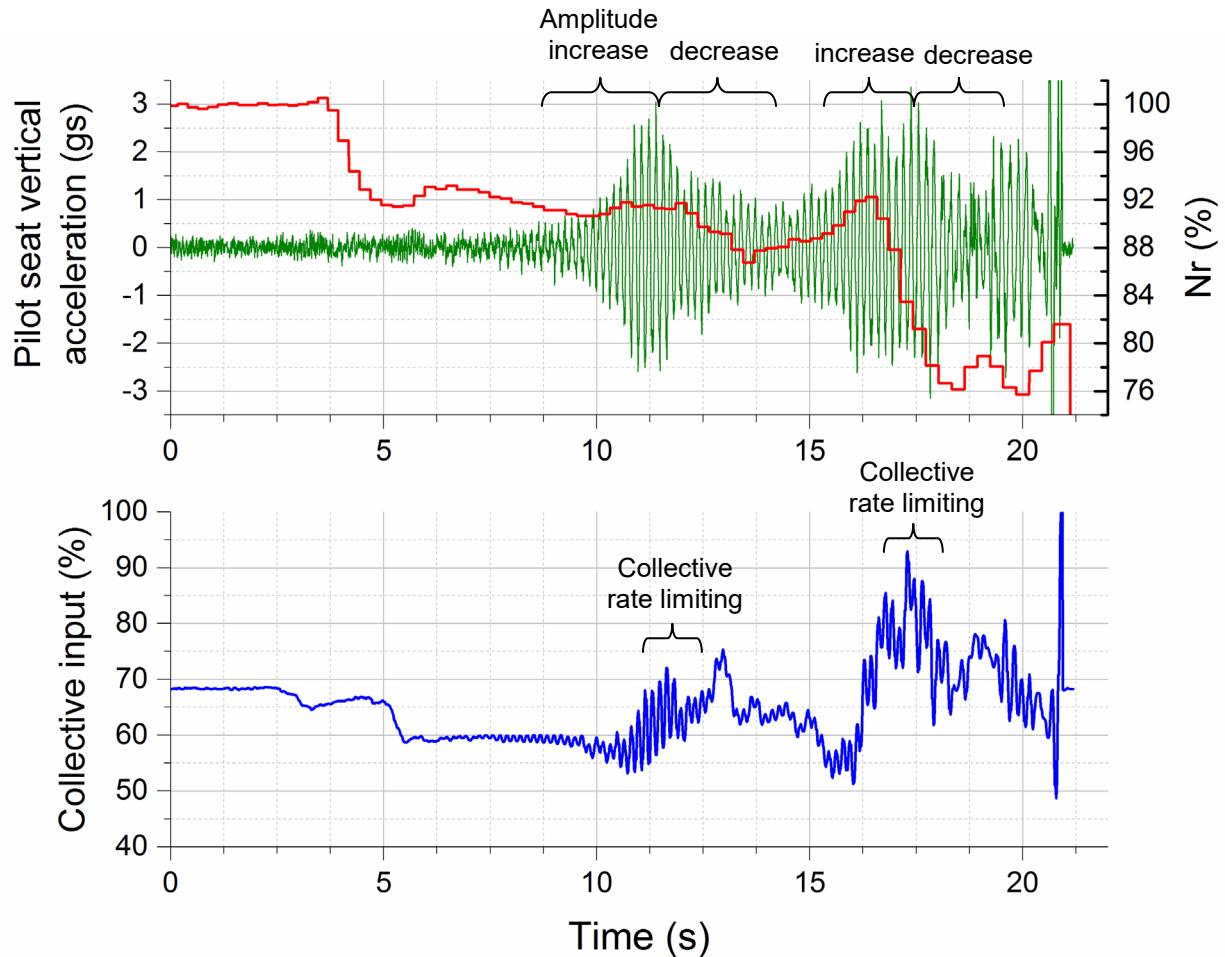
The rate limiting evidence correlated with decreases in the amplitude of the 6 Hz vibration at those times throughout the aircraft, Figure 15. However, these reductions in vibration amplitude also coincided with the rotor speed moving away from 92% Nr so the relative contribution of the control law rate limiting influence on the response amplitude could not be determined.

**Figure 15.** Vertical acceleration and collective input rate limiting.

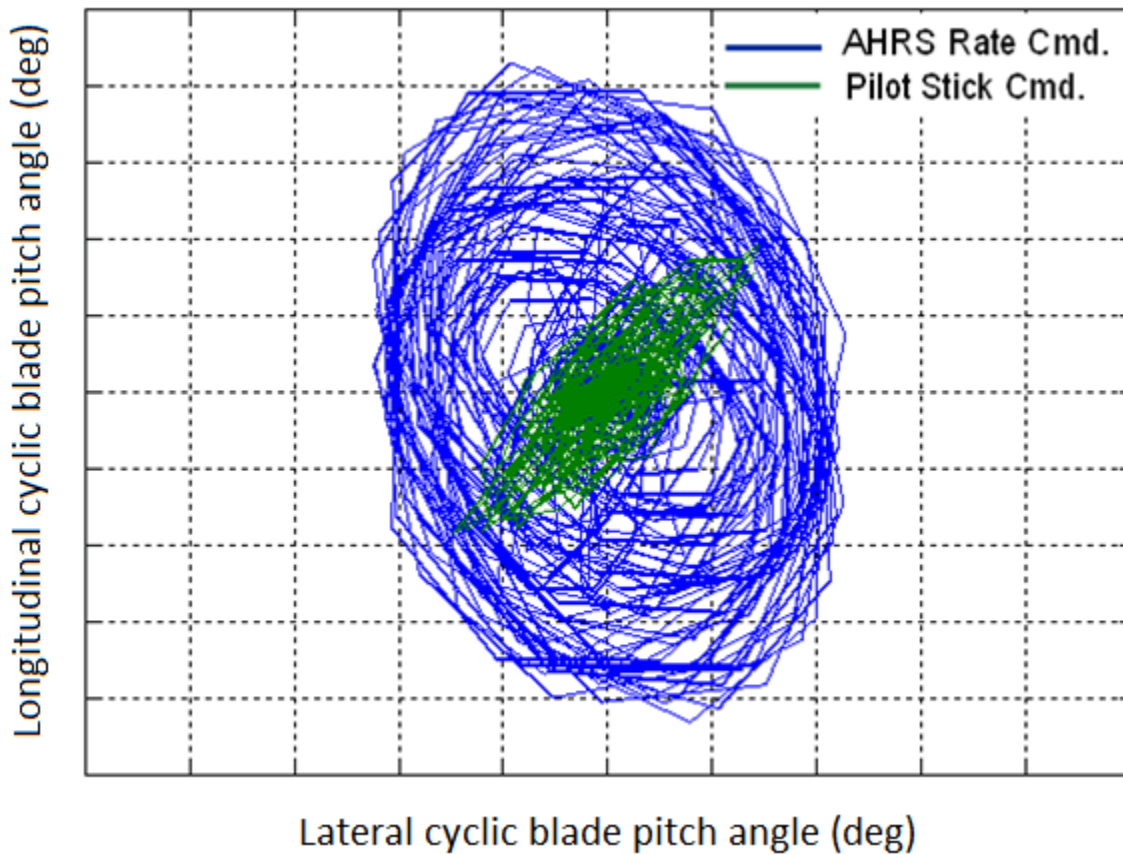
During earlier flight tests, cyclic stirrs of the swashplate were purposefully used to excite the scissors mode in the main rotor to measure and verify system damping<sup>9</sup>. During the accident record, excitation of the airframe’s first bending modes (lateral and vertical) induced the AHRS to respond with inputs intended to stabilize the aircraft. The corresponding inputs to the main rotor pitch angle can be seen in Figure 16. The AHRS was intended to work with the control laws as though the fuselage was a rigid body responding to wind gusts or similar low frequency inputs and was not intended for handling a 6 Hz vibration. Although the AHRS included filters on the signal outputs, the filters did not specifically target the 6-Hz stirring commands to the swashplate. The stirring actions of the AHRS system at this (~6 Hz) frequency were considered to be a driver of the scissors mode amplification of the main rotor.

**Figure 16.** Lateral versus longitudinal blade pitch angle due to AHRS and pilot input during the accident test flight. Plot courtesy of Bell Helicopter.

The manufacturer will focus on mitigating the biomechanical feedback and the AHRS induced swashplate stirring via control law filtering to prevent the amplification of the scissors mode response. This approach suggests that a damped system could be achieved by control law filtering of high frequency ( $\sim 6$  Hz) actuator commands.

To prevent the scissors mode amplification, the manufacturer plans to modify the control laws such that a biomechanically induced 6 Hz control input would be filtered so that the excitation is not passed to the actuators. The AHRS signal, which already included filters, will also be redesigned to not respond to 'high' frequency perturbations of the aircraft.
