National Transportation Safety Board

Performance Study

Location: Ypsilanti, Michigan
Date: March 8, 2017
Time: 1452 EST
Airplane: Boeing MD-83, N786TW
NTSB Number: DCA17FA076

DCA17FA076, Boeing MD-83, N786TW

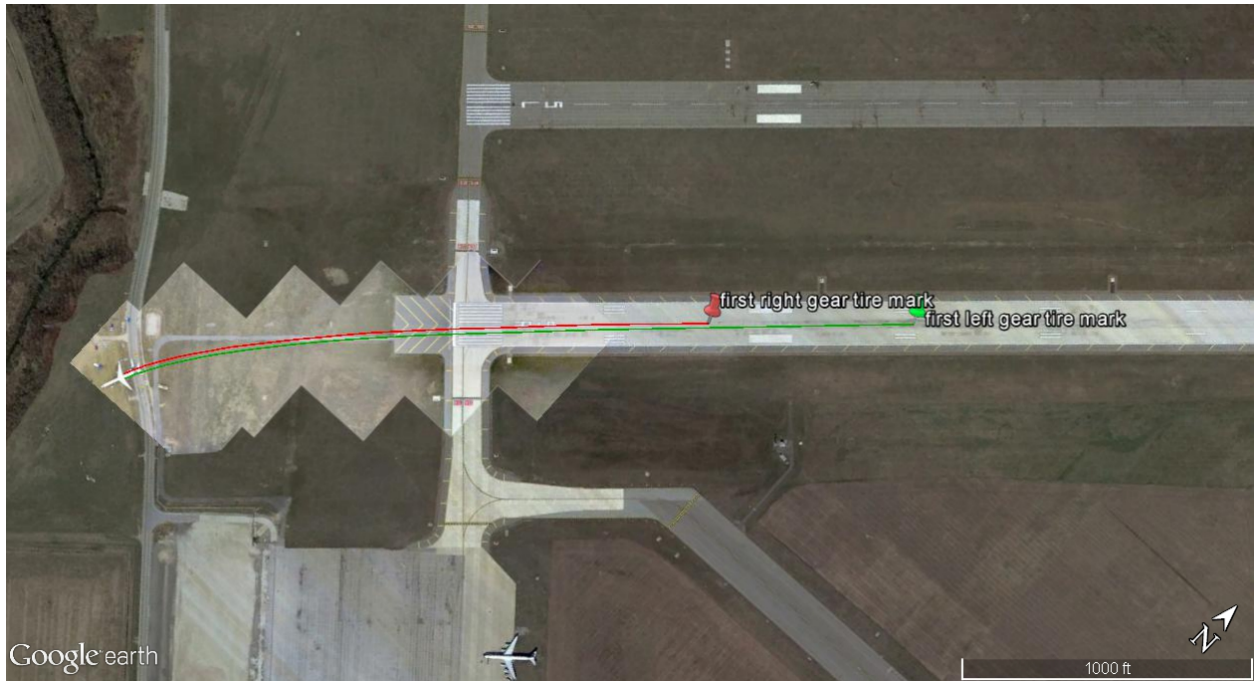
Runway 23L is 7543 ft long and 150 ft wide¹. The first clear tire marks on the accident runway were 5,956 ft from the beginning of the runway and were from the tires on the left main gear (Figure 1). Marks from the right main gear tires were 6,650 ft from the beginning of the runway. The airplane traveled off the end of runway 23L slightly left of centerline (see Figure 1 and Figure 2). The airplane continued to track to the left as it traveled 950 ft across the grass before coming to rest after crossing a raised airport perimeter road.

Figure 1. End of runway 23L, left and right main gear tire marks are highlighted green and red, and the airplane's final position can be seen.

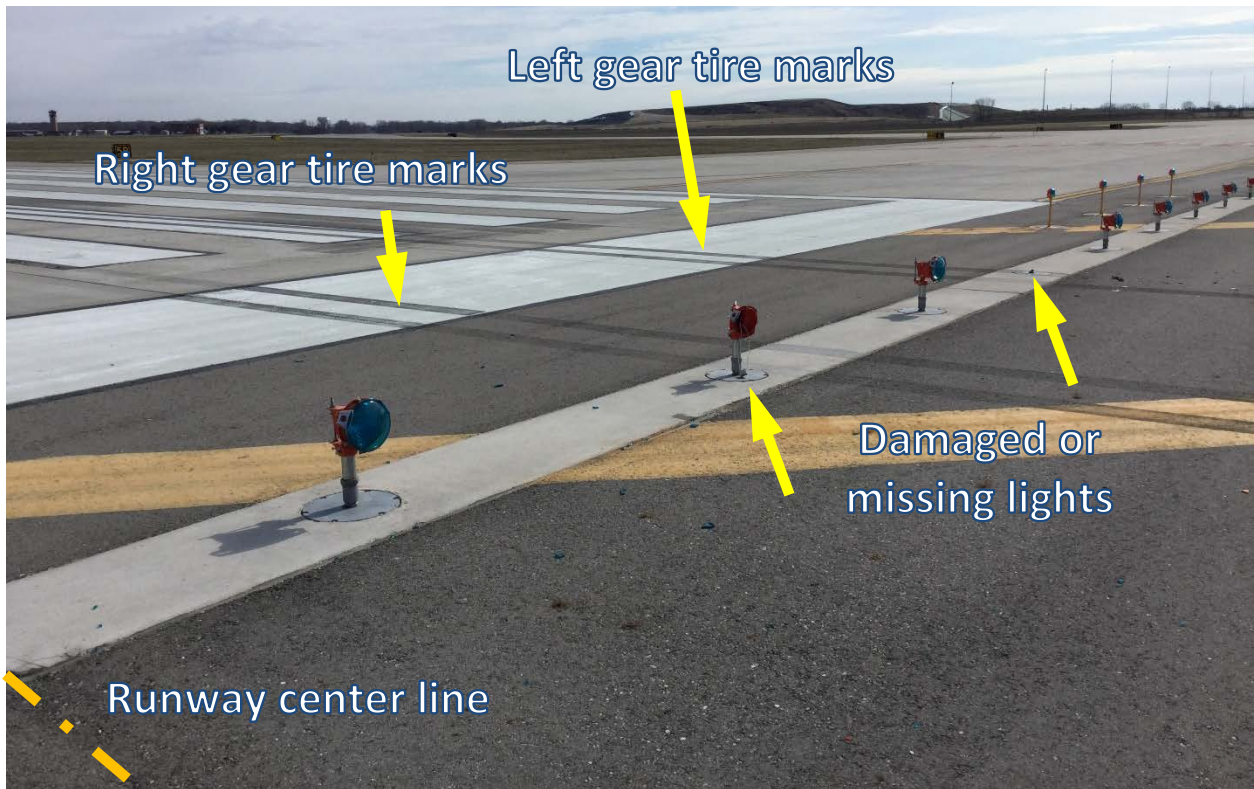
Figure 2. Threshold of runway 23L/5R and main gear tire marks on pavement.

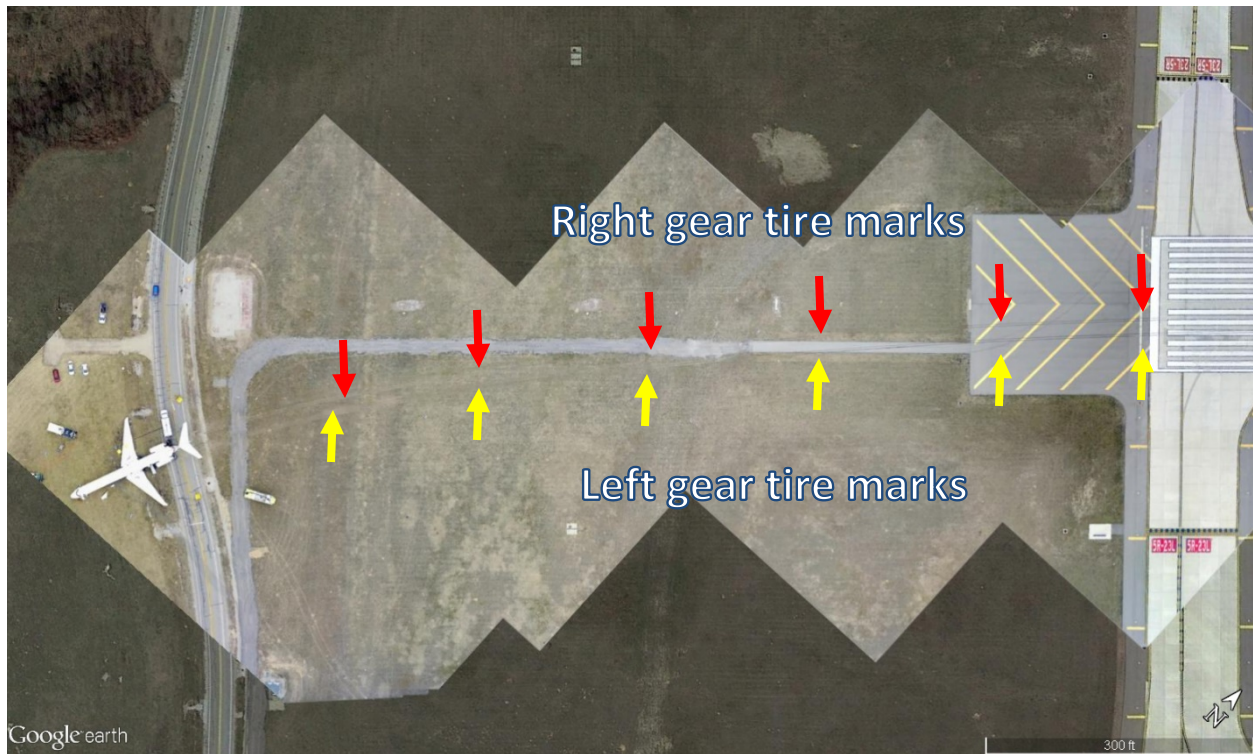
Figure 3. End of runway 23L, ground marks, and airplane final location.

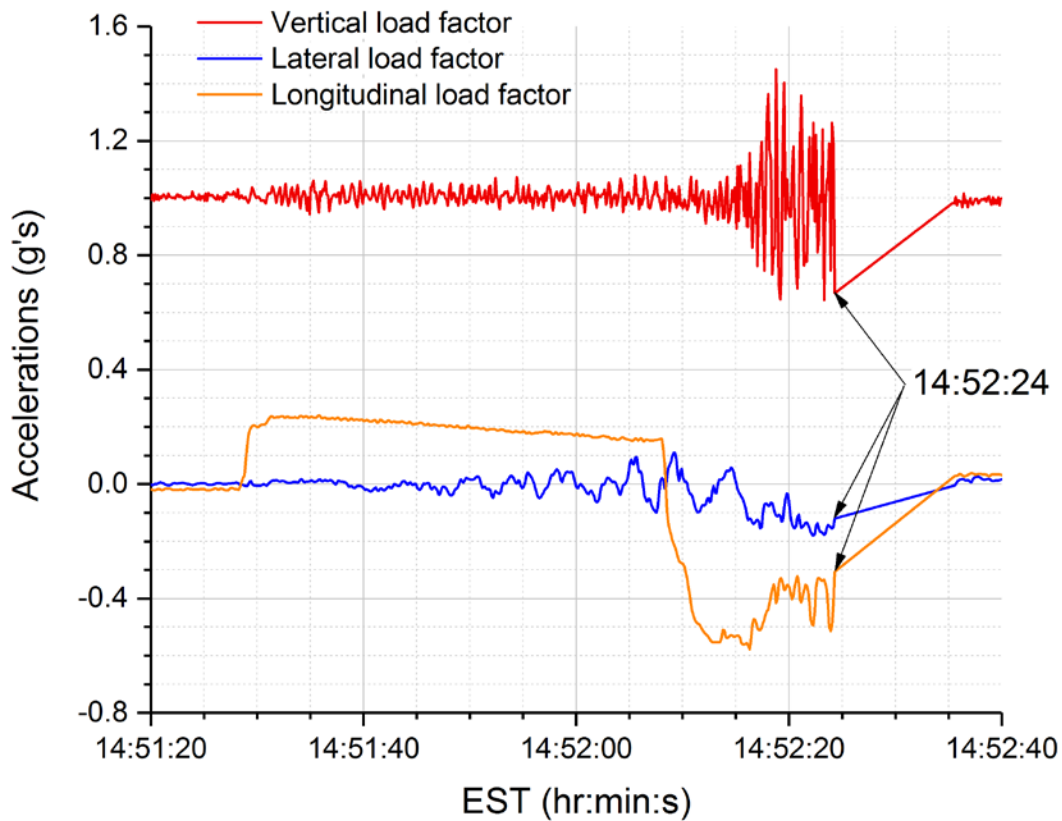
Figure 6 shows the portion of the accelerometer data associated with the attempted take-off. The aircraft began accelerating at 14:51:29 when the longitudinal acceleration increased from near zero to over 0.2 g's. The aircraft accelerated as it moved down the runway until 14:52:08 when the longitudinal acceleration began to drop, reaching a maximum deceleration of -0.54 g's by 14:52:12. At 14:52:15 the vertical load factor became much noisier and the airplane heading began to move to the left. At 14:52:24 the recorded data abruptly stopped, and it was determined that this time was when the airplane struck the raised perimeter road. Recording of the accelerometer data began again 11 seconds later, with the load factors being nearly constant (lateral and longitudinal load factors near zero, and vertical load factor near 1 g) consistent with the airplane at rest.

Figure 6. Airplane load factors during the accident ground roll.

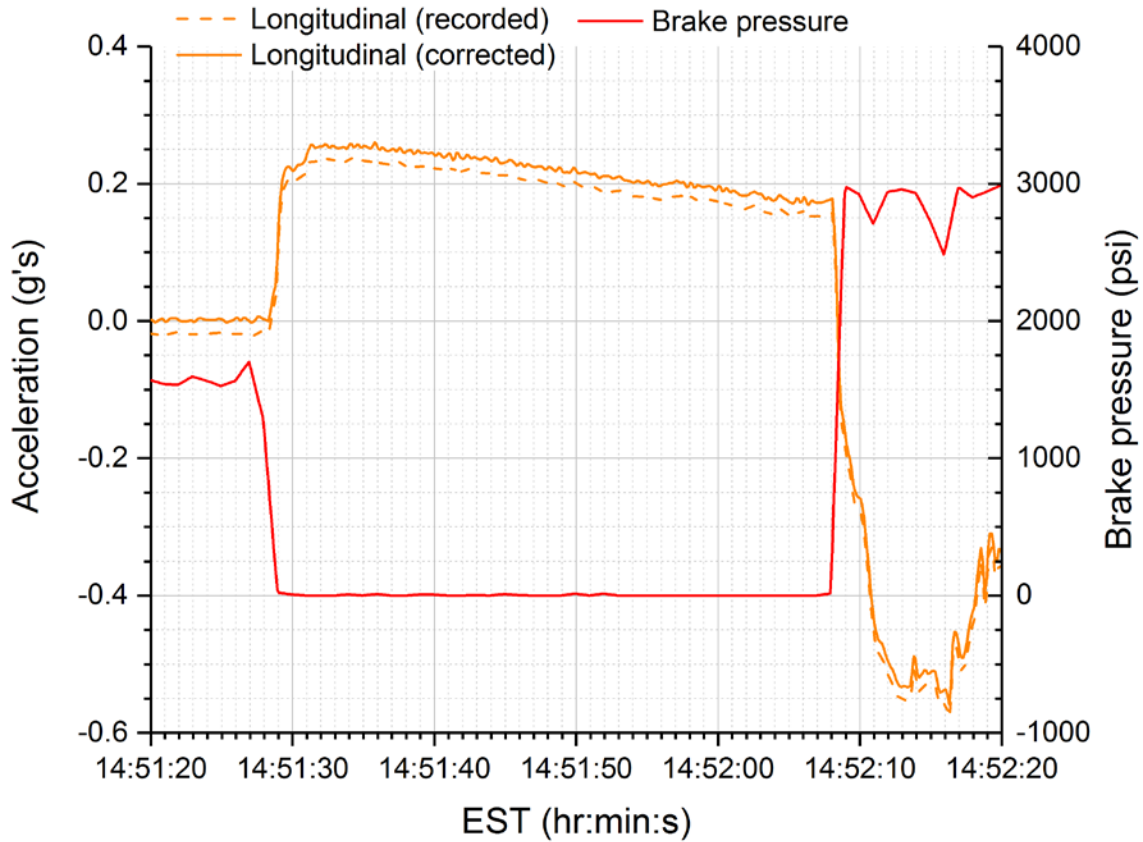
The longitudinal acceleration was positive until 14:52:08 when the brakes were applied and the acceleration quickly became negative. Spoiler and thrust reverser deployment will be discussed later in *Take-off Attempt*.

Figure 7. Longitudinal acceleration and brake pressure.

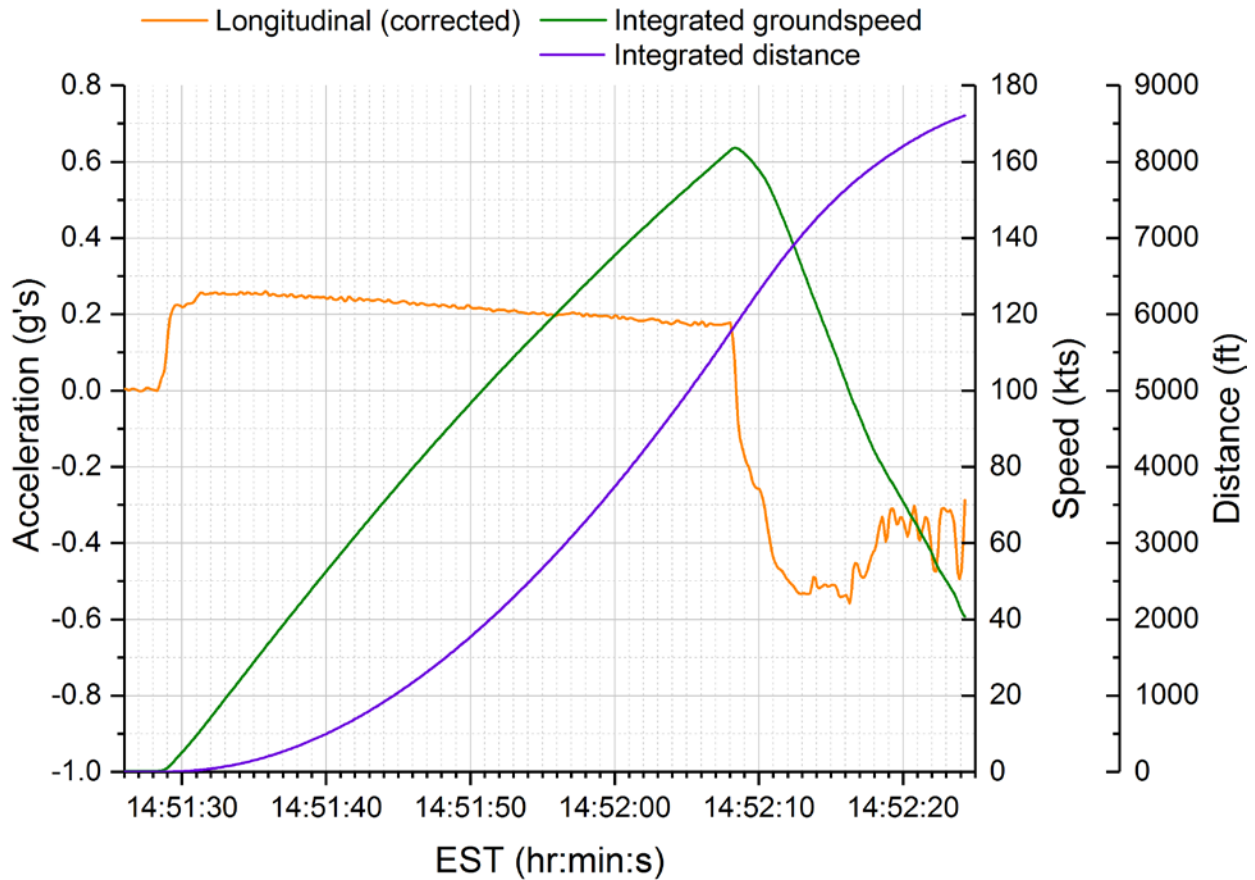
Figure 8 shows the recorded longitudinal acceleration and the integration results. The longitudinal acceleration increased from zero to over 0.2 g's at 14:51:29. The groundspeed steadily increased until 14:52:08 when it achieved a maximum speed of 163 kts. The integration was stopped at 14:52:24 when the acceleration data became discontinuous. The calculated groundspeed was 40 kts when the airplane impacted the perimeter road at 14:52:24.

Figure 8. Integration of longitudinal acceleration to groundspeed and distance.

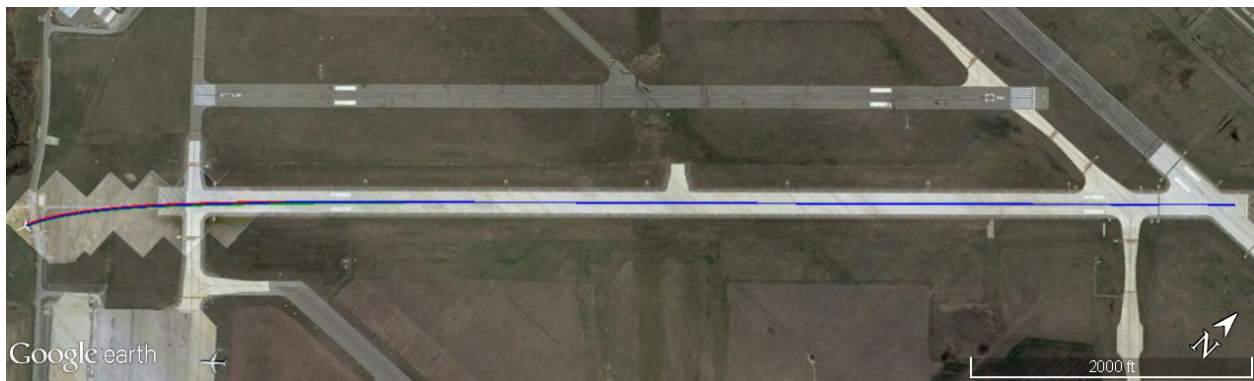
The integrated groundspeed showed the airplane covering 8,600 ft of ground during the attempted take-off. Matching 8,600 ft of travel from the airplane's final location along the ground marks and then down the runway results in the ground roll shown in Figure 9. This is consistent with the taxiing discussion from Figure 4 and Figure 5.

Figure 9. Accident ground roll.

The beginning of the ground roll line in Figure 9 is about 80 ft from the threshold of runway 23L. The integrated distance will be used throughout this report to reference where an event occurred during the ground roll. Zero feet on this scale refers to the beginning of the ground roll when the airplane's speed was zero.

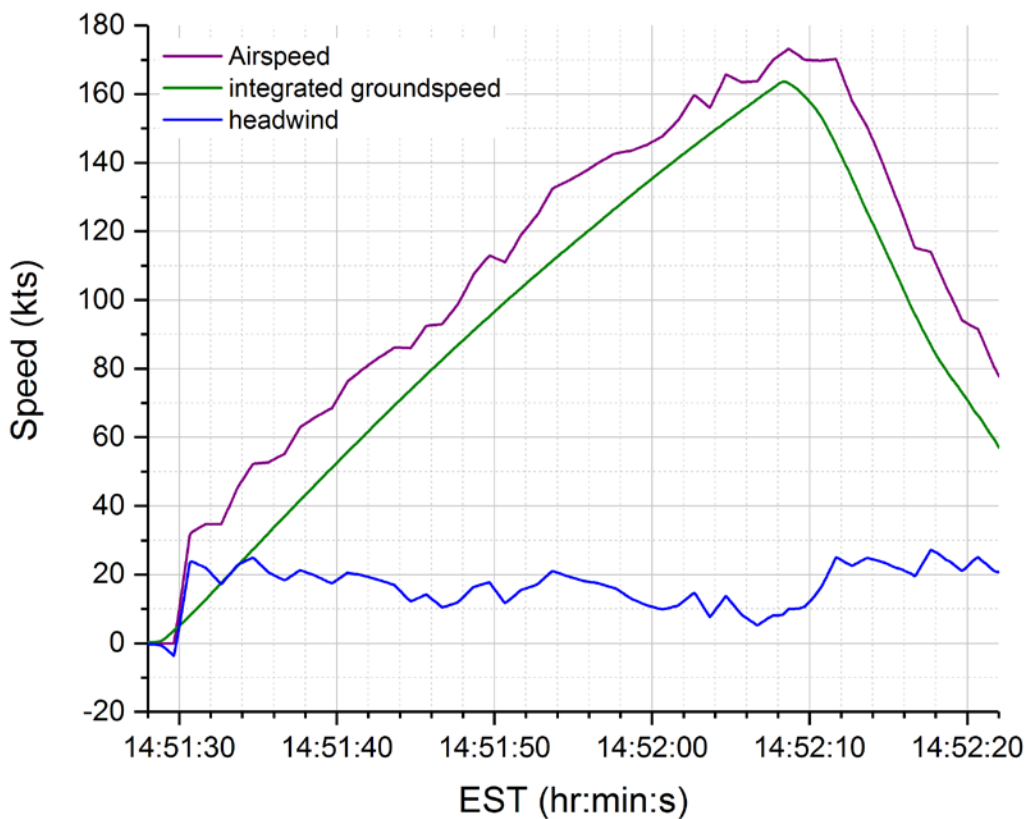
Headwinds were calculated from the recorded airspeed and integrated groundspeed (Figure 10). Airspeed measurements are less reliable when the airplane is on the ground and the wind calculations reflect the headwind component only, but the calculated winds were consistent with what had been reported that day.

Figure 10. Accident recorded airspeed, integrated groundspeed, and calculated headwind component.

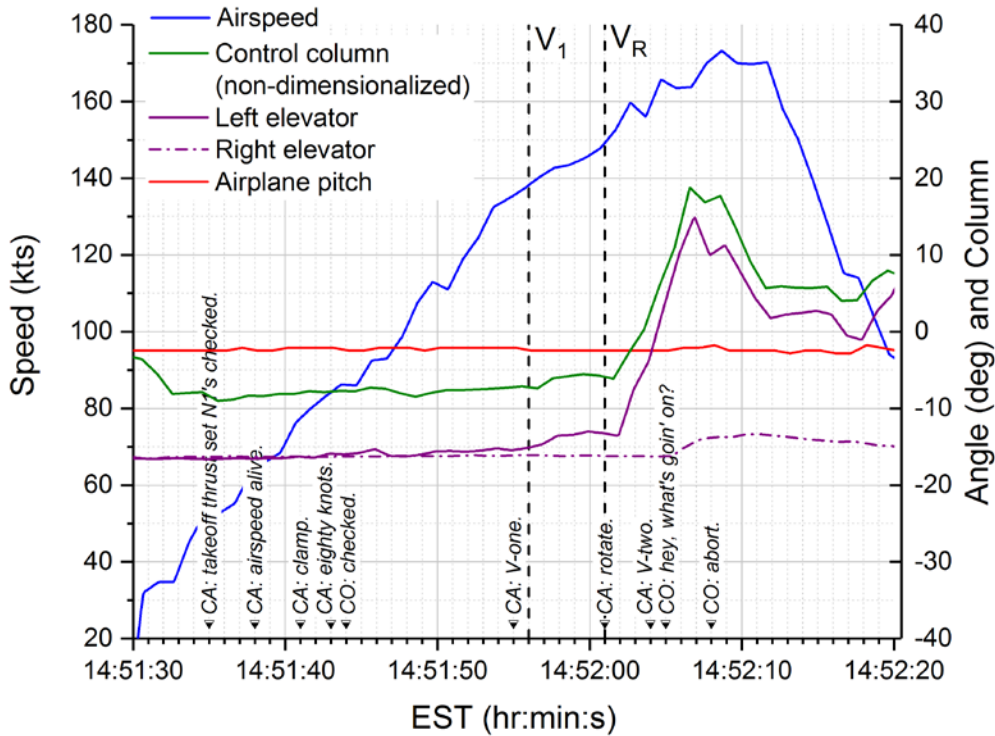
Figure 11 and Figure 12 show the recorded airspeed and the crew's attempt to rotate the airplane for take-off. At 14:51:56 (about 3,000 ft down the runway) and about 138 kts of airspeed, the control column was pulled back slightly from a non-dimensional value of -7 to -5.5². The airplane's left elevator follows the control input and moves from a position of -15° trailing edge down to -13° trailing edge down. The right elevator does not change and stays at approximately -16° trailing edge down. At 14:52:01 a large control column input was made (151 kts and 4100 ft down the runway) to a non-dimensional 18.5 and the left elevator moves to a position near 15° trailing edge up. After 14:52:05 the right elevator moves to -13° trailing edge down, but no more. The airplane does not respond in pitch and does not rotate. Figure 11 also includes selected CVR comments between the captain and check airman [3].

From the beginning of the large control column input at 14:52:01 to the peak left elevator deflection is about five seconds. The control column stays at the maximum input for another three seconds before being released. During these eight seconds the airplane travels 1,800 ft down the runway (from 4,100 to 5,900 ft).

Figure 11. Accident recorded airspeed, control column, elevators, and pitch versus time. CO indicates comments from the captain. CA indicates comments from the check airman.

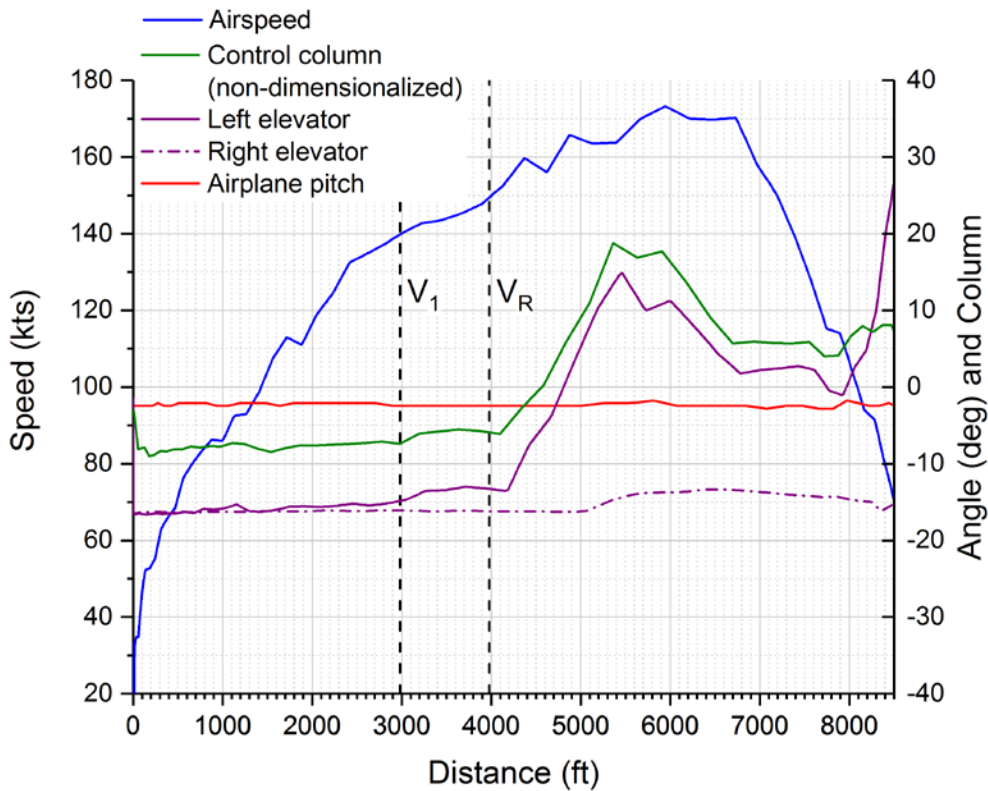
Figure 12. Accident recorded airspeed, control column, elevators, and pitch versus distance.

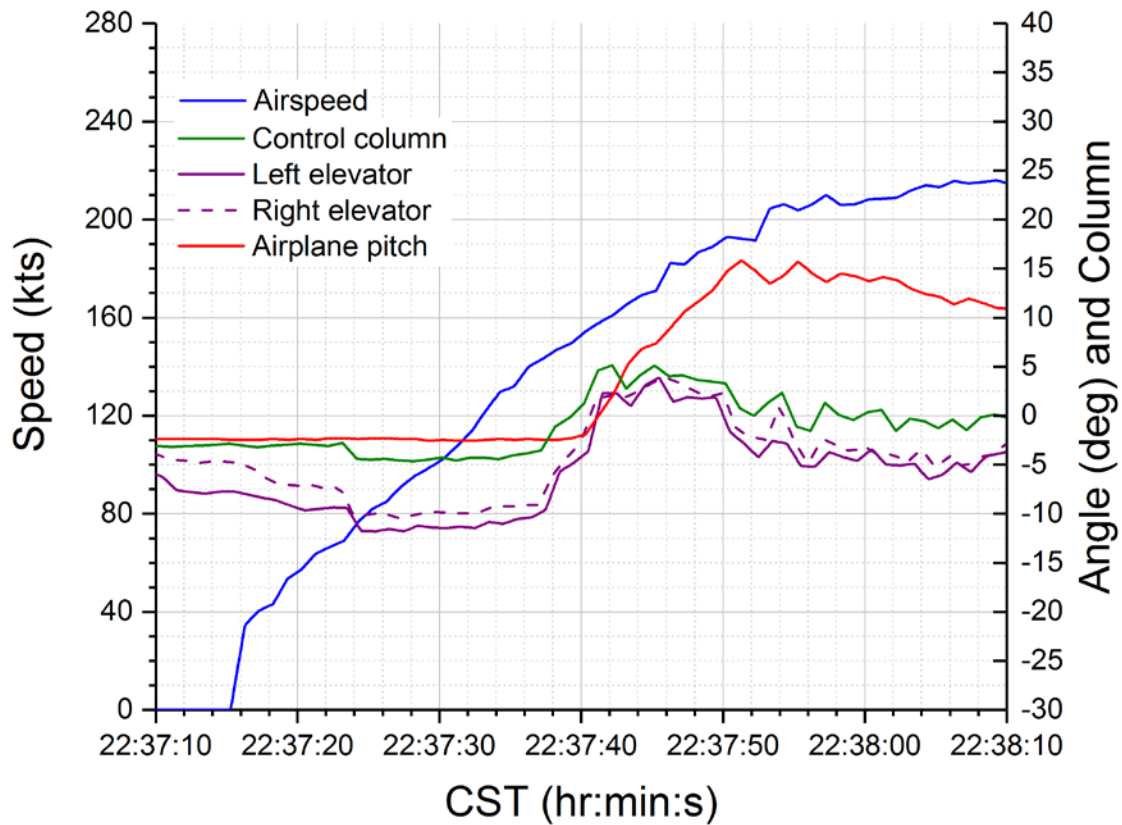
Figure 13 shows the prior take-off from Lincoln, Nebraska on March 5th for comparison. At an airspeed of about 140 kts, at about 22:37:36, the control column moved from a non-dimensional value of -3.5 to 5 over the course of five seconds. Both elevators responded by going from -10° trailing edge down to 3° trailing edge up. The airplane responded at 22:37:39 (within about 3 seconds) as the pitch increased from a recorded -2° to 15°.

Figure 13. Prior take-off recorded airspeed, elevators, and pitch versus time.

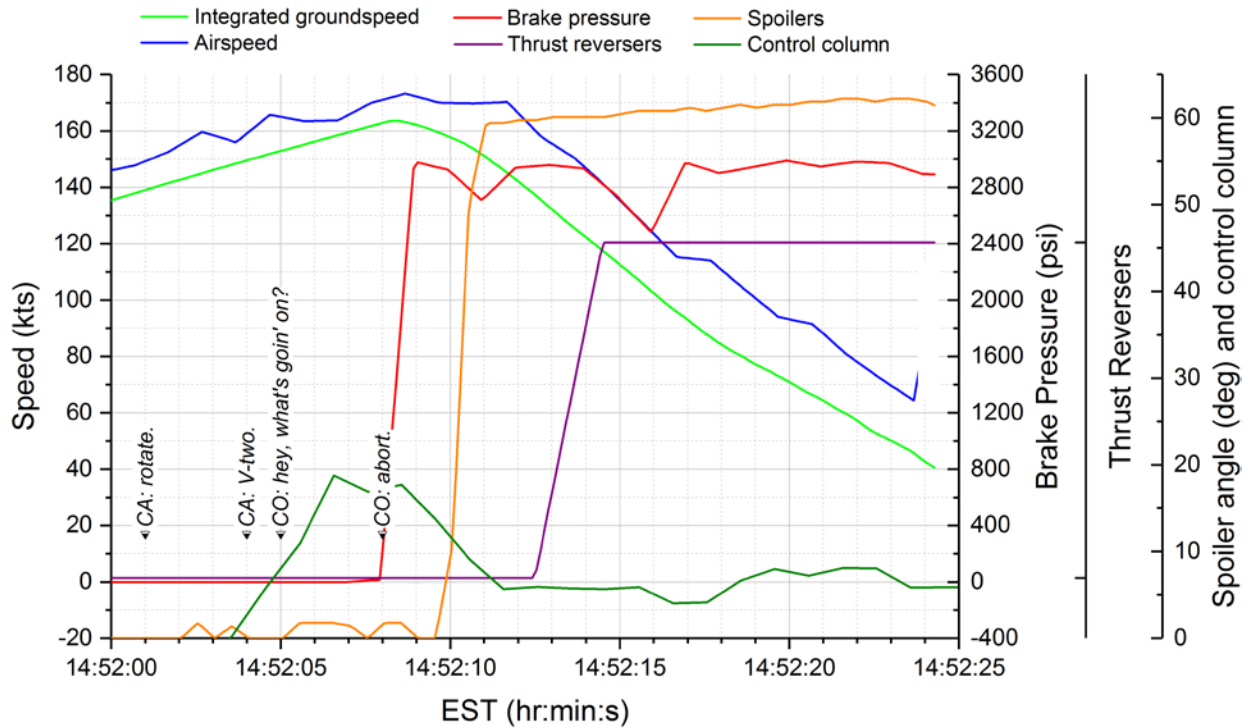
The maximum groundspeed for the accident take-off was 163 kts (173 kts airspeed) and the airplane began to decelerate as soon as the brakes were applied at 14:52:08 (Figure 14). Spoilers were deployed at 14:52:10 and thrust reversers were deployed between 14:52:13 and 14:52:15. Figure 15 shows the braking actions versus distance and include the ground mark locations relative to the integrated distance. The first evidence of tire scrub marks, the end of the runway, and the end of the paved surface are marked. The first tire mark was 5,956 ft down the runway; 1,780 ft from the end of the paved surface. The airplane's ground speed was 100 kts when it left the paved surface.

Figure 14. Accident braking versus time. CO indicates comments from the captain. CA indicates comments from the check airman.

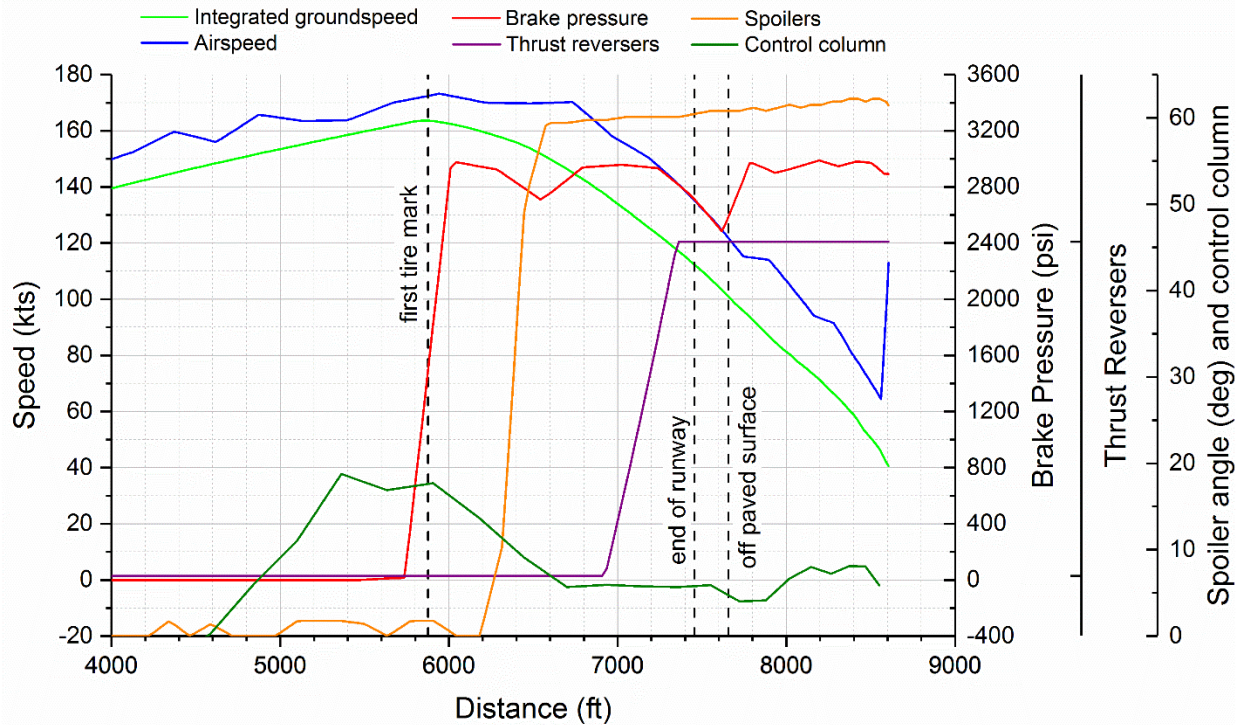
Figure 15. Accident braking versus distance.

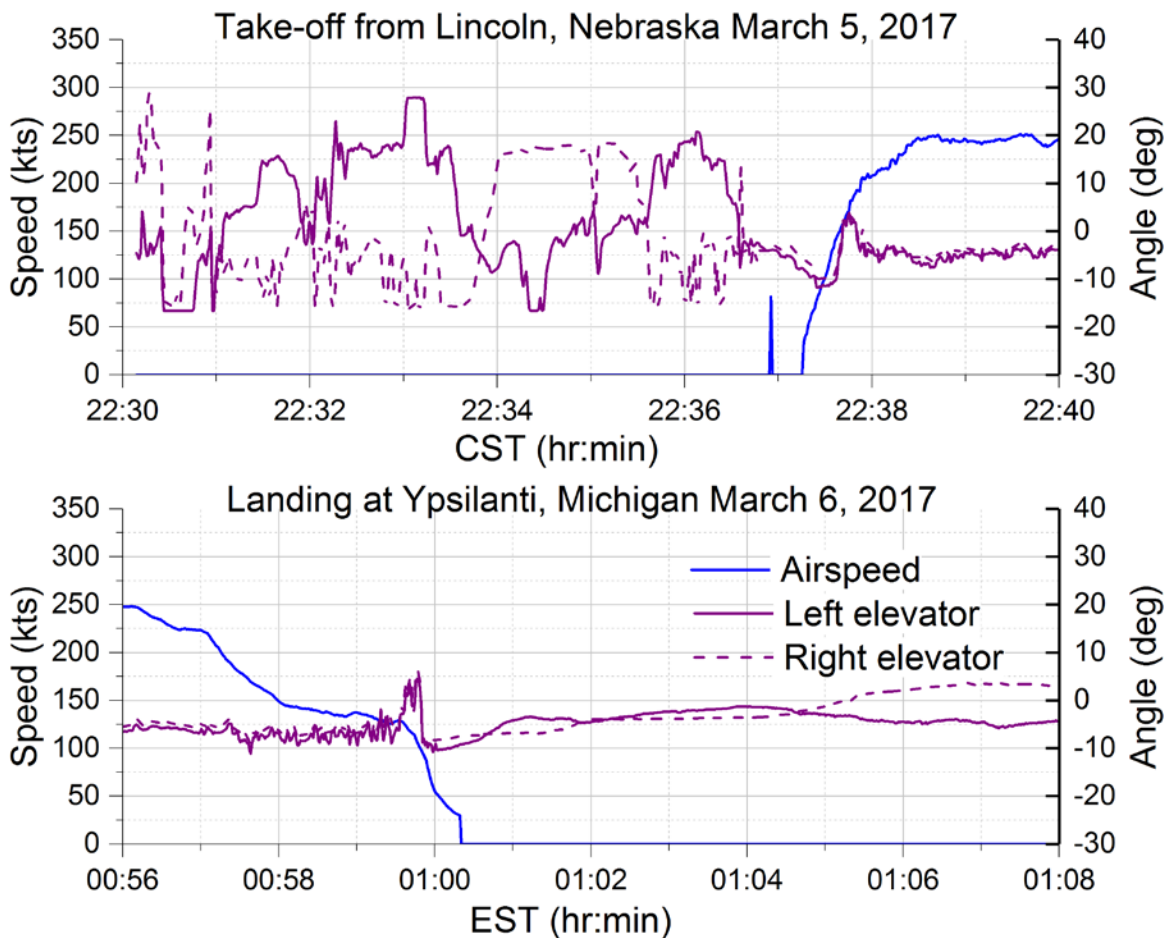
The flight data recorder captured several prior flights and activities between flights. Figure 16 shows the prior take-off and the landing at Ypsilanti and the movement of the elevator. The weather on March 5th in Lincoln Nebraska thirty minutes before take-off was winds from 170° at 22 kts, gusting to 32 kts. The wind activity was consistent with the movement of the floating elevators in the time before take-off. When the airplane landed in Ypsilanti, Michigan at 0100 EST the winds were reported from 110° at 3 kts. The much calmer winds were consistent with the much smaller movements in the elevators during taxi. For the prior flight, both elevators were moving as expected.

Figure 16. Airspeed and elevator positions for prior take-off and landing.

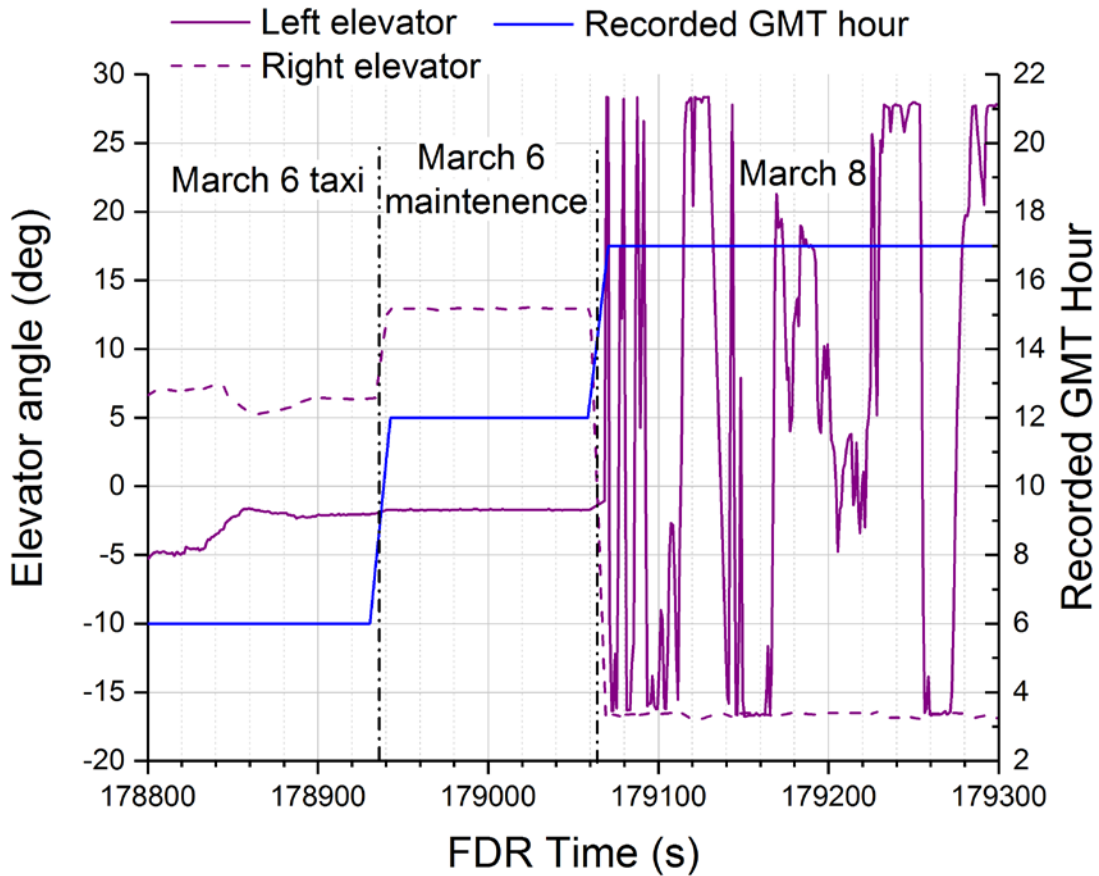
Figure 17 shows the elevator movement from the taxiing after the flight March 6th, a routine maintenance check later March 6th, and the initial powering on of the airplane on March 8th. It was not until March 8th that the right elevator came to be in its trailing edge down position. Throughout the day May 8th, the right elevator remained full trailing edge down while the left elevator moved in the strong winds.

Figure 17. Elevator position and recorded GMT hour versus FDR time.

While the right elevator behaved as expected on the prior flight and during earlier maintenance on May 6th, it was in its full trailing edge down position when the FDR was powered on May 8th, the day of the accident. The left elevator showed movement in the high winds, but the right elevator stayed in the same -15° position before take-off, only moving to -13° during the take-off.

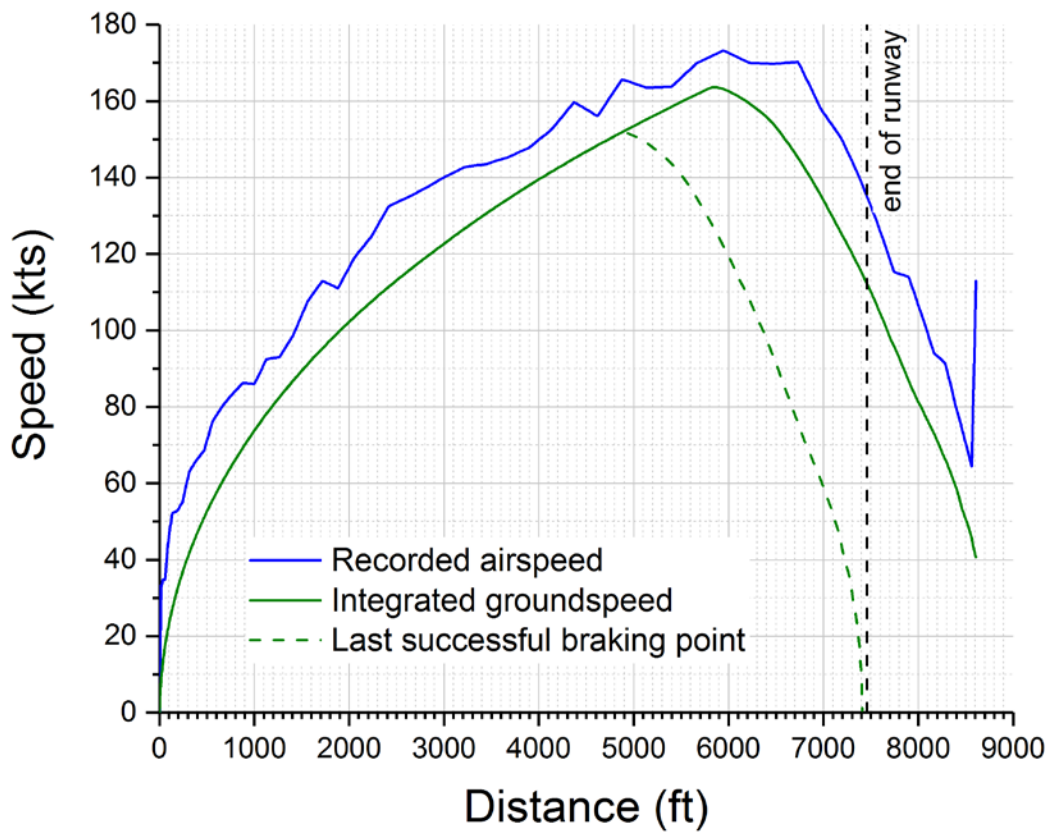
Of interest was when the crew would have had to begin braking to stop before the end of the runway. The deceleration profile of the groundspeed from the accident was shifted earlier until a point was found where the airplane would stop while still on the runway (Figure 18 and Figure 19). It was determined that the crew would have had to start braking before the 5,000 ft mark to come to a stop while still on the runway. At this point (14:52:04 during the accident roll, four seconds and 800 feet before the accident braking point), the airplane's airspeed was 164 kts and groundspeed was 151 kts. The control column input had begun three seconds earlier and the left elevator was only just reaching a neutral position and had not yet moved to be trailing edge up. During the earlier successful take-off the airplane was only just beginning to respond in pitch at this same point.

Figure 18. Accident airspeed and groundspeed and groundspeed of last successful braking point versus distance.

Assuming the same deceleration profile as the accident, the crew would have had to start braking before the 5000 ft mark, when the airplane's groundspeed was 151 kts, to come to a stop while still on the runway. However, this would have only been three seconds after the column input, and based on prior take-offs, the airplane's lack of rotational response would not yet have been apparent.

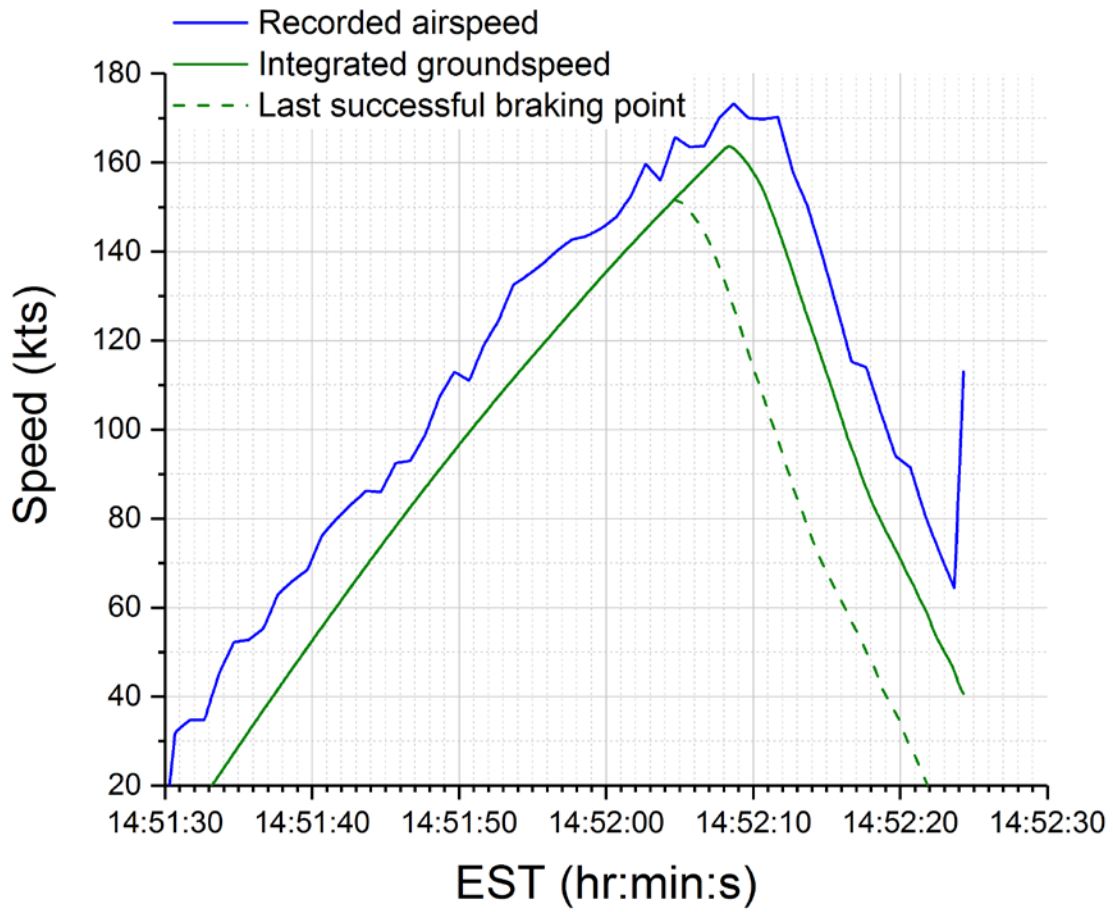
Figure 19. Accident airspeed and groundspeed and groundspeed of last successful braking point versus time.
