**National Transportation Safety Board**  
Office of Research and Engineering  
Washington, D.C. 20594

**Performance Study**

Location: San Francisco, California  
Date: July 7, 2017  
Time: 2356 PDT  
Airplane: Airbus A320, C-FKCK, ACA759  
NTSB Number: DCA17IA148

**Performance Study**  
**DCA17IA148, Airbus A320, C-FKCK, Air Canada Flight 759**

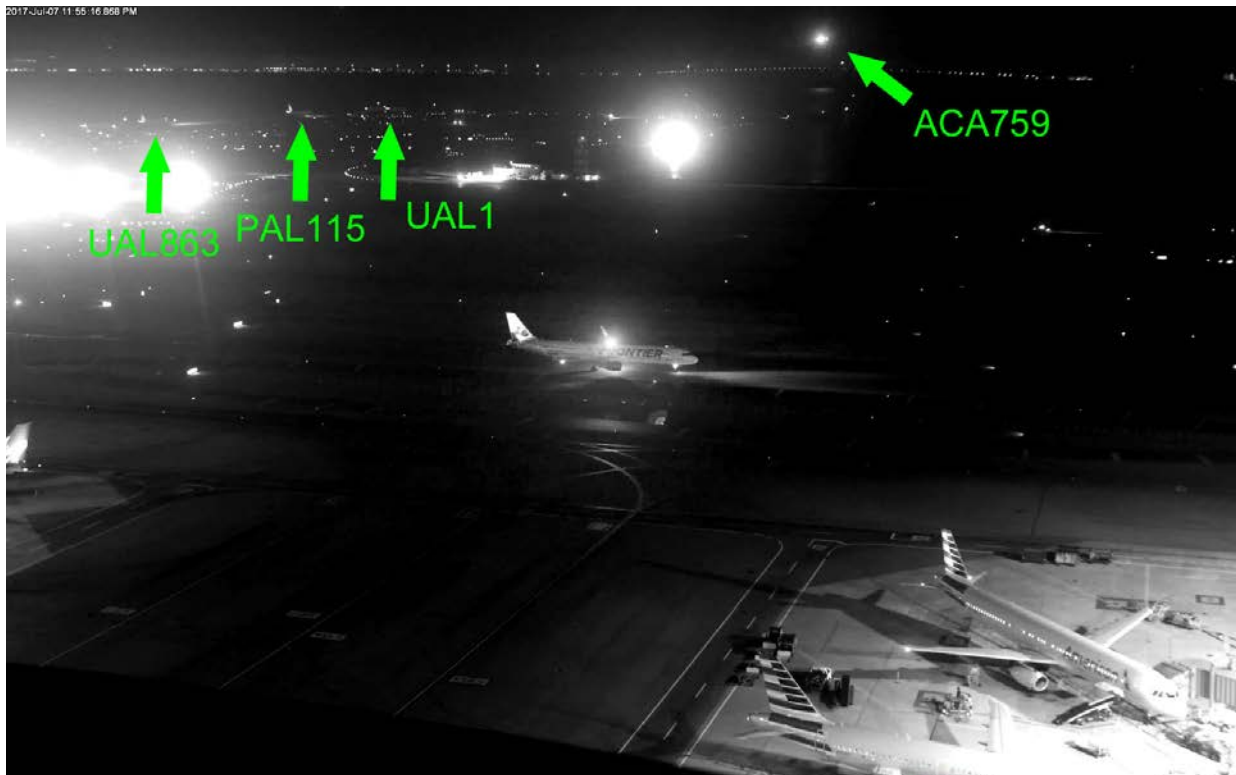
A security camera from Terminal 2 at SFO captured the incident and the video was provided to the NTSB. The incident occurred in the top quarter of the field of view, which is shown in its entirety in Figure 1. ACA759 is highlighted with a green arrow. The reflection of the airplane's lights can be seen on the water below. UAL1, PAL115, and UAL863 are visible in the frame.

**Figure 1.** Security camera video of incident. ACA759, UAL1, PAL115, and UAL863 are highlighted with green arrows.

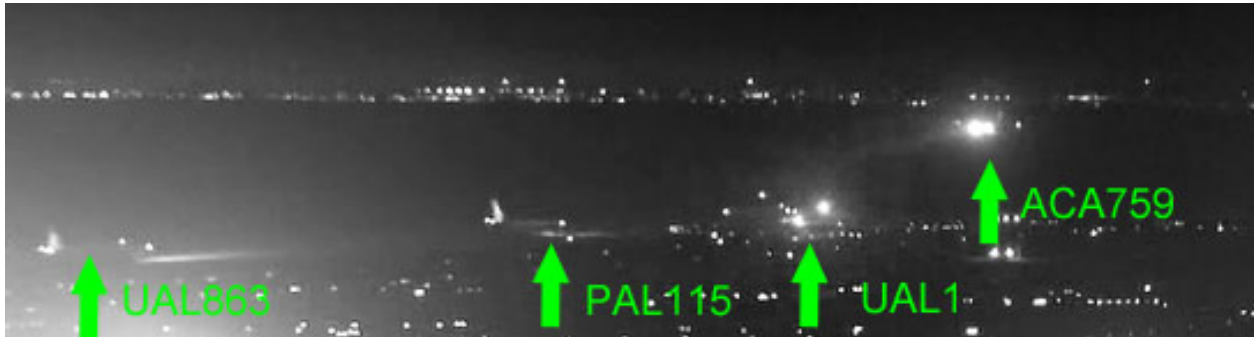
The next four figures (Figure 2 - Figure 5) show the incident sequence. All airplanes are highlighted with green arrows in Figure 2 as ACA759 passed over the seawall (the reflection in the water was no longer visible). The next figure shows the incident airplane passing over the first airplane (UAL1) on the taxiway. About this time the crew of PAL115 turned on their landing lights which illuminated the taxiway ahead of them and UAL1. In Figure 4, the lights from ACA759 illuminated the fuselage of PAL115. Figure 5 shows the lowest apparent altitude point as ACA759 passed over PAL115. Also in this figure, the attitude of the airplane has changed to be nose up. Subsequent frames of the video show the incident airplane gaining altitude over the taxiway and passing over UAL863.

**Figure 2.** ACA759 crosses the seawall. UAL1 lights flashing on (they are flashing off in Figure 1).

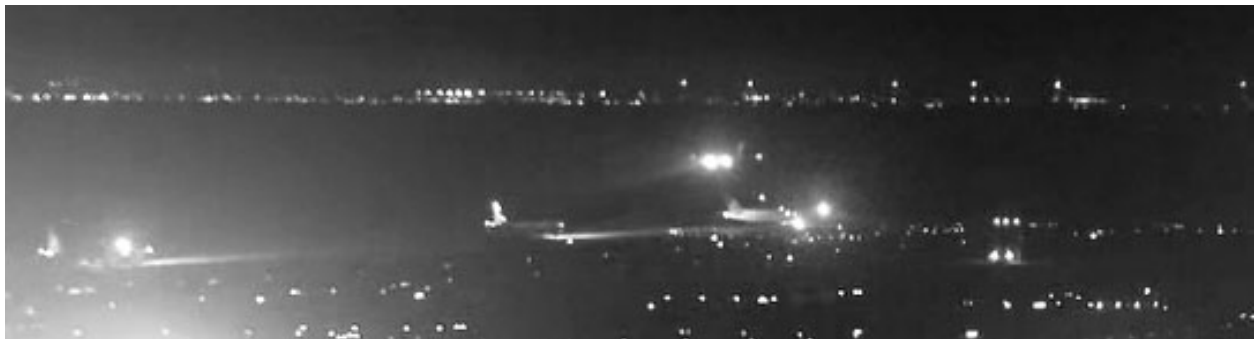
**Figure 3.** ACA759 crosses over UAL1. PAL115 turns on landing lights, illuminating UAL1.

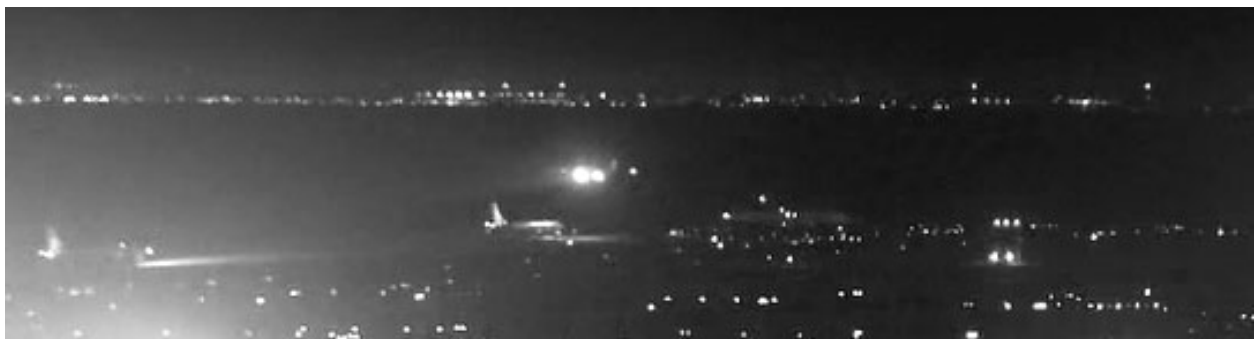
**Figure 4.** ACA759 landing lights illuminate PAL115.

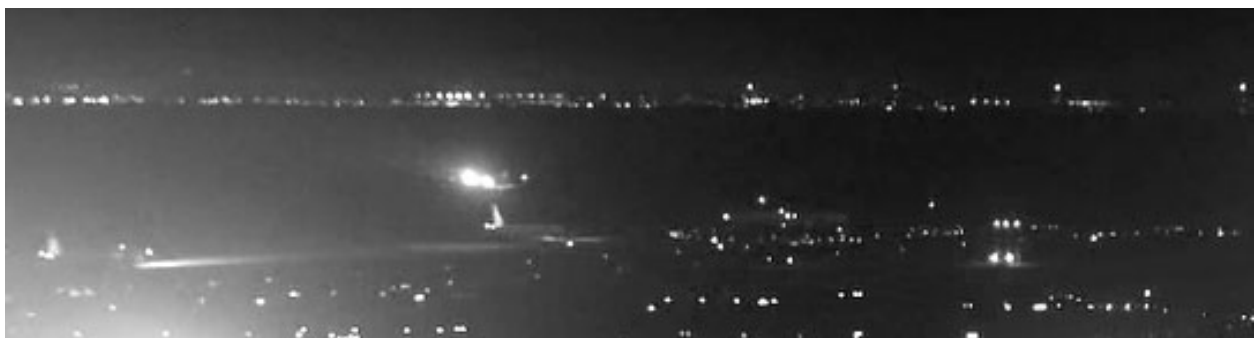
**Figure 5.** ACA759 passes low over PAL115. Incident airplane is now pitched up and climbing.

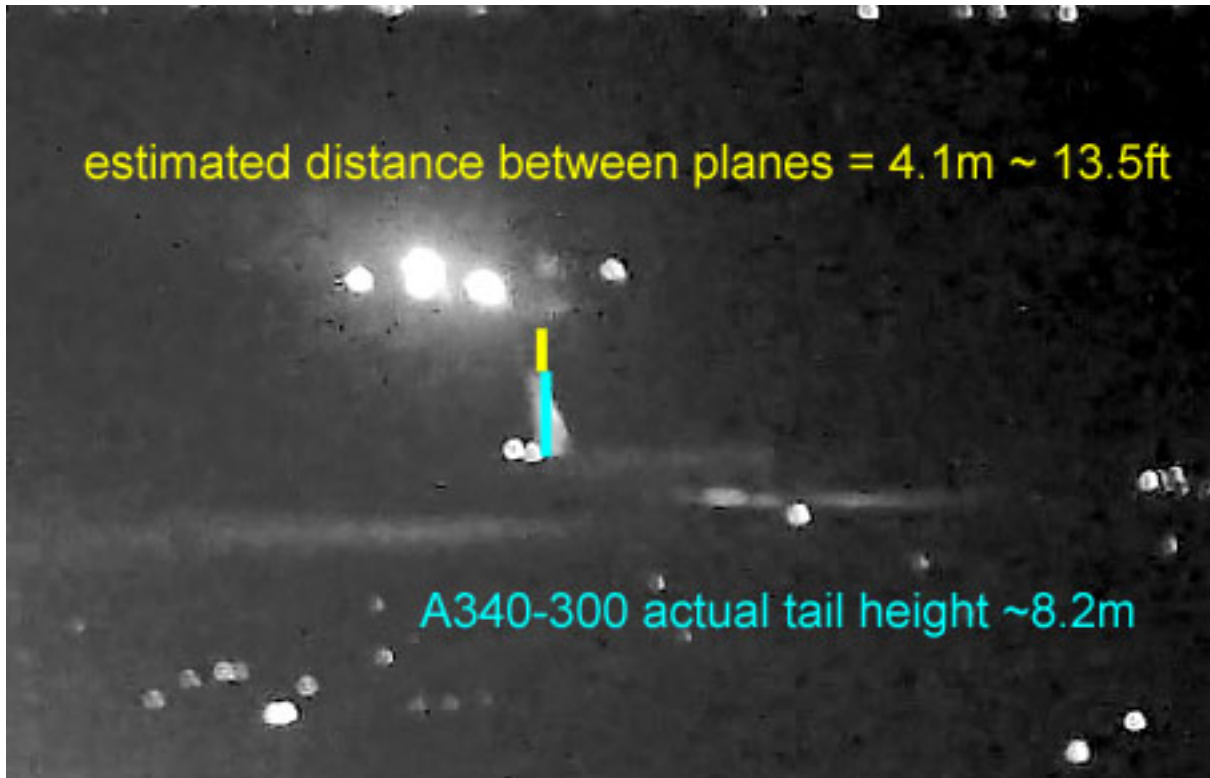
The lowest adjusted radio altitude (nominally indicating the bottom of the landing gear, the fuselage would be an additional 5 ft higher), which occurred as the airplane passed over PAL115, was 60 ft. Measurements were made using an image of the security camera footage to confirm this altitude reading. The image when ACA759 and PAL115 are closest is quite small in the camera frame, so measurements made from the pixelated image are approximate. The vertical stabilizer of the A340 was well illuminated and is 8.2 m (26.9 ft) tall (Figure 6). Assuming ACA759 passed directly over PAL115<sup>1</sup>, the distance between the two airplanes in the image was measured to be 13.5 ft. Allowing for uncertainty, this measurement was bracketed to be between 10 and 20 ft of air gap. An A340 is 55 ft tall, so the altitude of the fuselage of ACA759 as it passed over PAL115 was between 65 and 75 ft. This is consistent with the adjusted radio altitude.

**Figure 6.** Security camera video of incident.

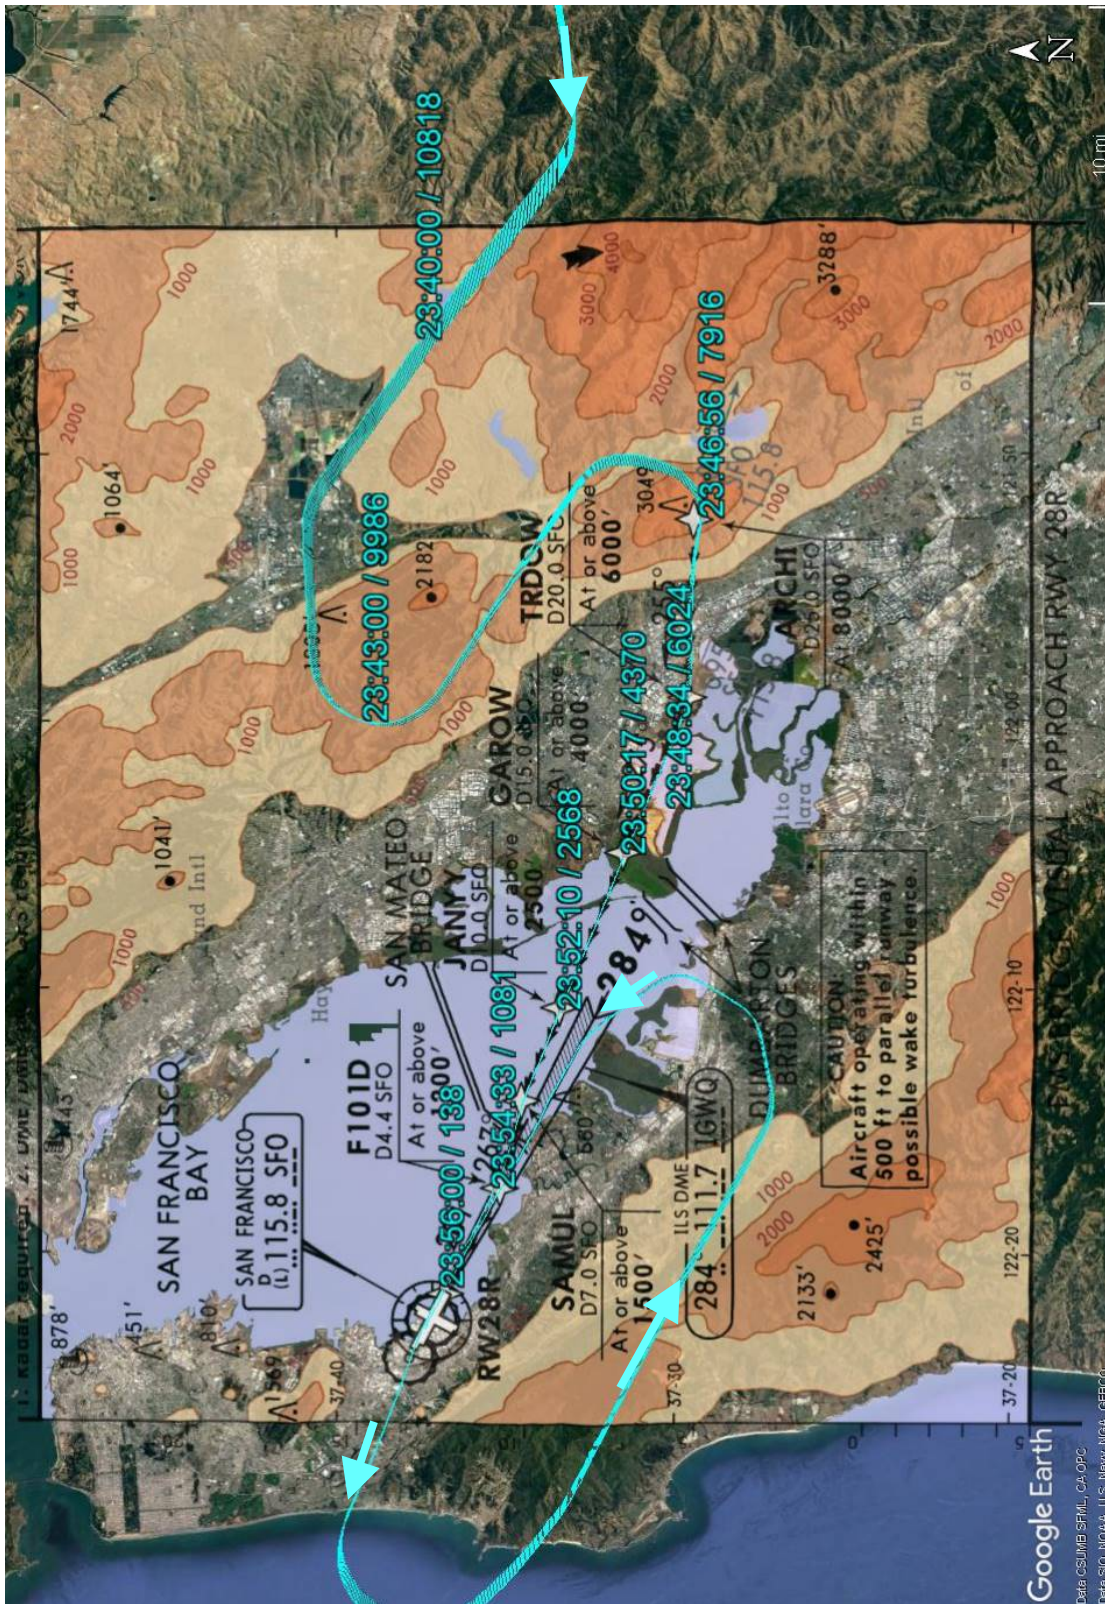
The airplane was on Air Canada's FMS Bridge Visual Runway 28R approach<sup>2</sup> which is shown overlaid with the flight path in Figure 7. The flight path is from the latitude and longitude recorded on the airplane, shifted 200 ft east to agree with the OAK radar, with overflight animations provided by the FAA of the incident, and with the subsequent landing on 28R. The descent, flyover of taxiway C, go-around, and subsequent landing on 28R are shown.

Figure 7. Airplane track with selected PDT times and altitudes marked. FMS Bridge Visual 28R approach plate is overlaid on image.

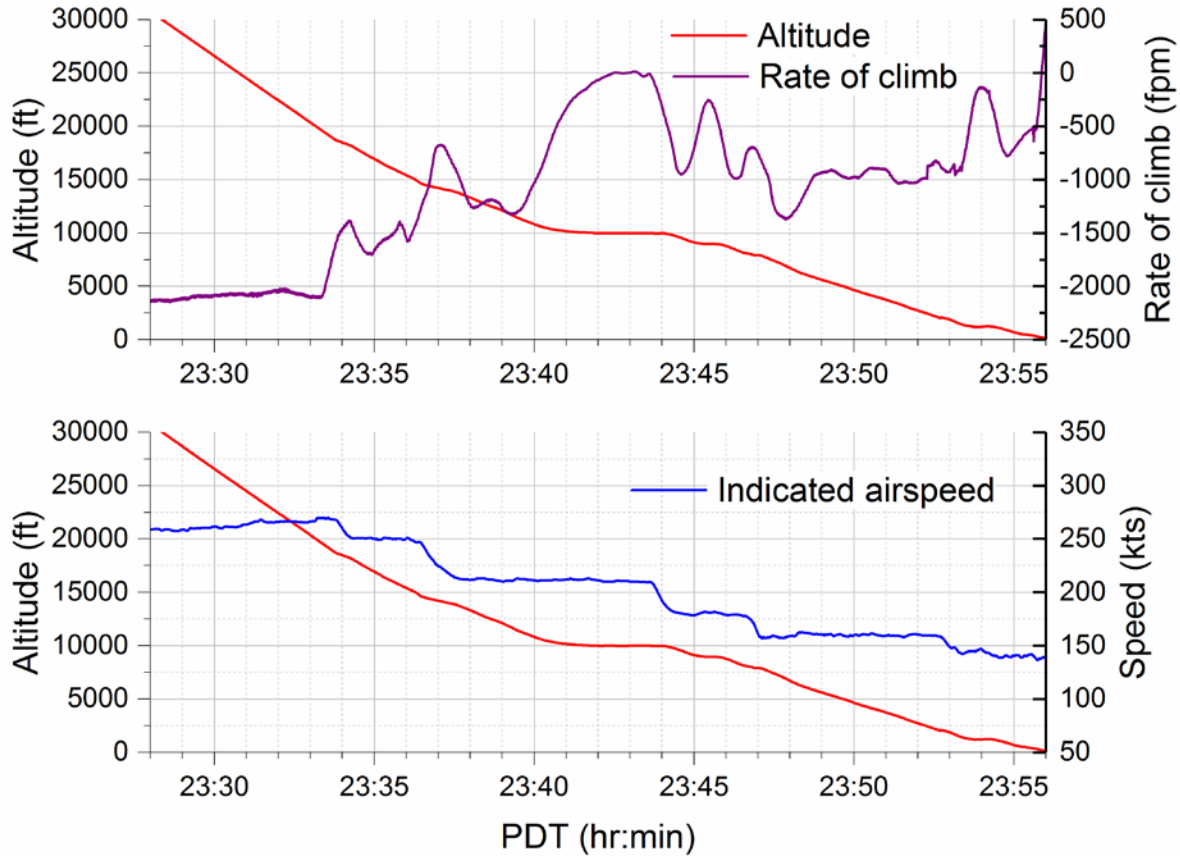
The airplane's descent from 30,000 ft is shown in Figure 8. The airplane's airspeed slowed from 250 kts to about 140 kts on final approach.

**Figure 8.** Airplane altitude, rate of climb, and indicated airspeed. Altitude is corrected from the FDR, rate of climb was calculated, and the indicated airspeed was as recorded on the FDR.

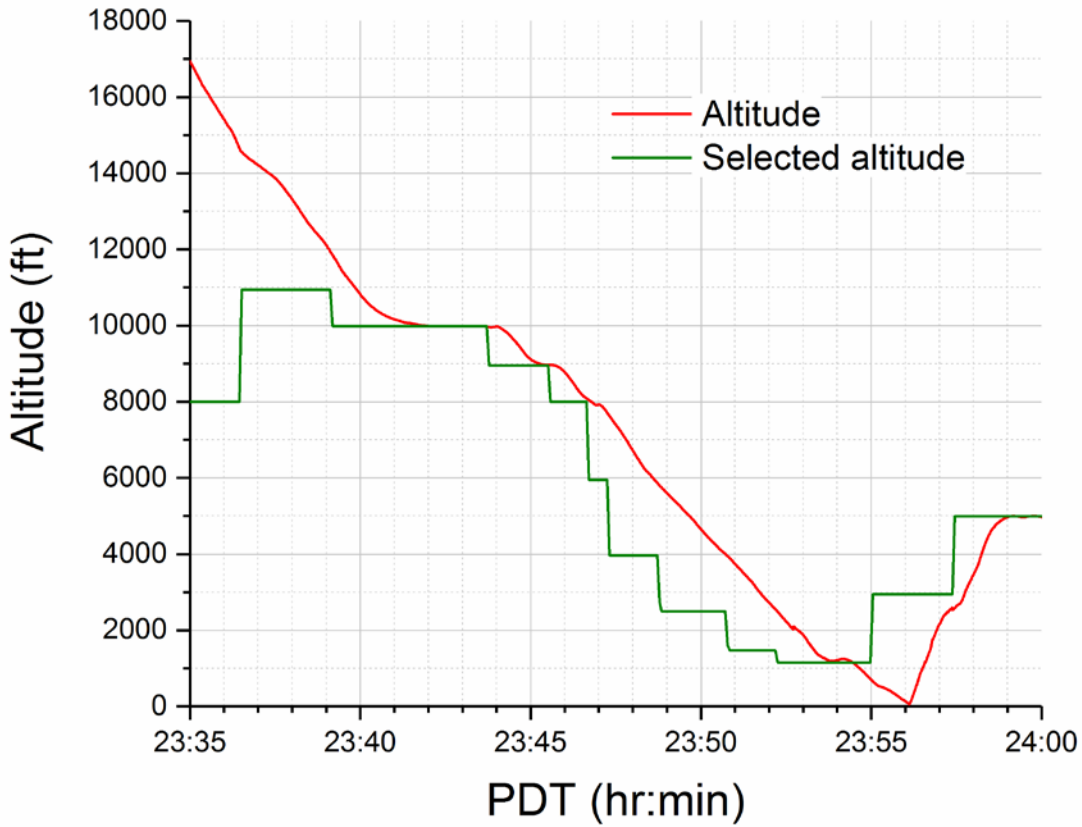
Figure 9 shows the airplane's altitude and selected altitude for the descent from 17,000 ft. Prior to 2335 (when the airplane was above 17,000 ft), the selected altitude was 8,000 ft.

**Figure 9.** Airplane altitude and selected altitude.

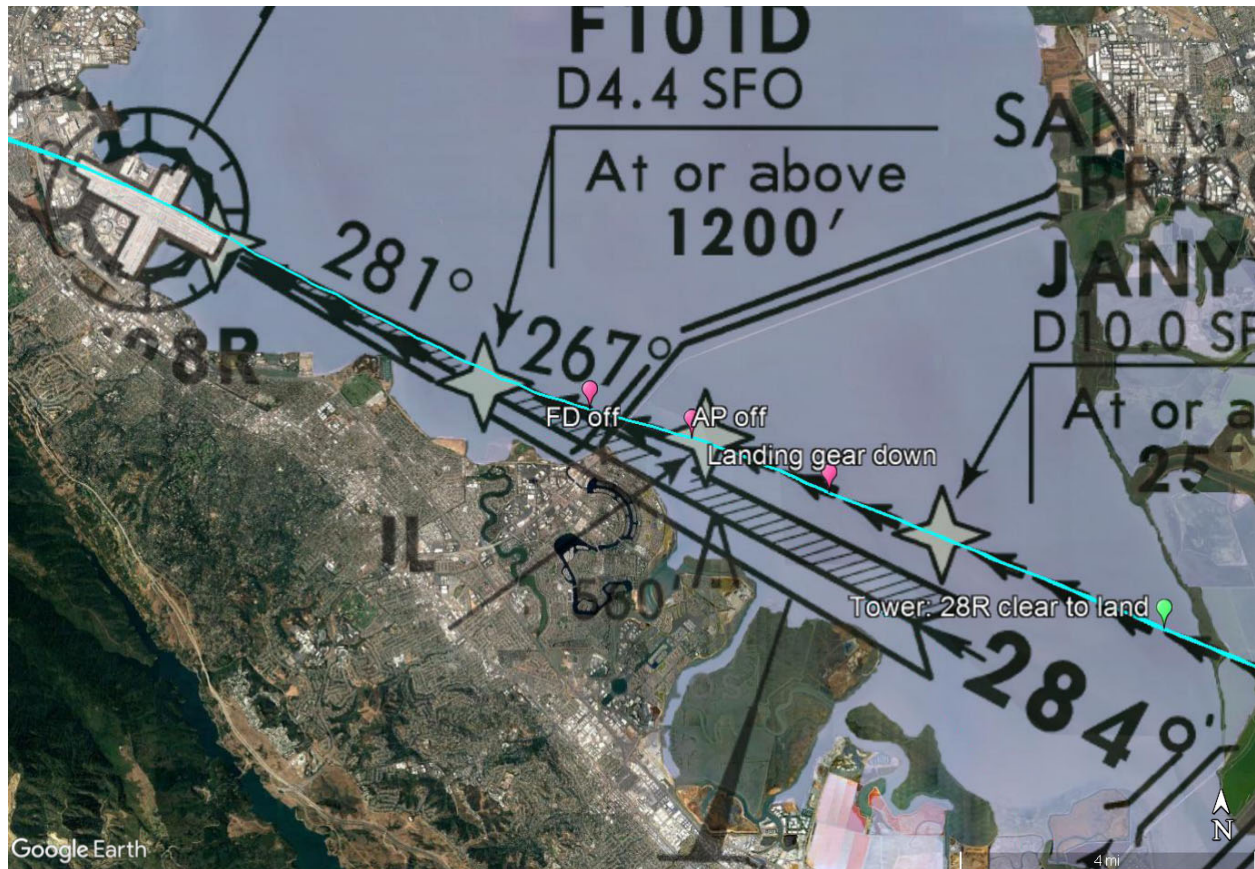
Figure 10 shows the location of the airplane when the tower gave clearance to land at 23:51:11, approximately 11.5 NM from the threshold of runway 28R. The landing gear were lowered at 23:52:46 and both the auto-pilot and flight director were turned off before passing the waypoint F101D.

Figure 10. Airplane track with selected events noted.

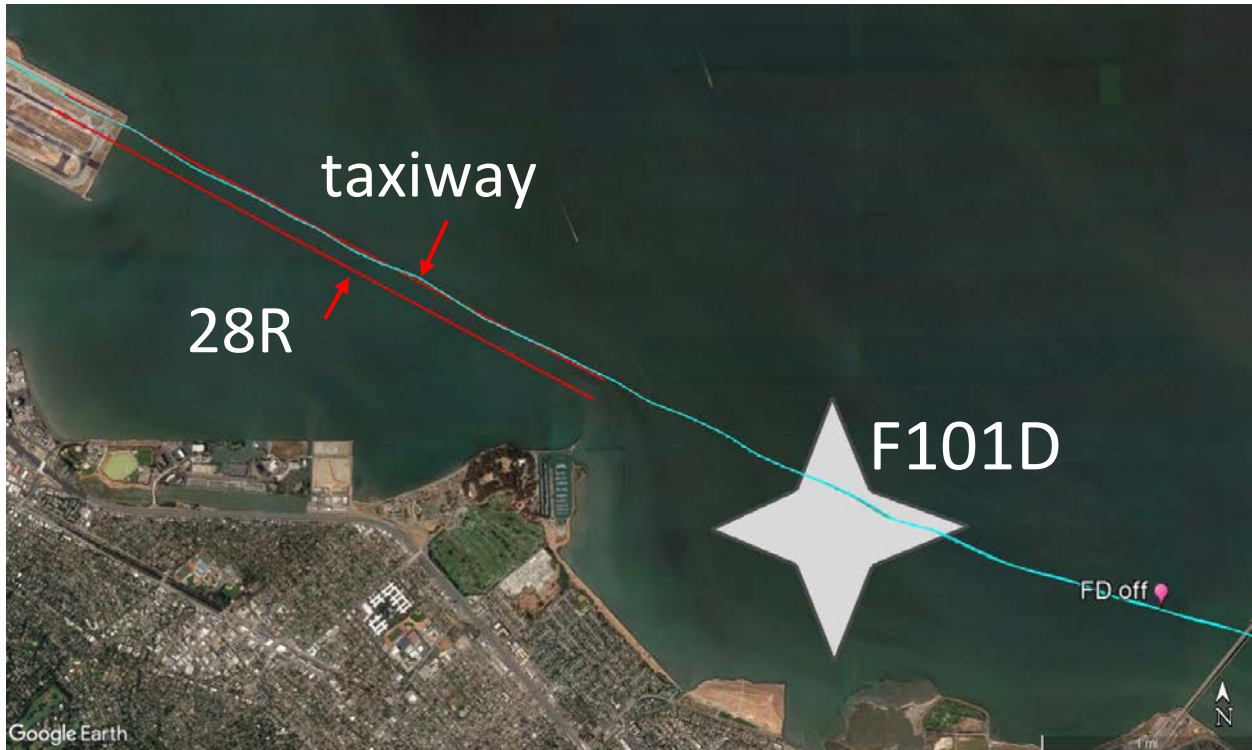
Figure 11 shows the airplane's track from waypoint F101D to taxiway C. The airplane's track lined up with taxiway C rather than 28R. The distance between the centerline of taxiway C and 28R is approximately 490 ft. Taxiway C and 28R are on the same heading. The airplane's localizer was not tuned to the frequency used for the approach to 28R.

**Figure 11.** Airplane track with approach tracks to 28R and taxiway C. F101D is shown at the scale of FMS Bridge Visual Runway 28R chart.

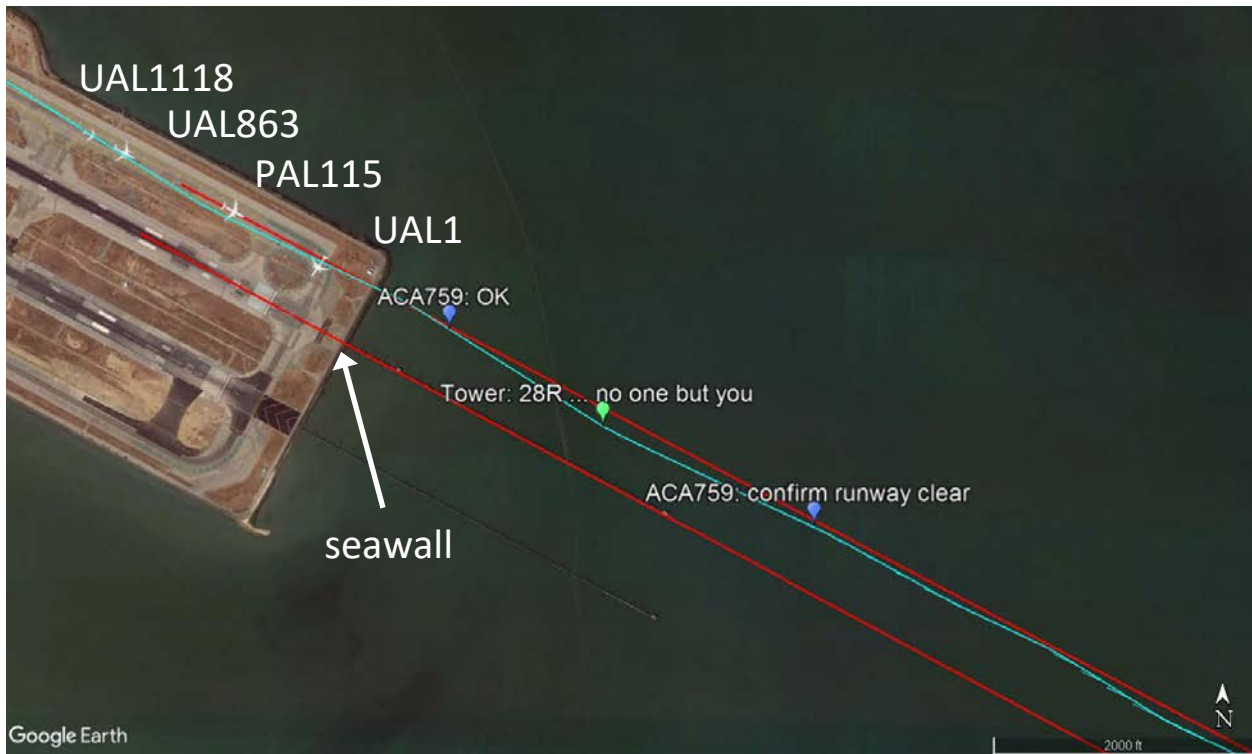
At 23:55:44, about 4000 ft from the airport seawall (see Figure 12), ACA759 asked the tower to confirm that runway 28R was clear. The tower confirmed that runway 28R was clear and ACA759 responded at 23:55:58, 800 ft from the seawall. Figure 12 shows this air traffic control (ATC) exchange. Four airplanes are shown on the taxiway in their approximate locations at the time of the overflight<sup>3</sup>.

**Figure 12.** Airplane track with approach tracks to 28R and taxiway C with ATC conversation.

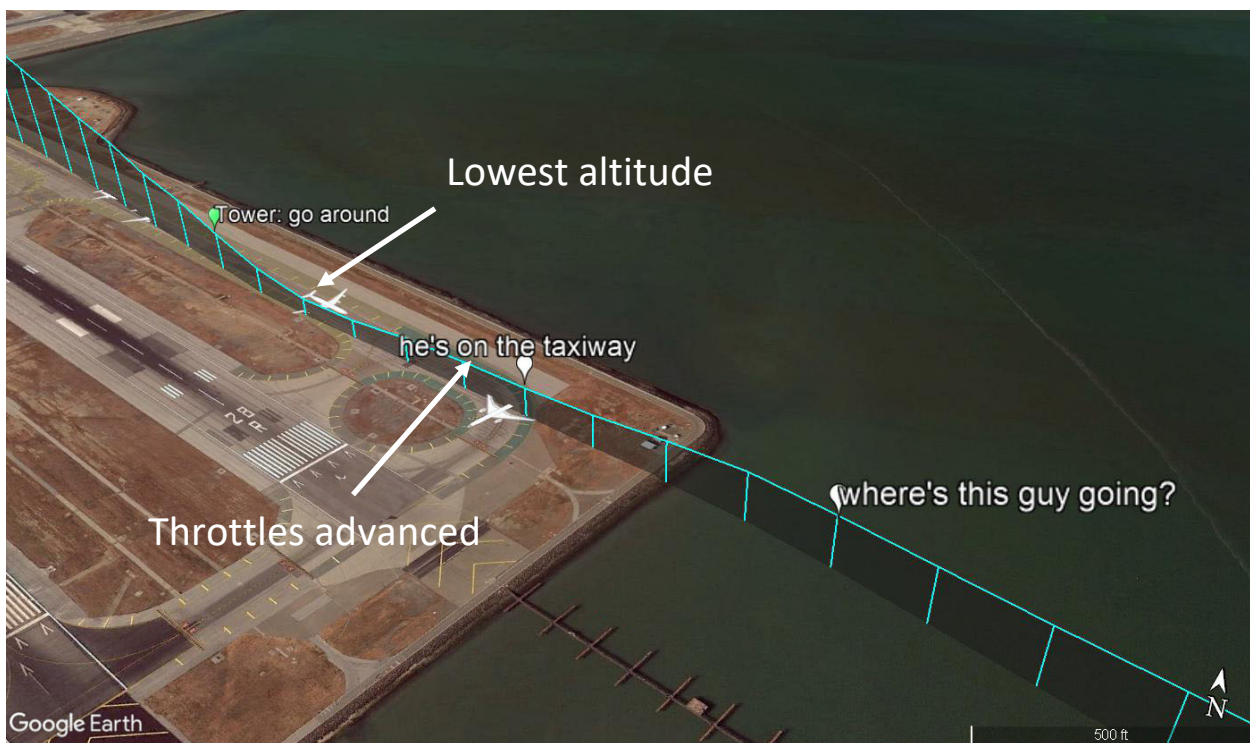
At 23:56:05 the throttles were advanced. The airplane continued to descend until 23:56:08 as the engines increased power and the airplane pitched up. The minimum recorded and corrected altitude was 60 ft<sup>4</sup>. At the time the airplane was passing over or near PAL15. The airplane began climbing. At 23:56:10 the tower called for a go-around. The airplane passed over two more airplanes as it continued to climb.

**Figure 13.** Airplane track with ATC conversation.

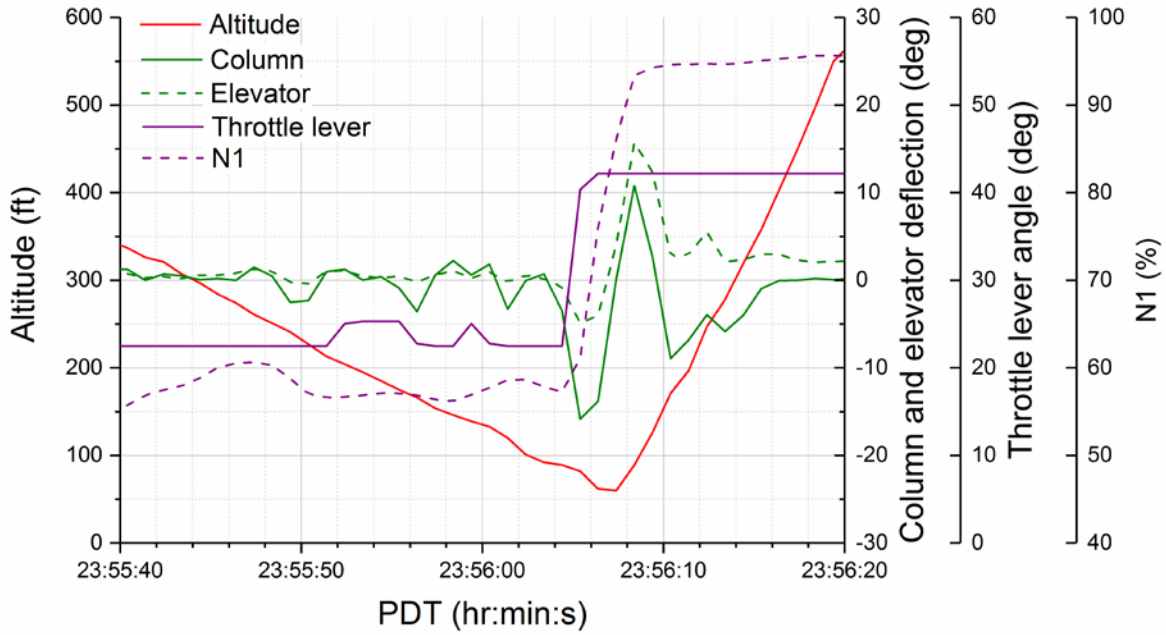
The initiation of the go-around at 23:56:05 was determined by the timing of the advancement of throttles ( $22.5^\circ$  to  $42^\circ$ ) and N1 (57% to 94%) and the control column shown in Figure 14. Engines and elevators were fully transitioned to their go-around position by 23:56:08. Engines and elevators were fully transitioned to their go-around position by 23:56:08.

**Figure 14.** Airplane altitude, column, elevator, throttle lever angle, and N1 from FDR.

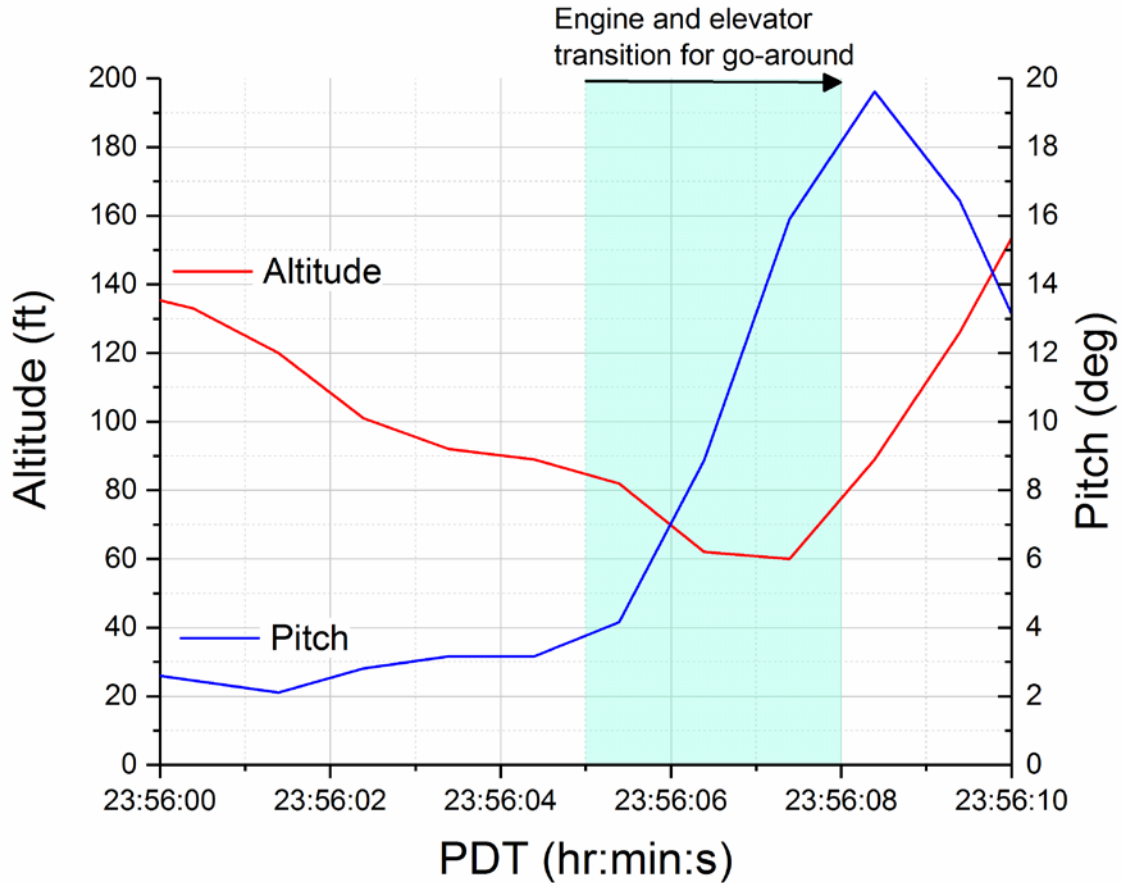
Figure 15 shows that the airplane continued to descend about another 30 ft for the three seconds it took the engines and elevators to transition to go-around. The landing gear were raised at 23:56:23. During these three seconds, as the airplane rotated to climb, it moved over 600 ft down the taxiway and passed over PAL115.

**Figure 15.** Airplane altitude and pitch during transition to go-around.
