**National Transportation Safety Board**  
Office of Research and Engineering  
Washington, D.C. 20594

**Radar Performance Study**

**Location:** Fargo, North Dakota  
**Date:** November 30, 2018  
**Time:** 1949 GMT (1349 CST)  
**Airplane:** Cessna 550 Citation II, N941JM  
**NTSB Number:** CEN19LA039

**Radar Study, Airplane Performance  
CEN19LA039, N941JM, Cessna 550 Citation II, 11/30/2018**

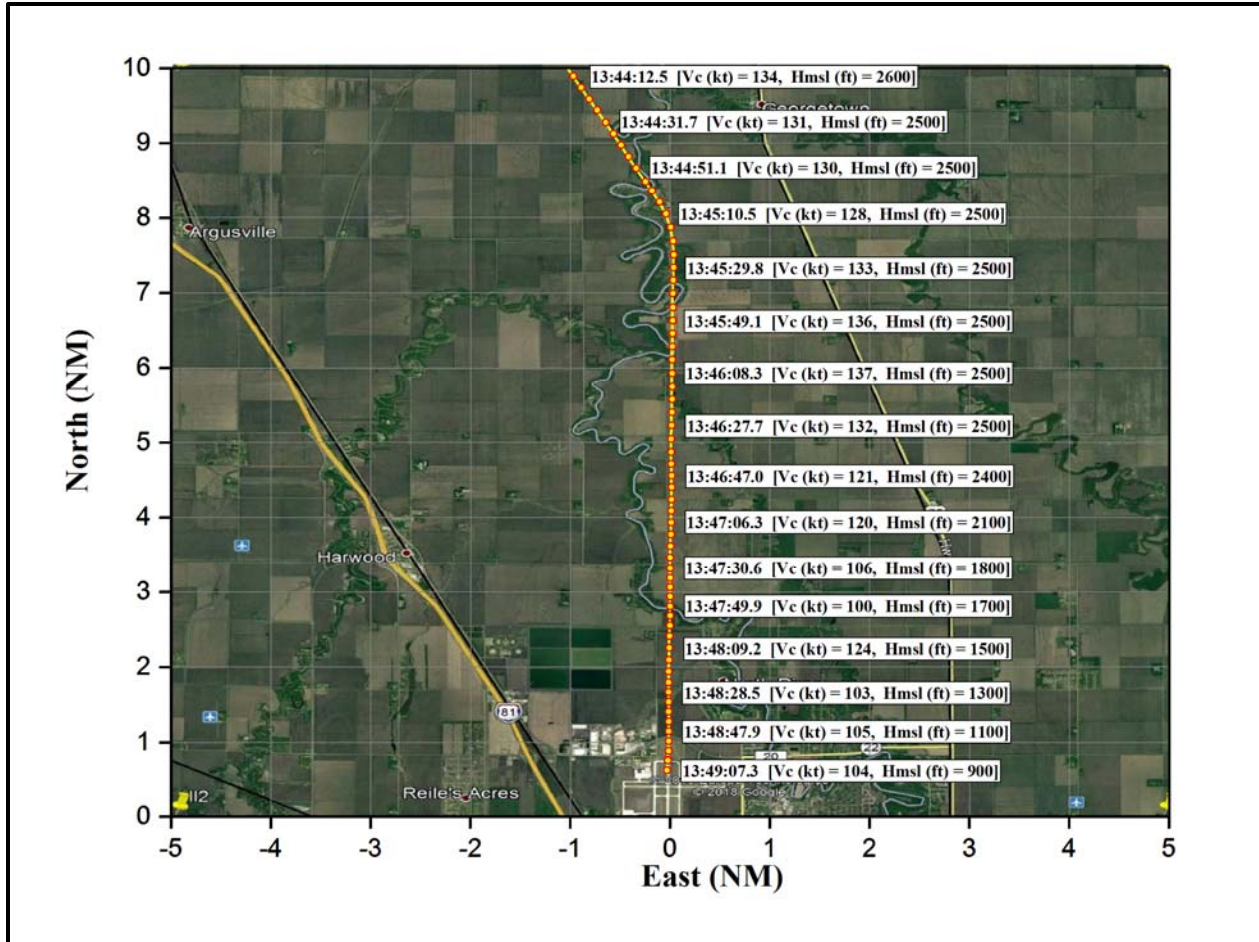
**Figure 4: Ground Track, Airspeed, and Altitude Based on Radar and Reported Winds**

Figure 4 shows the radar ground track closer to the airport and includes estimated airspeed and altitude for every fourth radar return. The last radar return recorded was at an altitude of 900 ft msl, the same as the touchdown zone elevation for runway 18.

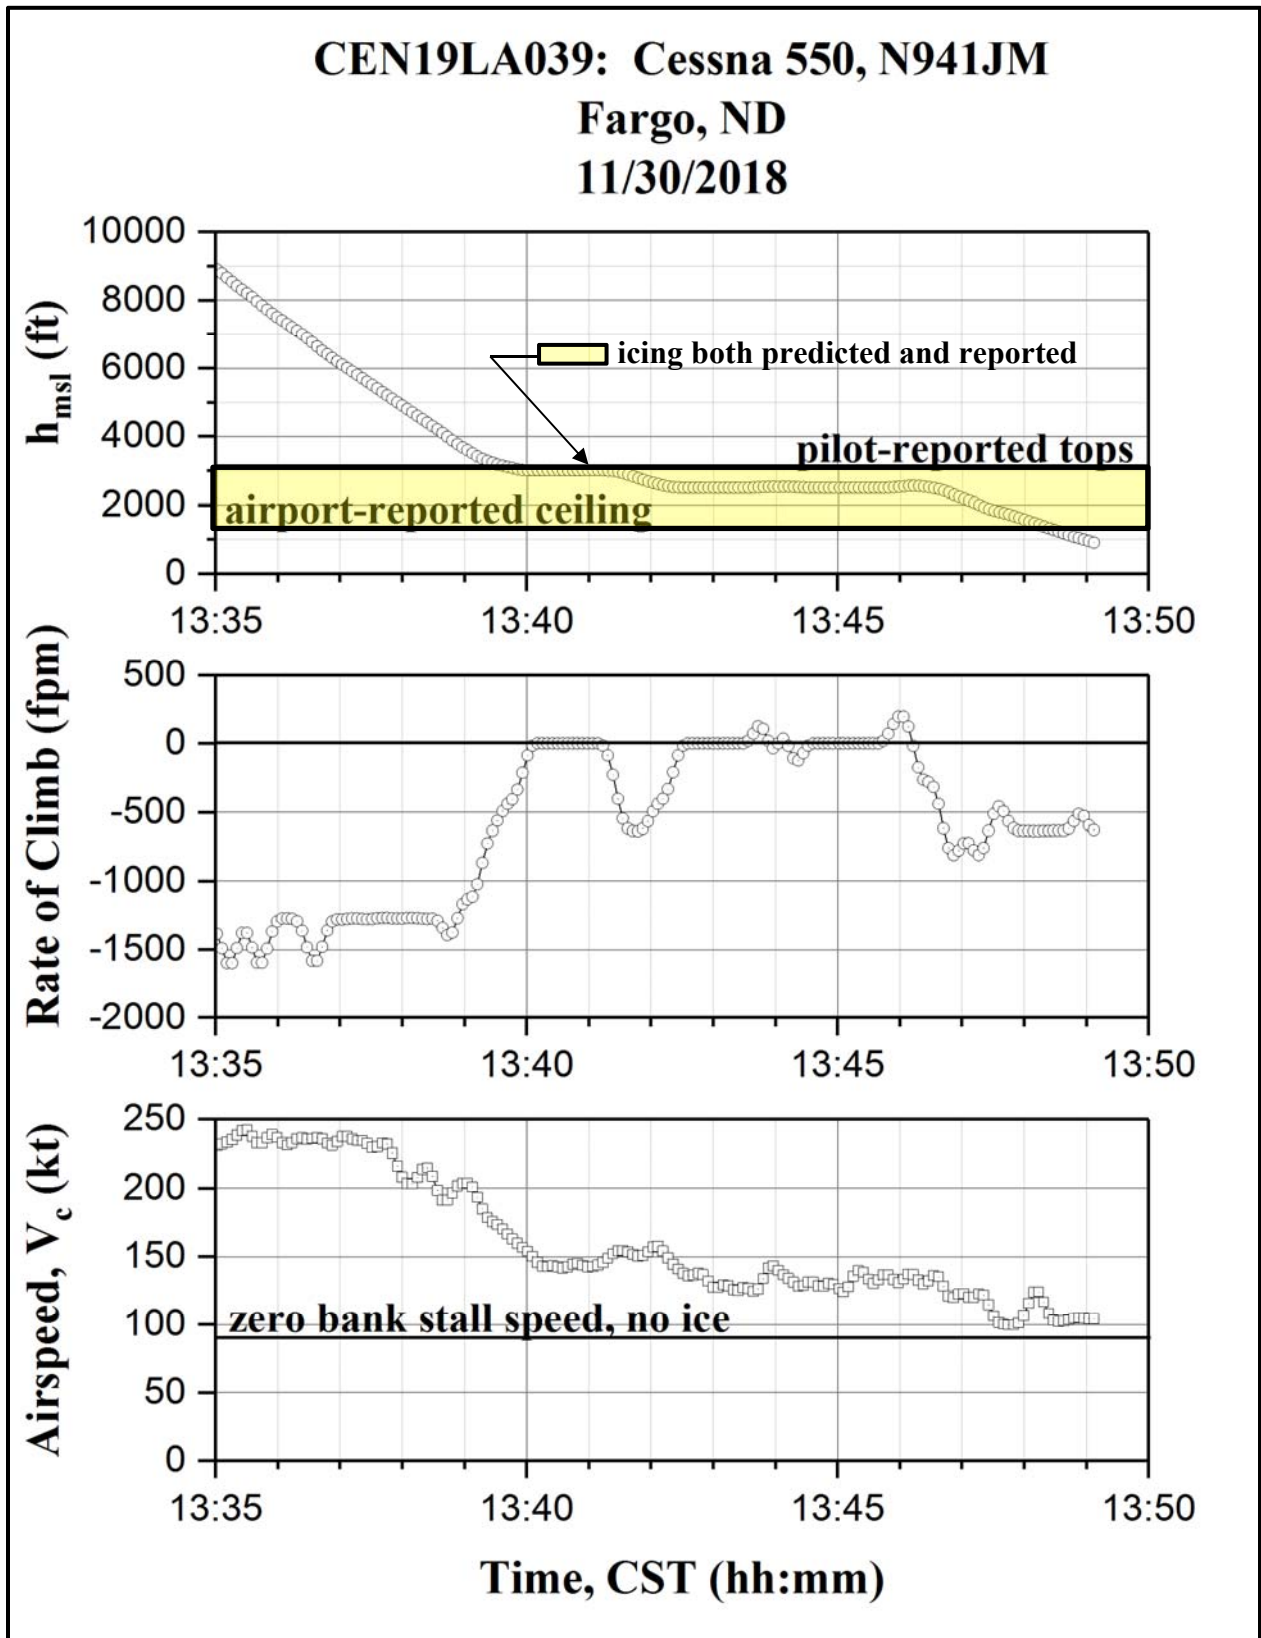
Figure 5: Estimated Altitude and Airspeed from Radar

Figure 5 highlights N941JM's descent from 9,000 ft to 2,500 ft, the top of the ILS 18 approach. (A more recent copy of the National Aeronautical Charting Office, NACO, approach plate for FAR ILS 18 is shown in Figure 6). The pilot reported entering the clouds just before 1340:00 CST at 3,100 ft, approximately 10 nm from FAR.

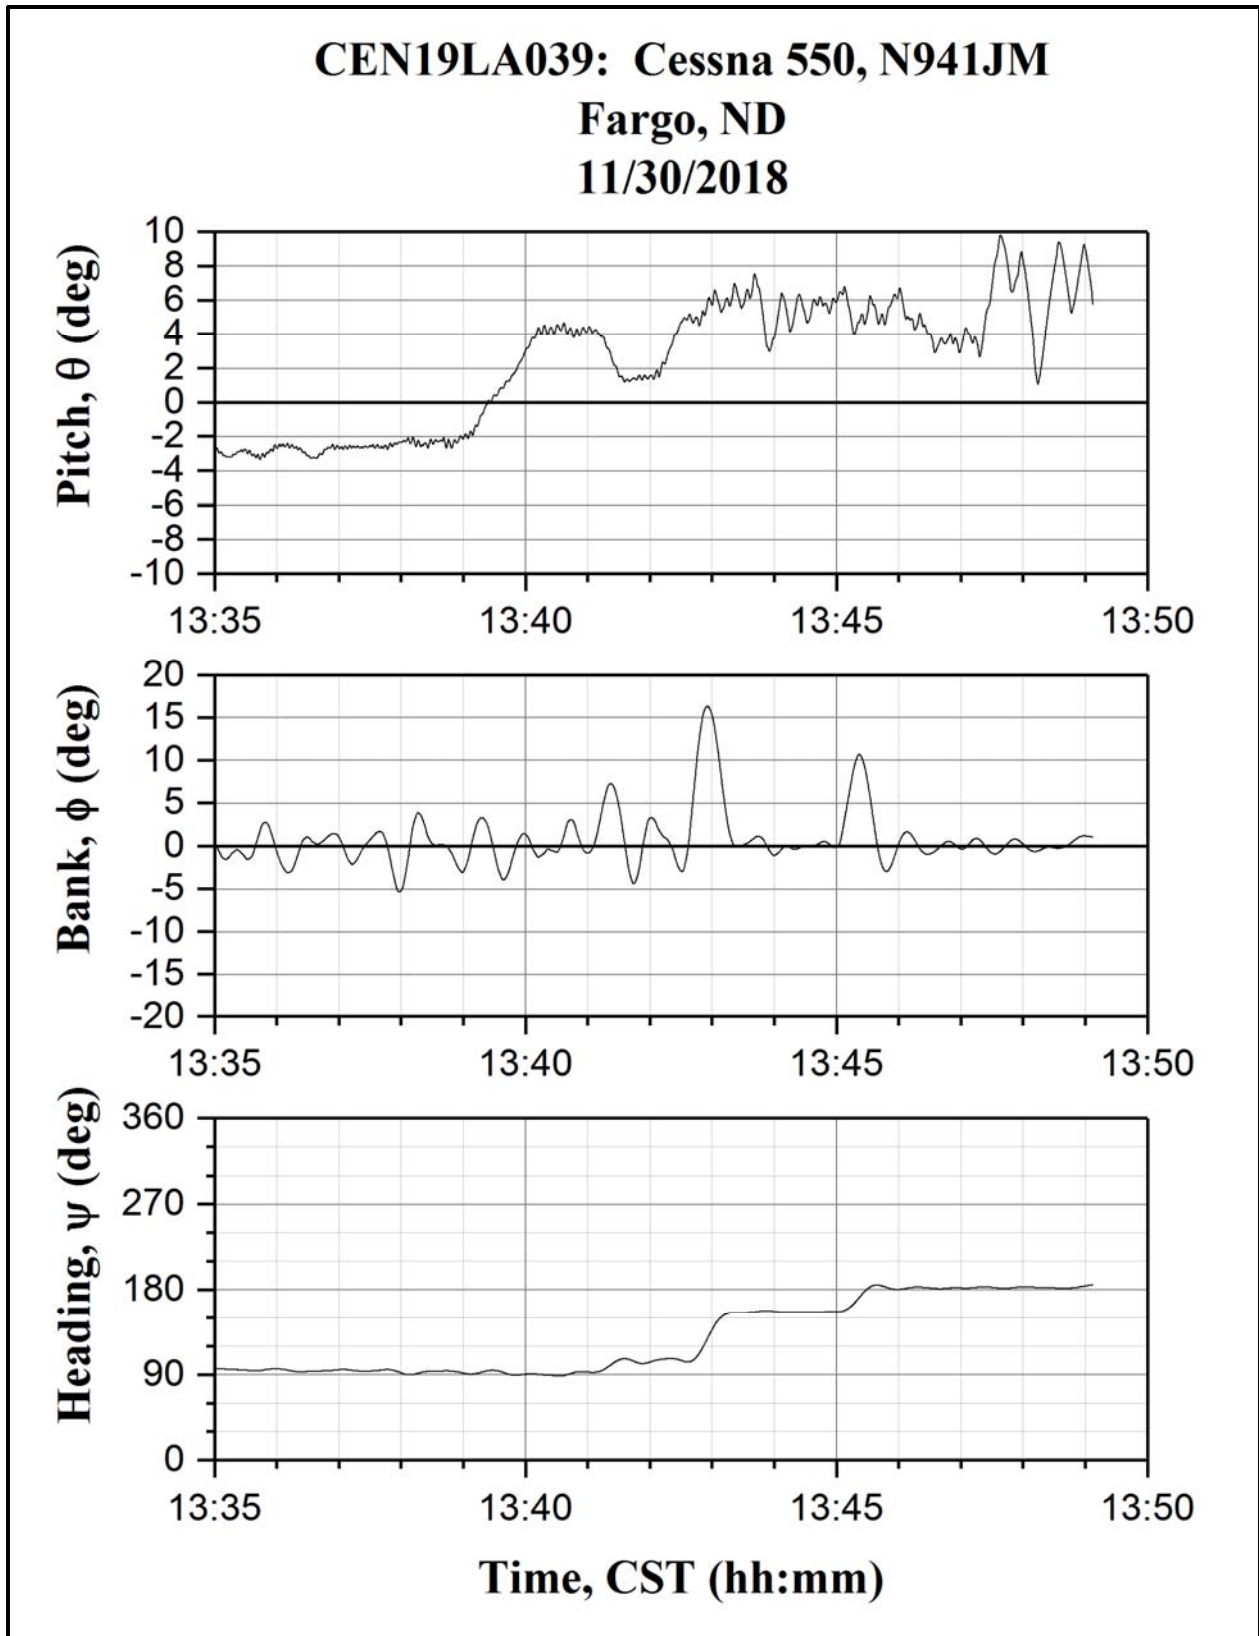
Figure 7: Estimated Pitch, Bank, and Heading from Simulation

Figure 7 shows the airplane Euler angles that resulted when the simulation was “flown” through the radar data. Note the slight right turn on short final as captured by bank angle and heading at approximately 1348:30, 30 seconds before the last radar return<sup>2</sup>.

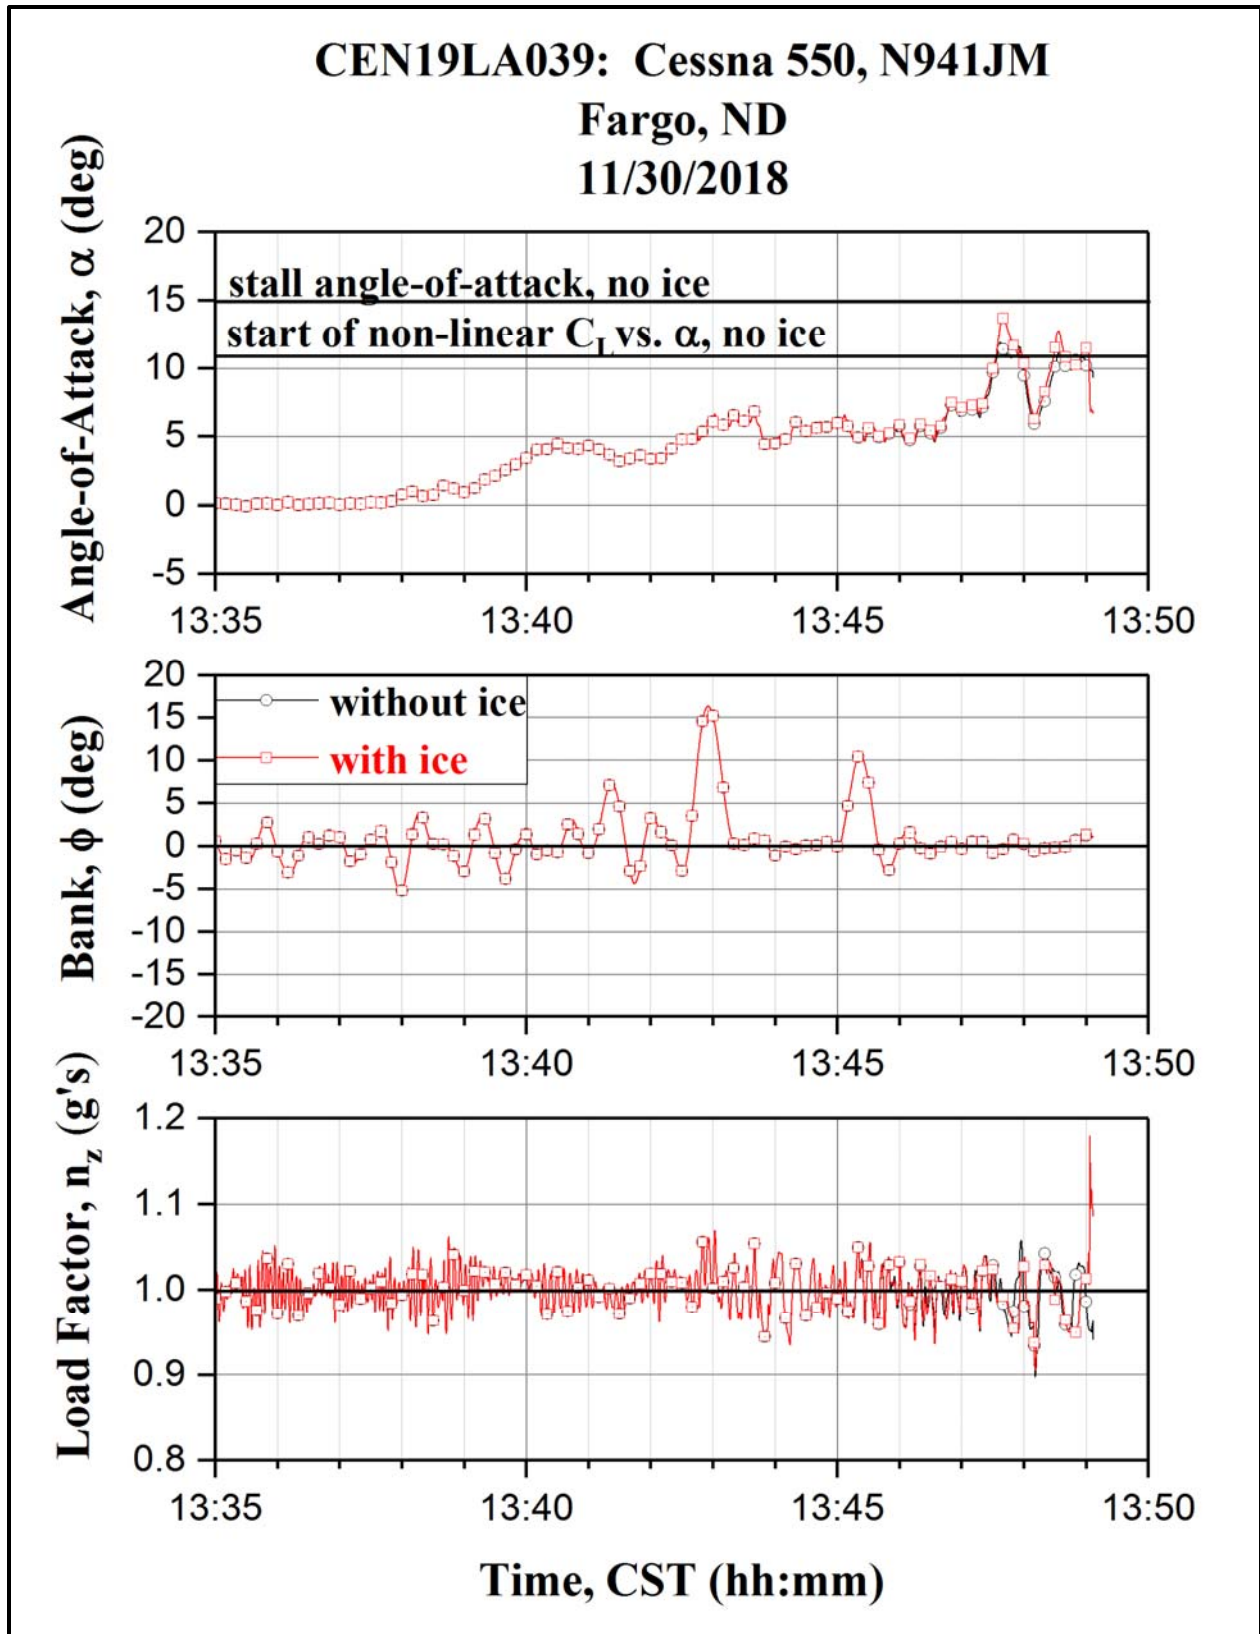
Figure 8: Estimated Angle-of-Attack, Bank, and Load Factor from Simulation, With and Without Ice

Figure 8 includes a time history of the angle-of-attack (AOA) from the Cessna 550 simulation. In order to match the radar data, the simulation AOA for the last two minutes of the flight approached angles very close to the stall AOA, and the AOA momentarily exceeded the linear portion of the Cessna 550 “no-ice” lift curve<sup>3</sup> with the flaps in the retracted position<sup>4</sup>.

In addition to the simulation results without any degradations due to ice, Figure 8 includes a simulation time history with the lift coefficient reduced by 5% to model the effect of ice accretion on the airplane’s wings during the ILS 18 approach (in red)<sup>5</sup>. The reduction was introduced shortly after the airplane descended into the clouds and leveled off at 2,500 ft, and it peaked at 5% at impact<sup>6</sup>. The AOA with the lift reduction was consistently into the non-linear portion of the no-ice lift curve for the last 30 seconds of the flight. Figure 9 shows the same AOA that resulted when the simulation was “flown” through the radar data but with a larger scale.

The pilot of N941JM could have increased the stall margin by extending the wing trailing edge flaps and possibly by activating the Cessna 550's wing and tail leading edge pneumatic de-ice boots more often.

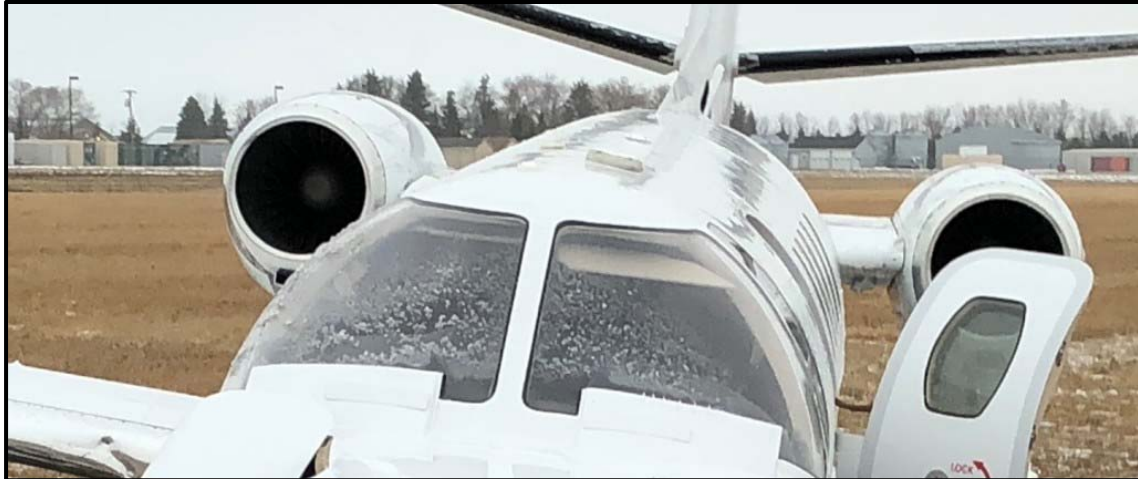
The Cessna 550 Citation II is equipped with an anti-ice system to prevent ice on the windshield and a de-ice system provides for removal of ice on the leading edge of the wing and tail by pneumatically expanding boots. The pilot of N941JM indicated that he activated the de-ice boots several times on the approach. However, the airplane was found with ice on the wings, horizontal tail, and vertical tail as shown in Figures 10-12 that were taken at the accident site.

**Figure 10: Ice on the Windshield of N941JM at the Accident Site**

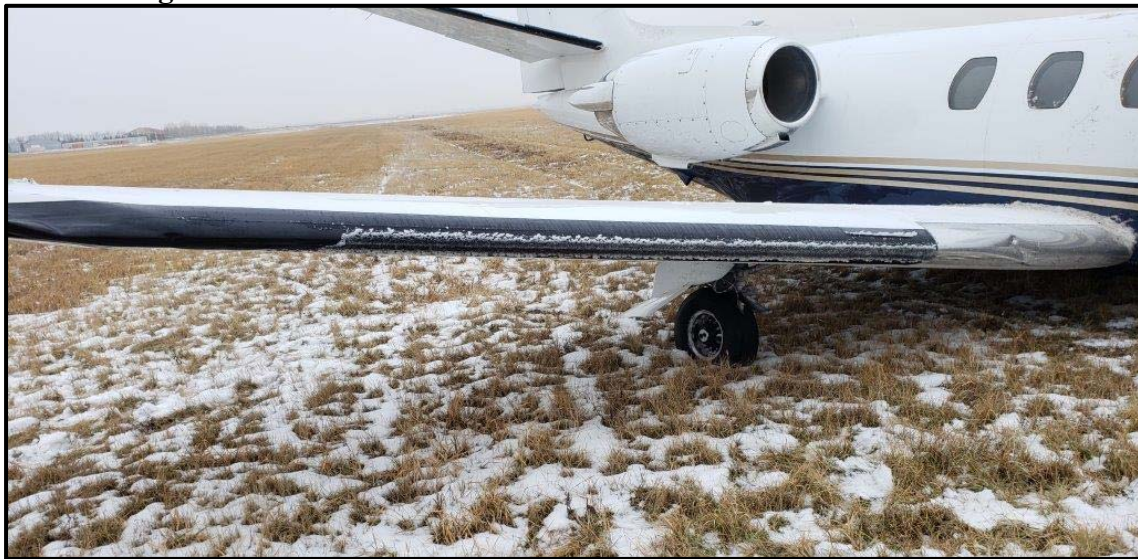
**Figure 11: Ice on the Wing Leading Edge of N941JM at the Accident Site**

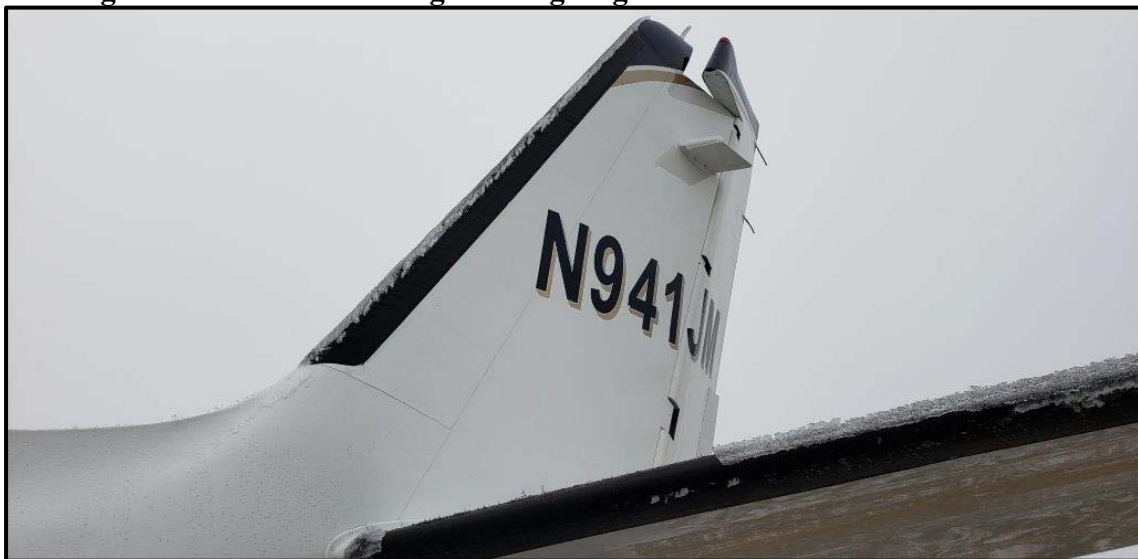
**Figure 12: Ice on the Vertical and Horizontal Tail of N941JM at the Accident Site**
