# **Bell Helicopter** **TEXTRON**

**Factual Observation Field Notes**  
**Saber Air Cargo 206B S/N 501 N8104J**  
**North Wilkesboro, North Carolina**  
**10-22-01**

**I. Introduction:**

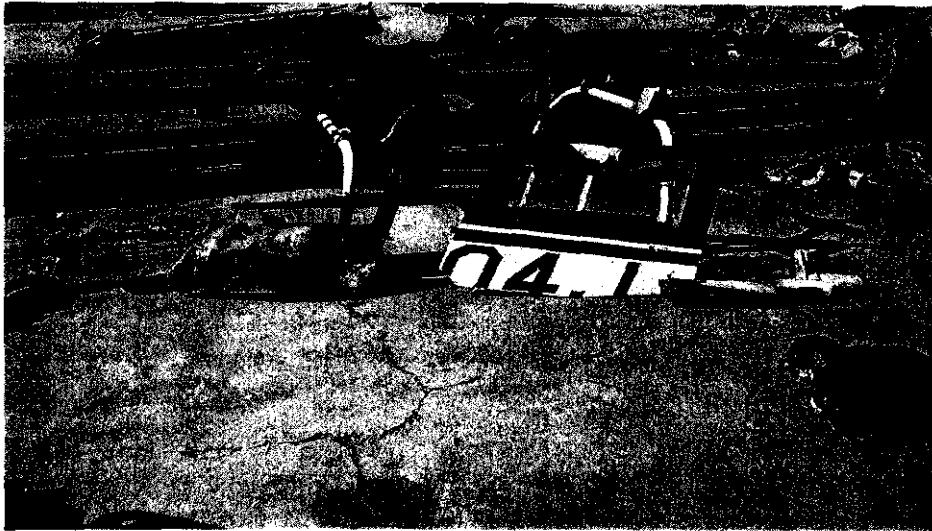
**Fuselage Remains**

1. The aircraft fuselage predominately consumed by the post-impact fire. Only minimal portions of the roof deck, engine firewalls, a left aft door and miscellaneous small pieces were not consumed in the fire. The instrument panel was not observed. Instruments from the panel were observed in the wreckage debris with extensive post-impact fire damage. The landing skids were observed extensively broken up. The cross tubes were observed predominately intact and appeared to have been separated during the impact sequence. The right side fore and aft crosstubes appeared to have been deformed inward.

No pre-impact abnormalities were observed with the fuselage remains.

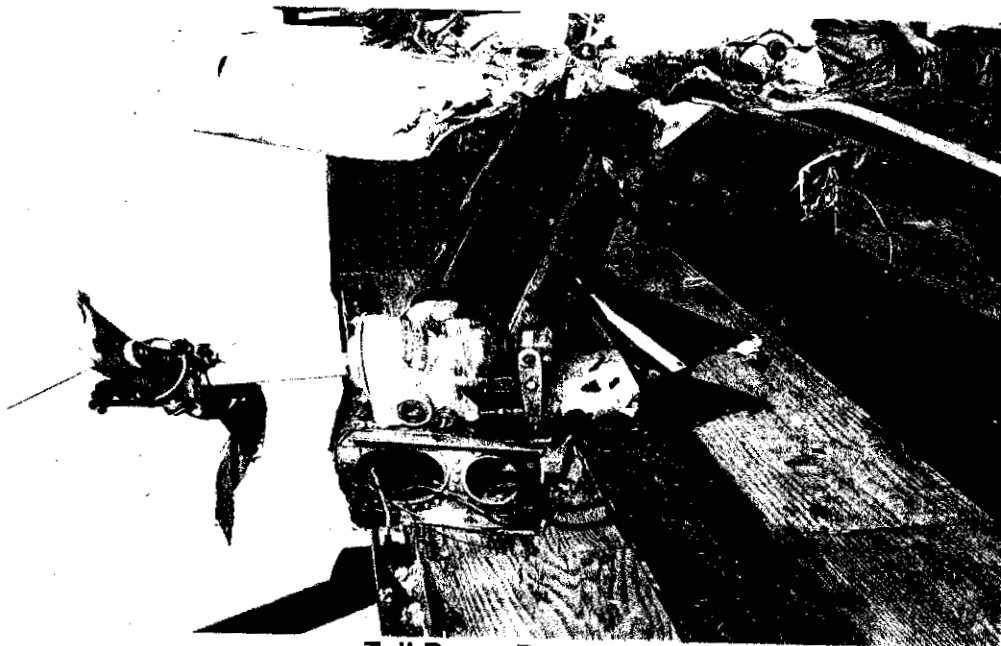
**Tail Boom Remains**

2. The tail boom was observed separated from the main wreckage. Evidence appears to indicate the tail boom was securely attached to its fuselage attach points during the impact sequence. Measurements indicate that approximately 27 inches of the forward portion of the tail boom had been consumed by the post impact fire. The tail boom forward of the horizontal stabilizer had been predominately consumed by the post-impact fire. The horizontal stabilizers exhibited evidence of significant deformation with the predominate damage occurring to the right side. The remaining portion of the tail boom was intact. The vertical fin had separated from the tail rotor gearbox mount during the impact sequence. The tail rotor gearbox had been separated from the mount.

No pre-impact abnormalities were observed with the tail boom structure.

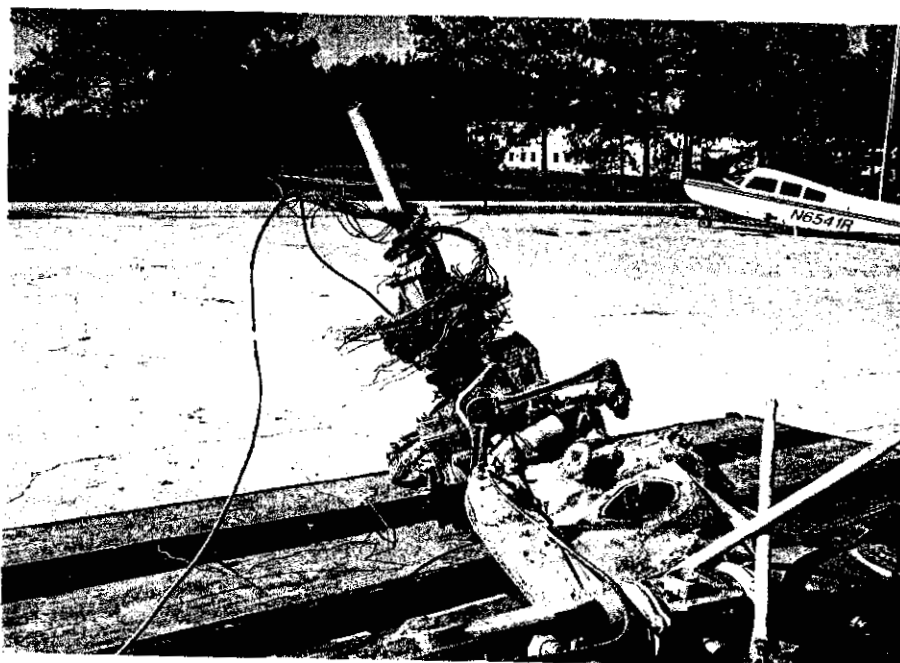
3. The rotating and non-rotating swashplates were intact and exhibited evidence of fire exposure. An approximate 1 inch high voltage power cable was observed wrapped several times around the mast and swashplate assemblies. The drive link was intact. The pitch links had been separated at the swashplate attach clevises. The swashplate support tube was intact. The collective lever was intact. The control linkage running to the non-rotating swashplate had been melted.

#### **Cable Wrapped Around Mast and Pitch Link Separations.**

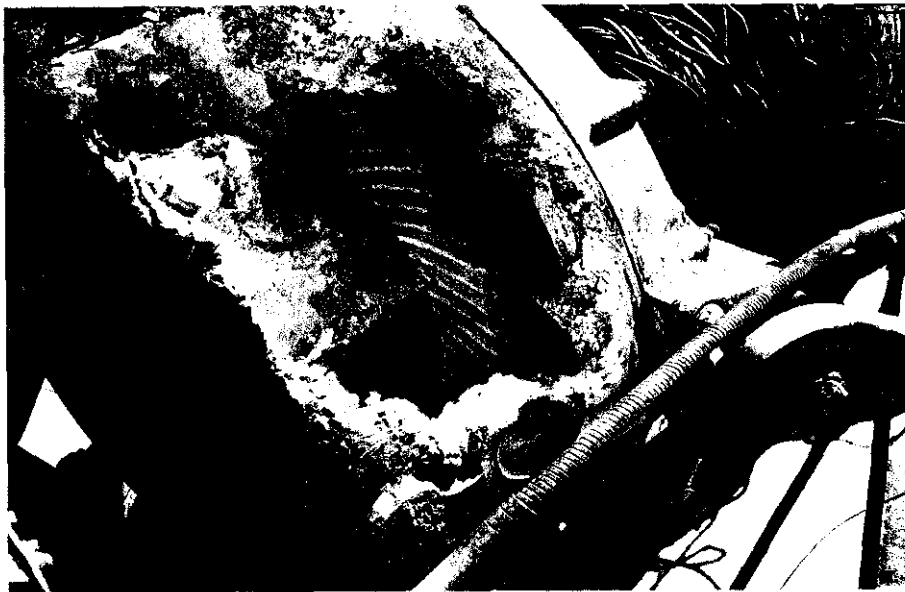
4. The transmission could not be manually rotated. The transmission case exhibited extensive post-impact fire damage. The transmission remained mounted in the pylon supports. The pylon supports had only melted portions of the fuselage structure attached. The main input drive shaft was had observed with extensive post impact fire damage. The mast had been fractured below the static stops. The separation appears typical of an overload condition. The remaining portion of the mast was removed from the rotor hub and some spline mis-alignment was noted. The rotor hub assembly did not exhibit any indications of distress and the main rotor blades were securely attached to the hub assembly.

No indications of pre-impact distress were noted.

**Transmission Case Damage**

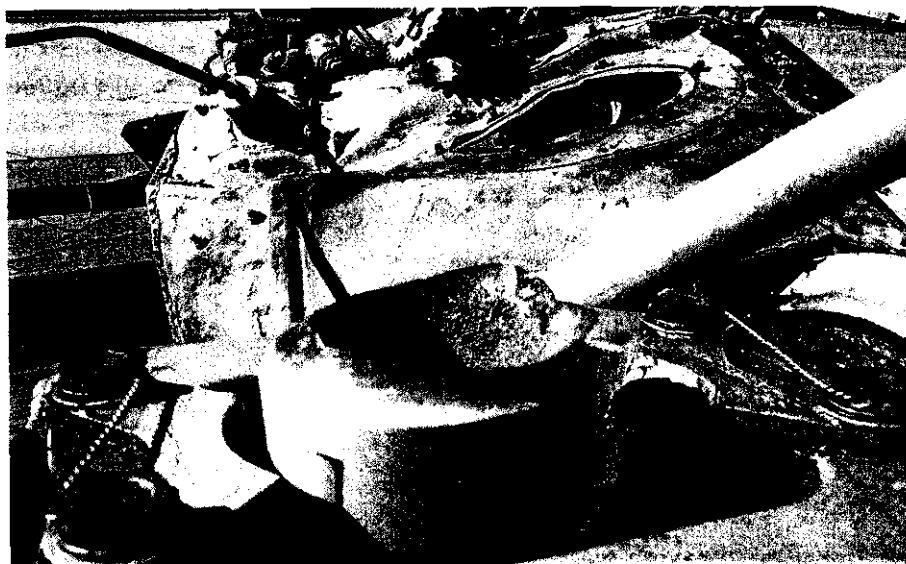
### **Mast Overload Separation**

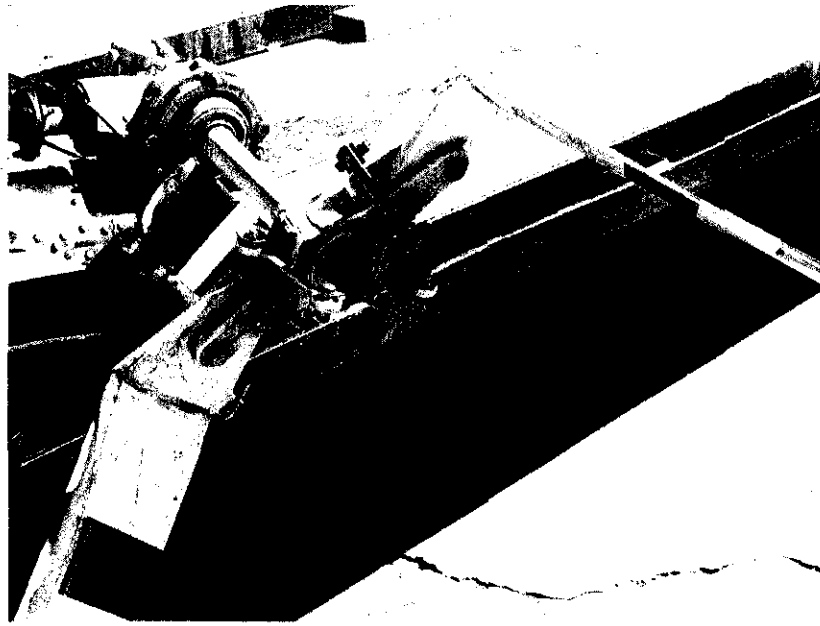
**Tail Rotor System**

6. The tail rotor blade damage appeared consistent between each blade. The blades were bent outward approximately 7 inches from the root end of each blade. Each blade appeared securely attached to the hub assembly. Pitch control to the tail rotor blade was established from the point of tail boom separation to the tail rotor blades. The tail rotor gearbox had separated from the gearbox mount. The separations appear typical of overload and appear impact related. The tail rotor gearbox was manually rotated verifying operation and continuity. The chip plug was observed free of debris.

No indications of pre-impact abnormalities were noted with the tail rotor system.

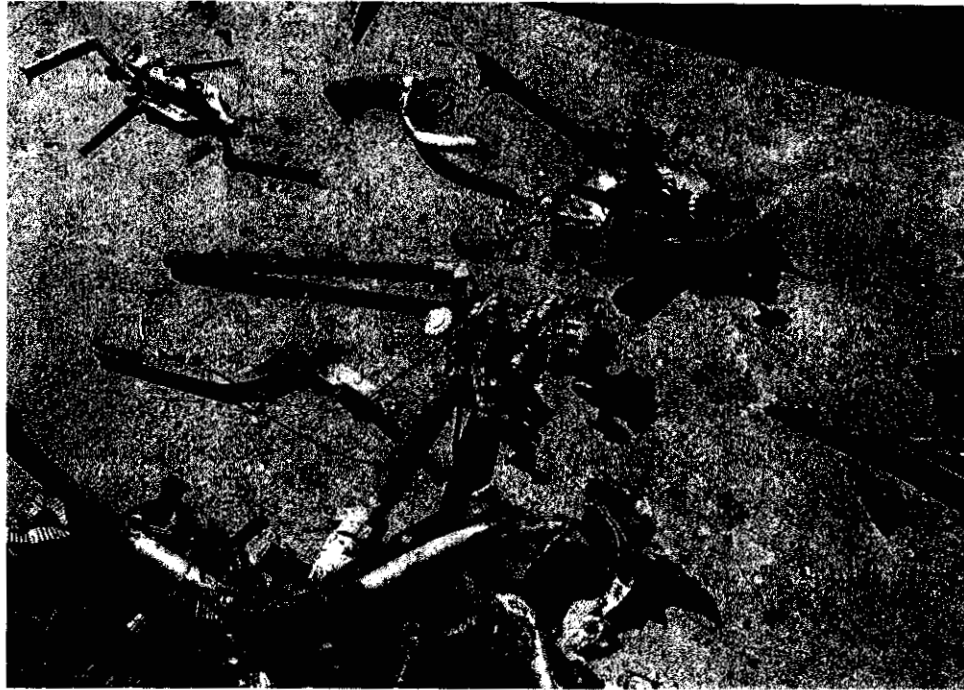
**Pilot's Cockpit Controls**

The cockpit controls exhibited extensive post-impact fire damage. The pilot's damaged cyclic and collective were recovered. The cyclic had been fractured approximately ten inches from the grip. The pilot's collective had been fractured at the jack shaft attach point. The throttle appears to have been in the full "ON" position. The pilot's anti-torque pedals had been significantly deformed to the right.

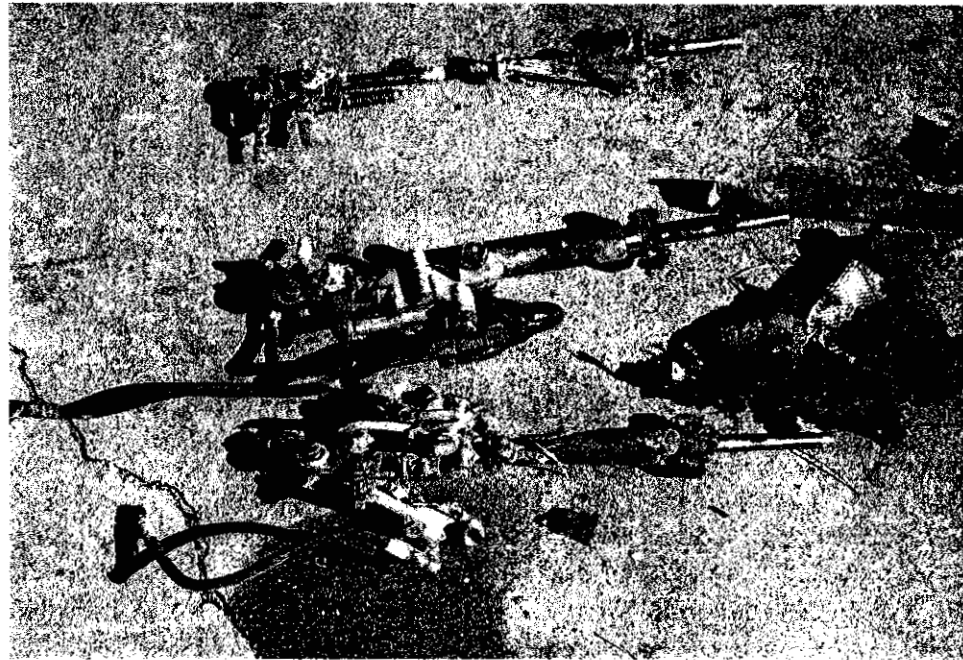
**Hydraulic Boost Actuators**

8. The majority of the flight control system had been consumed by the post impact fire and was not observed. The hydraulic boost actuators exhibited extensive post impact fire damage that prevented detailed analysis.
