## **NATIONAL TRANSPORTATION SAFETY BOARD**

# **AIRFRAME EXAMINATION**

**WPR15FA158**

Location: Spokane, Washington  
Date: May 7, 2015  
Aircraft: Piper PA-46-350P, Registration Number: N962DA, Serial #: 4636031  
NTSB IIC: Elliott Simpson

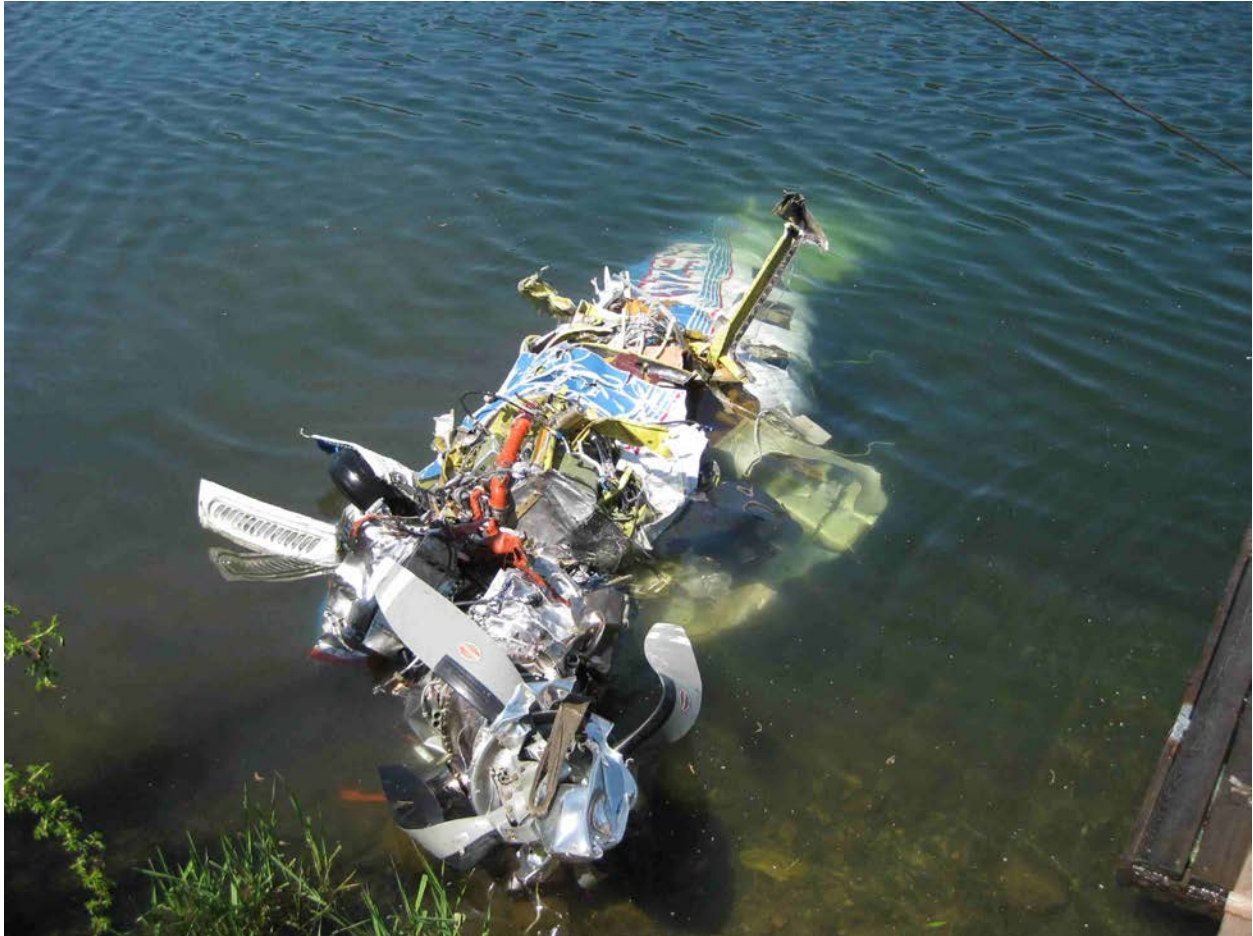
Photo 1 - Airframe in Water

The fuselage sustained crush damage and fragmentation from the firewall through to the right-side emergency exit door. The engine remained attached to the firewall, and the propeller hub with all four blades remained attached to the engine gearbox (Photo 1). All blades were bent about 90 degrees aft, 8 to 12 inches from their roots (Photo 2). Both wings had separated from the airframe, and at the time of examination, the right wing outboard of the main landing gear had not been recovered from the accident site (Spokane River). The horizontal stabilizer had separated from the tailcone.

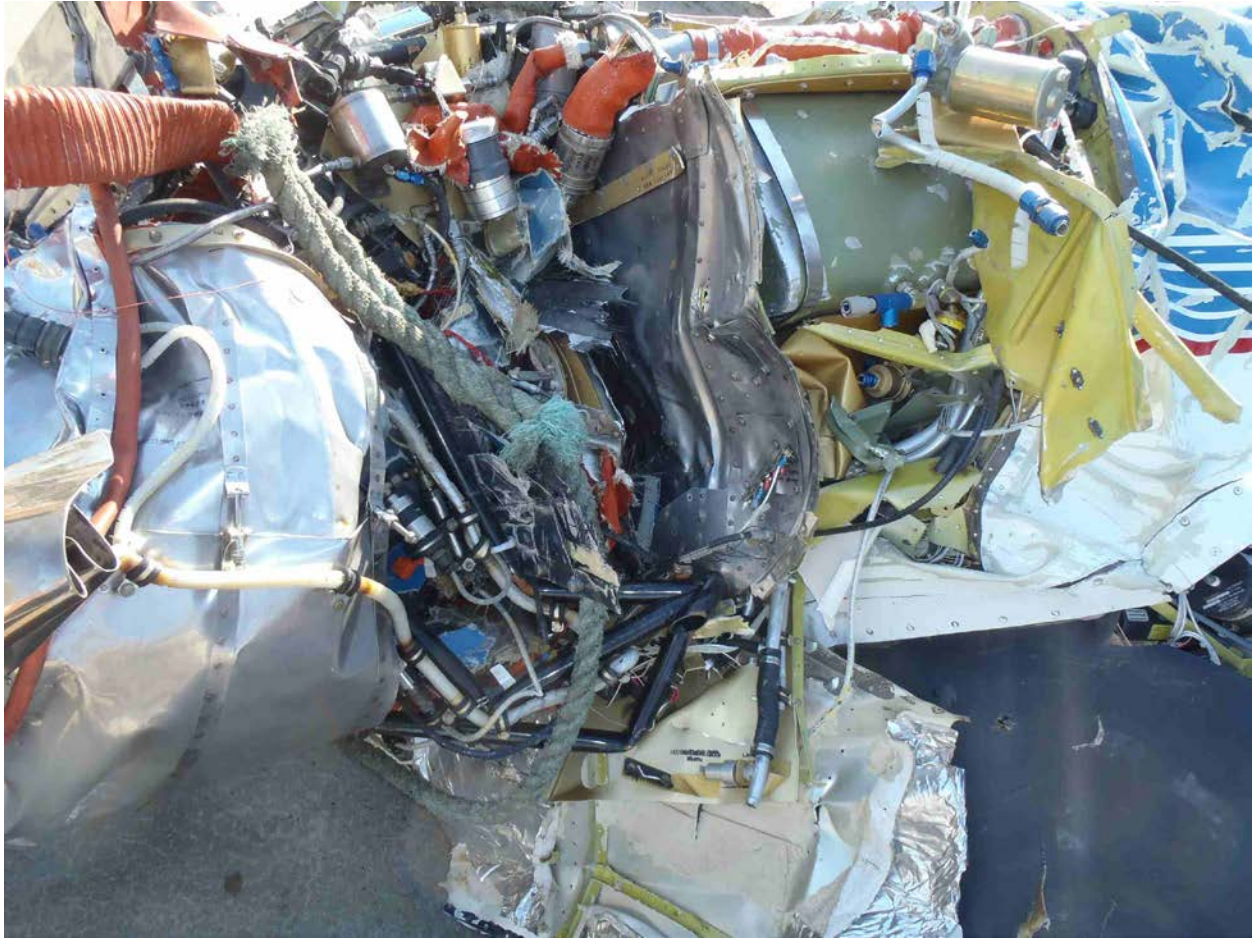
Photo 3 - Firewall and Header Tank

The forward fuselage skins and cowling on the right side had been forced aft and out, exposing the contents of the cockpit and forward cabin, along with the header tank, baggage bay, and wiring side of the instrument panel (Photo 3).

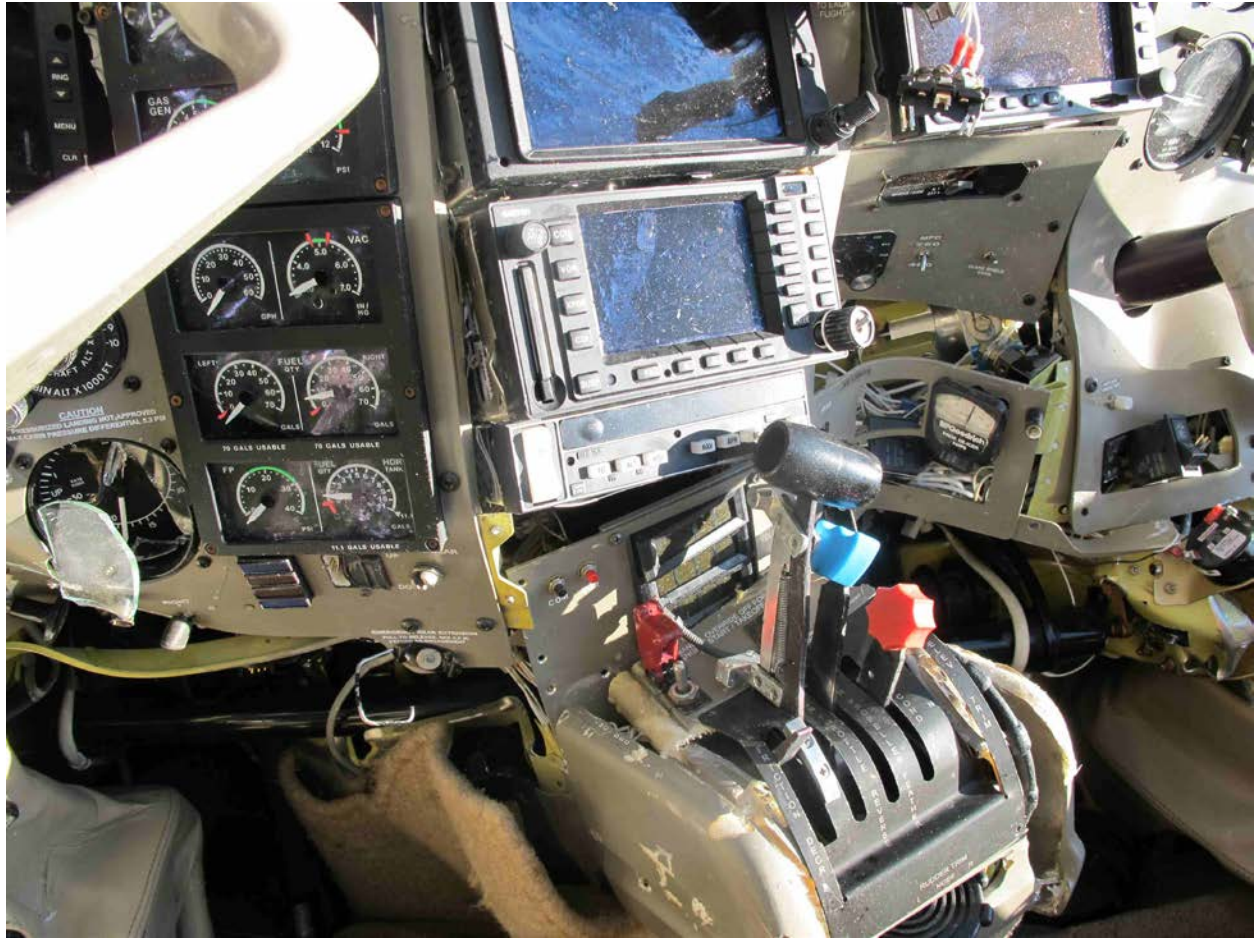
Photo 4 - Throttle Quadrant

The instrument panel was fragmented, resulting in varying degrees of damage to all of the flight instruments and avionics. The Hobbs hour meter indicated 1170.6 hours. The engine throttle and propeller levers were in the full forward position, and the condition lever was in the ON position (Photo 4). The right-side control yoke had separated from the control column, the fracture area exhibited conical separation with granular surface features (Photo 5). The left-side yoke remained attached to its control column.

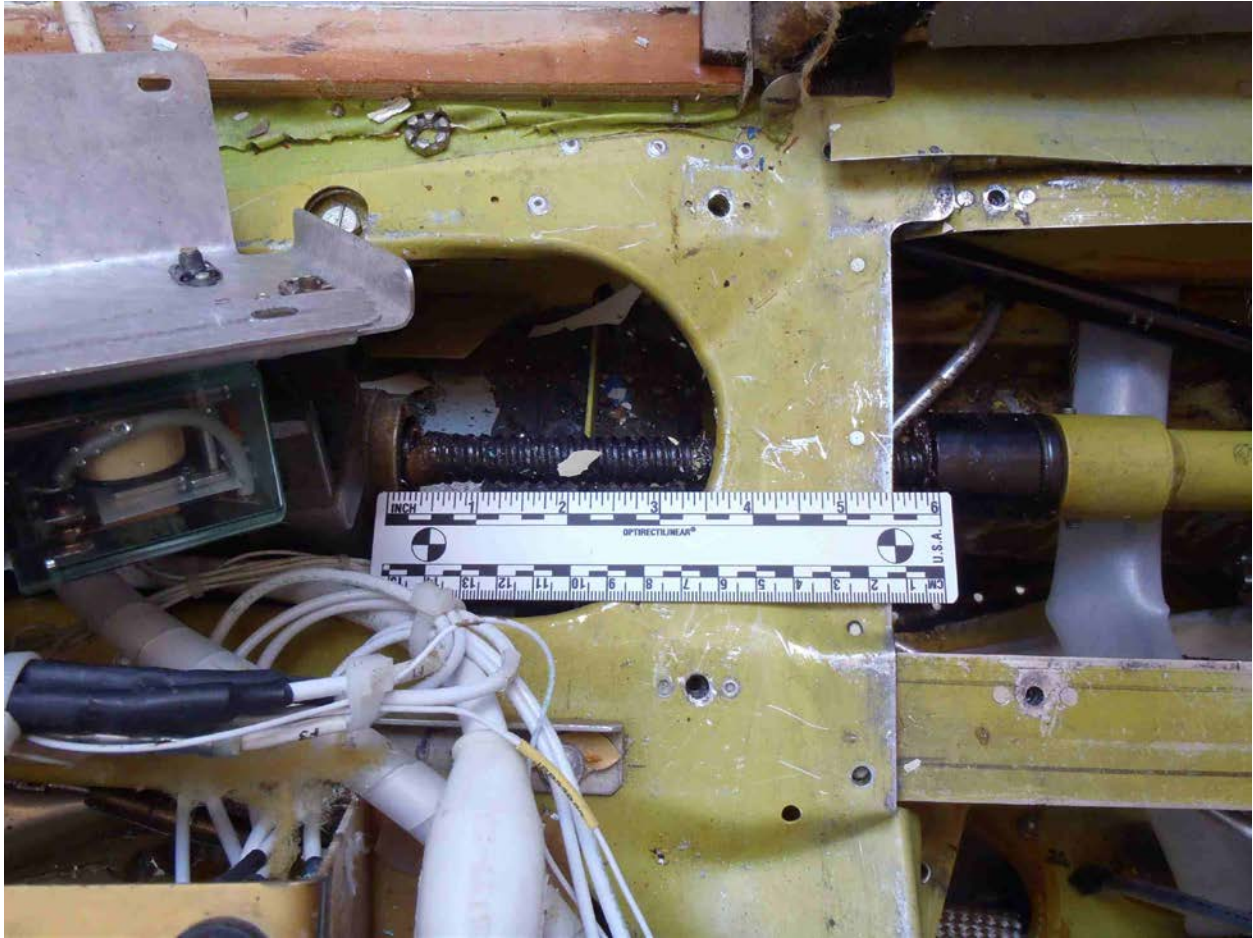
Photo 6 - Flap Actuator

The flap actuator assembly was examined under the left aft seat. Thirty six threads were visible at the actuator shaft, corresponding to 6 inches of exposure (Photo 6). According to Piper documentation, full flaps correspond with 5.1 inch shaft exposure and 30 threads.

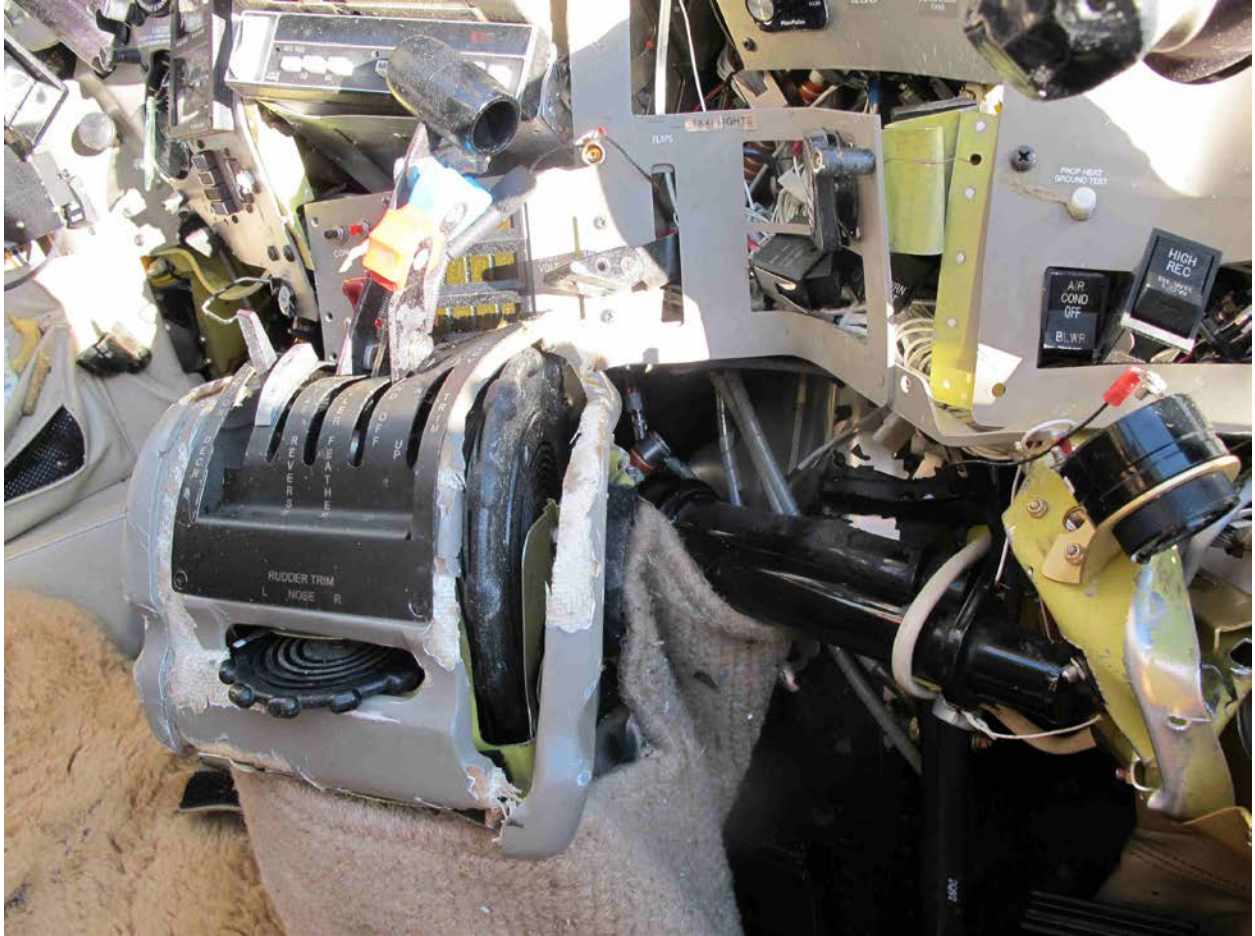
Photo 7 - Rudder Trim Position

The rudder trim wheel indicator was in the full left position (Photo 7).

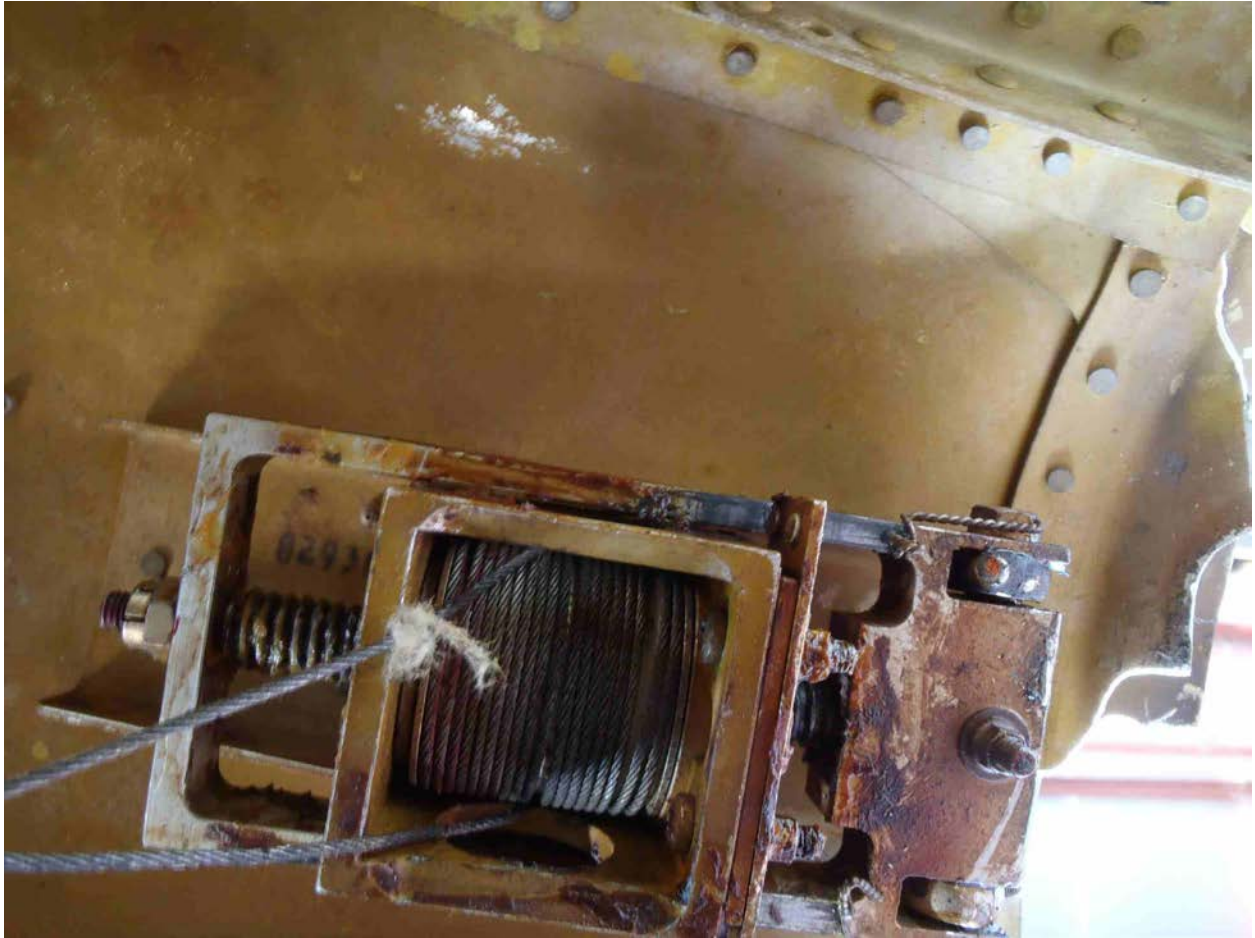
Photo 8 - Elevator Trim Actuator

The elevator trim actuators drum was positioned such that eight actuator threads were visible on the forward side and six on the rear, which according to Piper documentation was consistent with neutral trim (Photo 8).

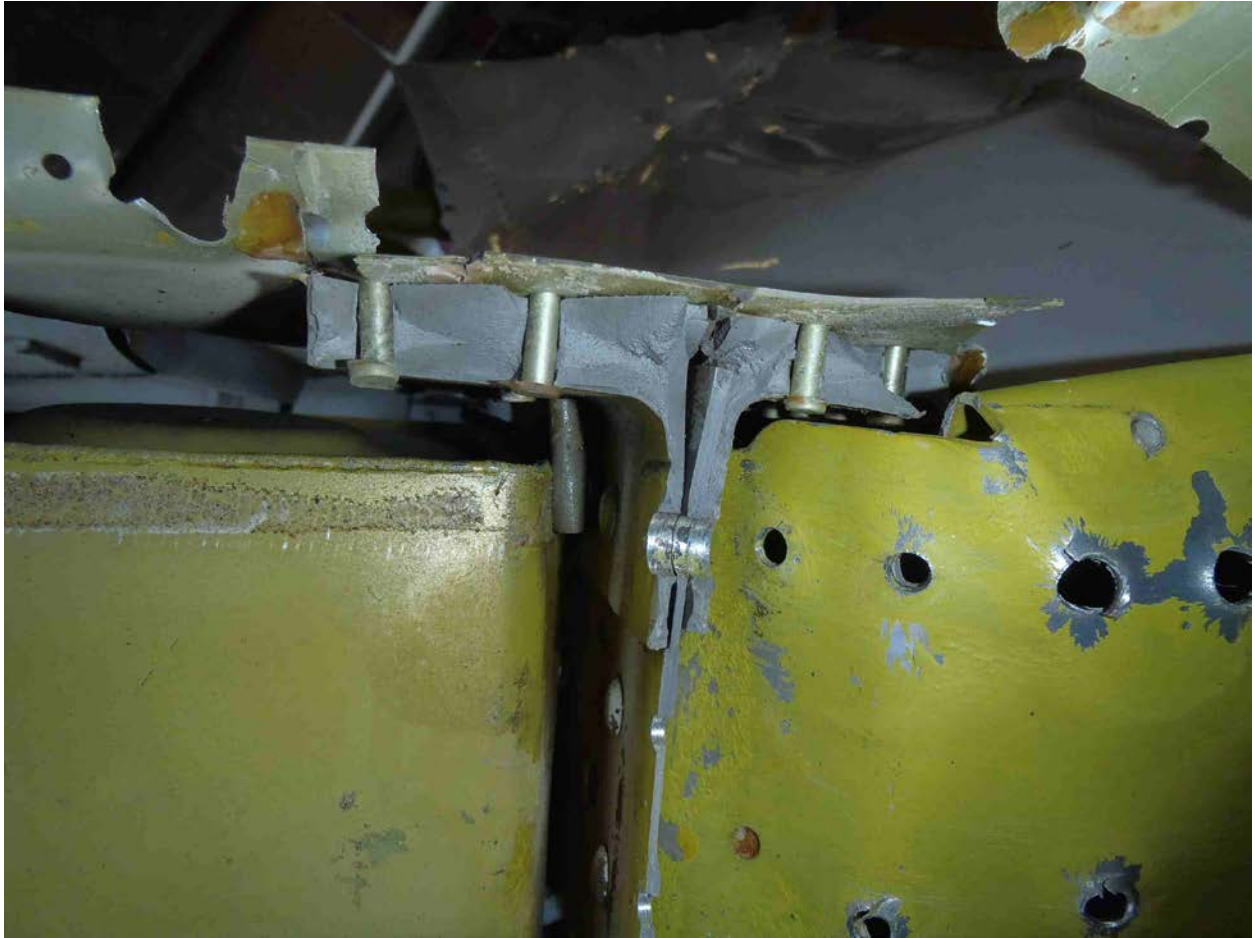
Photo 9 - Left Wing Spar Cap Fracture Surface

The left wing center and aft spar had separated at the root, with the forward spar remaining attached to its mounting bolt and frame bracket, which had separated from the airframe. All failure surfaces propagated in an aft direction, and exhibited granular surface features and 45 degrees sheer lips (Photo 9).

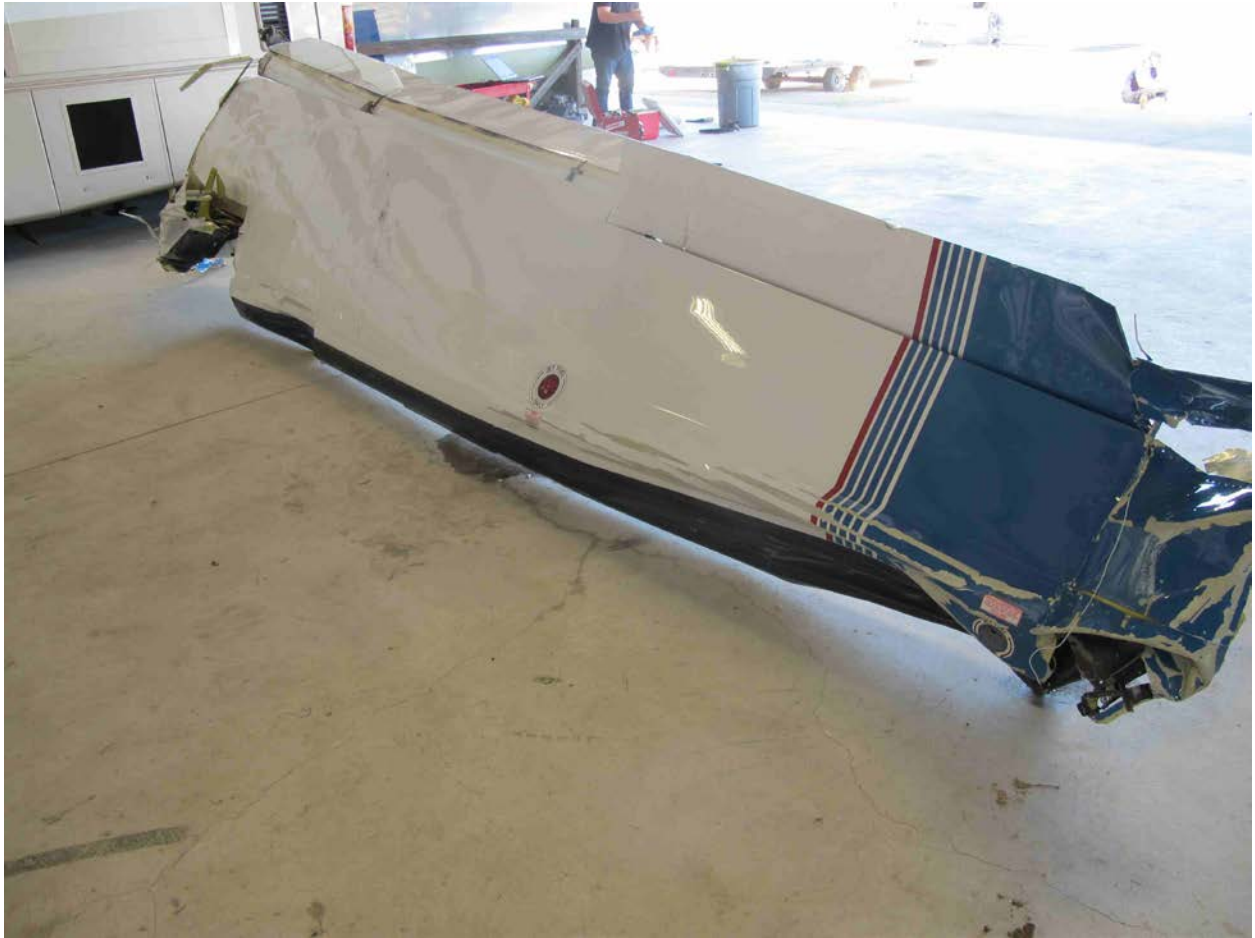
Photo 10 - Left Wing

The wing remained largely intact, and had sustained leading edge crush damage to the outboard 6 ft including the tip (Photo 10). The landing gear remained attached and was in the extended position.

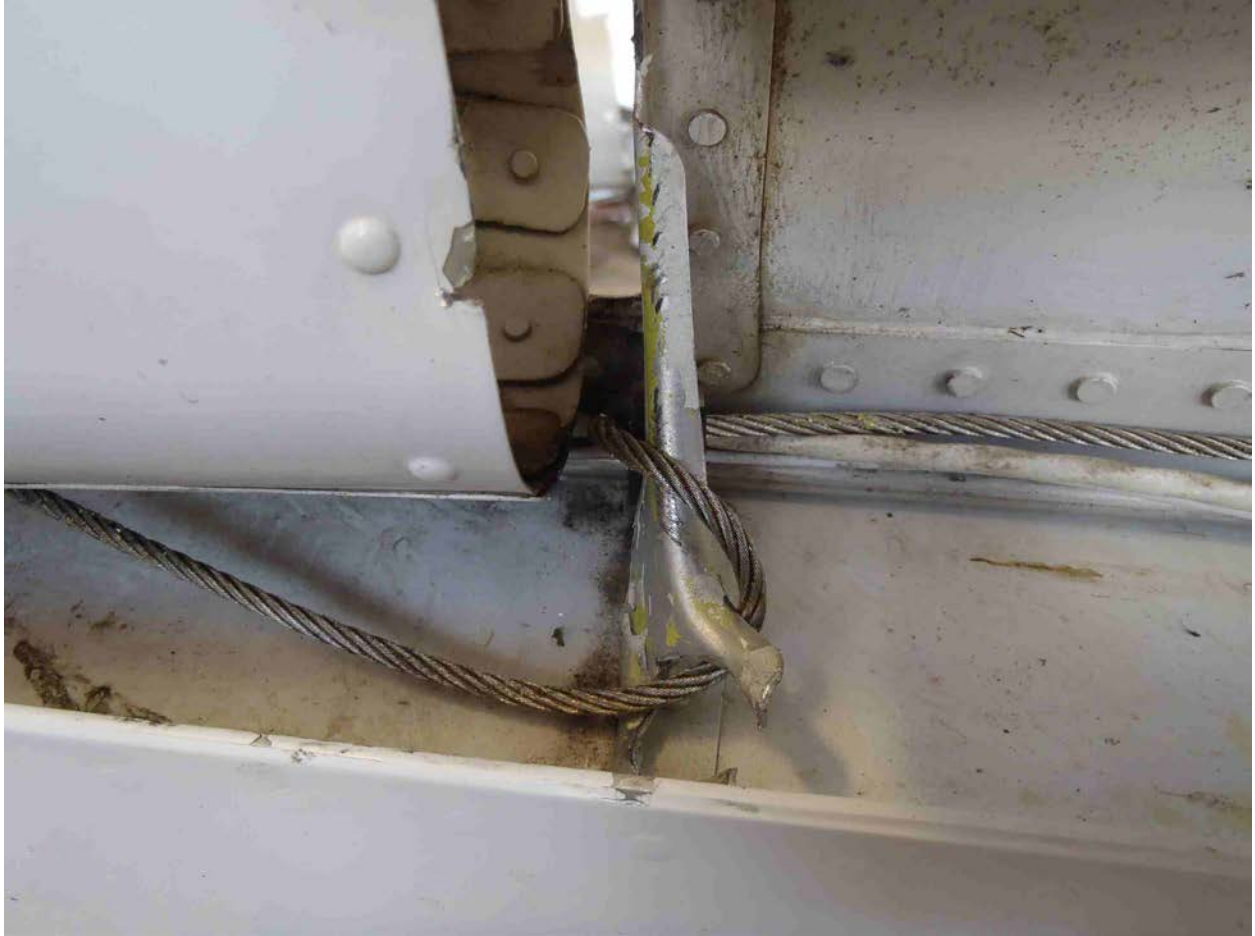
Photo 11 - Left Wing Aileron Cable

The aileron remained attached at the inboard hinge, and partially attached at the outboard hinge where the tip had become bent upwards. The aileron control cable remained attached to upper portion of the control sector wheel, and had looped back through the lower balance cable rib pass-through hole. The hole had been torn open, and both the aft section of the rib and the forward surface of the hole exhibited serrations consistent with cable contact (Photo 11). The rest of the cable passed through the wing rib at the flap outboard hinge, and then was separated approximate to the wing root. The balance cable was not attached to the lower sector wheel. All cable pulleys rotated freely, and sustained varying degrees of damage to their rims.

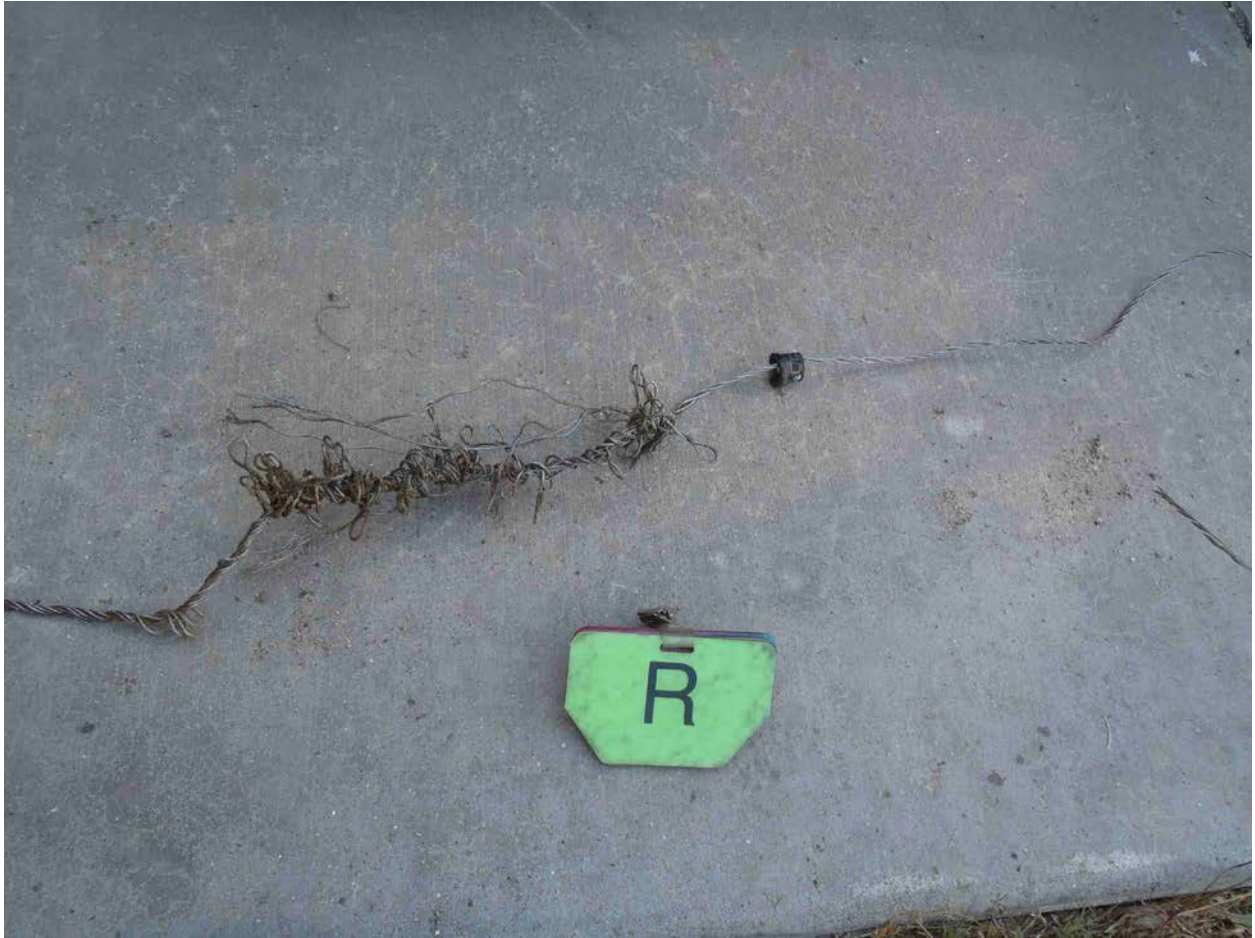
Photo 12 - Aileron Balance Cable, Right Side

The aileron balance cable remained attached to the center section of the airframe, with the cable swage balls intact at both ends. The right side of the cable exhibited bunching, where four of its strands had separated (Photo 12). The remaining control cables within the airframe were continuous through to both control yoke assemblies. The left yoke sector wheel had separated in an area where it had become impinged against panel components.

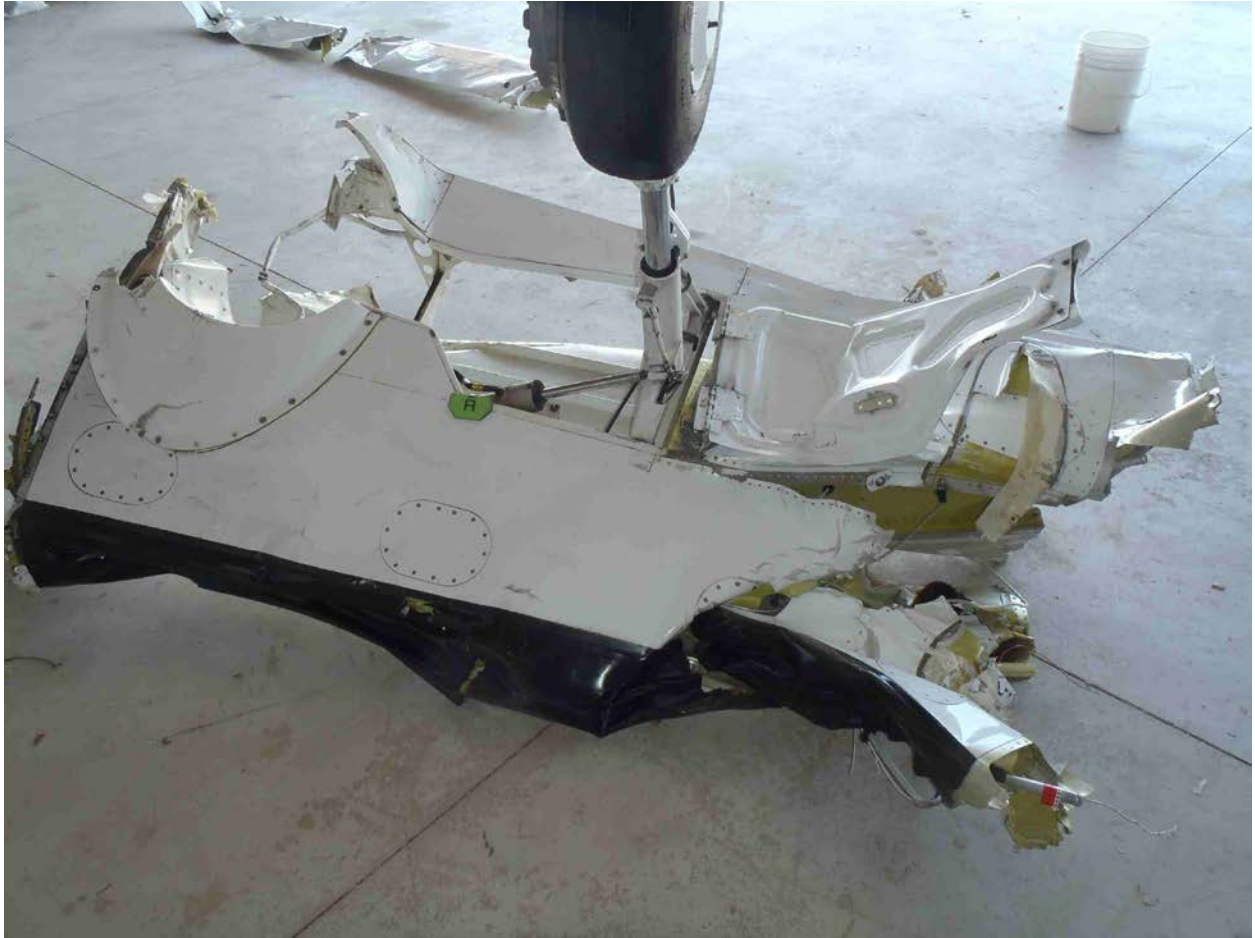
Photo 13 - Inboard Left Wing and Landing Gear

The inboard section of the right wing was recovered, extending 3 ft outboard of the landing gear, which was in the extended position. Leading edge crush damage was present, and the upper skins had separated at the aft spar (Photo 13). The spars had separated from the airframe in a similar manner to the left wing. The flap had become detached and separated in two. The aileron was not present.

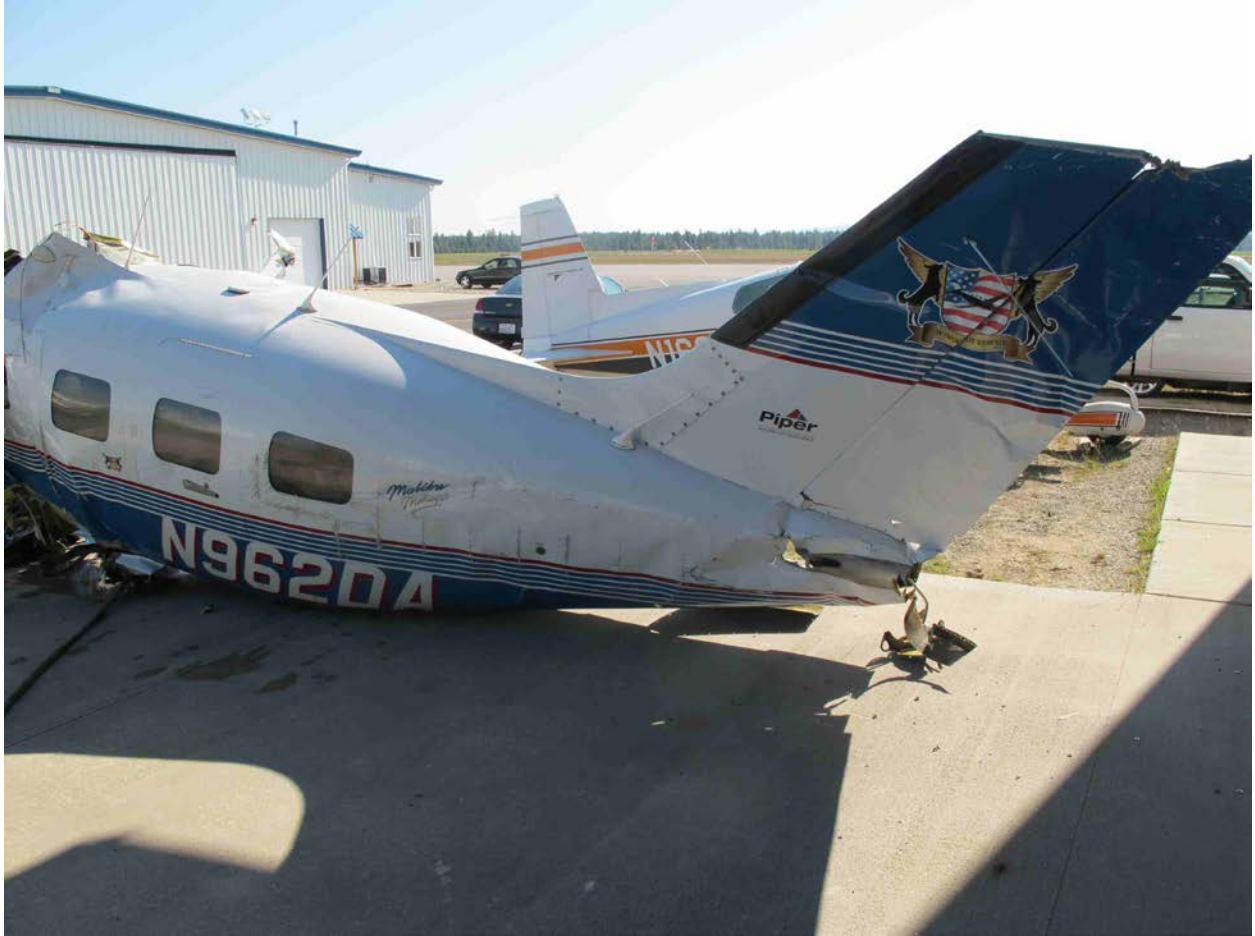
Photo 14 - Rear Cabin and Vertical Stabilizer

The vertical stabilizer and rudder remained attached to the tailcone, and were largely intact (Photo 14). The rudder balance weight had torn free from the structure and was located adjacent to the main cabin at the accident site.

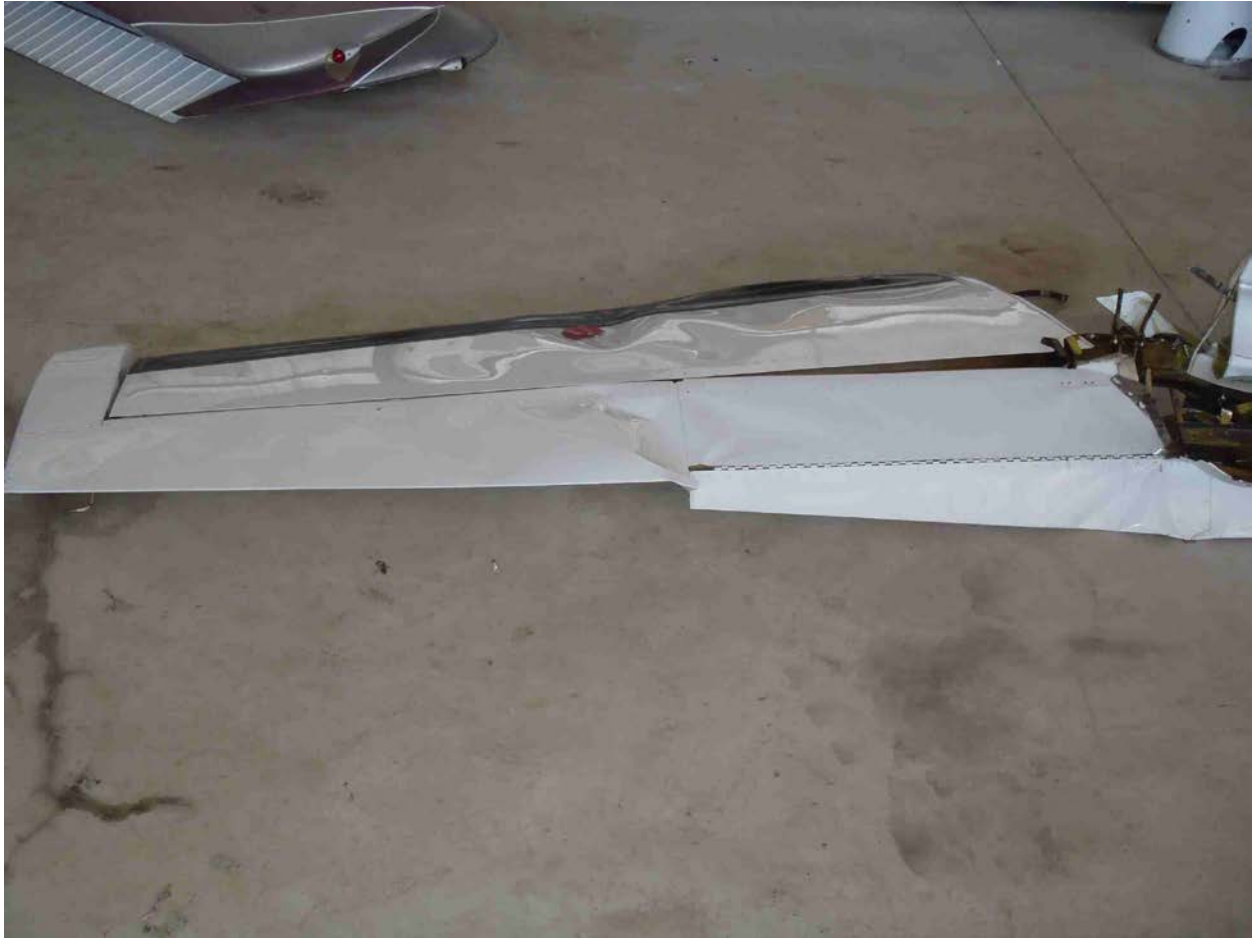
Photo 15 - Horizontal Stabilizer and Elevator, Left Side

The horizontal stabilizer had separated from the tailcone. The left side remained largely intact with the elevator attached aft spar (Photo 15). The right side exhibited upwards bending damage twisting the leading edge up to 60 degrees relative to the direction of travel (Photo 16). The elevator remained attached at the center hinge and had bent aft. The trim tab was still attached.
