NATIONAL TRANSPORTATION SAFETY BOARD

AIRFRAME EXAMINATION (Rev A)

**NTSB Accident: WPR18FA143
Accident Date: May 19, 2018**

Location: Near Avenal, California
Date: May 19, 2018
Aircraft: ICA-Brasov IS-29D Lark, N38ES, Serial # 38
NTSB IIC: Michael Huhn

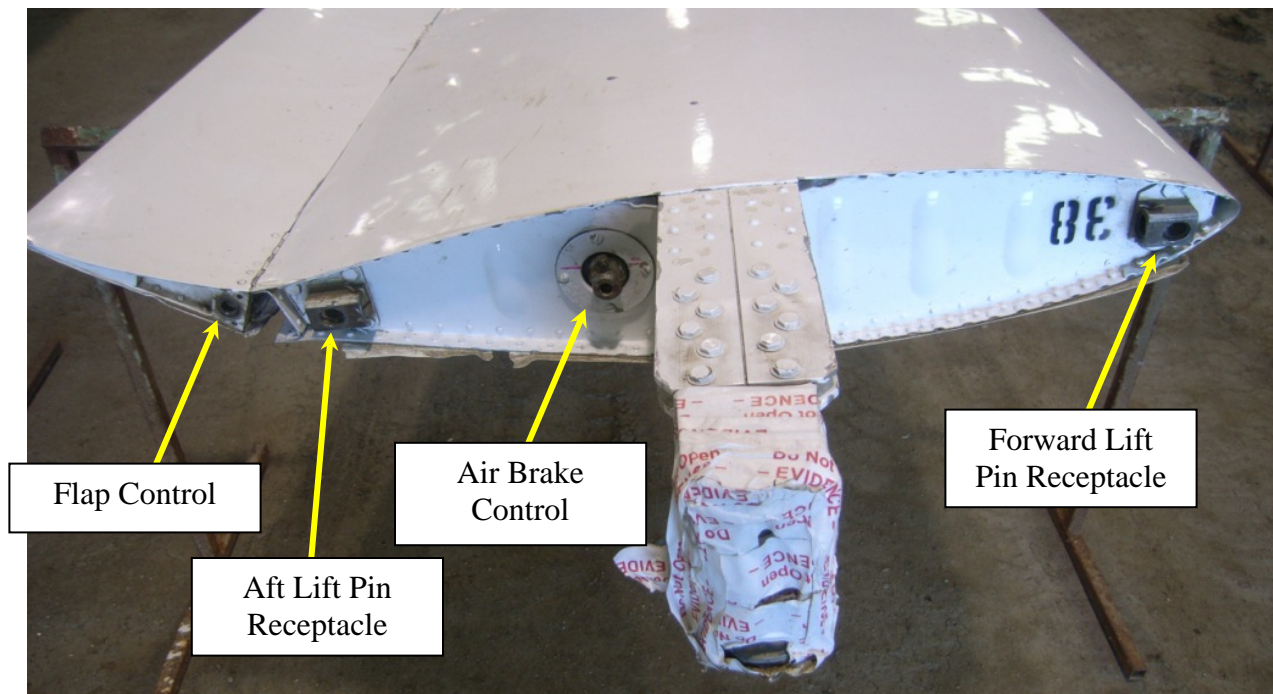
Figure 1 - Right Wing Root (inverted)

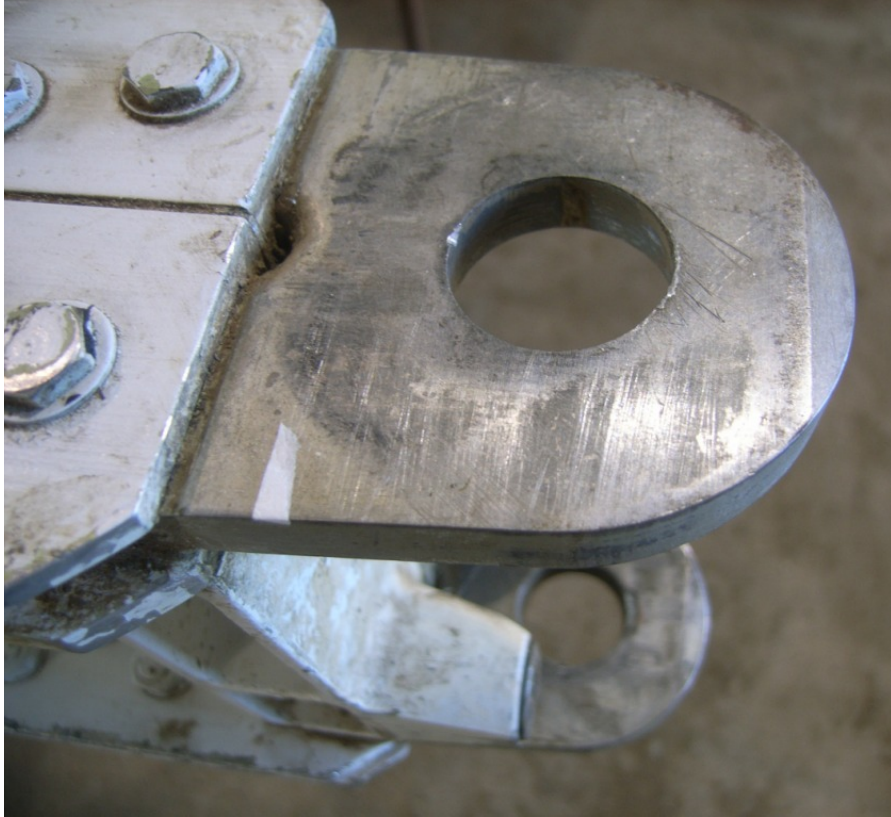
Figure 2 - Left Wing Clevis Tangs

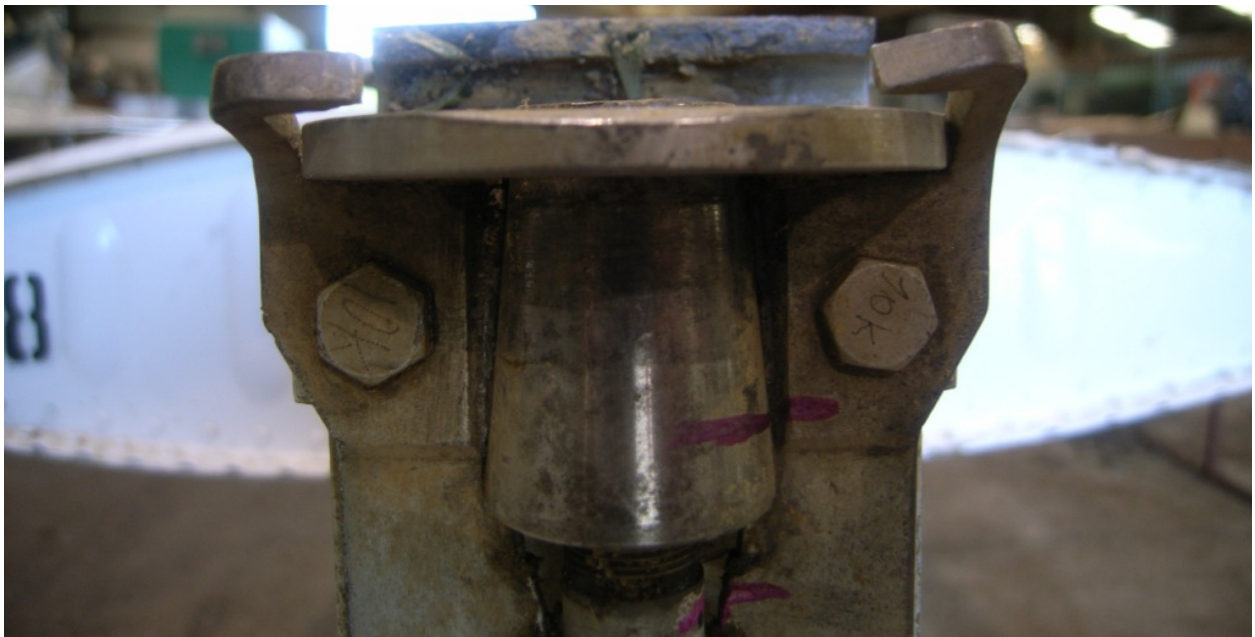
- The fingers on the aft plate pointed forward, and the fingers on the forward plate pointed aft
 - All 4 fingers were bent inboard, so that they partially blocked the spaces between the clevis legs- the deformations appeared at first glance to be as-manufactured but were subsequently recognized as being the result of the accident

Figure 3 - Right Wing Upper Clevis Legs, Fingers, and Cone Nut

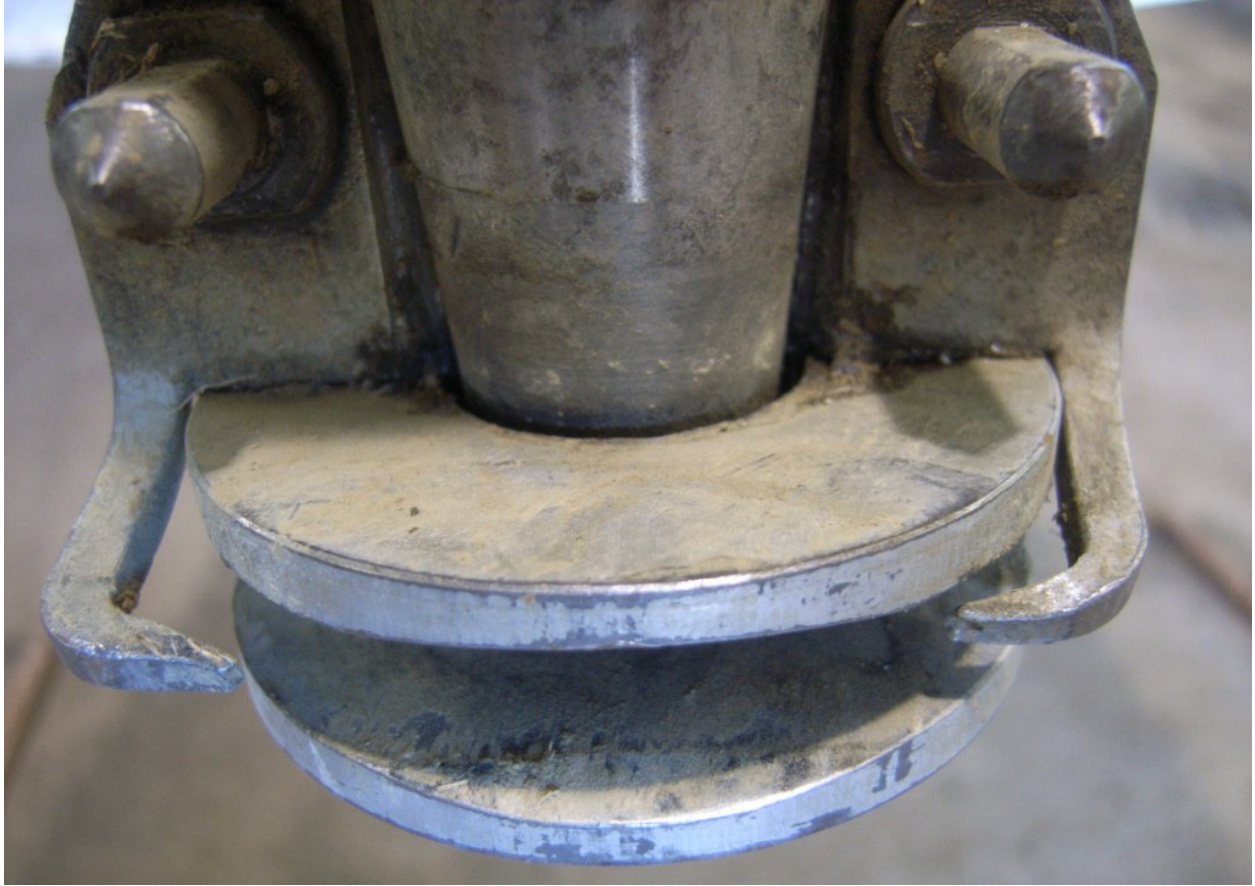
Figure 4 - Right Wing Lower Clevis Legs, Fingers, and Cone Nut

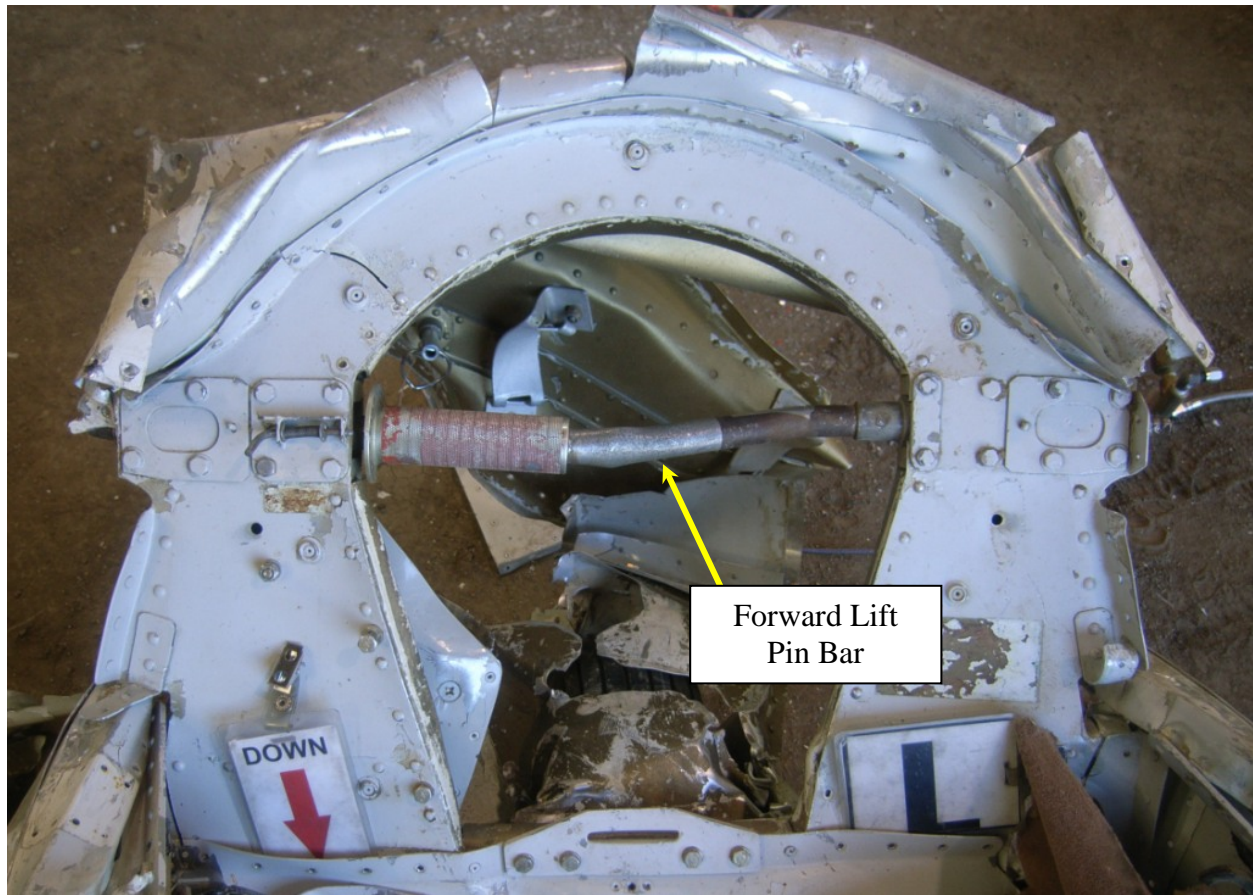
Figure 5 - Forward Lift Pin Adjustment Bar

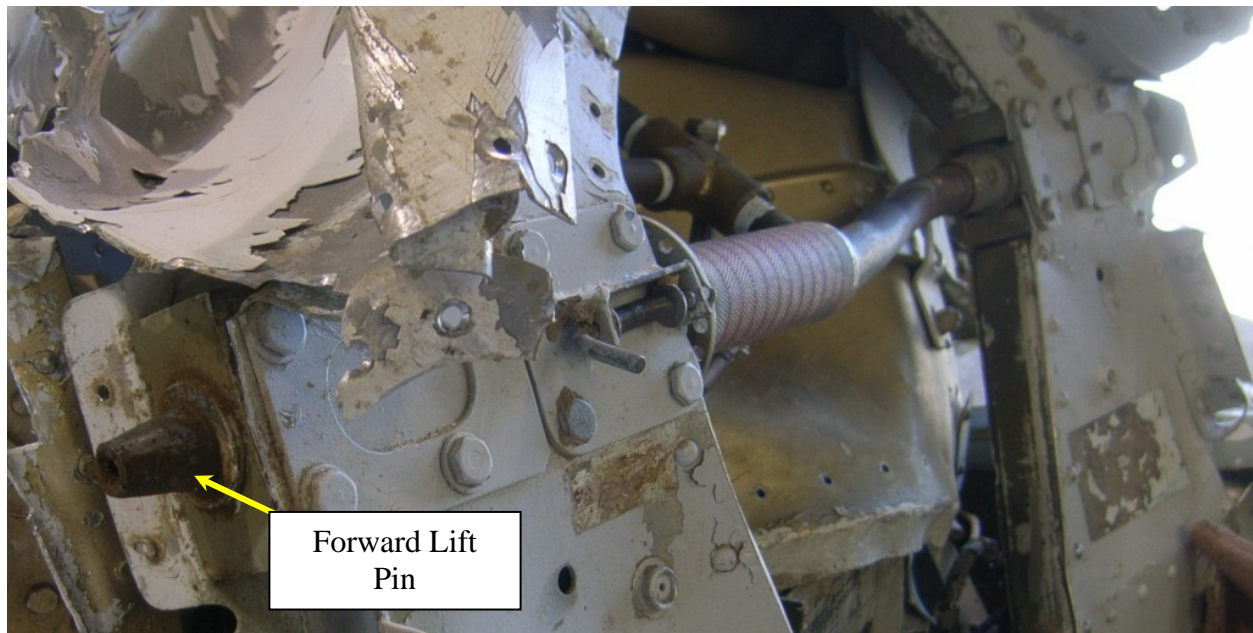
Figure 6 - Forward Right Lift Pin and Adjustment Mechanism

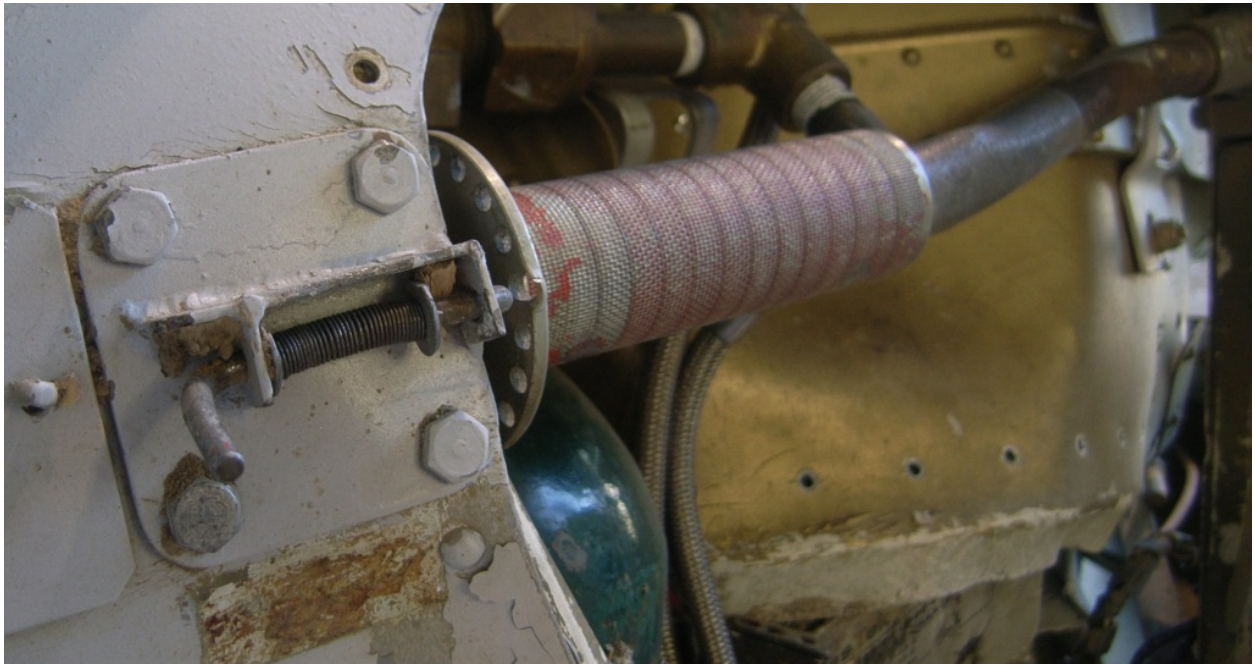
Figure 7 - Forward Lift Pin Adjustment Mechanism

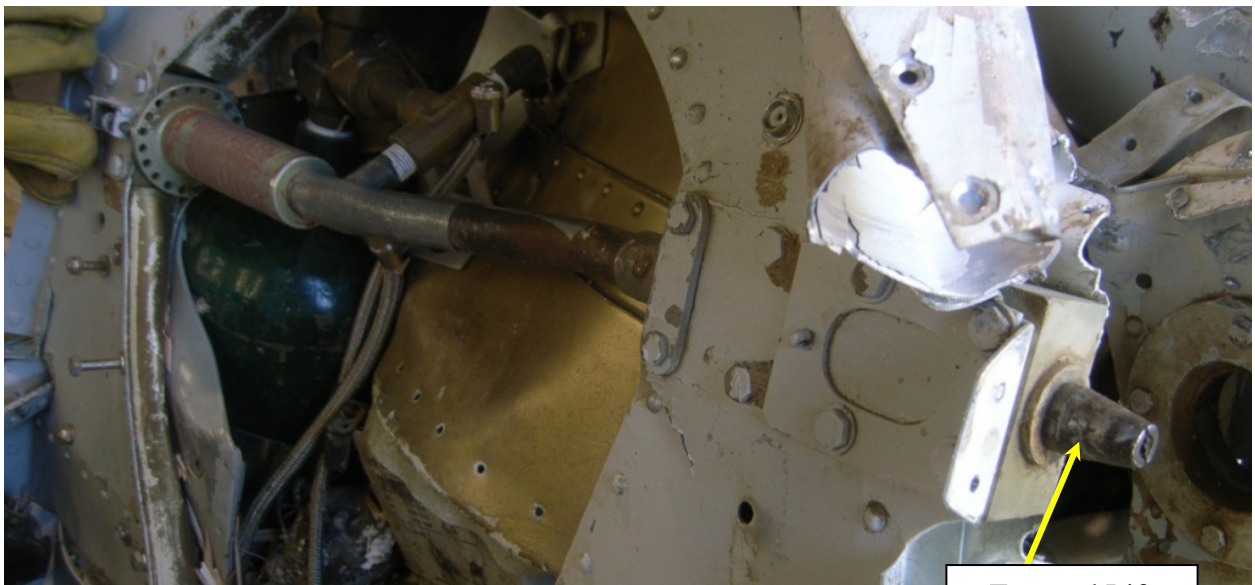
Figure 8 - Forward Left Lift Pin

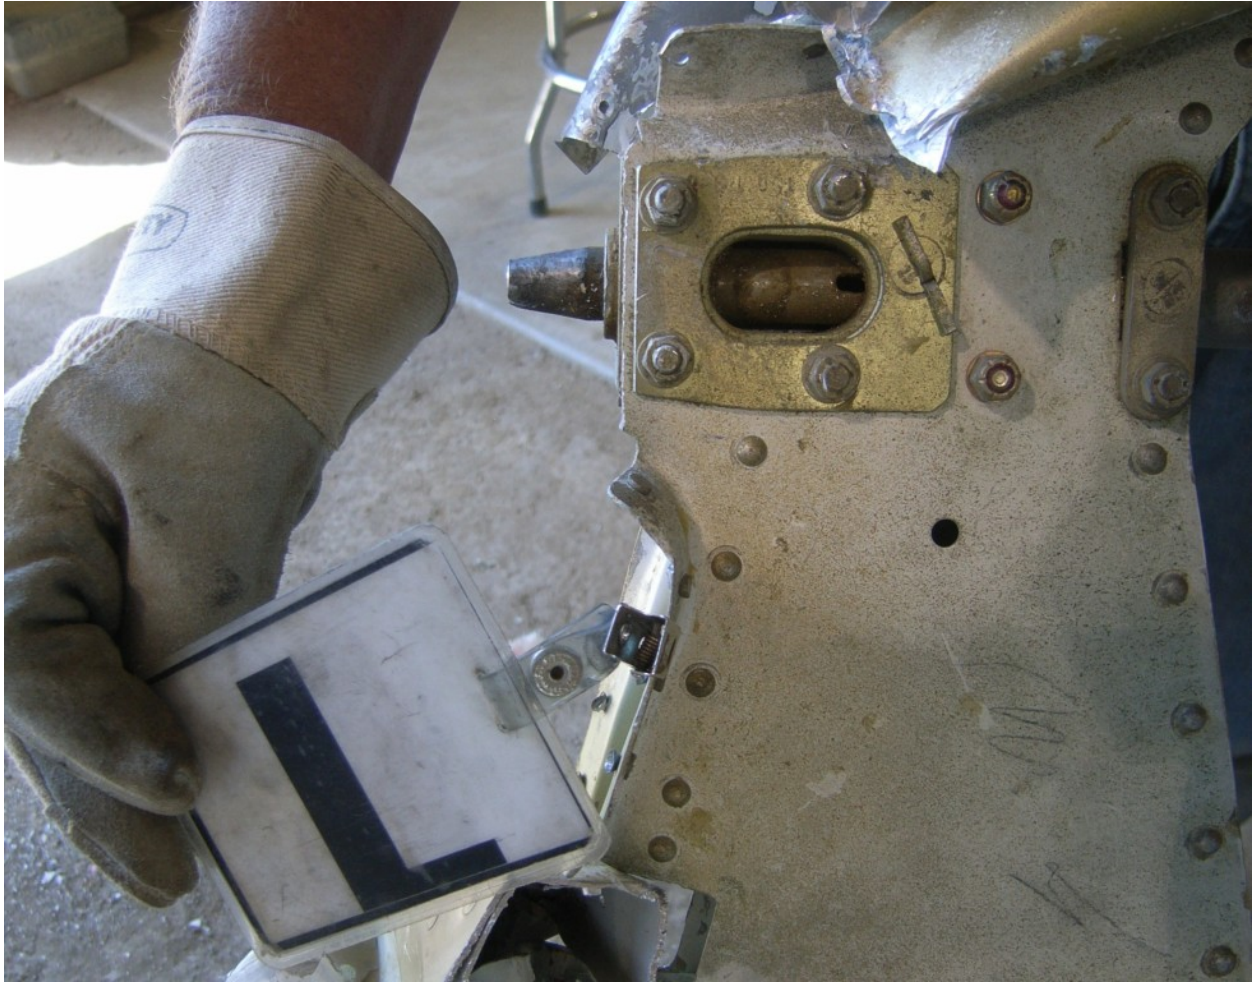
Figure 9 - Forward Left Lift Pin

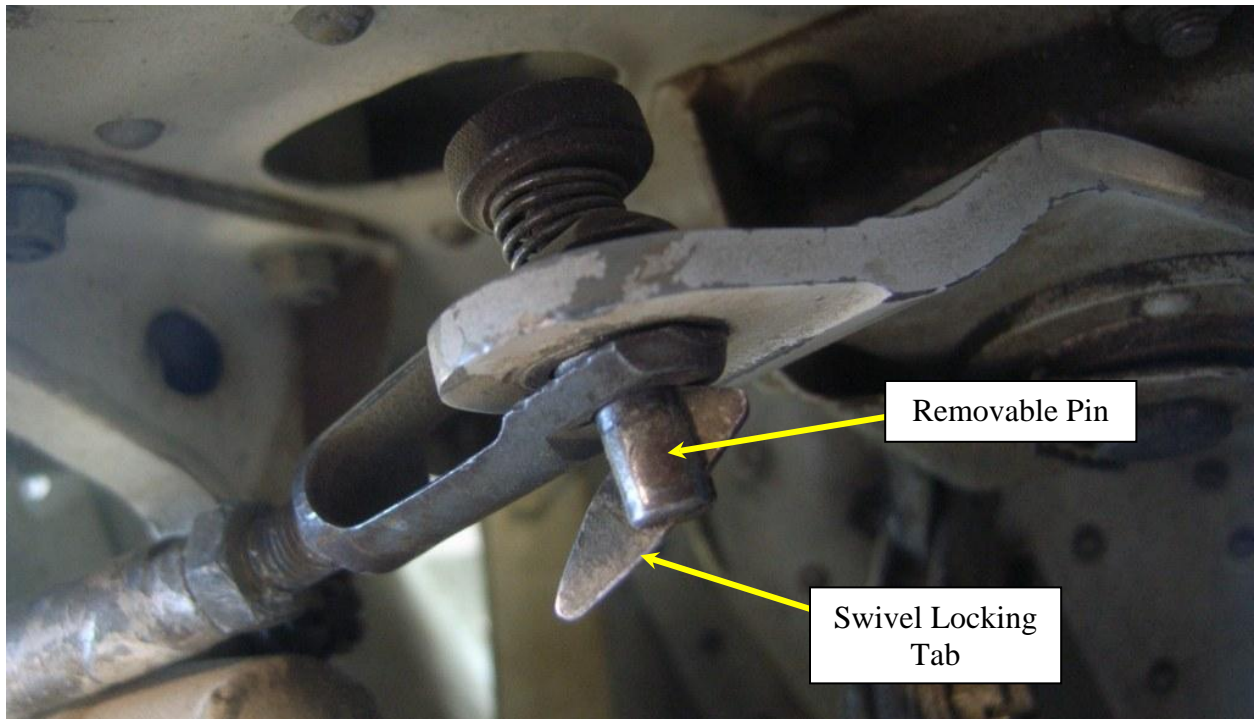
Figure 10 - Aileron Control Assembly/Disassembly Connection

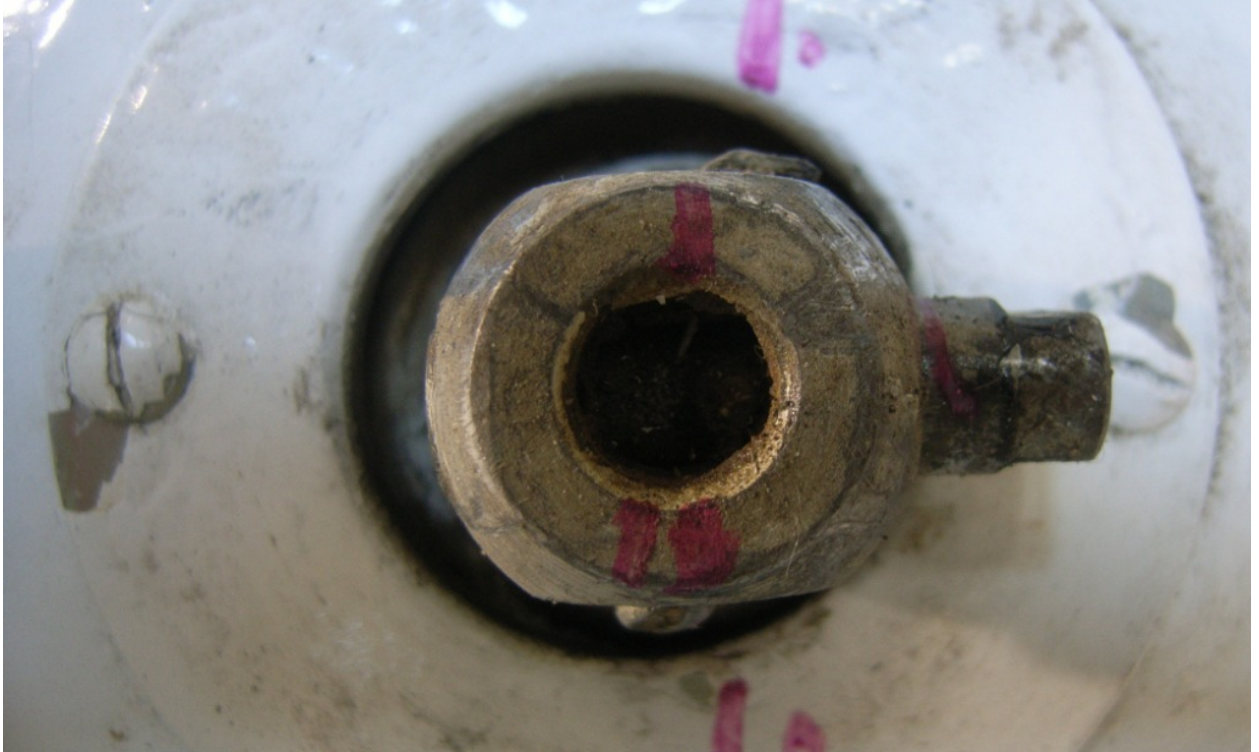
- The keying pin of the left wing was observed to be properly (symmetrically) installed, but the keying pin of the right wing tube end was displaced
 - The cotter key remained in place but was highly deformed

- The timing (pre-assembly vs during in flight wing separation) of the right pin displacement could not be positively determined, but it seemed likely that its damaged condition was the result of significant force, and that the pilot would have noticed such damage upon inspection prior to assembly

- In its displaced-pin configuration, the right air brake wing-fuselage connection could not be fully accomplished; the wing torque tube end could only be partially inserted into the fuselage receptacle; the normal engagement distance of ~3/4" was reduced to less than ~1/4"

Figure 11 -Right Wing Air Brake Torque Tube End

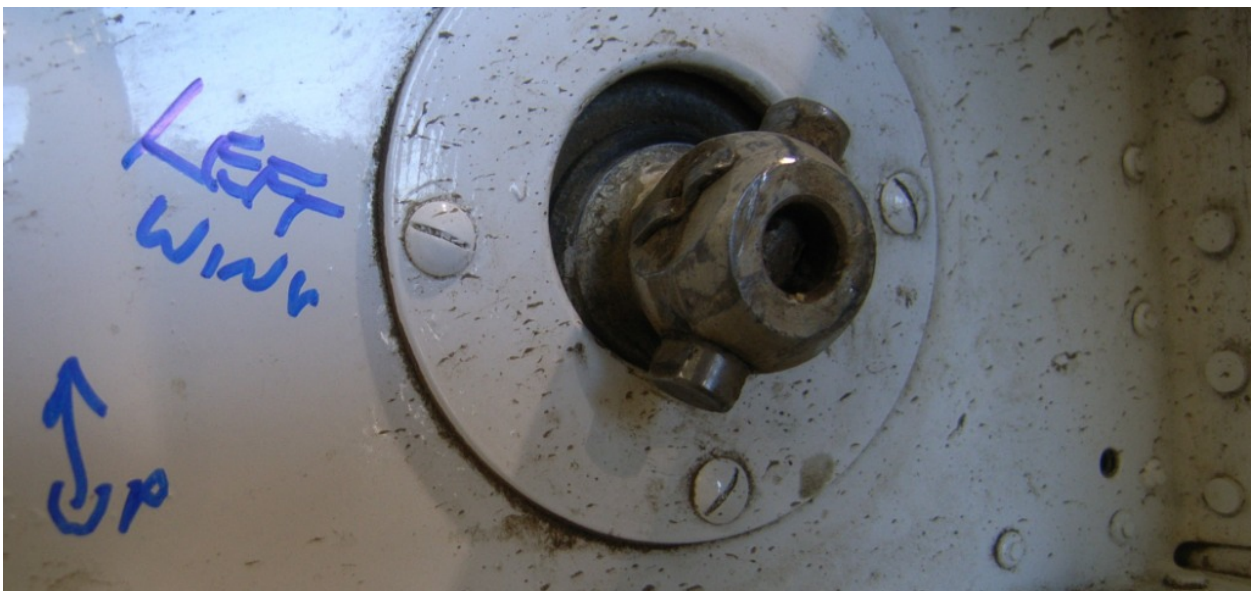
Figure 12 - Left Wing Air Brake Torque Tube End

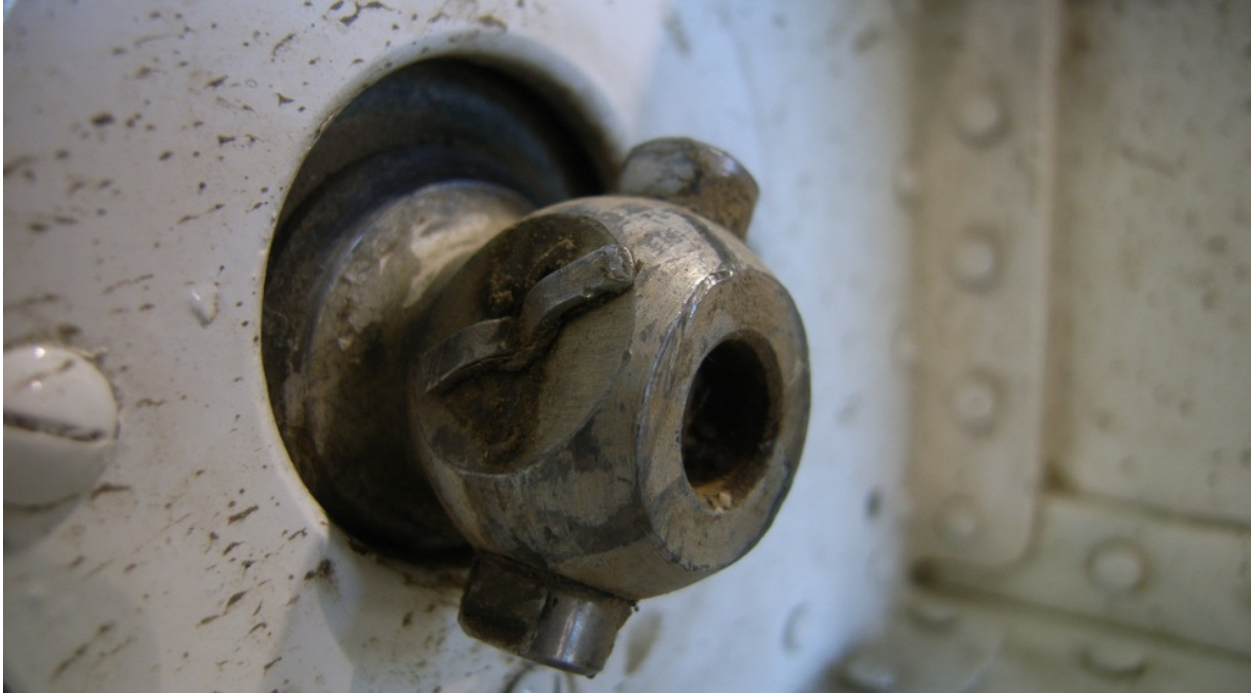
- Attempts to fully insert the visually undamaged left wing torque tube end into its visually undamaged fuselage receptacle were unsuccessful; the apparent cause of this was the improper use of a cotter key to secure the keying pin in the torque tube end.

Figure 13 - Left Wing Air Brake Torque Tube End (note cotter key)

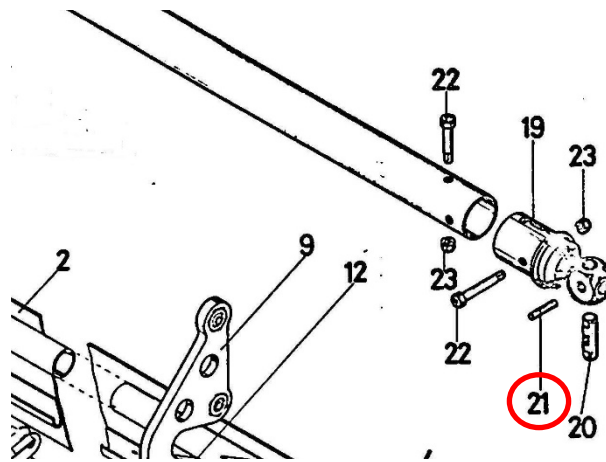
- Each keying pin was secured by a cotter key that was oriented 90° to the pin, and the ends of which protruded out the sides of the torque tube
 - The manufacturer's Parts Catalog (PC) specified that the keying pin was to be retained by a "rivet", part number "2017.D-3-24."

- The PC illustration depicted the "rivet" as straight pin with no head; its appearance is congruent with an aviation hardware item called a "roll pin"

Figure 14 - PC Illustration of Torque Tube End

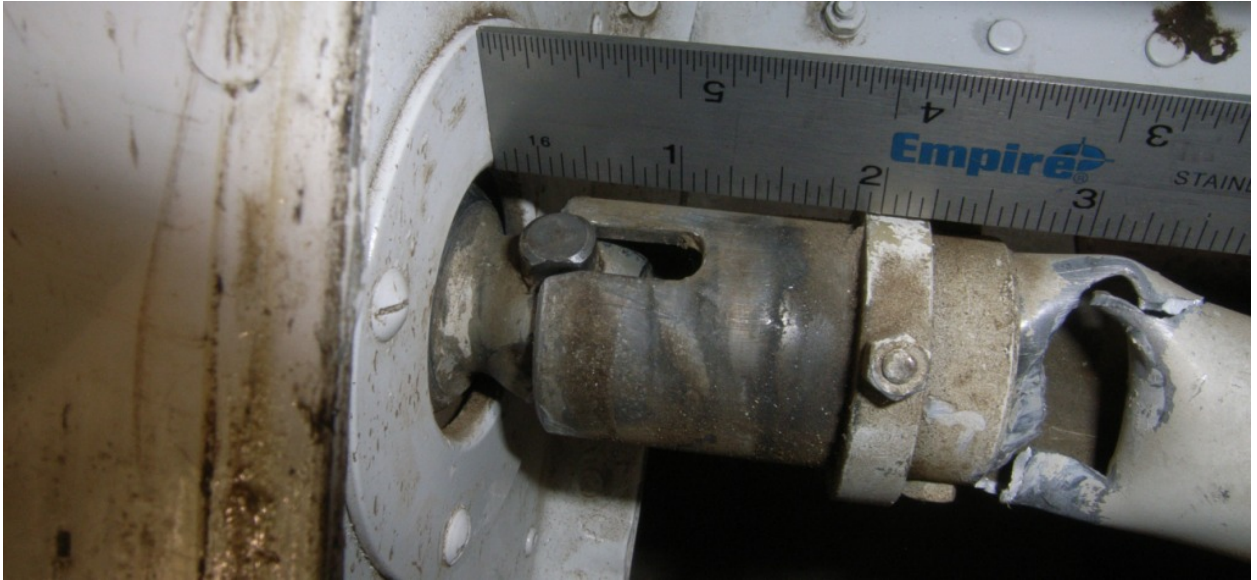
- The observed insertion distance was only ~3/8", instead of the desired ~3/4 "
 - Despite this partial connection, the joint was functional; rotation of the fuselage receptacle resulted in rotation of the wing torque tube, and actuation of the air brakes

- This air brake linkage mis-fit, if it existed during the wing installation process, would prevent the affected wing from being fully and properly abutted to the fuselage.
- It could not be determined what effect, if any, either the displaced pin on the right wing, or the mis-fit of the left wing linkage, had on actual wing installation

Figure 16 – Improper/Incomplete Fit of Left Wing Air Brake Control Connection

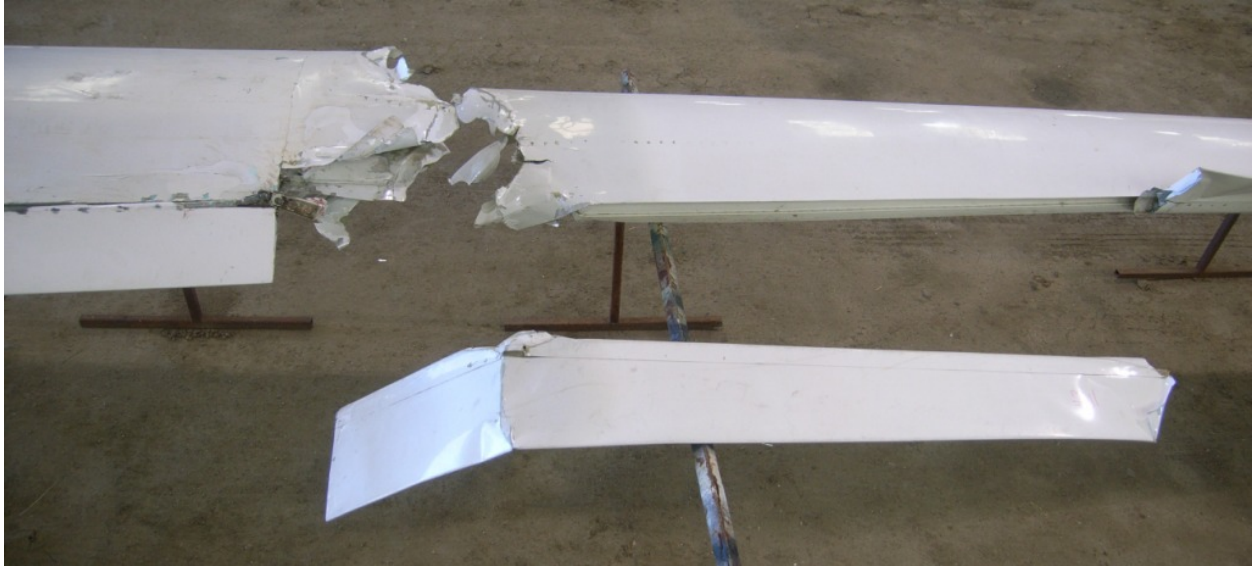
- The left wing was intact for its full span
- The right wing was fractured into 2 sections, at about the $2/3$ span point
 - The aileron was also fractured into 2 sections, 1 of which remained attached to the outboard wing section
- The horizontal stabilizer and elevator assembly was separated from the sailplane as a unit,
 - The assembly exhibited significant C-shaped crush damage from the leading edge, in the aft direction
 - The damage appeared to be centered about the lateral center of the assembly
 - The shape and size of the crush damage was consistent with a strike from either the right wing (at its fracture point) or the fuselage just aft of the wing location
- Two oxygen bottles were found inside the fuselage
 - Although damaged from the impact, both bottles/valves remained intact, and both contained some residual gas under pressure

Figure 17 - Fractured Right Wing and Aileron

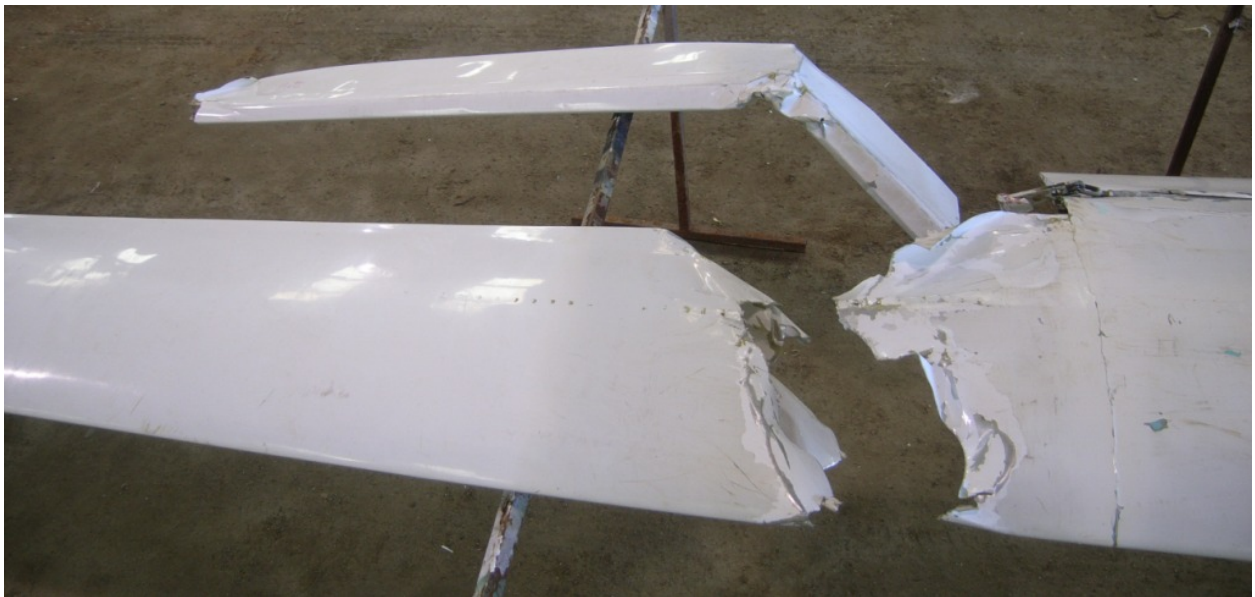
Figure 18 - Fractured Right Wing and Aileron

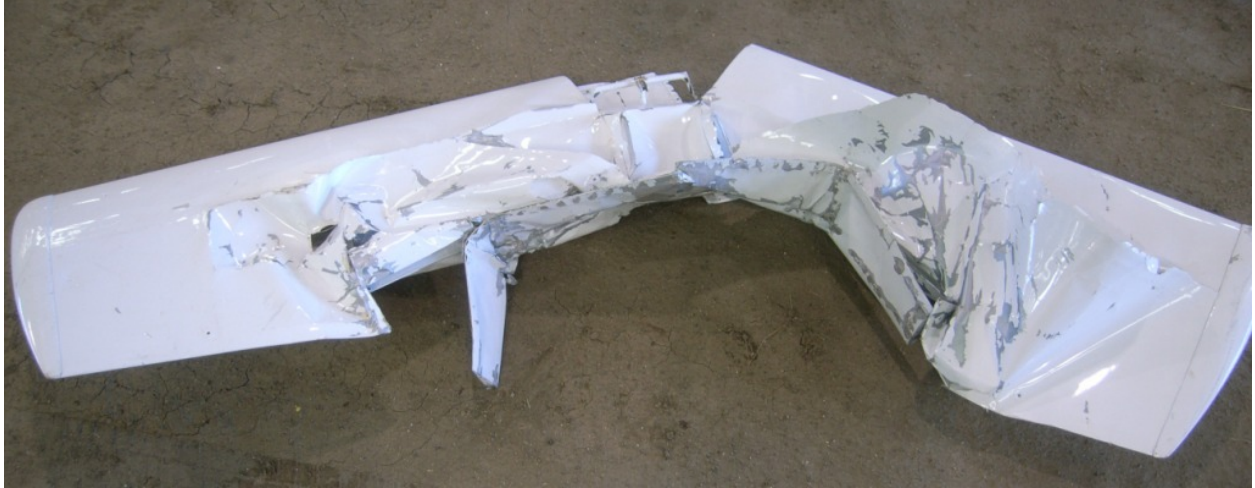
Figure 19 - Horizontal Stabilizer and Elevator Assembly
