AIRCRAFT WRECKAGE EXAMINATION REPORT

NTSB Accident #: ERA13LA242
Aircraft Model & S/N: SA318C, S/N: 2130
Aircraft Registration: N318DB
Operator: Mile High Helicopters
Location: Everglades near Tampa, Florida
Date: 08 May 2013
Time: 0930 EST (1430 GMT)

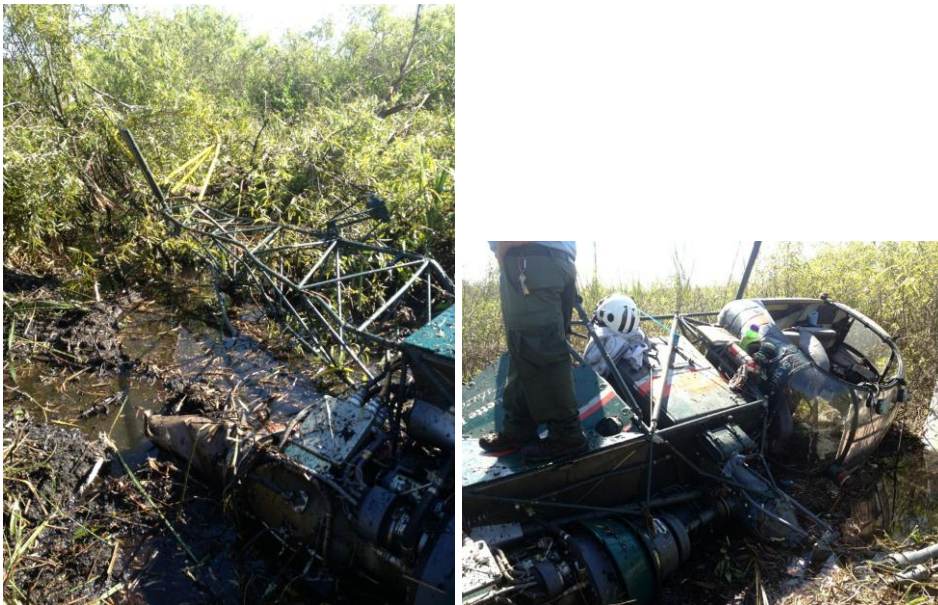
- The accident site was located in the Florida Everglades near Tampa, Florida, approximately miles from the boat ramp.

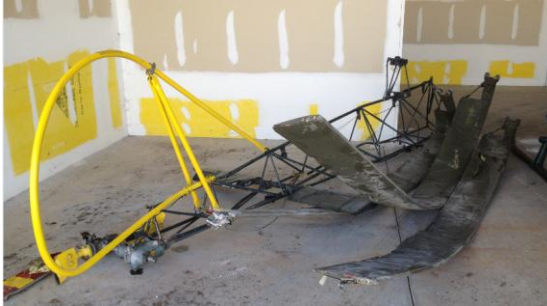
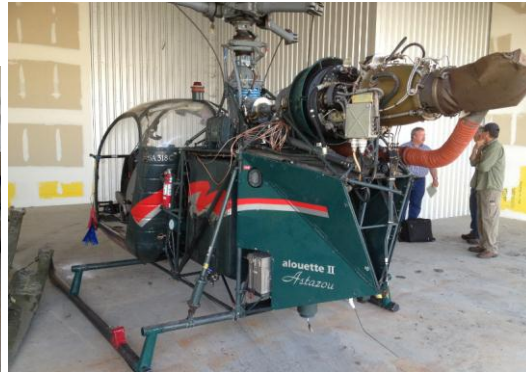
- The aircraft was substantially damaged.
- Several cracks were noted in the airframe, and the aircraft's nitrogen crack indicators were red in color, indicating a loss of pressure in the airframe due to cracking.

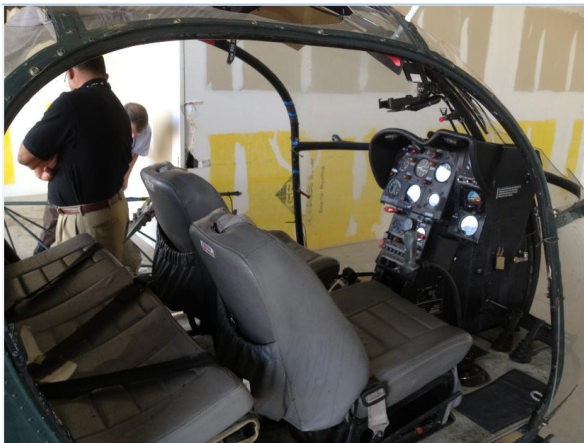
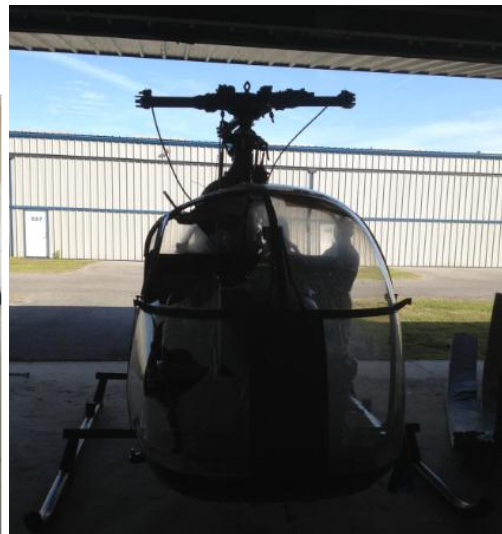
- The cabin stayed intact; the only significant evidence of damage to the cabin was a broken right windscreen and water damage.
- Battery power was applied, and the indicators indicated 140 liters of fuel, 16% main rotor pitch (after movement during continuity check), and the appropriate caution/warning lights illuminated.
- The radio stack, transponder, and GPS had been removed from the aircraft and were not available for examination.

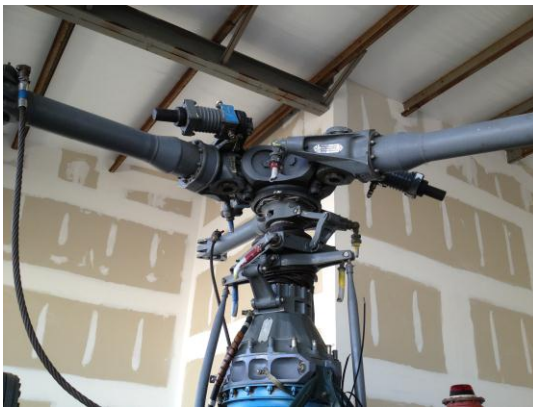
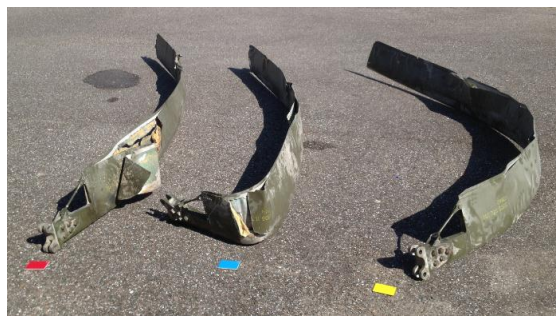
- All three main rotor pitch links were separated in overload.
- All three blade sleeves and dampers exhibited impact and/or overload separation damage consistent with sudden stoppage of the main rotor blades.
- All three of the metal constructed main rotor blades exhibited severe downwards bending, trailing edge splitting, and some leading edge impact damage.
- The red and blue blades exhibited upper skin damage near the root.

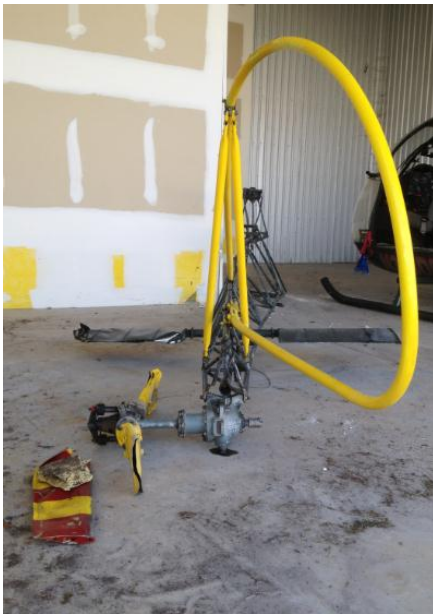
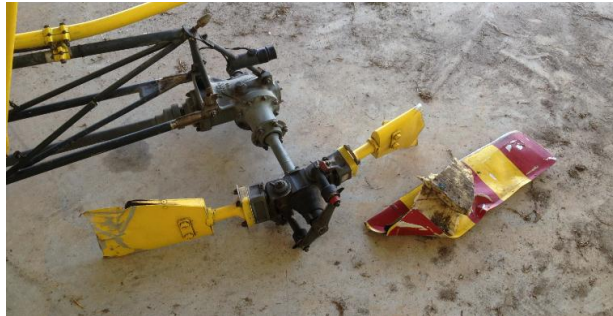
- Both tail rotor blades (metal construction) separated approximately $\frac{1}{4}$ of the length of the blades from the hub consistent with rotation at impact; only one of the two separated blade sections was recovered.
- The tail rotor drive shaft was disconnected from the engine output prior to recovery
- The shaft was bent about $\frac{1}{3}$ aft of the airframe junction, but all hangar bearings were free to rotate.
- Rotation of the shaft resulted in corresponding rotation of the tail rotor.

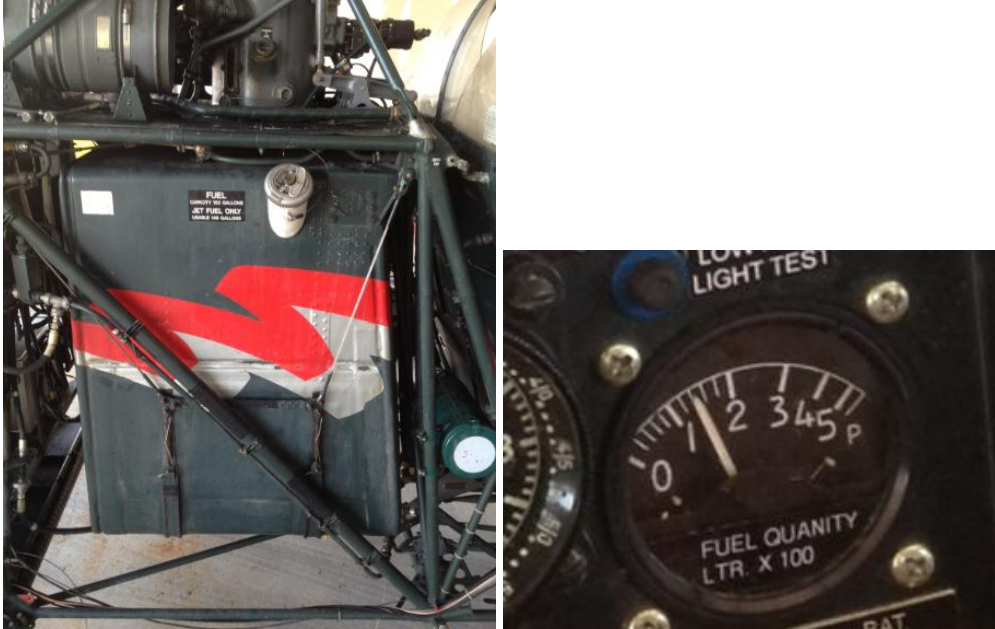
- The fuel tank and system remained intact.
- Approximately 140 liters of fuel was present in the tank during the examination.
