NTSB Accident Number: CEN16LA335

Aircraft Registration # N981LL

Soloy Cessna MKI S/N U20606937

**Aircraft inspection and troubleshooting IDOT hanger**

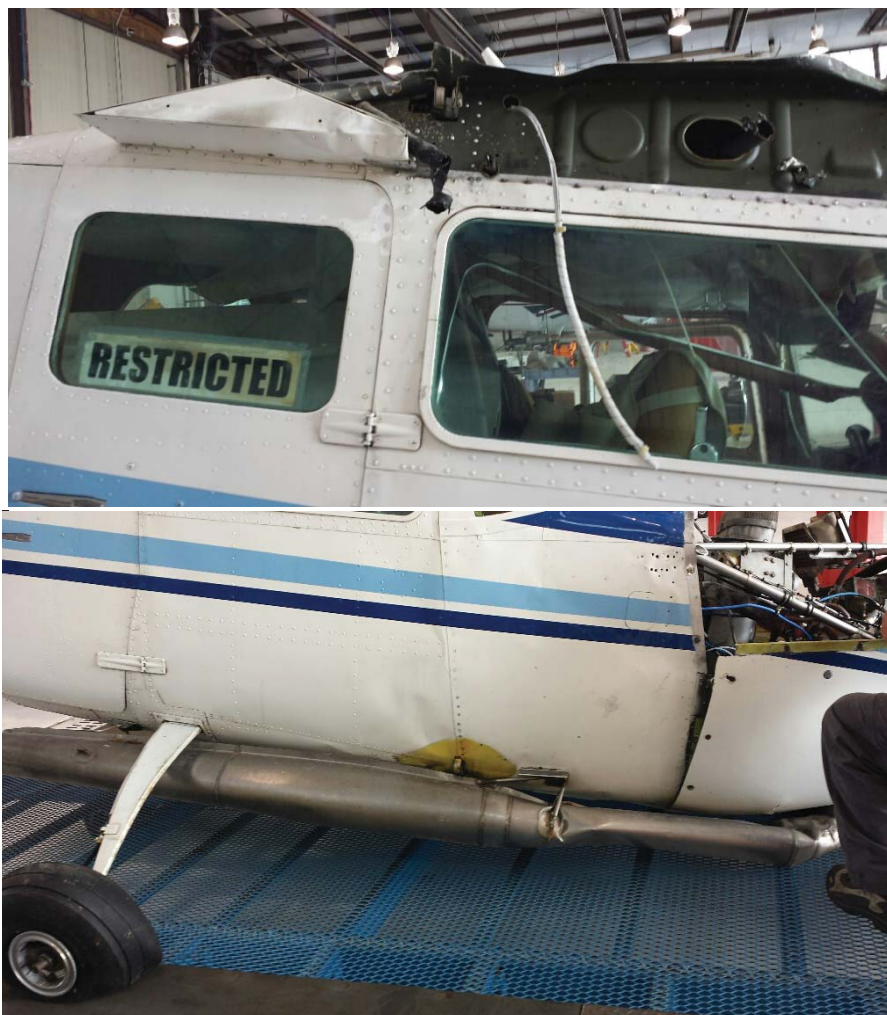
- The selector was in the off position at this time.
- Visual inspection of engine after cowl removal nothing noted.
- The fuel cut off lever was in the on position less than .25" from the full on stop.

- The fuel selector valve was removed and checked for proper operation. Also the bottom cover plate was removed to check the alignment of the ports, no defects noted.
- The wing vent system was checked, no defects noted.
- The low fuel warning system was checked, both left and right warning lights did illuminate with the floats at about 2" from the bottom of the tank. The annunciator box press to test didn't illuminate the left and right lights, but the fuel configuration lights did illuminate.
- A vacuum check was done from the engine pump filter bowl to the fuel valve no defects noted.
- A review of the aircraft recovery was discussed with the mechanics who had removed the wings from the aircraft. Fuel removed from the right wing was estimated at 20 gallons. An estimated 5 gallons was recovered from the left wing.

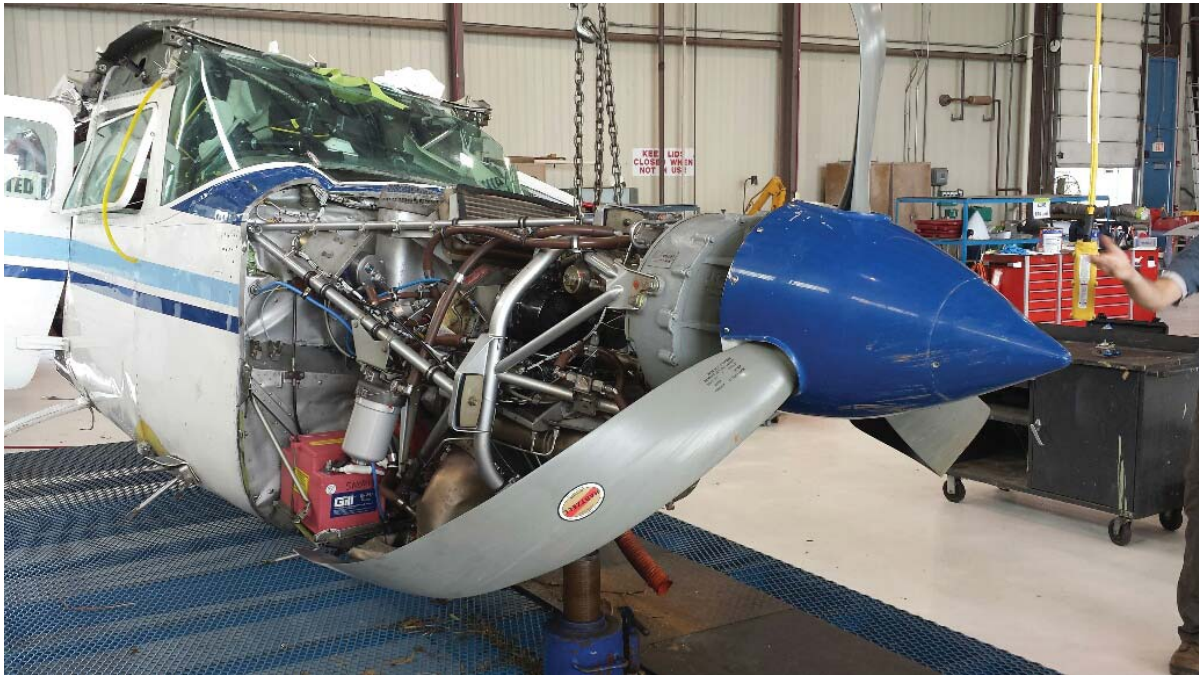
- Propeller control was in max speed.
- Power control above the flight idle gate.
- Fuel computer showed 325 pounds remaining 225 used.
- Fuel flow was checked at nozzle by selecting right on the selector valve and motoring the engine, no fuel flowed from the line. Flow was then checked at the high pressure check valve by cracking a fitting and motoring the engine, fuel flow was good. It was finally rechecked again back at the nozzle and flow was good.

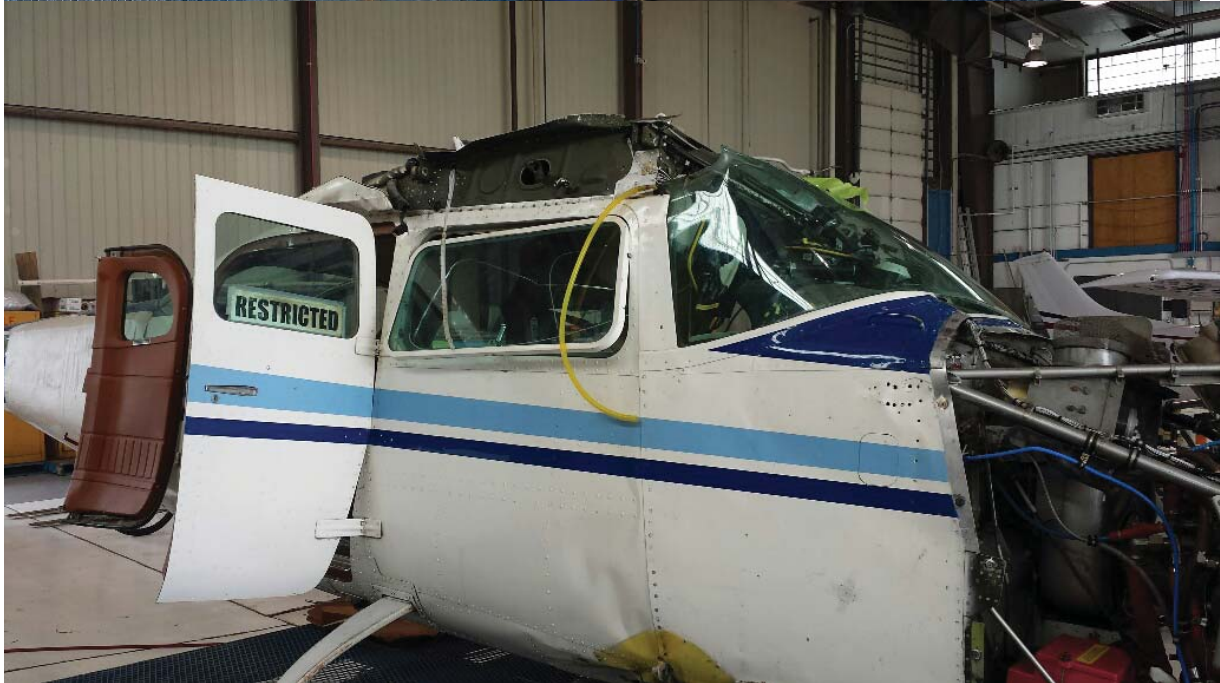
- The supply lines from the wing root to the inlet port on the engine pump were checked both left and right side looked good. About a gallon of fuel was recovered from the left fuel line, header and filter. The valve was switched to right and over a half gallon of fuel was collected from that
